NC DEPARTMENT OF TRANSPORTATION  
DIVISION OF HIGHWAYS  
BRIDGE MANAGEMENT UNIT

# BRIDGE INSPECTION REPORT

INSPECTION TYPE: Routine Inspection

COUNTY COLUMBUS BRIDGE NUMBER 230175 INSPECTION CYCLE 2 YRS  
ROUTE SR1504 ACROSS DUNN SWAMP M.P. 0

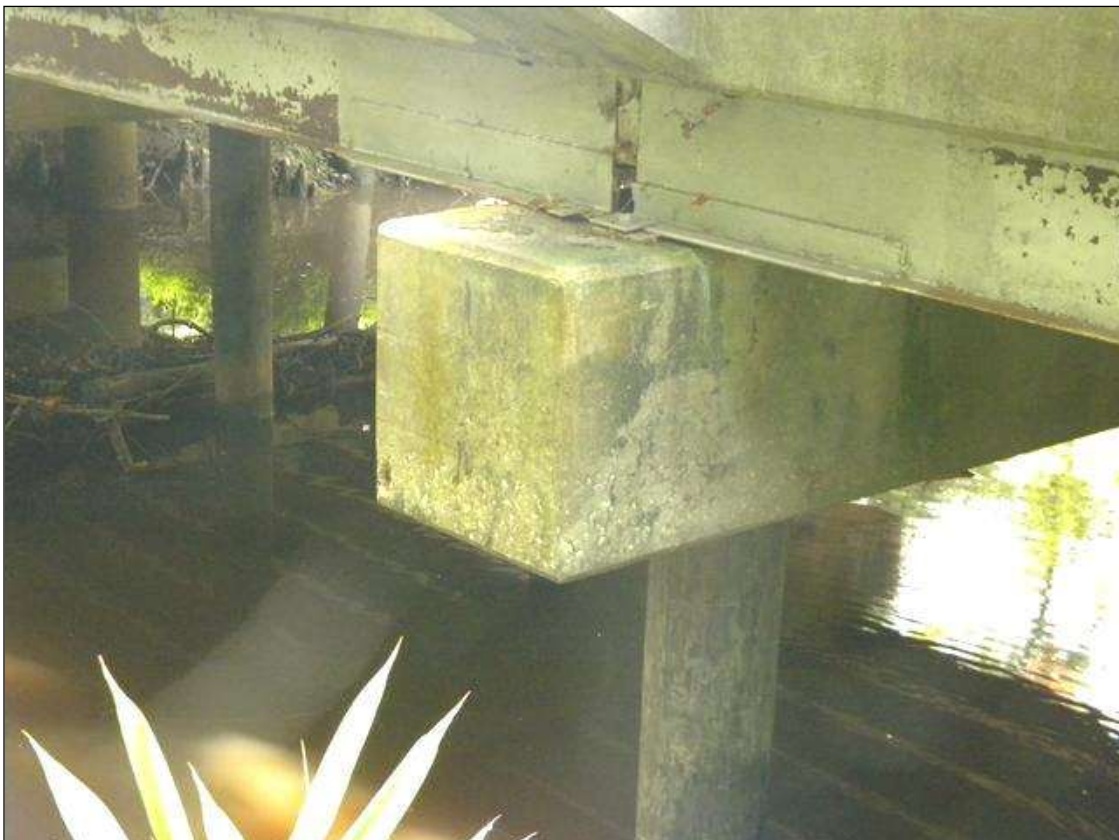
NORTH END OF BENT 1 CAP

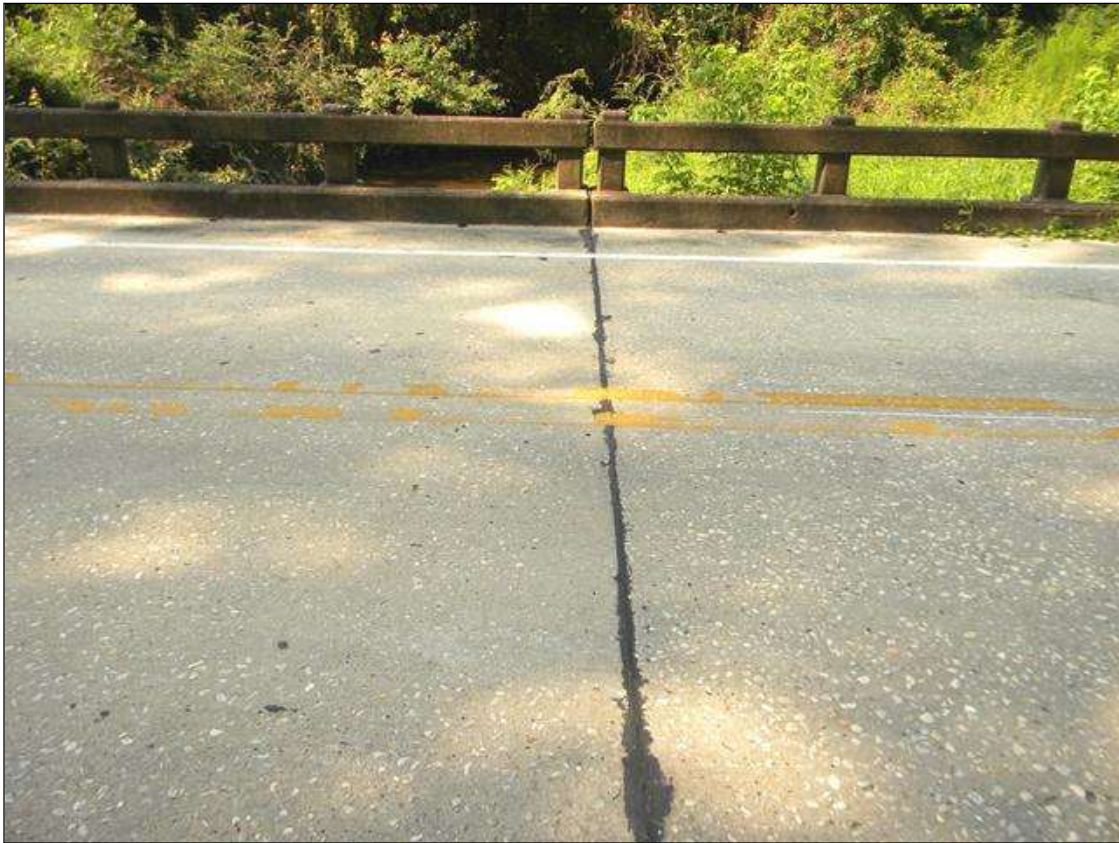
| <b>6d</b> | <b>P</b> | THERE IS A SURFACE SPALL IN RAIL END POST AT NORTHEAST CORNER. (PHOTO)<br>( STANDARD JOINTS ) THE BENT JOINTS ARE CRACKED, SETTLING, AND ARE LEAKING. (PHOTO) | |

BENT 1 STANDARD JOINT
