NC DEPARTMENT OF TRANSPORTATION  
DIVISION OF HIGHWAYS  
BRIDGE MANAGEMENT UNIT

# BRIDGE INSPECTION REPORT

COUNTY GUILFORD BRIDGE NUMBER 400189 INSPECTION CYCLE 2 YRS  
ROUTE SR2719 ACROSS PRONG REEDY FORK M.P. 0

INSPECTION DATE 06/04/2014

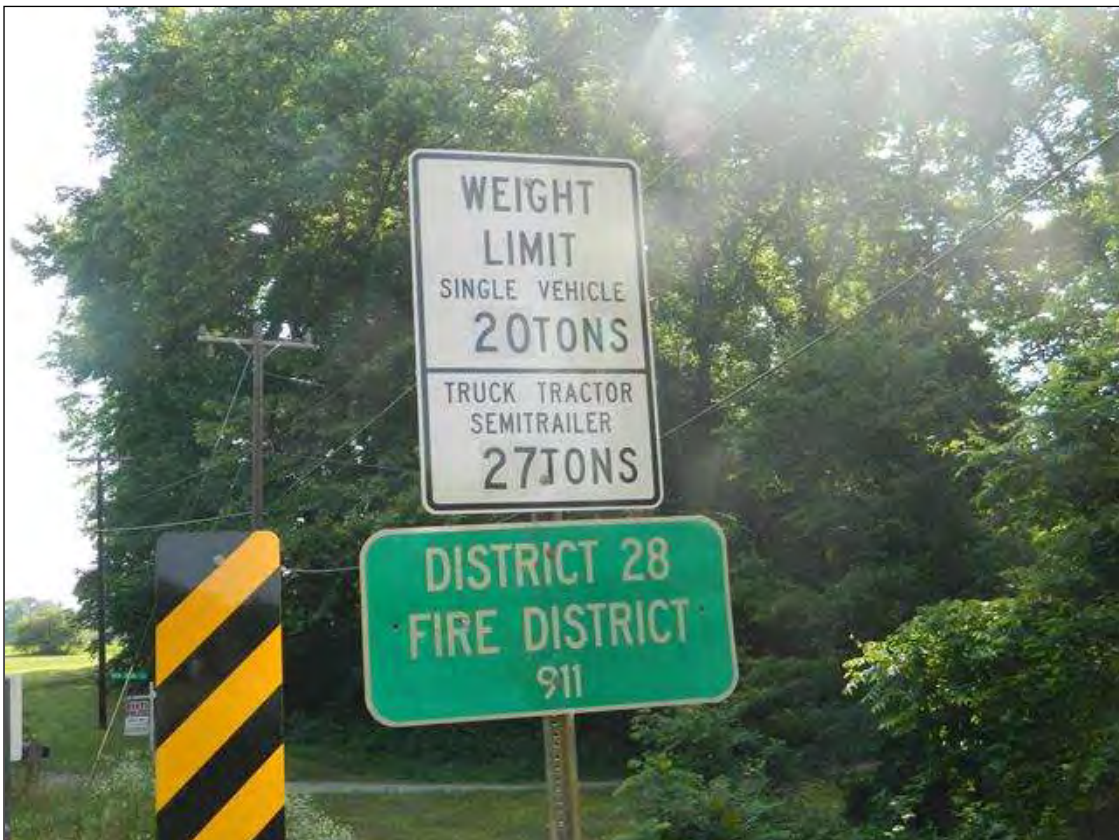
POSTING SV20/TTS27

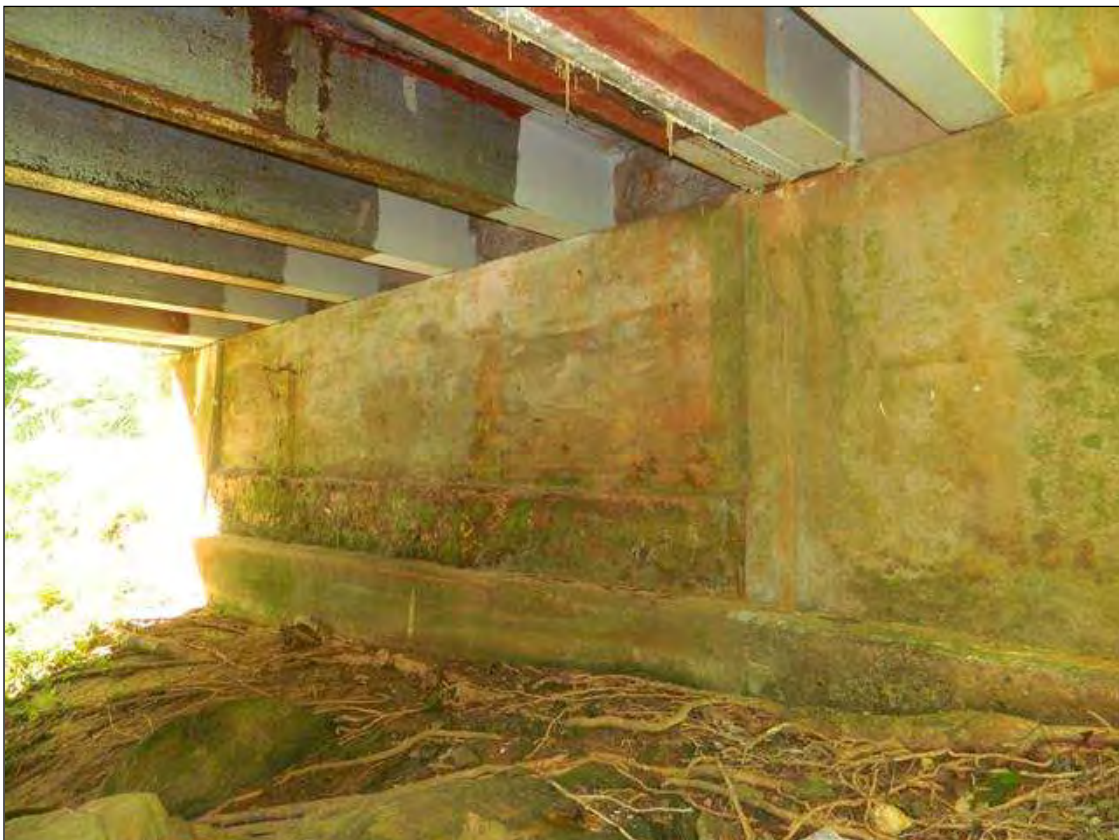
| Bridge I&A Form 1(82)H<br>State of North Carolina<br>Dept. of Transportation<br>Division of Highways | | <h1 style="text-align: center;">FIELD INSPECTION REPORT</h1> <p style="text-align: center;"><u>Bridge Inspeccion &amp; Analysis</u></p> | |
|---|---|---|--|
| 36a | F | CAPS ..... BOTH ABUTMENTS HAVE SCATTERED H/L CRACKS UP TO 2 1/2 INCH HONEYCOMBING ALONG RUBBLE MASONRY SECTION . | |
| 36e | F | FOOTINGS ..... EXTERIOR FACE OF ABUTMENT 1 FOOTING EXPOSED AND DETERIORATED 3". | |

ABUTMENT 1, ABUTMENT 2 SIMILAR

| MMS Code | Description of Function | Unit | Quantity | Remarks | Est. Cost |
|---|---|---|---|---|---|
| 3348 | Maintain Concrete Substructure Components | LF | 50 | BOTH ABUTMENTS HAVE SCATTERED H/L CRACKS UP TO 2 1/2 INCH HONEYCOMBING ALONG RUBBLE MASONRY SECTION . | |

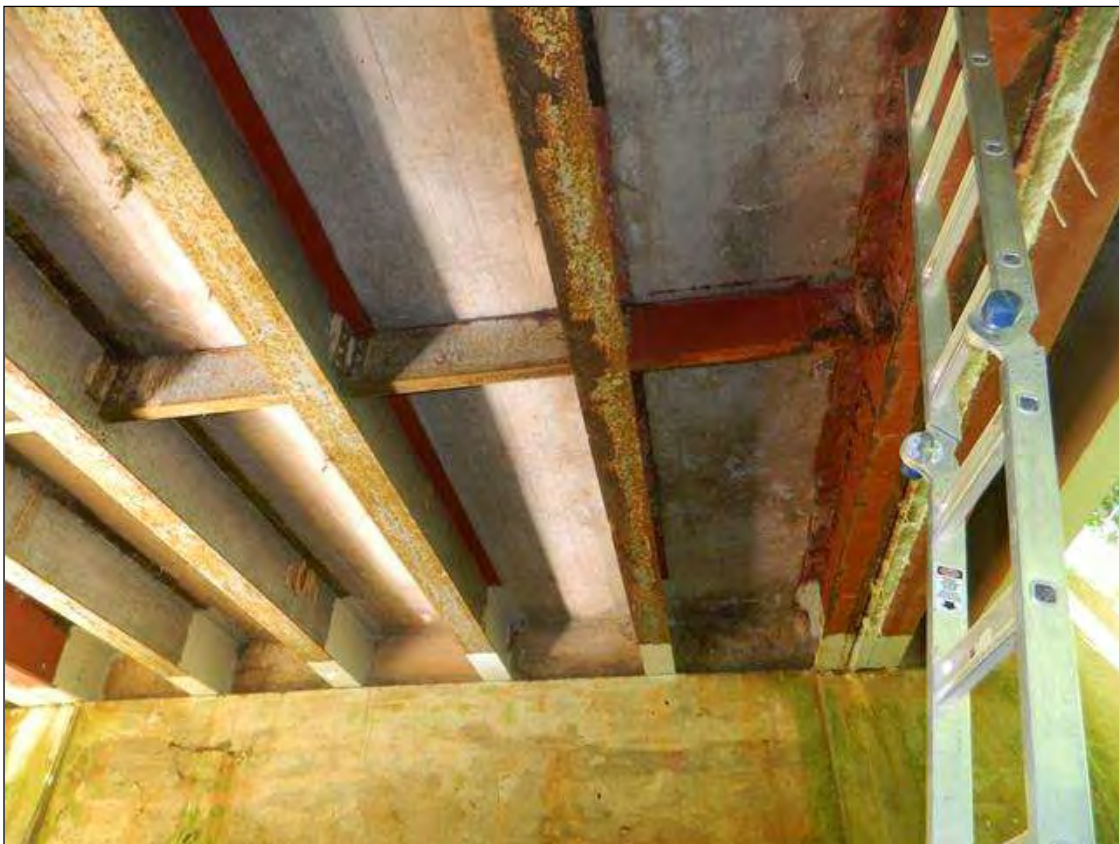
SUPERSTRUCTURE

| Bridge I&A Form 1(82)H<br>State of North Carolina<br>Dept. of Transportation<br>Division of Highways | | <h1 style="text-align: center;">FIELD INSPECTION REPORT</h1> <p style="text-align: center;"><u>Bridge Inspeccion &amp; Analysis</u></p> | |
|---|---|---|--|
| 12 | P | INT. DISPHRAGMS....<br><br>PRIORITY MAINT., BAY 3, DIAPHRAGM 1 HAS A 5" LONG X 2" HIGH HOLE IN LOWER WEB<br><br>PRIORITY MAINT., BAY 7, DIAPHRAGM 1 HAS 6" LONG X 1 1/2" HIGH HOLE<br><br>ALL INT. DIAPS HAVE SURFACE RUST .<br><br>DIAPHRAGMS ARE AT 1/4 POINTS IN ALL BAYS | |

| MMS Code | Description of Function | Unit | Quantity | Remarks | Est. Cost |
|---|---|---|---|---|---|
| 3342 | Clean and Paint Structural Steel | SF | 500 | UNDERSIDE OF DECK IN BAY 8, 4' FROM ABUTMENT 2 HAS 1/4" DEEP HONEYCOMBING 1' X 1' AREA<br>ALL BEAMS AND DIAPHRAGMS HAVE AREAS OF PAINT FAILURE AND SURFACE RUST ALONG LENGTH. | |
