# BRIDGE INSPECTION REPORT

INSPECTION TYPE: Routine Inspection

COUNTY GUILFORD BRIDGE NUMBER 400271 INSPECTION CYCLE 2 YRS  
ROUTE SR3343 ACROSS STINKING QUARTER CREEK M.P. 0

INSPECTION DATE 02/20/2013

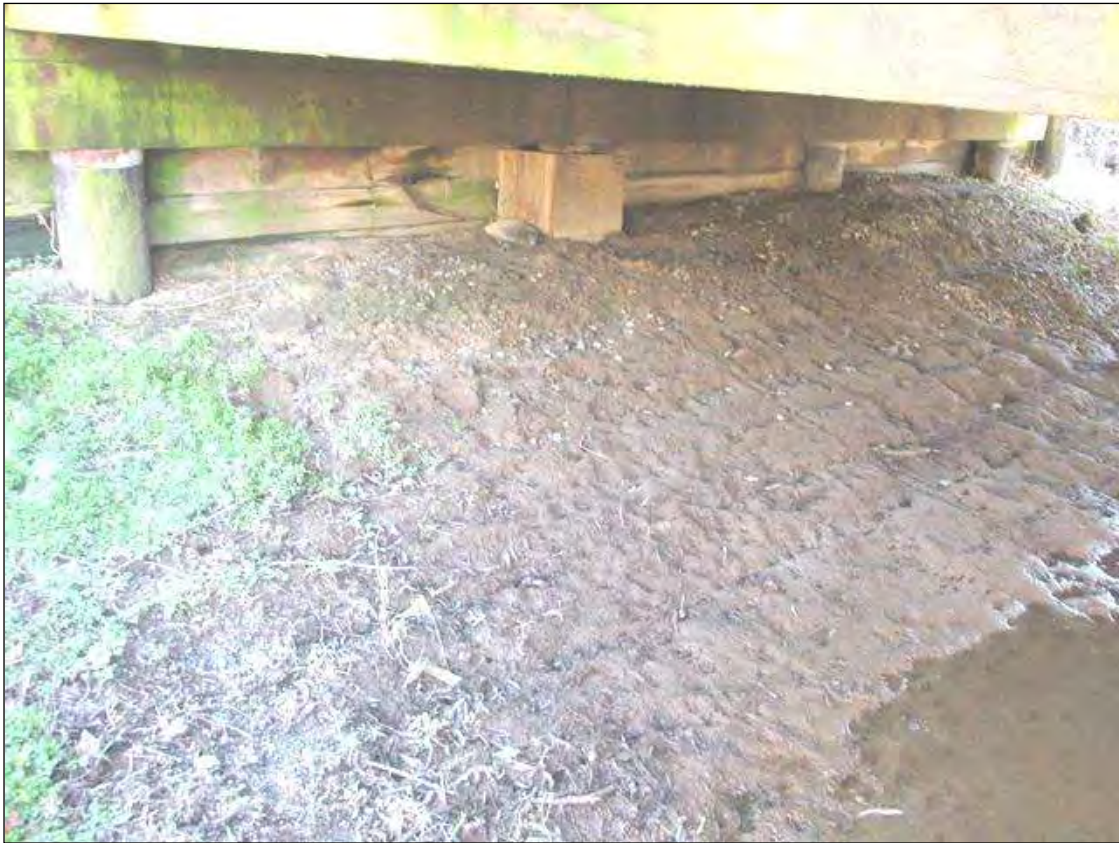
| Bridge I&A Form 1(82)H<br>State of North Carolina<br>Dept. of Transportation<br>Division of Highways | | <h1>FIELD INSPECTION REPORT</h1> <p><u>Bridge Inspeccion &amp; Analysis</u></p> | |
|---|---|---|--|
| 35c | F | TEMP. REPAIR, ABUTMENT 1, PILE 4 ABU 2 PILE 2<br>BULKHEADS .....ABUTMENT 2 BULKHEAD HAS 1 BOARD DECAYED BETWEEN PILES 1 AND 2.<br><br>ABUTMENT 1, RIGHT WINGWALL HAS 1 BOARD DECAYED | |

ABUTMENT 2 BULKHEAD HAS 1 BOARD DECAYED BETWEEN PILES 1 AND 2.

| MMS Code | Description of Function | Unit | Quantity | Remarks | Est. Cost |
|---|---|---|---|---|---|
| 3346 | Repair / Maintain Timber Wings & Blkhds | SF | 50 | BULKHEADS .....ABUTMENT 2 BULKHEAD HAS 1 BOARD DECAYED BETWEEN PILES 1 AND 2.<br>ABUTMENT 1, RIGHT WINGWALL HAS 1 BOARD DECAYED | |

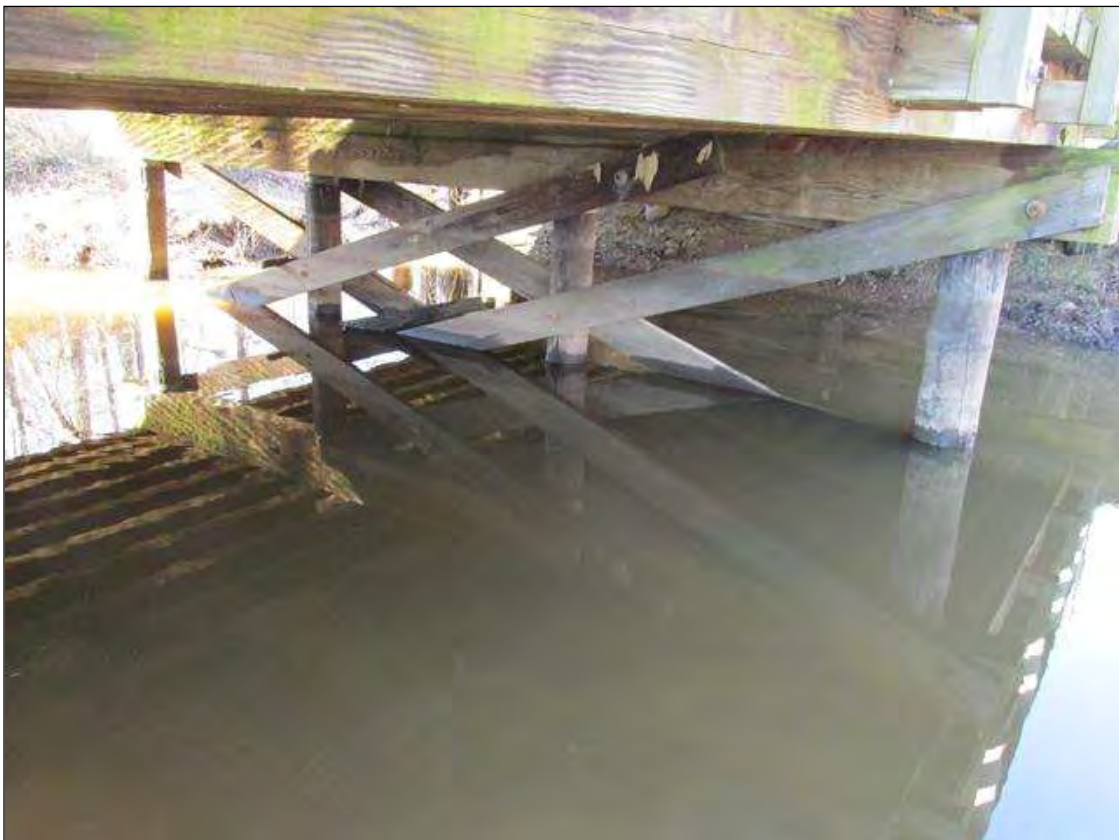
PIER 1, PIER 2 SIMILAR

| Bridge I&A Form 1(82)H<br>State of North Carolina<br>Dept. of Transportation<br>Division of Highways | | <h1>FIELD INSPECTION REPORT</h1> <p><u>Bridge Inspeccion &amp; Analysis</u></p> | |
|---|---|---|--|
| 35b | F | PILES.....<br>PRIORITY MAINT. PILE 1 @ ABUTMENT 1 IS DECAYED UP TO 3" DEEP INSIDE A 1" SOLID SHELL AROUND 50% OF DIAMETER FROM GROUNDLINE TO CAP.<br><br>PILE 2 @ PIER 1 HAS UP TO 1" DEEP DECAY ON THE EAST FACE FROM WATERLINE UP 1' HIGH.<br><br>PILE 4 @ PIER 1 HAS UP TO 1" DEEP DECAY ON THE EAST FACE FROM WATERLINE UP 1' H<br><br>ABUTMENT 1, PILE 2 IS DECAYED AT GROUNDLINE ON FACE UP TO 1" DEEP AND SOFT ON EXTERIOR.<br><br>ABUTMENT 1, PILE 3 IS DECAYED 1/2" DEEP X 3" HIGH FROM FACE TO LEFT SIDE. AREA IS 5" FROM GROUNDLINE.<br><br>PIERS 1 AND 2 , PILES 1 AND 4 DELAMINATED IN SPOTS.<br><br>ALL PILES WEATHER CRACKING AND SOFT ON EXTERIOR. | |

PILE 2 @ PIER 1 HAS UP TO 1" DEEP DECAY ON THE EAST FACE FROM WATERLINE UP 1' HIGH.

| MMS Code | Description of Function | Unit | Quantity | Remarks | Est. Cost |
|---|---|---|---|---|---|
| 3344 | Repair / Replace Timber Substructure Components | LF | 20 | PILE 2 @ PIER 1 HAS UP TO 1" DEEP DECAY ON THE EAST FACE FROM WATERLINE UP 1' HIGH.<br>PILE 4 @ PIER 1 HAS UP TO 1" DEEP DECAY ON THE EAST FACE FROM WATERLINE UP 1' H<br>ABUTMENT 1, PILE 2 IS DECAYED AT GROUNDLINE ON FACE UP TO 1" DEEP AND SOFT ON EXTERIOR.<br>ABUTMENT 1, PILE 3 IS DECAYED 1/2" DEEP X 3" HIGH FROM FACE TO LEFT SIDE. AREA IS 5" FROM GROUNDLINE. | |

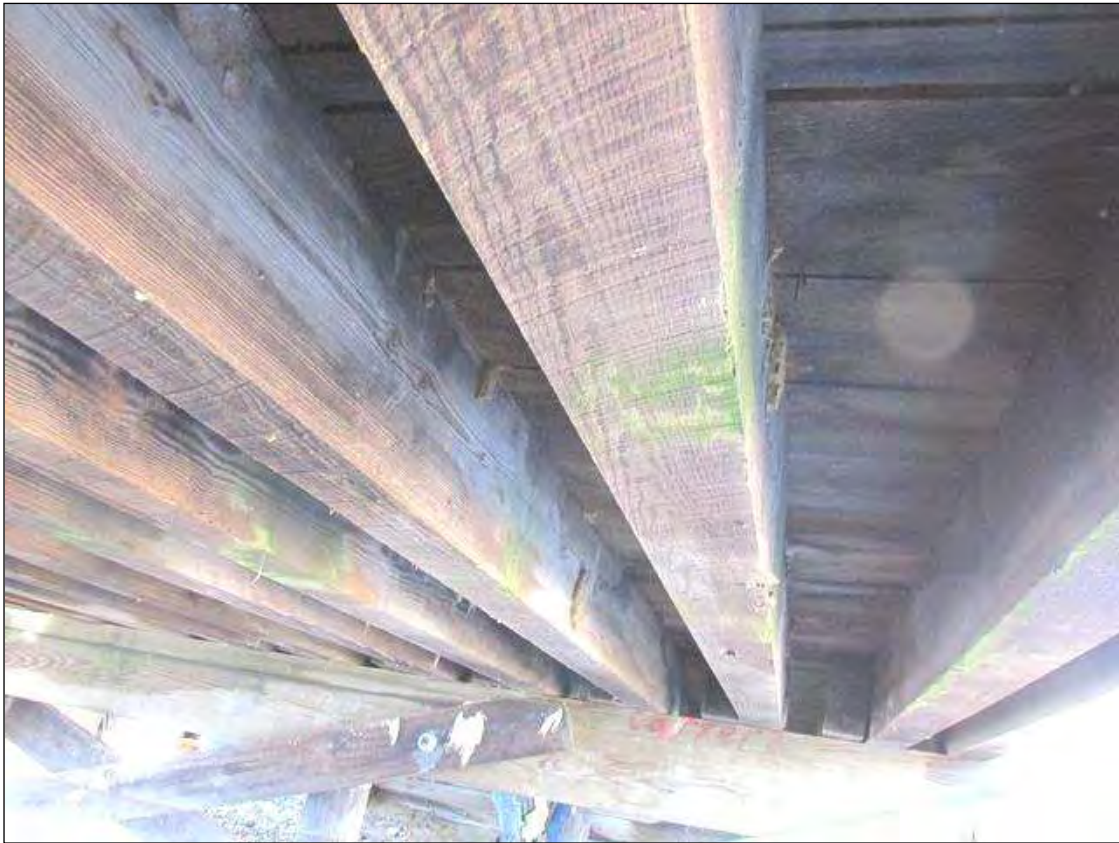
SUPERSTRUCTURE SPAN 2, ALL SIMILAR

| Bridge I&A Form 1(82)H<br>State of North Carolina<br>Dept. of Transportation<br>Division of Highways | | <h1>FIELD INSPECTION REPORT</h1> <p><u>Bridge Inspeccion &amp; Analysis</u></p> | |
|---|---|---|--|
| 11 | F | JOISTS ..... JOIST 1 IN SPAN 2 AT PIER 1 DECAYING ALONG BOTTOM AND SIDE 1" DEEP WHERE NAIL WAS DRIVEN. | |

| MMS Code | Description of Function | Unit | Quantity | Remarks | Est. Cost |
|---|---|---|---|---|---|
| 3304 | Maintain/Replace Timber Superstructure Components | LF | 2 | JOISTS ..... JOIST 1 IN SPAN 2 AT PIER 1 DECAYING ALONG BOTTOM AND SIDE 1" DEEP WHERE NAIL WAS DRIVEN. | |

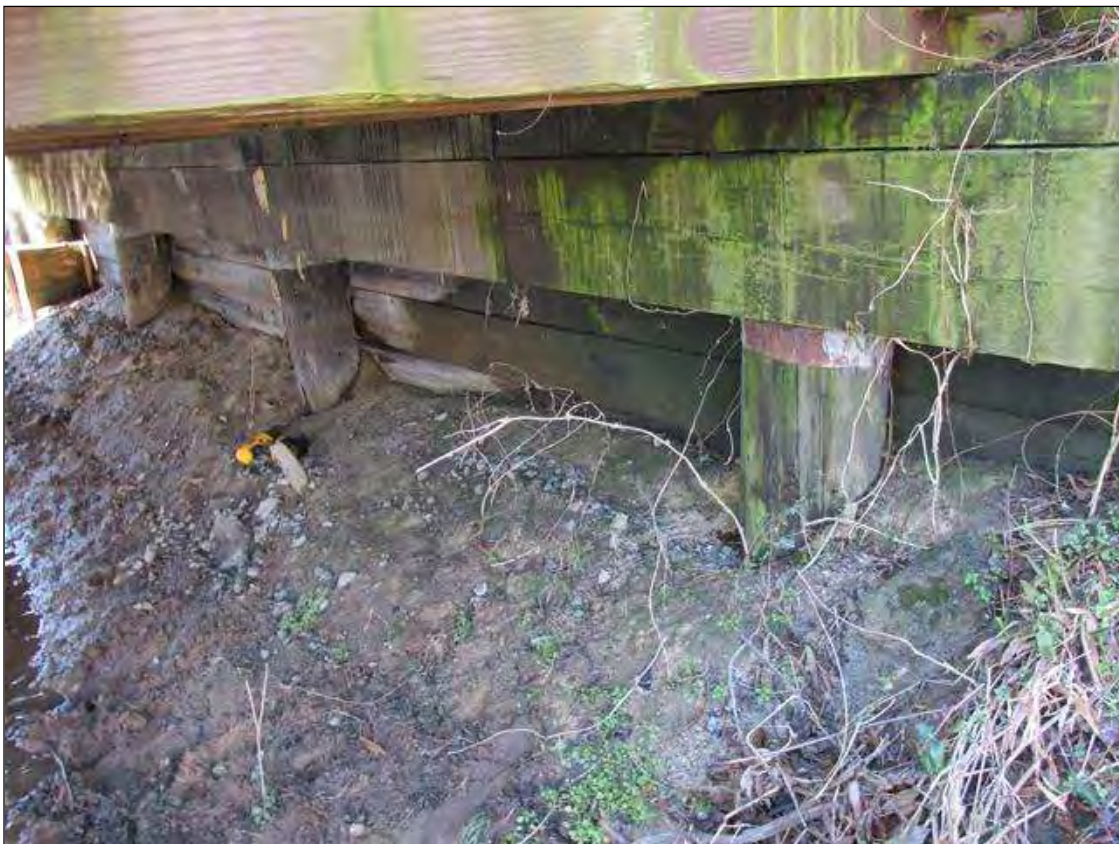
PRIORITY MAINT. PILE 1 @ ABUTMENT 1 IS DECAYED UP TO 3" DEEP INSIDE A 1" SOLID SHELL AROUND 50% OF DIAMETER FROM GROUNDLINE TO CAP.

| MMS Code | Description of Function | Unit | Quantity | Remarks | Est. Cost |
|---|---|---|---|---|---|
| 3344 | Repair / Replace Timber Substructure Components | LF | <i>2' TSC</i><br><i>3/18/13</i> | PRIORITY MAINT. PILE 1 @ ABUTMENT 1 IS DECAYED UP TO 3" DEEP INSIDE A 1" SOLID SHELL AROUND 50% OF DIAMETER FROM GROUNDLINE TO CAP. | |
