# BRIDGE INSPECTION REPORT

INSPECTION TYPE: Routine Inspection

BRIDGE NUMBER 670077

ROUTE SR1113

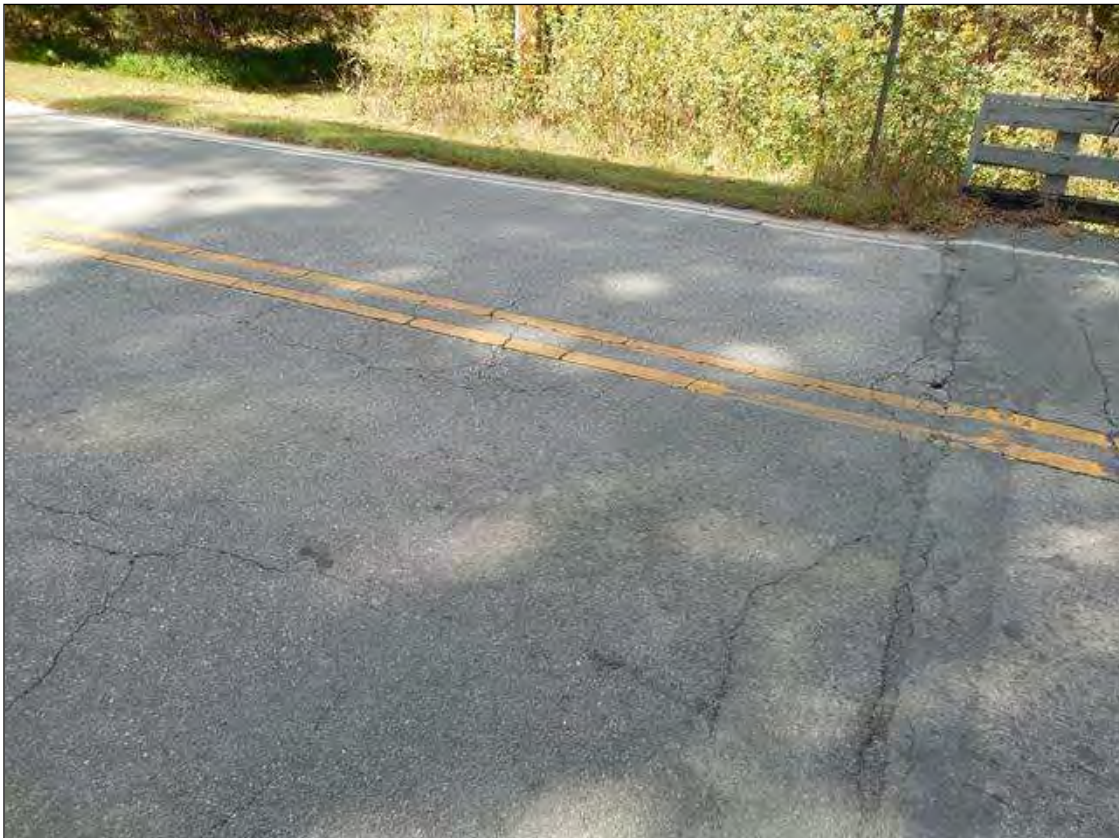
WEST END APPROACH

| Bridge I&A Form 1(82)H<br>State of North Carolina<br>Dept. of Transportation<br>Division of Highways | | <h1>FIELD INSPECTION REPORT</h1> <p><u>Bridge Inspection &amp; Analysis</u></p> | |
|---|---|---|--|
| 50 | F | BOTH APPROACHES CRACKED AND SETTLED, 1" TO 1-3/4" AT FILL FACE. | |

| MMS Code | Description of Function | Unit | Quantity | Remarks | Est. Cost |
|---|---|---|---|---|---|
| 2816 | Asphalt Surface Repair or Replacement | SY | 40 | APPROACHES CRACKED AND SETTLED | |

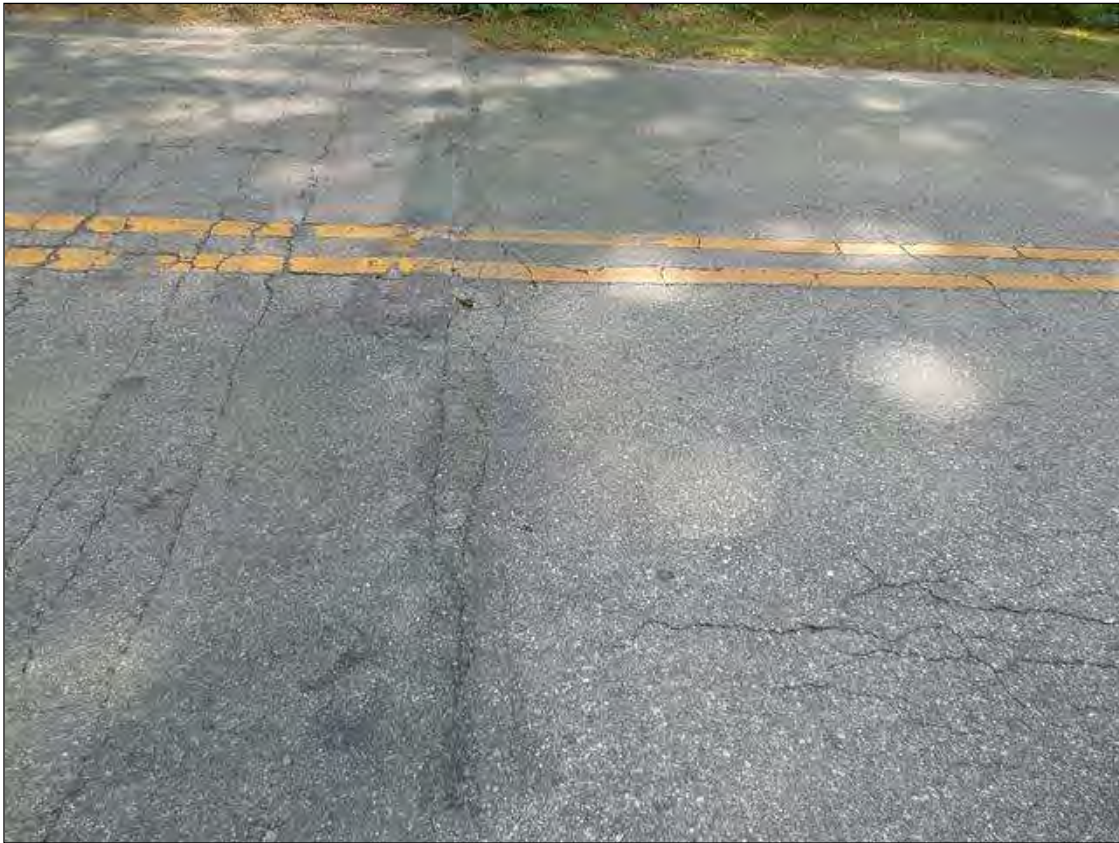
WEAR SURFACE AT END BENT 1

| Bridge I&A Form 1(82)H<br>State of North Carolina<br>Dept. of Transportation<br>Division of Highways | | <h1>FIELD INSPECTION REPORT</h1> <p><u>Bridge Inspection &amp; Analysis</u></p> | |
|---|---|---|--|
| 1 | F | AWS HEAVILY CRACKED ALONG TIMBER DECKING EDGES, UP TO 1/2"WIDE. SEVERAL PATCHED AREAS ALONG CENTERLINE. | |

WEAR SURFACE CRACKING AT END BENT 1

| MMS Code | Description of Function | Unit | Quantity | Remarks | Est. Cost |
|---|---|---|---|---|---|
| 2816 | Asphalt Surface Repair or Replacement | SY | 100 | AWS CRACKING ON DECK | |

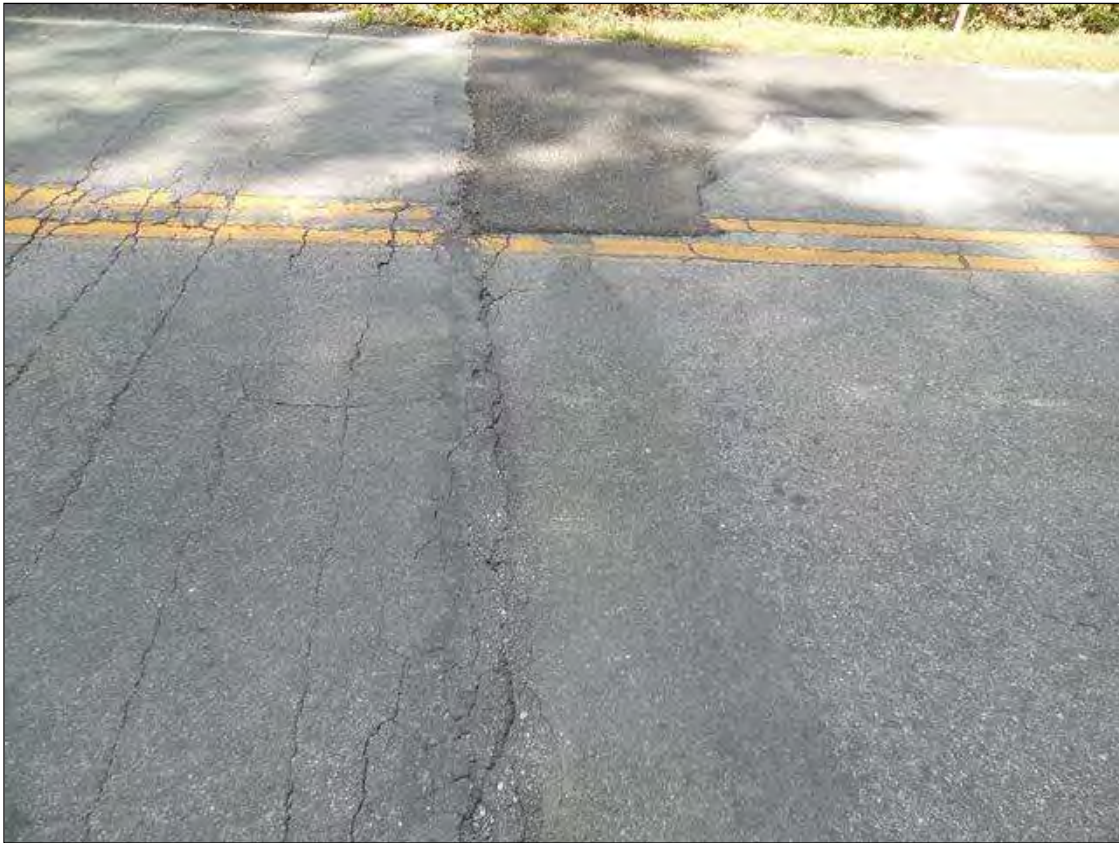
WEAR SURFACE AT END BENT 2

WEAR SURFACE CRACKING AT END BENT 2

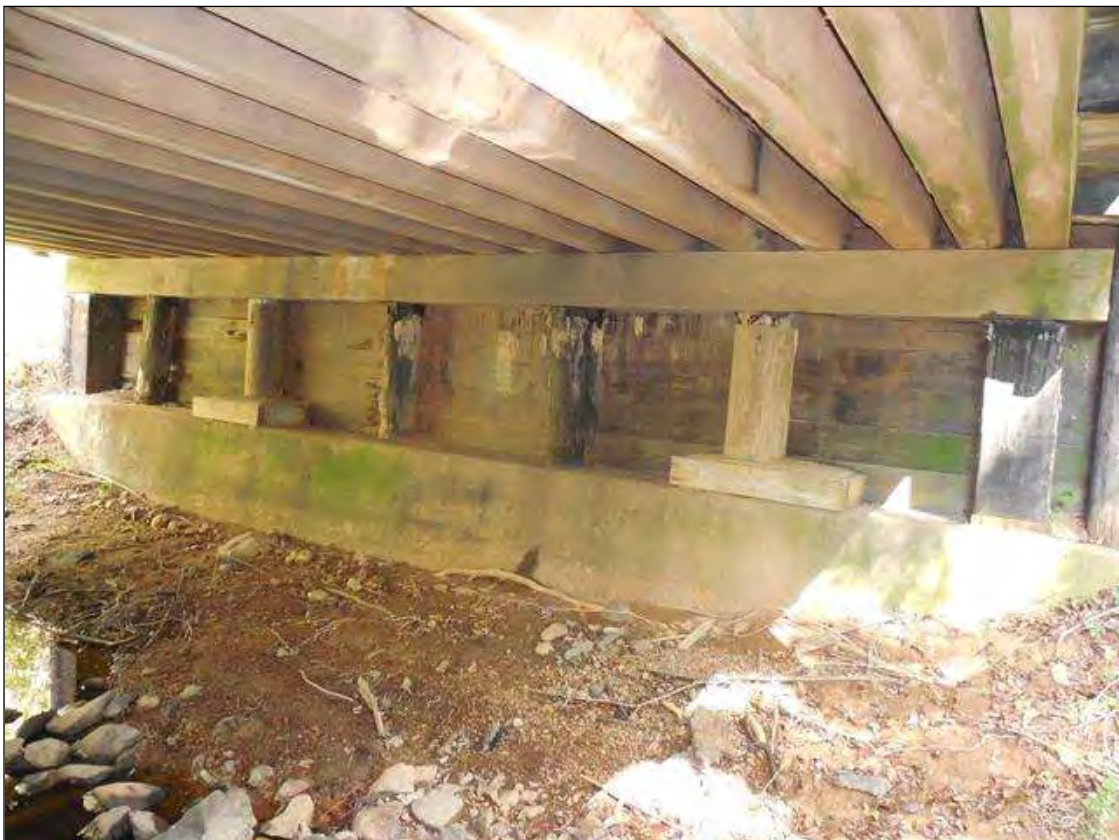
| Bridge I&A Form 1(82)H<br>State of North Carolina<br>Dept. of Transportation<br>Division of Highways | | <h1>FIELD INSPECTION REPORT</h1> <p><u>Bridge Inspection &amp; Analysis</u></p> | |
|---|---|---|--|
| 35c | P | TIMBERS SHOWING DECAY FULL THICKNESS ALONG FILL TO BE EXPOSED. END BENT 1 DECAY IS AROUND PILE 5 TO OUTSIDE WING, WING POST HAVE FULL DEPTH DECAY ALONG BASE AT CONCRETE FOOTING. END BENT 2 HAS BACKWALL DECAY AROUND PILE 1 EXTENDING OVER TO PILE 2, FULL THICKNESS. | |

DECAY ON BULKHEAD AT END BENT 2 BETWEEN PILES 1 AND 2

| MMS Code | Description of Function | Unit | Quantity | Remarks | Est. Cost |
|---|---|---|---|---|---|
| 3346 | Repair / Maintain Timber Wings & Blkhs | SF | 90 | BULKHEAD AND WING TIMBERS SHOWING DECAY | |

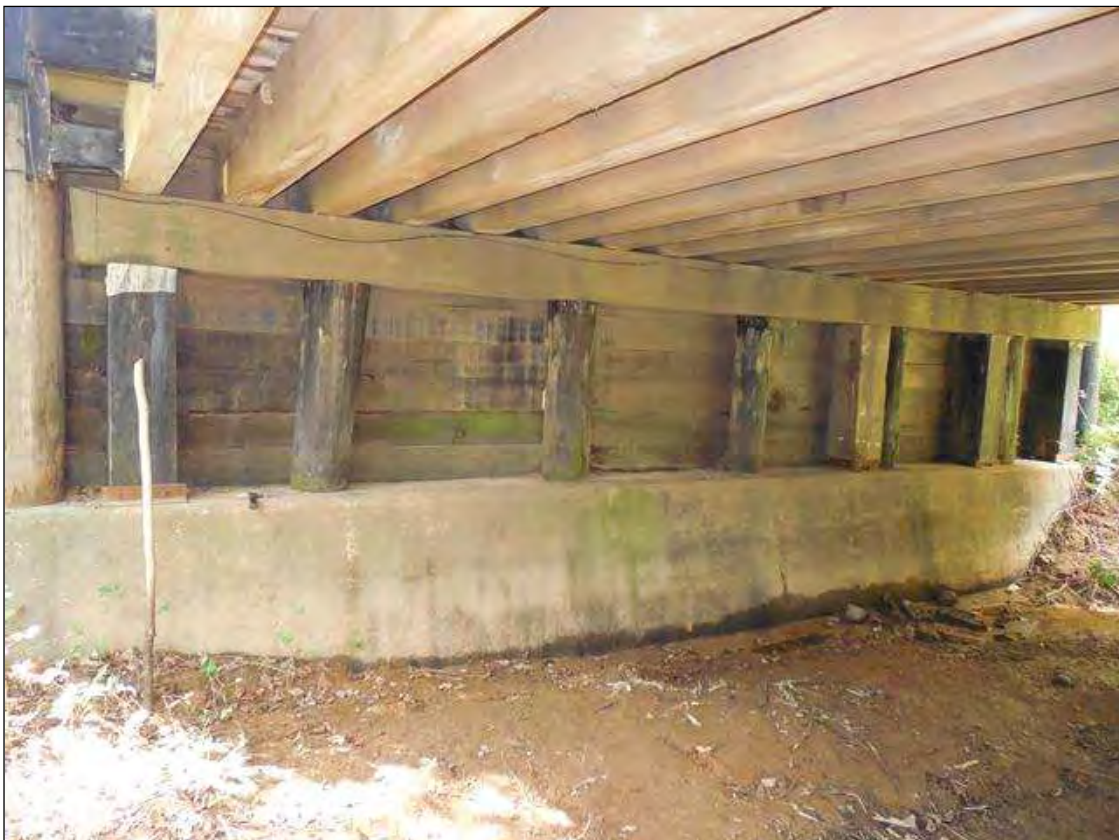
| Bridge I&A Form 1(82)H<br>State of North Carolina<br>Dept. of Transportation<br>Division of Highways | | <h1>FIELD INSPECTION REPORT</h1> <p><u>Bridge Inspection &amp; Analysis</u></p> | |
|---|---|---|--|
| 35b | F | TIMBERS WEATHERED AND CHECKED WITH DELAM AROUND CHECK CRACKS. DECAYED PILES AT END BENT 1 HAVE HAD SISTER PILES PLACED BESIDE THEM. | |

DECAY ON BULKHEAD AT END BENT 1 BEHIND PILE 6
