NC DEPARTMENT OF TRANSPORTATION  
DIVISION OF HIGHWAYS  
BRIDGE MANAGEMENT UNIT

# BRIDGE INSPECTION REPORT

INSPECTION TYPE: Routine Inspection - Contract

COUNTY ROWAN BRIDGE NUMBER 790149 INSPECTION CYCLE 0 YRS  
ROUTE SR2132 ACROSS N.PRONG OF CHURCH M.P. 0

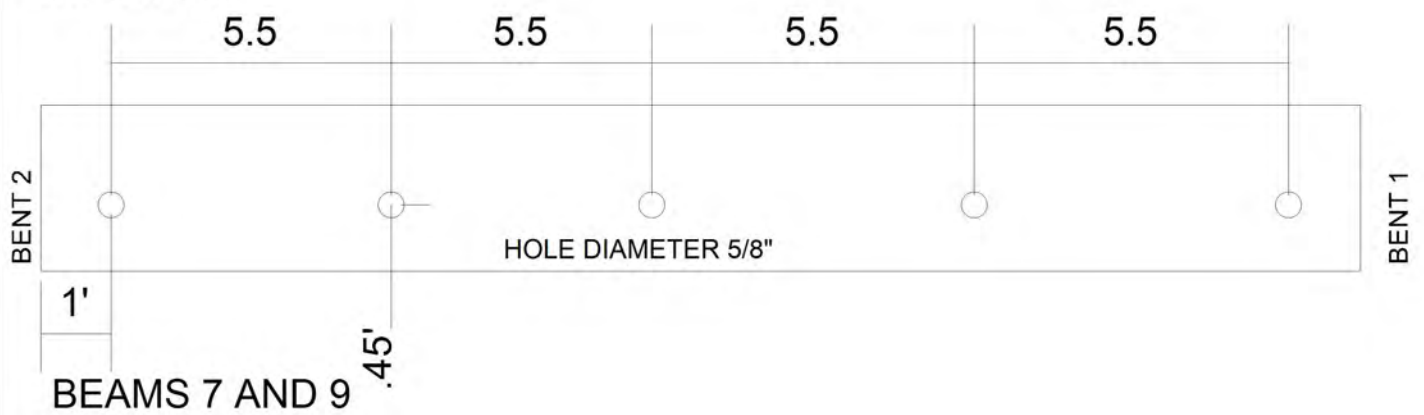
**Title**  
HOLES IN BEAMS

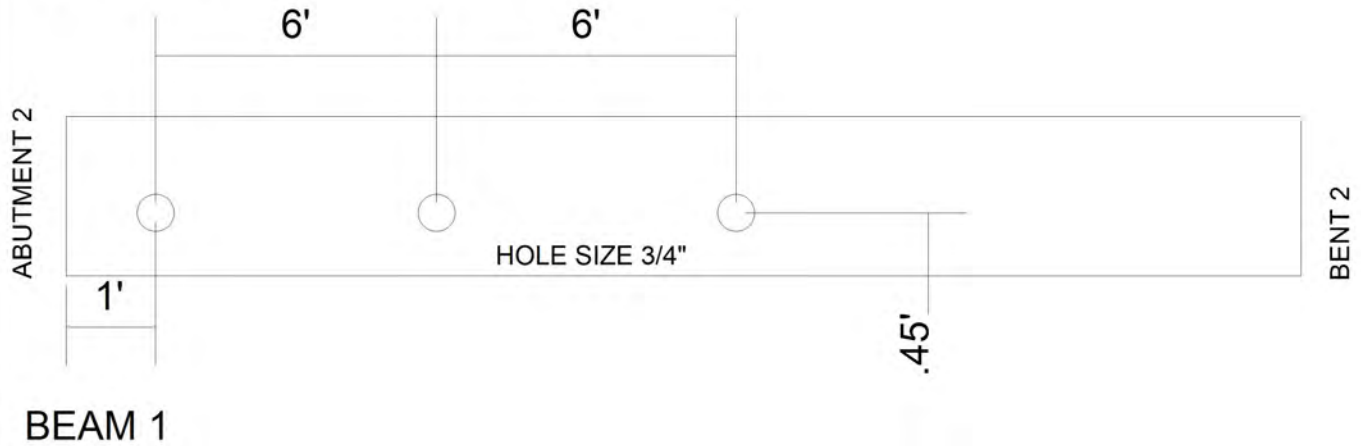
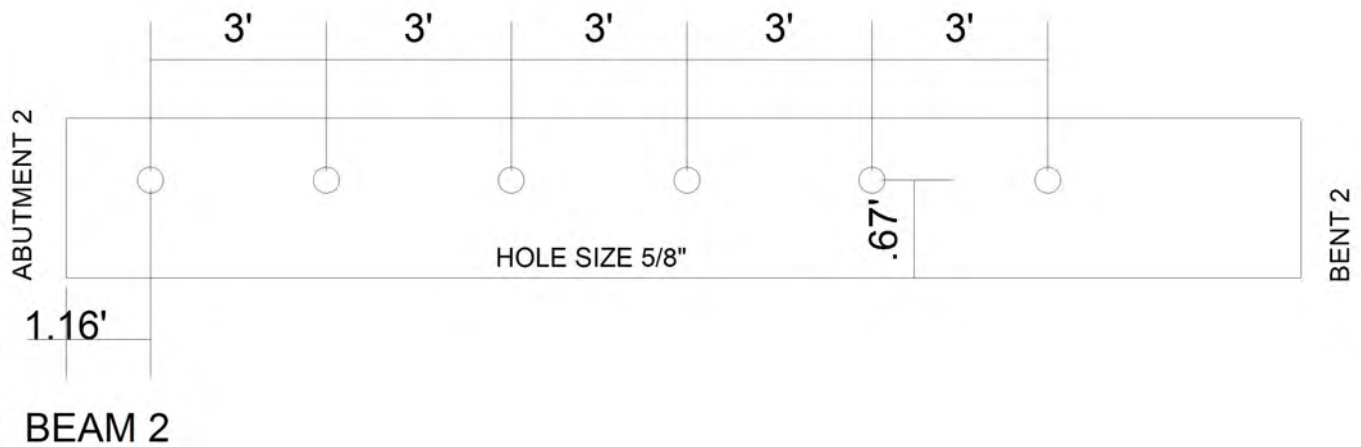
HOLES IN BEAMS 2

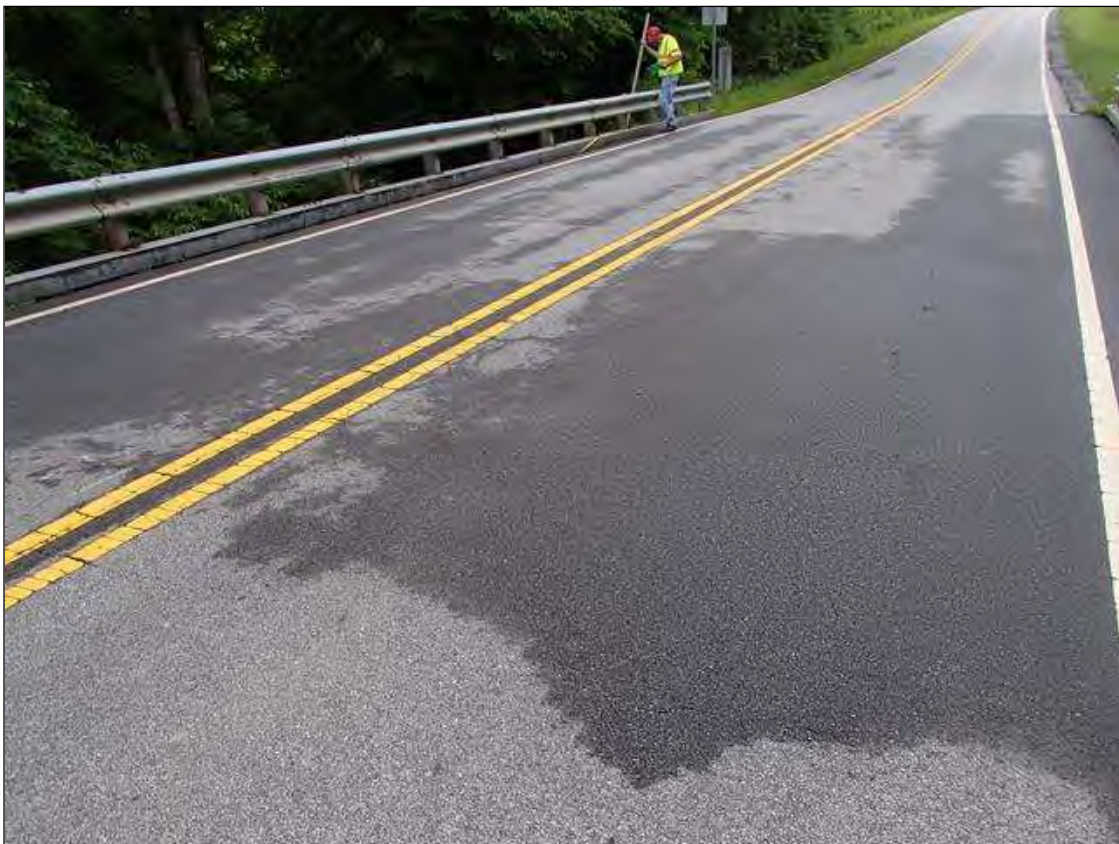
WEARING SURFACE SPAN 3

ASPHALT WEARING SURFACE SPAN 3: LONGITUDINAL CRACKING UP TO 1/8" WIDE (SIMILAR ALL SPANS)

| MMS Code | Description of Function | Unit | Quantity | Remarks | Est. Cost |
|---|---|---|---|---|---|
| 2816 | Asphalt Surface Repair or Replacement | SY | 160 | CRACKING IN ASPHALT WEARING SURFACE ALL SPANS | |

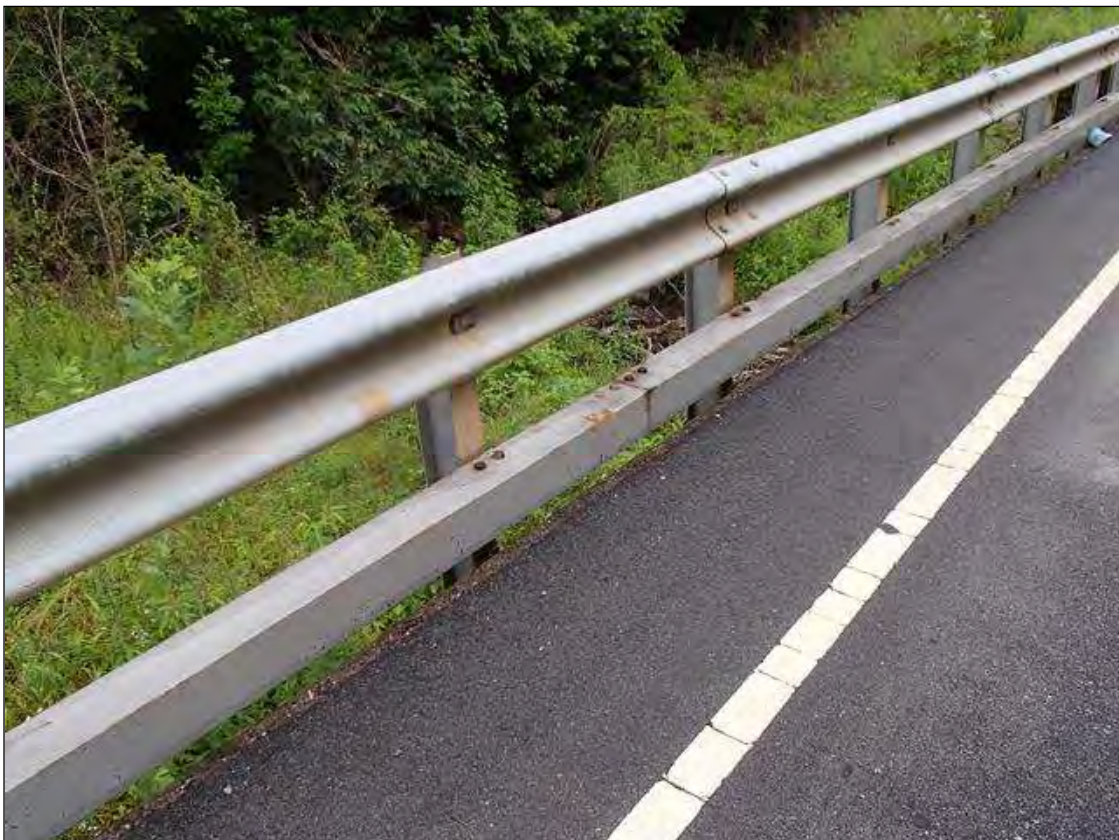
LEFT SIDE RAIL SPAN 3: CORROSION ON TOP FACE

| MMS Code | Description of Function | Unit | Quantity | Remarks | Est. Cost |
|---|---|---|---|---|---|
| 3322 | Maint to Steel Handrail | LF | 120 | IMPACT DAMAGE AT NORTHEAST CORNER AND CORROSION ON RAIL AND CURB SIMILAR BOTH SIDES | |
