# BRIDGE INSPECTION REPORT

INSPECTION TYPE: Routine Inspection - Contract

COUNTY ROWAN BRIDGE NUMBER 790353 INSPECTION CYCLE 0 YRS  
ROUTE SR1349 ACROSS CREEK M.P. 0

INSPECTION DATE 06/13/2014

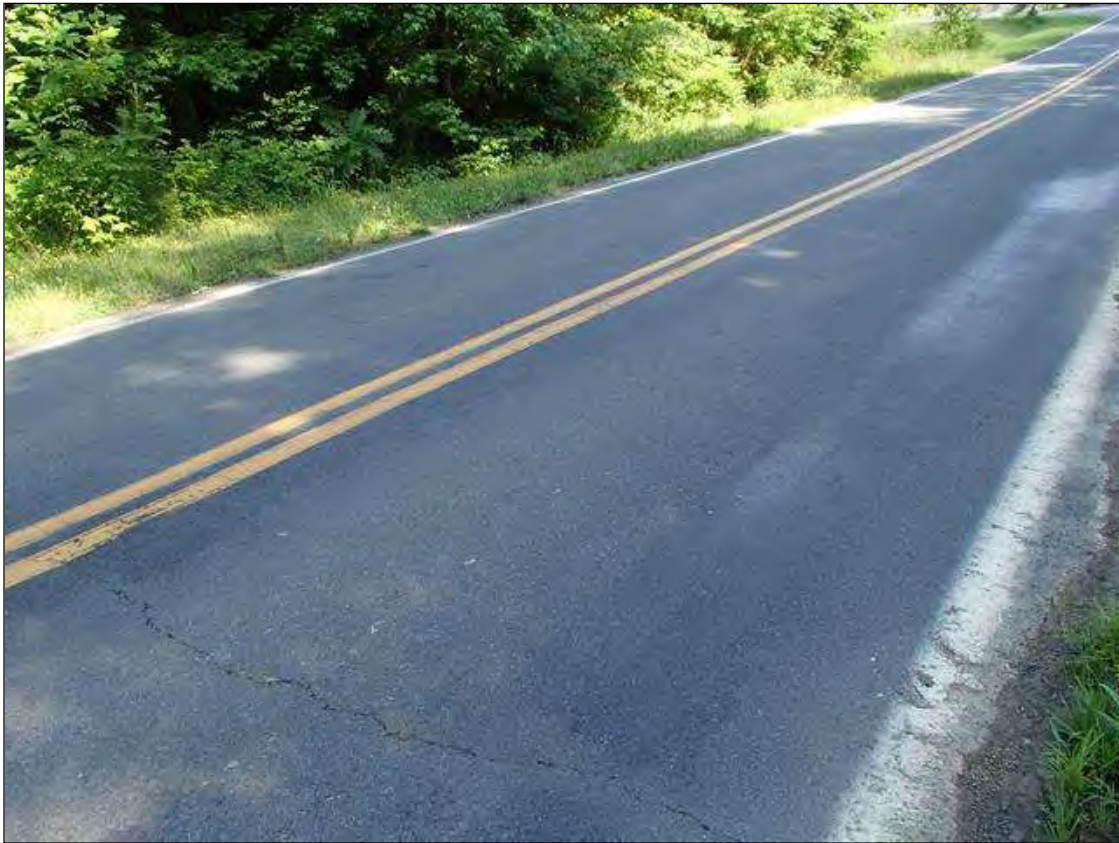
| 50 | F | APPROACH ROADWAY<br><br>ASPHALT AT NORTH APPROACH: TRANSVERSE CRACKING UP TO 1/8" WIDE<br>ASPHALT AT NORTH APPROACH: TRANSVERSE CRACKING UP TO 1/8" WIDE ALONG JOINT AT ABUTMENT 2<br>ASPHALT AT SOUTH APPROACH: TRANSVERSE CRACKING UP TO 1/4" WIDE<br>ASPHALT AT SOUTH APPROACH: TRANSVERSE CRACKING UP TO 1/4" WIDE ALONG JOINT AT ABUTMENT 1<br>- | |

NORTH APPROACH

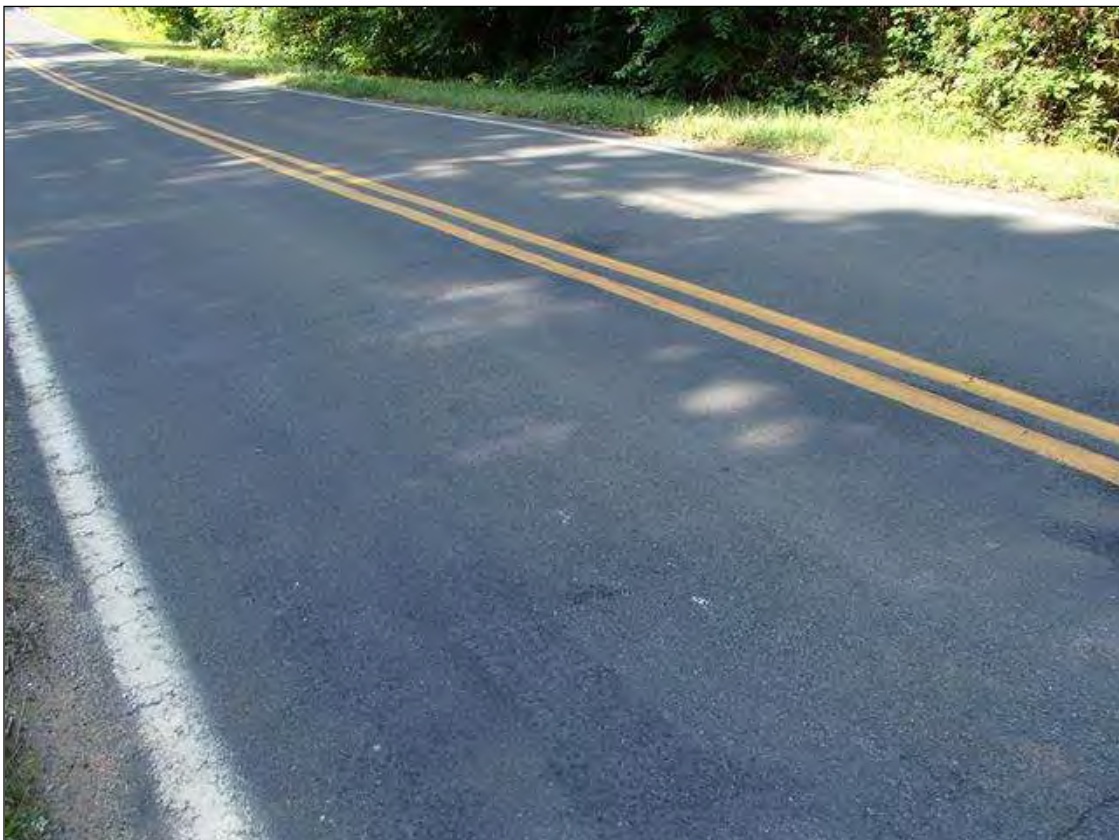
SOUTH APPROACH

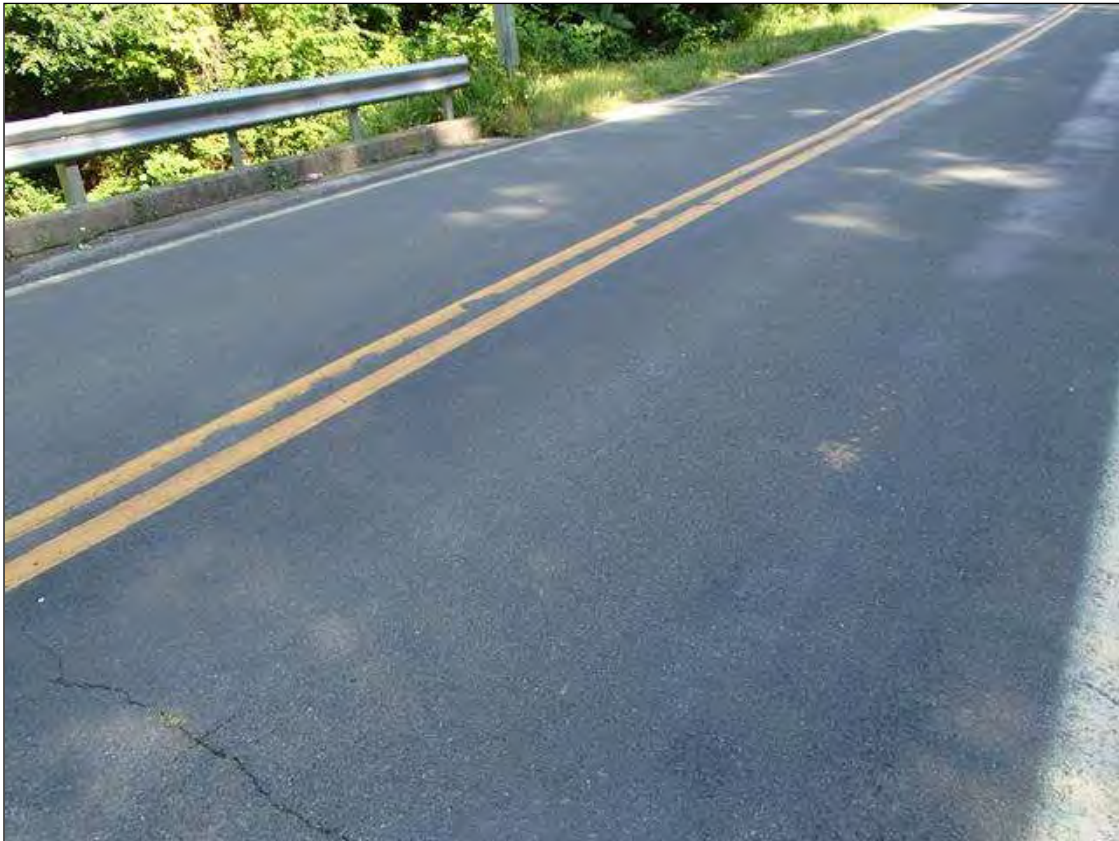
| Bridge I&A Form 1(82)H<br>State of North Carolina<br>Dept. of Transportation<br>Division of Highways | | <h1 style="text-align: center;">FIELD INSPECTION REPORT</h1> <p style="text-align: center;"><u>Bridge Inspection &amp; Analysis</u></p> | |
|---|---|---|--|
| 1 | G | WEARING SURFACE | |
| | | THERE IS CRACKING ALONG BOTH JOINTS UP TO 1/4" WIDE | |

WEARING SURFACE ON DECK

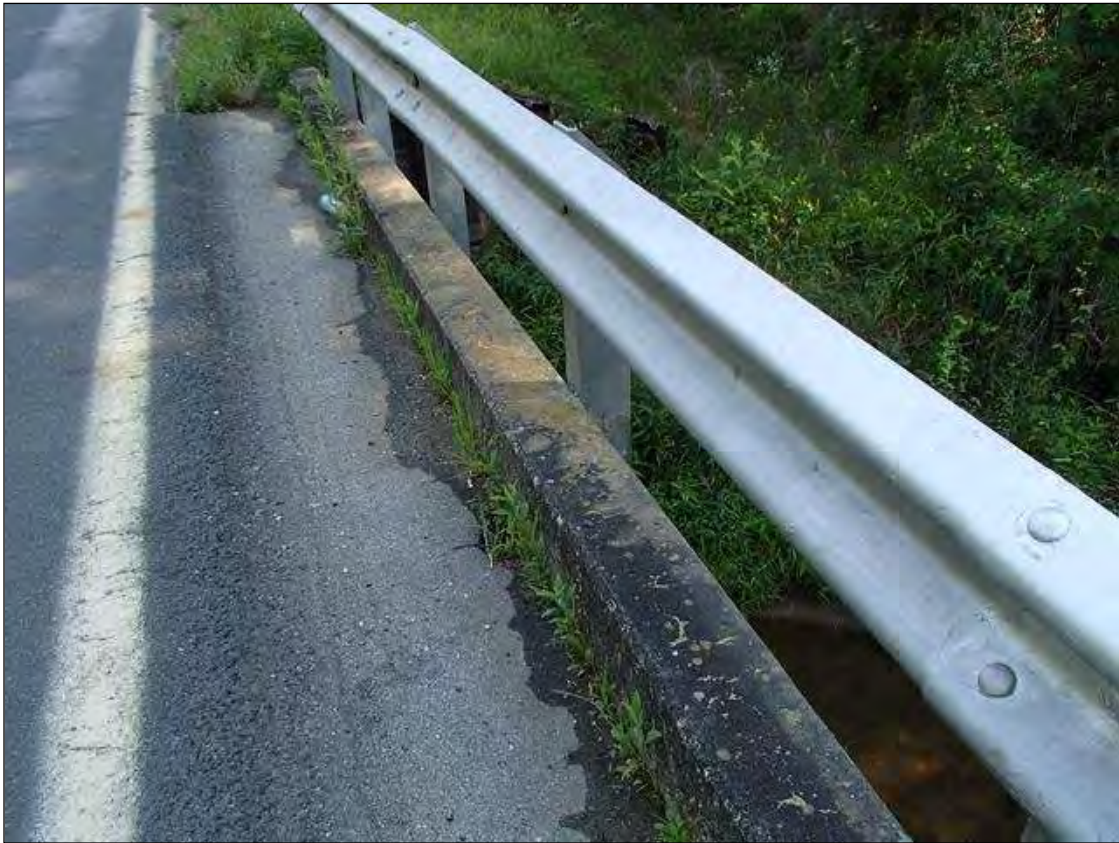
| Bridge I&A Form 1(82)H<br>State of North Carolina<br>Dept. of Transportation<br>Division of Highways | | <h1 style="text-align: center;">FIELD INSPECTION REPORT</h1> <p style="text-align: center;"><u>Bridge Inspection &amp; Analysis</u></p> | |
|---|---|---|--|
| | | RIGHT SIDE CURB: TRANSVERSE CRACKING UP TO 1/64" WIDE (SIMILAR SEVERAL LOCATIONS THROUGHOUT) | |

RIGHT SIDE RAIL AND CURB

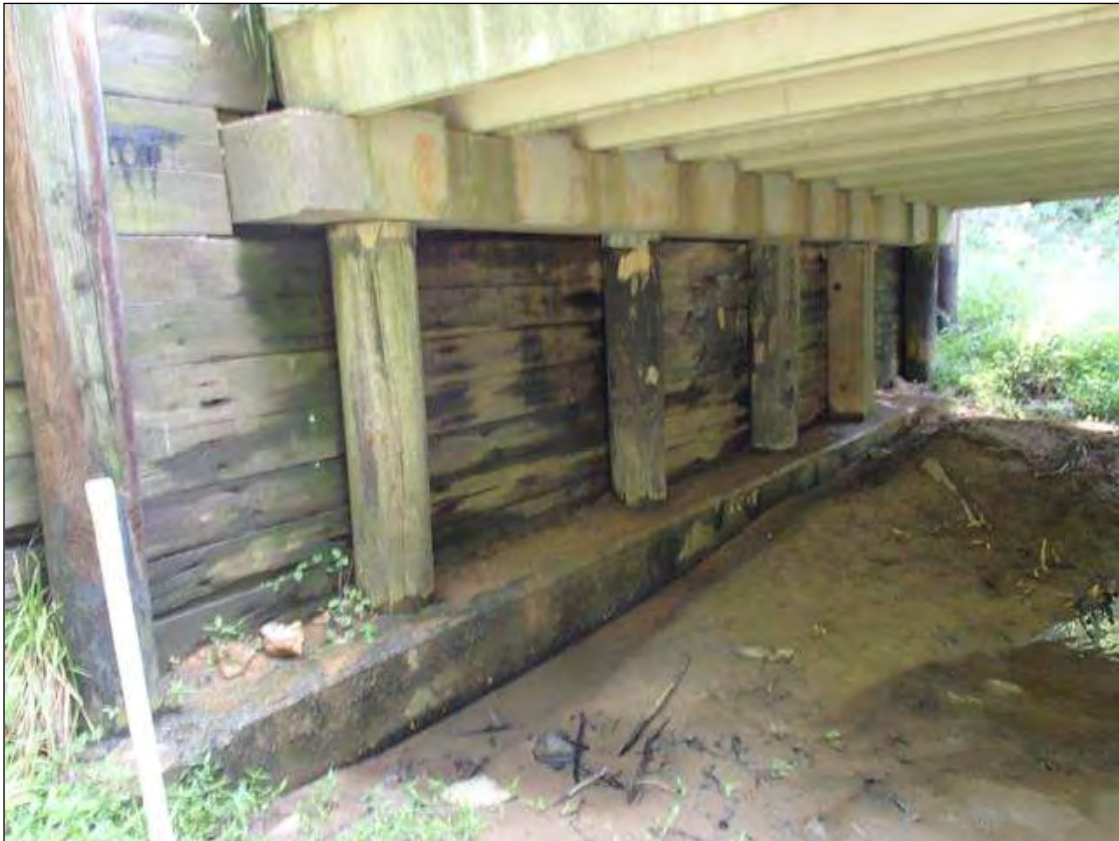
ABUTMENT 2

| 36a | G | <p>ABUTMENT CAPS</p> <p>ABUTMENT 2 UNDER BEAM 8: VERTICAL CRACKING UP TO 1/64" WIDE (SIMILAR SEVERAL LOCATIONS)</p> <p>-</p> | |
