NC DEPARTMENT OF TRANSPORTATION  
DIVISION OF HIGHWAYS  
BRIDGE MANAGEMENT UNIT

# BRIDGE INSPECTION REPORT

INSPECTION TYPE: Routine Inspection

COUNTY CUMBERLAND BRIDGE NUMBER 250042 INSPECTION CYCLE 2 YRS  
ROUTE SR2030 ACROSS CREEK M.P. 0

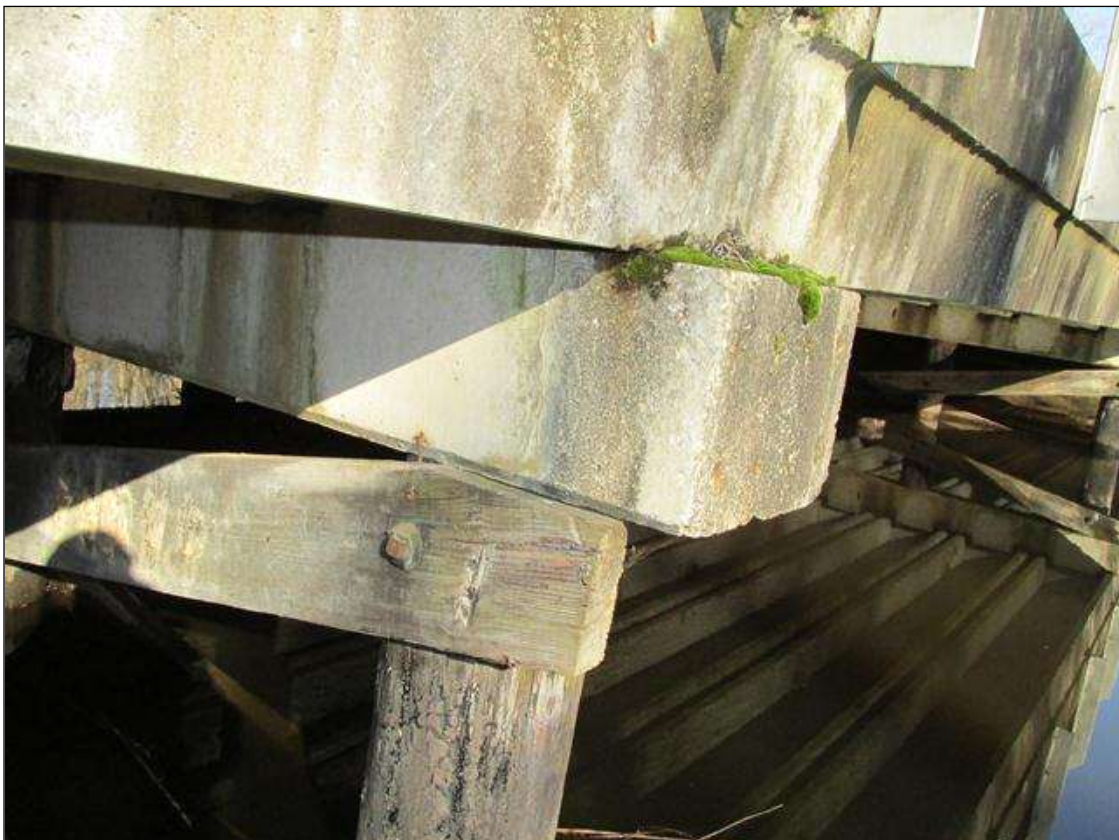
| <b>36a</b> | <b>G</b> | ( PPC CAPS ) BENT 1 CAP, SPAN 1 FACE IS SPALLED 4" DIAMETER X 1" DEEP UNDER CHANNEL 10. (PHOTO)<br><br>THERE ARE EXPOSED CABLE ENDS AT EAST END OF BENT 1 CAP. (PHOTO) ALL CAPS ARE SIMILAR. | |
