NC DEPARTMENT OF TRANSPORTATION  
DIVISION OF HIGHWAYS  
BRIDGE MANAGEMENT UNIT

# BRIDGE INSPECTION REPORT

INSPECTION TYPE: Routine Inspection - Contract

COUNTY CALDWELL BRIDGE NUMBER 130123 INSPECTION CYCLE 0 YRS  
ROUTE SR1356 ACROSS ESTES MILL CREEK M.P. 0

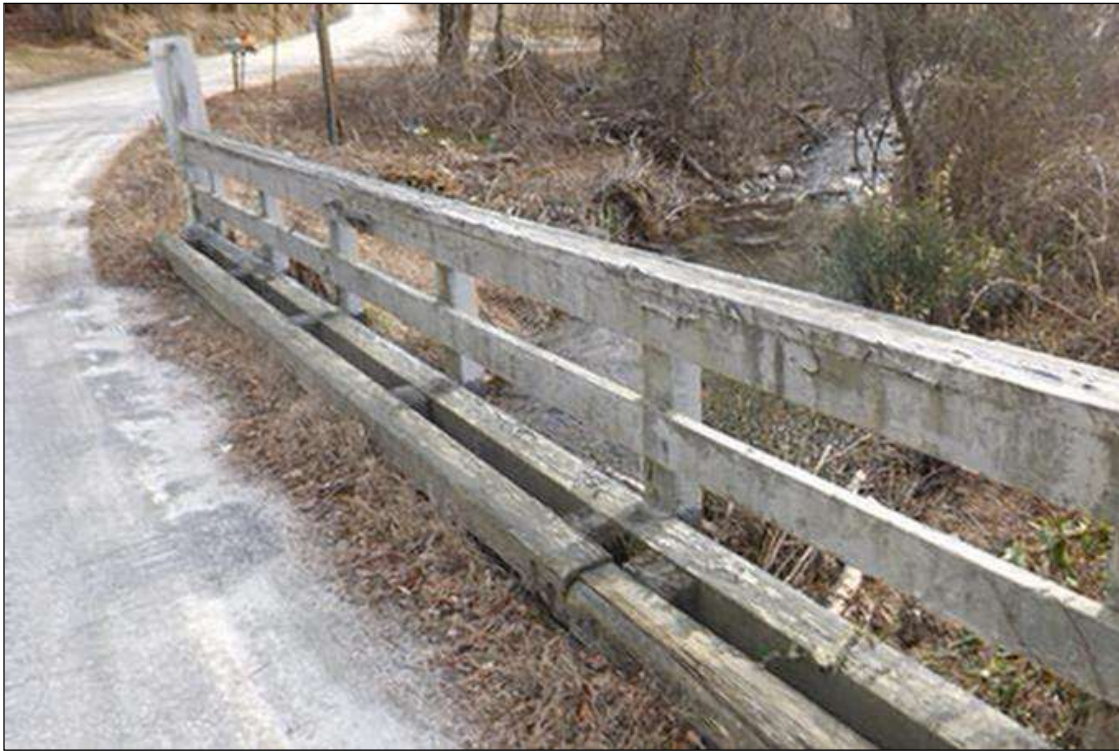
| Bridge I&A Form 1(82)H<br>State of North Carolina<br>Dept. of Transportation<br>Division of Highways | | <h1 style="text-align: center;">FIELD INSPECTION REPORT</h1> <p style="text-align: center;"><u>Bridge Inspeccion &amp; Analysis</u></p> | |
|---|---|---|--|
| 3b | F | 2 1/2" X 1 1/2" X 3 1/2" DEEP AREA OF DECAY IN WEST BRIDGE RAIL NEAR ABUTMENT 1.<br>PEELING PAINT WITH CHECKS ON WEST BRIDGE RAIL. | |

BRIDGE RAIL ON EAST SIDE (WEST SIDE SIMILAR)

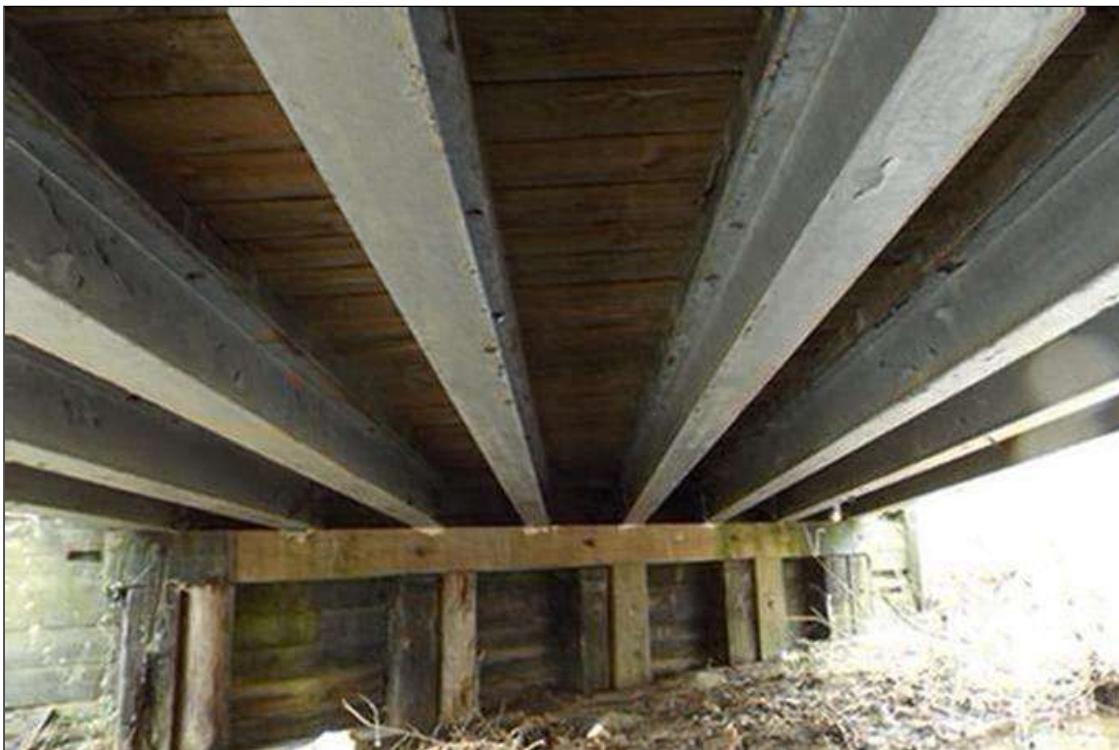
| Bridge I&A Form 1(82)H<br>State of North Carolina<br>Dept. of Transportation<br>Division of Highways | | <h1 style="text-align: center;">FIELD INSPECTION REPORT</h1> <p style="text-align: center;"><u>Bridge Inspeccion &amp; Analysis</u></p> | |
|---|---|---|--|
| 10 | G | PEELING PAINT WITH SURFACE RUST ON BOTH FLANGES OF EACH BEAM.<br>FLAKING RUST ON TOP FLANGE OF BEAM 1. | |

UNDERSIDE OF SUPERSTRUCTURE

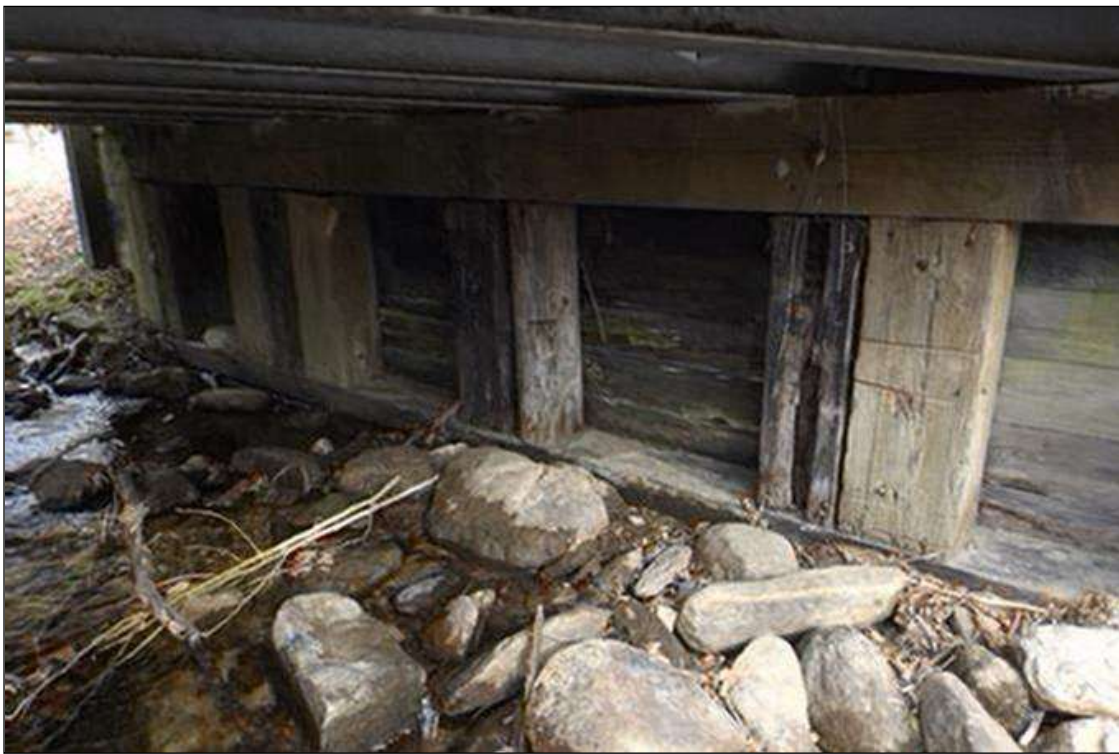
| Bridge I&A Form 1(82)H<br>State of North Carolina<br>Dept. of Transportation<br>Division of Highways | | <h1 style="text-align: center;">FIELD INSPECTION REPORT</h1> <p style="text-align: center;"><u>Bridge Inspeccion &amp; Analysis</u></p> | |
|---|---|---|--|
| 35a | F | 5" NORTHERN LEAN OF ABUTMENT 1<br>8" SOUTHERN LEAN OF ABUTMENT 2.<br>FULL LENGTH UP TO 1/8" HORIZONTAL CRACK IN ABUTMENT 2 CAP. | |
| 35b | F | 56" X 6" X 4" DEEP AREA OF DECAY IN BULKHEAD PILE AT EAST END OF ABUTMENT 1.<br>VERTICAL CRACK IN PILE 5 OF ABUTMENT 2 (ALL PILES SIMILAR).<br>LACK OF BEARING AT PILE 4 OF ABUTMENT 2 TEMPORARY REPAIR.<br>UP TO 15" X 5" X 1 1/2" DEEP AREA OF DECAY IN BULKHEAD PILE ON WEST END OF ABUTMENT 1. | |

ABUTMENT 2 (ABUTMENT 1 SIMILAR)

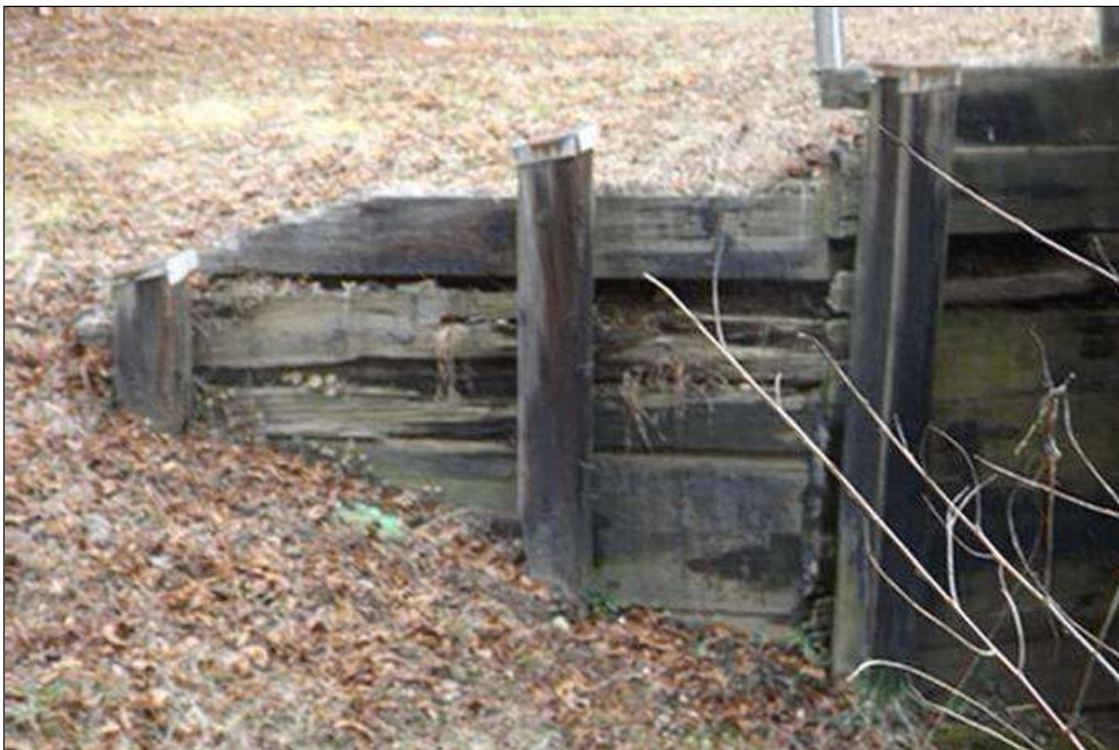
| MMS Code | Description of Function | Unit | Quantity | Remarks | Est. Cost |
|---|---|---|---|---|---|
| 3346 | Repair / Maintain Timber Wings & Blkhds | SF | 10 | 60" X 2 1/2" X 3" DEEP AREA OF DECAY IN SOUTHEAST WINGWALL.<br>27" X 3" X 3" DEEP AREA OF DECAY IN NORTHEAST WINGWALL.<br>72" X 17" X 3" DEEP AREA OF DECAY IN NORTHWEST WINGWALL. | |

NORTHWEST WINGWALL (ALL OTHERS SIMILAR)
