NC DEPARTMENT OF TRANSPORTATION  
DIVISION OF HIGHWAYS  
STRUCTURE MANAGEMENT UNIT

## Structure Safety Report

### 2 Year Complete Topside and Underwater Element Inspection

COUNTY: WILKES STRUCTURE NUMBER: 960150 FREQUENCY: 24 MONTHS

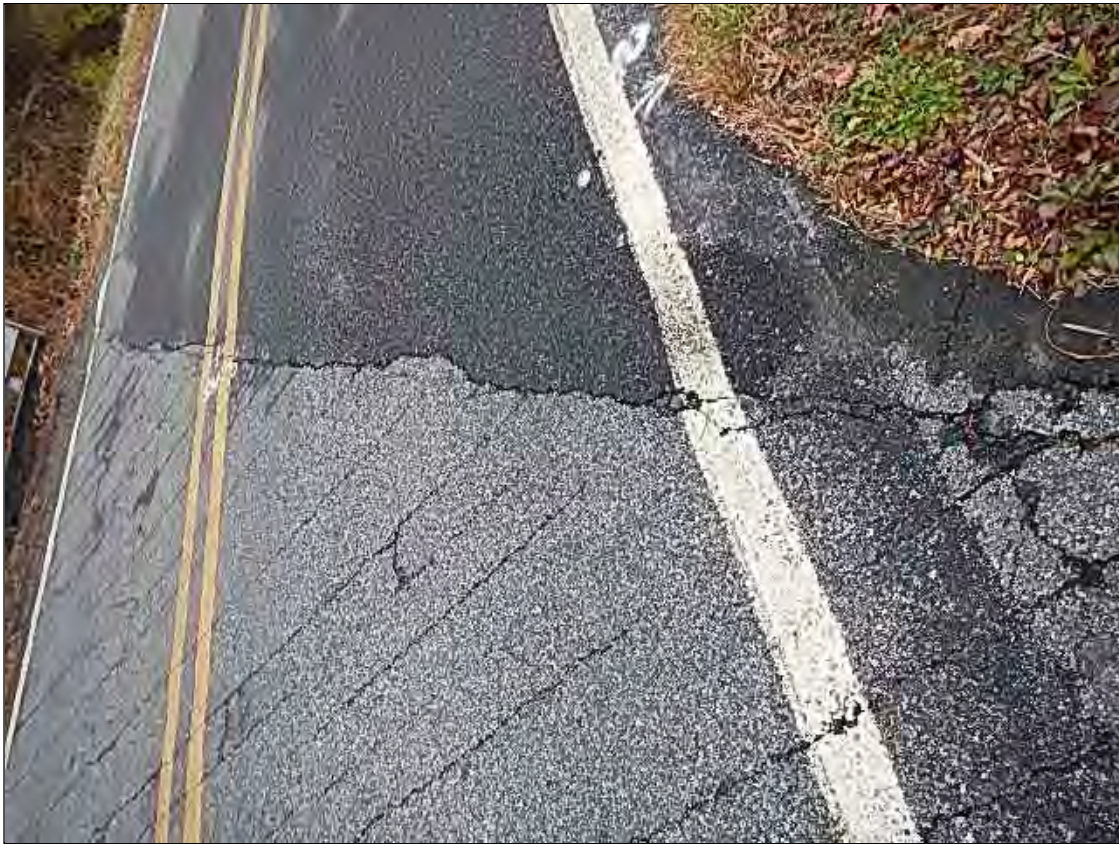
EAST APPROACH ROADWAY

1 Square Feet of Effectiveness (Wearing Surface): The wearing surface is no longer effective. AREA MISSING AWS.  
646 Square Feet of Crack (Wearing Surface): Width of more than 0.05 in. or spacing of less than 1.0 ft. CRACKED ALONG DECK BOARD JOINTS.
