NC DEPARTMENT OF TRANSPORTATION  
DIVISION OF HIGHWAYS  
STRUCTURE MANAGEMENT UNIT

## Structure Safety Report

### Routine Element Inspection - Contract

COUNTY: WILKES STRUCTURE NUMBER: 960151 FREQUENCY: 24 MONTHS

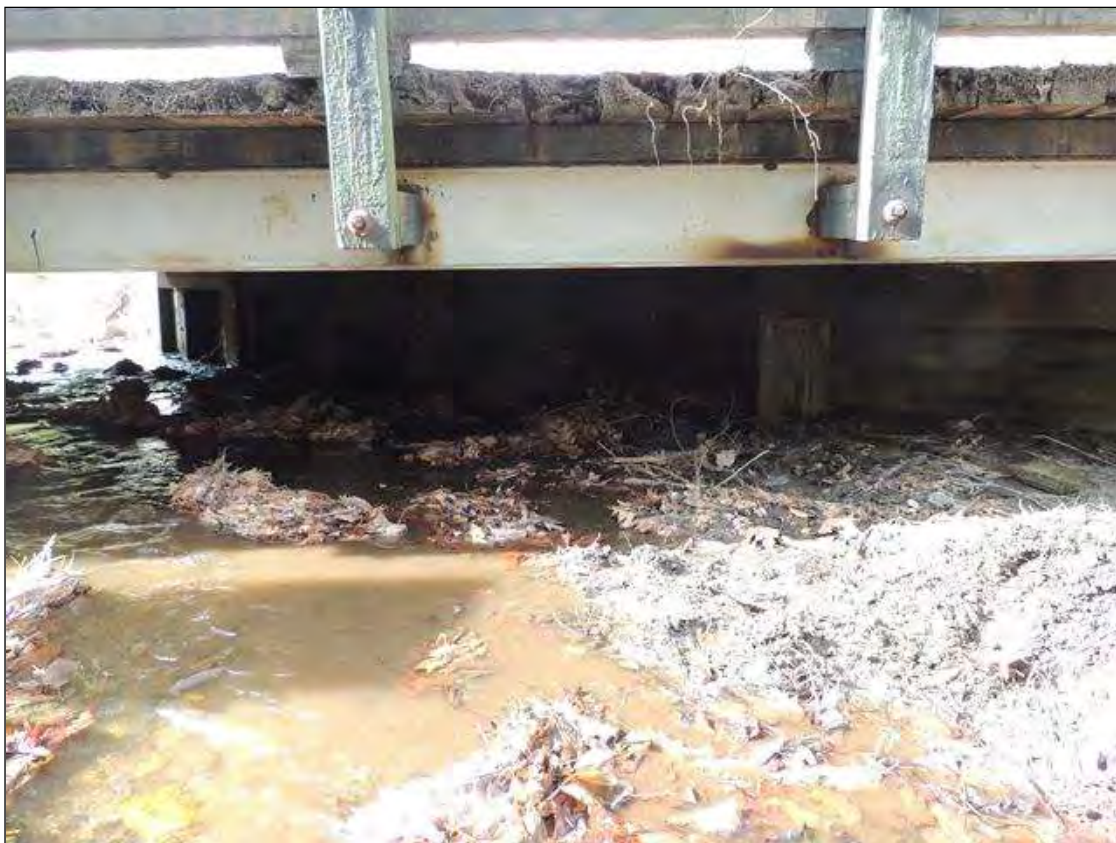
end bent 2

End Bent 2 Cap : 2 Feet of Decay/Section Loss: Affects 10% or more of the member but does not warrant structural review. cap segment 2 rt end cap decayed from end back 16" 10 1/2" w x top down 10" x 3" deep.

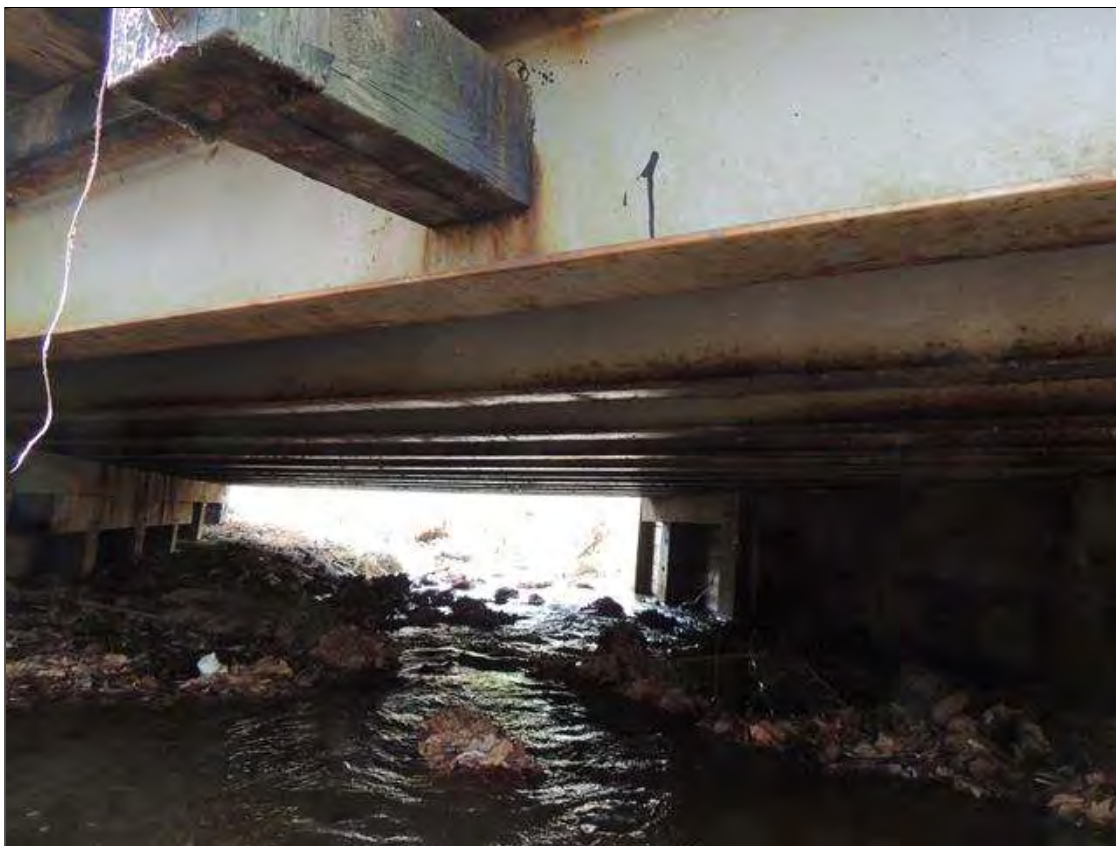
superstructure

15 Feet of Corrosion: Section loss is evident or pack rust is present but does not warrant structural review. along top flange up to 1/16" loss  
12 Feet of Corrosion: Freckled Rust. Corrosion of the steel has initiated.  
115 Square Feet of Peeling/Bubbling/Cracking (steel Protective Coatings): Finish and primer coats.

10 Feet of Connection: The condition warrants a structural review to determine the effect on strength or serviceability of the element or bridge; OR a structural review has been completed and the defects impact strength or serviceability of the element or bridge. timber nailer on top beam 4 decay from end bent 1 out 10' soft and wet.

15 Feet of Corrosion: Section loss is evident or pack rust is present but does not warrant structural review. along top flanges up to 1/16"

21 Feet of Corrosion: Section loss is evident or pack rust is present but does not warrant structural review. 1/16" to 1/8" along top flanges also
