NC DEPARTMENT OF TRANSPORTATION  
DIVISION OF HIGHWAYS  
STRUCTURE MANAGEMENT UNIT

# Structure Safety Report

## Routine Element Inspection

COUNTY: CHOWAN STRUCTURE NUMBER: 200020 FREQUENCY: 24 MONTHS

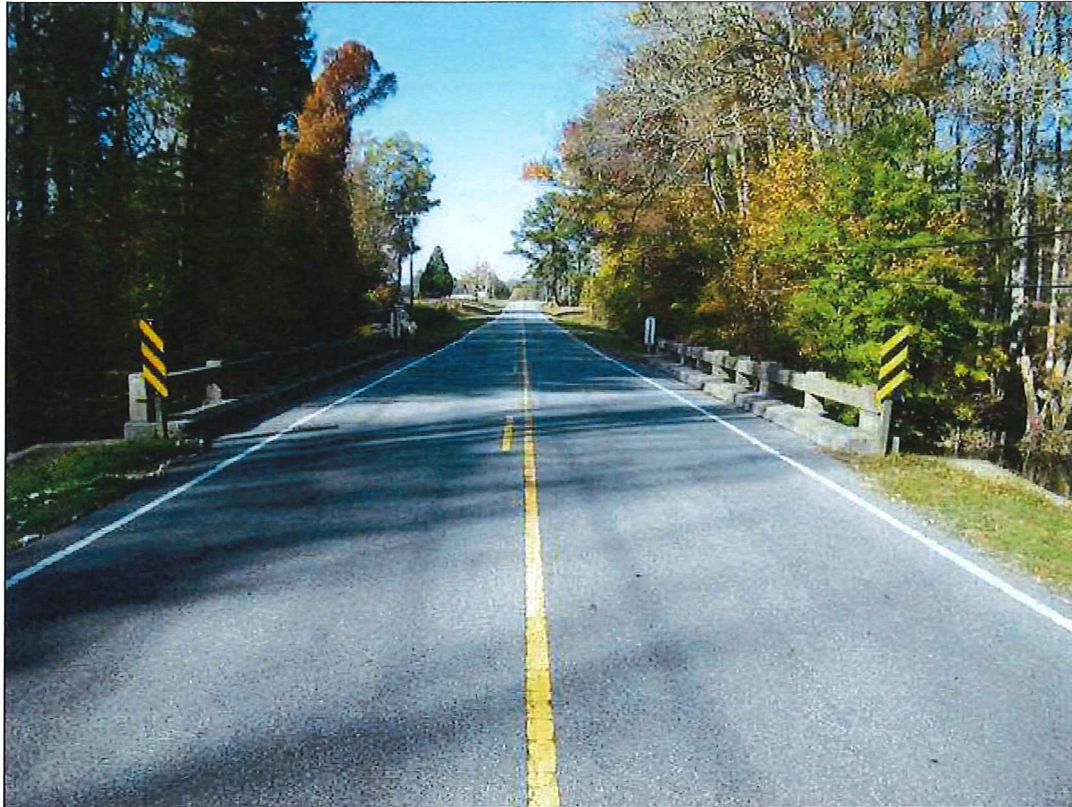
LOOKING NORTH

decayed wings on all corners

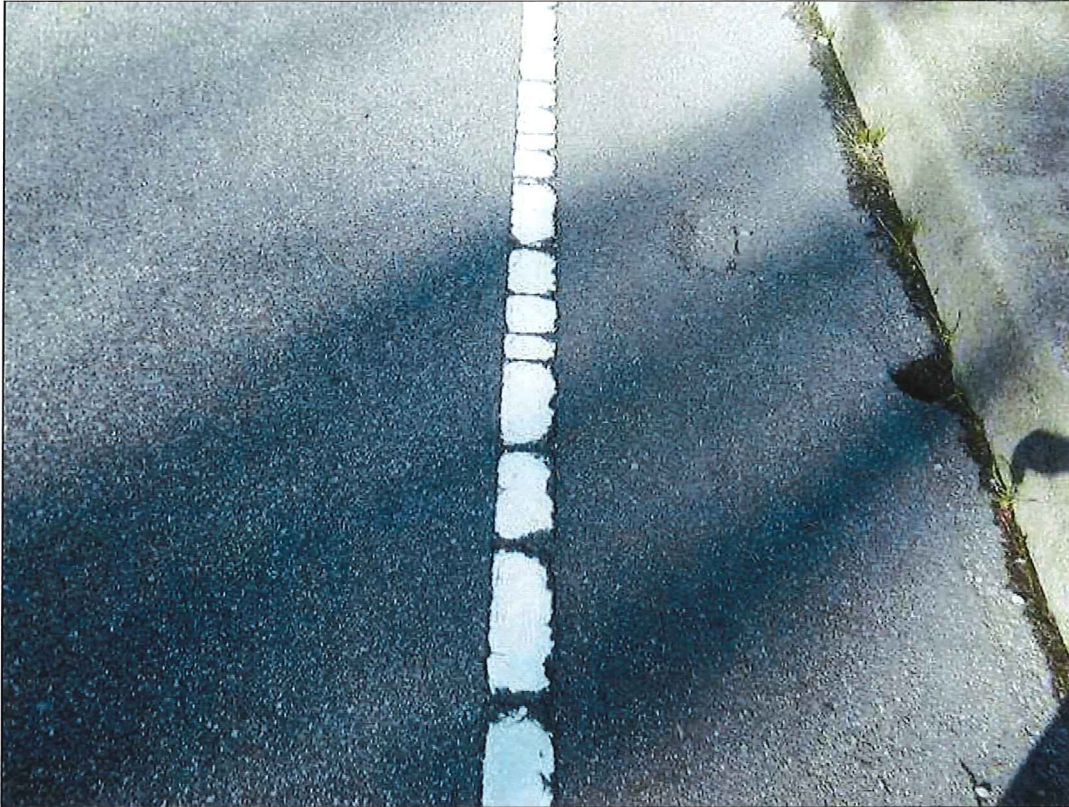
WEARING SURFACE

36 Square Feet of Crack (Wearing Surface): Width of more than 0.05 in. or spacing of less than 1.0 ft. in both lanes.

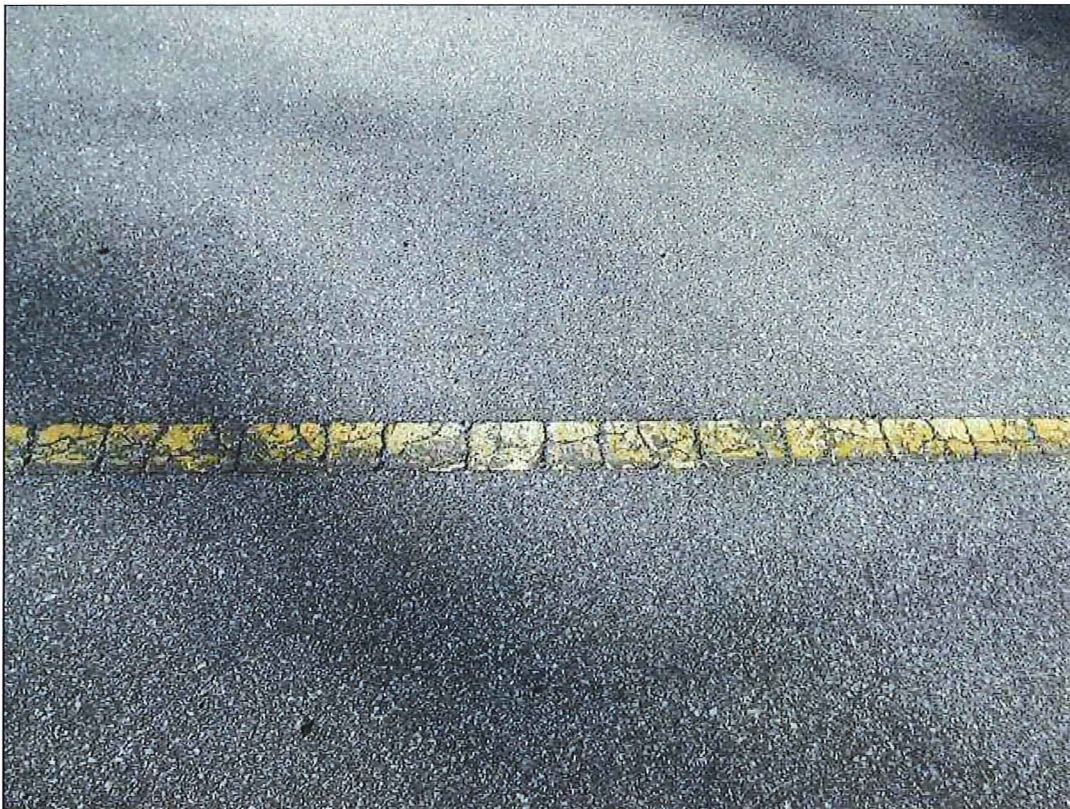
WEARING SURFACE

8 Square Feet of Crack (Wearing Surface): Width 0.012-0.05 in. or spacing of 1.0-3.0 ft.

2 Square Feet of Crack (Wearing Surface): Width of more than 0.05 in. or spacing of less than 1.0 ft.

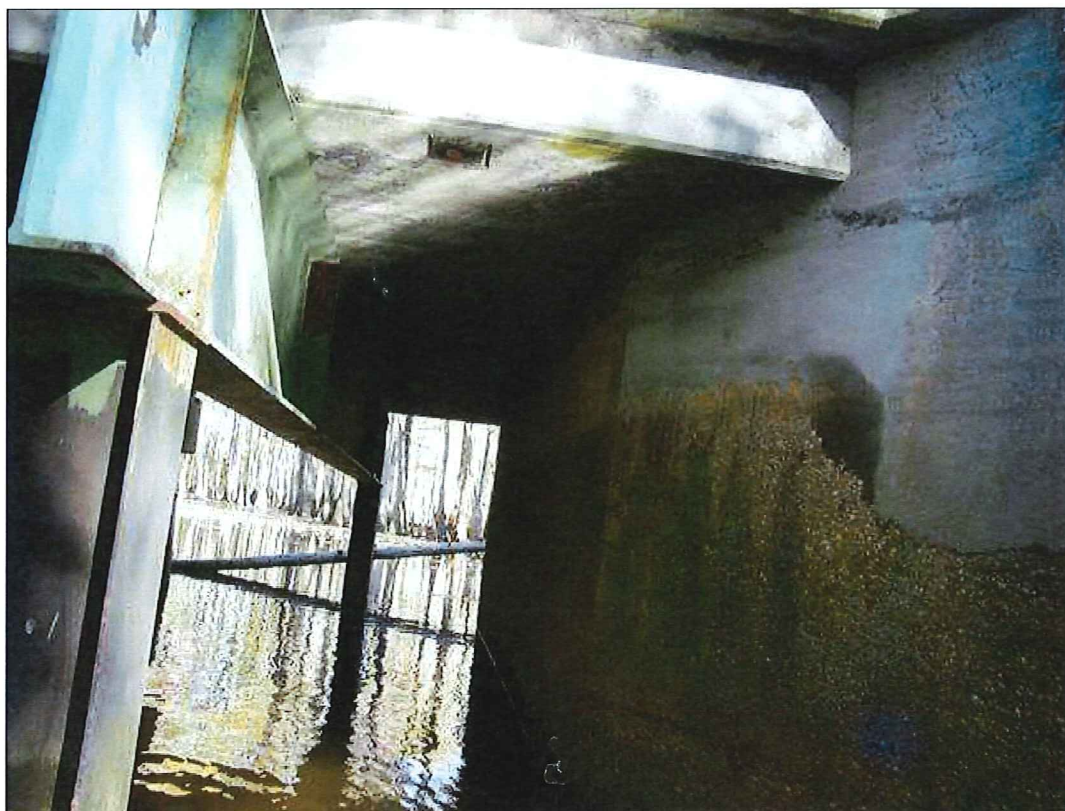
END BENT 1

End Bent 1:1 Feet of spalled Area: Spall greater than 1 in. deep or greater than 6 in. diameter. Area is 1' long, 84" below deck, and 1.5" deep. Does not warrant structural review.

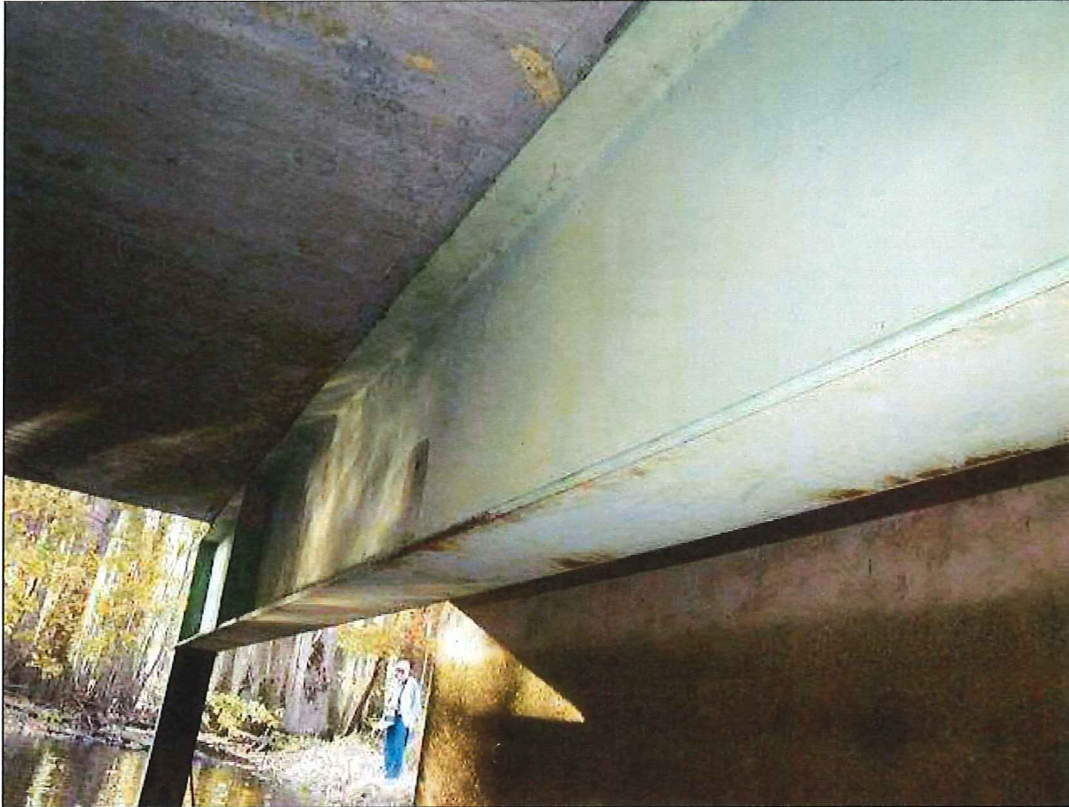
span 4 crutch bent, span 3 crutch similar
