# Structure Safety Report

## Routine Element Inspection

COUNTY: HALIFAX STRUCTURE NUMBER: 410066 FREQUENCY: 24 MONTHSFACILITY CARRIED: SR1100 MILE POST: LOCATION: 0.9MI. W JCT NC125FEATURE INTERSECTED: DEEP CREEKLATITUDE: 36° 4' 27.26" LONGITUDE: 77° 26' 19.59"SUPERSTRUCTURE: STEEL PLANK FLOOR ON CONT. I-BEAMS.SUBSTRUCTURE: E.BTS&INT.BT:TIMBER CAP/TIMBER PILES @ 6' CTS.SPANS: 1@21';1@19'6 CONTINUOUS☐ FRACTURE CRITICAL ☐ TEMPORARY SHORING ☐ SCOUR CRITICAL ☒ SCOUR PLAN OF ACTIONPRESENT CONDITION: Fair INSPECTION DATE: 08/24/2015POSTED SV: 31 POSTED TTST: 34OTHER SIGNS PRESENT: 4 DELINEATORS

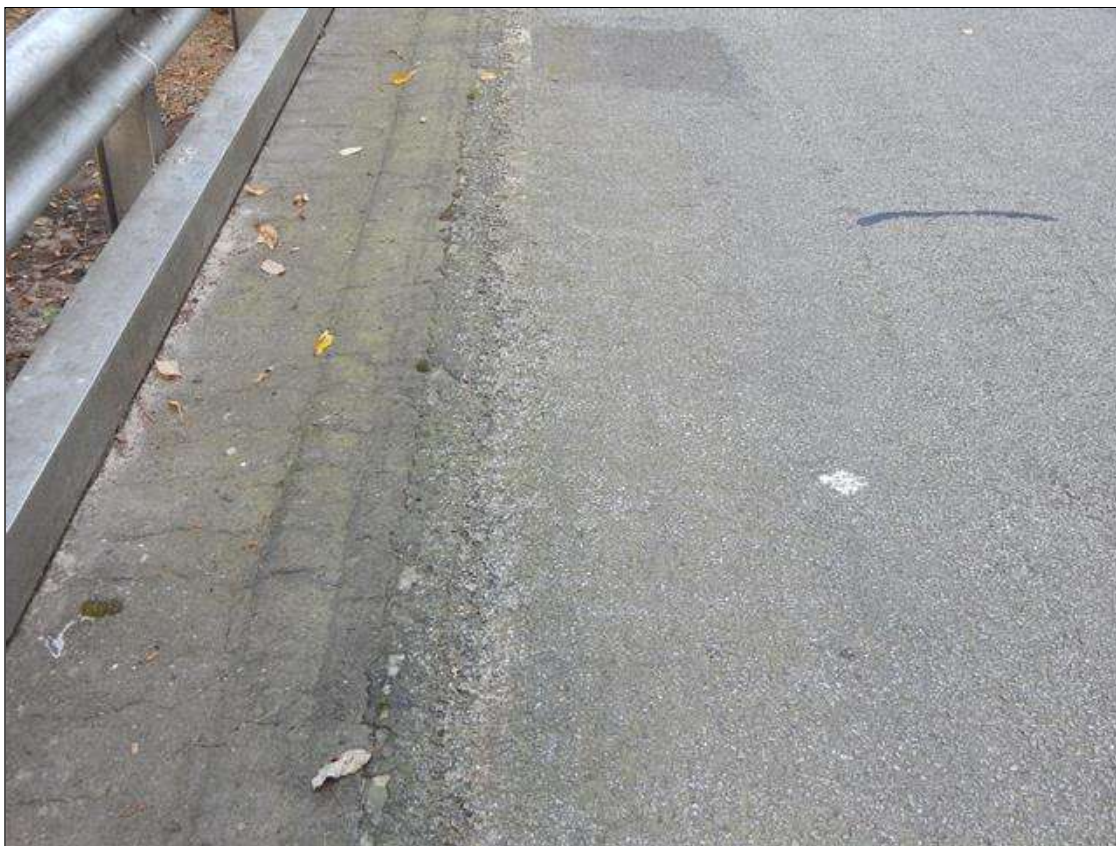
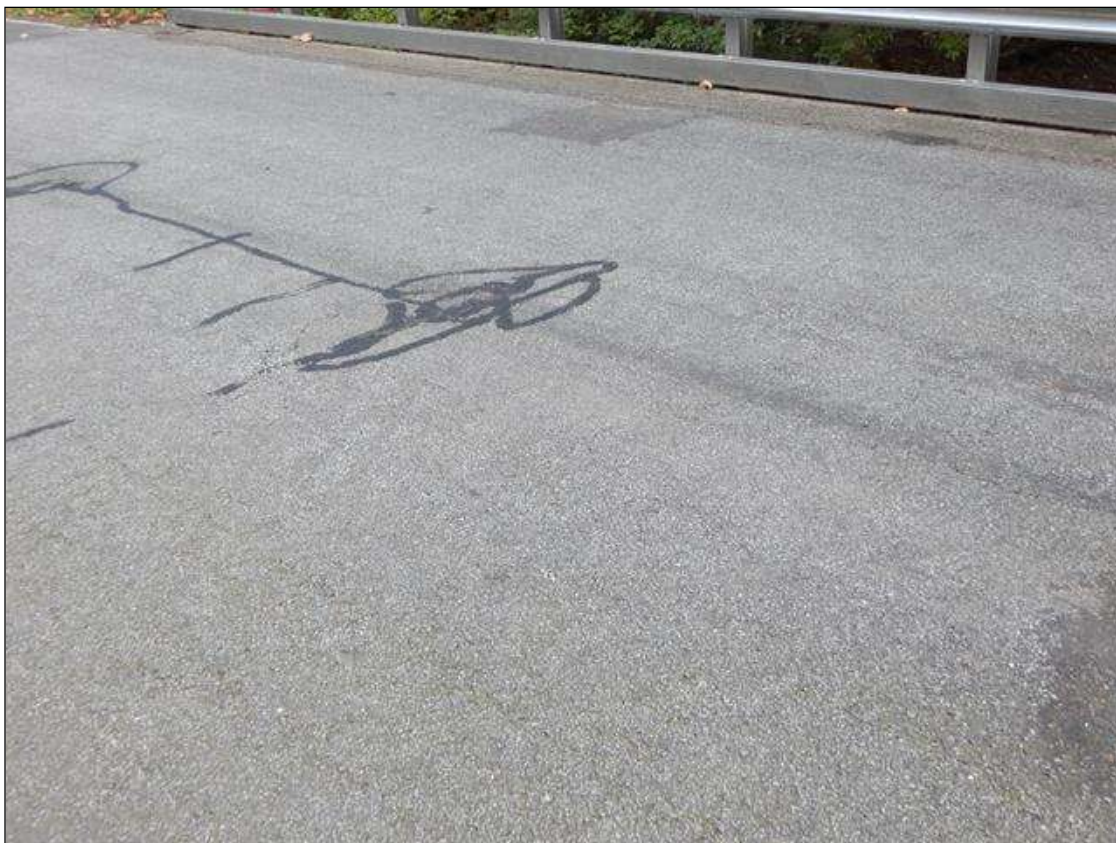
WEARING SURFACE

20 Square Feet of Crack (Wearing Surface): Width 0.012-0.05 in. or spacing of 1.0-3.0 ft.

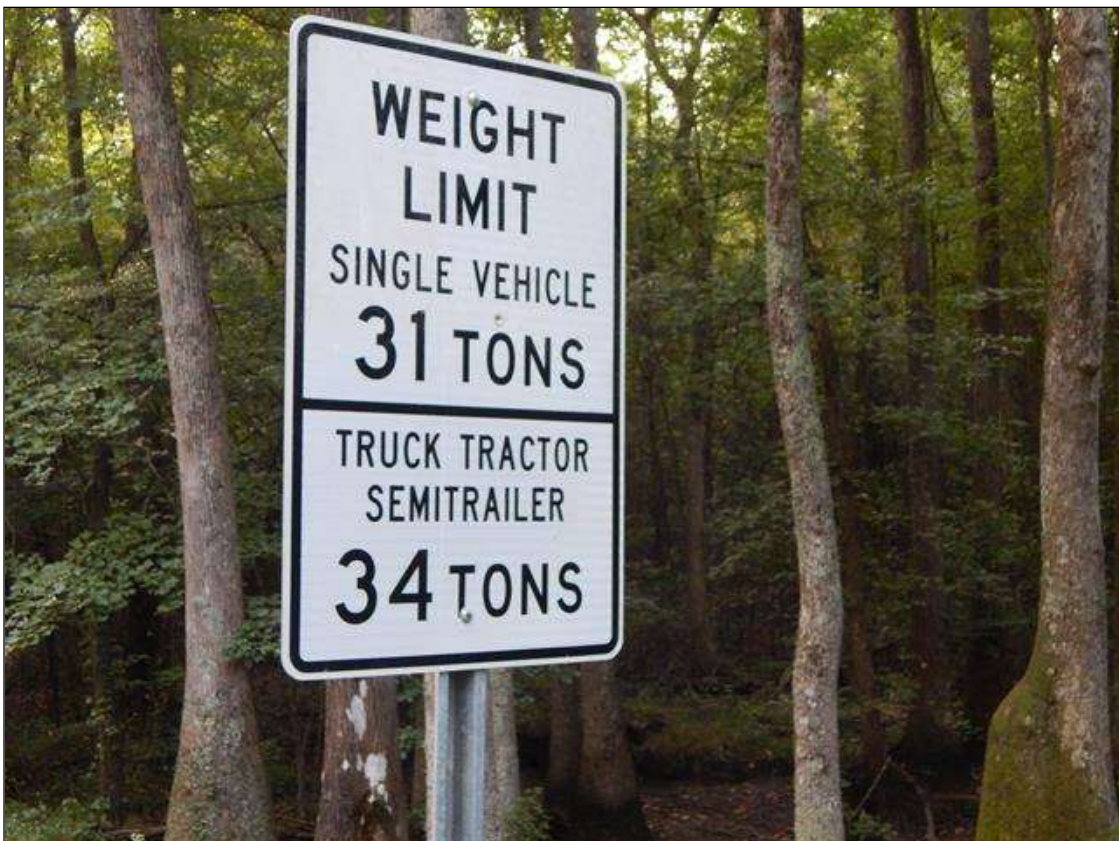
CLOSEUP OF WEIGHT LIMIT SIGN

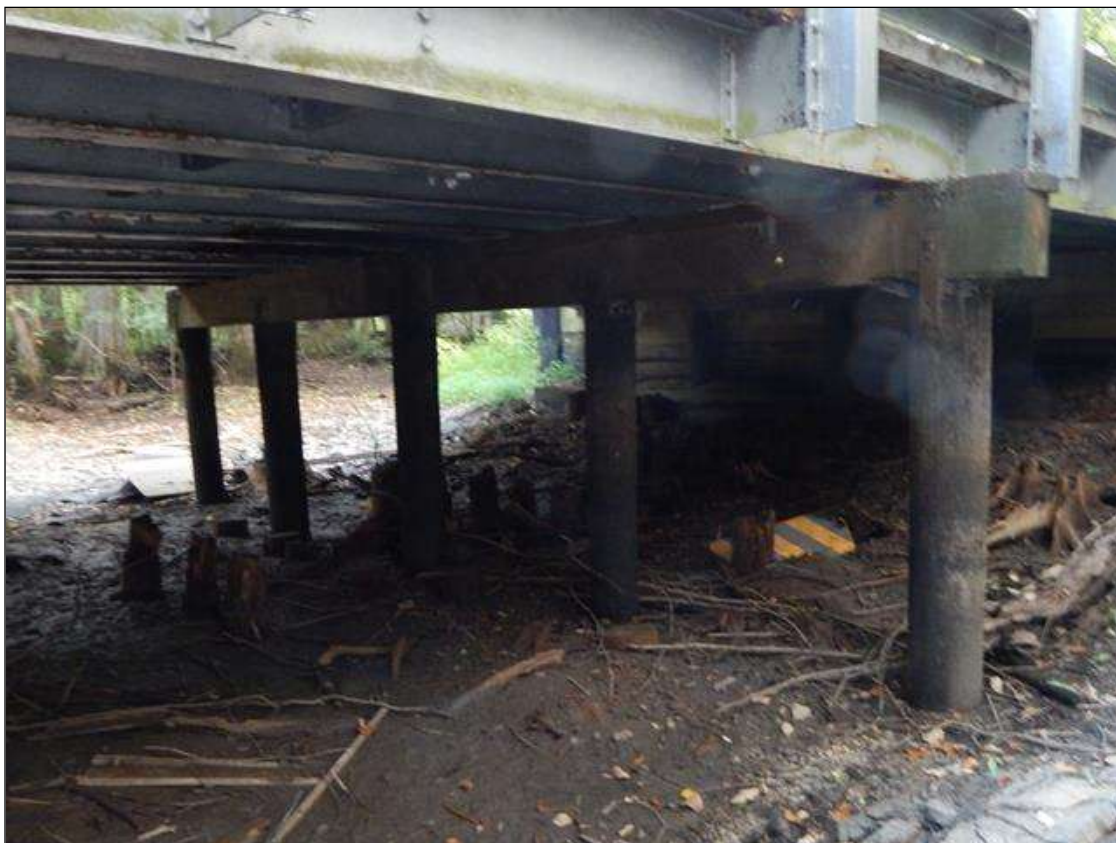
15 Feet of Corrosion OVER BENT 1, WITH DOWN TO 1/4" REMAINING.: Section loss is evident or pack rust is present but does not warrant structural review.

20 Feet of Corrosion OVER BENT 1 WITH DOWN TO 1/8" REMAINING IN FLANGES: Section loss is evident or pack rust is present but does not warrant structural review.

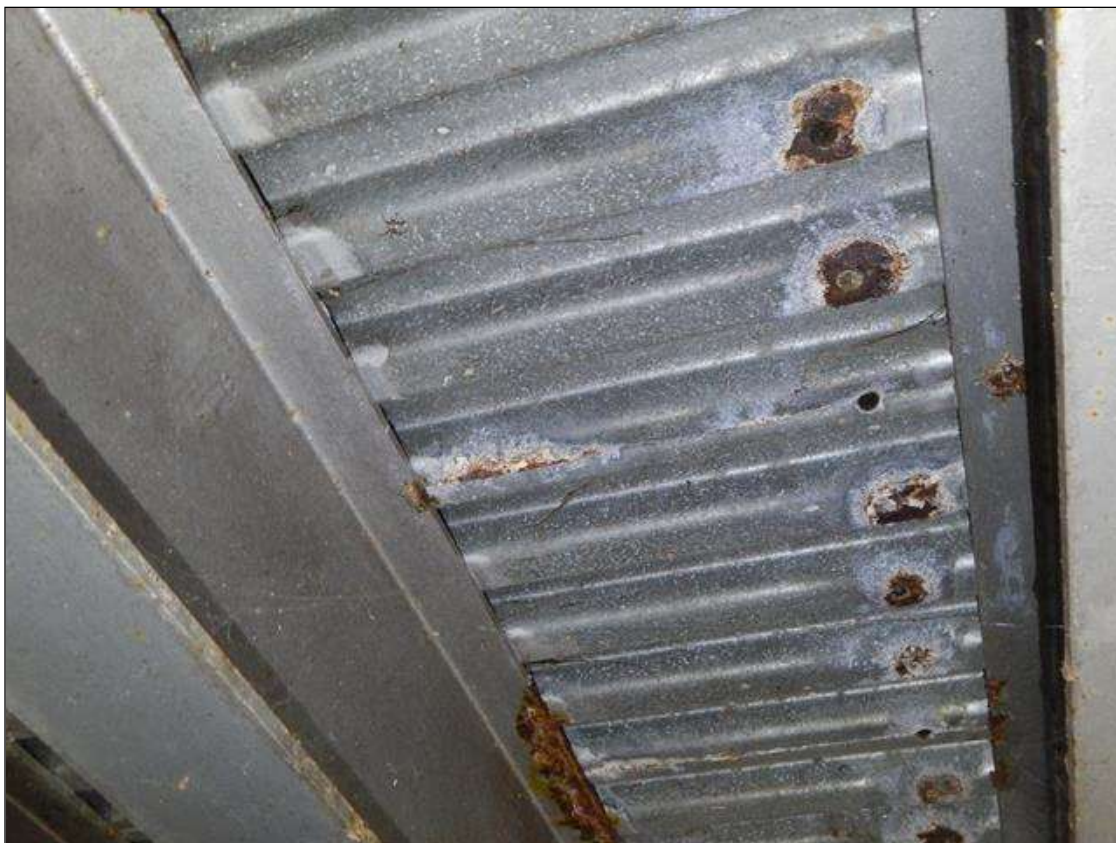
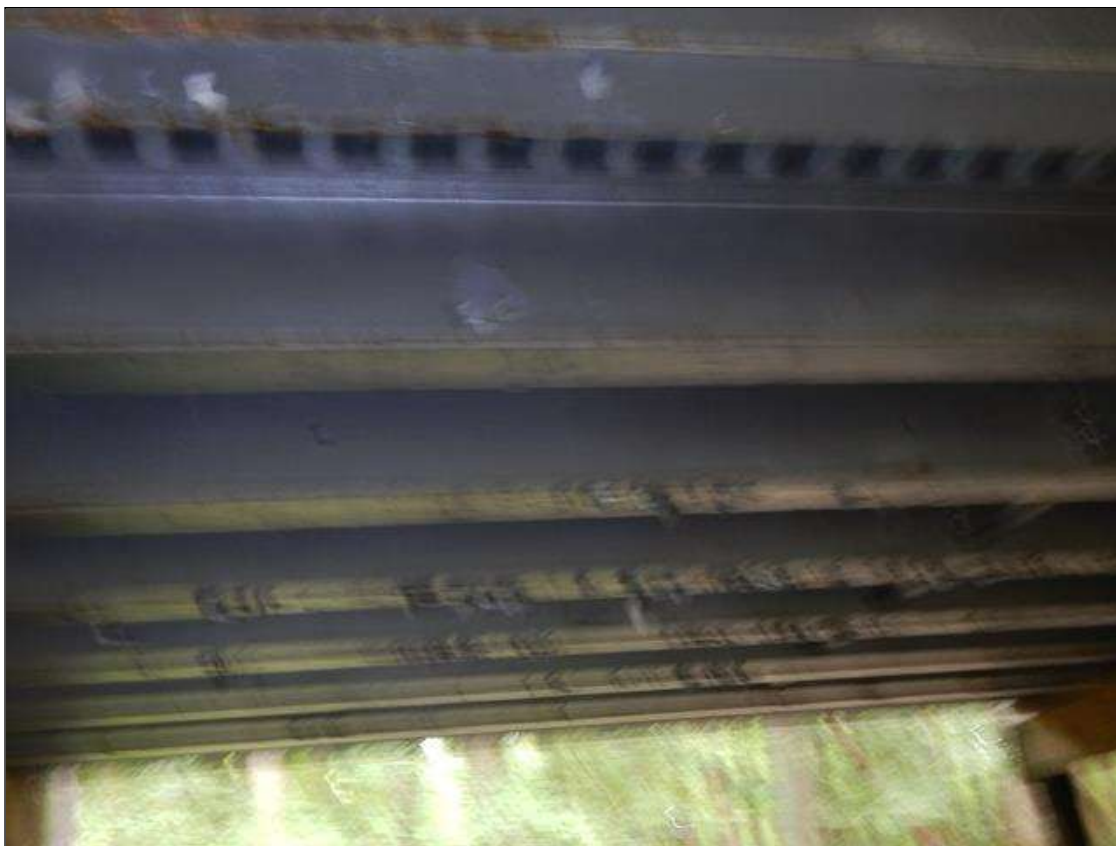
BOTTOM OF DECK

200 Square Feet of Corrosion: Section loss WITH DOWN TO 1/8" REMAINING is evident or pack rust is present but does not warrant structural review.

100 Square Feet of Corrosion: Freckled Rust. Corrosion of the steel has initiated.
