NC DEPARTMENT OF TRANSPORTATION  
DIVISION OF HIGHWAYS  
STRUCTURE MANAGEMENT UNIT

## Structure Safety Report

### Routine Element Inspection

COUNTY: JOHNSTON STRUCTURE NUMBER: 500046 FREQUENCY: 24 MONTHS  
FACILITY CARRIED: SR1124 MILE POST: \_\_\_\_\_  
LOCATION: 0.1 MI. N. OF SR1122  
FEATURE INTERSECTED: MILL CREEK  
LATITUDE: 35° 17' 16.38" LONGITUDE: 78° 25' 48.78"  
SUPERSTRUCTURE: PRESTRESSED CONCRETE CHANNELS(STD.BMD-13)  
SUBSTRUCTURE: E.BTS&BTS:PPC CAPS TIM.PILES@BT.1PILE3 SPLICED ENC.W/CONC.  
SPANS: 3@30'  
☐ FRACTURE CRITICAL ☐ TEMPORARY SHORING ☐ SCOUR CRITICAL ☒ SCOUR PLAN OF ACTION  
PRESENT CONDITION: Fair INSPECTION DATE: 12/08/2015  
POSTED SV: 26 POSTED TTST: 30  
OTHER SIGNS PRESENT: 4 Delineators

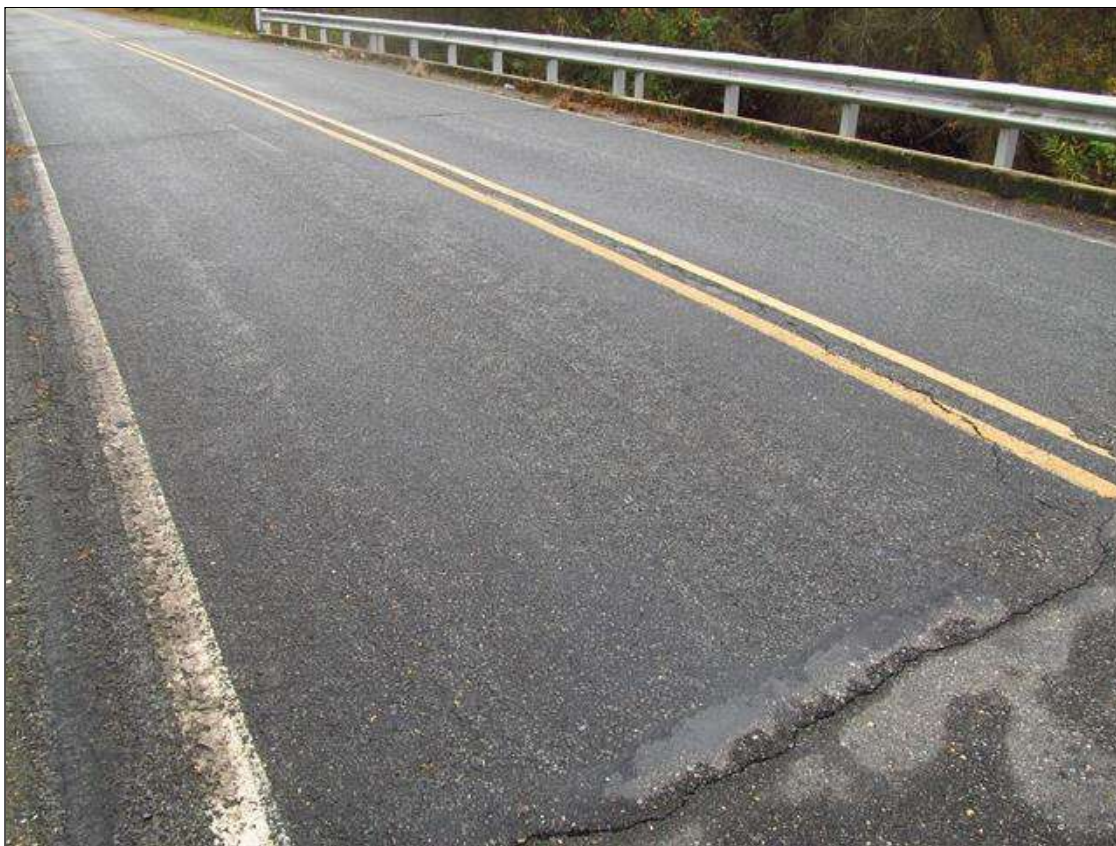
24 Square Feet of Cracking over End Bent 1 (Wearing Surface): Width of more than 0.05 in. or spacing of less than 1.0 ft.

30 Square Feet of longitudinal Cracking along centerline of span (Wearing Surface): Width of more than 0.05 in. or spacing of less than 1.0 ft.

Span 1 Asphalt wearing surface overview
