NC DEPARTMENT OF TRANSPORTATION  
DIVISION OF HIGHWAYS  
STRUCTURE MANAGEMENT UNIT

## Structure Safety Report

### Routine Element Inspection - Contract

COUNTY: JOHNSTON STRUCTURE NUMBER: 500145 FREQUENCY: 24 MONTHS

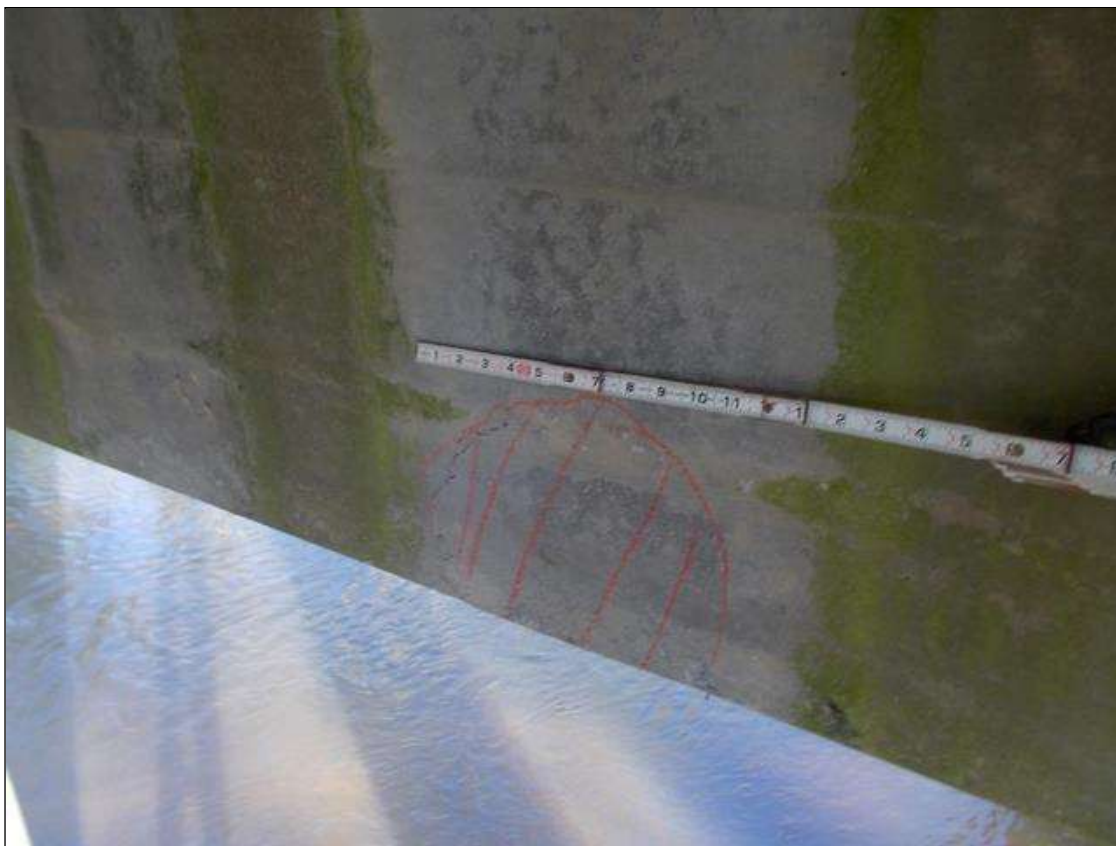
Bent 2 Cap : 10" DIAMETER DELAMINATION, SPAN 2 FACE, BOTTOM OF CAP, NEAR MIDSPAN.

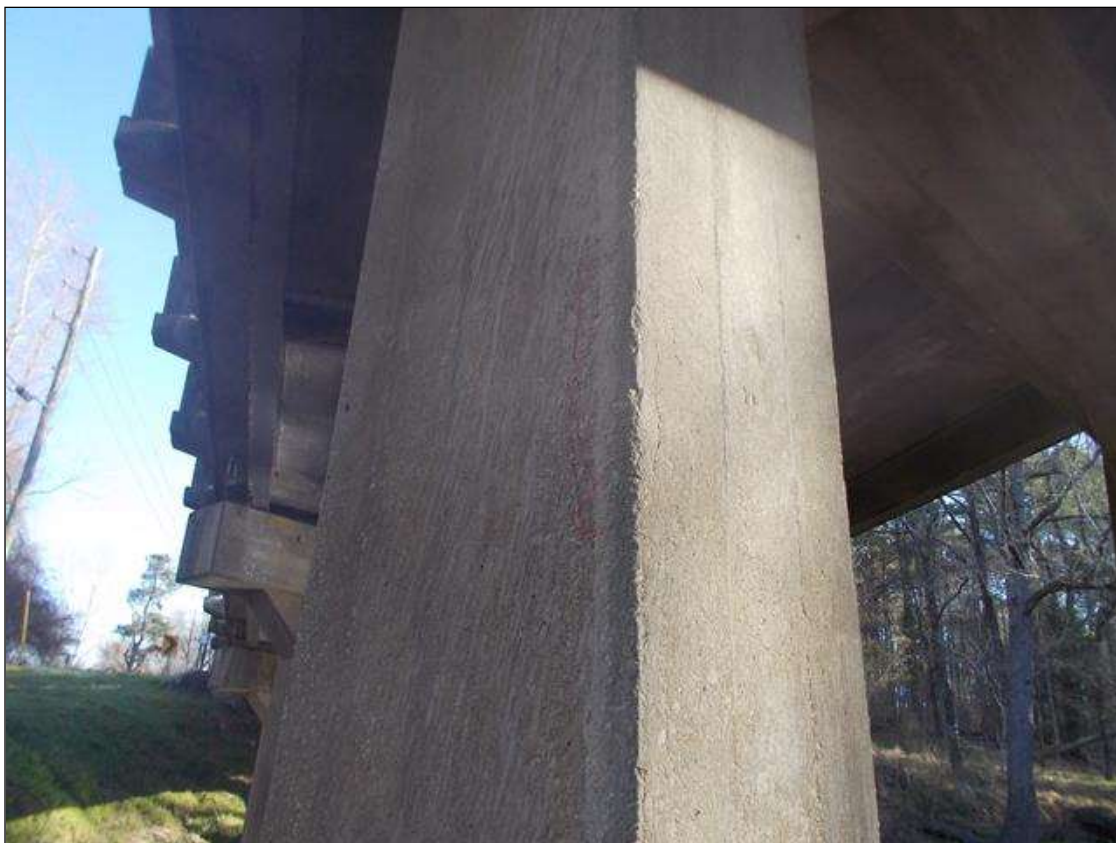
Bent 2 Pile 1: 14" X 3" DELAMINATION, UPSTREAM FACE, MID HEIGHT.

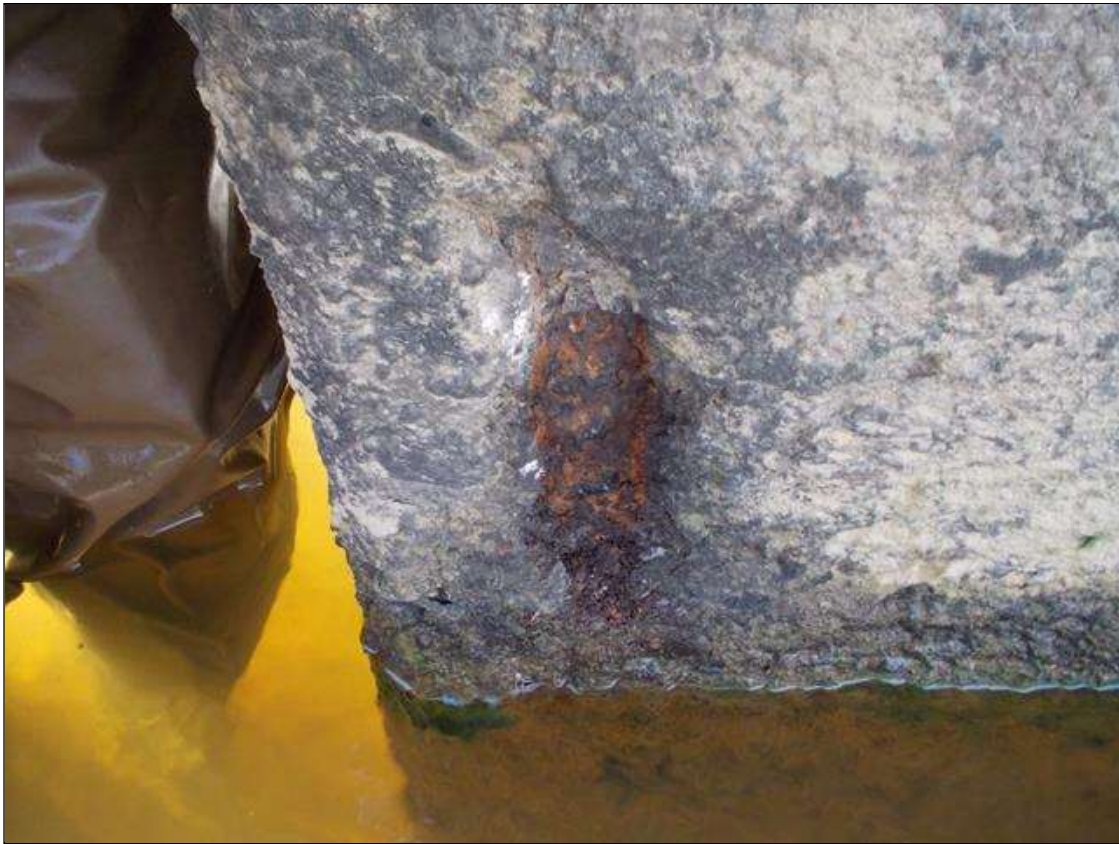
Bent 2 Pile 2: 9" SECTION OF EXPOSED REINFORCING WITH MINOR SECTION LOSS, SPAN 3 FACE, AT WATER SURFACE. (PRIORITY MAINTENANCE)

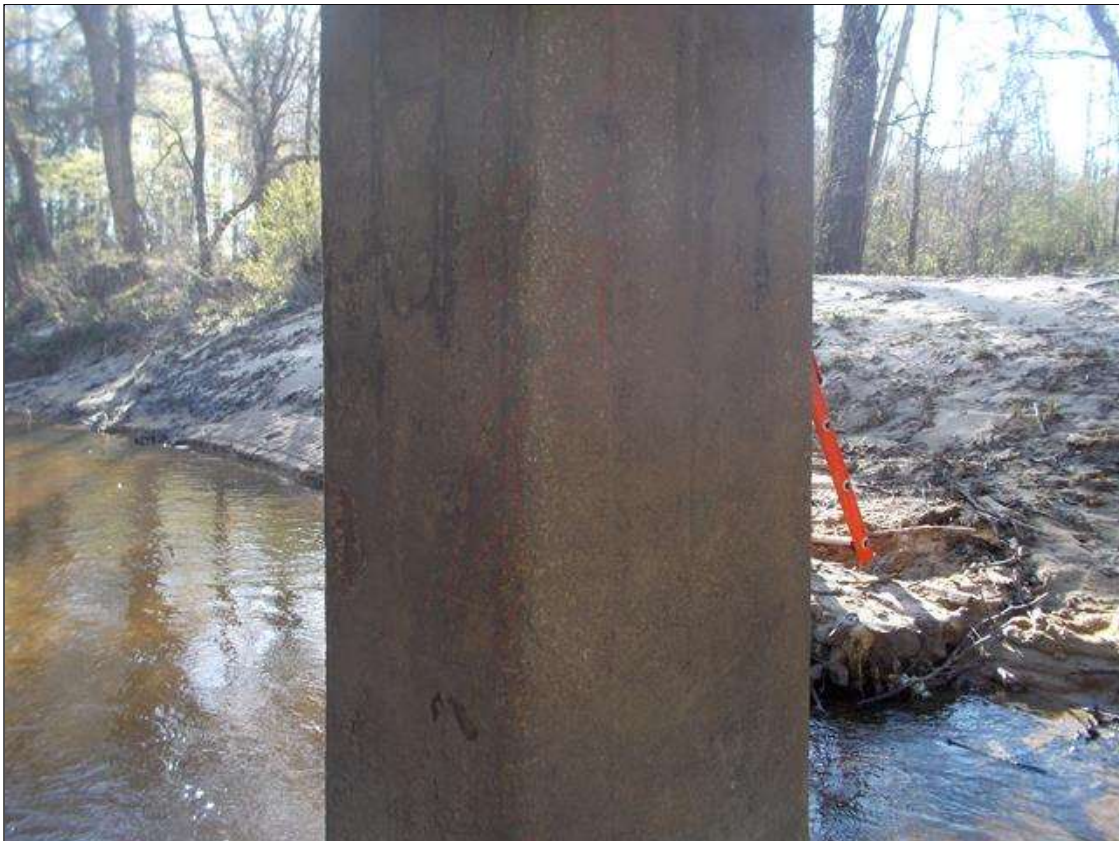
Bent 2 Pile 2: 30"X6" CORNER DELAMINATION ON UPSTREAM FACE, 12"X6" ON SPAN 3 FACE, MID-HEIGHT.

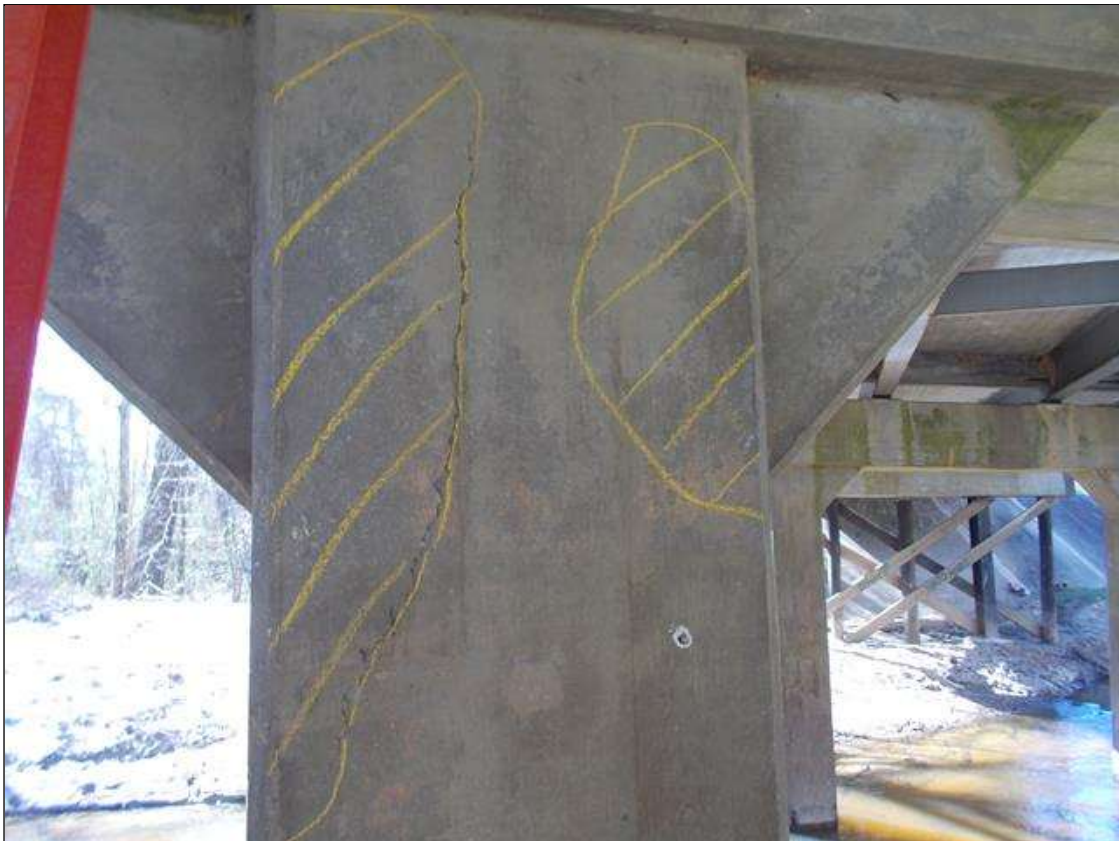
Bent 3 Pile 2: (2) DELAMINATIONS, 36" X 9" X 3" CORNER DELAMINATION, 16" X 10" DELAMINATION, BOTH AT TOP OF COLUMN, SPAN 4 FACE.

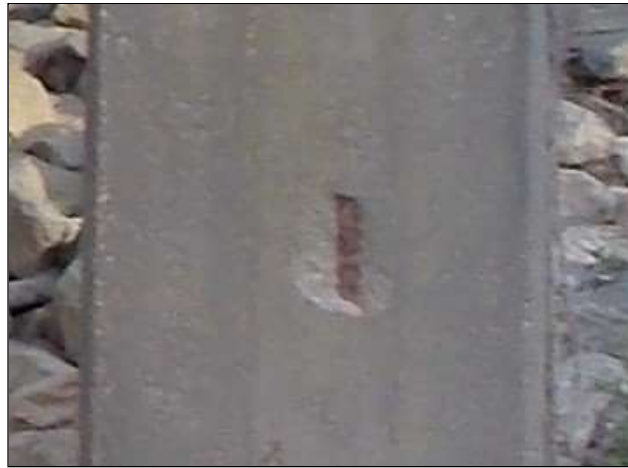
Bent 4 Pile 2: 6" X 3" X 1/2" SPALL WITH EXPOSED REINFORCING, SPAN 4 FACE, 4' FROM GROUND.  
(PRIORITY MAINTENANCE)

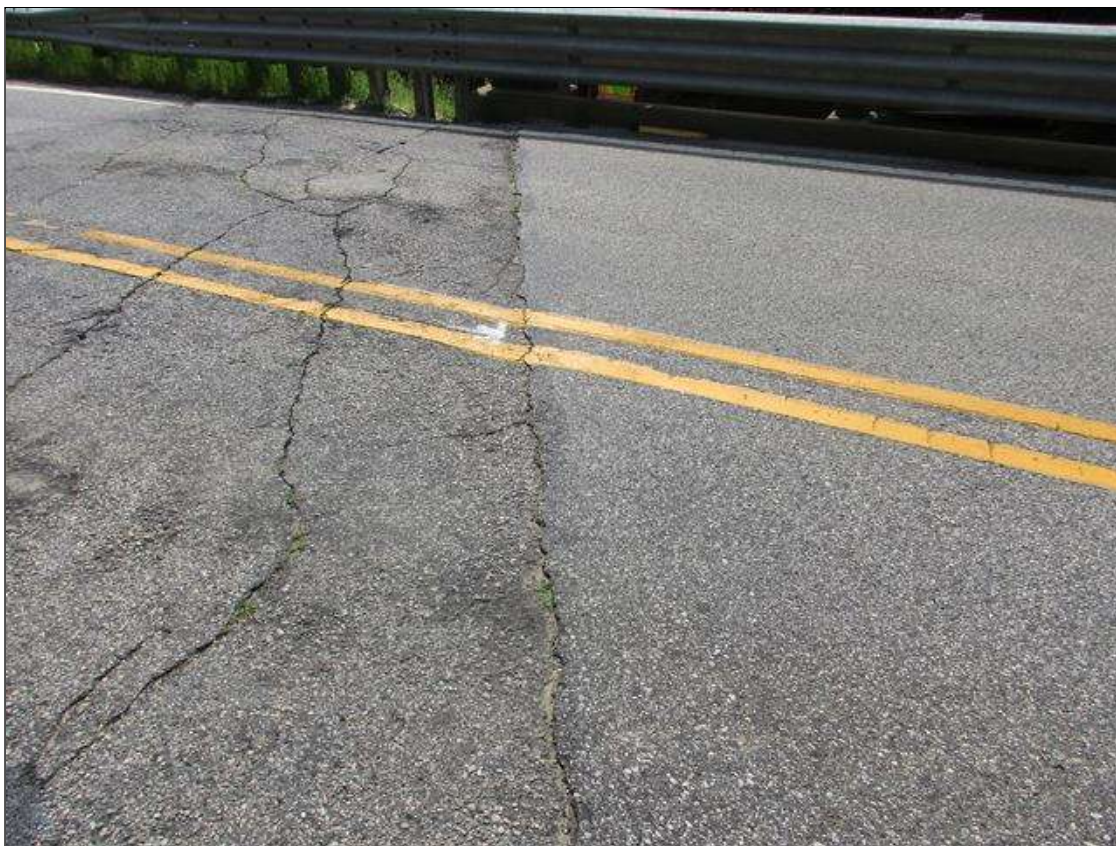
CRACK IN ASPHALT WEARING SURFACE OVER END BENT 1, LOOKING WEST

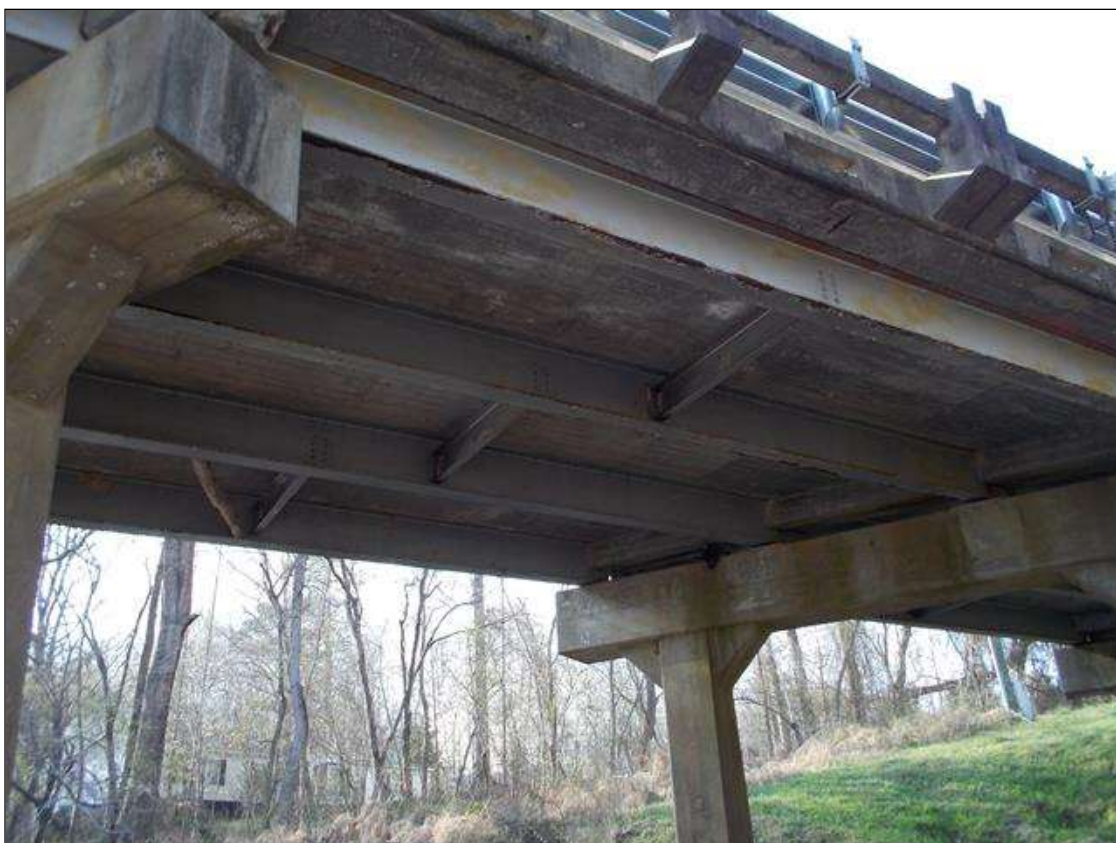
BENT 3 ELEVATION, LOOKING NORTH

Bent 3 Cap : 4' X 1/32" CRACK, BENEATH BAY 1, SPAN 3 FACE.

Bent 3 Cap : 24" X 10" DELAMINATION WITH 1/32" WIDE HAIRLINE LONGITUDINAL CRACK, SPAN 3 FACE, BENEATH BEAM 2.

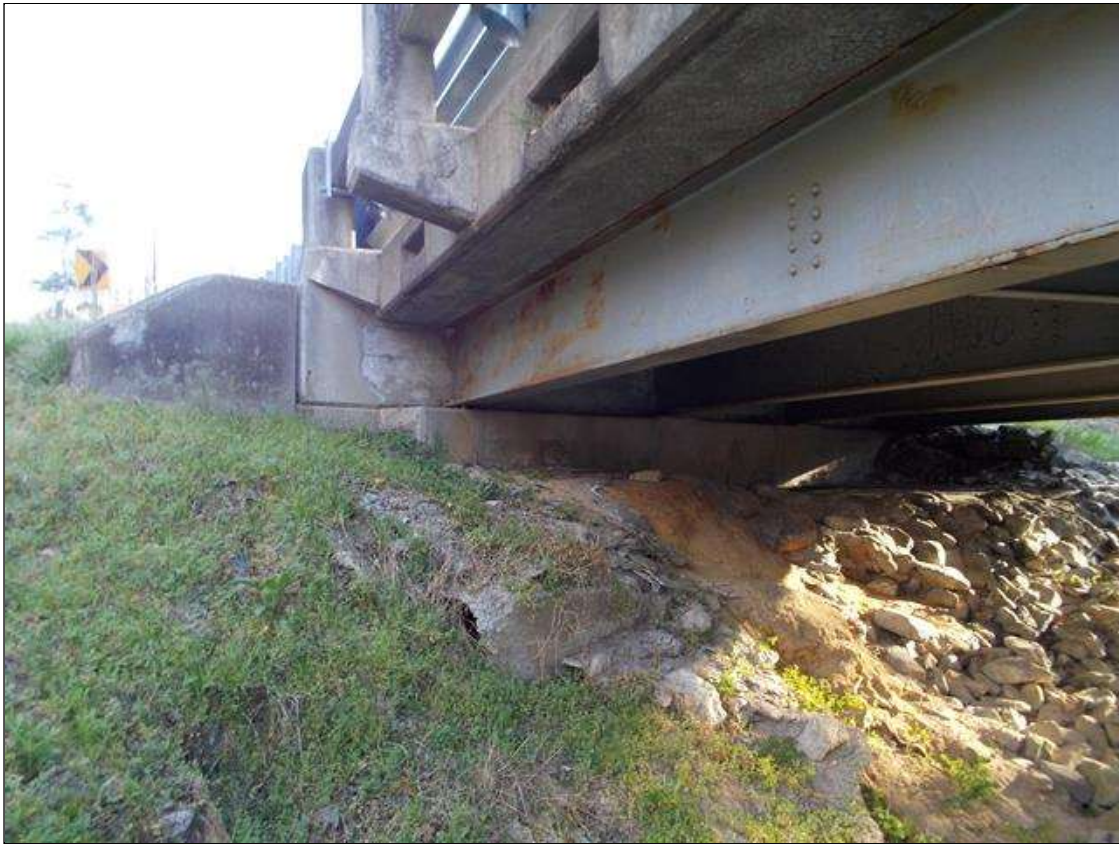
SUPERSTRUCTURE UNDERSIDE SPAN 4

Span 4 Beam 1: 5' RUST SCALE WITH SECTION LOSS, 0.5" REMAINING, BOTTOM FLANGE AND EXTENDING 3" IN THE WEB, AT BENT 3 BEARING (PRIORITY MAINTENANCE).

Span 4 Beam 3: 1' RUST SCALE WITH SECTION LOSS, 0.44" REMAINING, WEB AT BENT 3 DIAPHRAGM (PRIORITY MAINTENANCE).

Span 4 Beam 4: 1' RUST SCALE WITH SECTION LOSS, 0.45" REMAINING, BOTTOM FLANGE AND WEB, AT BENT 3 BEARING (PRIORITY MAINTENANCE).

Span 4 Beam 4: 1' RUST SCALE WITH SECTION LOSS, 0.3" REMAINING, BOTTOM FLANGE AND WEB, AT BENT 4 BEARING (PRIORITY MAINTENANCE).

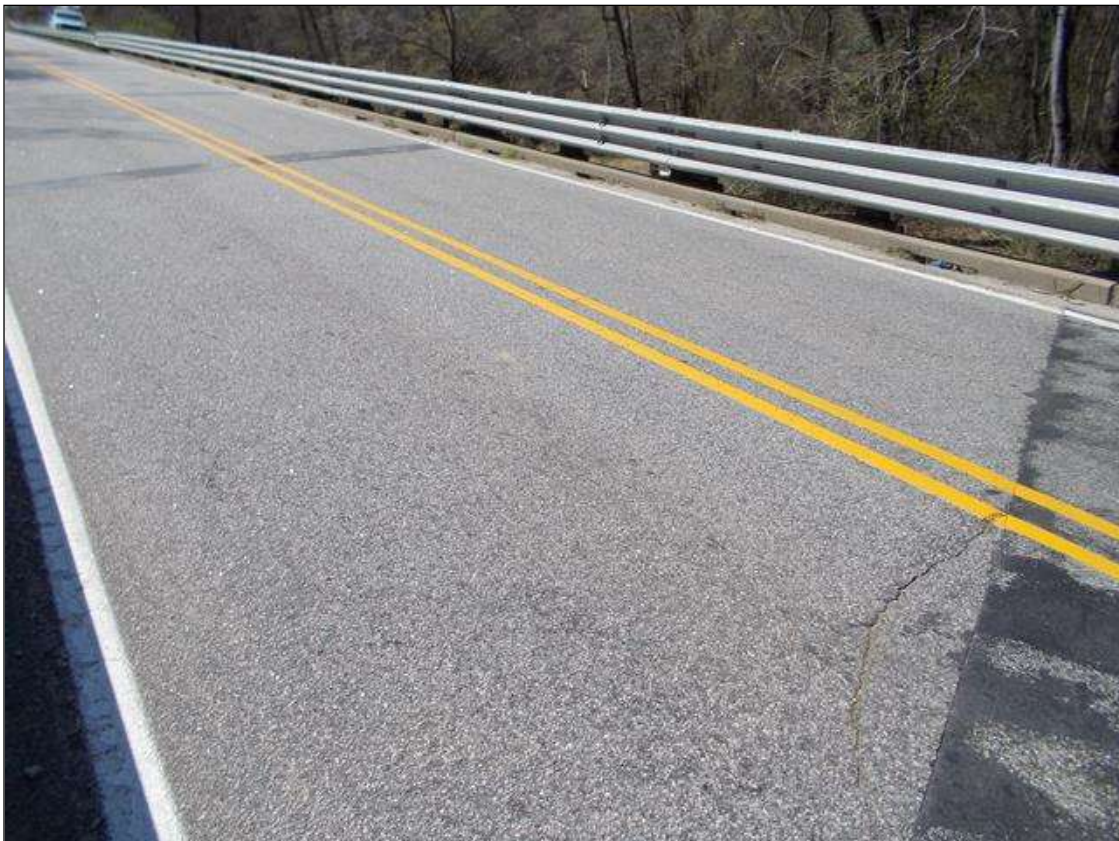
ASPHALT WEARING SURFACE, SPAN 5, LOOKING WEST

Span 5 Wearing Surface: 10' X UP TO 1/8" LONGITUDINAL CRACK, 3' FROM LEFT RAIL, MEASURED FROM BENT 4.
