NC DEPARTMENT OF TRANSPORTATION  
DIVISION OF HIGHWAYS  
BRIDGE MANAGEMENT UNIT

# BRIDGE INSPECTION REPORT

INSPECTION TYPE: Routine Inspection

COUNTY JOHNSTON BRIDGE NUMBER 500216 INSPECTION CYCLE 2 YRS  
ROUTE SR2143 ACROSS LITTLE BUFFALO CREEK M.P. 0

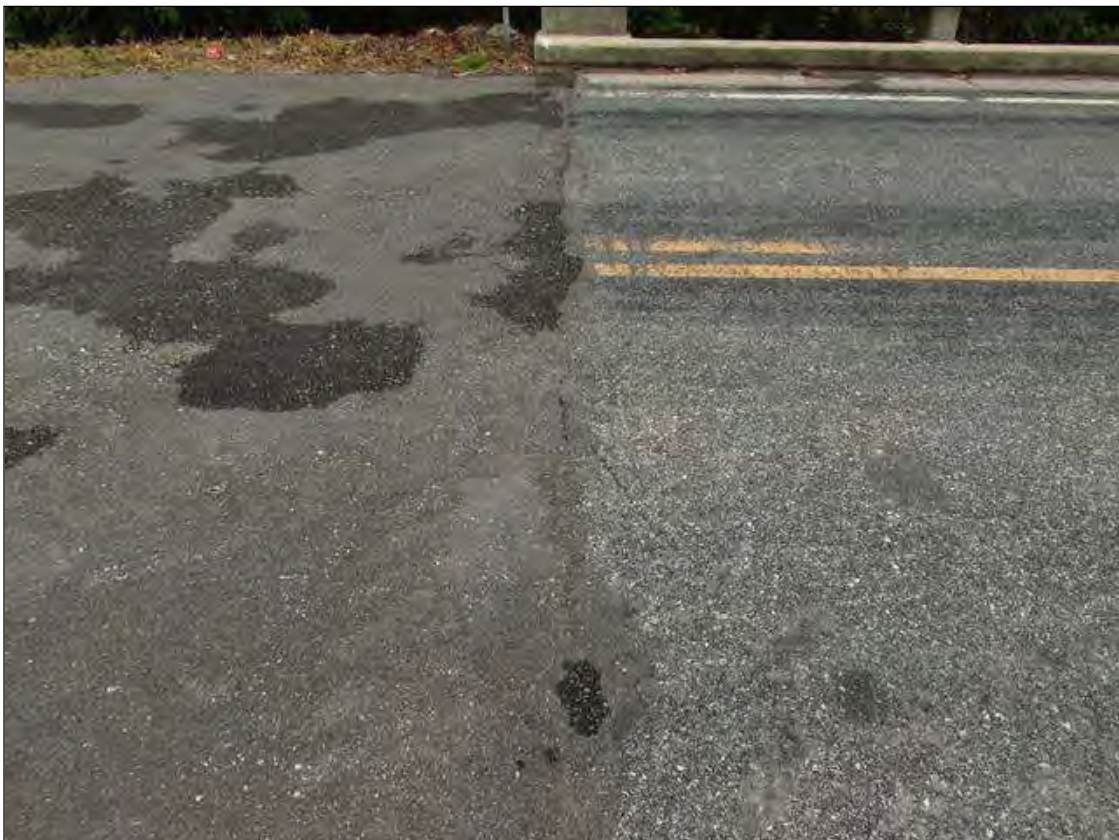
JOINT AT END BENT 1

| 6d | P | STANDARD JOINTS<br>JOINTS ARE LEAKING , ALL CAPS AND ENDS OF JOISTS ARE WET. | |

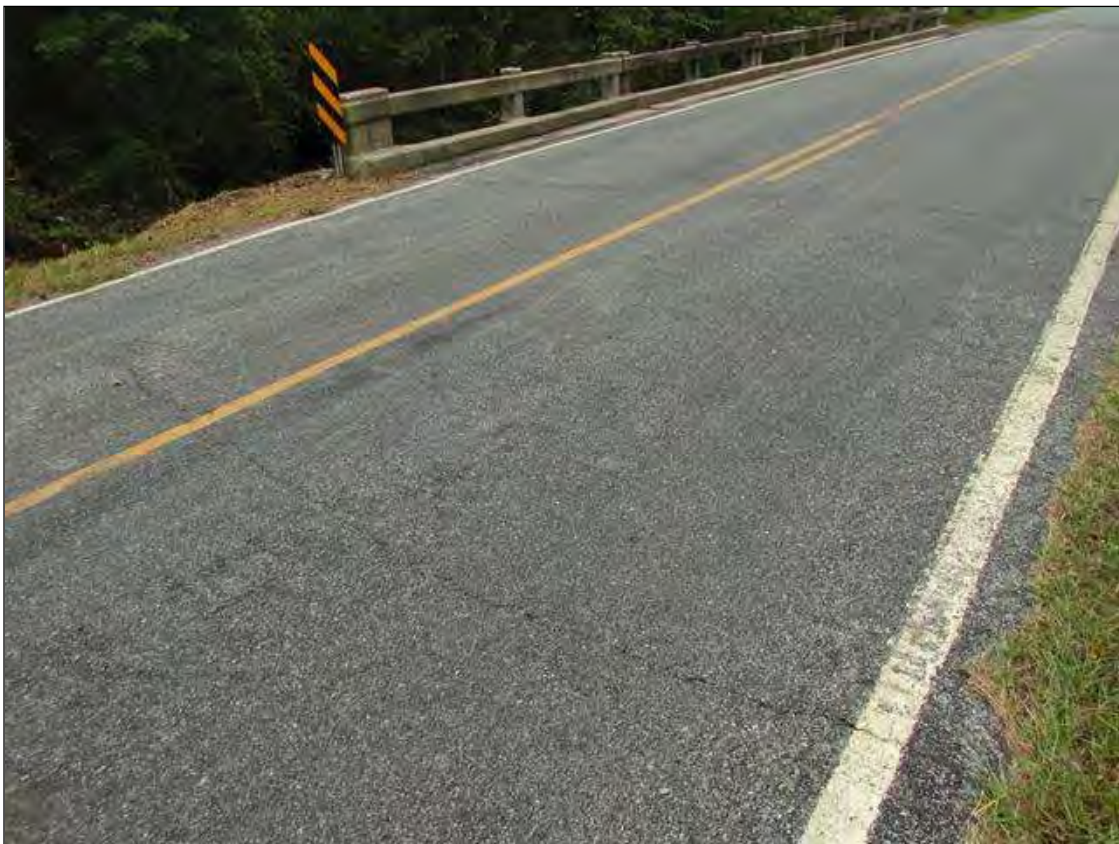
| 50 | F | <p>APPROACH ROADWAY CONDITION</p> <p>APPROACH 1</p> <p>THE ASPHALT IN APPROACH 1 AT END BENT 1 HAS BEEN REPLACED THE FULL WIDTH OUT 15 FT.</p> <p>APPROACH 2</p> <p>TRANSVERSE CRACK IN ASPHALT OVER END BENT 2 WITH 1/2 IN. SETTLEMENT .</p> | |

| MMS Code | Description of Function | Unit | Quantity | Remarks | Est. Cost |
|---|---|---|---|---|---|
| 2816 | Asphalt Surface Repair or Replacement | SY | 150 | APPROACH 2 CRACKED SETTLED. ASPHALT OVER EXPANSION JOINTS CRACKED. | |

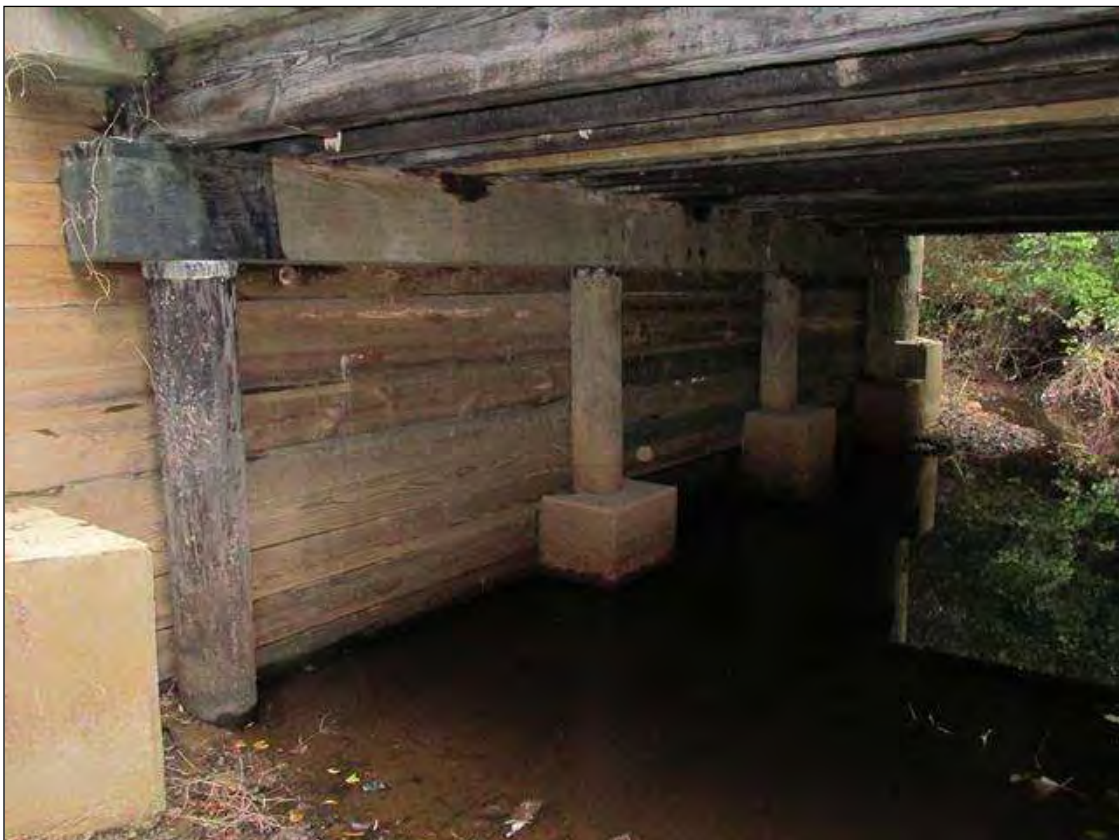
END BENT 1 OVERVIEW

| 35b | F | <p>TIMBER PILES<br/> WEATHERING CRACKS AND SOFTNESS IN FACES.<br/> END BENT 1<br/> PILES 1,2,3 HAVE BEEN SPLICED AND HAVE A 30 IN. X 30 IN. CONCRETE COLLAR.<br/> PILE 4 END BENT 1 SOUNDS HOLLOW WHEN STRUCK, SHELL IS STILL SOLID.</p> <p>BENT 1<br/> PILE 1 HAS BEEN SPLICED AND HAS A 24 IN. DIAMETER CONCRETE COLLAR.<br/> PILES 2 AND 3 HAVE BEEN SPLICED AND HAVE 30 IN. X 30 IN. CONCRETE COLLARS.</p> <p>BENT 2<br/> PILE 1 HAS BEEN SPLICED AND HAS A 24 IN. DIAMETER CONCRETE COLLAR.<br/> CONCRETE HAS A 3/8 IN. WIDE CRACK.<br/> PILE 2 HAS BEEN SPLICED AND HAS A 4 FT. PIECE OF 10 IN. I-BEAM BOLTED TO THE LEFT AND RIGHT SIDE WITH 8 IN. WIDE X 2 1/2 IN. DEEP DECAY IN ORIGINAL CUTOFF PILE FROM CUT TO GROUND LINE.<br/> PILE 3 HAS BEEN SPLICED AND HAS A 30 IN. X 30 IN. CONCRETE COLLAR.</p> <p>BENT 3<br/> ALL PILES HAVE BEEN SPLICED AND HAVE 30 IN. X 30 IN. CONCRETE COLLARS.</p> <p>BENT 4<br/> PILES 1,2, AND 4 HAVE BEEN SPLICED AND HAVE 30 IN. X 30 IN. , 30 IN. DIAMETER , AND 30 IN. X 30 IN. CONCRETE COLARS RESPECTIVELY.</p> <p>END BENT 2<br/> ALL PILES HAVE BEEN SPLICED AND HAVE 24 IN. X 24 IN. CONCRETE COLLARS.</p> | |

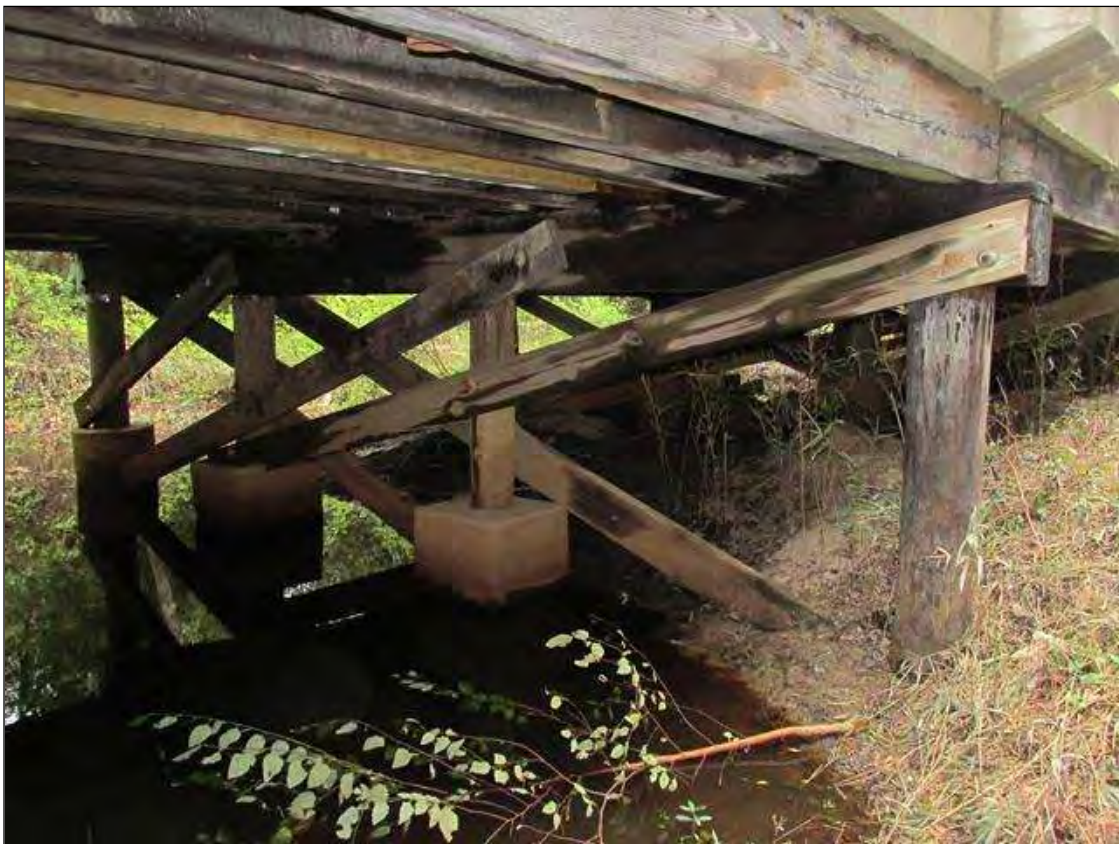
BENT 1 SPAN 1 SIDE - OTHER BENTS SIMILAR

| 35a | F | <p>TIMBER CAPS<br/> WEATHERING CRACKS AND UP TO 1/2 IN. DEEP SOFTNESS IN FACES . ALL CAPS AND CROWNSTRIPS ARE WET.<br/> END BENT 1<br/> CAP AND CROWNSTRIP ARE REPLACEMENTS.<br/> BENT 1<br/> SPAN 1 AND SPAN 2 SIDE OF CAP IS SOFT UP TO 1/2 IN. DEEP .<br/> RIGHT END OF BENT 1 CAP DECAYED 5 IN. WIDE X 4 IN. HIGH X 14 IN. LONG IN THE BOTTOM CORNER. PRIORITY MAINTENANCE ISSUED<br/> RIGHT END OF BENT 1 CROWNSTRIP DECAYED 2 IN. WIDE X 2 IN. HIGH X 7 IN. LONG.<br/> BENT 2<br/> LEFT END OF CAP DECAYED 1 IN. WIDE X 2 IN. HIGH X 1 IN. DEEP.<br/> BENT 4<br/> THE LEFT END OF BENT 4 CAP IS DECAYED 2 IN. DIAMETER X 7 IN. DEEP AND DECAYED 4 IN. DIAMETER EXTENDING 21 IN. INTO THE SPAN 5 SIDE FACE 4 IN. HIGH X 2 IN. DEEP BEHIND THE CROSSBRACE CONNECTION OVER PILE 1. THERE IS A 1/4 WIDE SPLIT IN THE AREA OF DECAY 2 IN. DEEP IN THE SPAN 5 SIDE. PRIORITY MAINTENANCE ISSUED<br/> END BENT 2<br/> 1 TO 2 IN. OF DIRT ON TOP OF END BENT 2 CAP.</p> | |
