NC DEPARTMENT OF TRANSPORTATION  
DIVISION OF HIGHWAYS  
STRUCTURE MANAGEMENT UNIT

## Structure Safety Report

### Routine Element Inspection - Contract

COUNTY: ROWAN STRUCTURE NUMBER: 790063 FREQUENCY: 24 MONTHS

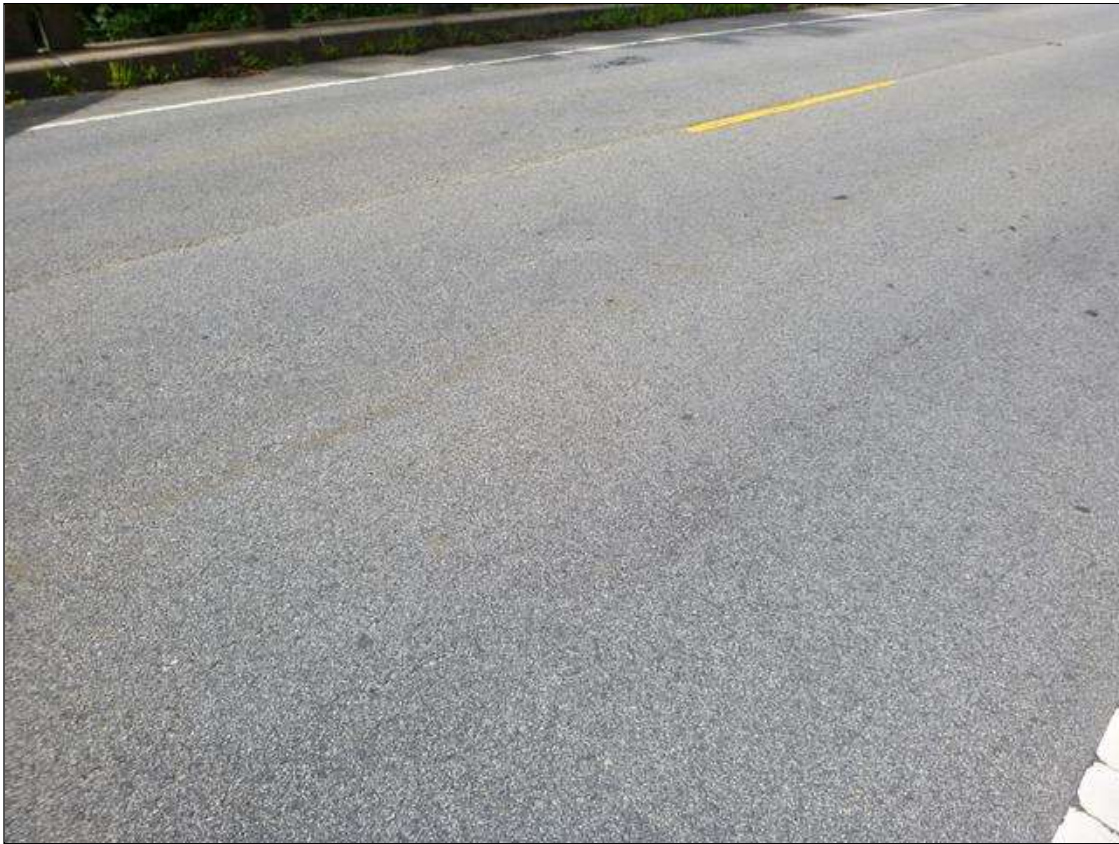
30' TRANSVERSE CRACK UP TO 1/8" IN ASPHALT WEARING SURFACE, OVER END BENT 1.

40' LONGITUDINAL CRACK UP TO 1/8" AT CENTERLINE.

UP TO 25% OF AREA HAS HAIRLINE MAP CRACKING UP TO 1/16" AT 5' SPACING, WEST BOUND LANE.

ASPHALT WEARING SURFACE, SPAN 1, LOOKING SOUTH

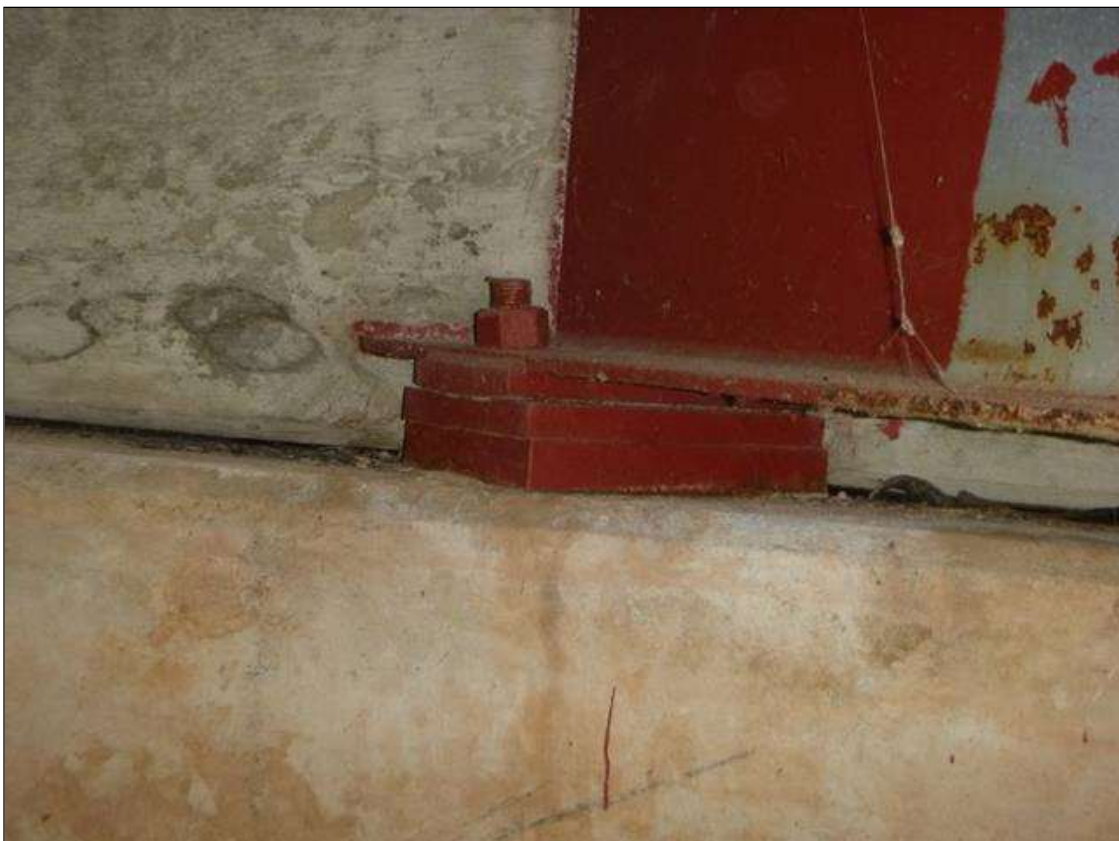
CORROSION ON FAR BEARING ASSEMBLY UP TO 50%, WITH RUST STAINING AND EFFLORESCENCE ON CAP BELOW.

BEARING ASSEMBLY, END BENT 2, BEAM 3, LOOKING EAST

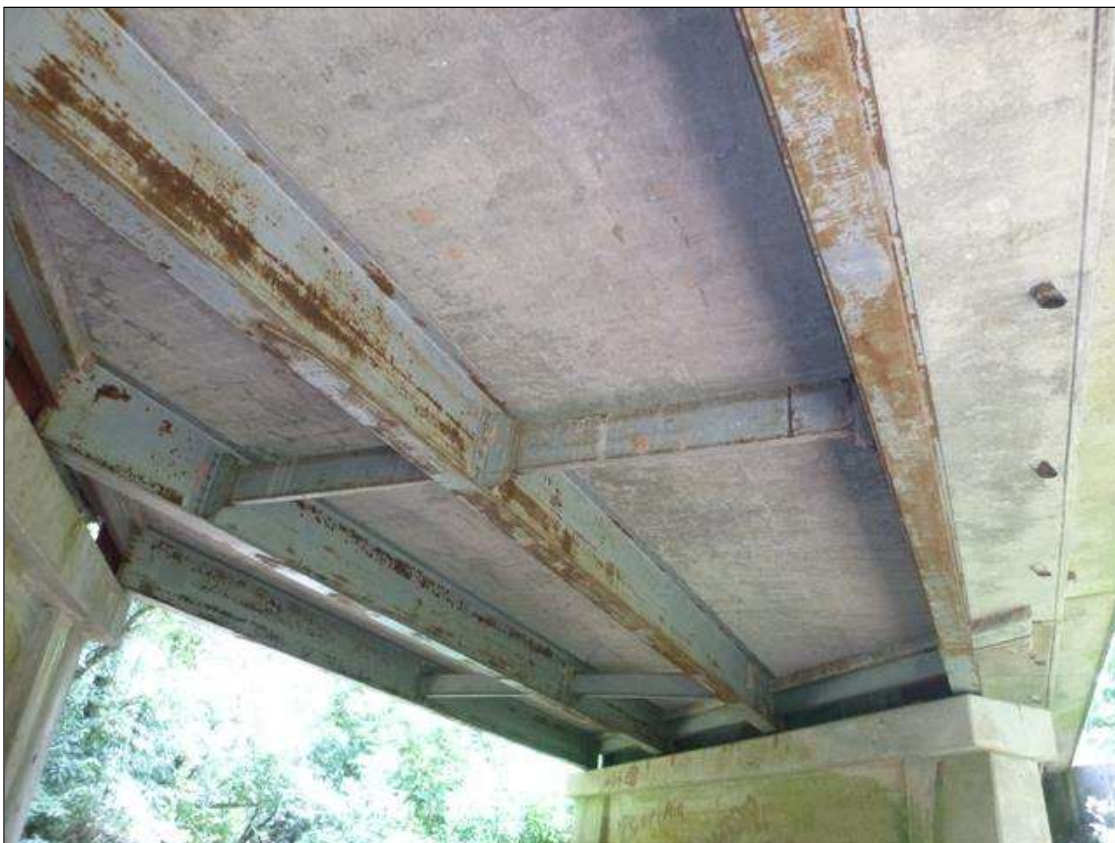
CORROSION ON UP TO 50% OF BEAM SURFACE AT RANDOM THROUGHOUT, EXCEPT PAINTED ENDS.

SUPERSTRUCTURE UNDERSIDE, SPAN 2, LOOKING WEST

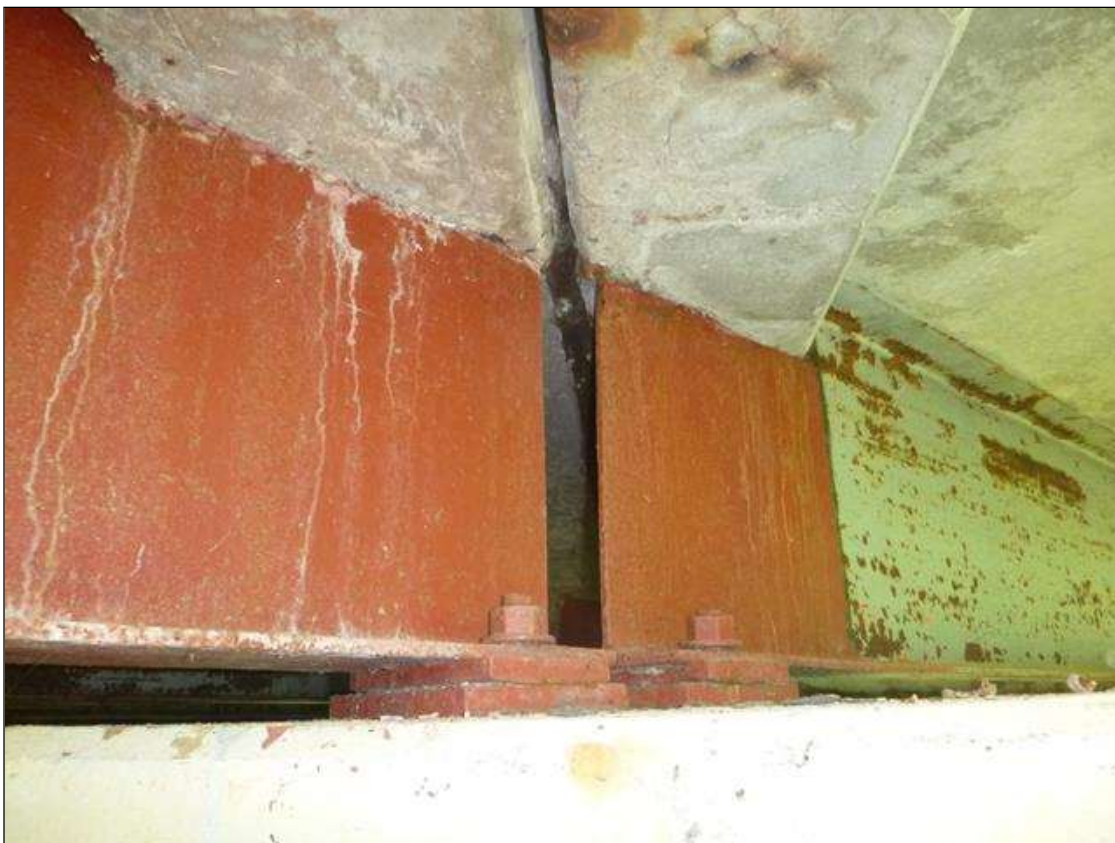
CORROSION ON NEAR BEARING ASSEMBLY UP TO 50%.

BEARING ASSEMBLY OVER BENT 1, BEAM 4, LOOKING NORTH

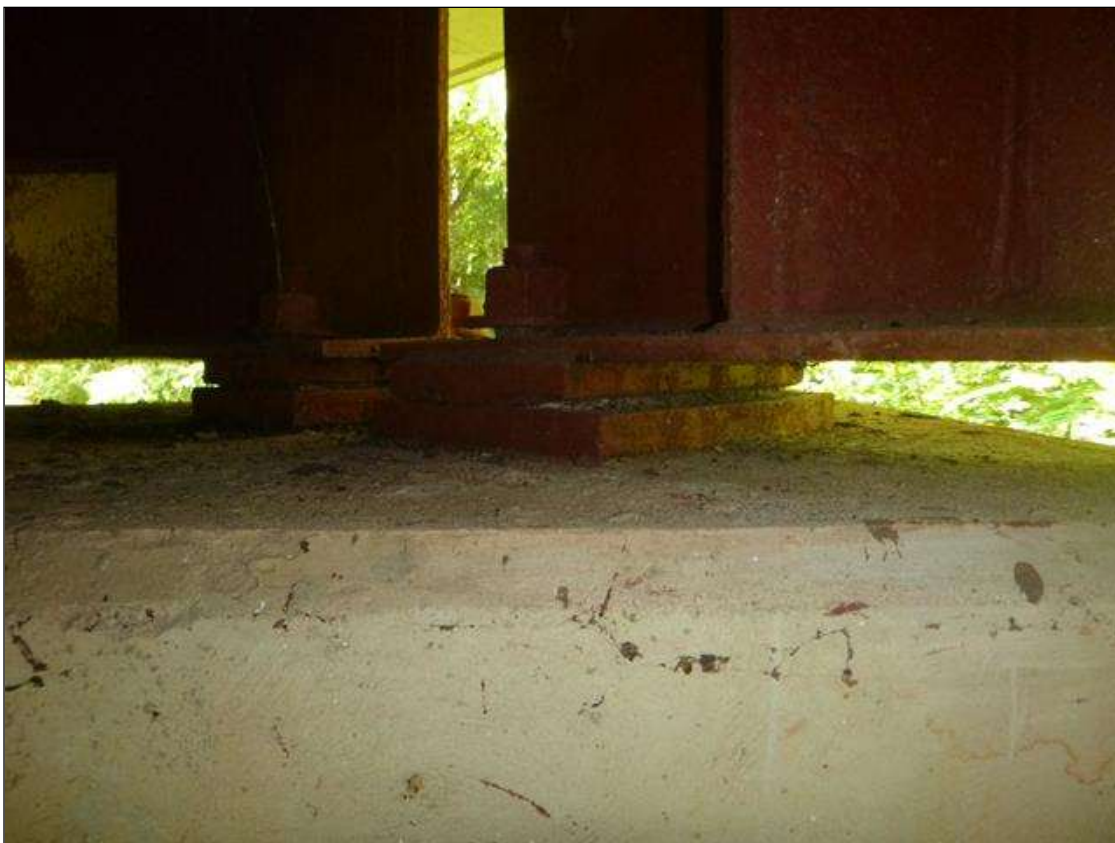
BEARING ASSEMBLY, BEAM 4, BENT 1, LOOKING EAST
