NC DEPARTMENT OF TRANSPORTATION  
DIVISION OF HIGHWAYS  
STRUCTURE MANAGEMENT UNIT

## Structure Safety Report

### Routine Element Inspection - Contract

COUNTY: SURRY STRUCTURE NUMBER: 850310 FREQUENCY: 24 MONTHS

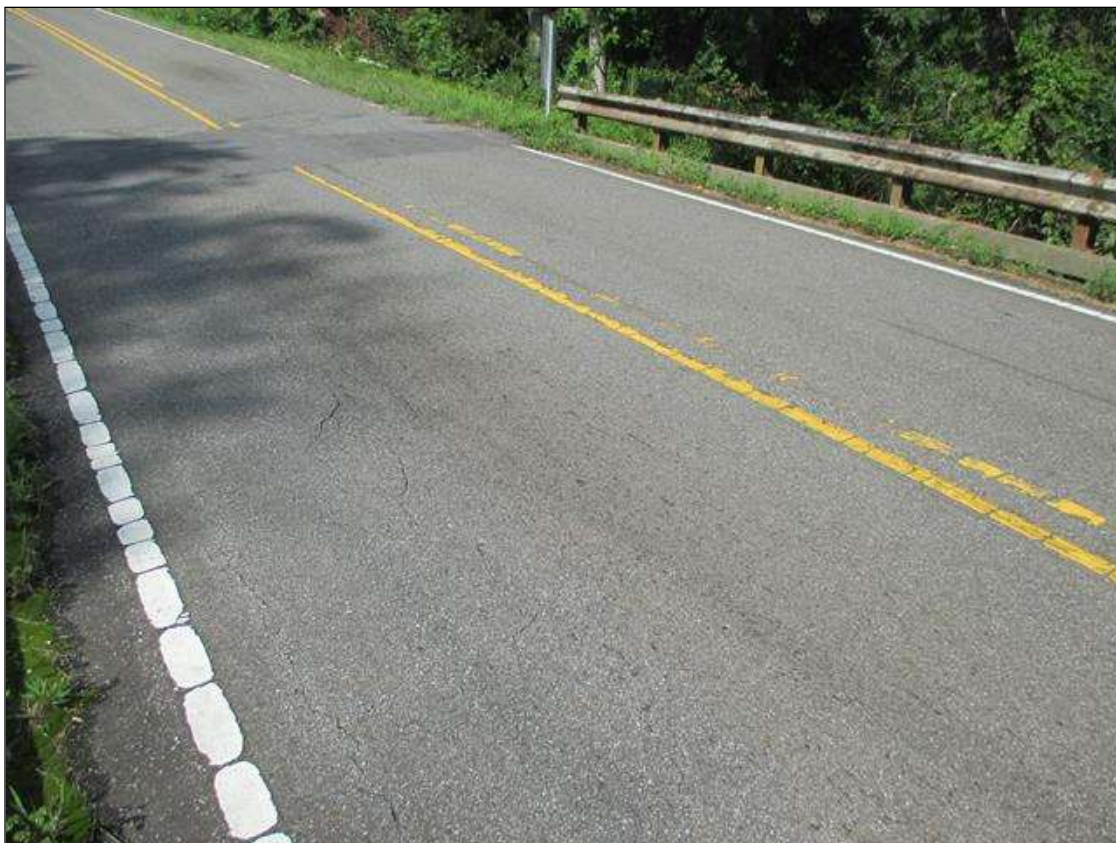
Span 1 wearing surface

24 Square Feet of Crack (Wearing Surface): Width of more than 0.05 in. or spacing of less than 1.0 ft. at end bent 1

120 Square Feet of Crack (Wearing Surface): Width of more than 0.05 in. or spacing of less than 1.0 ft. in southbound lane

812 Square Feet of Crack (Wearing Surface): Width 0.012-0.05 in. or spacing of 1.0-3.0 ft.
