# BRIDGE INSPECTION REPORT

INSPECTION TYPE: Routine Inspection

COUNTY ROBESON BRIDGE NUMBER 770026 INSPECTION CYCLE 2 YRS  
ROUTE SR1955 ACROSS TEN MILE SWAMP M.P. 0

INSPECTION DATE 05/15/2014

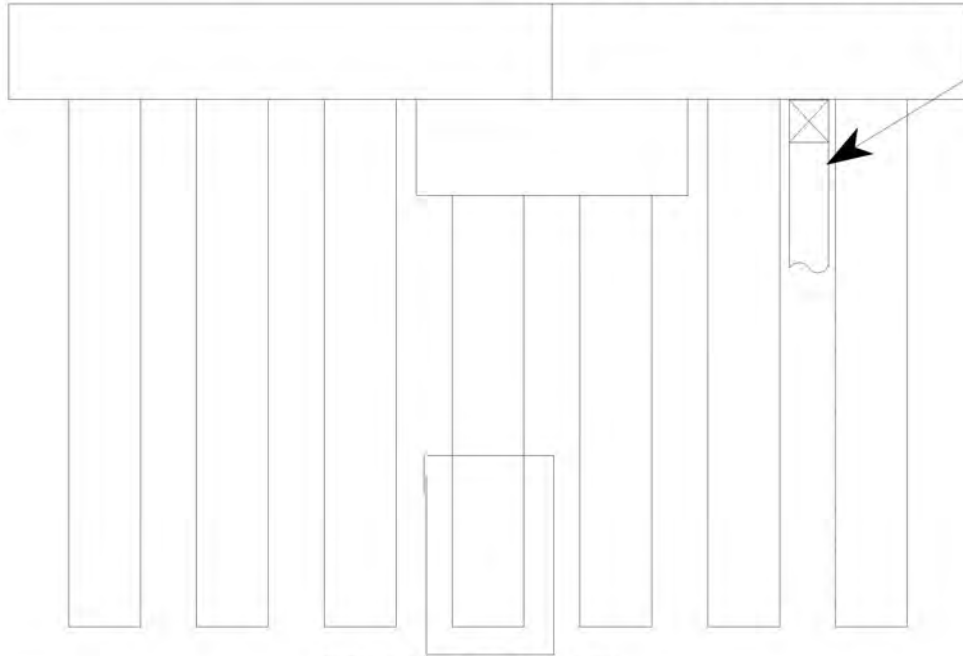
BENT-3 HAS 4.17' CRUTCHBENT WITH 2-12" PILES

PILE 4 AT EBT2 ENCASED

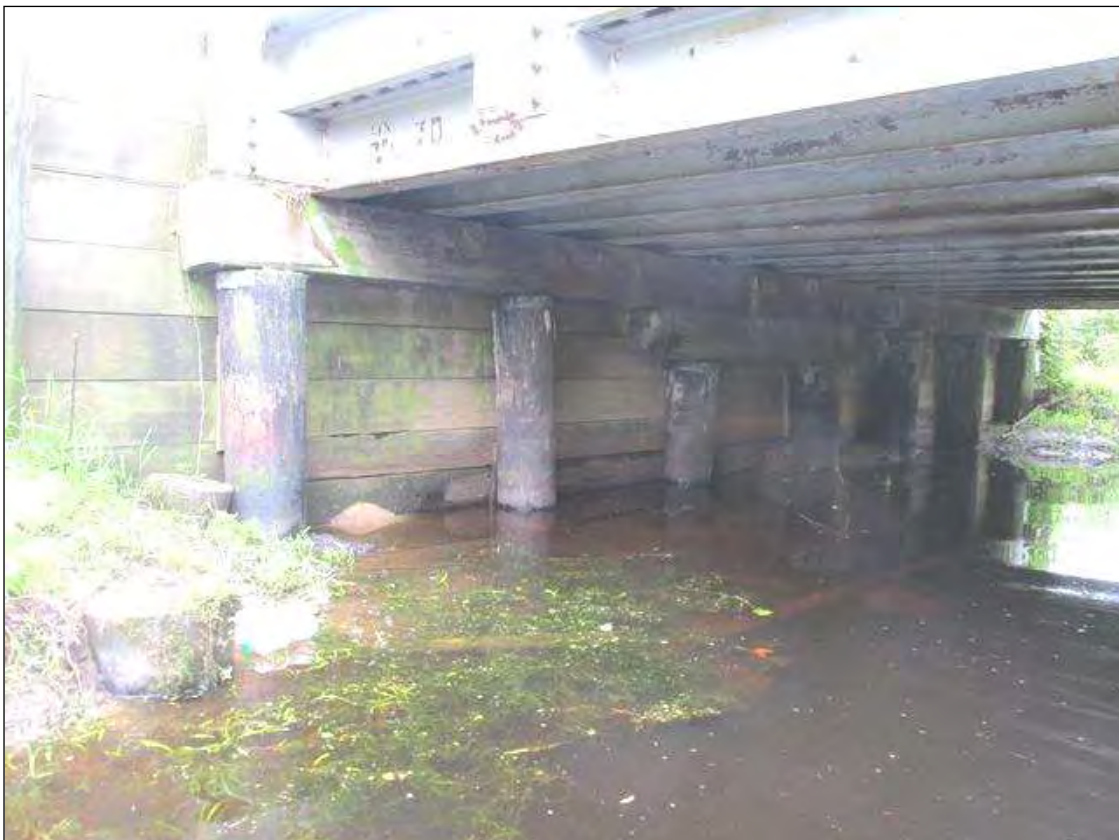
| 35a | F | RUST ALONG SPAN 4 BEAMS, PAINT FAILURE. ALL SPANS ARE SIMILAR. (PHOTO)<br>( TIMBER CAPS ) END BENT 1 MAIN CAP IS ROTATED 3/4" OUT OF PLUMB WITH 3/4" SPACING AT PILE TOPS. (PHOTO)<br><br>EAST END OF BENT 1 CAP IS DECAYED 6" W X 7" H X 3" D. (PHOTO)<br><br>BENT 2 SUB CAP, SPAN 2 FACE HAS 1/4" CHECKS. (PHOTO) | | |

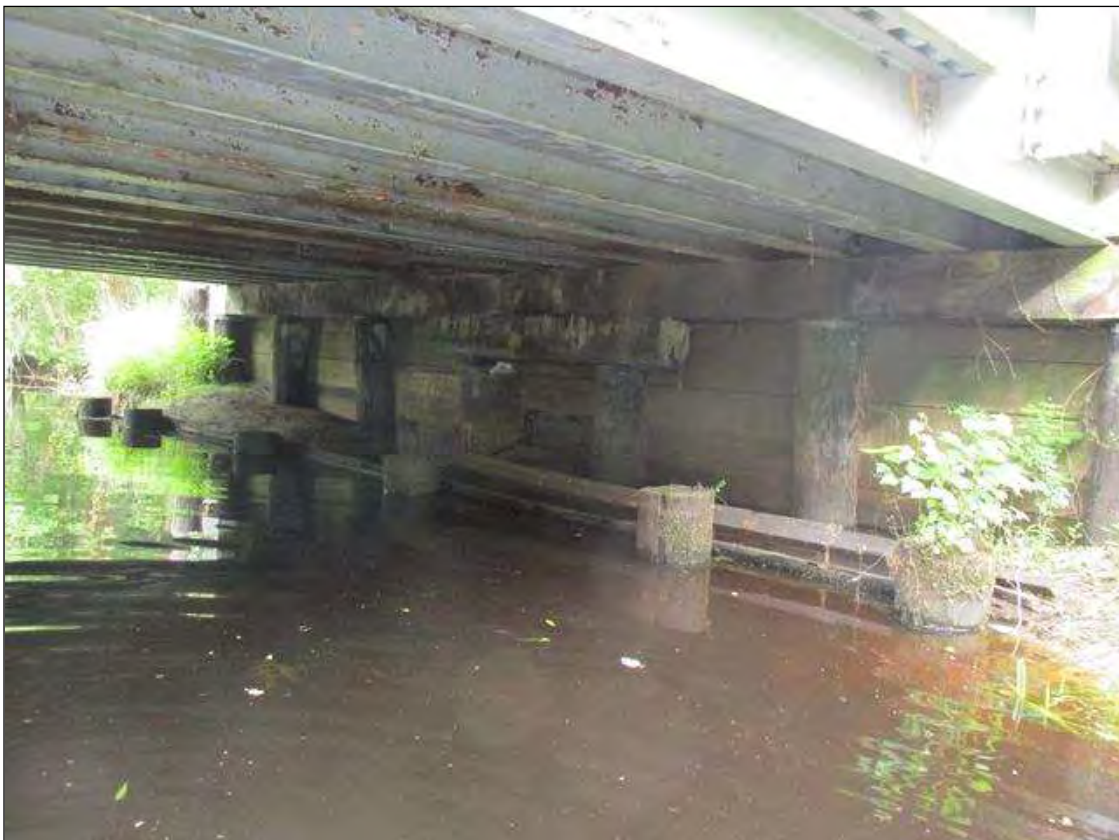
| 35b | F | END BENT 2 MAIN CAP IS ROTATED 1/2" OFF TOP OF PILES. (PHOTO)<br>( TIMBER PILES ) PILE 1 AT END BENT 1 IS SURFACE DECAYED. (PHOTO)<br><br>PILE 1 AT BENT 1 WEST FACE HAS 1/4" WIDE X 1" DEEP VERTICAL CHECK. (PHOTO)<br><br>TIMBER CRUTCH BENT RIGHT OF PILE 4 AT BENT 2, TEMP REPAIR. (PHOTO)<br><br>PILE 2 AT BENT 1 SPAN 2 NORTH FACE IS DELAMED AND SURFACE DECAYED 42" H X 8" W X 1" D. (PHOTO)<br><br>TIMBER CRUTCH BENT BETWEEN PILES 6 AND 7 AT BENT 2, TEMP REPAIR. (PHOTO)<br><br>TIMBER CRUTCH BENT RIGHT OF PILE 1 AT BENT 3, TEMP REPAIR. (PHOTO)<br><br>PILE 4 AT END BENT 2 IS ENCASED, TEMP REPAIR. (PHOTO)<br><br>PILE 4 AT BENT 3 WEST FACE IS DECAYED 2' HIGH X 10" WIDE X 4" DEEP. (PHOTO)<br>ALSO SEE SKETCH.<br><br>PILE 3 AT END BENT 2 IS DECAYED FULL CIRCUMFERENCE X 13" H X UP TO 2" DEEP. (PHOTO)<br><br>PILE 6 AT END BENT 2 IS SURFACE DECAYED 12" H X 4" W X UP TO 2" D. (PHOTO)<br><br>PILE 1 AT END BENT 2 HAS FIBER SEPARATION 12" H X 3" W X 1" D. (PHOTO)<br><br>PILE 6 AT BENT 3, SPAN 4 FACE IS DECAYED 5" HIGH X 1 1/2" WIDE X 1" DEEP NEAR CAP. (PHOTO) | | |
