NC DEPARTMENT OF TRANSPORTATION  
DIVISION OF HIGHWAYS  
BRIDGE MANAGEMENT UNIT

# BRIDGE INSPECTION REPORT

COUNTY ROBESON BRIDGE NUMBER 770432 INSPECTION CYCLE 2 YRS  
ROUTE SR1157 ACROSS BACK SWAMP CANAL M.P. 0

INSPECTION DATE 04/08/2014

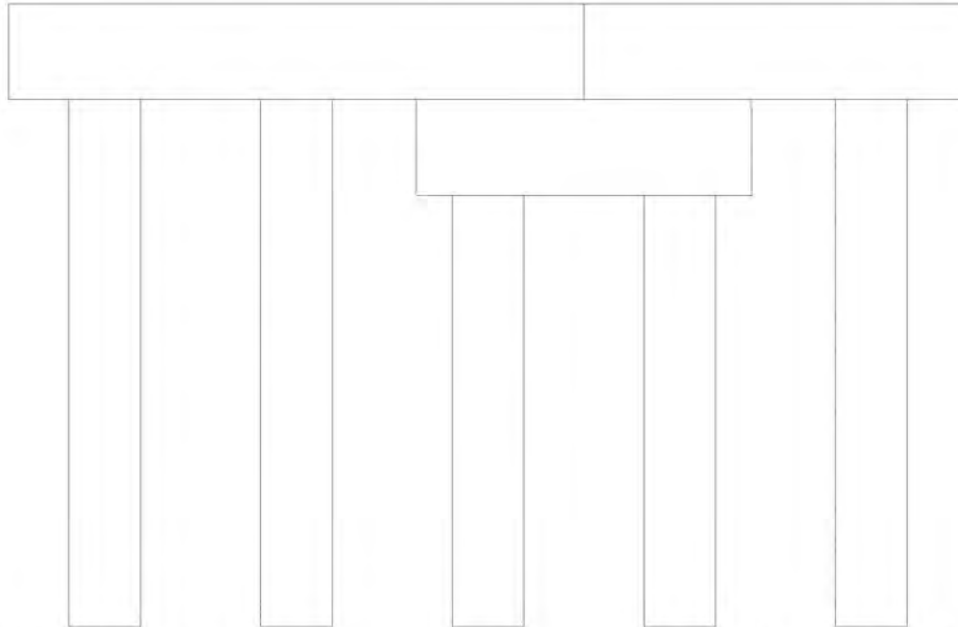
SKETCH IS SIMILAR FOR END BENT 1, BENT 2 AND END BENT 2

NOTE: PILE 2 AT EBT2 IS ENCASED IN CONCRETE

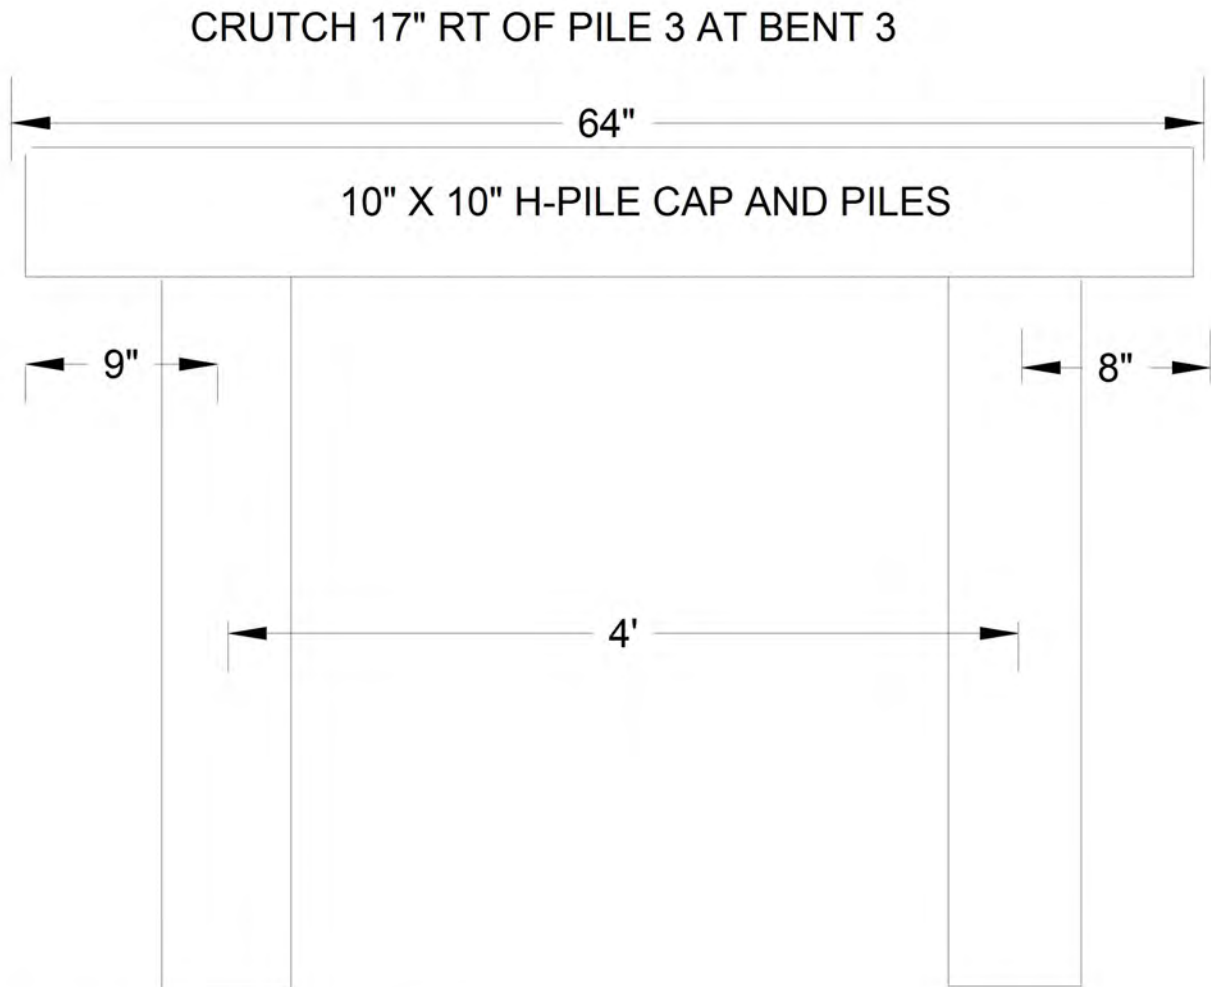
**Title**  
BENT 3 PILE 3 CRUTCH BENT

| Bridge I&A Form 1(82)H<br>State of North Carolina<br>Dept. of Transportation<br>Division of Highways | | <h1 style="text-align: center;">FIELD INSPECTION REPORT</h1> <p style="text-align: center;"><u>Bridge Inspeccion &amp; Analysis</u></p> | |
|---|---|---|--|
| 37b | G | ( STEEL PILES ) THERE IS A STEEL CRUTCHBENT NOTED AT BENT 3 17" RIGHT OF ORIGINAL PILE 3. (PHOTO) | |
