NC DEPARTMENT OF TRANSPORTATION  
DIVISION OF HIGHWAYS  
STRUCTURE MANAGEMENT UNIT

## Structure Safety Report

### Routine Element Inspection

COUNTY: HALIFAX STRUCTURE NUMBER: 410127 FREQUENCY: 24 MONTHS  
FACILITY CARRIED: SR1002 MILE POST: \_\_\_\_\_  
LOCATION: 0.4 MI.E.JCT.SR1210  
FEATURE INTERSECTED: JACKET SWAMP  
LATITUDE: 36° 12' 24.34" LONGITUDE: 77° 43' 48.15"  
SUPERSTRUCTURE: PPC CHANNELS  
SUBSTRUCTURE: EBTS&IBTS:PPC CAPS/TIMBER PILES @ 5"9 CTS.  
SPANS: 2@25.5'  
2@25"6  
☐ FRACTURE CRITICAL ☒ TEMPORARY SHORING ☐ SCOUR CRITICAL ☒ SCOUR PLAN OF ACTION  
PRESENT CONDITION: Fair INSPECTION DATE: 07/15/2015  
POSTED SV: 25 POSTED TTST: 29  
OTHER SIGNS PRESENT: 4 DELINEATORS

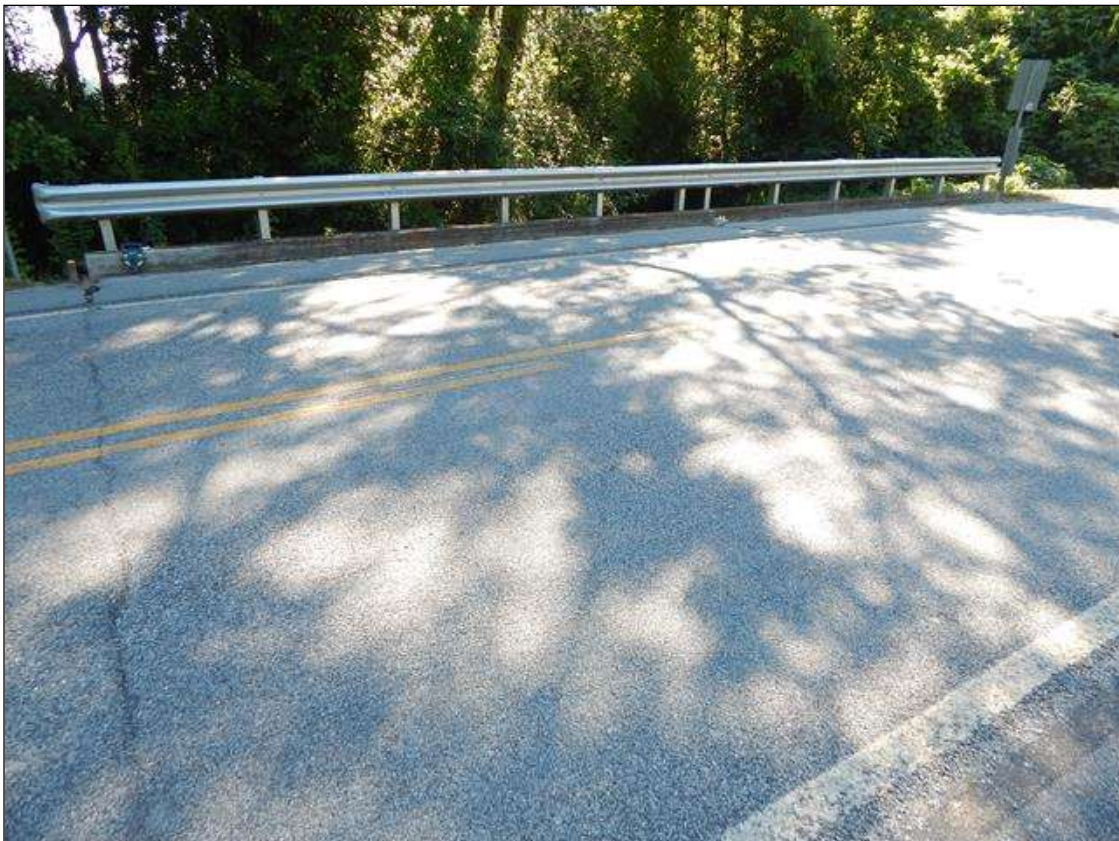
WEARING SURFACE

3 Square Feet of Crack (Wearing Surface): Width 0.012-0.05 in. or spacing of 1.0-3.0 ft.

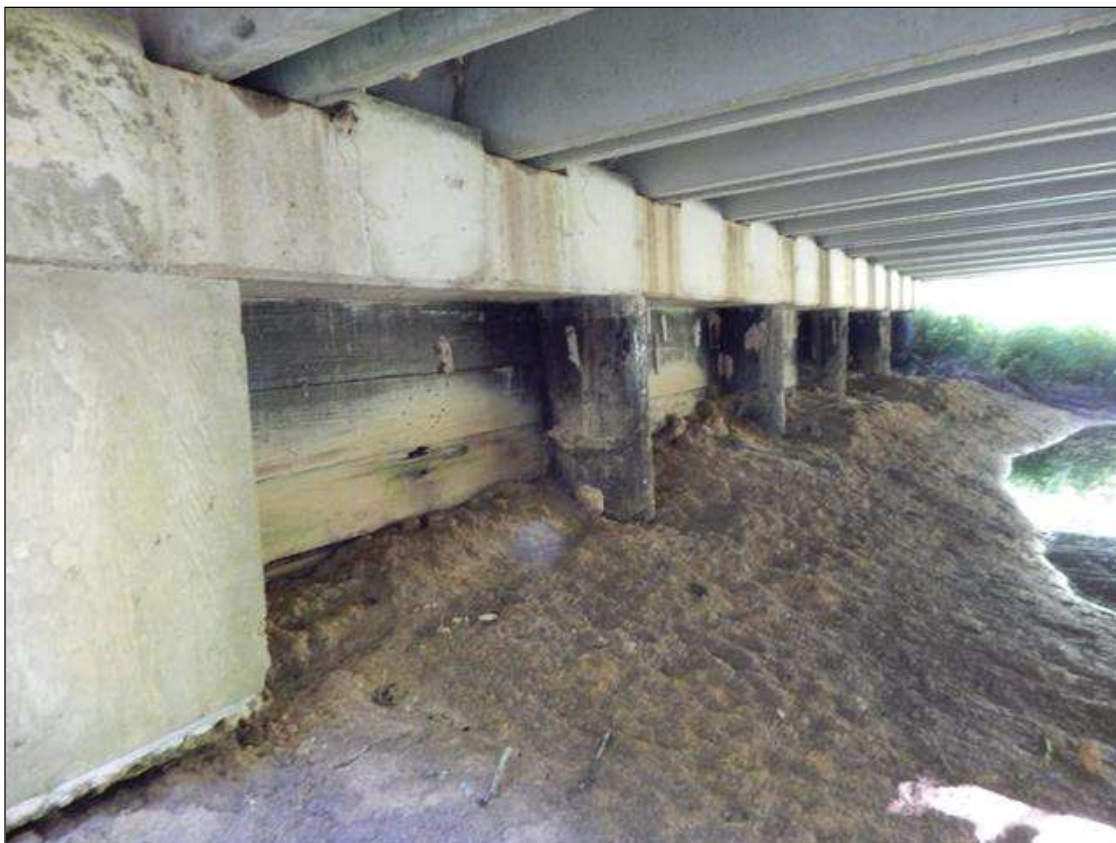
END BENT 2

End Bent 2 Abutment/Backwall : 4 Feet of Decay/Section Loss BETWEEN PILES 1 AND 2: Affects 10% or more of the member but does not warrant structural review.

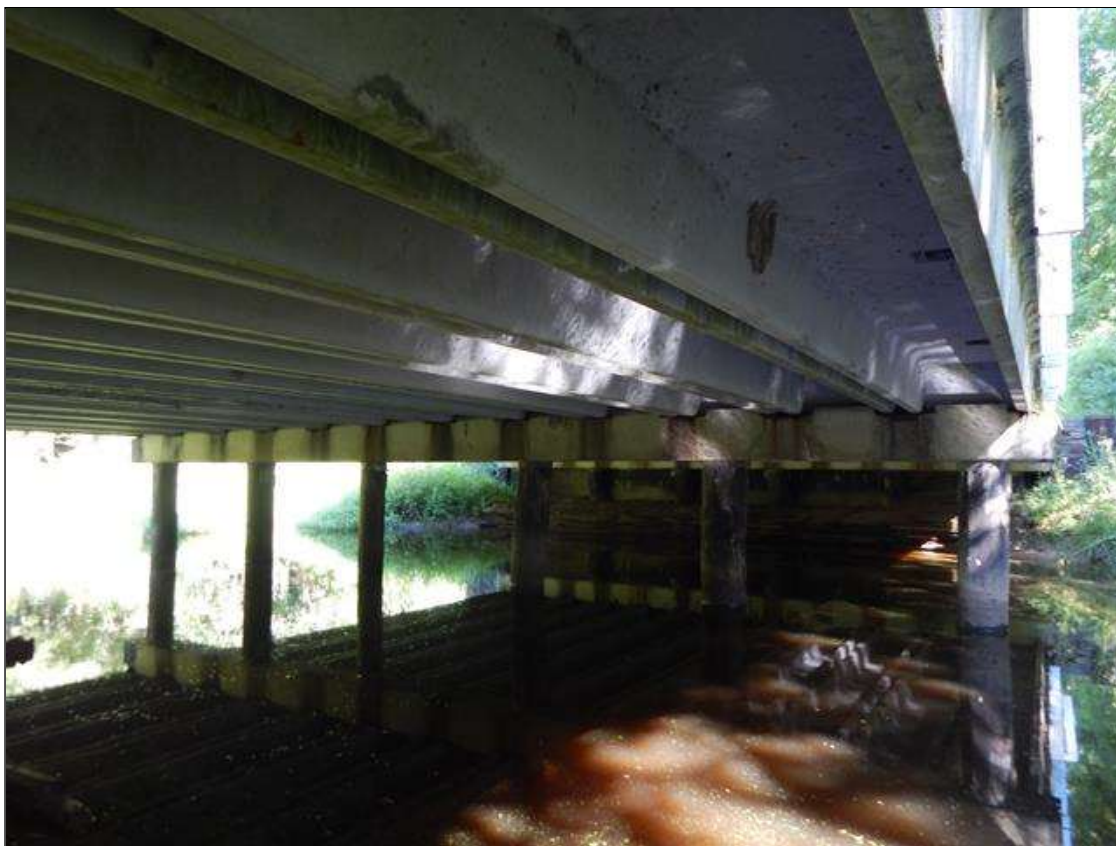
PILE 4 INT. BENT 1 IS A 10" DIA REPLACEMENT W/ 20" DIA CONC COLLAR

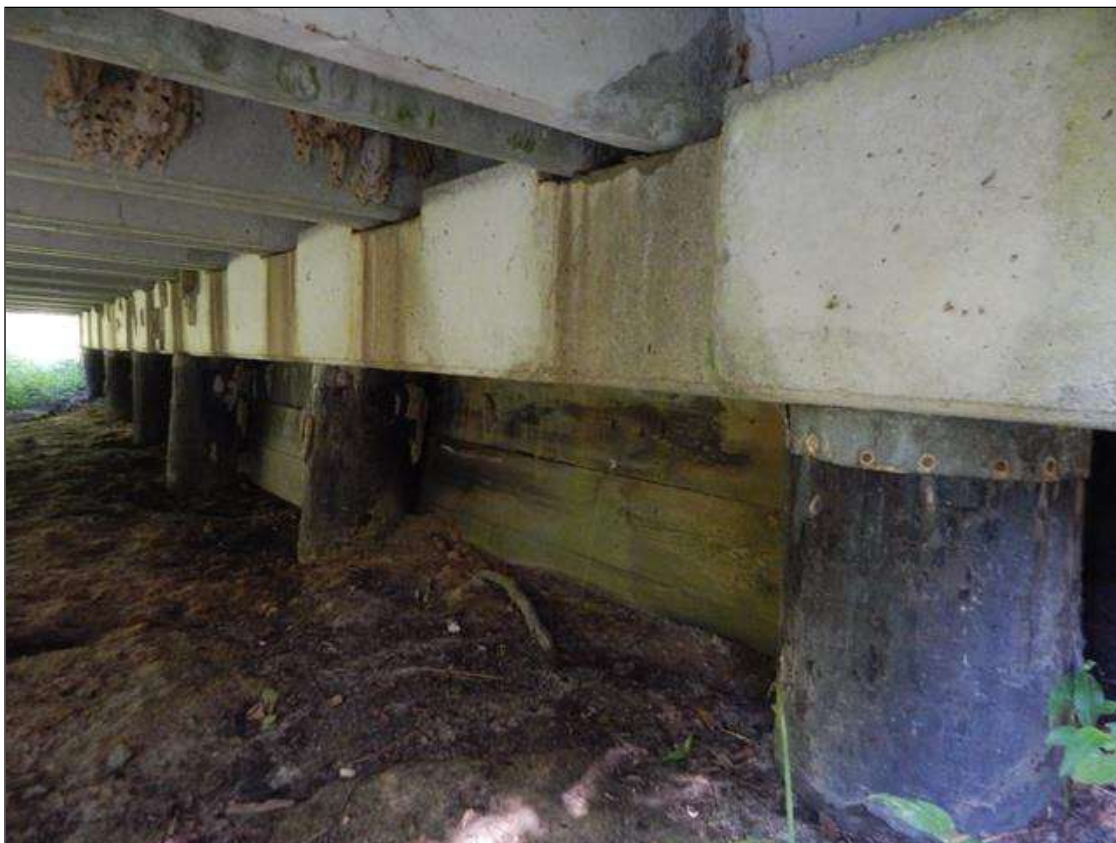
END BENT 1

End Bent 1 Abutment/Backwall : 4 Feet of Decay/Section Loss ON LEFT SIDE AT END BENT 1: Affects 10% or more of the member but does not warrant structural review.
