NC DEPARTMENT OF TRANSPORTATION  
DIVISION OF HIGHWAYS  
STRUCTURE MANAGEMENT UNIT

## Structure Safety Report

### Routine Element Inspection - Contract

COUNTY: ROBESON STRUCTURE NUMBER: 770149 FREQUENCY: 24 MONTHS  
FACILITY CARRIED: SR1122 MILE POST: \_\_\_\_\_  
LOCATION: 1.0 MI. NE. OF JCT. US501  
FEATURE INTERSECTED: FIRST SWAMP  
LATITUDE: 34° 36' 17.28" LONGITUDE: 79° 19' 7.54"  
SUPERSTRUCTURE: REINFORCED CONCRETE FLOOR ON TIMBER JOISTS  
SUBSTRUCTURE: E.BTS&IBT:TIM.CAPS/TIM.PILES;E.BT1 STL CRUTCH  
SPANS: 2@18'  
☐ FRACTURE CRITICAL ☒ TEMPORARY SHORING ☐ SCOUR CRITICAL ☒ SCOUR PLAN OF ACTION  
PRESENT CONDITION: Fair INSPECTION DATE: 04/13/2016  
POSTED SV: 17 POSTED TTST: 24  
OTHER SIGNS PRESENT: (4) DELINEATORS

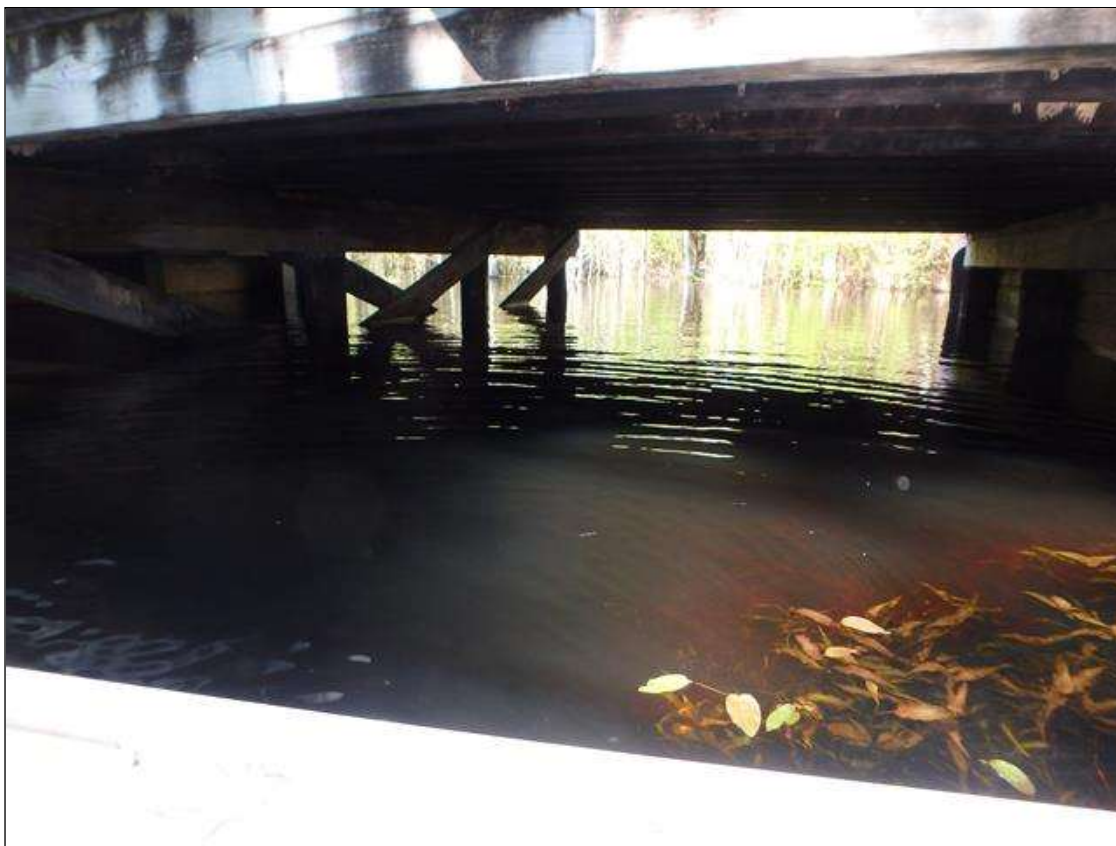
LOOKING UPSTREAM

SPAN 2 END OF JOIST 2 AT INT. BENT, VERTICAL C/L SPLIT & DECAY FULL HEIGHT X 2IN. WIDE X 19IN. LONG AT TOP, 9IN. LONG AT BOTTOM. PRIORITY MAINTENANCE

2 Feet of Decay/Section Loss: The condition warrants a structural review to determine the effect on strength or serviceability of the element or bridge; OR a structural review has been completed and the defects impact strength or serviceability of the element or bridge.
