NC DEPARTMENT OF TRANSPORTATION  
DIVISION OF HIGHWAYS  
STRUCTURE MANAGEMENT UNIT

## Structure Safety Report

### Routine Element Inspection

COUNTY: ASHE STRUCTURE NUMBER: 040023 FREQUENCY: 24 MONTHS  
FACILITY CARRIED: NC194 MILE POST: \_\_\_\_\_  
LOCATION: 100 FT.S.JCT.SR1353  
FEATURE INTERSECTED: OLD FIELD BRANCH  
LATITUDE: 36° 29' 56.6" LONGITUDE: 81° 30' 39.72"  
SUPERSTRUCTURE: STEEL PLANK FLOOR ON I-BEAMS  
SUBSTRUCTURE: REINFORCED CONCRETE ABUTMENTS  
SPANS: 1@ 33'-5"  
☐ FRACTURE CRITICAL ☐ TEMPORARY SHORING ☐ SCOUR CRITICAL ☐ SCOUR PLAN OF ACTION  
PRESENT CONDITION: Poor INSPECTION DATE: 05/12/2016  
POSTED SV: Not Posted POSTED TTST: Not Posted  
OTHER SIGNS PRESENT: NONE

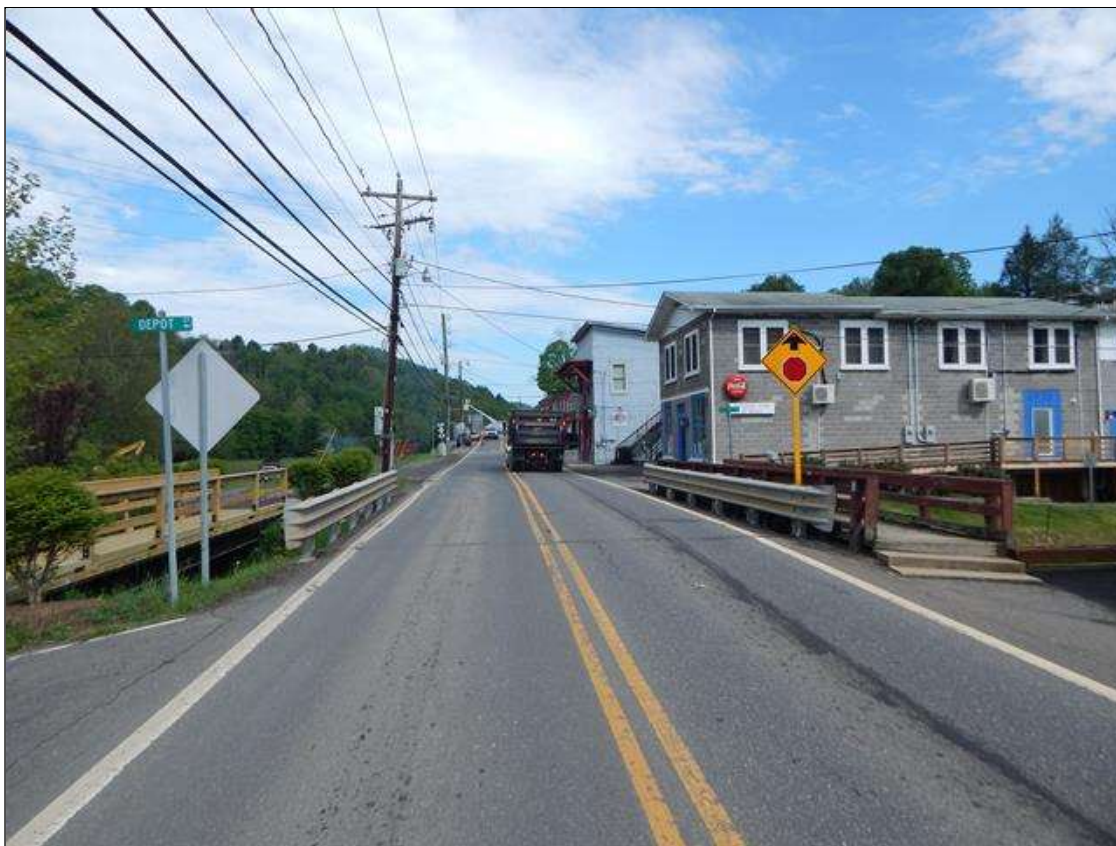
SOUTH TO NORTH

Span 1 Left Bridge Rail: 1 Square Feet of Corrosion: Section loss is evident or pack rust is present but does not warrant structural review. LEFT RAIL POST BLOCK (6) CORROSION TO TOP AND BOTTOM FLANGES WITH (1/4") AVG REMAINING AND (1/8") LOSS OF SECTION. CORROSION TO WEB WITH (1/16") LOSS
