NC DEPARTMENT OF TRANSPORTATION  
DIVISION OF HIGHWAYS  
STRUCTURE MANAGEMENT UNIT

## Structure Safety Report

### Routine Element Inspection

COUNTY: WATAUGA STRUCTURE NUMBER: 940278 FREQUENCY: 24 MONTHS  
FACILITY CARRIED: SR1540 MILE POST: \_\_\_\_\_  
LOCATION: 25 FT.W.JCT.US221,321  
FEATURE INTERSECTED: CREEK  
LATITUDE: 36° 10' 9.1" LONGITUDE: 81° 38' 47.88"  
SUPERSTRUCTURE: TIMBER FLOOR ON I-BEAMS

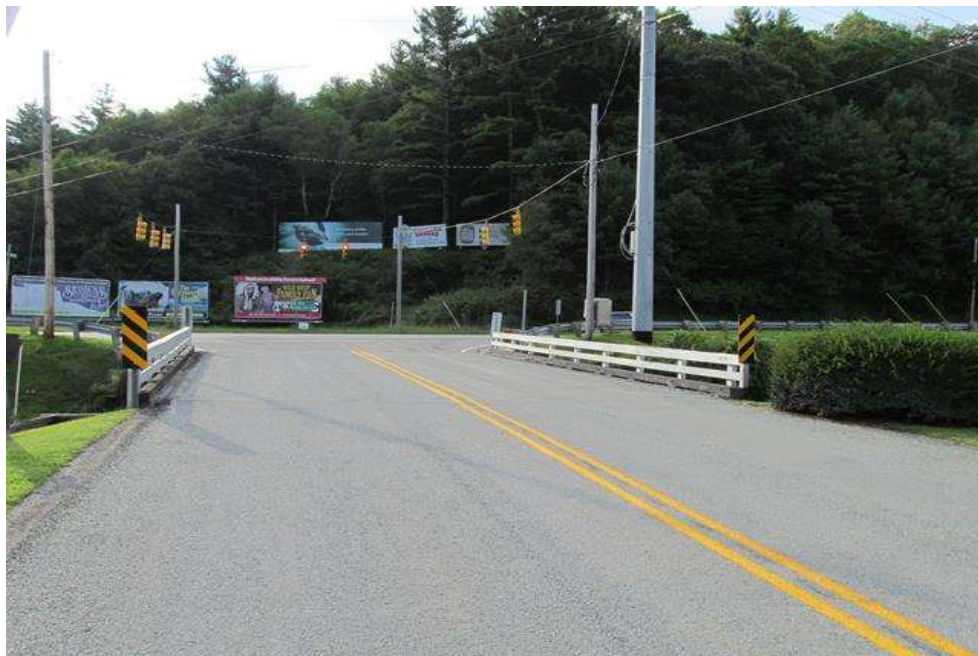
ATTENTION: **CRITICAL FIND (2) WEIGHT LIMIT SIGNS MISSING,  
PMN'S ISSUED FOR SUBSTRUCTURE,  
SUPERSTRUCTURE...**

OTHER SIGNS PRESENT: 4 DEILINEATORS

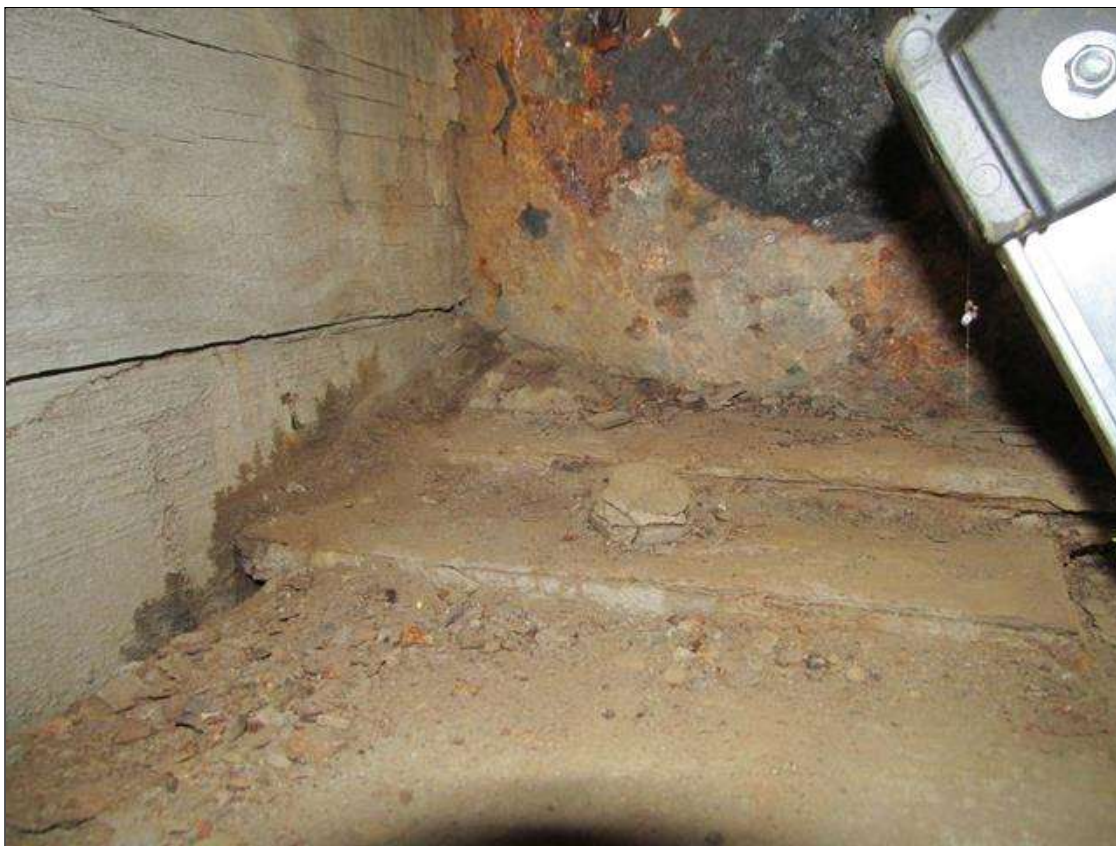
FIXED BEARING, ALL SIMILAR.
