NC DEPARTMENT OF TRANSPORTATION  
DIVISION OF HIGHWAYS  
STRUCTURE MANAGEMENT UNIT

## Structure Safety Report

### Routine Element Inspection - Contract

DIVISION: 6 COUNTY: CUMBERLAND STRUCTURE NUMBER: 250043 FREQUENCY: 24 MONTHS

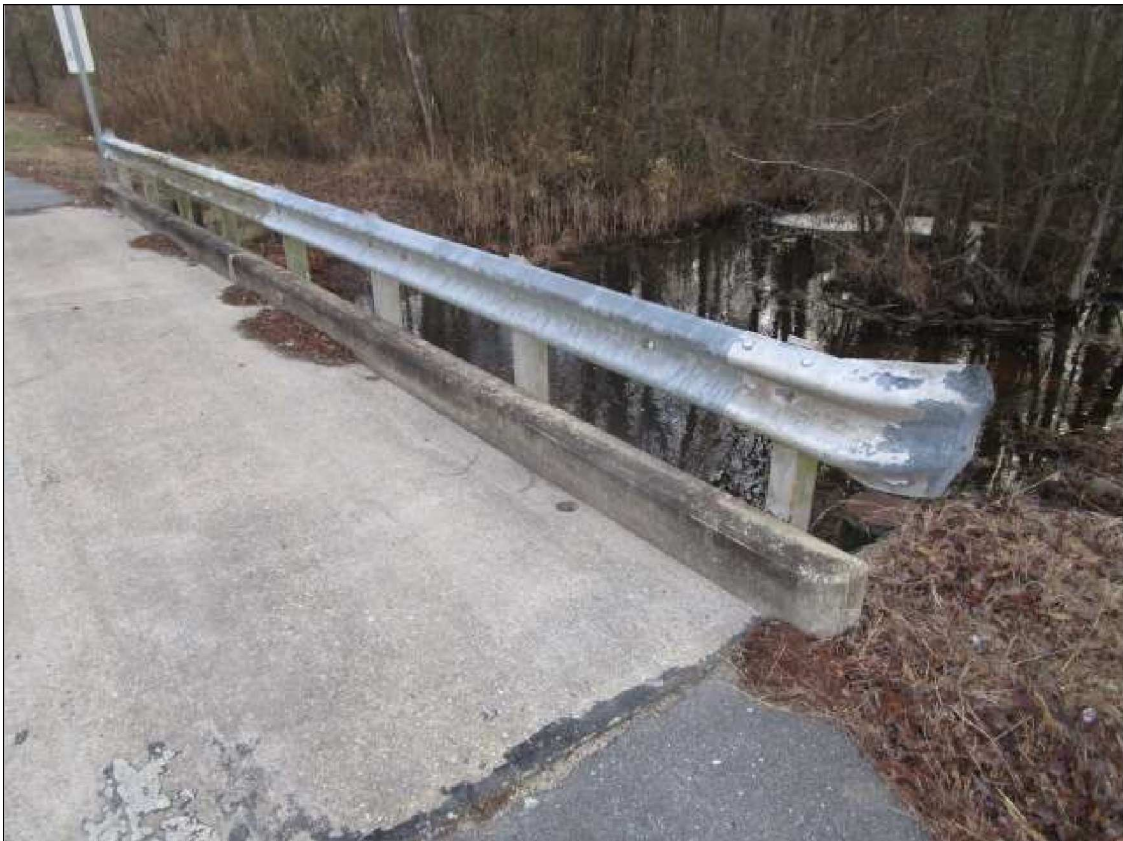
TYPICAL RAIL

| Element Number | Defect Type | Defect Description | CS | CS Qty | Maint Qty | |
|---|---|---|---|---|---|---|
| 515 | Peeling/Bubbling/Cracking (steel Protective Coatings) | PEELING AND FLAKING PAINT ON FRONT AND BACK OF RAIL | 2 | 15 | 15 | Square Feet |
