NC DEPARTMENT OF TRANSPORTATION  
DIVISION OF HIGHWAYS  
STRUCTURE MANAGEMENT UNIT

# Structure Safety Report

## Routine Element Inspection - Contract

DIVISION: 13 COUNTY: MCDOWELL STRUCTURE NUMBER: 580312 FREQUENCY: 24 MONTHS

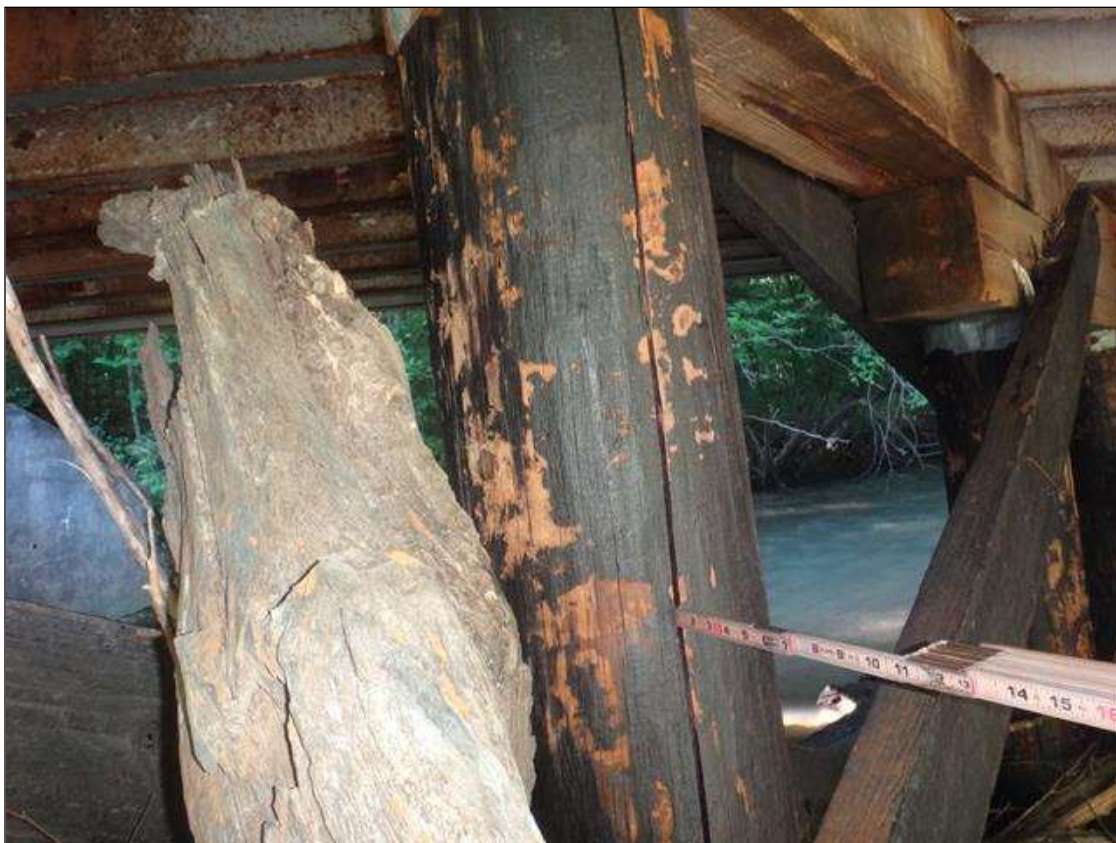
Bent 1 Pile 2: south face below cap, check (4ft x 1/2in x 1in)

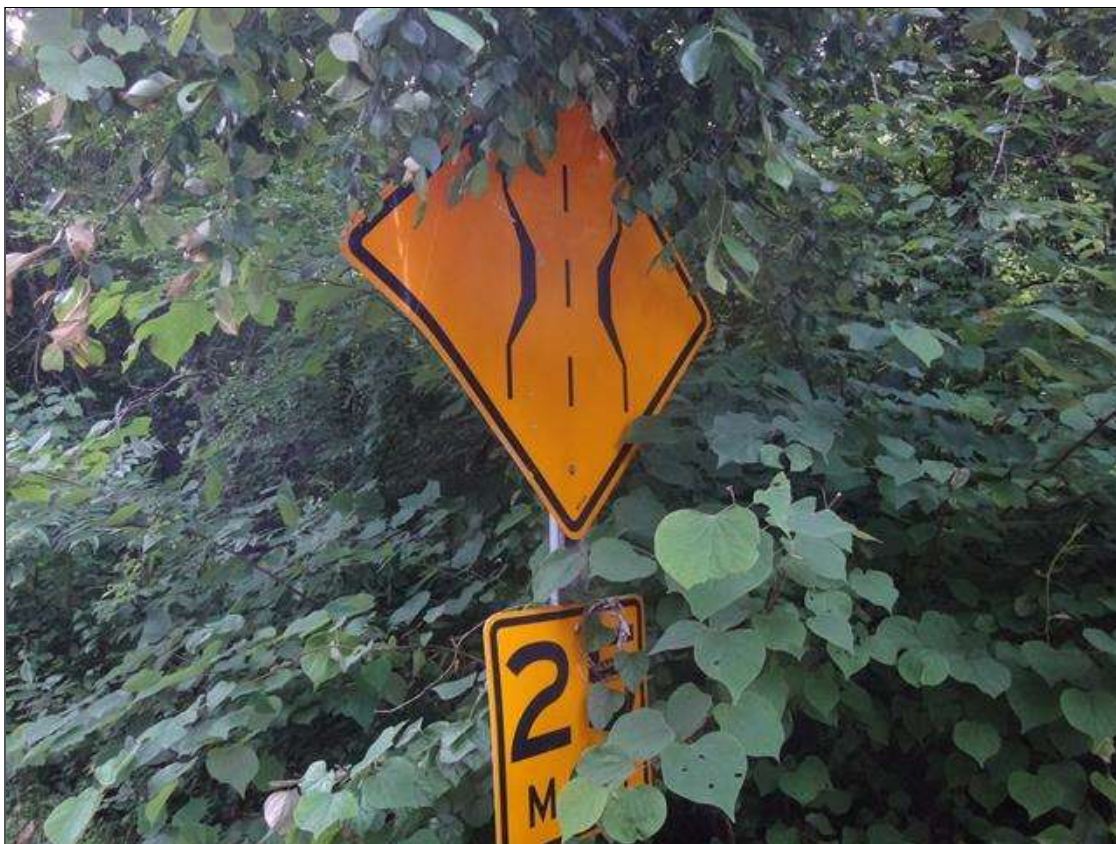
narrow bridge sign (south approach) at approximately 0.1 miles from structure

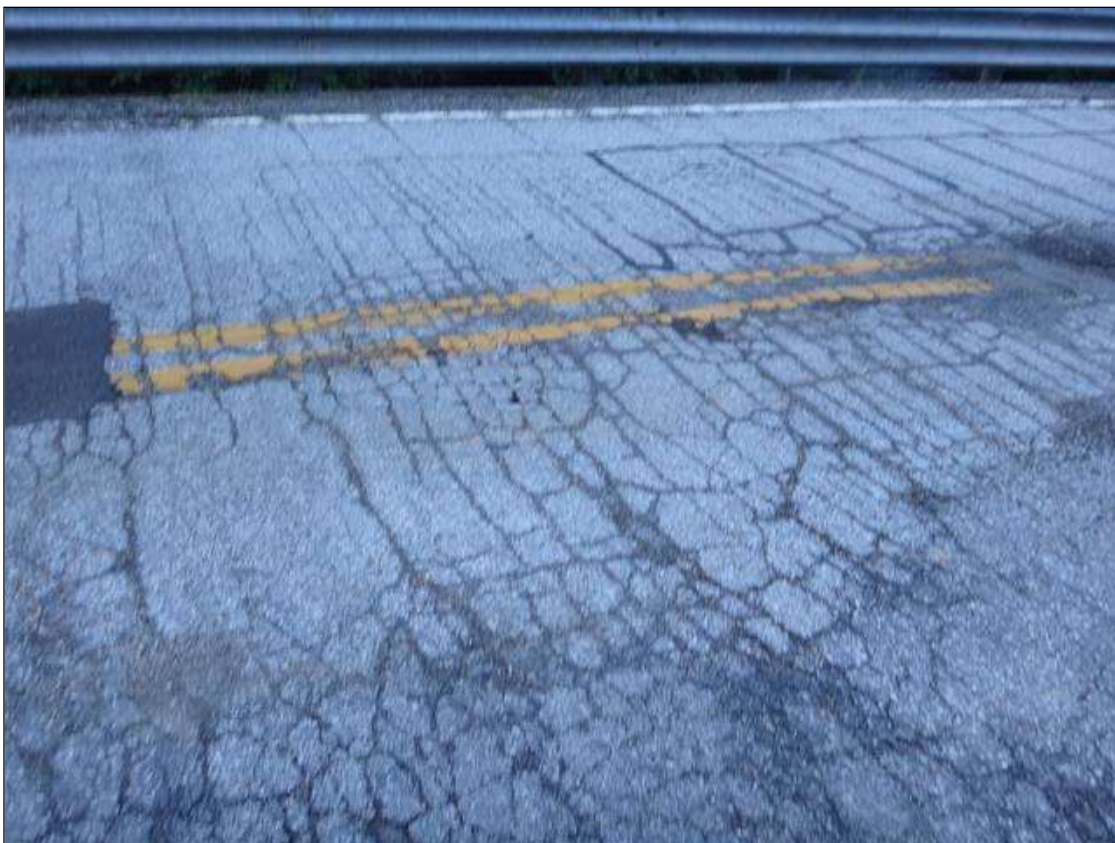
| Element Number | Defect Type | Defect Description | CS | CS Qty | Maint Qty | |
|---|---|---|---|---|---|---|
| 510 | Delamination/Spall (Wearing Surfaces) | southbound lane and center of lanes near bent 1, (2) potholes (up to 30in x 16in x full depth) | 3 | 5 | 5 | Square Feet |

asphalt over bent 1

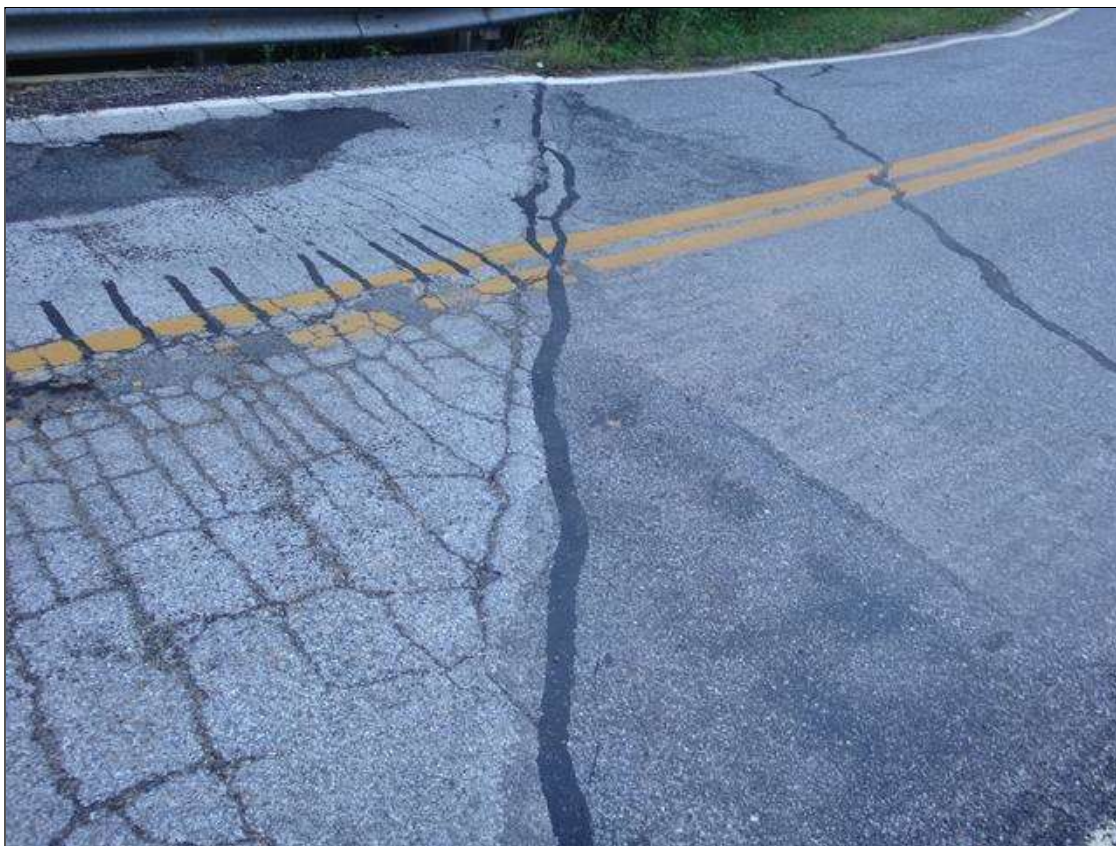
| Element Number | Defect Type | Defect Description | CS | CS Qty | Maint Qty | |
|---|---|---|---|---|---|---|
| 510 | Delamination/Spall (Wearing Surfaces) | center of lanes at 6ft from end bent 1, pothole (1ft x 7in x 1-1/2in) | 3 | 1 | 1 | Square Feet |
| 510 | Delamination/Spall (Wearing Surfaces) | northbound lane at 7ft from end bent 1, pothole (18in x 12in x full depth) | 3 | 2 | 2 | Square Feet |
| 510 | Patched Area/Pothole (Wearing Surface) | northbound lane at 3ft from end bent 1, patched area (14ft x 4ft) | 2 | 54 | | Square Feet |

asphalt over end bent 1

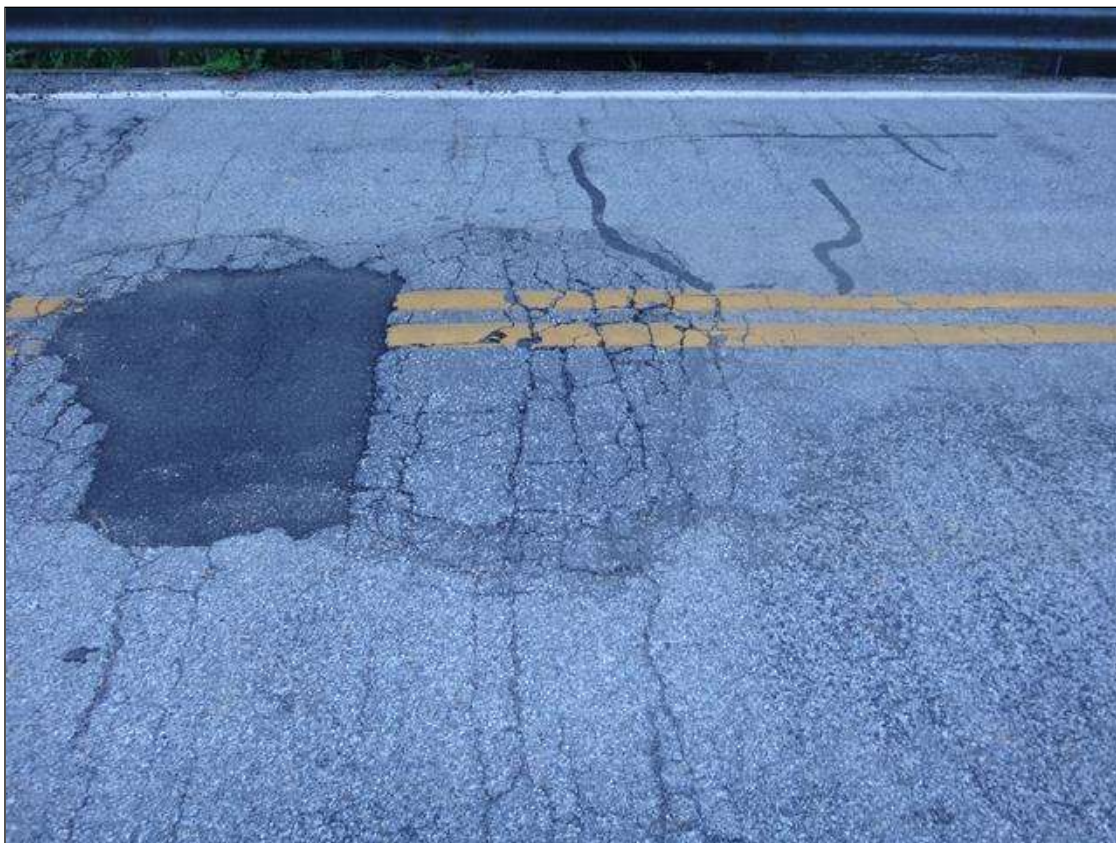
| Element Number | Defect Type | Defect Description | CS | CS Qty | Maint Qty | |
|---|---|---|---|---|---|---|
| 510 | Crack (Wearing Surface) | both lanes, scattered map cracking (75% of deck area x up to 1in) | 3 | 549 | 549 | Square Feet |
| 510 | Patched Area/Pothole (Wearing Surface) | center of lanes, multiple patched areas (up to 8ft x 4ft) | 2 | 60 | | Square Feet |

asphalt wearing surface

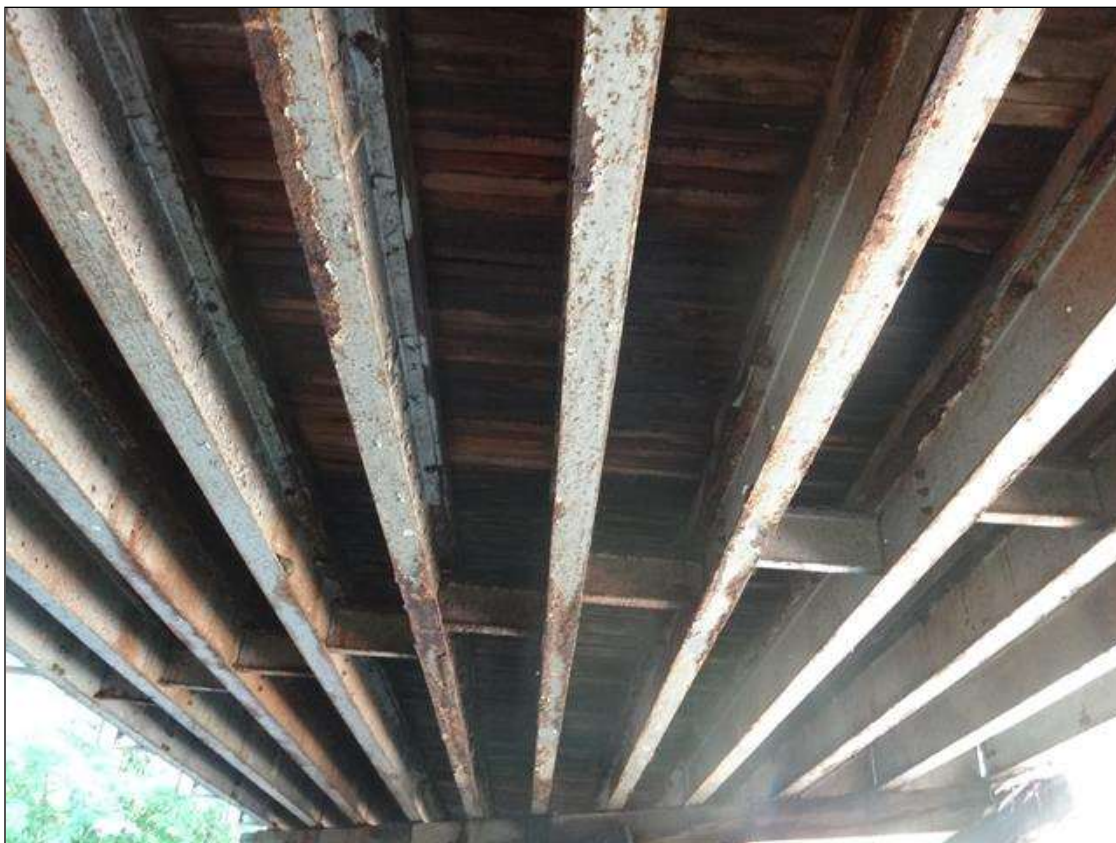
| Element Number | Defect Type | Defect Description | CS | CS Qty | Maint Qty | |
|---|---|---|---|---|---|---|
| 31 | Damage | underside throughout all bays, soft with water stains (75%) | 2 | 566 | 566 | Square Feet |

underside of deck

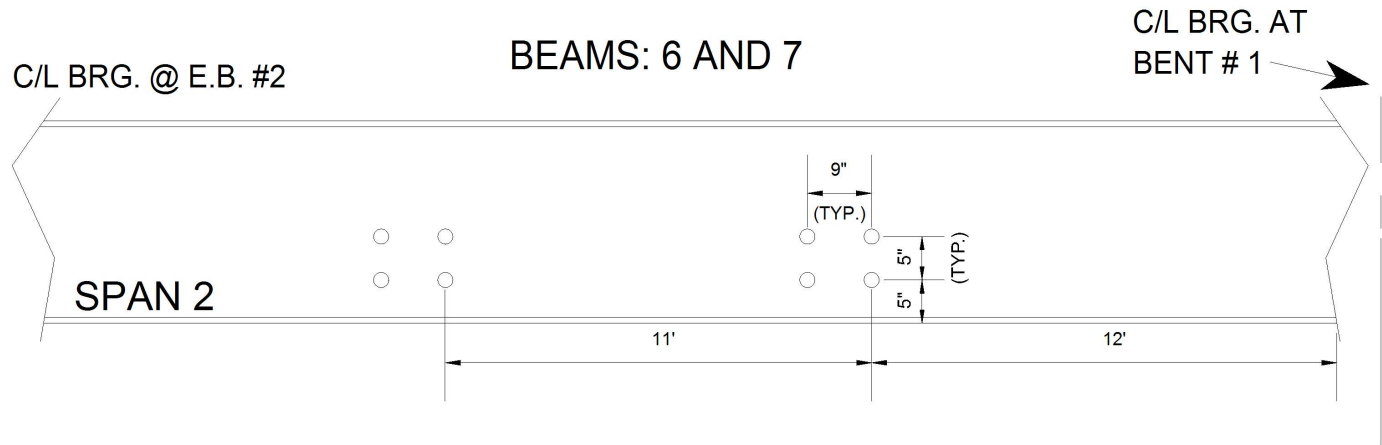
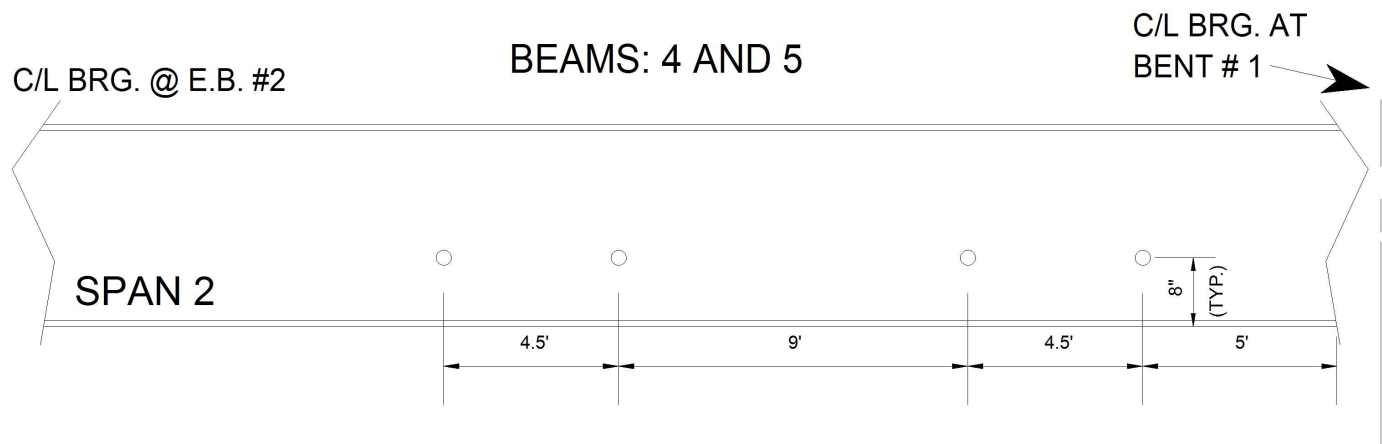
ALL HOLES ARE 3/4" DIAM. DRILLED

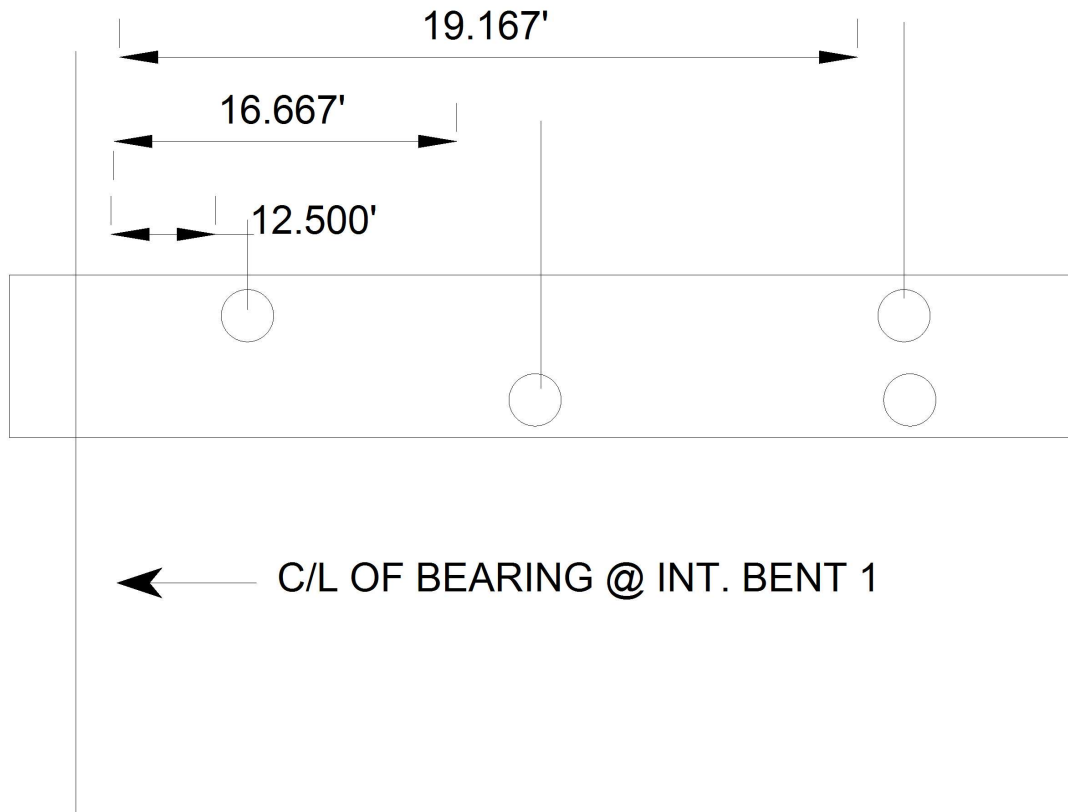
BOTTOM FLANGE OF BEAM 10 IN SPAN 2  
HOLES ARE 11/16 DIAMETER DRILLED

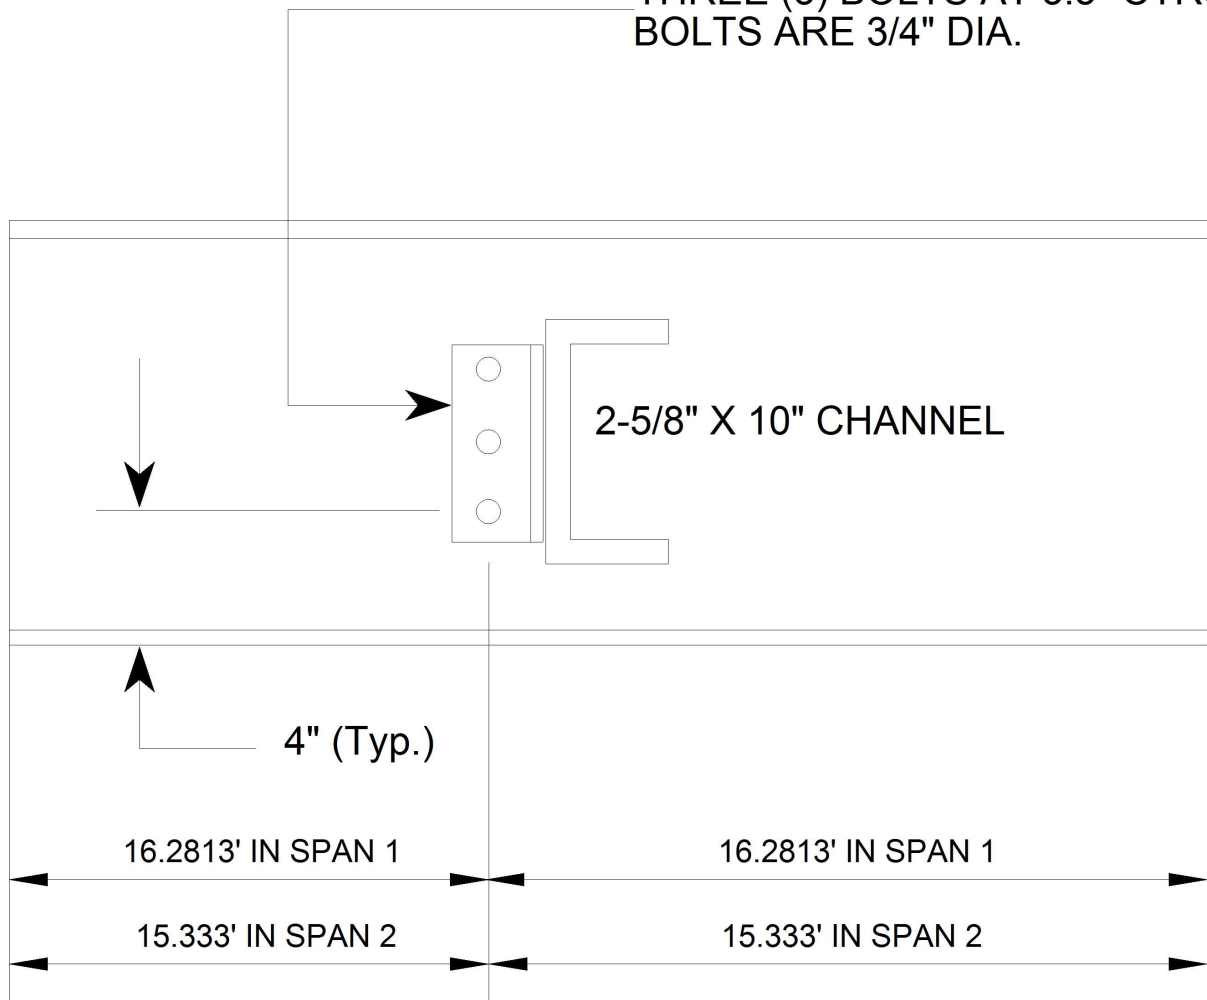
DIAPHRAGM IN SPANS A AND B

THREE (3) BOLTS AT 3.5" CTRS.  
BOLTS ARE 3/4" DIA.

ONE (1) LINE OF DIAPHRAGM IN ALL BAYS OF BOTH SPANS
