NC DEPARTMENT OF TRANSPORTATION  
DIVISION OF HIGHWAYS  
STRUCTURE MANAGEMENT UNIT

## Structure Safety Report

### Routine Element Inspection

COUNTY: MITCHELL STRUCTURE NUMBER: 600207 FREQUENCY: 24 MONTHS

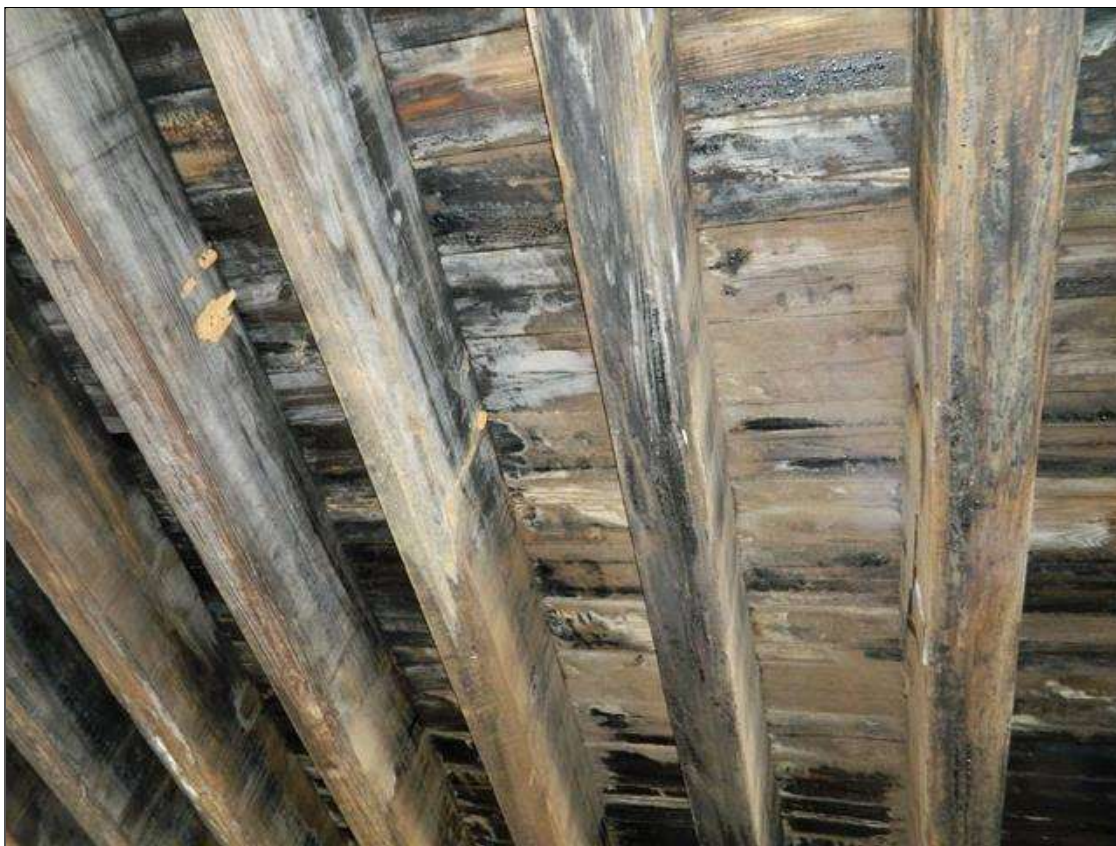
DECK UNDERSIDE

| Element Number | Defect Type | Defect Description | CS | CS Qty | Maint Qty | |
|---|---|---|---|---|---|---|
| 31 | Decay/Section Loss | FUNGUS STAINING AND SOFT THROUGHOUT THE UNDERSIDE. | 2 | 329 | | Square Feet |

| Element Number | Defect Type | Defect Description | CS | CS Qty | Maint Qty | |
|---|---|---|---|---|---|---|
| 111 | Decay/Section Loss | DELAMINATED ALONG THE TOP OF THE JOIST. FUNGUS STAINED AND SOFT OVER THE END BENT CAPS. | 2 | 16 | | Feet |
