NC DEPARTMENT OF TRANSPORTATION  
DIVISION OF HIGHWAYS  
STRUCTURE MANAGEMENT UNIT

# Structure Safety Report

## Routine Element Inspection - Contract

DIVISION: 11 COUNTY: ALLEGHANY STRUCTURE NUMBER: 020035 FREQUENCY: 24 MONTHS

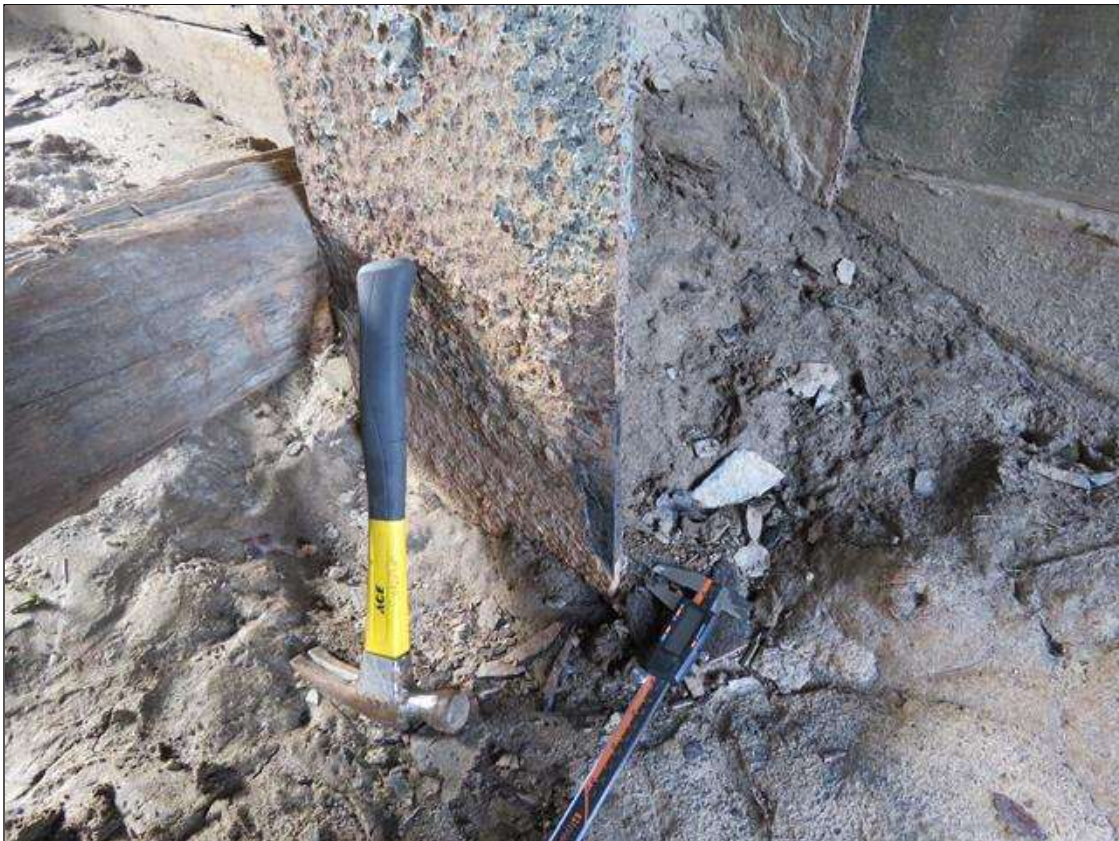
END BENT 1 PILE 2 FAR FACE FLANGE AT GRADE 1.5' HEIGHT x FULL WIDTH MINOR SCALE AND PITTING WITH 1/8" SECTION LOSS (28%), 5/16" REMAINING OF 7/16" ORIGINAL (PM PHOTO)

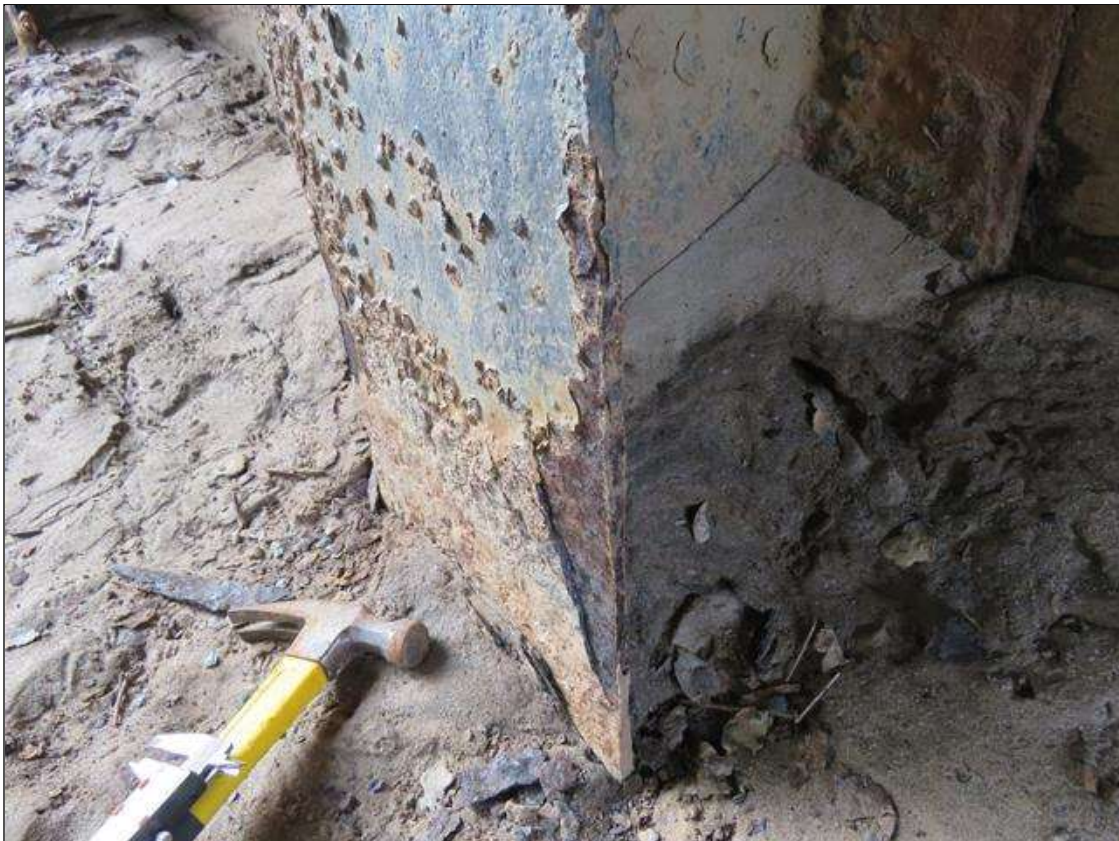
END BENT 1 PILE 4 FAR FACE FLANGE AT GRADE 1.5' HEIGHT x FULL WIDTH MINOR SCALE AND PITTING WITH 1/8" SECTION LOSS (28%), 5/16" REMAINING OF 7/16" ORIGINAL (PM PHOTO)

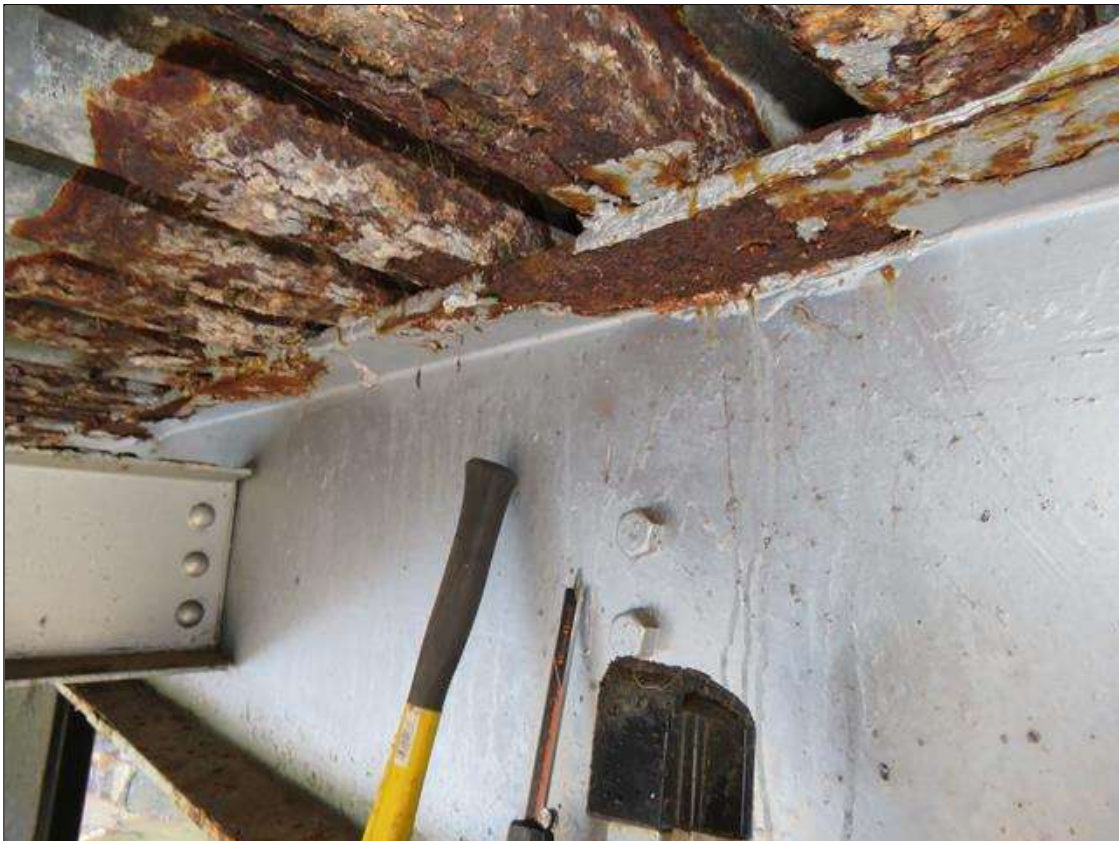
TYPICAL MINOR SCALE WITH 1/16" TAPERED SECTION LOSS (6%) 1/2" REMAINING AT EDGE OF 9/16" ORIGINAL FOR FULL LENGTH SPAN 1 BEAM 6

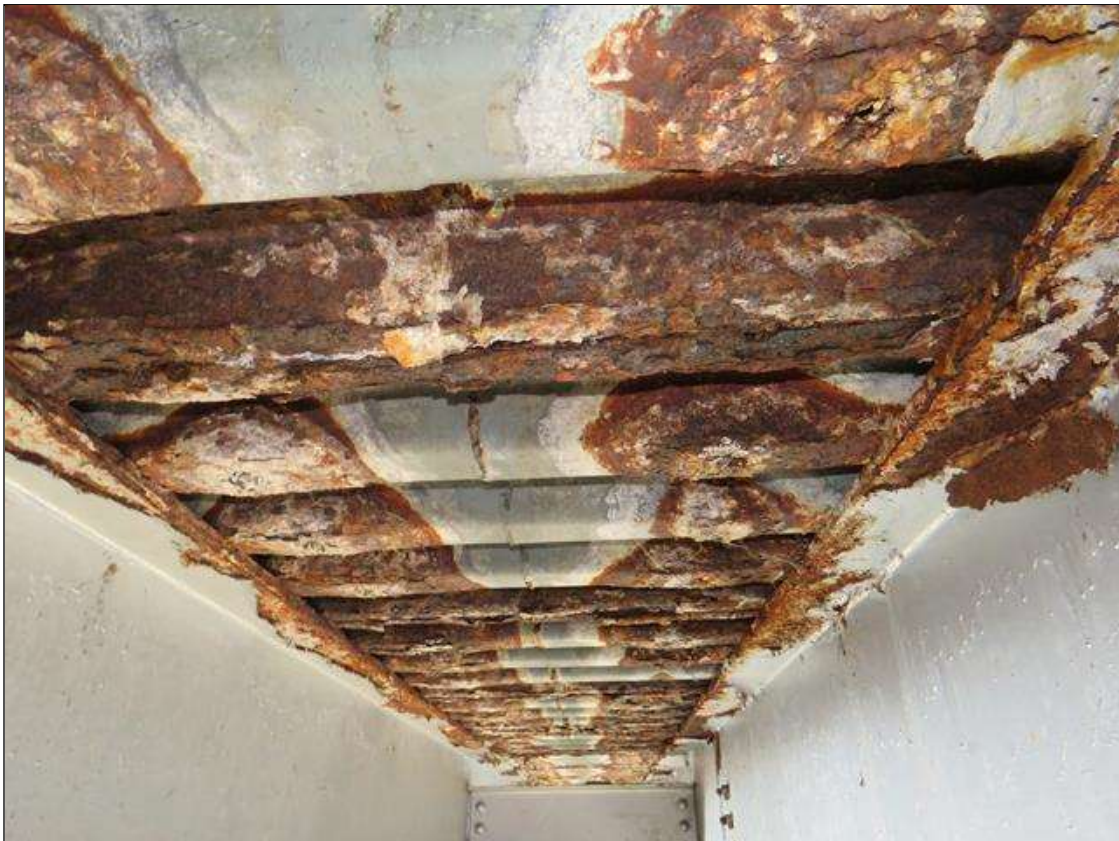
| Element Number | Defect Type | Defect Description | CS | CS Qty | Maint Qty | |
|---|---|---|---|---|---|---|
| 30 | Corrosion | UNDERSIDE CORRUGATED PANS INTERMITTENT MODERATE SCALE WITH UP TO 30% SECTION LOSS THROUGHOUT (PM) | 3 | 970 | 970 | Square Feet |

SPAN 1 DECK UNDERSIDE CORRUGATED PANS INTERMITTENT MODERATE SCALE WITH UP TO 30% SECTION LOSS BAY 5 (PM PHOTO)

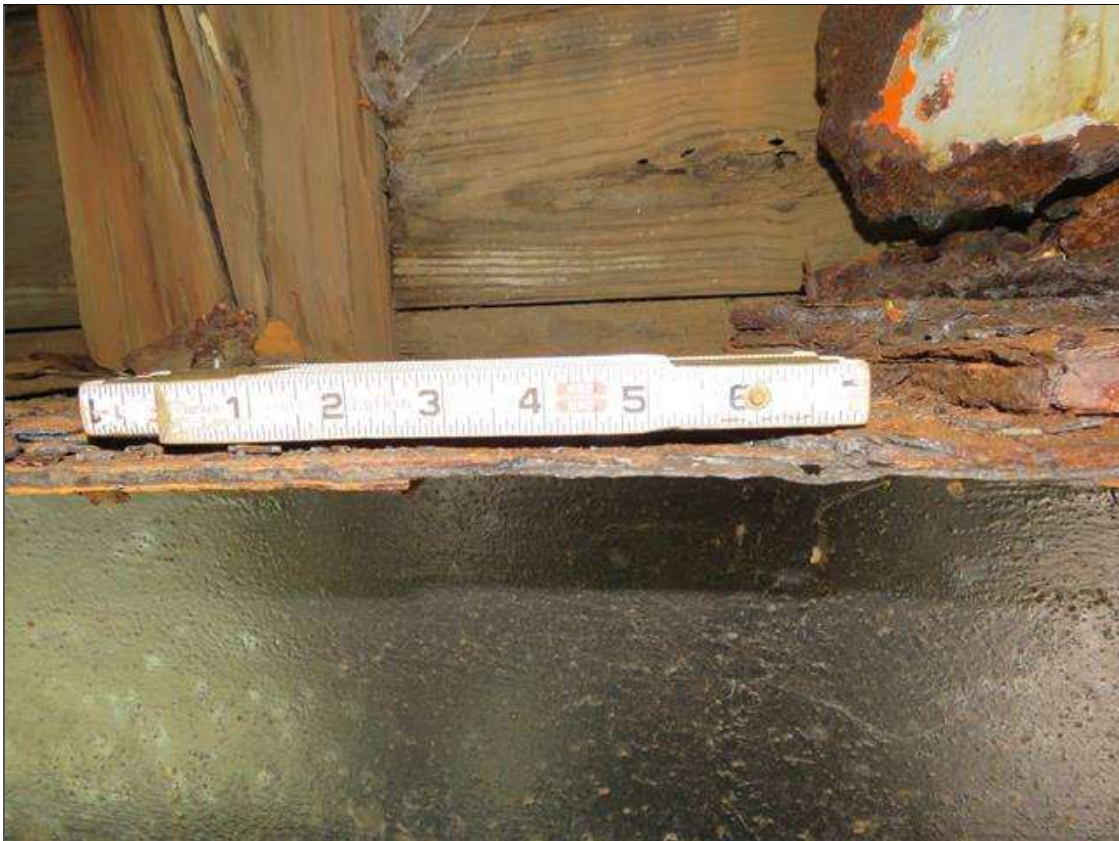
END BENT 1 CAP TOP FLANGE FULL WIDTH MODERATE SCALE WITH TAPERED SECTION LOSS (35% LOSS) 1/8" REMAINING AT EDGE OF 7/16" ORIGINAL FOR 2.5' LENGTH BETWEEN BEAMS 6 AND 7 (PM PHOTO)

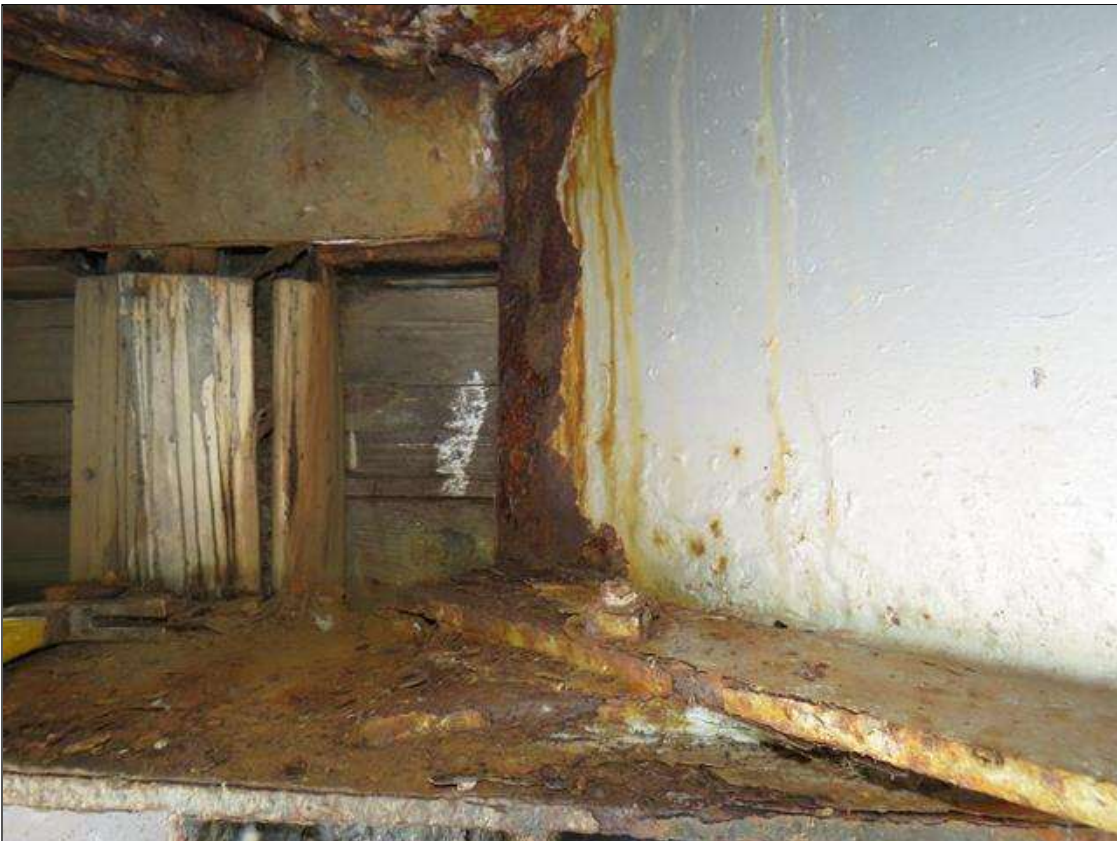
SPAN 2 BEAM 4 MINOR SCALE, WEB WITH 1/16" SECTION LOSS (17%) AND 5/16" REMAINING TO 6" LENGTH x FULL HEIGHT, FAR END

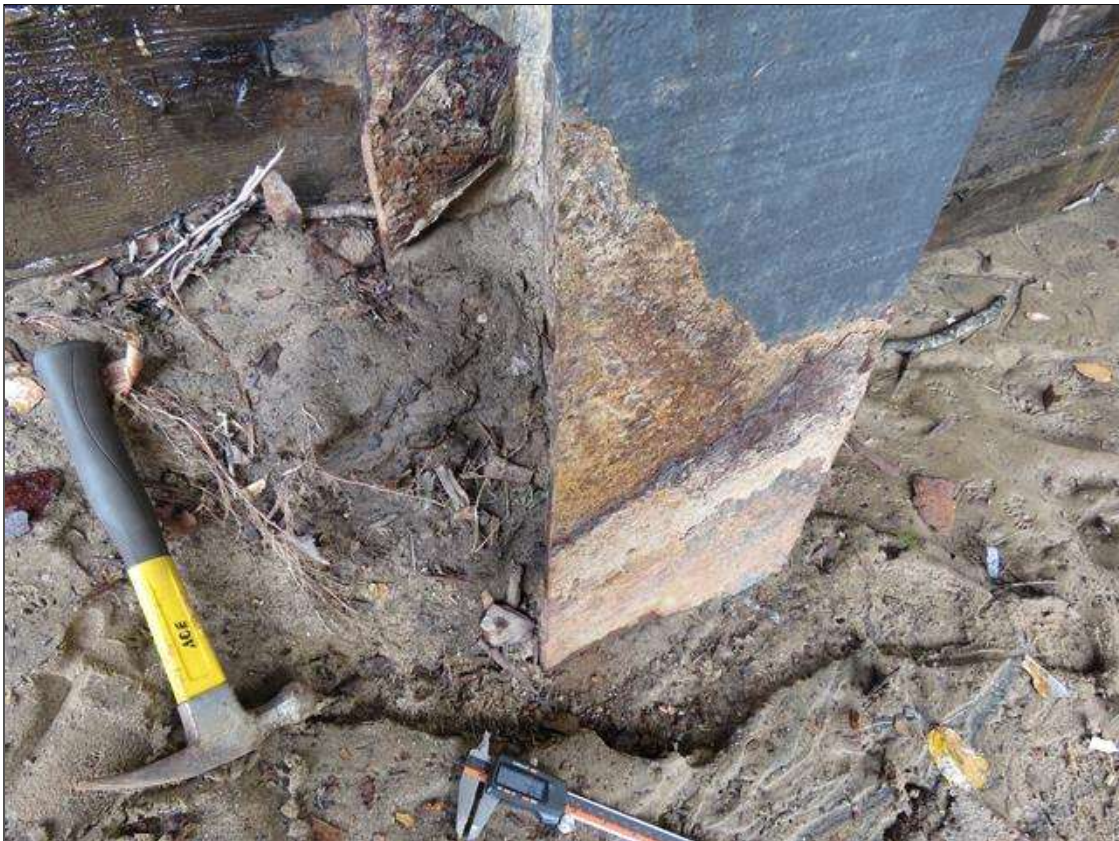
END BENT 2 PILE 3 NEAR AND FAR FACE FLANGES AT GRADE 1.5' HEIGHT x FULL WIDTH MINOR SCALE AND PITTING WITH 3/16" SECTION LOSS (42%), 1/4" REMAINING OF 7/16" ORIGINAL (PM PHOTO)

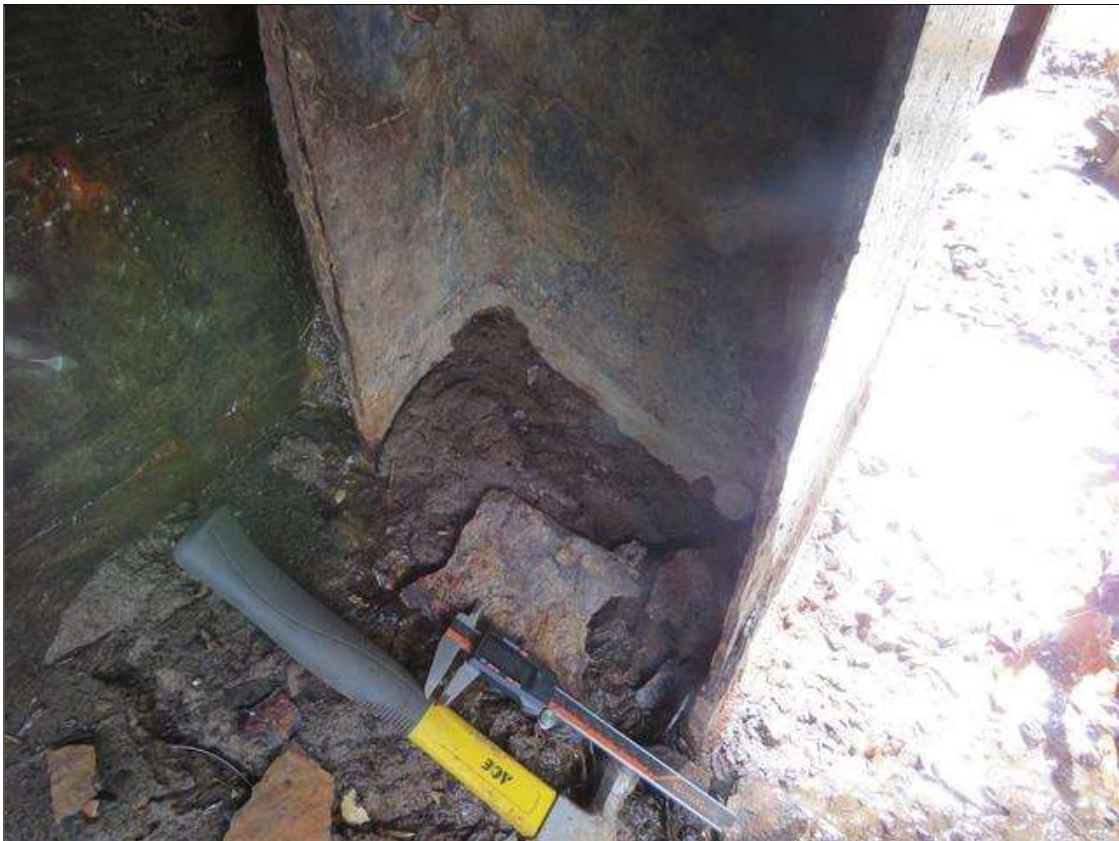
END BENT 2 PILE 5 NEAR AND FAR FACE FLANGES AT GRADE 1' HEIGHT x FULL WIDTH MINOR SCALE AND PITTING WITH 3/16" SECTION LOSS (42%), 1/4" REMAINING OF 7/16" ORIGINAL (PM PHOTO)

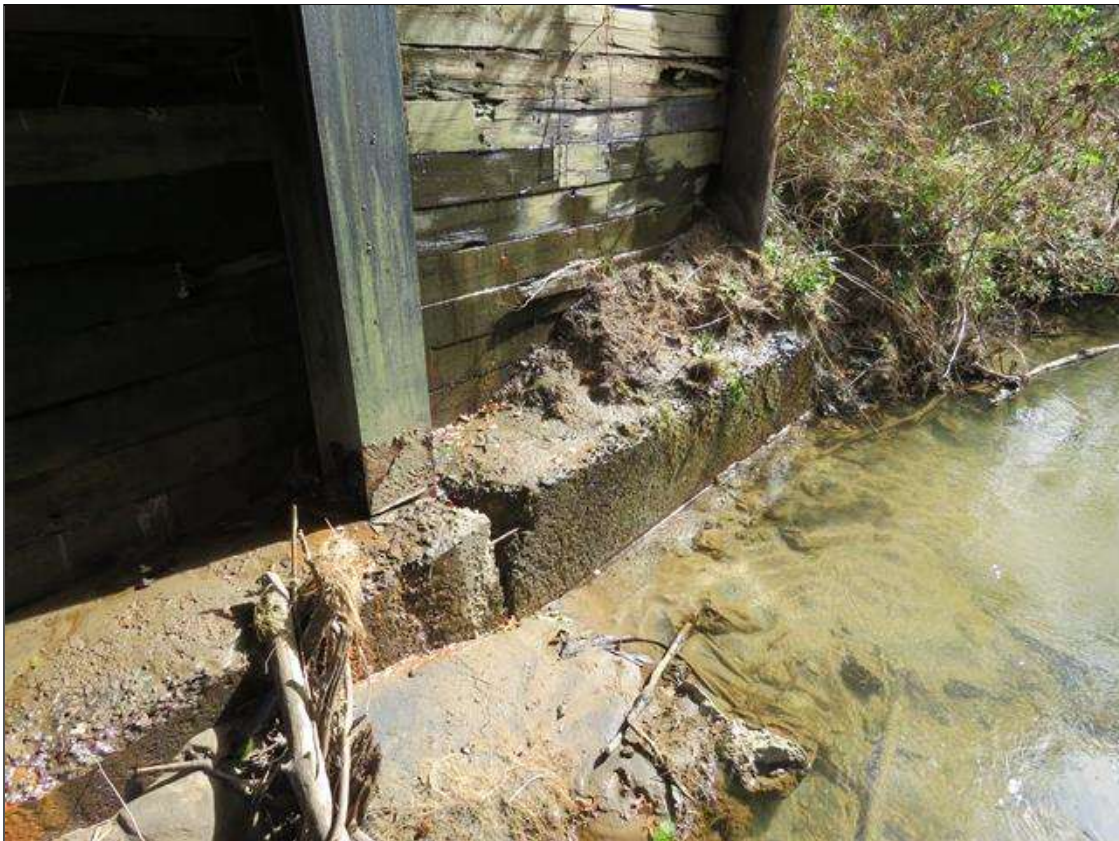
END BENT 2 SILL MINOR SCOUR (1.5'x 10' LENGTH) FOOTING NOT EXPOSED NO UNDERMINE

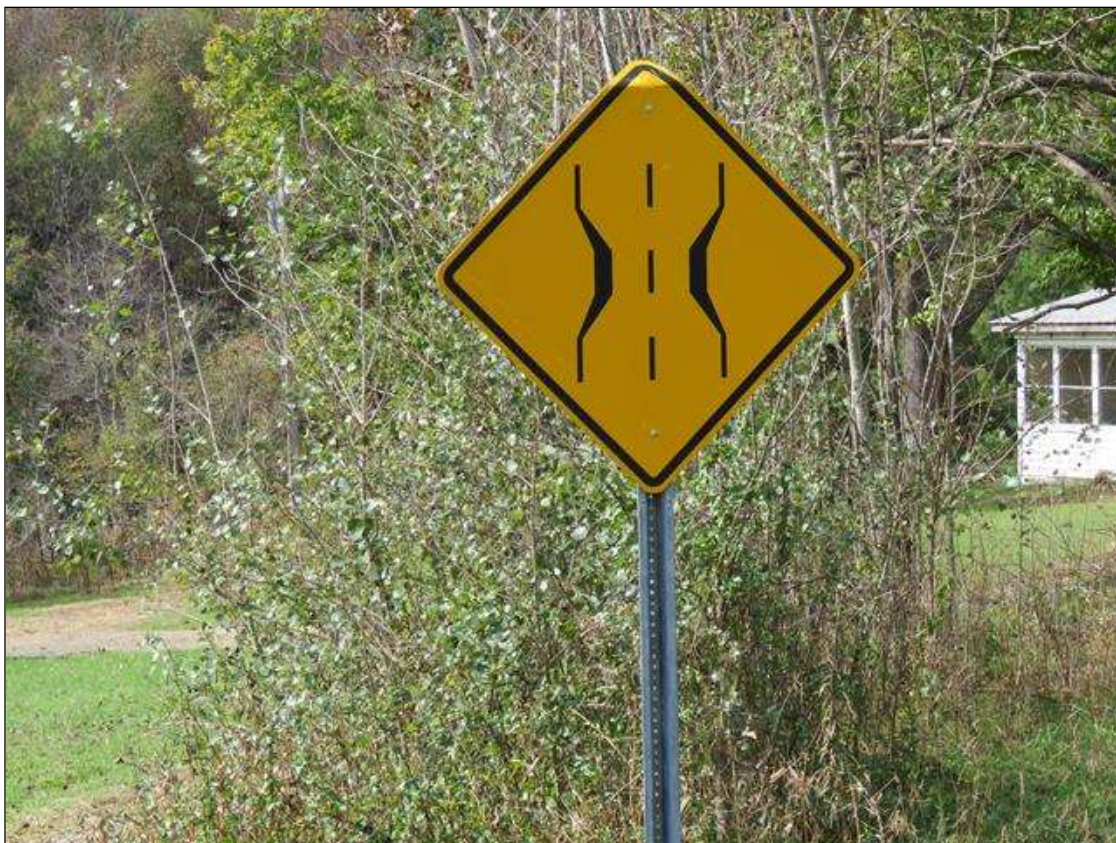
FAR APPROACH NARROW BRIDGE 500' FROM BRIDGE

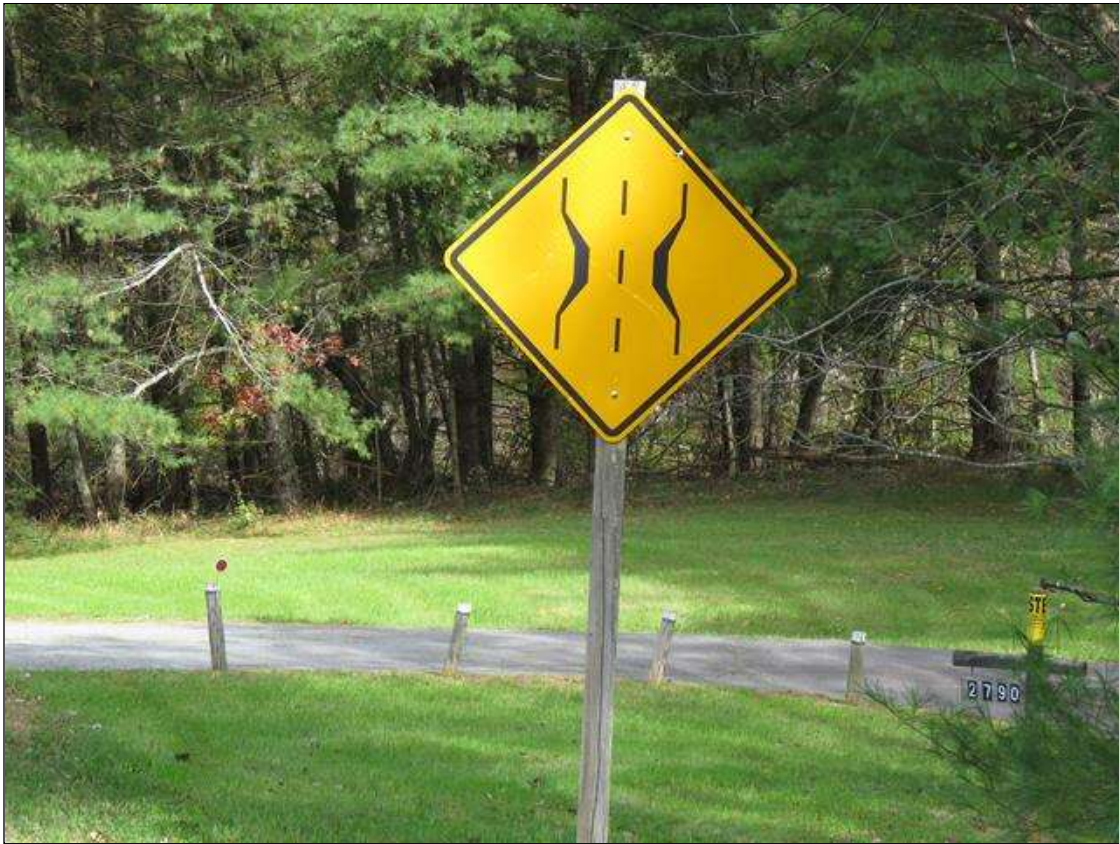
NEAR APPROACH NARROW BRIDGE 500' FROM BRIDGE
