NC DEPARTMENT OF TRANSPORTATION  
DIVISION OF HIGHWAYS  
STRUCTURE MANAGEMENT UNIT

# Structure Safety Report

## 2 Year Complete Topside and Underwater Element Inspection

DIVISION: 11 COUNTY: ALLEGHANY STRUCTURE NUMBER: 020133 FREQUENCY: 24 MONTHS

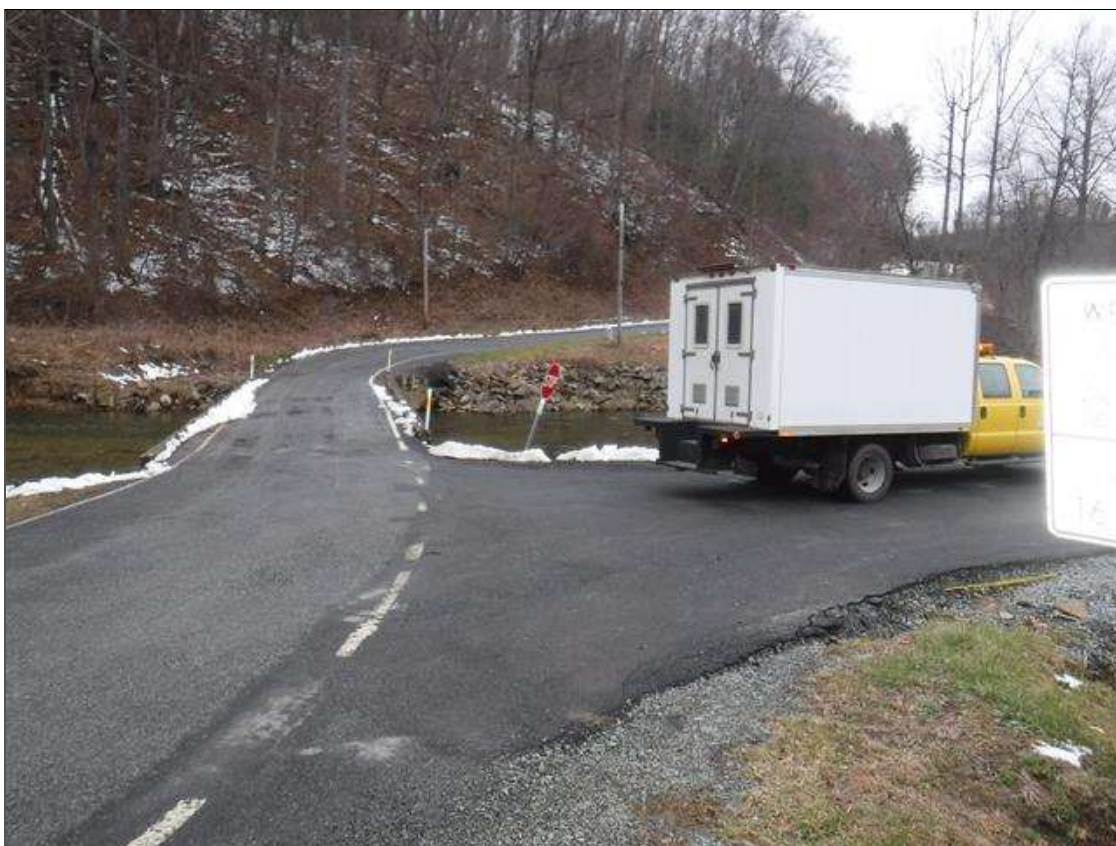
NORTHWEST WING DAMAGE

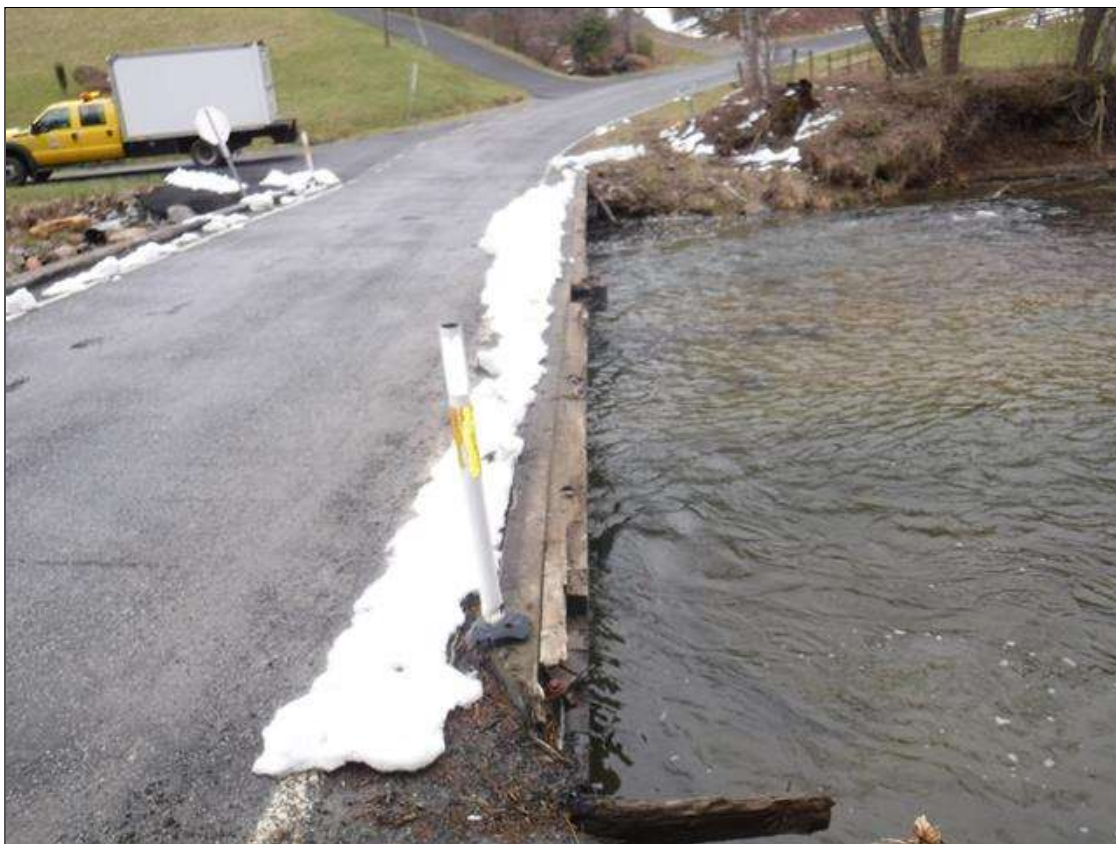
WEARING SURFACE

| Element Number | Defect Type | Defect Description | CS | CS Qty | Maint Qty | |
|---|---|---|---|---|---|---|
| 510 | Crack (Wearing Surface) | RANDOM CRACKS ALONG DECK BOARD JOINTS. | 2 | 24 | 24 | Square Feet |
| 510 | Effectiveness (Wearing Surface) | TRAFFIC WEAR. | 2 | 462 | | Square Feet |

486 Square Feet of Effectiveness (Wearing Surface): Substantially effective. Deterioration of the protected element has slowed. TRAFFIC WEAR.
