NC DEPARTMENT OF TRANSPORTATION  
DIVISION OF HIGHWAYS  
STRUCTURE MANAGEMENT UNIT

## Structure Safety Report

### Routine Element Inspection - Contract

DIVISION: 14 COUNTY: HAYWOOD STRUCTURE NUMBER: 430142 FREQUENCY: 24 MONTHS

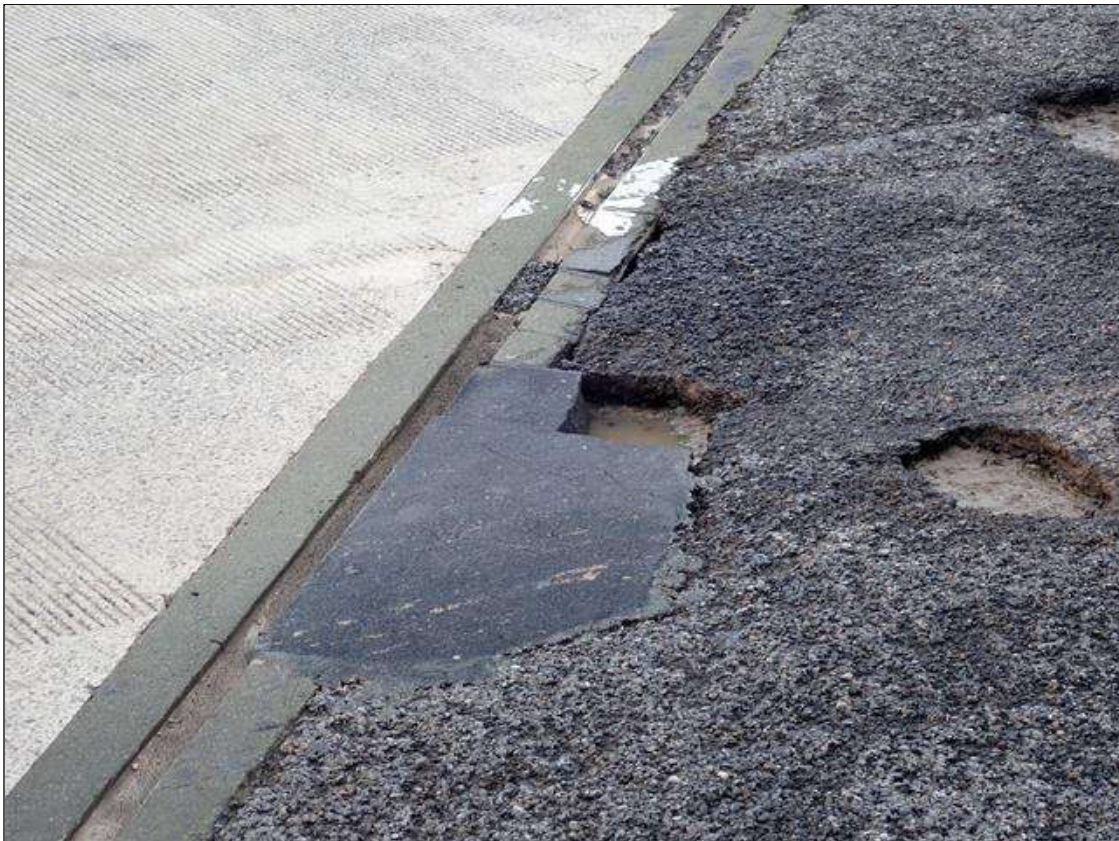
Expansion Joint At End Bent 2: 1 FT X 1 FT FAILED PATCH IN THE LEFT EASTBOUND LANE, RIGHT WHEEL PATH

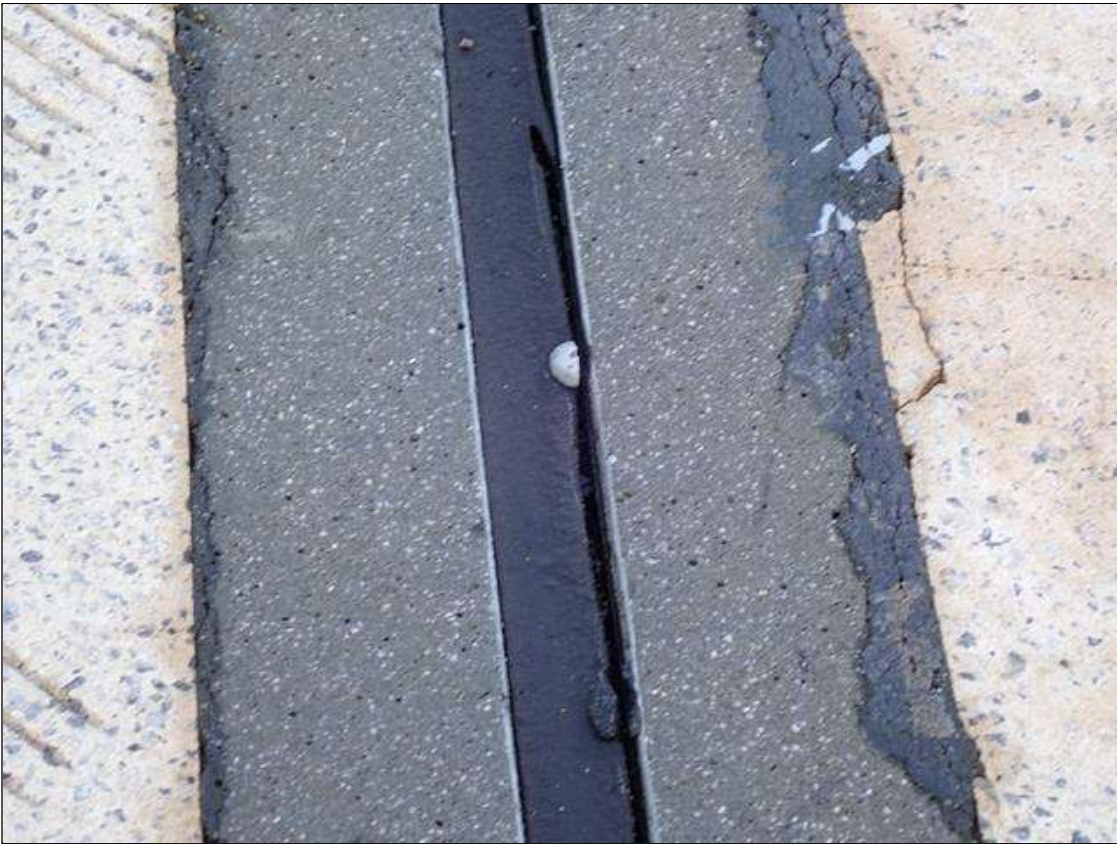
Expansion Joint At Bent 4: SEAL ADHESION LOSS, LESS THAN FULL DEPTH, FOR 12 FT IN THE LEFT TRAVEL LANE OF THE WESTBOUND LANES

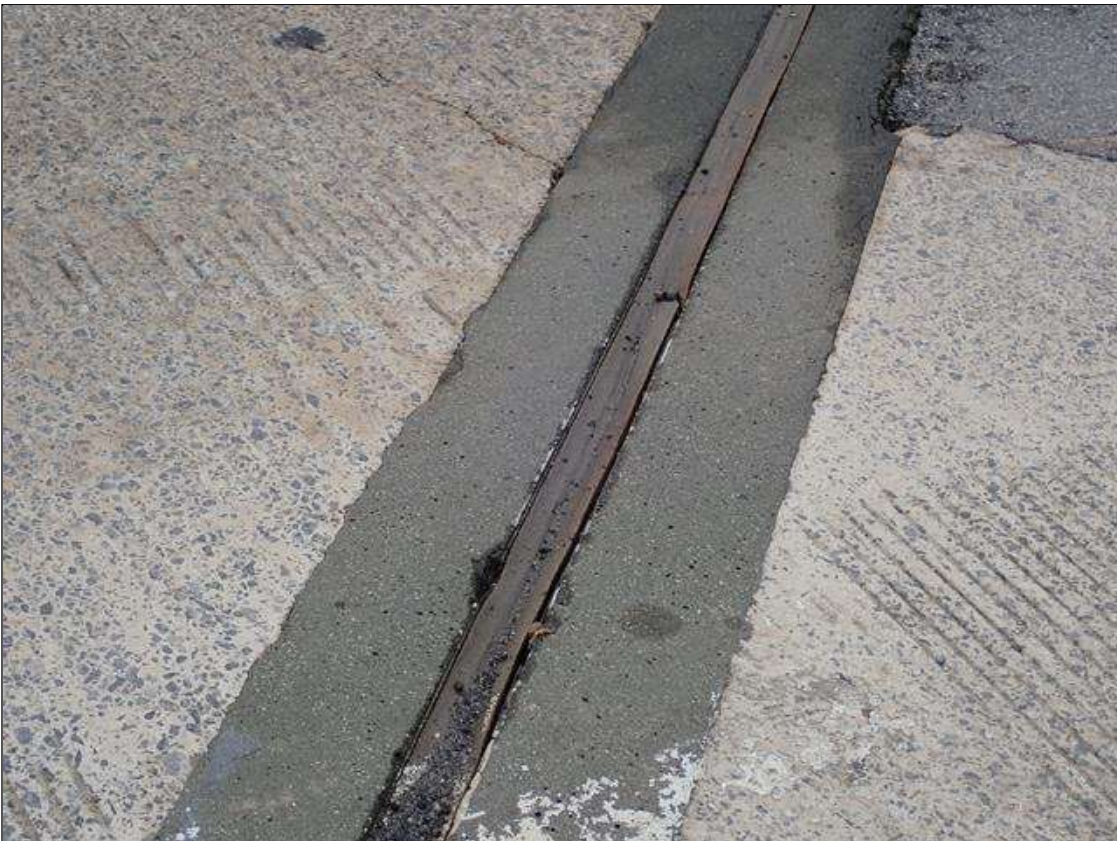
Expansion Joint At Bent 1: SEAL ADHESION LOSS, LESS THAN FULL DEPTH, FOR 8 FT IN THE LEFT LANE OF THE EASTBOUND LANES

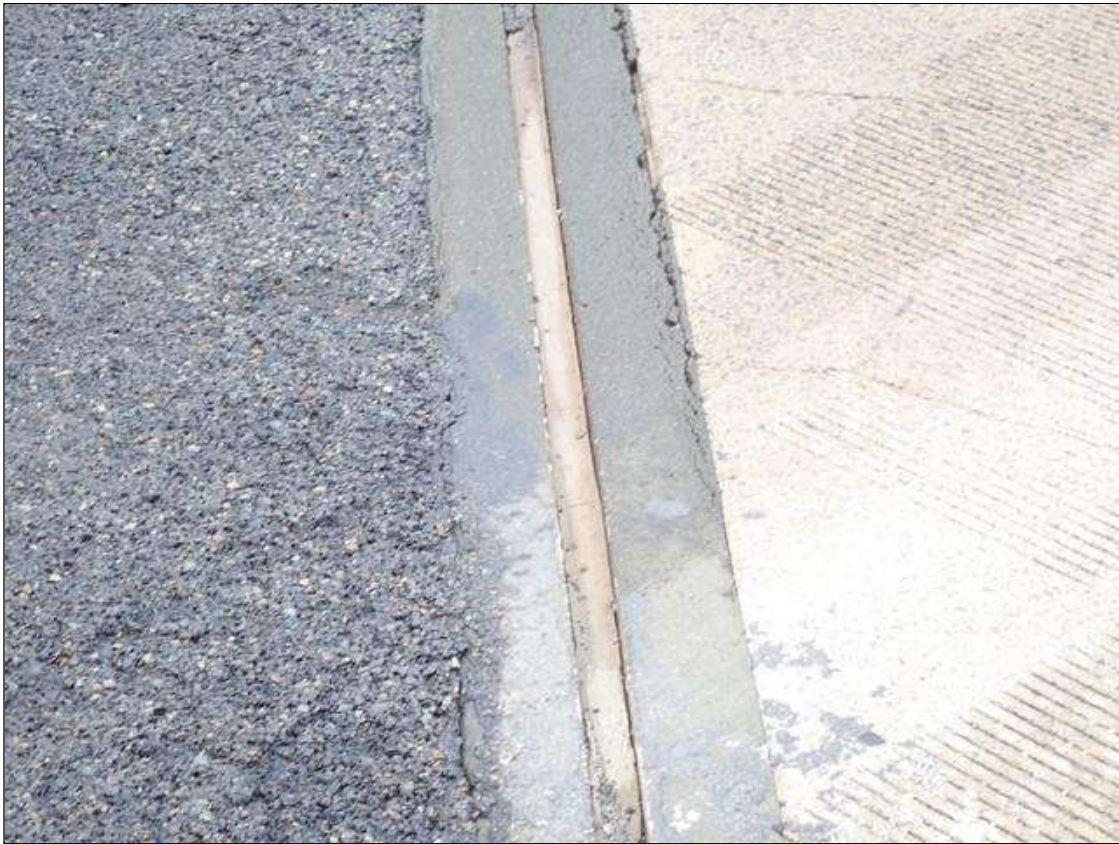
Expansion Joint At End Bent 1: SEAL ADHESION LOSS, LESS THAN 50% OF THE DEPTH, SCATTERED THROUGHOUT

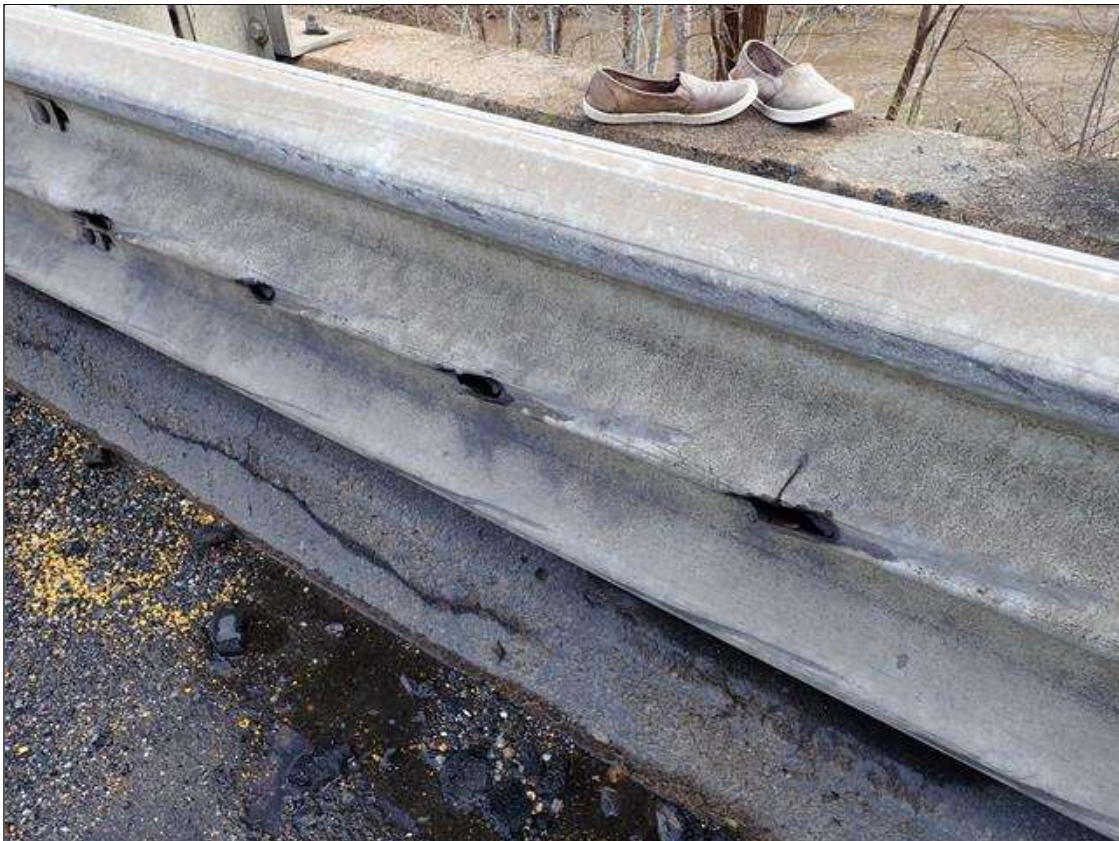
Span 5 Left Bridge Rail: SPAN 5 LEFT METAL RAIL HAS 10 FT. OF 2 INCH WIDE TEARS THRU OUT THE LENGTH OF THE RAIL. GUARDRAIL REMAINS FUNCTIONAL.

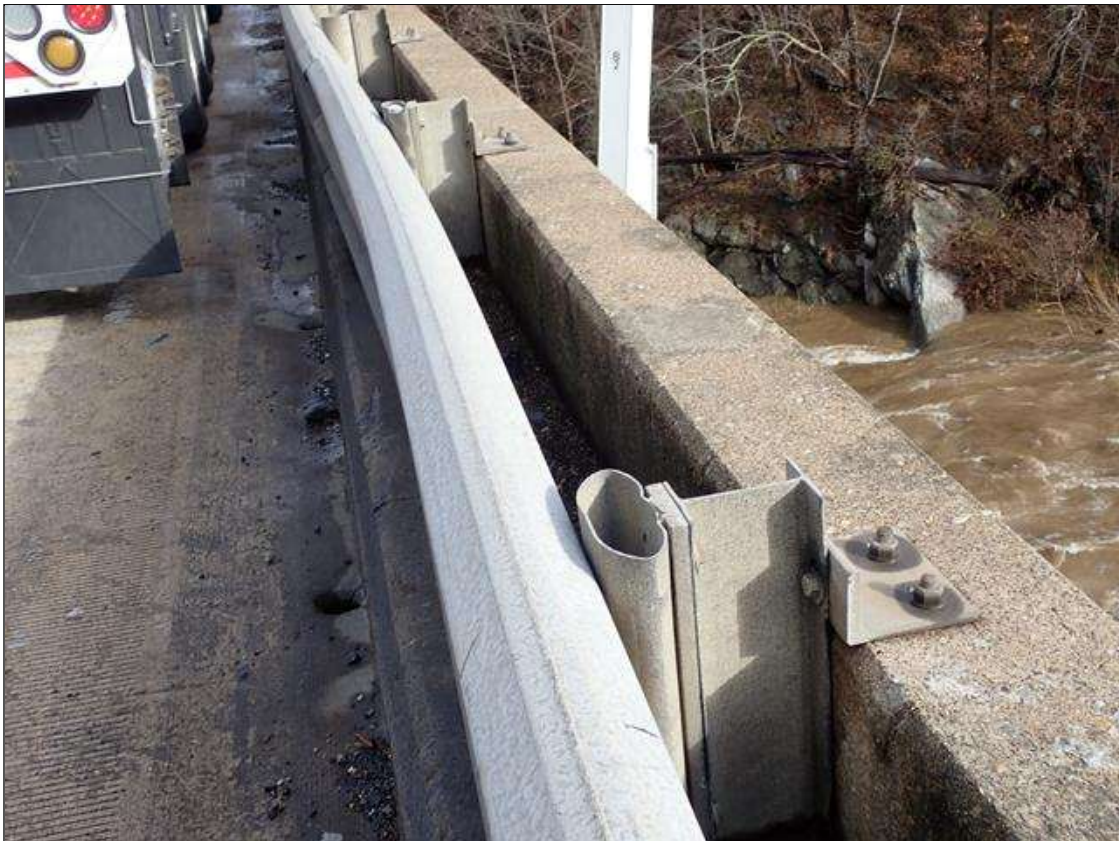
Span 4 Left Bridge Rail: SPAN 4, LEFT RAIL HAS 25 FT. OF IMPACT DAMAGE, WITH THE SPACER PIPES CRUSHED, STARTING AT BENT 4; SIMILAR AT BENT 3

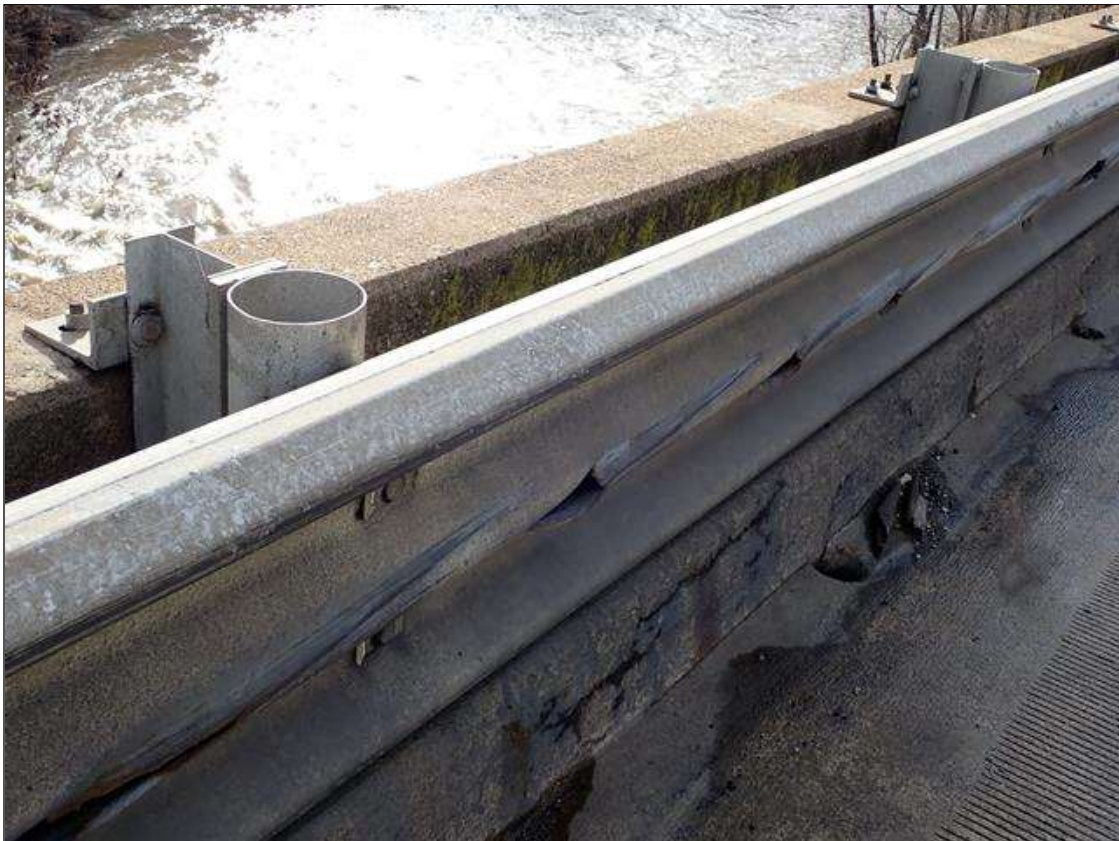
Span 3 Left Bridge Rail: SPAN 3 LEFT RAIL HAS 12 FT. OF 2 INCH WIDE TEARS THRU OUT THE RAIL. GUARDRAIL REMAINS FUNCTIONAL.

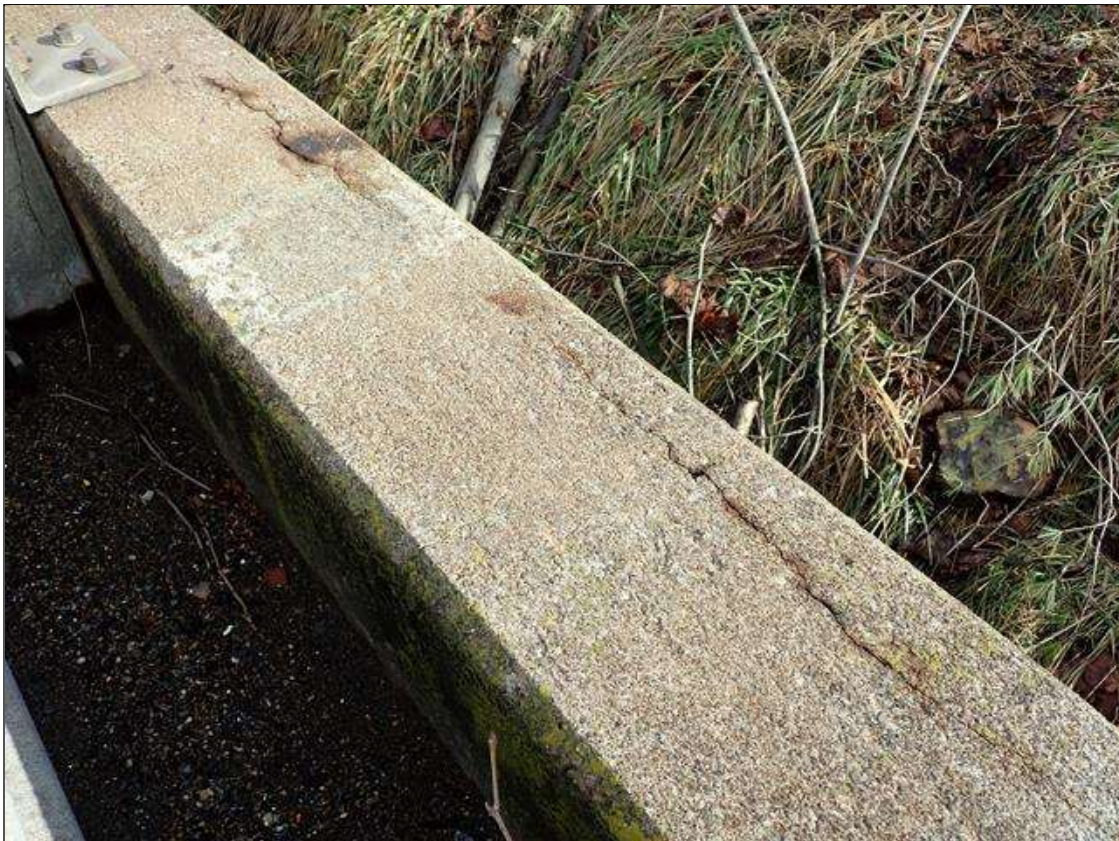
| Element Number | Defect Type | Defect Description | CS | CS Qty | Maint Qty | |
|---|---|---|---|---|---|---|
| 330 | Damage | CONCRETE CURB HAS LONGITUDINAL HAIRLINE CRACKING WITH RUST STAINS SCATTERED THROUGHOUT | 2 | | | Feet |

Span 1 Left Bridge Rail: CONCRETE CURB HAS LONGITUDINAL HAIRLINE CRACKING WITH RUST STAINS SCATTERED THROUGHOUT

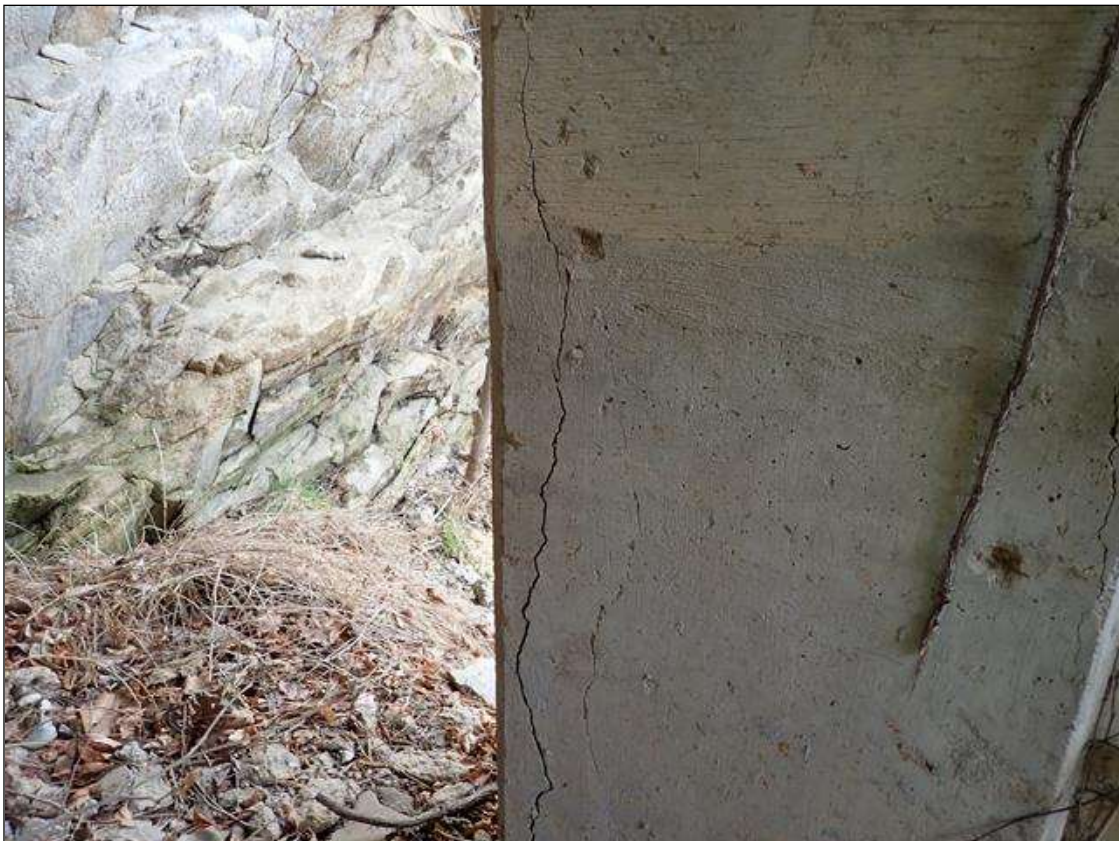
Bent 1 Pile 4: 6 FT X 8" X 6" DELAMINATION IN THE NORTHWEST CORNER AT THE GROUND LINE; SIMILAR ALL CORNERS

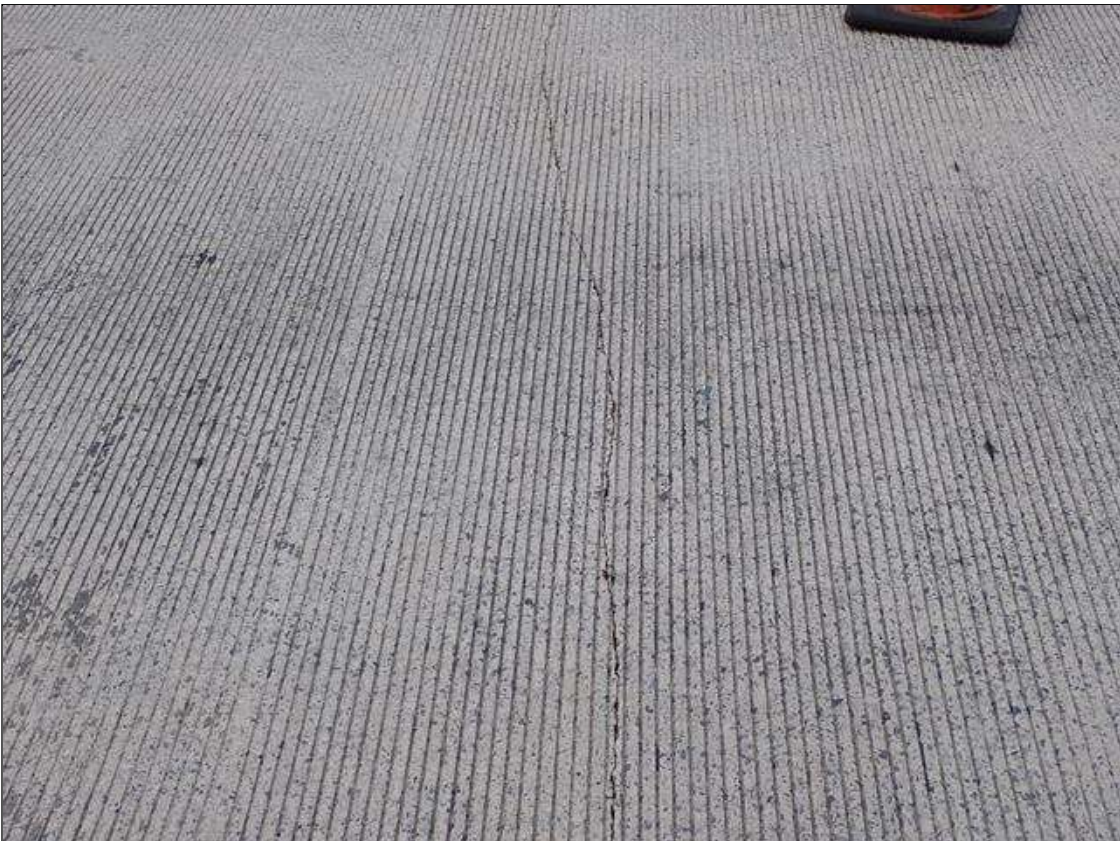
| Element Number | Defect Type | Defect Description | CS | CS Qty | Maint Qty | |
|---|---|---|---|---|---|---|
| 12 | Cracking (RC and Other) | TRANSVERSE CRACKS, UP TO FULL WIDTH, UP TO 1/16" WIDE, SCATTERED THROUGHOUT THE TOP OF THE DECK | 3 | 1,000 | 1,000 | Square Feet |

Span 1 Deck: TRANSVERSE CRACKS, UP TO FULL WIDTH, UP TO 1/16" WIDE, SCATTERED THROUGHOUT THE TOP OF THE DECK

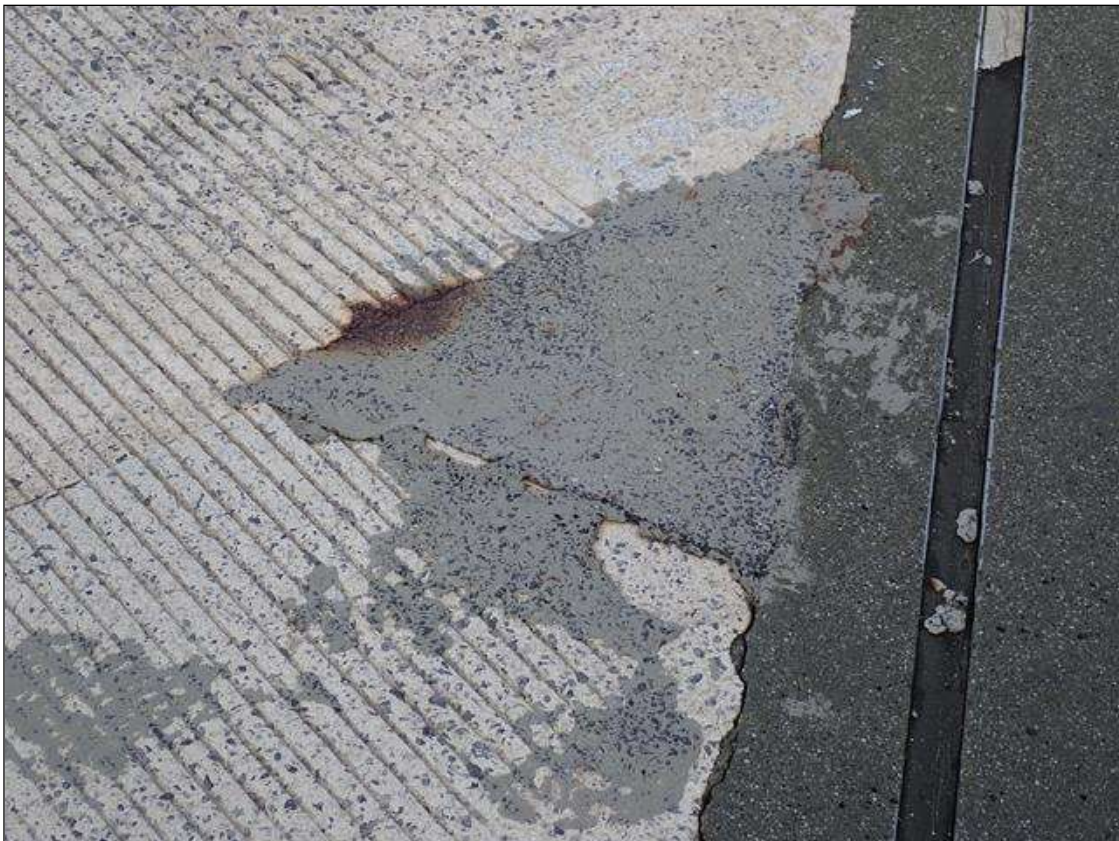
Span 2 Deck: 12" X 12" SOUND PATCH IN TOP OF DECK IN WESTBOUND LANES AT BENT 1, SIMILAR PATCH AT MIDSPAN.

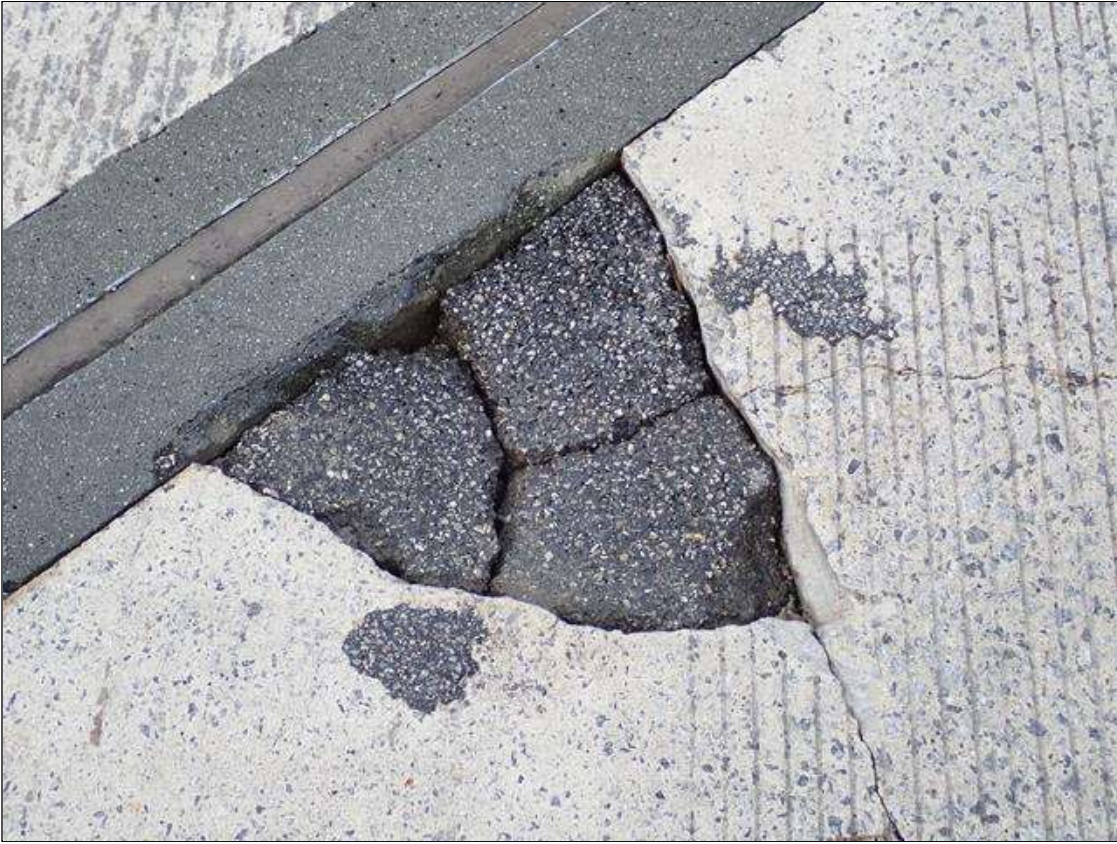
Span 2 Deck: 14" X 12" X 2" UNSOUND ASPHALT PATCH IN TOP OF DECK IN WESTBOUND LANES AT BENT 2

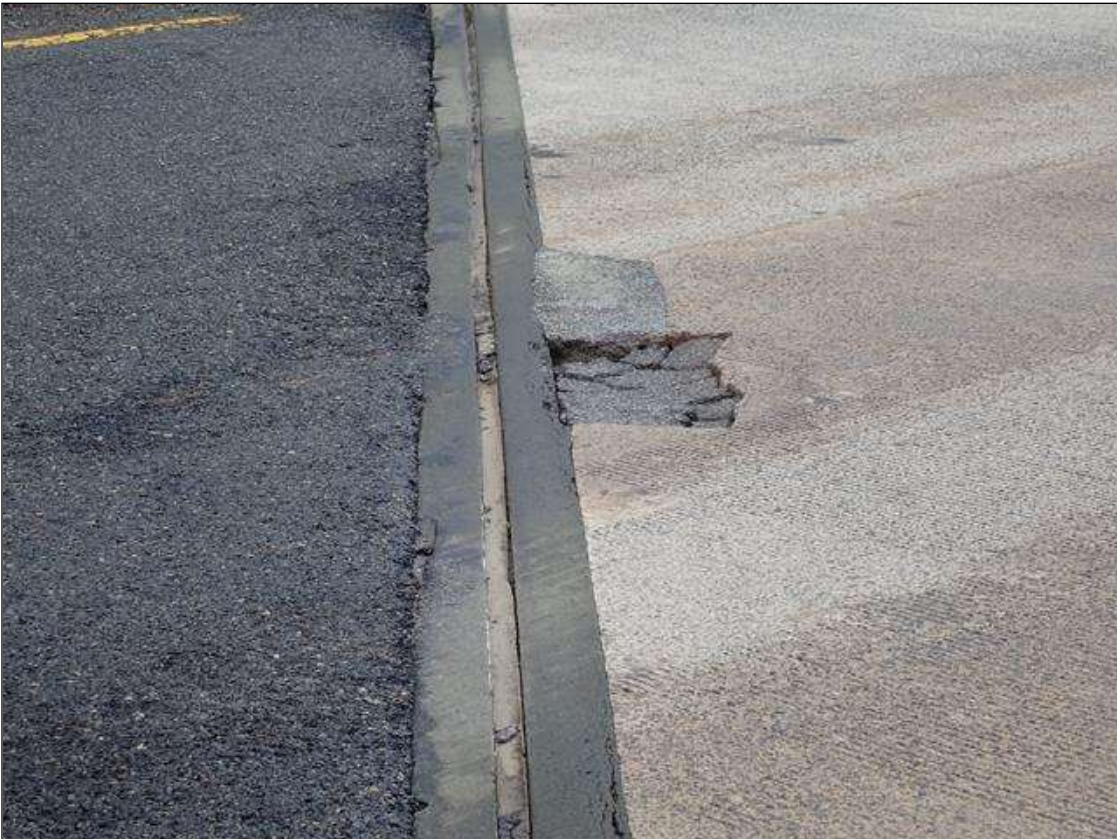
| Element Number | Defect Type | Defect Description | CS | CS Qty | Maint Qty | |
|---|---|---|---|---|---|---|
| 12 | Patched Areas | 3 FT X 18" X 2.5" DEEP UNSOUND PATCH WITH SPALLING IN TOP OF DECK IN EASTBOUND TRAVEL LANES AT END BENT 1, NO EXPOSED REINFORCEMENT. | 3 | 5 | 5 | Square Feet |

Span 1 Deck: 3 FT X 18" X 2.5" DEEP UNSOUND PATCH WITH SPALLING IN TOP OF DECK IN EASTBOUND TRAVEL LANES AT END BENT 1, NO EXPOSED REINFORCEMENT.

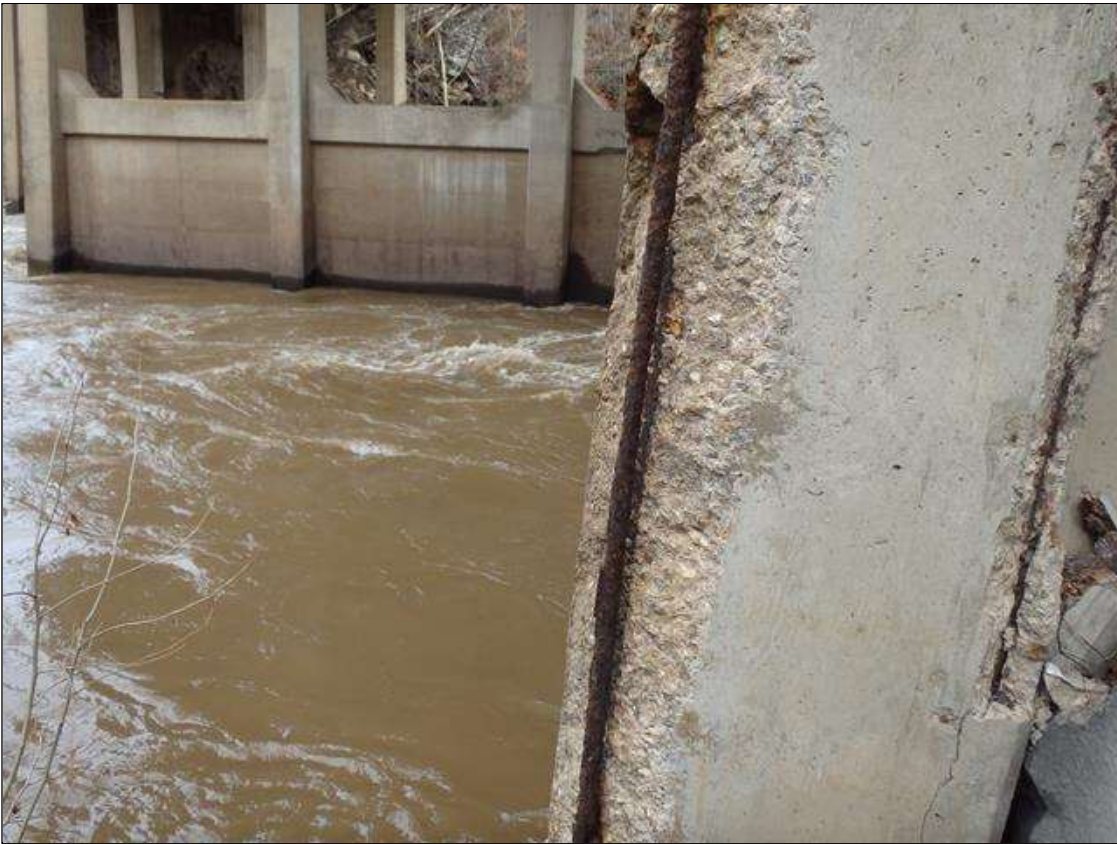
Bent 4 Pile 5: 10 FT HIGH X 12" X 7" X UP TO 4" DEEP SPALL WITH EXPOSED REINFORCEMENT IN SOUTHEAST CORNER OF COLUMN, BEGINNING AT GROUNDLINE. APPROXIMATELY 90% SECTION REMAINING IN MAIN REINFORCING STEEL, REINFORCING STEEL IS COMPLETELY SEPARATED FROM CONCRETE. (PRIORITY MAINTENANCE)

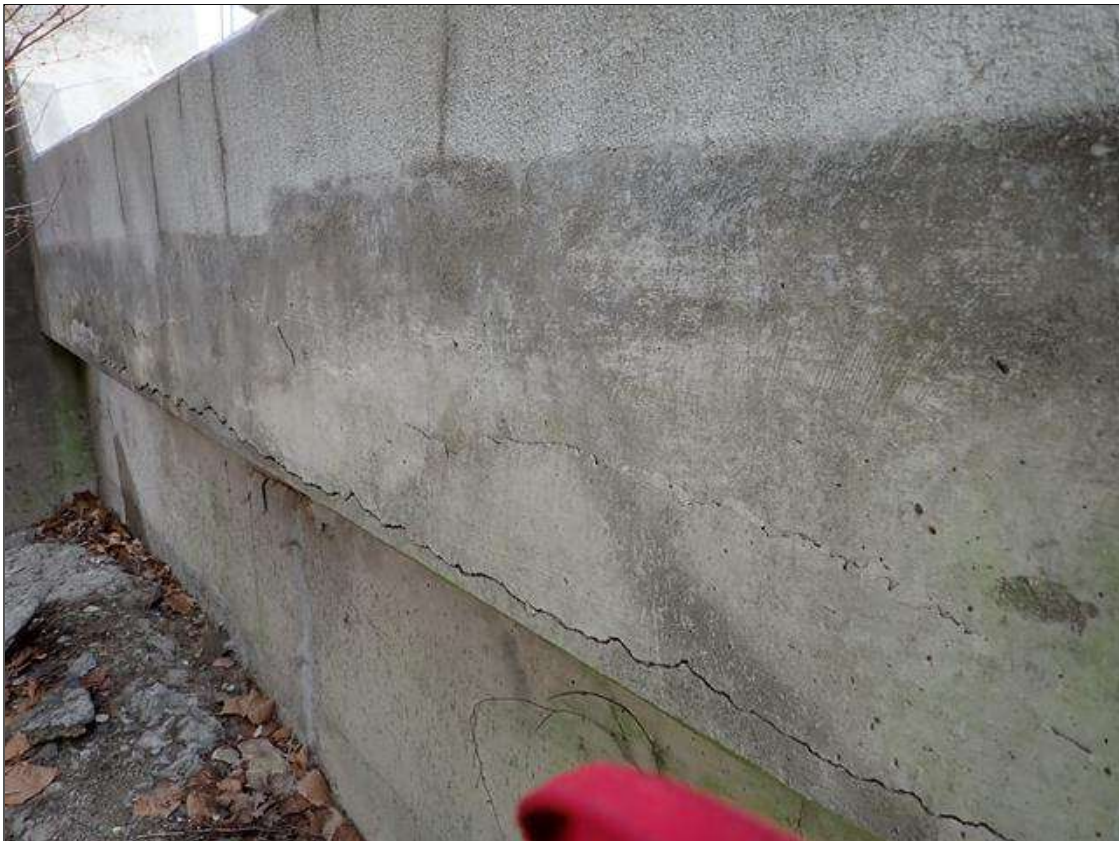
Bent 4 Pile 1: DELAMINATION ON EAST FACE OF STRUT BETWEEN COLUMNS 1 AND 2. DELAMINATION IS FULL WIDTH OF STRUT X 14" HIGH. SIMILAR ON WEST FACE.

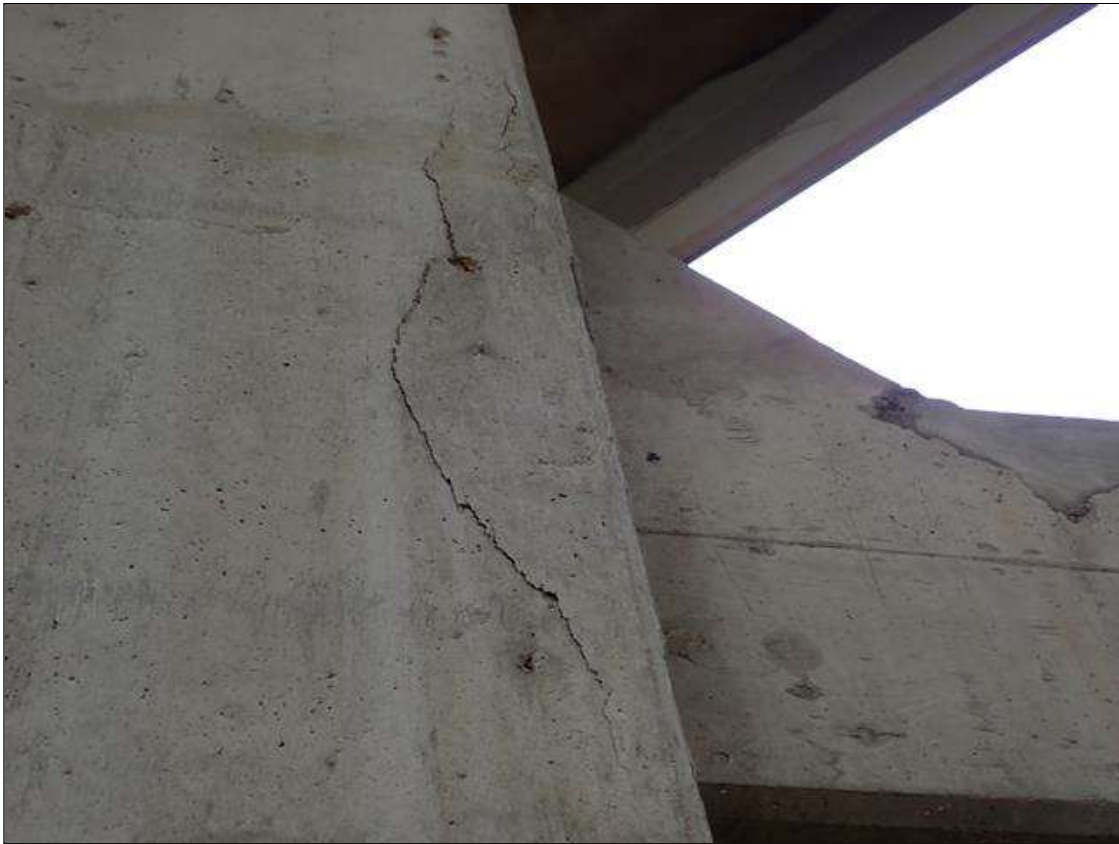
Bent 4 Pile 4: 4 FT HIGH X 10" X 8" DELAMINATION ON WEST FACE OF COLUMN AT STRUT.

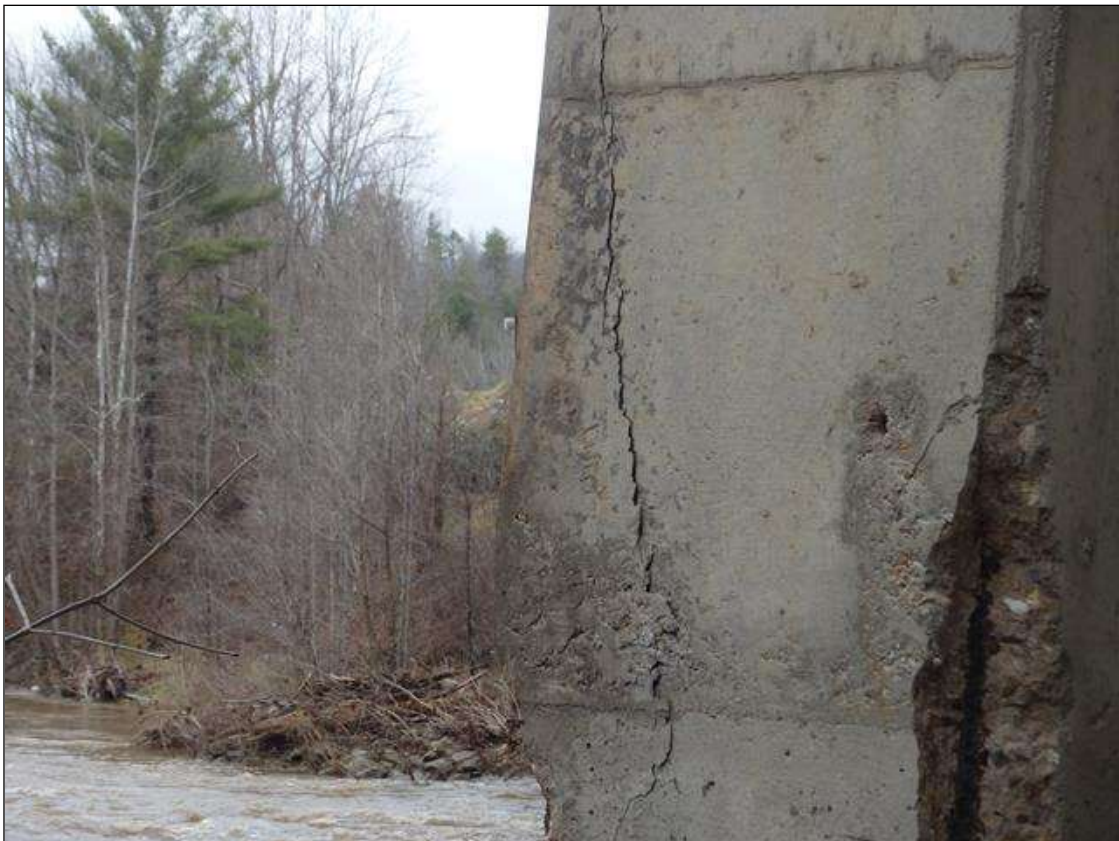
Bent 4 Pile 5: 8 FT X 1 FT X 1 FT DELAMINATION ON EAST FACE OF COLUMN, DIRECTLY ABOVE SPALL.

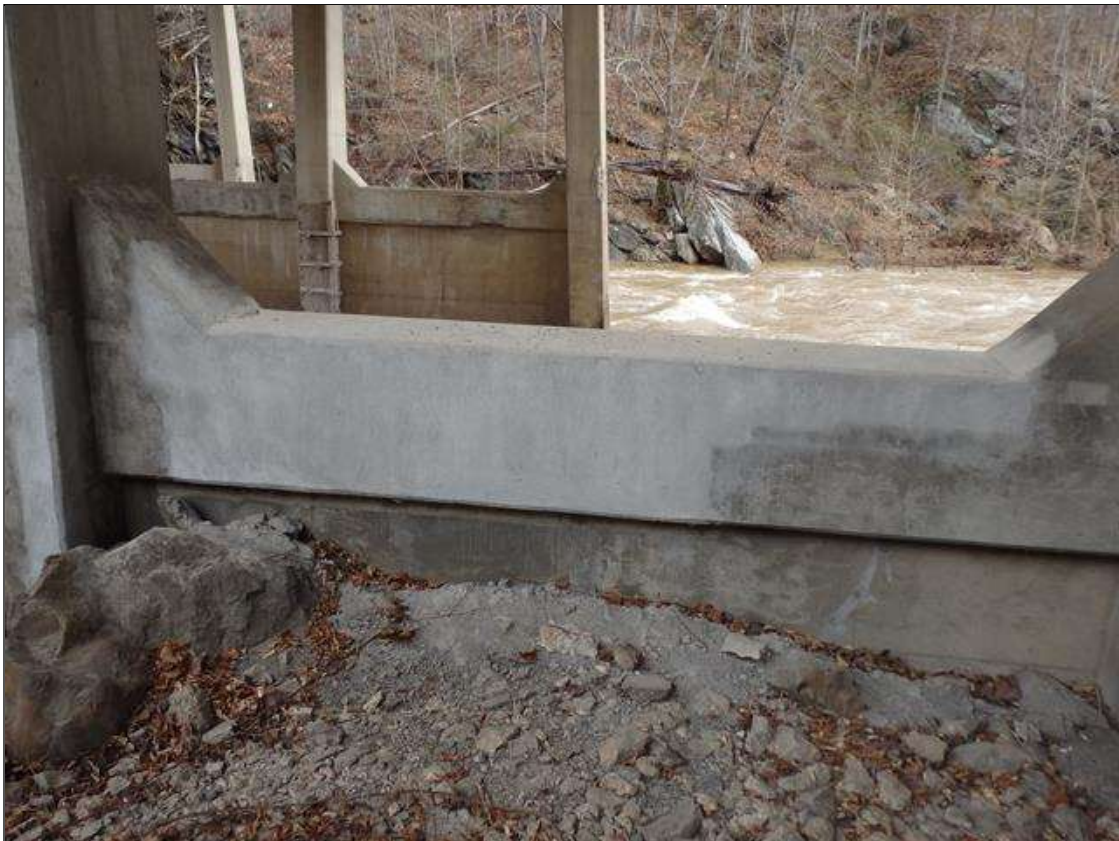
Bent 4 Pile 3: SOUND PATCH IN STRUT BETWEEN COLUMNS 3 AND 4. PATCH IS FULL LENGTH OF STRUT X FULL WIDTH OF STRUT X UP TO FULL DEPTH OF STRUT.

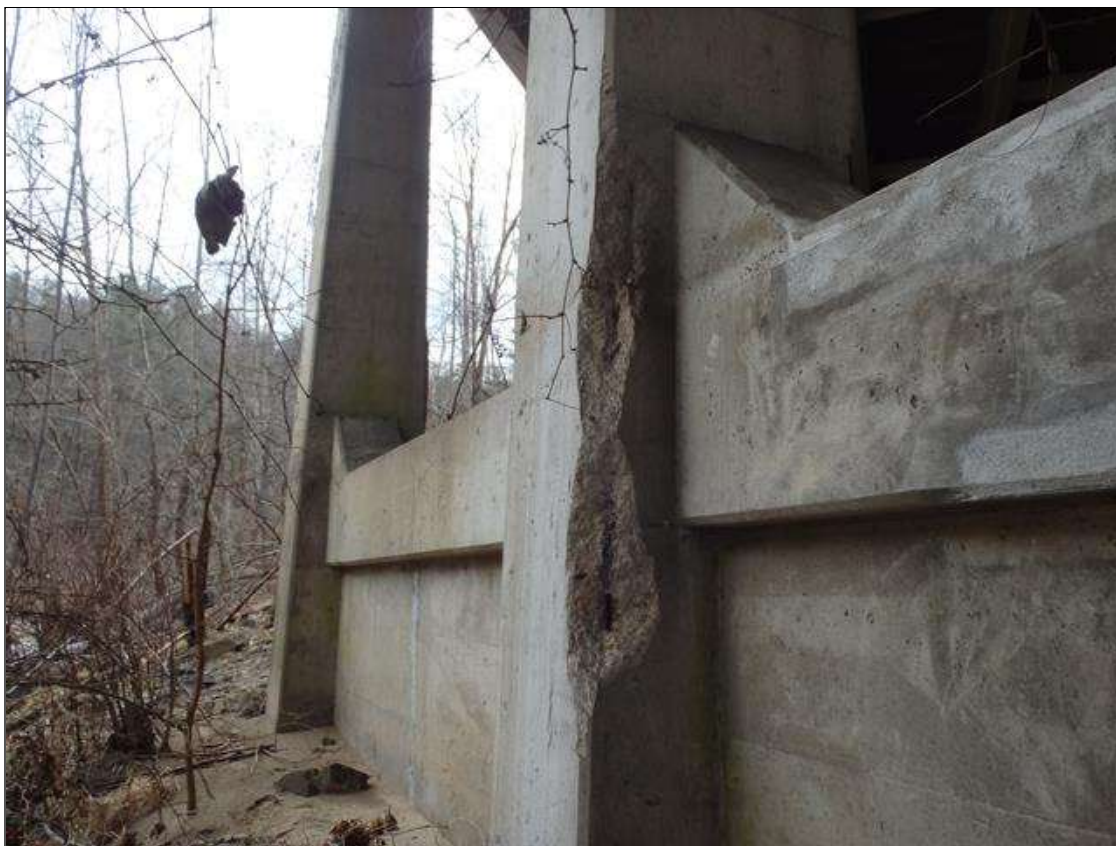
Bent 4 Pile 3: 9 FT HIGH X 6" X 6" X UP TO 6" DEEP SPALL WITH EXPOSED REINFORCEMENT IN SOUTHEAST CORNER OF COLUMN WITH 90% SECTION REMAINING OF EXPOSED REINFORCEMENT, AT HEIGHT OF STRUT. (PRIORITY MAINTENANCE).

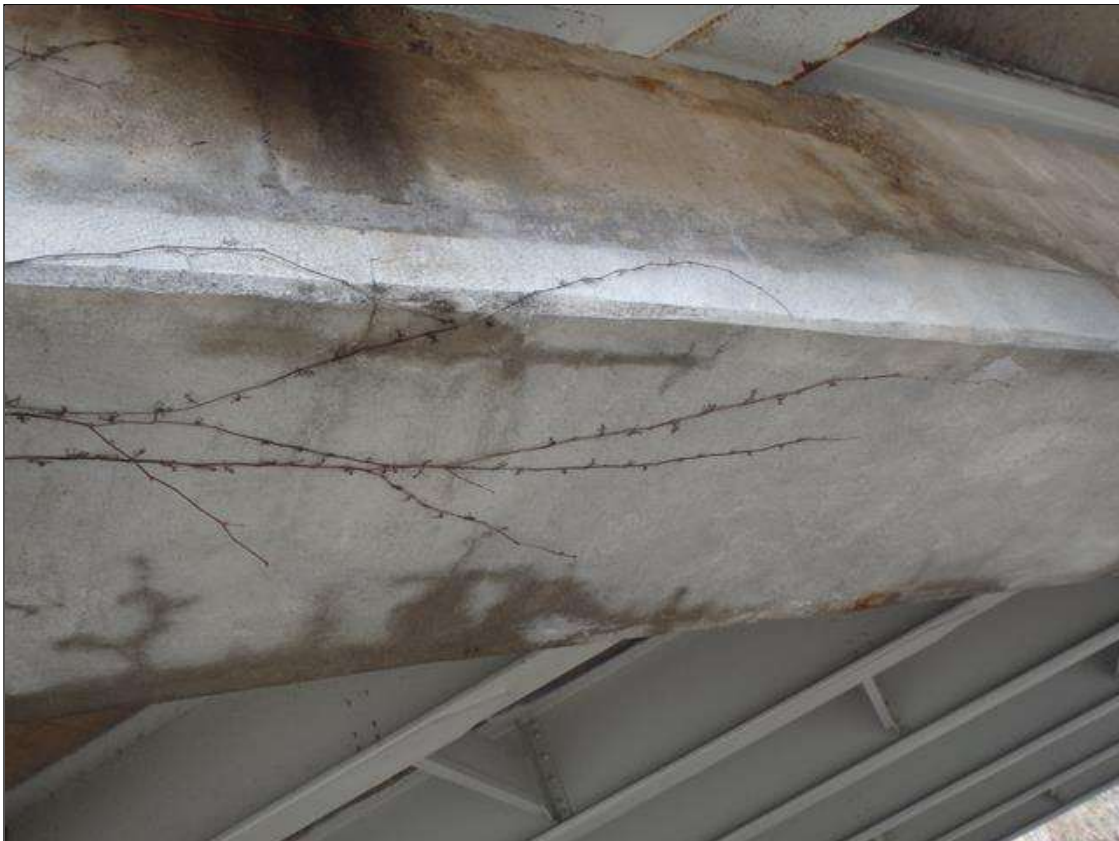
Bent 4 Cap 1: SOUND PATCH IN UNDERSIDE OF CAP BETWEEN COLUMNS 1 AND 2. PATCH IS FULL DISTANCE BETWEEN COLUMNS X WIDTH OF CAP X UP TO 8" HIGH IN FACE OF CAP.

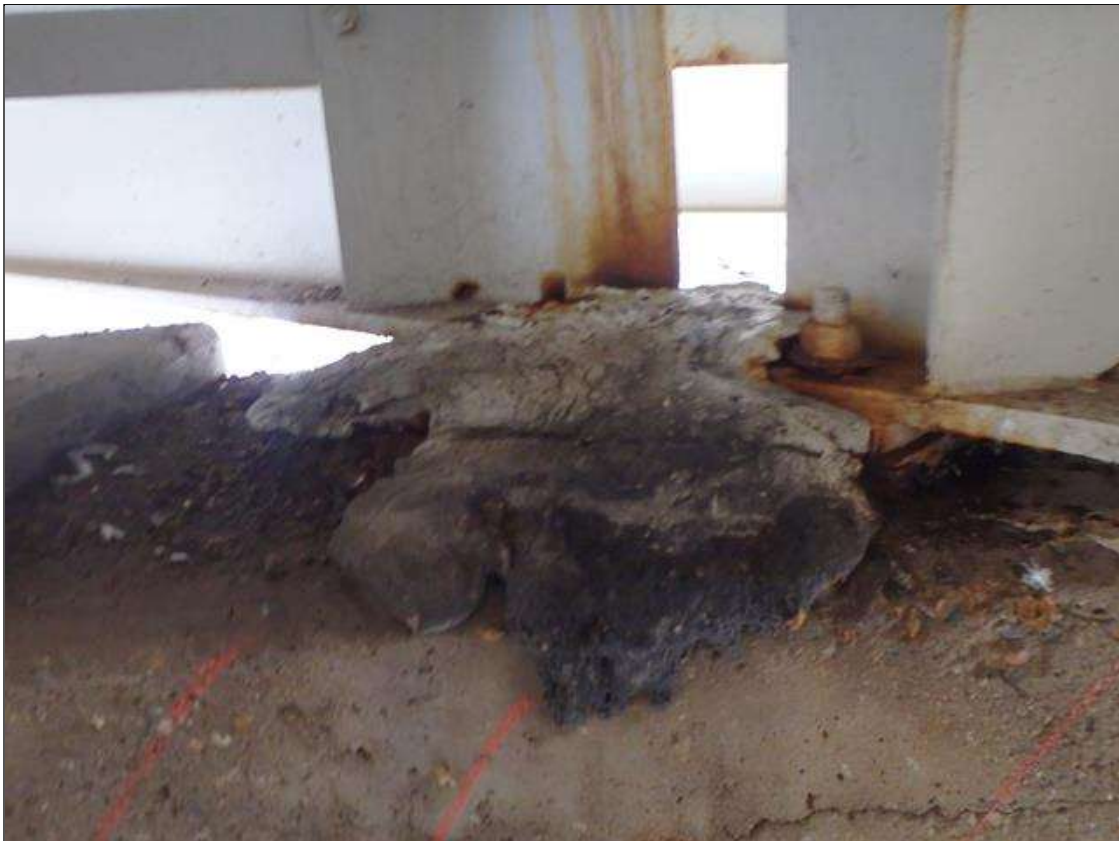
DEBRIS FROM REPAIRS ON BEAM 2 BEARINGS AT BENT 4.

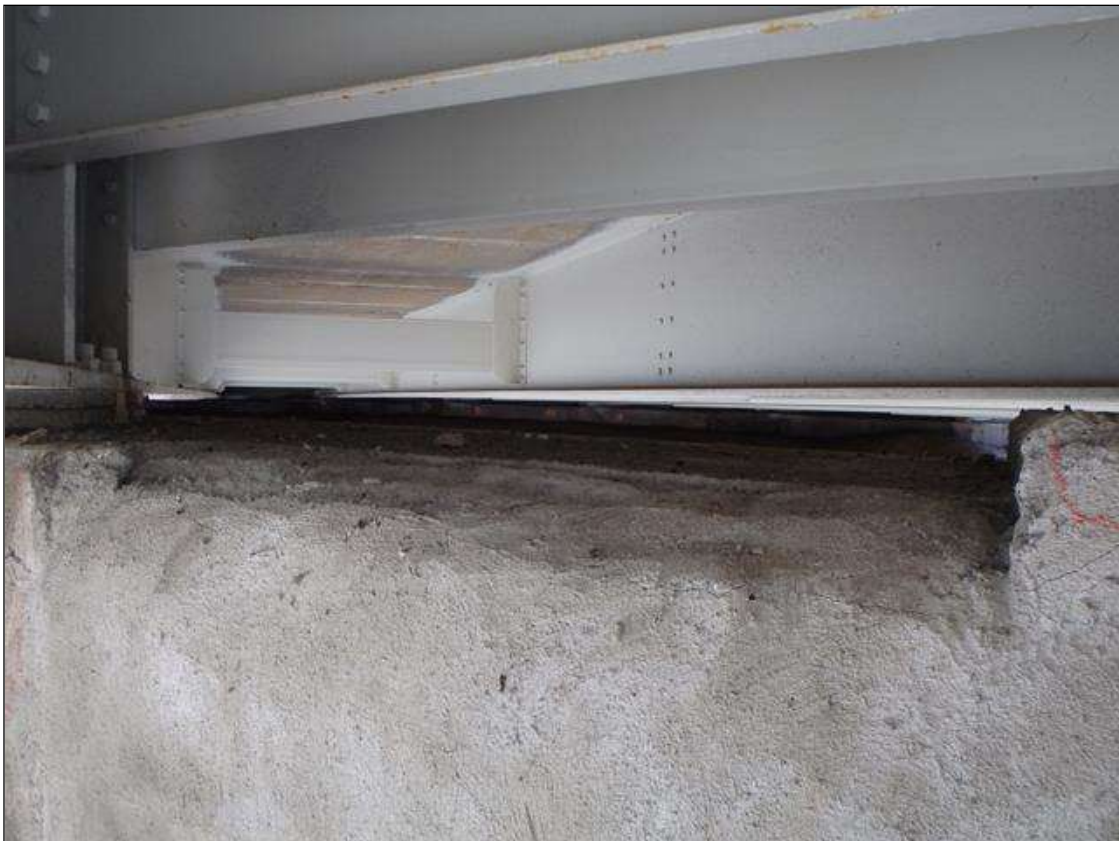
Bent 4 Cap 1: SOUND PATCH IN FACE AND TOP OF CAP, SPAN 4 SIDE, 5 FT X 2 FT X UP TO 1 FT INTO TOP OF CAP IN BAY 3 NEAR BEAM 3, AT TOP OF CAP.

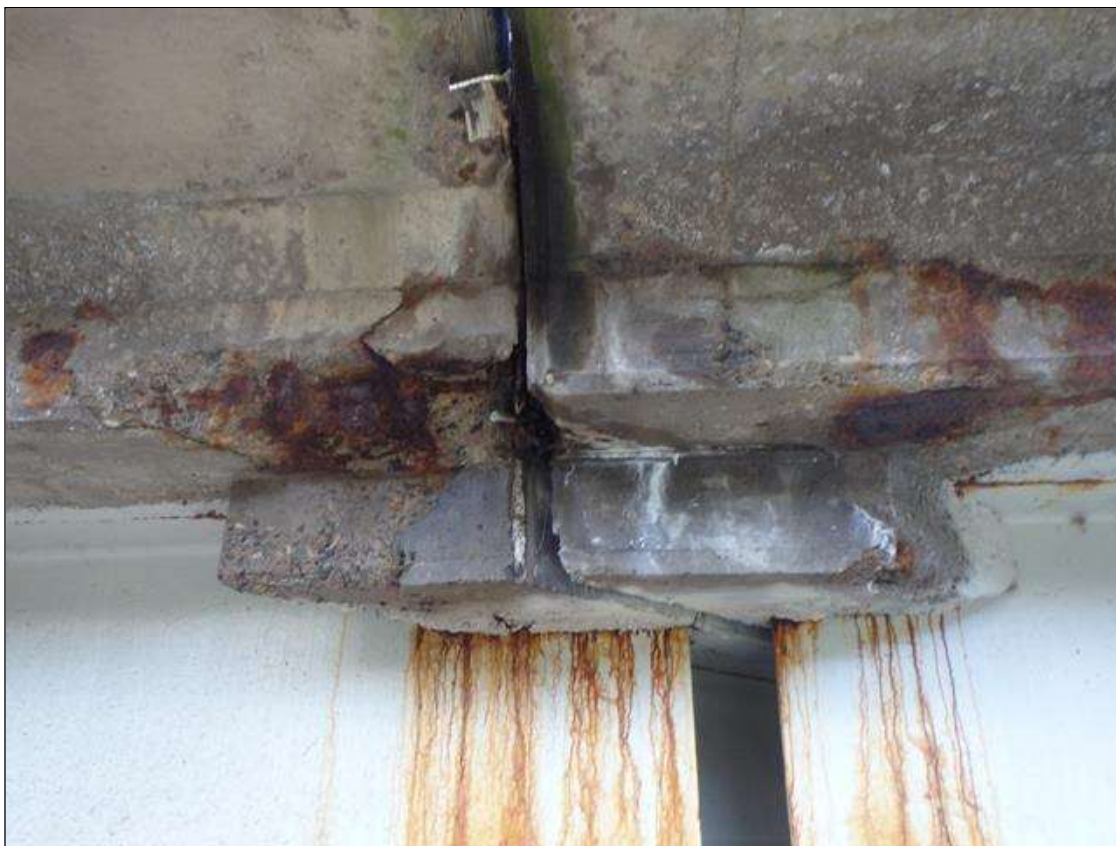
Span 5 Deck: 2 FT X 1 FT X UP TO 3" DEEP SPALL WITH EXPOSED REINFORCEMENT IN UNDERSIDE OF LEFT OVERHANG AT BENT 4 WITH RUST STAINING ONTO BEAM BELOW, NO MEASURABLE SECTION LOSS IN EXPOSED REINFORCEMENT.
