NC DEPARTMENT OF TRANSPORTATION  
DIVISION OF HIGHWAYS  
STRUCTURE MANAGEMENT UNIT

## Structure Safety Report

### Routine Element Inspection - Contract

DIVISION: 14 COUNTY: HAYWOOD STRUCTURE NUMBER: 430142 FREQUENCY: 24 MONTHS

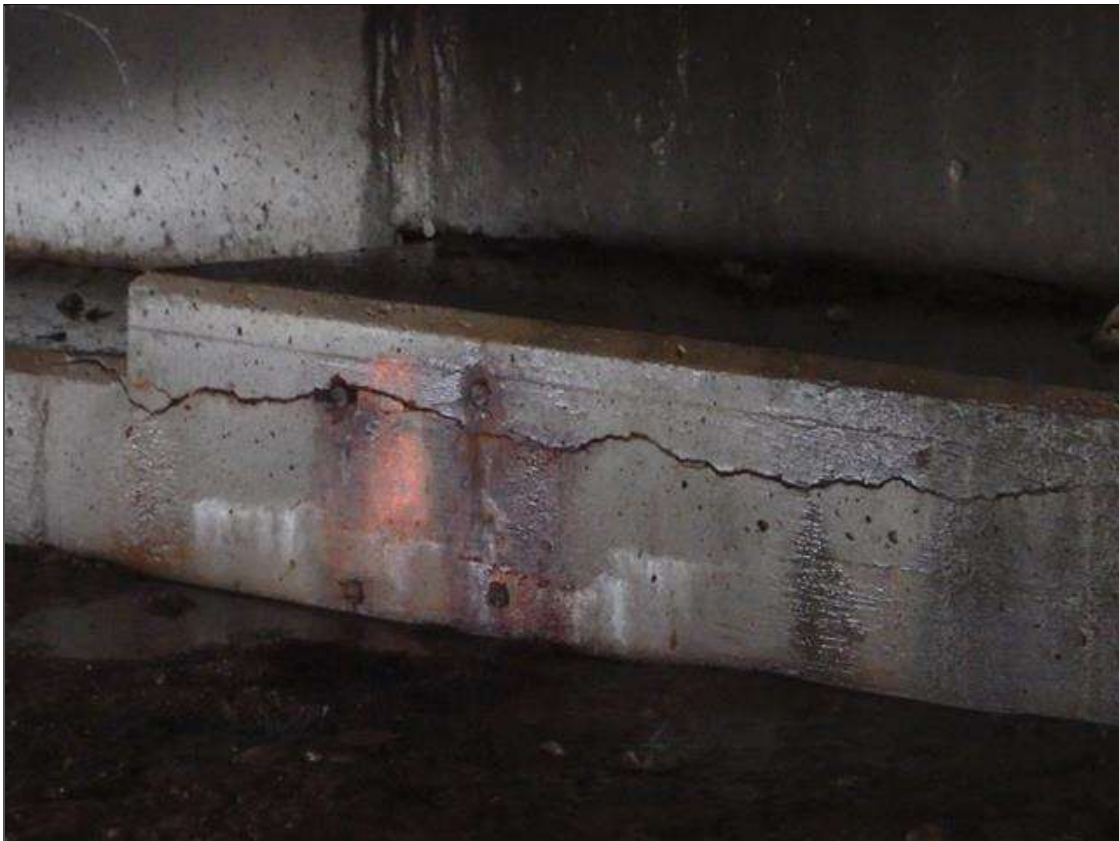
End Bent 2 Cap 1: 10 FT LONGITUDINAL CRACK WITH RUST STAINING UP TO 1/4" WIDE IN FACE OF CAP BELOW BAYS 3 AND 4

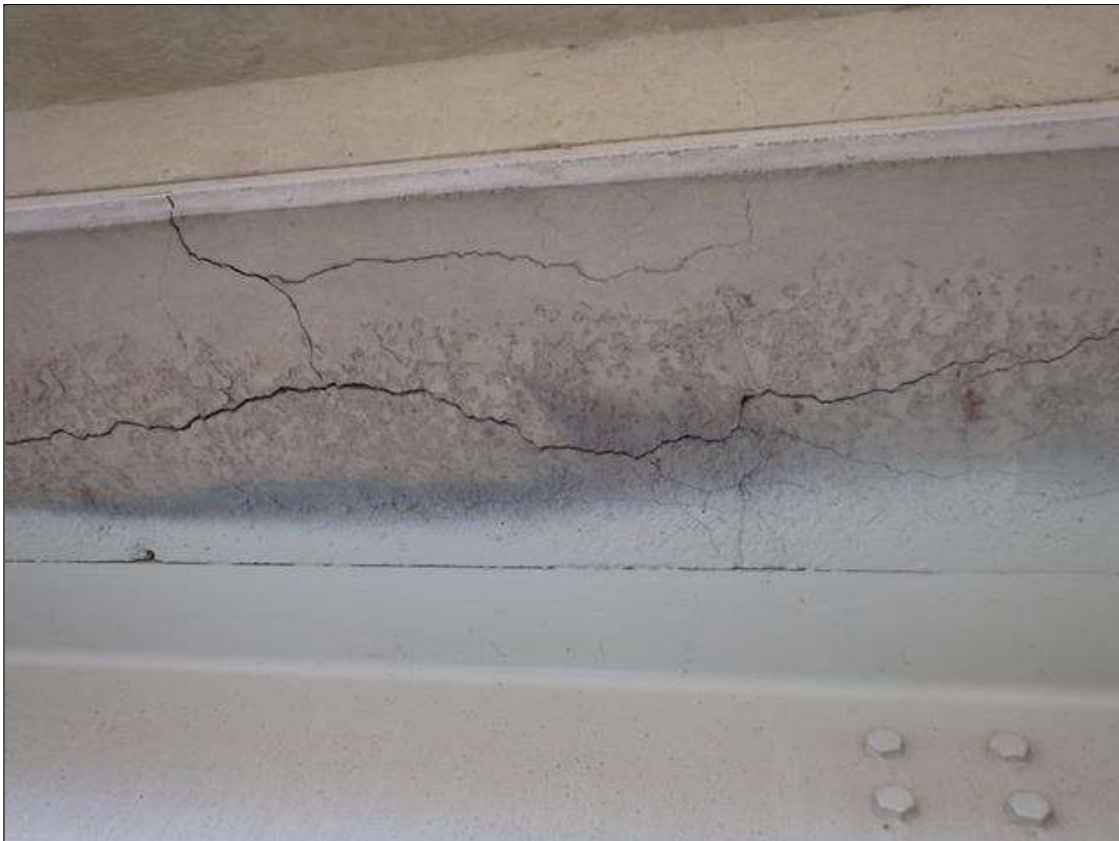
Span 5 Deck: SCATTERED DELAMINATION AND CRACKING UP TO 1/4" WIDE WITH RUST STAINING IN UNDERSIDE OF OF BOTH OVERHANGS.

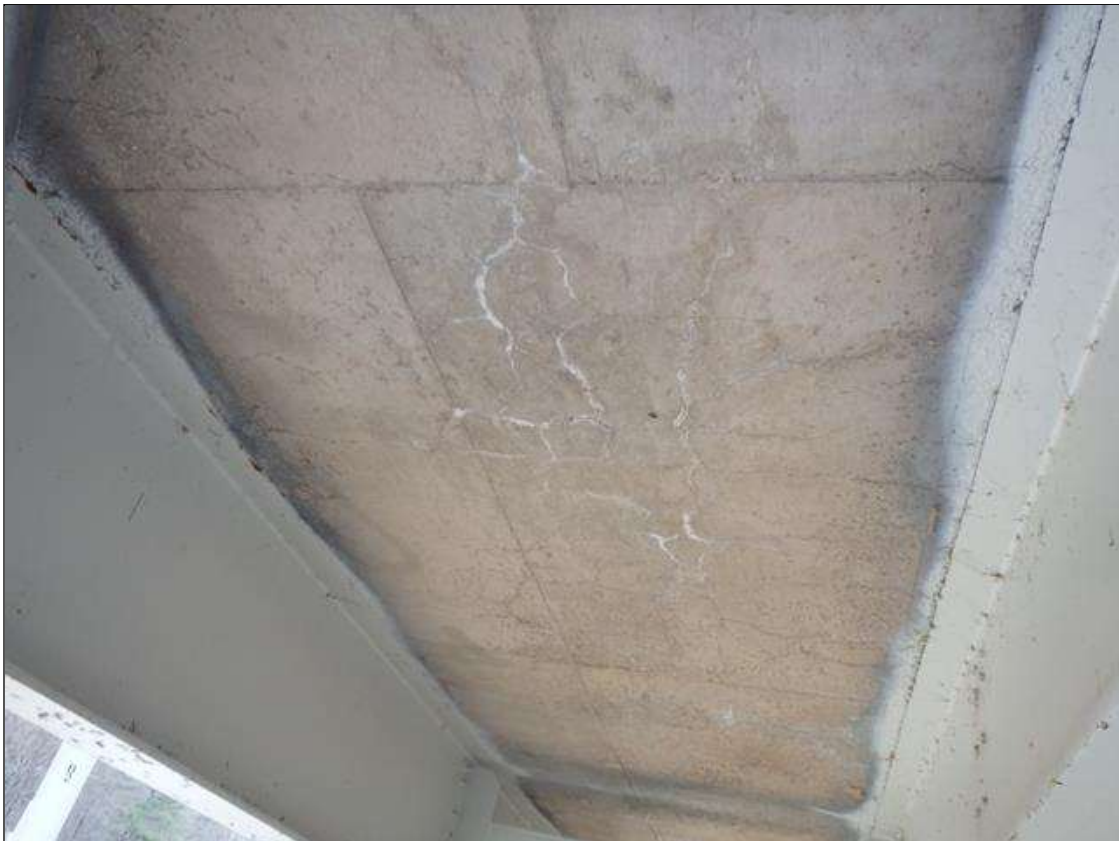
Span 4 Deck: SCATTERED HAIRLINE MAP CRACKING WITH AREAS OF EFFLORESCENCE THROUGHOUT UNDERSIDE OF DECK.

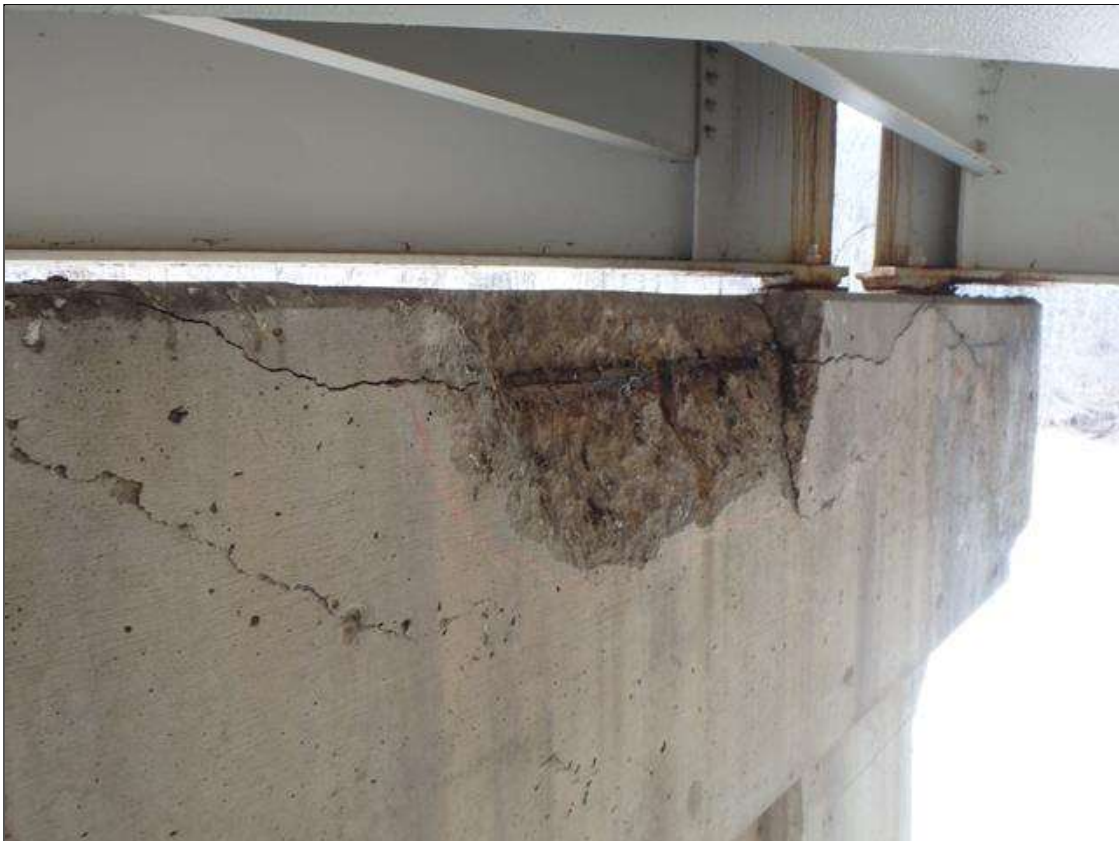
Bent 3 Cap 1: SPALL WITH EXPOSED REINFORCEMENT, SPAN 4 FACE OF CAP IN BAY 1. 3 FT X 16" X UP TO 3" DEEP, NO MEASURABLE SECTION LOSS OF EXPOSED REINFORCEMENT.

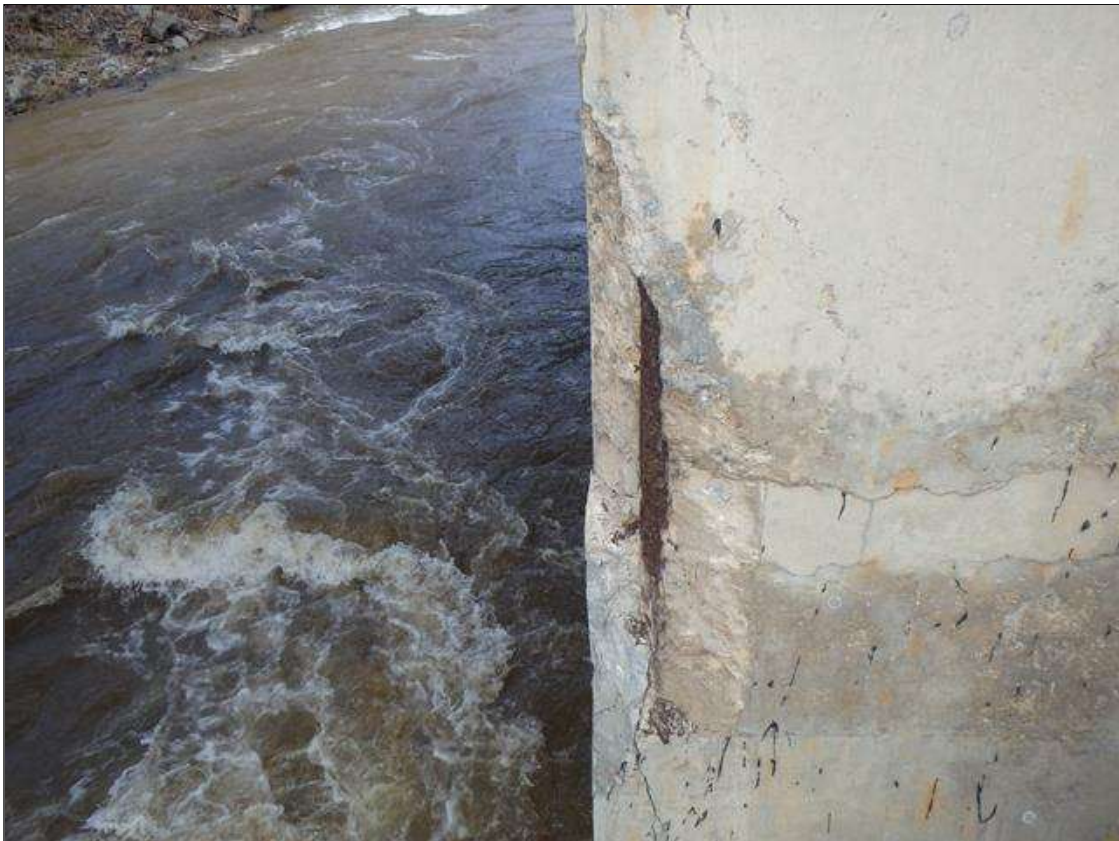
Bent 3 Pile 1: 3 FT X 8" X 8" X 2" DEEP SPALL WITH EXPOSED REINFORCEMENT, EAST FACE AT HEIGHT OF STRUT, NO SECTION LOSS OF EXPOSED REINFORCEMENT.

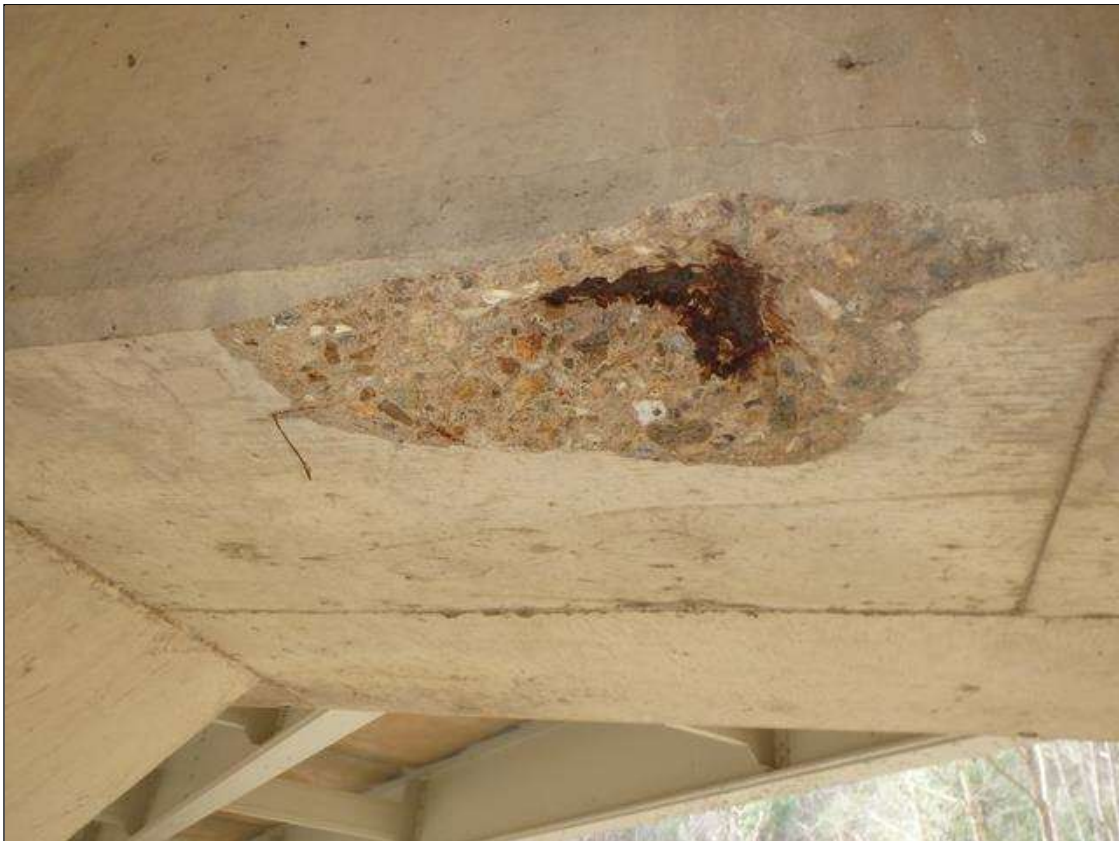
Bent 3 Cap 1: 16" X 1 FT X 2" DEEP SPALL WITH EXPOSED REINFORCEMENT IN UNDERSIDE OF CAP IN BAY 6, 90% SECTION REMAINS OF EXPOSED REINFORCEMENT.

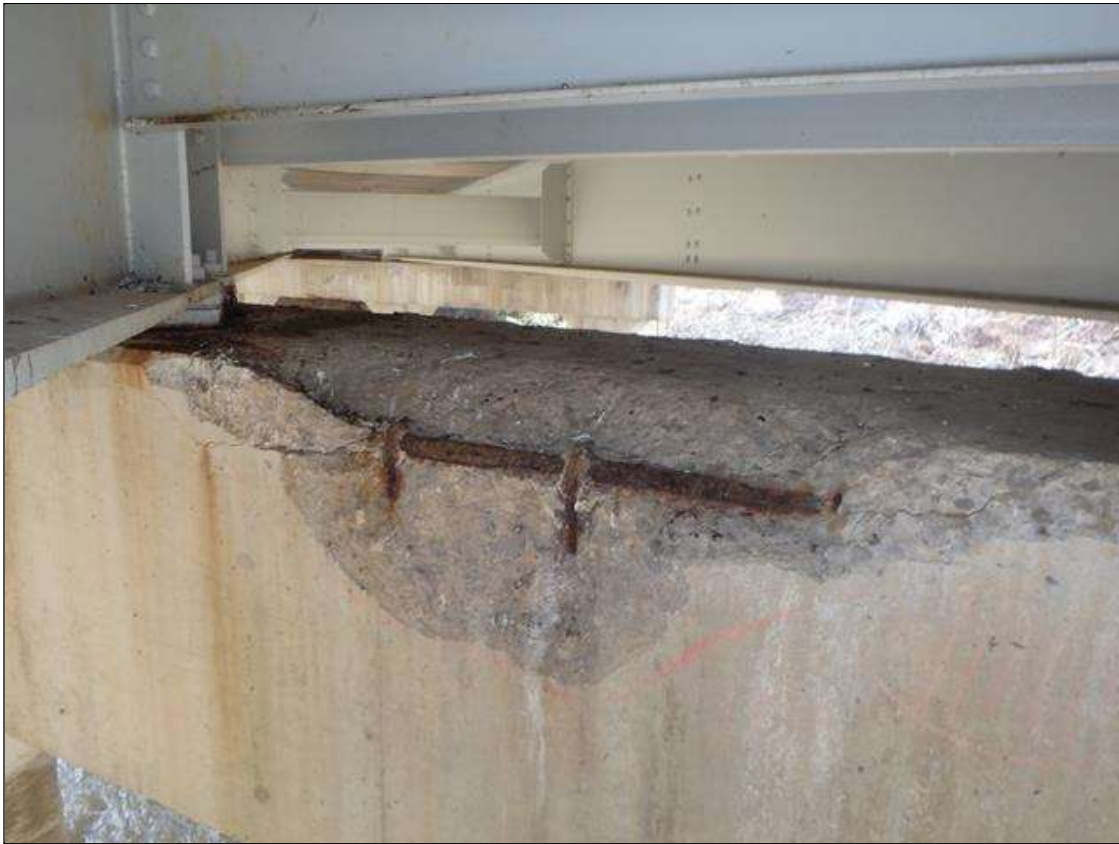
Bent 3 Cap 1: 6 FT X 18" HIGH X 12" INTO TOP OF CAP X UP TO 3.5" DEEP SPALL WITH EXPOSED REINFORCEMENT IN TOP OF CAP IN BAY 5 NEAR BEAM 6, NO MEASURABLE SECTION LOSS OF EXPOSED REINFORCEMENT.

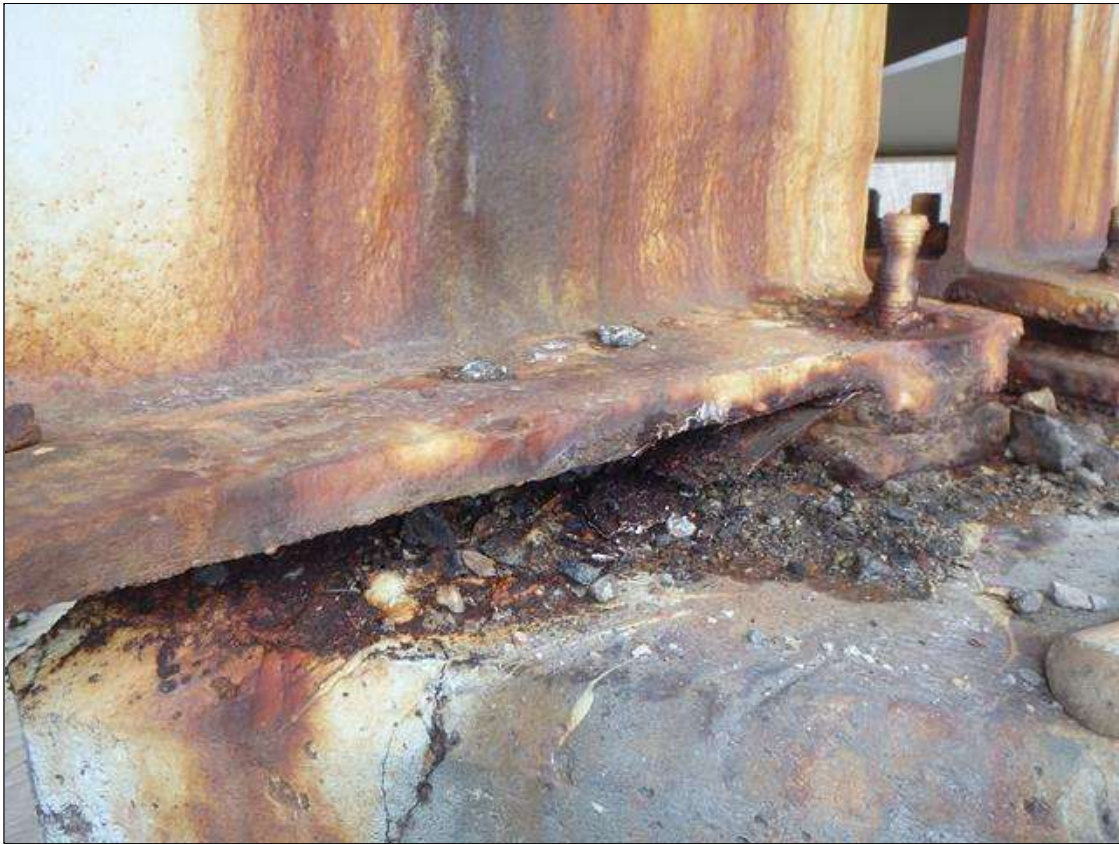
Span 4 Beam 1: PAINTED OVER SECTION LOSS IN BOTTOM FLANGE AND WEB AT BENT 3. AREA OF SECTION LOSS IN BOTTOM FLANGE IS 6" LONG X FULL FLANGE WIDTH X 2 FT LONG X 15/16" THICKNESS REMAINING. PITTING IN WEB FOR UP TO 6" HIGH X 2 FT LONG X UP TO 5/8" THICKNESS REMAINING. CORROSION ON BOTTOM FLANGE IS NO LONGER ARRESTED.

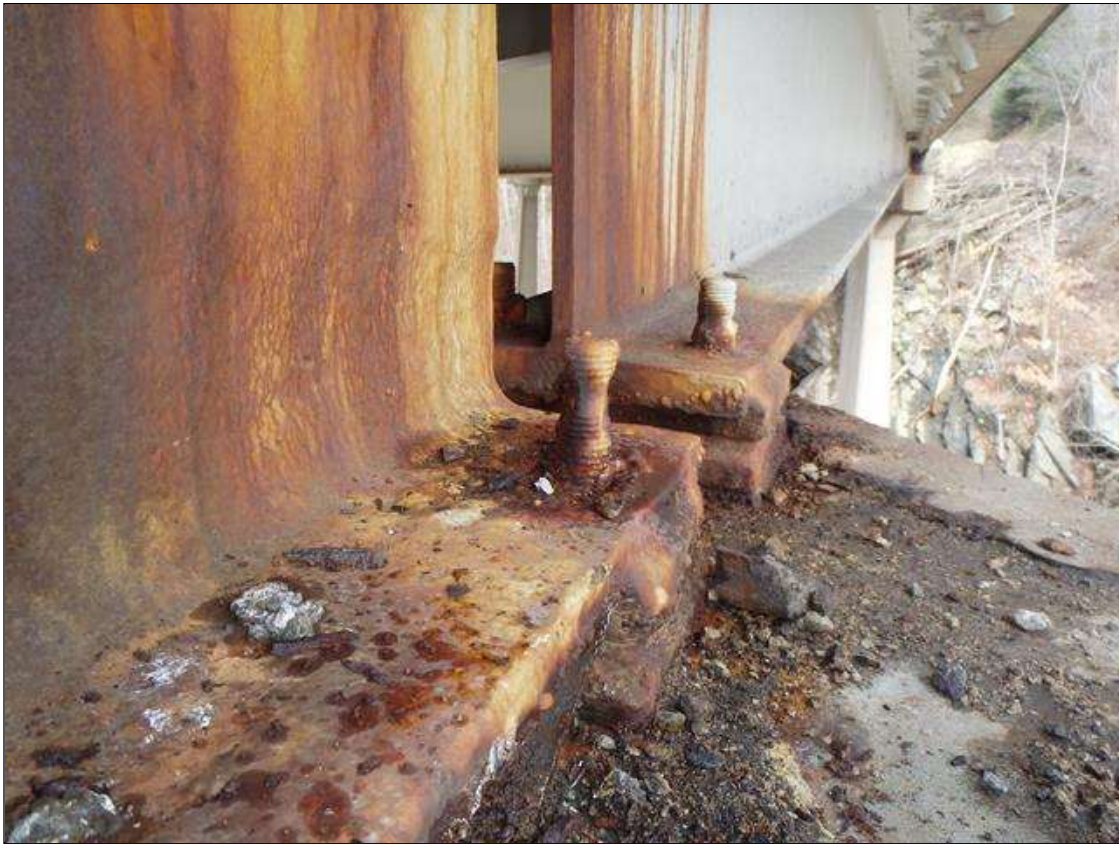
Span 4 Beam 1 Near Bearing: NO OUTBOARD ANCHOR BOLT NUT, UP TO 70% SECTION REMAINING OF OUTBOARD ANCHOR BOLT.

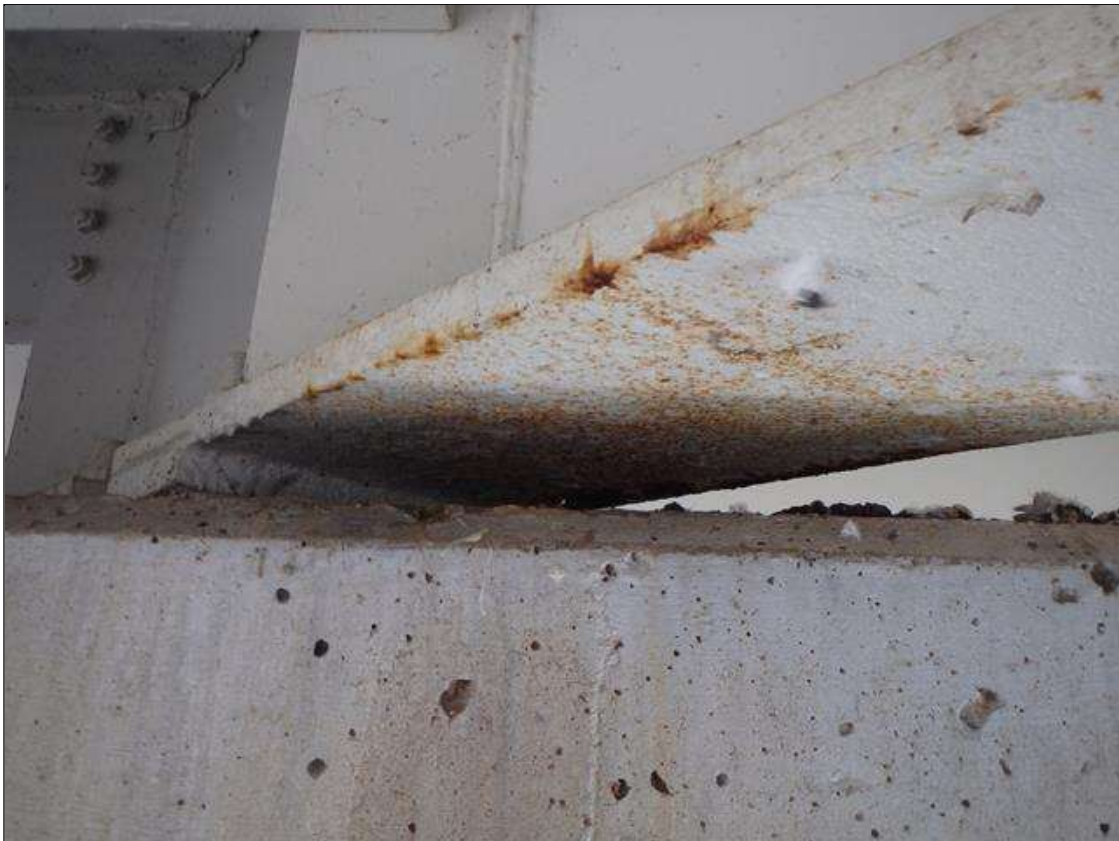
Span 4 Beam 4: SURFACE CORROSION ON UNDERSIDE OF BOTTOM FLANGE FOR FULL WIDTH FOR 2 FT LONG BEGINNING AT BENT 3, NO SECTION LOSS.

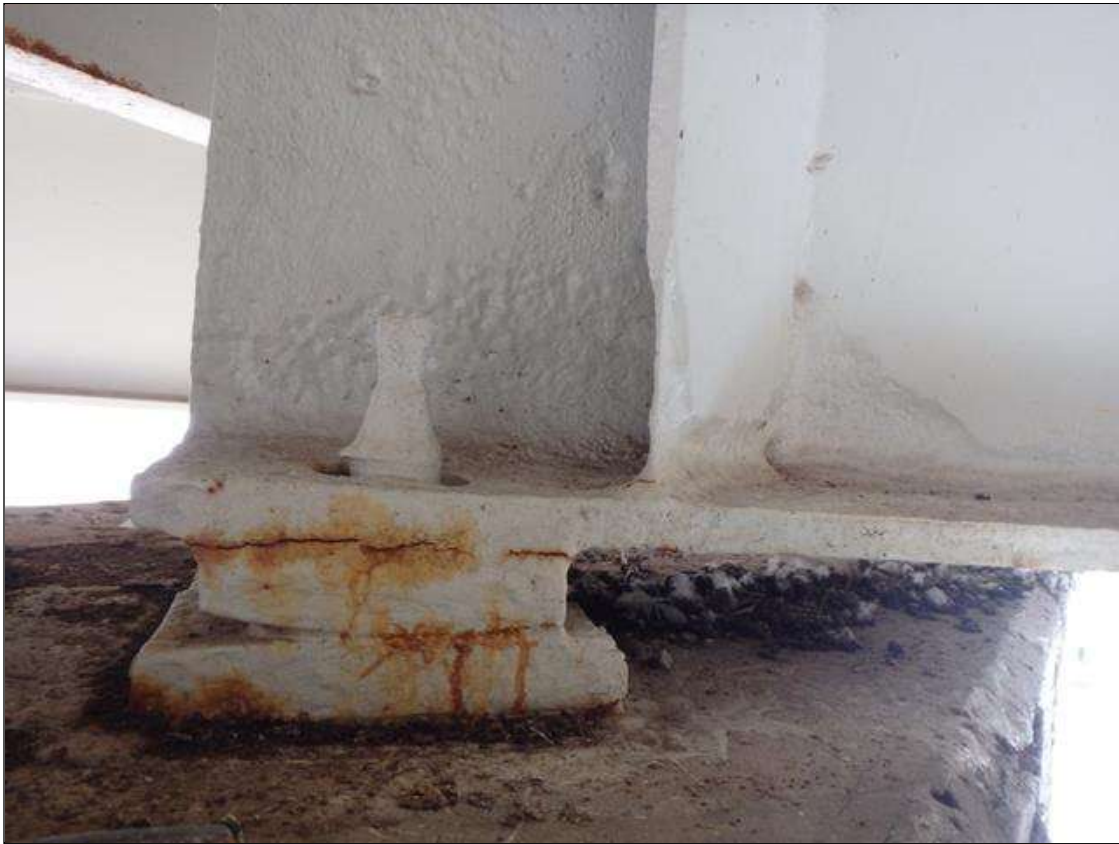
Span 3 Beam 3: PAINTED OVER SECTION LOSS IN WEB, BOTTOM FLANGE, AND BEARING STIFFENER AT BENT 2. SECTION REMAINING IN WEB IS 12" LONG X UP TO 4" HIGH X 0.55" THICKNESS REMAINING. SECTION REMAINING IN BOTTOM FLANGE IS 12" LONG X 5" WIDE X 0.85" THICKNESS REMAINING. SECTION REMAINING IN STIFFENER IS 7" LONG X 1" HIGH X UP TO 1/8" THICKNESS REMAINING. SECTION LOSS HAS BEEN ARRESTED, FRECKLED SURFACE CORROSION BEGINNING TO FORM ON BOTTOM FLANGE.

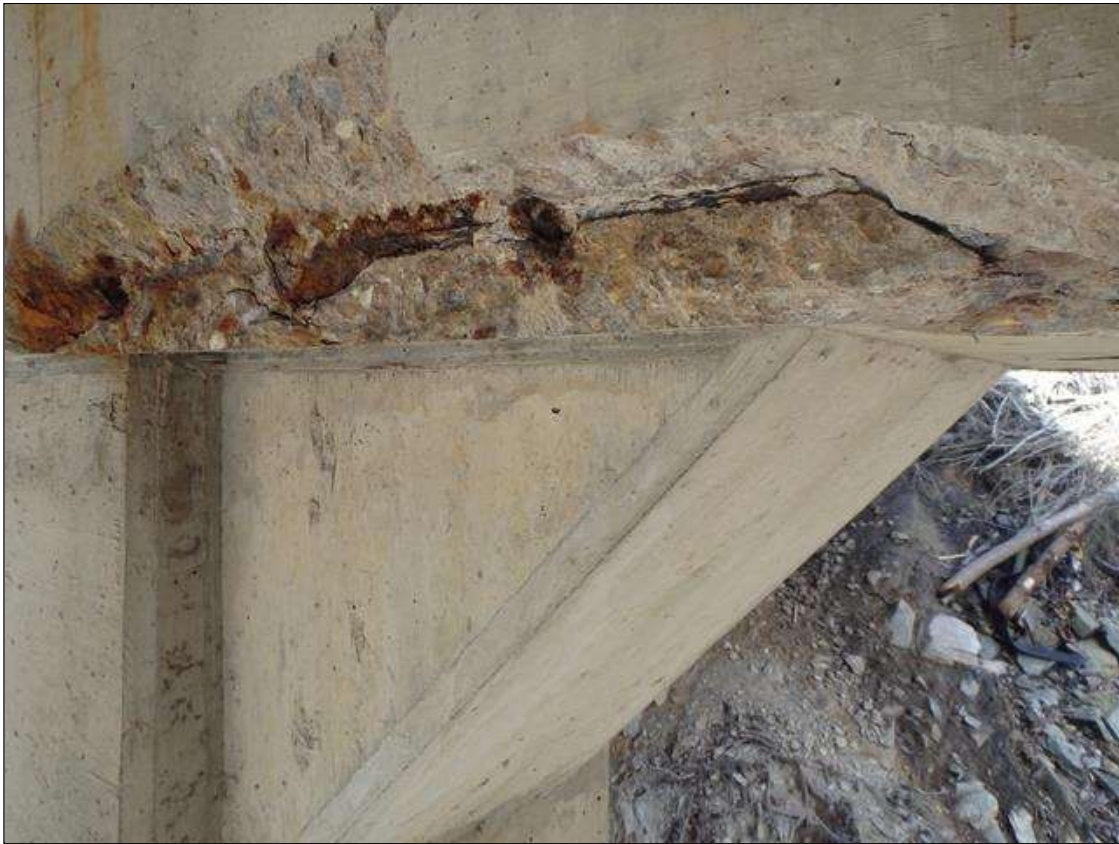
Bent 2 Cap 1: 3 FT X 8" X 3" DEEP SPALL WITH EXPOSED REINFORCEMENT IN BOTTOM CORNER, SPAN 3 FACE ABOVE COLUMN 3, NO MEASURABLE SECTION LOSS OF EXPOSED REINFORCEMENT.

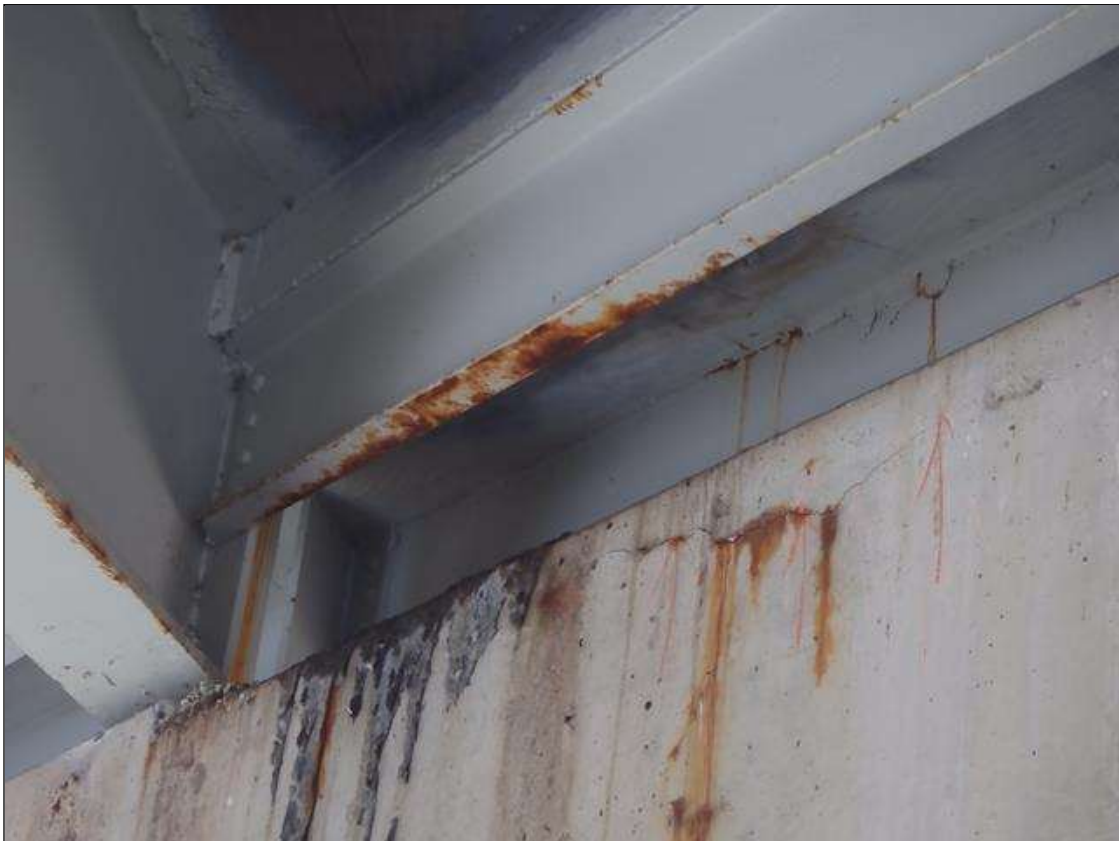
Span 2 Beam 4: SURFACE CORROSION ON BAY 4 DIAPHRAGM AT BENT 3, NO SECTION LOSS.

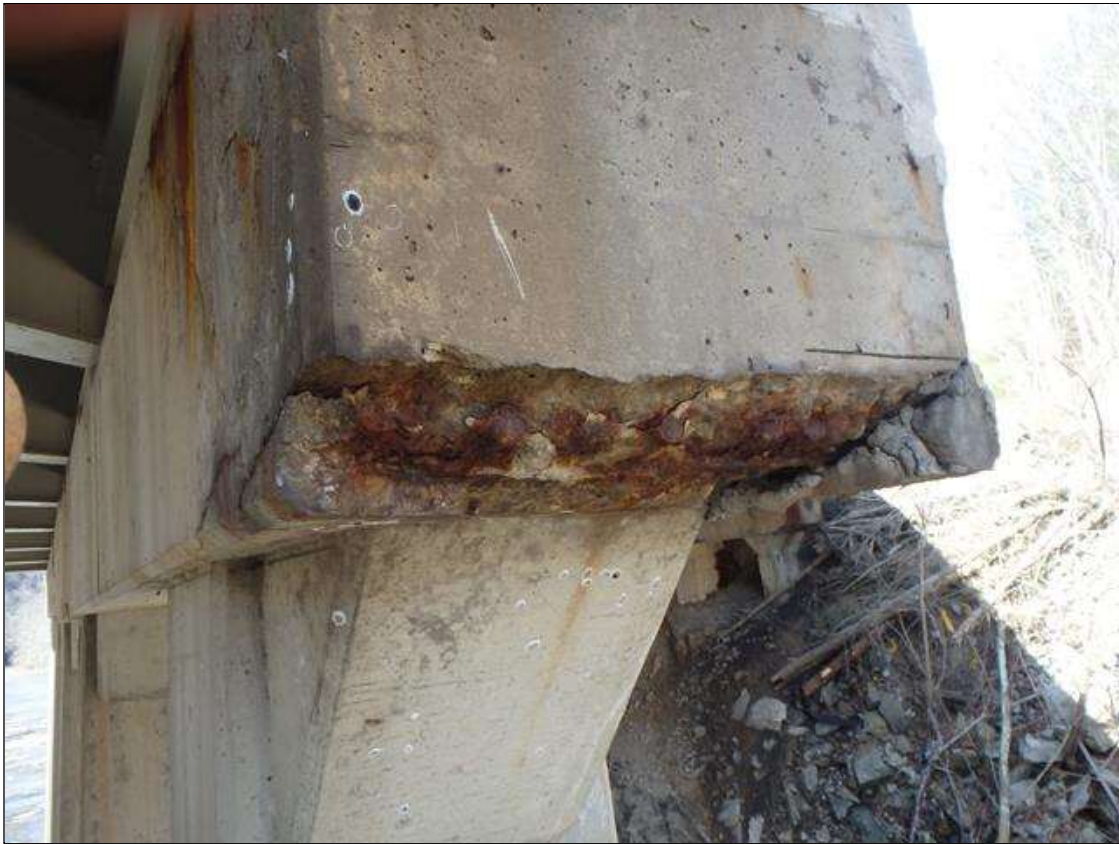
Bent 2 Cap 1: 3 FT X 8" X 3" DEEP SPALL WITH EXPOSED REINFORCEMENT IN BOTTOM CORNER, SPAN 3 FACE ABOVE COLUMN 3, 95% SECTION REMAINING OF EXPOSED REINFORCEMENT.

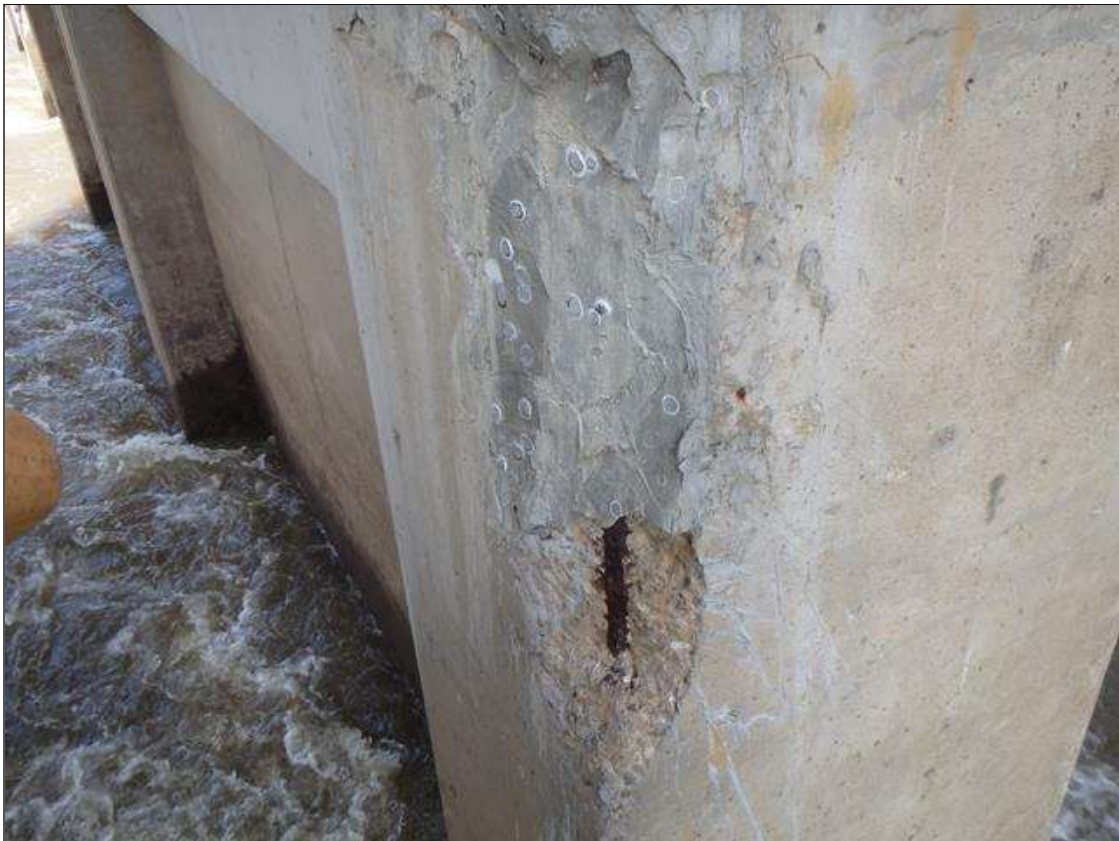
Bent 2 Pile 1: 18" X 10" X 3" DEEP SPALL WITH EXPOSED REINFORCEMENT IN NORTHEAST CORNER OF COLUMN AT STRUT, NO MEASURABLE SECTION LOSS OF EXPOSED REINFORCEMENT.

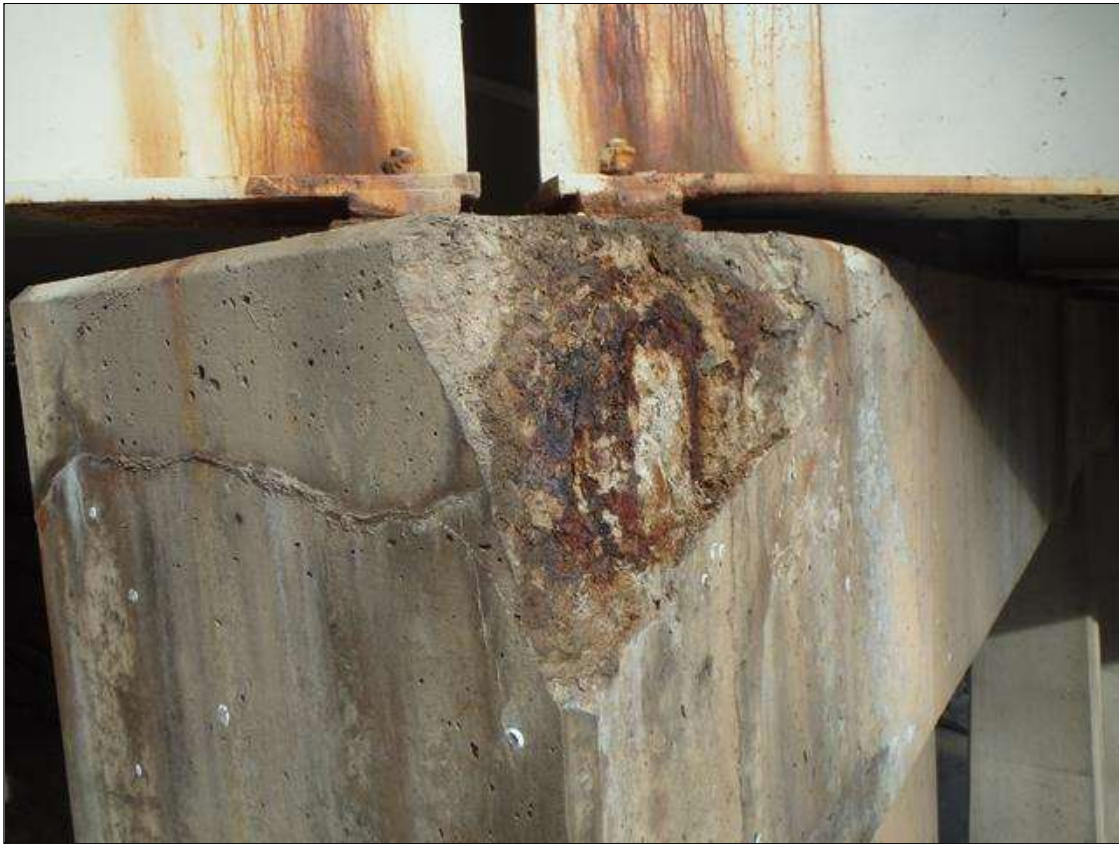
Bent 2 Cap 1: 2 FT LONG X 18" HIGH X UP TO 3" DEEP SPALL WITH EXPOSED REINFORCEMENT IN SPAN 3  
FACE OF CAP BELOW BEAM 8 WITH ADJACENT DELAMINATION OF SIZE 2.5 FT X 6" X UP TO 8" INTO TOP OF  
CAP, BEAM 8 BEARING AREA UNAFFECTED.

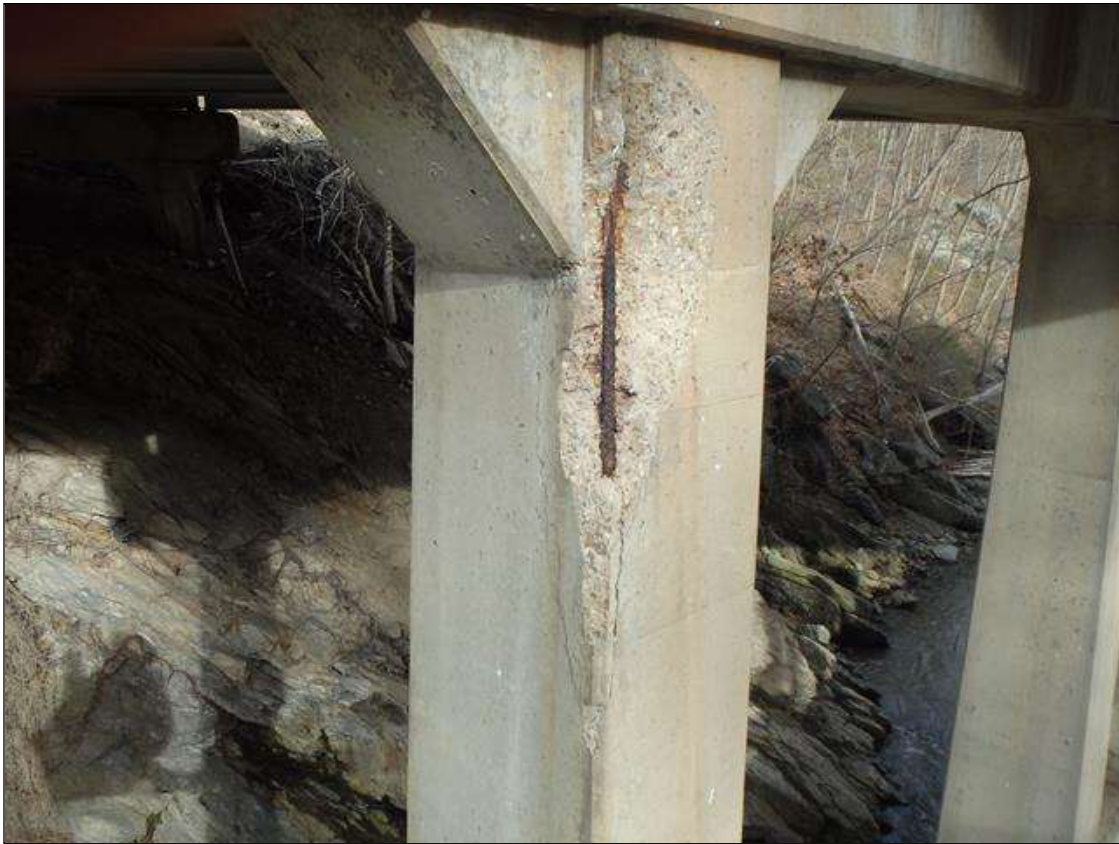
Bent 2 Pile 5: 16" X 4 FT HIGH X 3" DEEP SPALL WITH EXPOSED REINFORCEMENT AND ADJACENT DELAMINATION, SPALL STARTS 8" FROM BOTTOM OF CAP, NO MEASURABLE SECTION LOSS OF EXPOSED REINFORCEMENT.

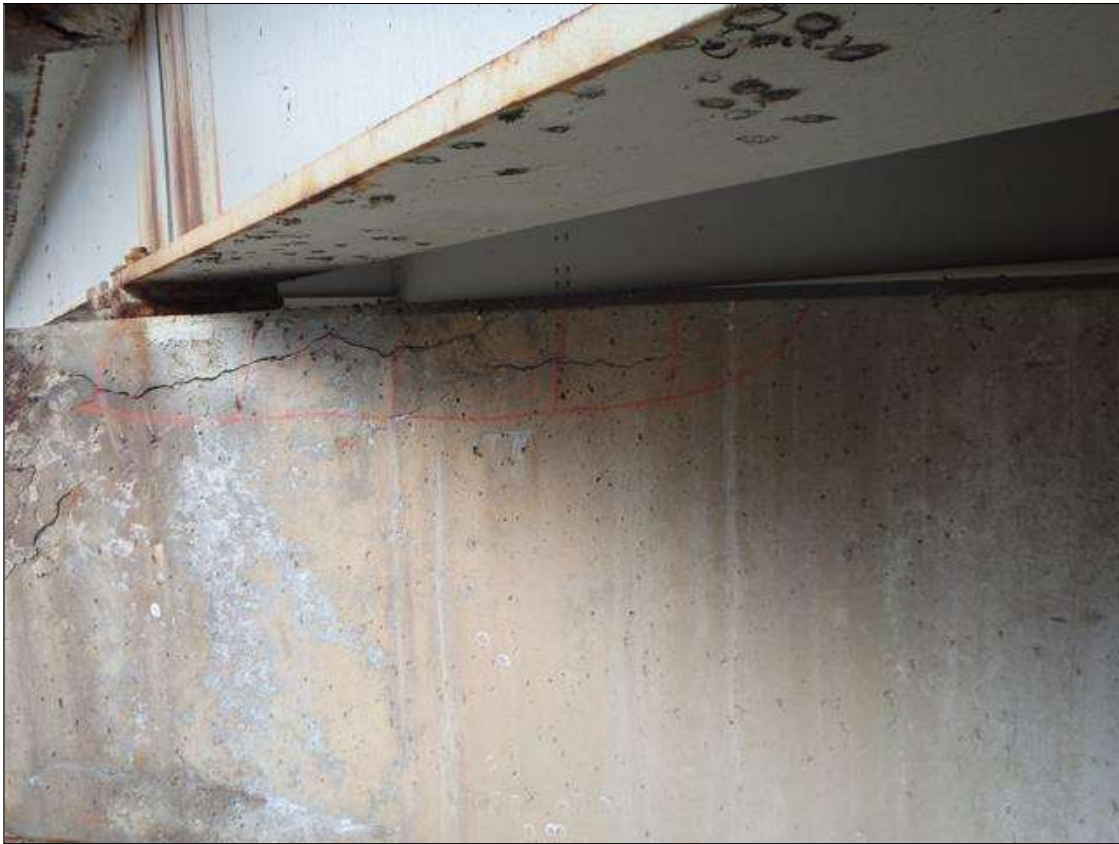
Bent 2 Cap 1: 2 FT LONG X 18" HIGH X UP TO 3" DEEP SPALL WITH EXPOSED REINFORCEMENT IN SPAN 3  
FACE OF CAP BELOW BEAM 8 WITH ADJACENT DELAMINATION OF SIZE 2.5 FT X 6" X UP TO 8" INTO TOP OF  
CAP, BEAM 8 BEARING AREA UNAFFECTED.

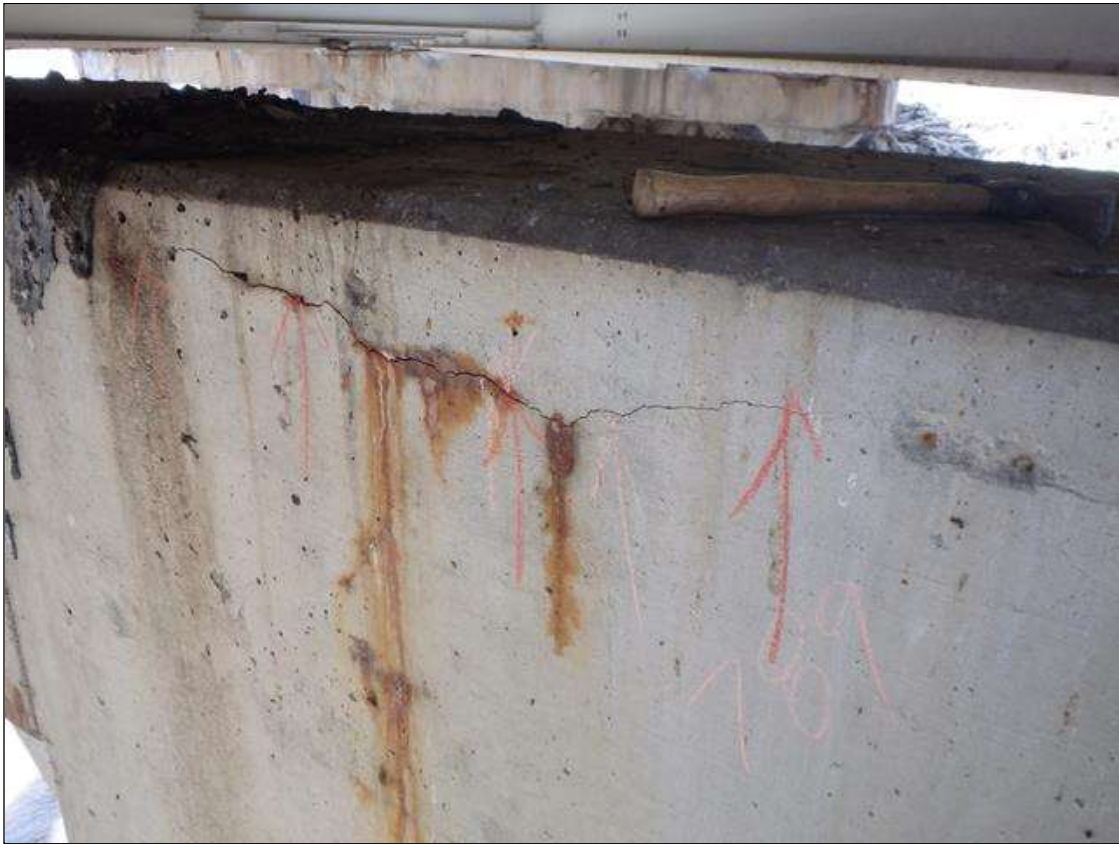
Bent 2 Cap 1: LONGITUDINAL CRACK UP TO 1/16" WIDE IN BAY 4, NEAR TOP EDGE, 2 FT LONG WITH RUST STAINS

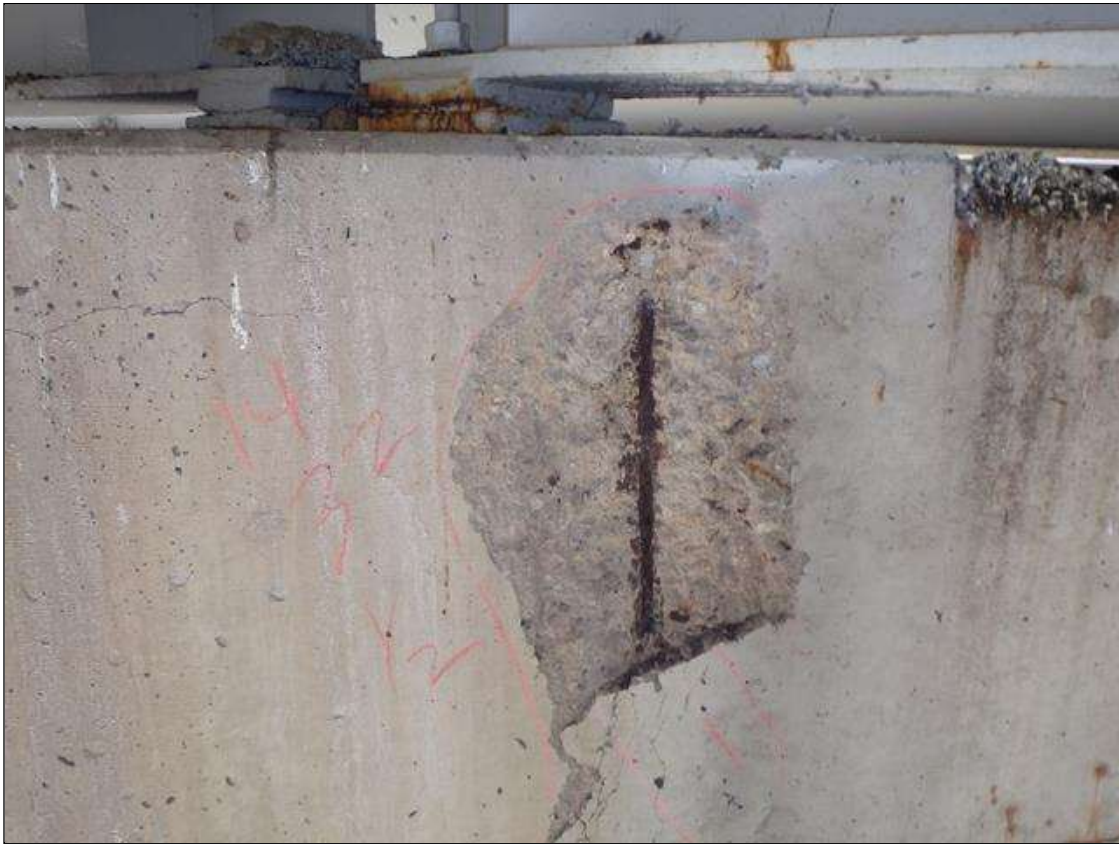
Bent 2 Cap 1: 2 FT X 1 FT X 1" DEEP SPALL WITH EXPOSED REINFORCEMENT AND ADJACENT 1 FT X 1 FT DELAMINATION IN SPAN 3 FACE OF CAP BELOW BEAM 5, NO MEASURABLE SECTION LOSS OF EXPOSED REINFORCEMENT.

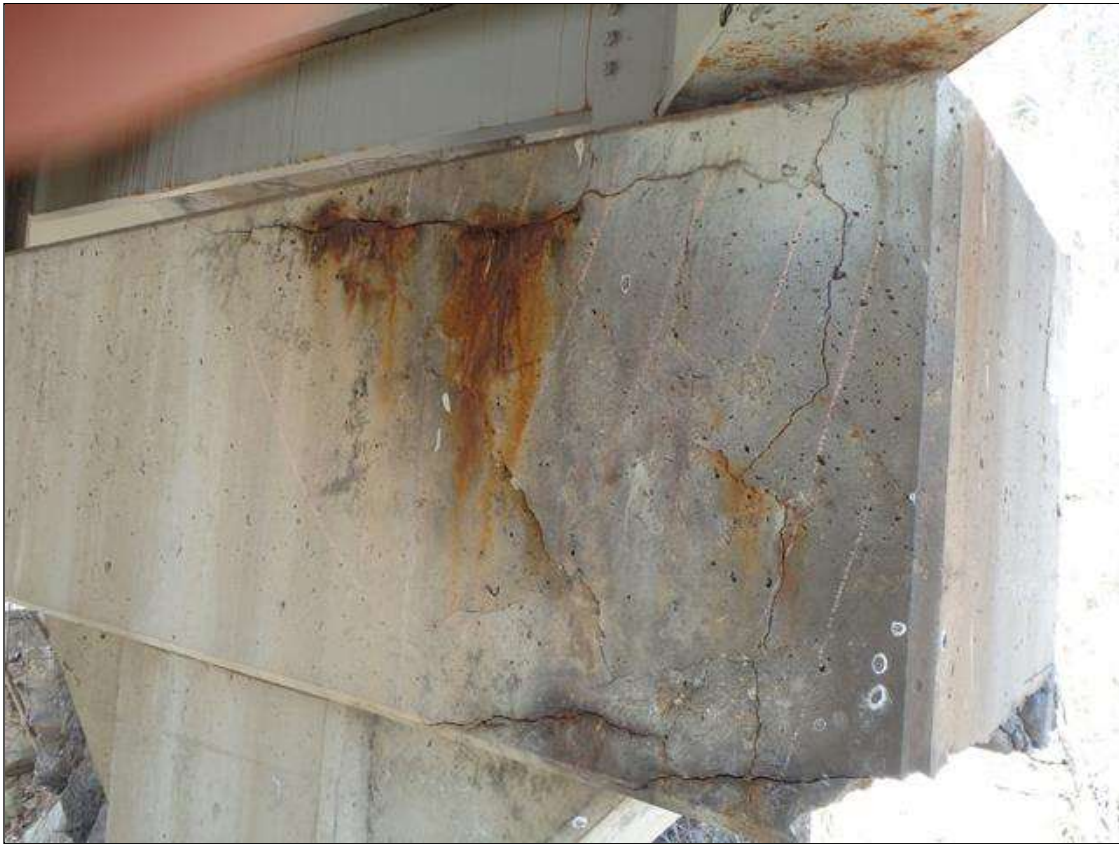
Bent 2 Cap 1: 5 FT WIDE X UP TO FULL HEIGHT AREA OF DELAMINATION WITH SCATTERED CRACKING UP TO 1/16" WIDE AND RUST STAINS IN SPAN 3 FACE OF CAP BELOW BEAM 1.

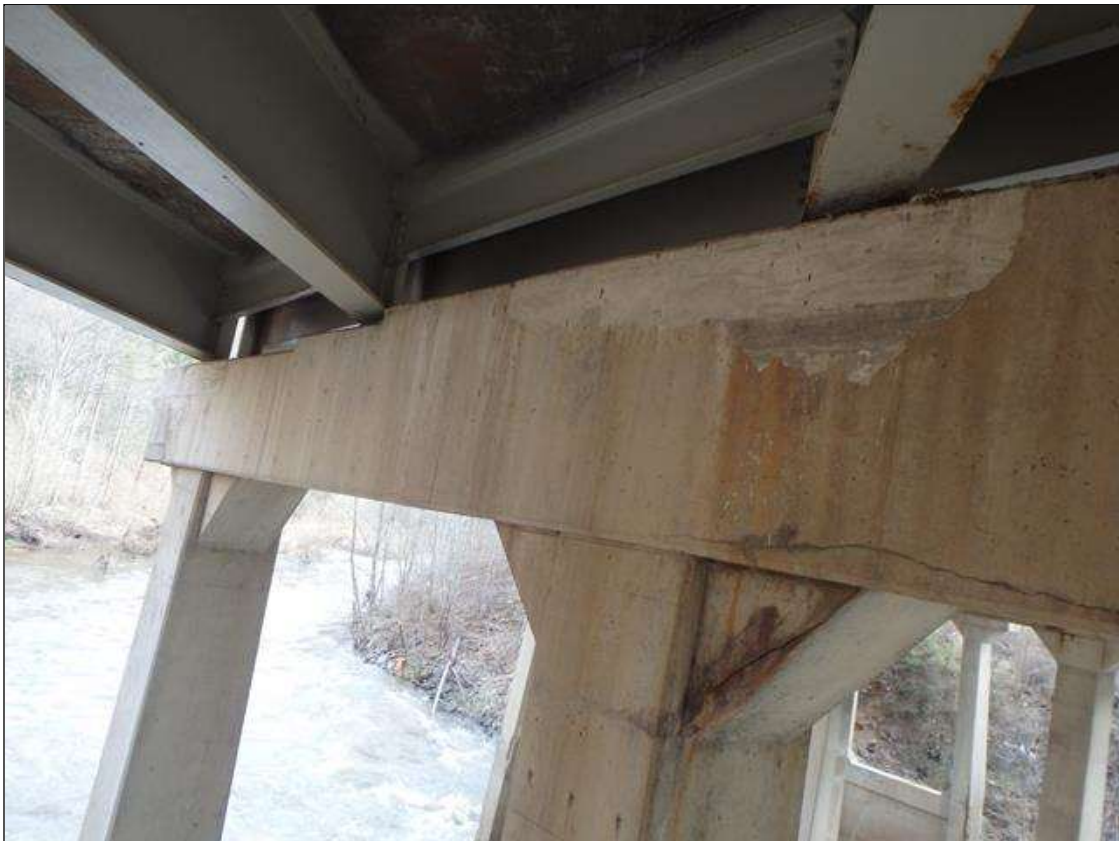
Bent 2 Cap 1: 7 FT X 1 FT SOUND PATCH IN FACE OF CAP AT TOP, SPAN 2 SIDE, BELOW BEAM 3 AND BAY 2.

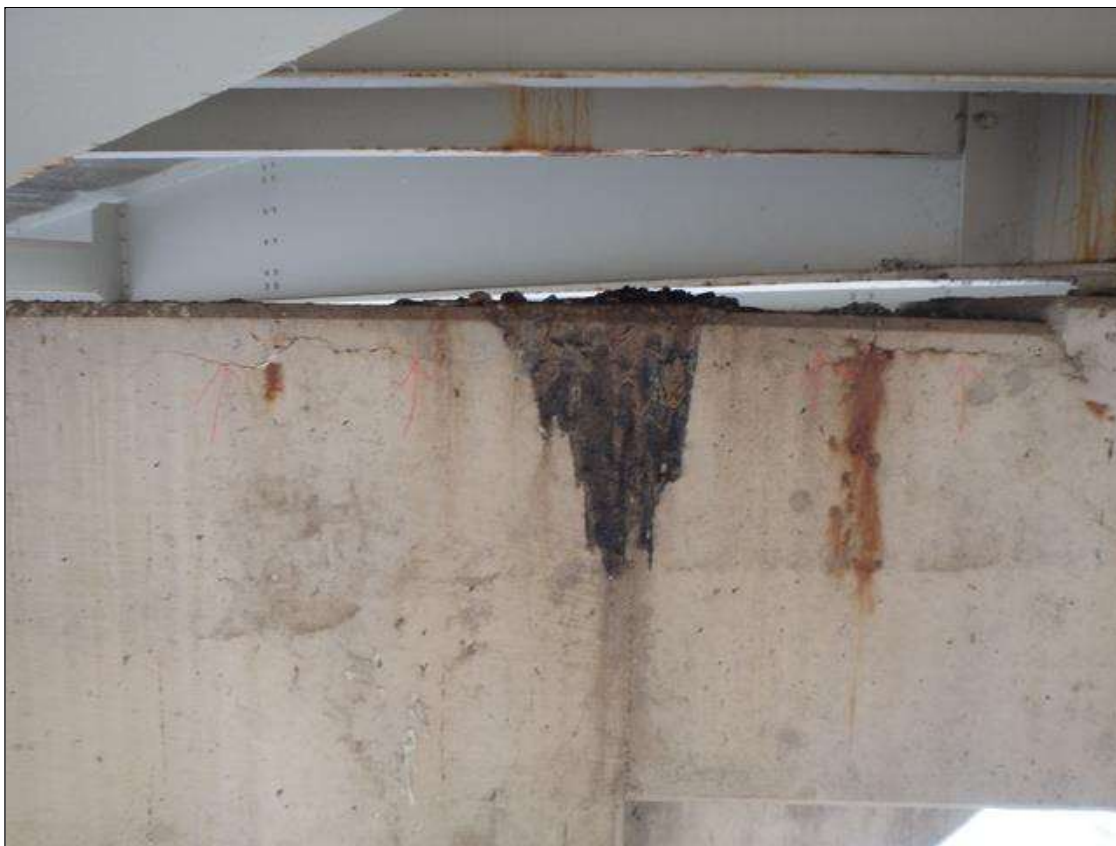
Bent 2 Cap 1: 8 FT HORIZONTAL CRACK UP TO 1/16" WIDE, NEAR TOP CORNER, SPAN 2 FACE, BELOW BAY 4.
