NC DEPARTMENT OF TRANSPORTATION  
DIVISION OF HIGHWAYS  
STRUCTURE MANAGEMENT UNIT

## Structure Safety Report

### Routine Element Inspection - Contract

DIVISION: 14 COUNTY: HAYWOOD STRUCTURE NUMBER: 430142 FREQUENCY: 24 MONTHS

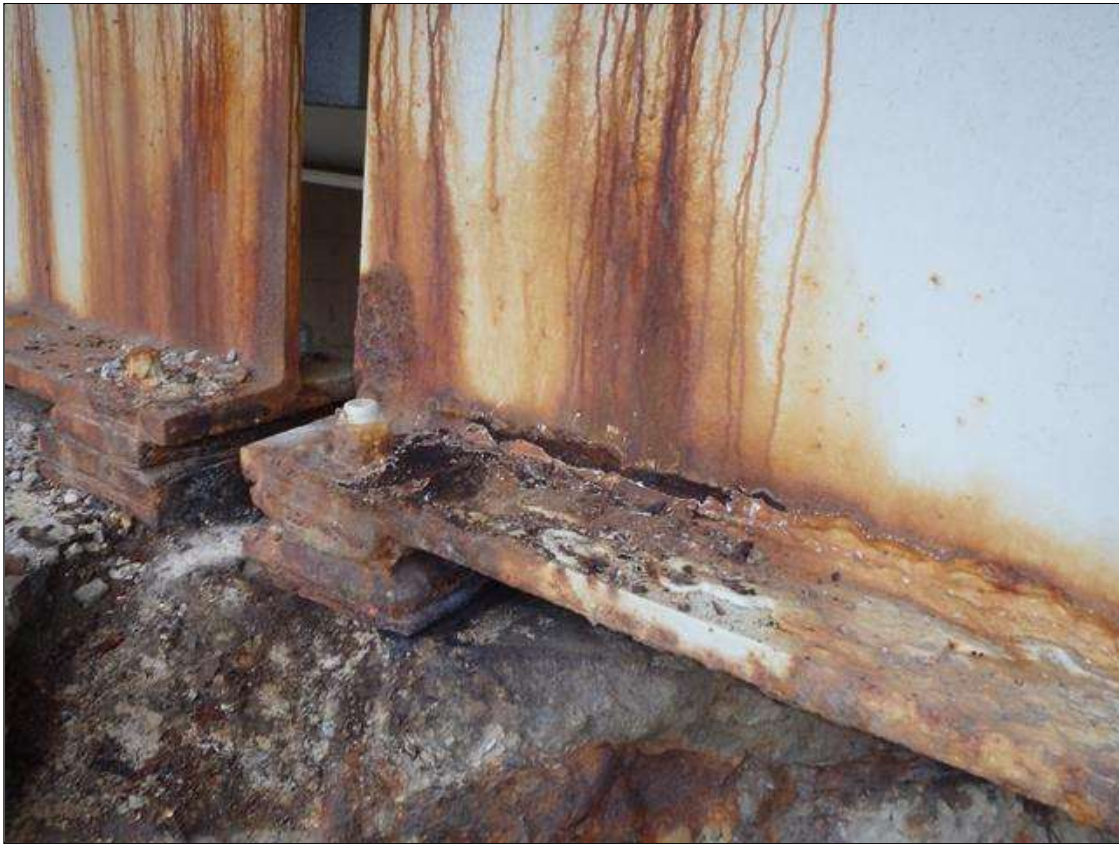
Span 2 Beam 8: CORROSION ON WEB AND BOTTOM FLANGE AT BENT 1 FOR 3 FT LONG WITH PAINTED OVER LAMINATED CORROSION. AREA OF SECTION LOSS IN BOTTOM FLANGE IS 3 FT LONG X UP TO 5" WIDE X 7/8" THICKNESS REMAINING. AREA OF SECTION LOSS IN WEB IS 3 FT LONG X UP TO 1" HIGH X 11/16" THICKNESS REMAINING.

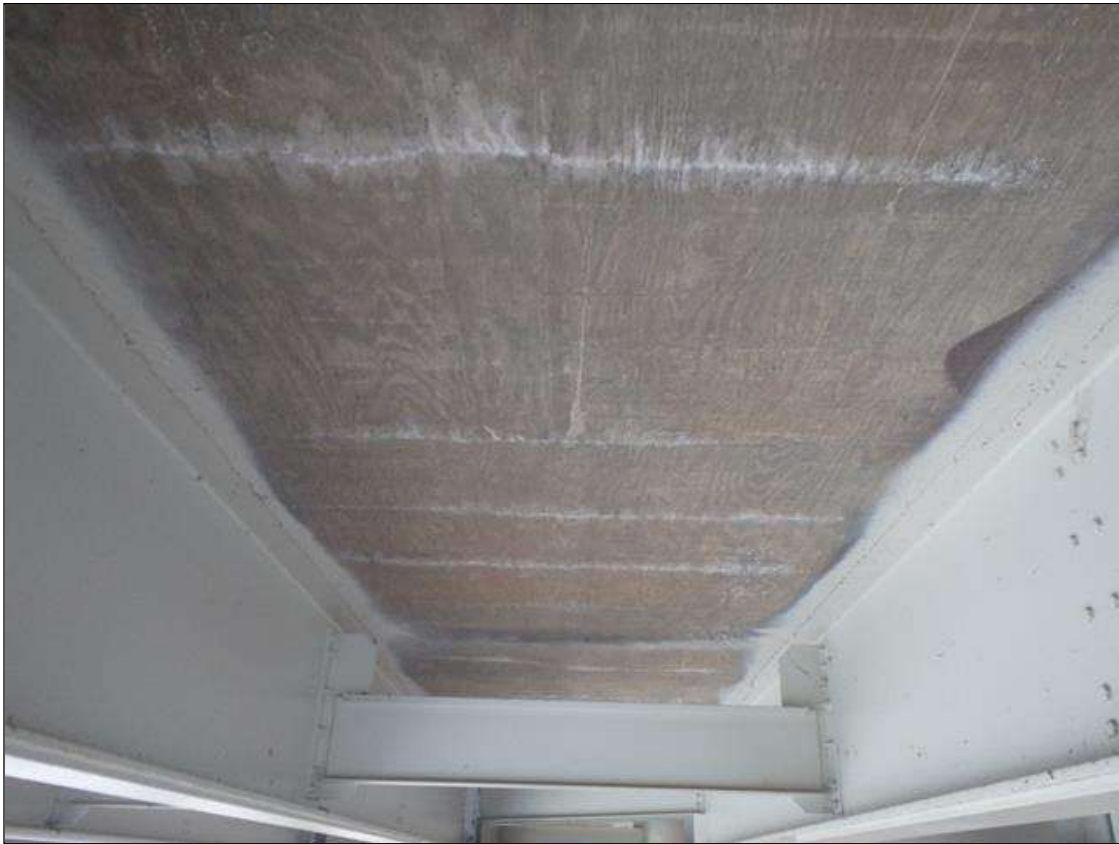
Span 2 Deck: TRANSVERSE HAIRLINE CRACKS, SOME WITH EFFLORESCENCE, UP TO FULL BAY WIDTH, SCATTERED THROUGHOUT UNDERSIDE OF DECK.

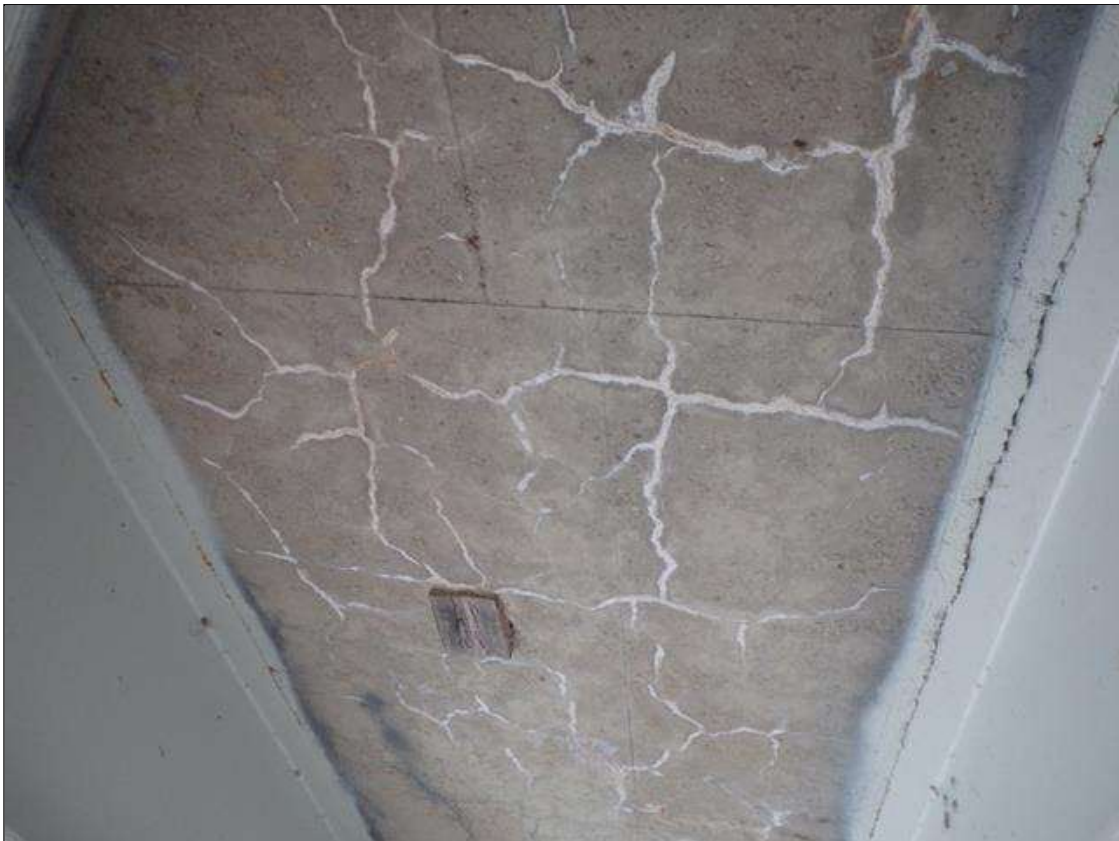
Span 2 Deck: SCATTERED MAP CRACKING UP TO 1/32" WIDE WITH SOME AREAS OF EFFLORESCENCE, THROUGHOUT UNDERSIDE OF DECK.

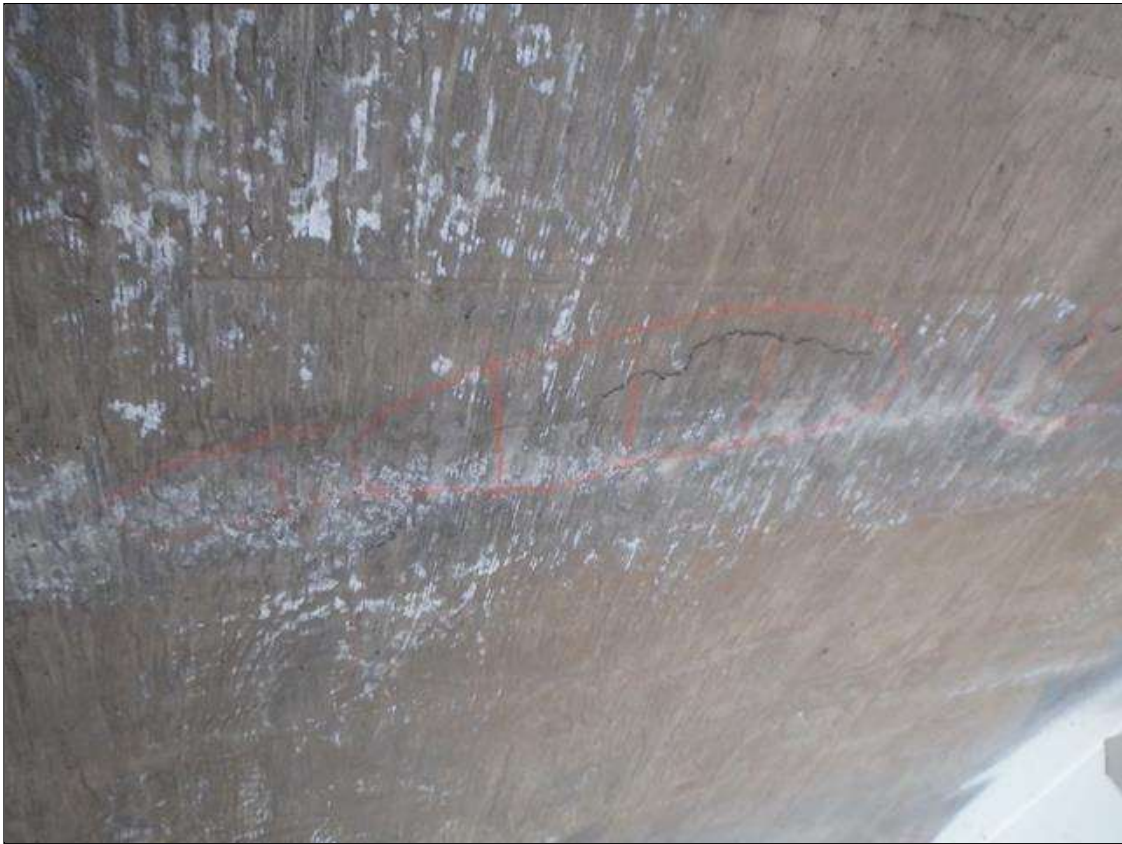
Span 2 Deck: SCATTERED DELAMINATIONS IN UNDERSIDE OF DECK, UP TO 10" X 3 FT.

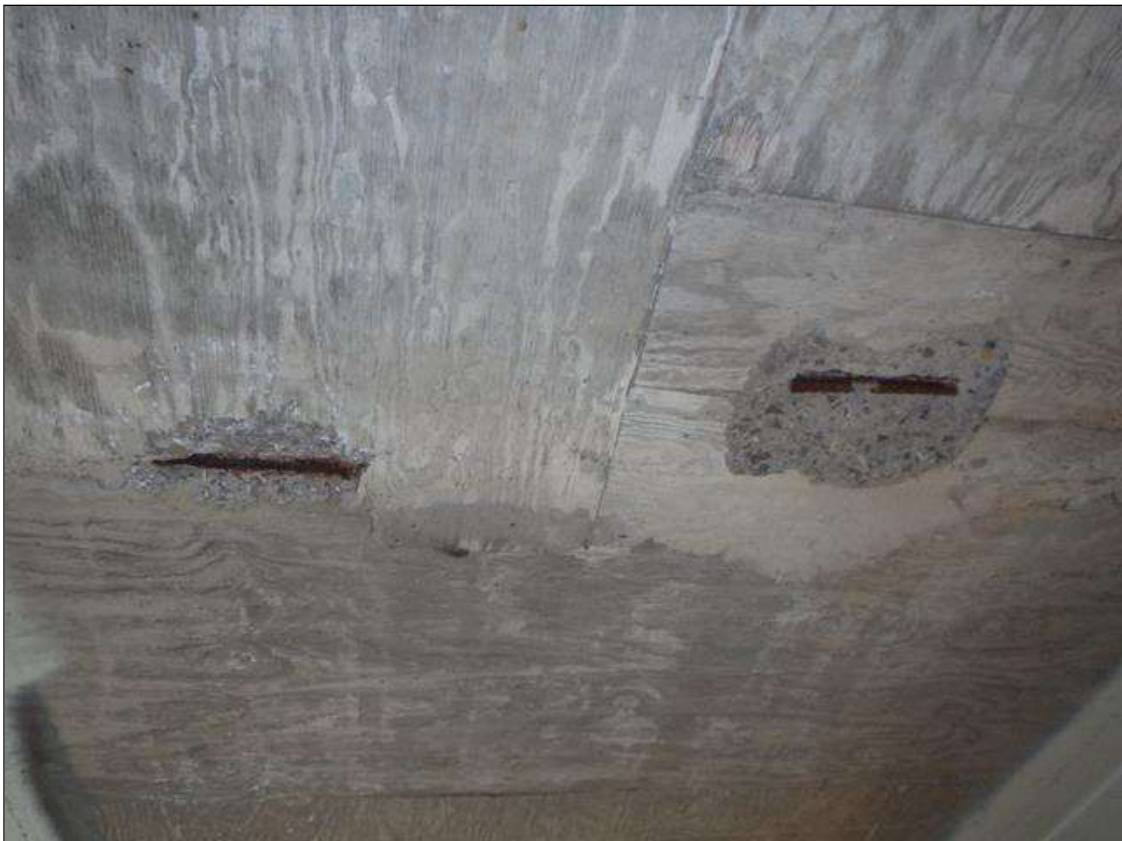
Span 2 Deck: (2) SPALLS WITH EXPOSED REINFORCEMENT UP TO 12" X 12" X 1" DEEP IN UNDERSIDE OF DECK, BAY 4 AT BENT 1, NO SECTION LOSS OF EXPOSED REINFORCEMENT.

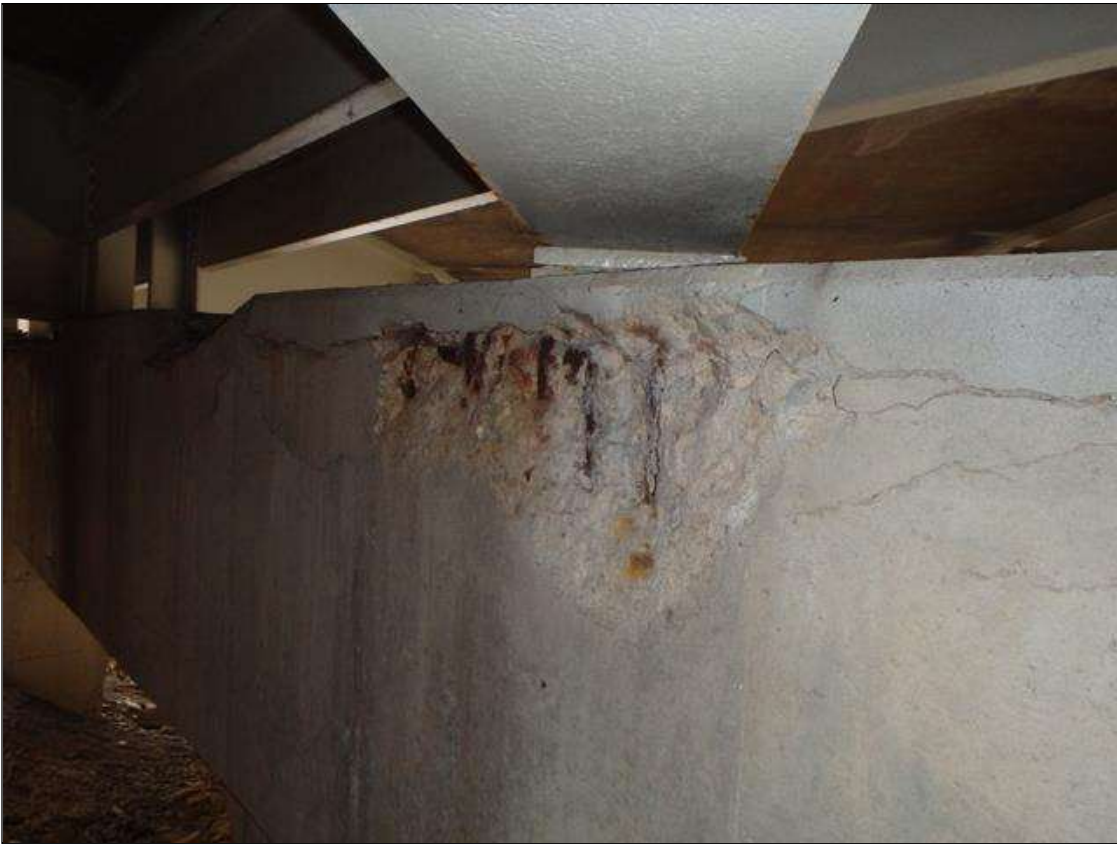
Bent 1 Cap 1: 3 FT X 18" X 3" DEEP SPALL WITH EXPOSED REINFORCEMENT IN SPAN 1 FACE OF CAP BELOW BEAM 3, NO MEASURABLE SECTION LOSS OF EXPOSED REINFORCEMENT.

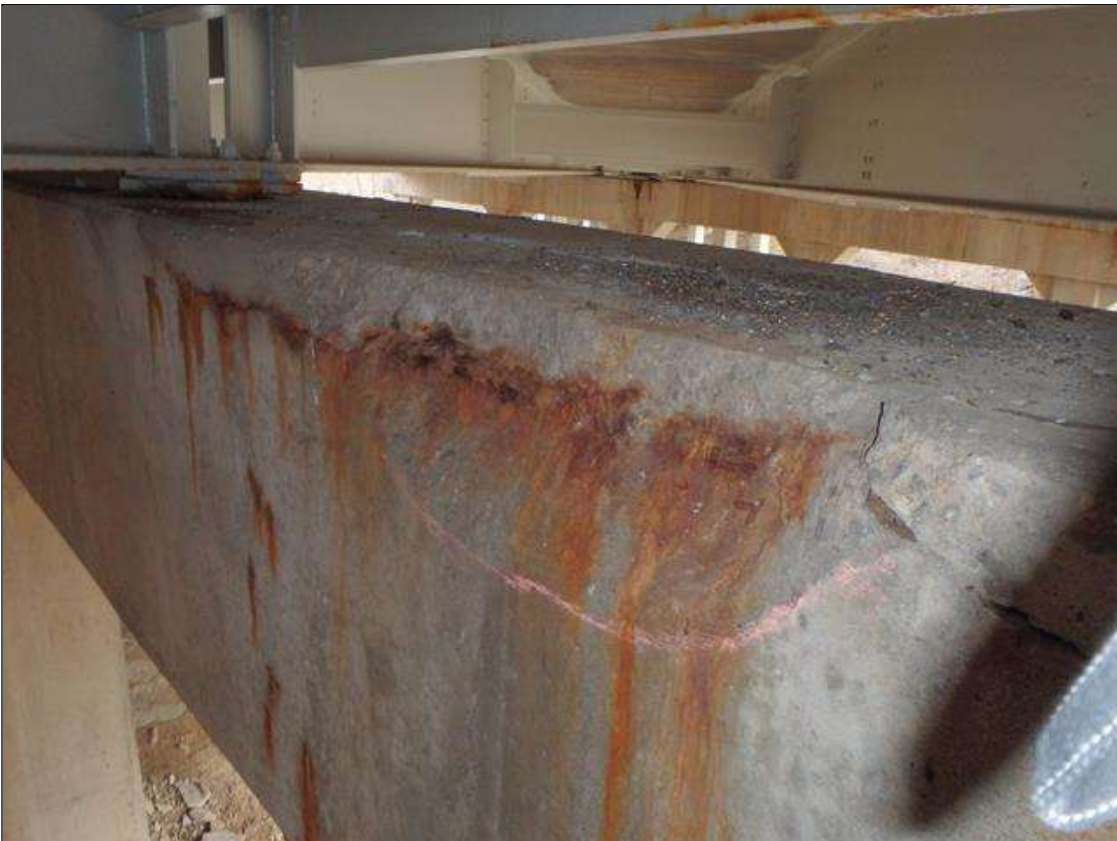
Bent 1 Cap 1: 4 FT X 12" X UP TO 3" DEEP SPALL WITH EXPOSED REINFORCEMENT IN TOP CORNER OF CAP, SPAN 1 SIDE, BELOW BAY 4, NO MEASURABLE SECTION LOSS OF EXPOSED REINFORCEMENT.

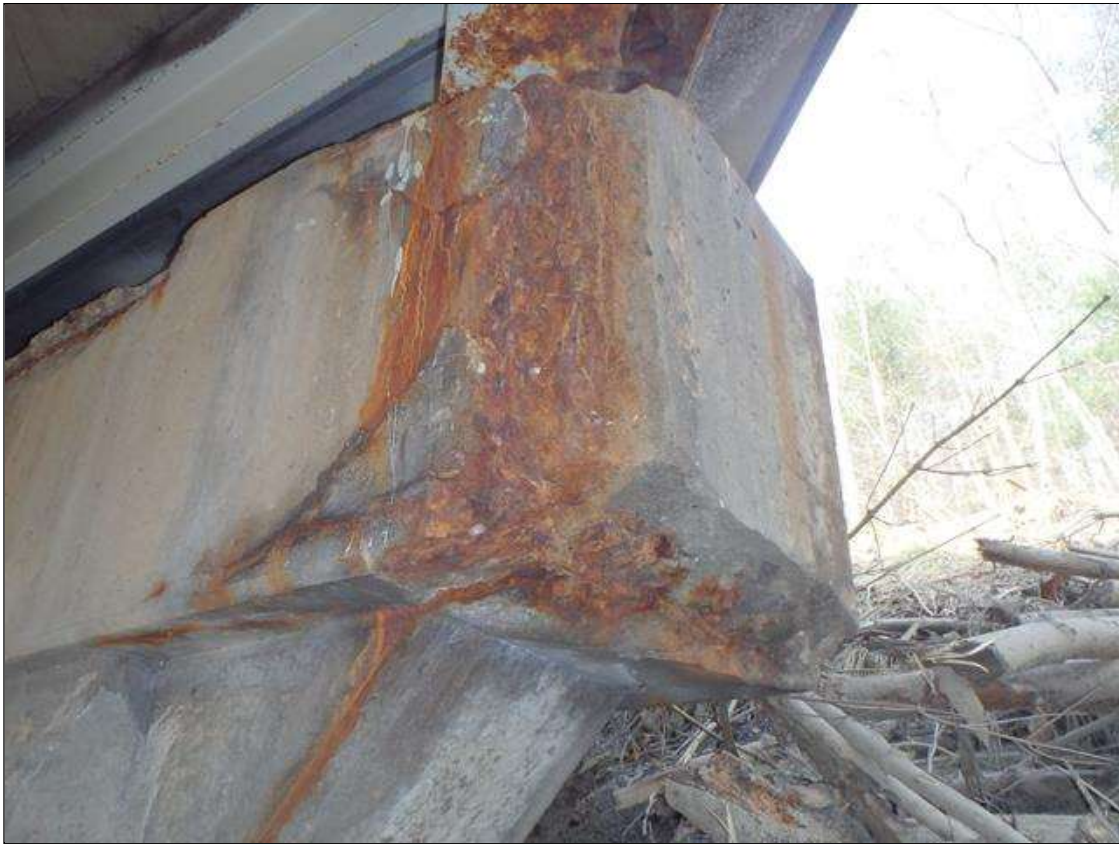
Bent 1 Cap 1: FULL HEIGHT X 12" WIDE X UP TO 3" DEEP SPALL WITH EXPOSED REINFORCEMENT IN UNDERSIDE OF CAP BELOW BEAM 1, NO MEASURABLE SECTION LOSS OF EXPOSED REINFORCEMENT.

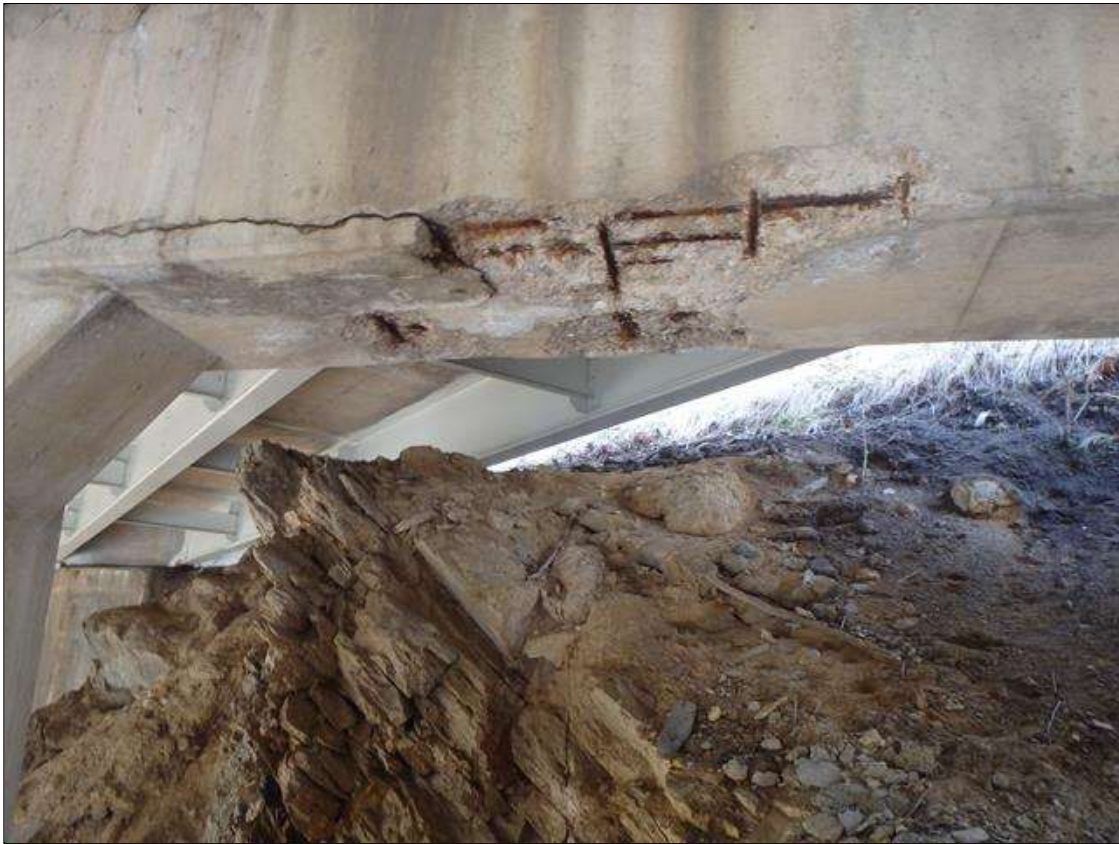
Bent 1 Cap 1: SPALL WITH EXPOSED REINFORCEMENT IN UNDERSIDE OF CAP BETWEEN COLUMNS 1 AND 2. SPALL IS FULL WIDTH OF CAP X 5 FT LONG X UP TO 3" DEEP, NO MEASURABLE SECTION LOSS OF EXPOSED REINFORCEMENT.

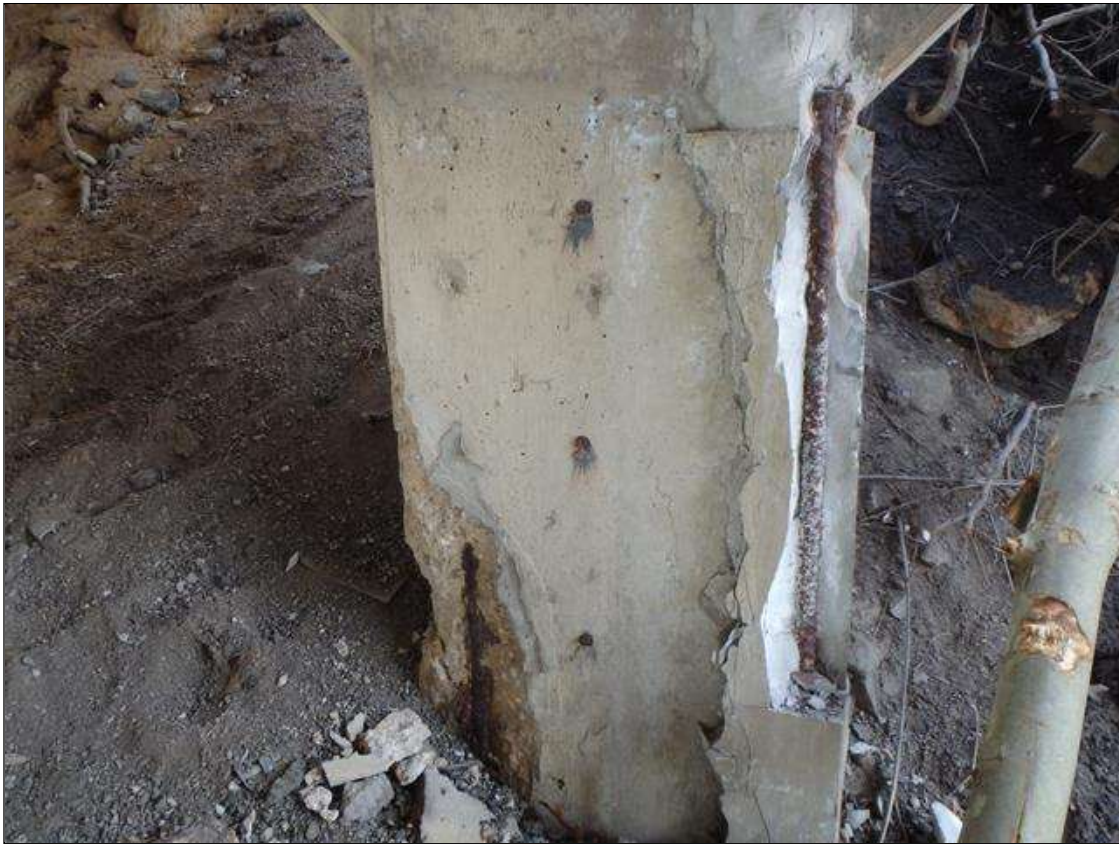
Bent 1 Pile 1: 8" X 8" X 3.5 FT HIGH SPALL WITH EXPOSED REINFORCEMENT IN NORTHEAST CORNER OF COLUMN, BEGINNING 1.5 FT BELOW CAP, NO SECTION LOSS OF EXPOSED REINFORCEMENT.

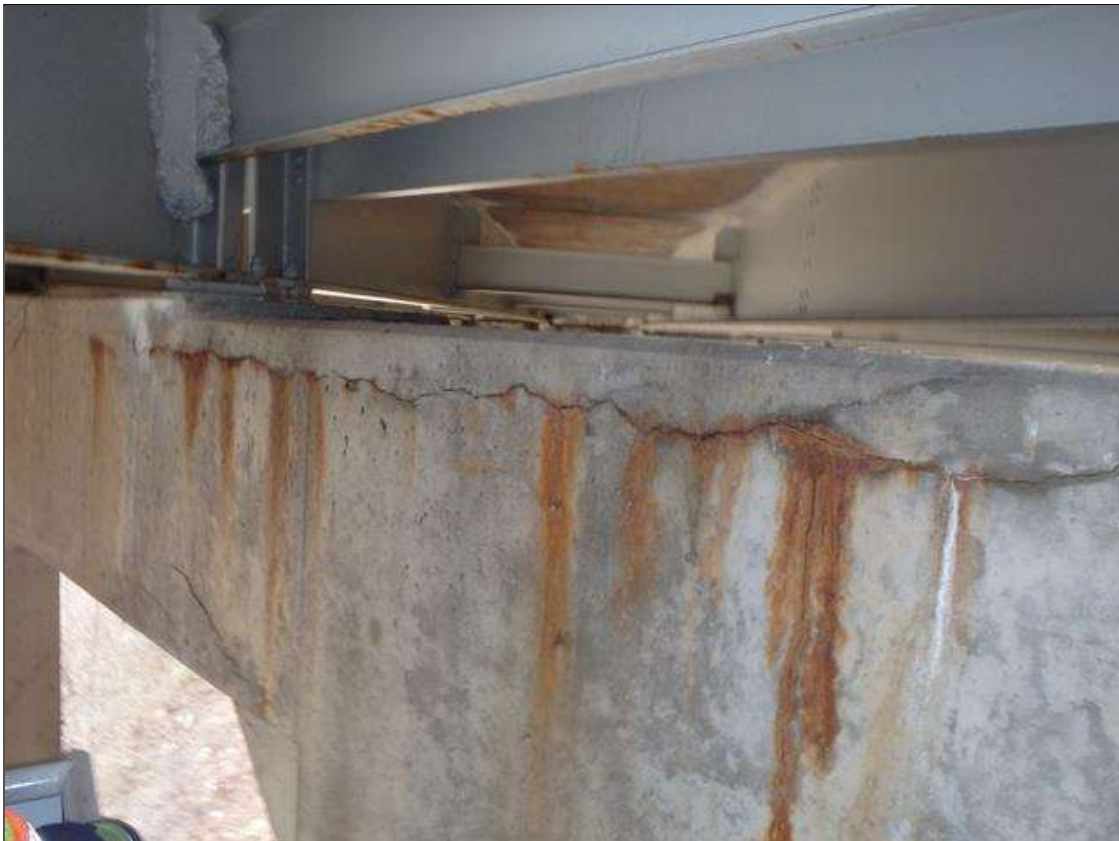
Bent 1 Cap 1: 10 FT HORIZONTAL CRACK UP TO 1/8" WIDE WITH RUST STAINING IN FACE OF CAP, NEAR TOP, SPAN 2 FACE BELOW BAY 4.

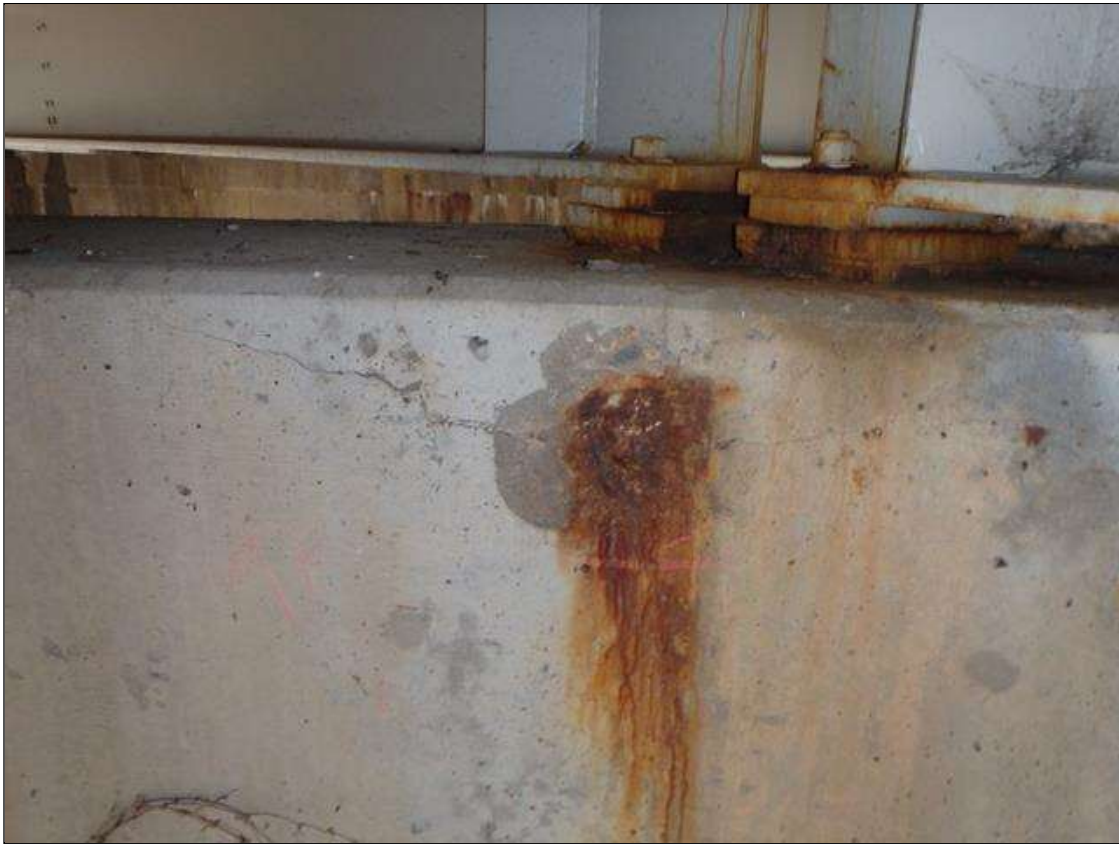
Bent 1 Cap 1: 8" DIAMETER X 1" DEEP SPALL WITH EXPOSED REINFORCEMENT IN SPAN 2 FACE OF CAP BELOW BEAM 5, NO MEASURABLE SECTION LOSS OF EXPOSED REINFORCEMENT.

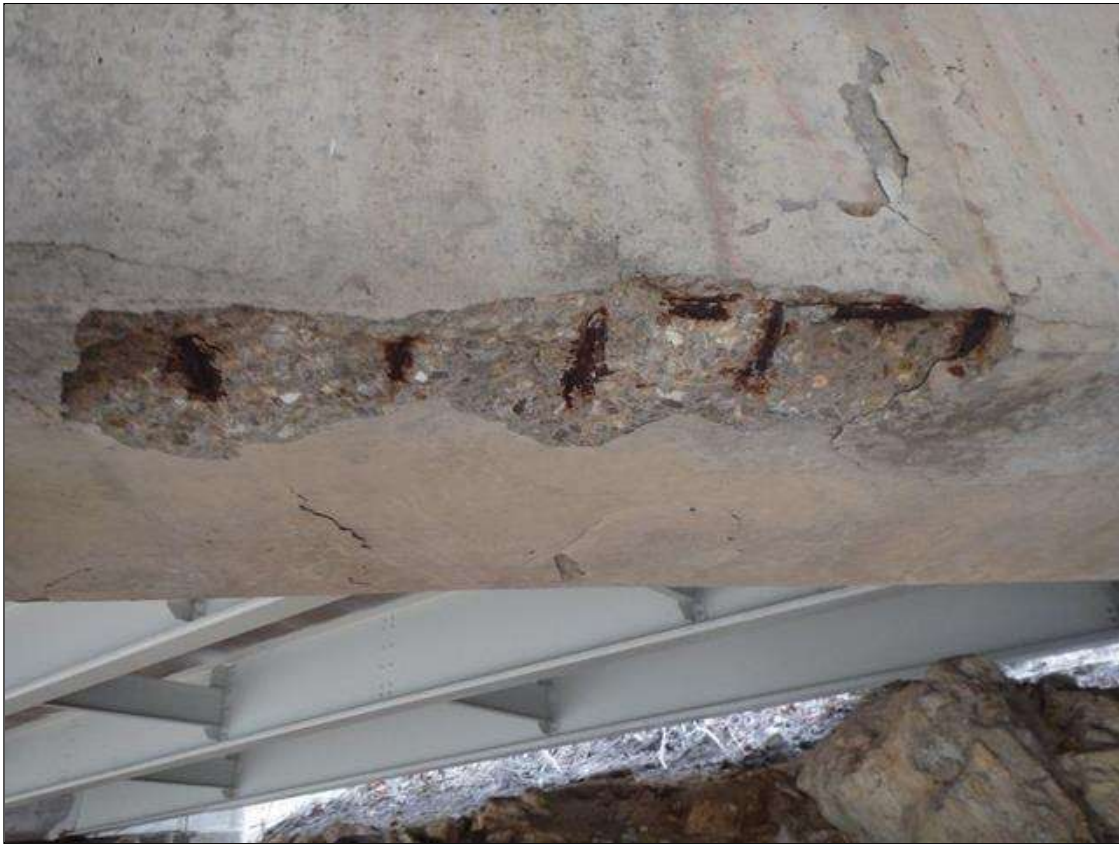
Bent 1 Cap 1: UNDERSIDE OF CAP OF CAP BETWEEN PILES 2 AND 3 HAS AN AREA OF DELAMINATION FOR FULL COLUMN SPACING X UP TO FULL WIDTH OF CAP AND SPALLING WITH EXPOSED REINFORCEMENT UP TO 4 FT X 1 FT X 2" DEEP, NO MEASURABLE SECTION LOSS OF EXPOSED REINFORCEMENT.

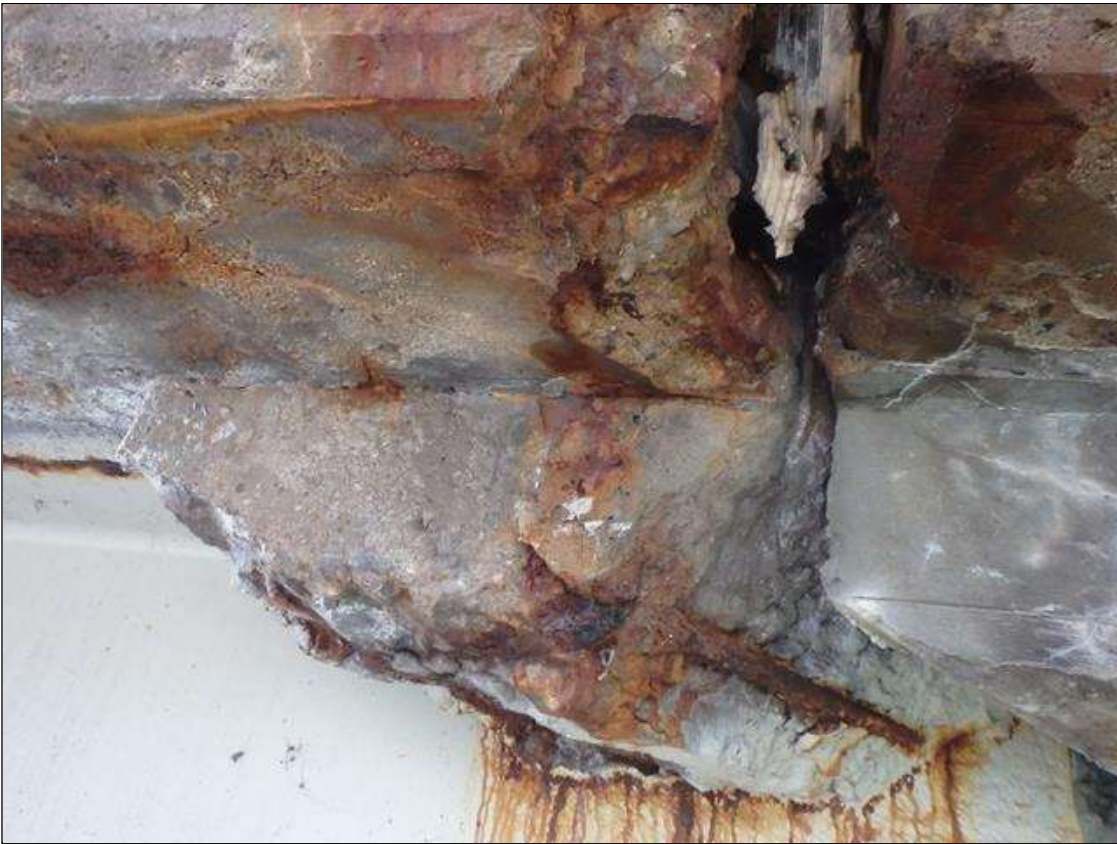
Span 1 Deck: SPALL WITH EXPOSED REINFORCEMENT IN EDGE BEAM AT BEAM 1, 1 FT X 6" X 2" DEEP WITH RUST STAINING ONTO BEAM BELOW, NO MEASURABLE SECTION LOSS OF EXPOSED REINFORCEMENT.

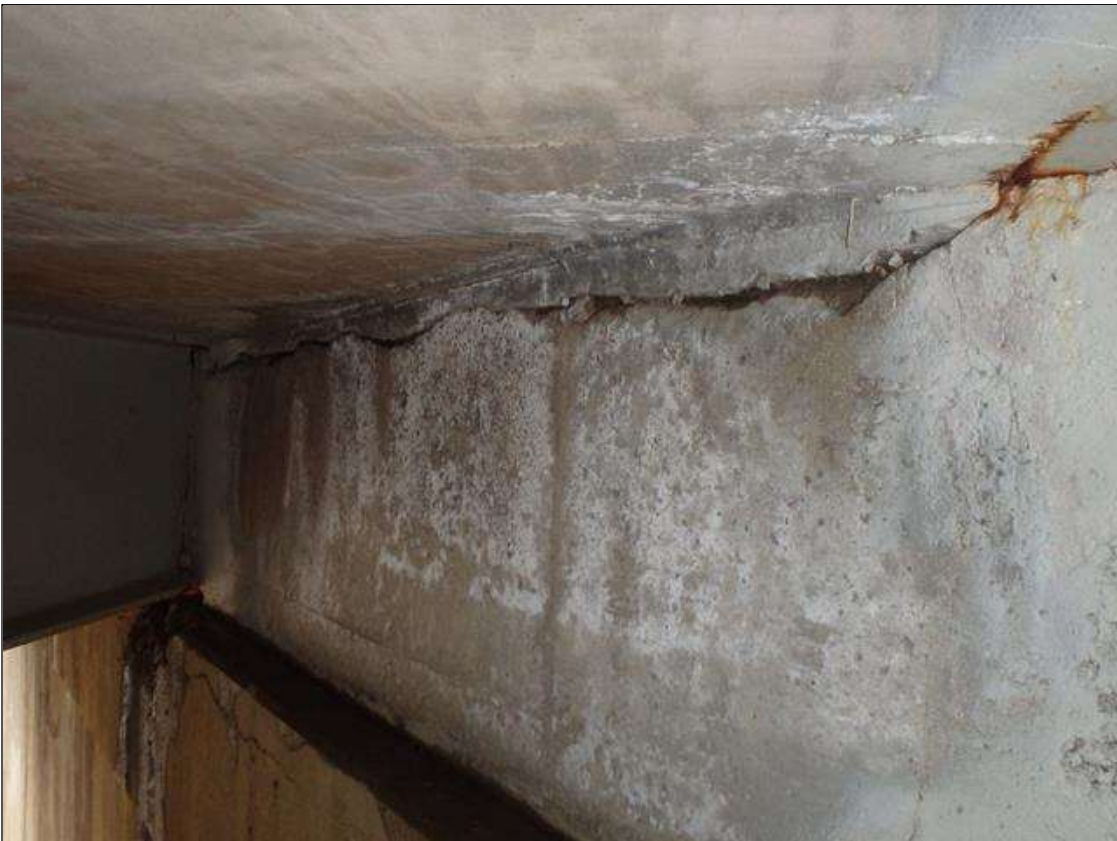
End Bent 1 Abutment/Backwall : FULL BAY WIDTH LONGITUDINAL CRACK IN BACKWALL OF BAY 3, UP TO 1" WIDE, 4" BELOW DECK UNDERSIDE.

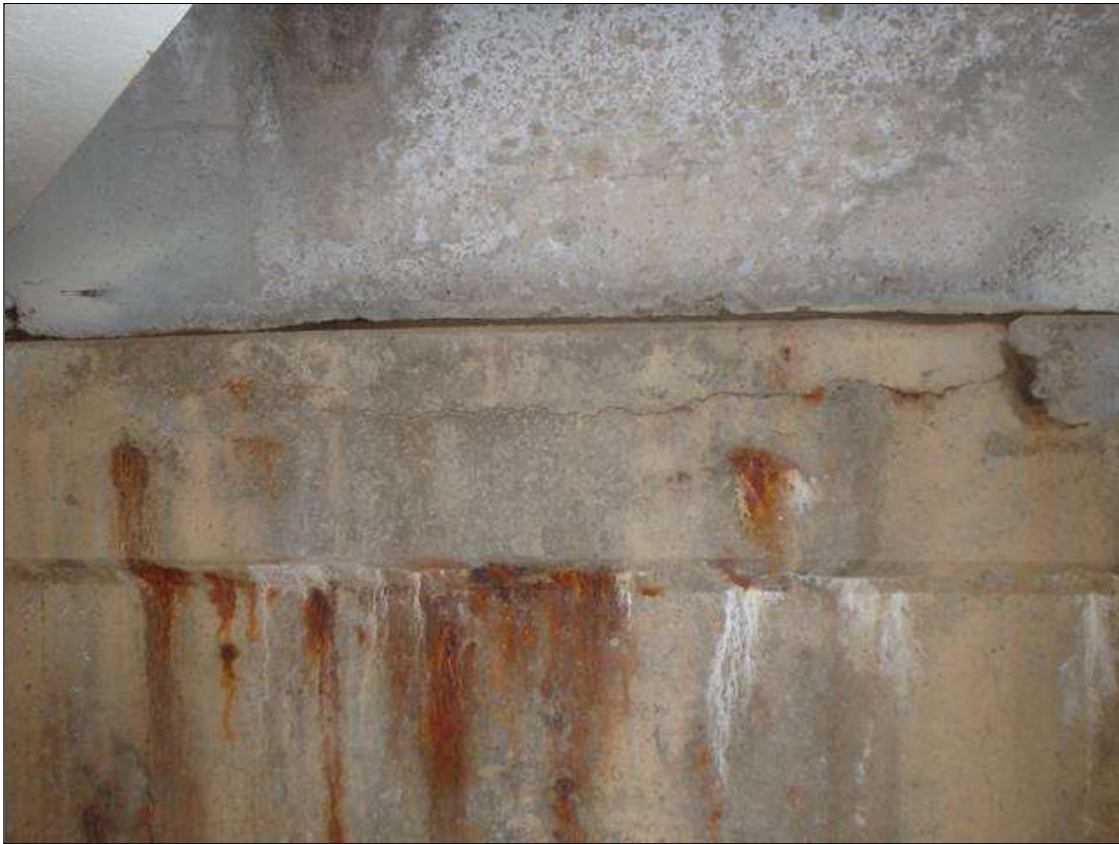
End Bent 1 Abutment/Backwall : SCATTERED HORIZONTAL CRACK IN FACE OF ABUTMENT BELOW BEARING SEATS, UP TO 1/8" WIDE BEGINS BELOW BAY 3 AND TRAVELS TO RIGHT END OF CAP.

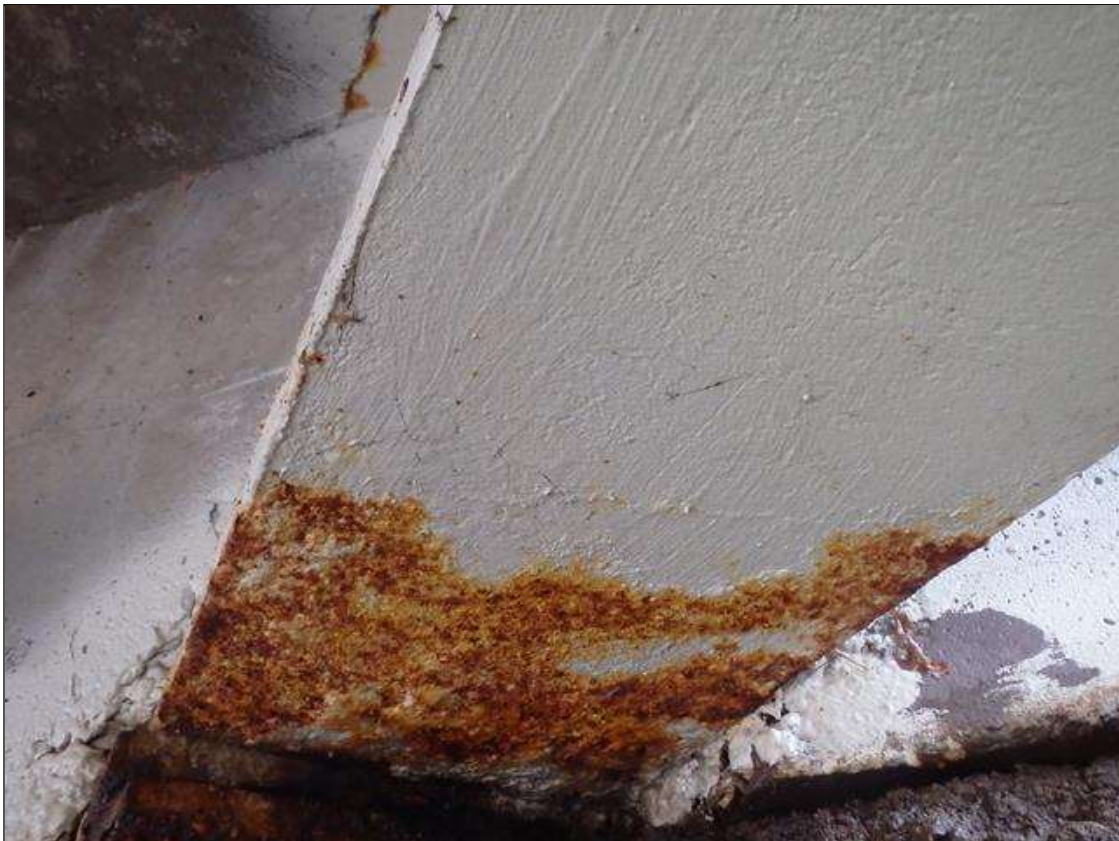
Span 1 Beam 1: SURFACE CORROSION FOR FULL WIDTH OF FLANGE FOR 1 FT LONG AT END BENT 1, NO SECTION LOSS.

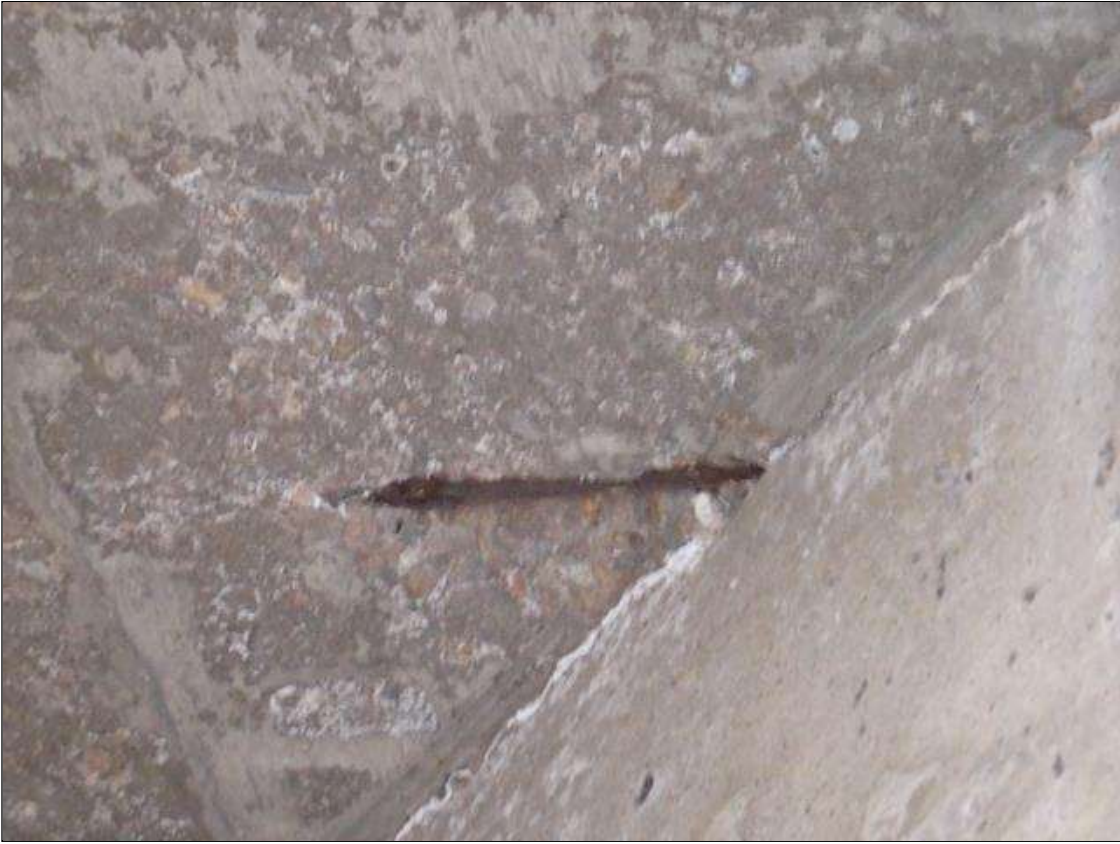
Span 1 Deck: 10" OF EXPOSED REINFORCEMENT IN UNDERSIDE OF DECK, BAY 1 AT END BENT 1, NO SECTION LOSS.

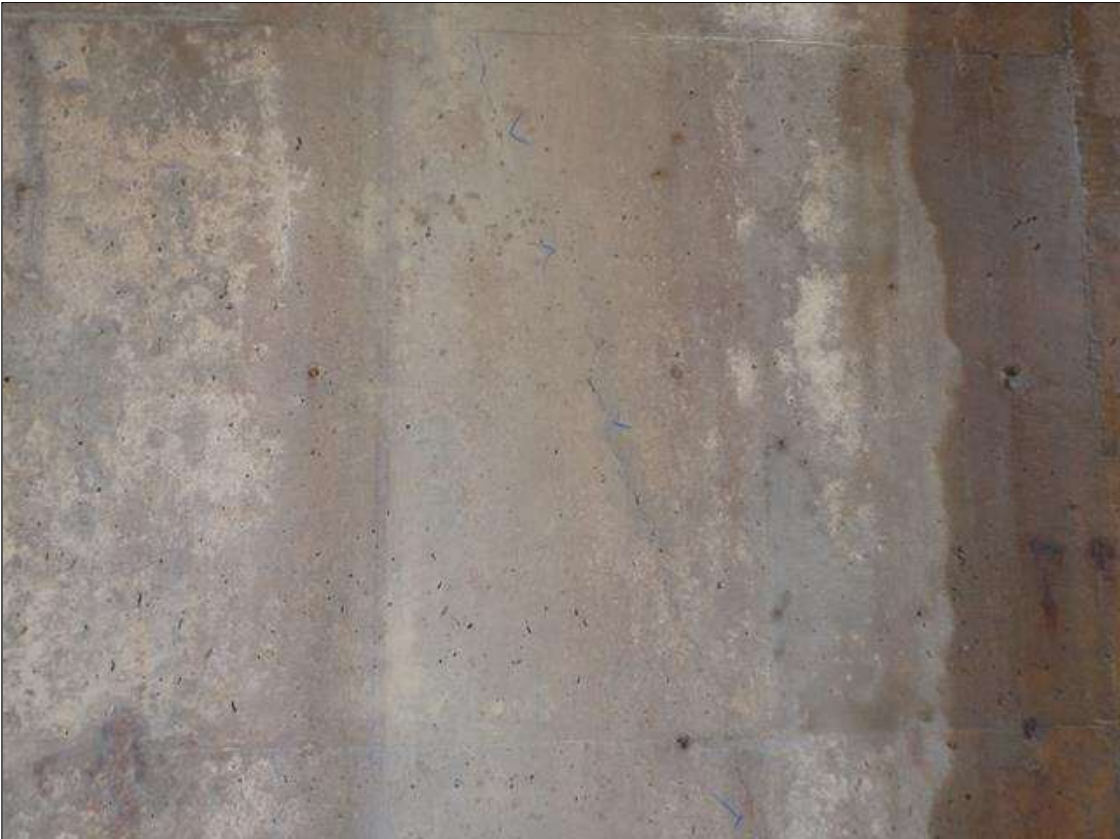
End Bent 1 Abutment/Backwall : FULL HEIGHT VERTICAL CRACK UP TO 1/16" WIDE IN FACE OF ABUTMENT BELOW BAY 2, BEGINS AT GROUNDLINE.

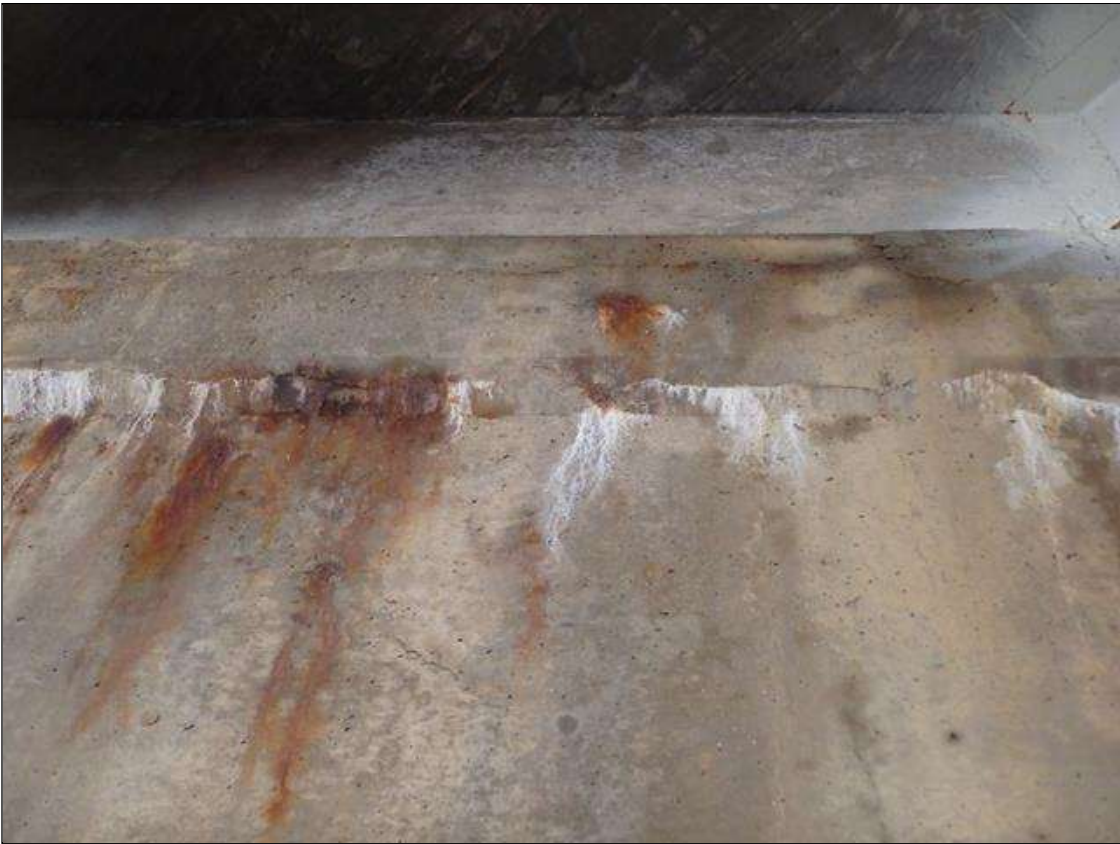
End Bent 1 Abutment/Backwall : SCATTERED HORIZONTAL HAIRLINE CRACKS WITH RUST STAINING AND EFFLORESCENCE THROUGHOUT FACE OF ABUTMENT BELOW BEARINGSS.

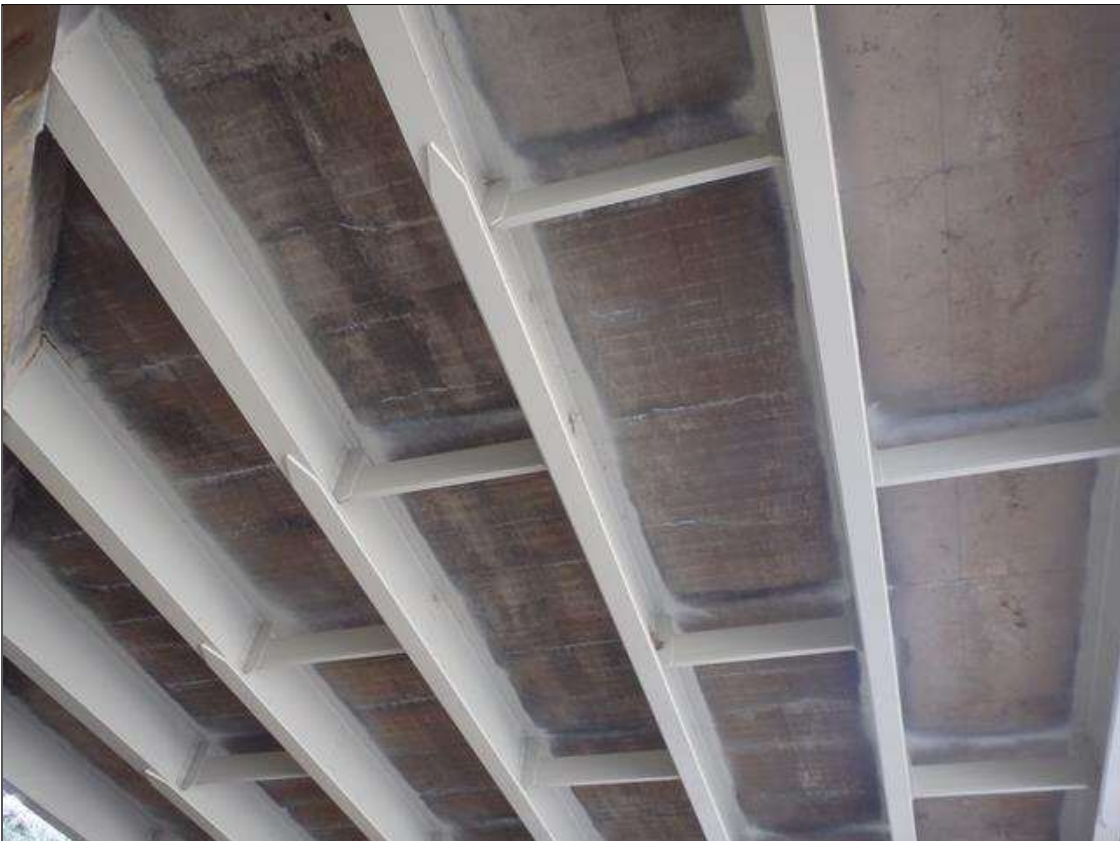
Span 1 Deck: SCATTERED TRANSVERSE HAIRLINE CRACKS, SOME WITH EFFLORESCENCE, THROUGHOUT UNDERSIDE OF DECK.

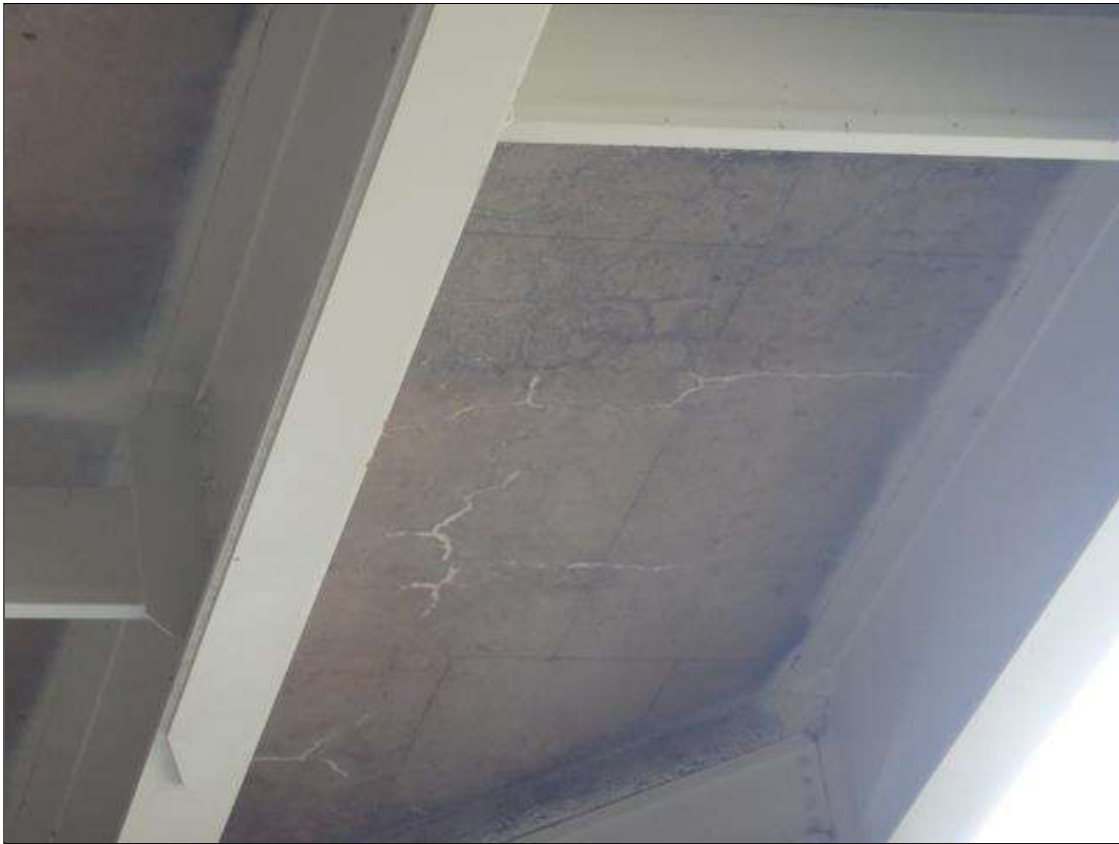
Span 1 Deck: SCATTERED MAP CRACKING WITH SOME EFFLORESCENCE UP TO 1/32" WIDE THROUGHOUT UNDERSIDE OF DECK

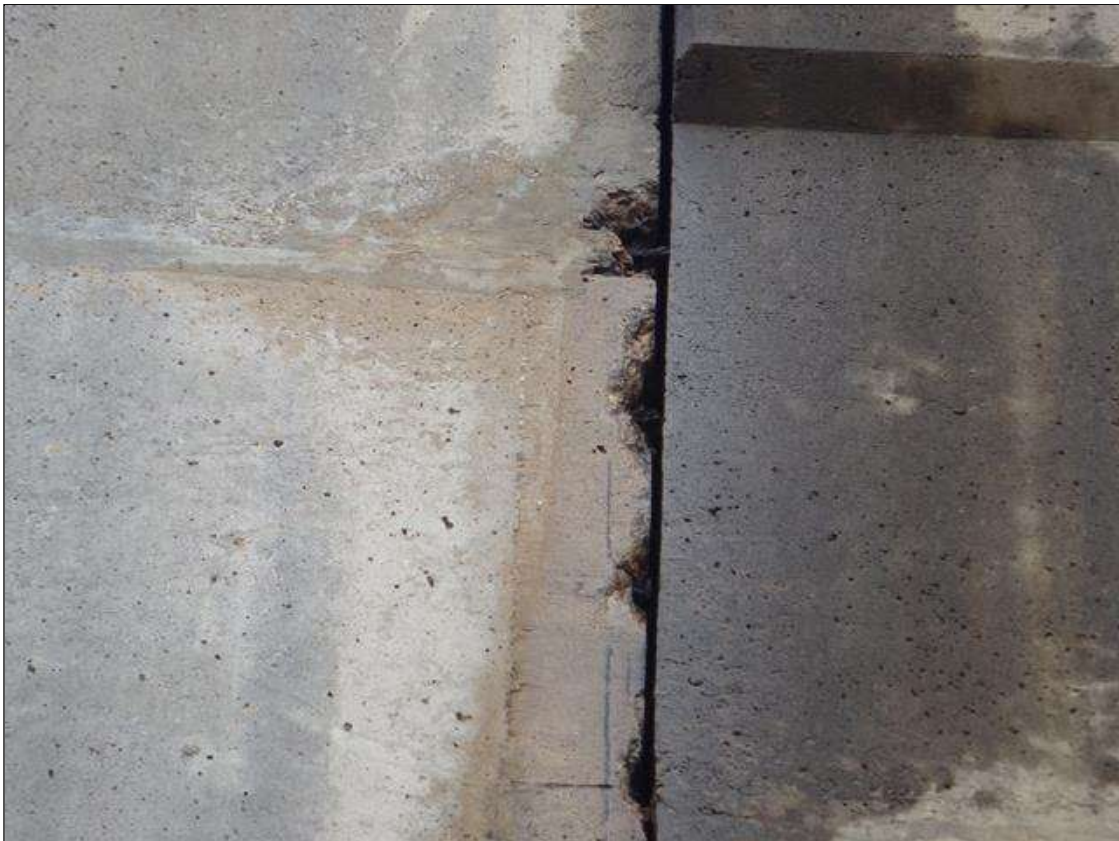
(4) SPALLS UP TO 4" DIAMETER X 1" DEEP IN SOUTHWEST WINGWALL OUTSIDE OF GIRDER 8, NO EXPOSED REINFORCEMENT.
