NC DEPARTMENT OF TRANSPORTATION  
DIVISION OF HIGHWAYS  
STRUCTURE MANAGEMENT UNIT

## Structure Safety Report

### Routine Element Inspection - Contract

DIVISION: 14 COUNTY: HAYWOOD STRUCTURE NUMBER: 430142 FREQUENCY: 24 MONTHS

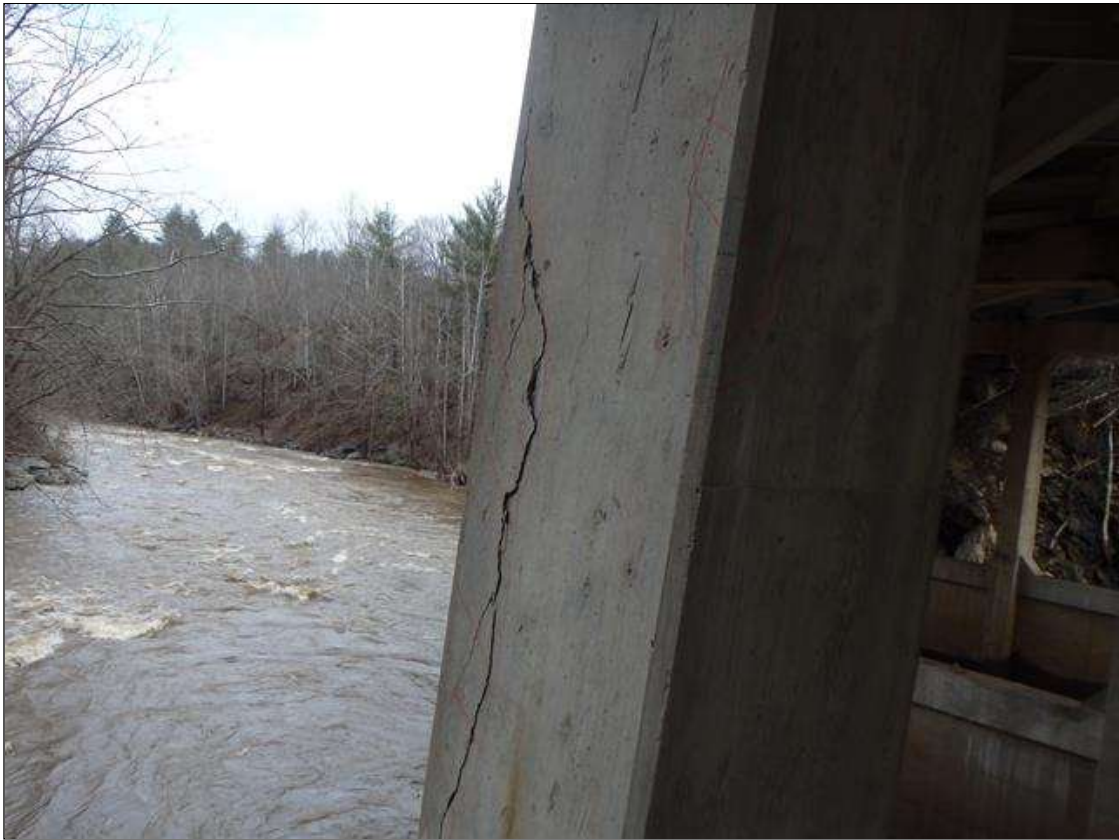
Bent 4 Pile 5: 8 FT X 1 FT X 1 FT DELAMINATION ON EAST FACE OF COLUMN, DIRECTLY ABOVE SPALL.

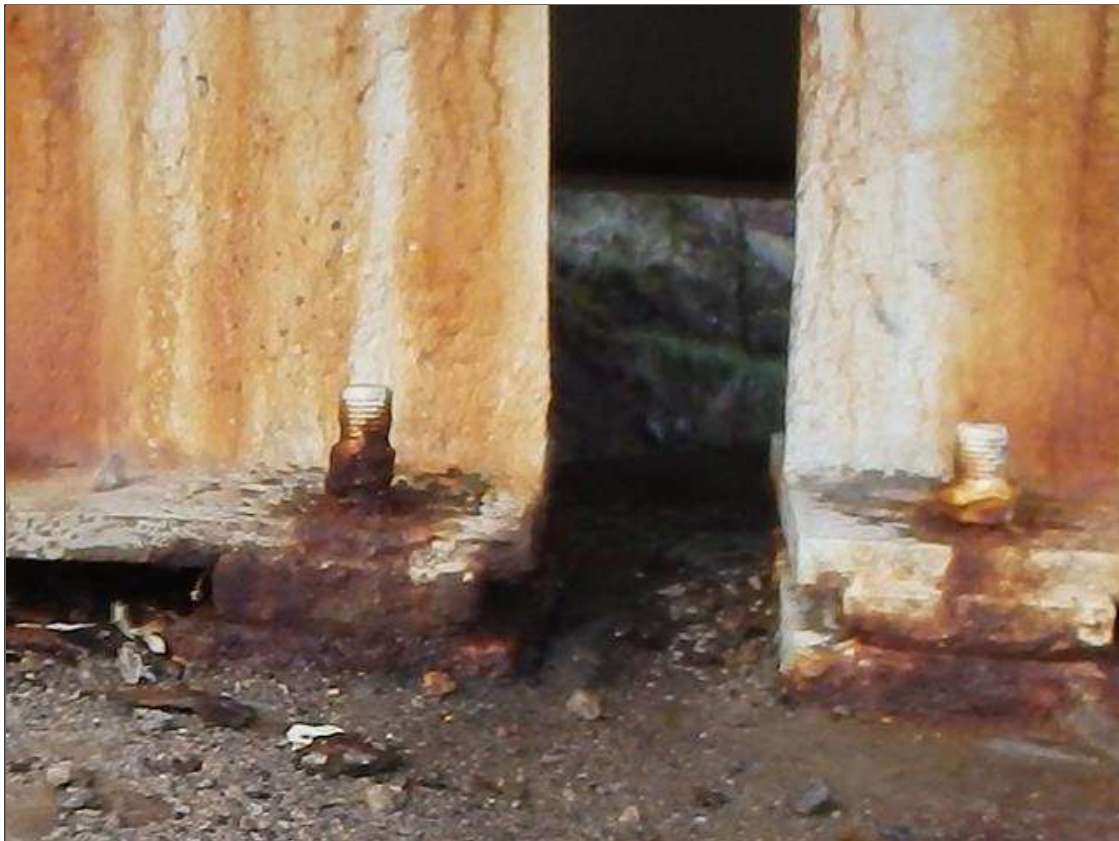
Span 5 Beam 1 Near Bearing: CORROSION WITH PACK RUST, NO MEASURABLE SECTION LOSS.

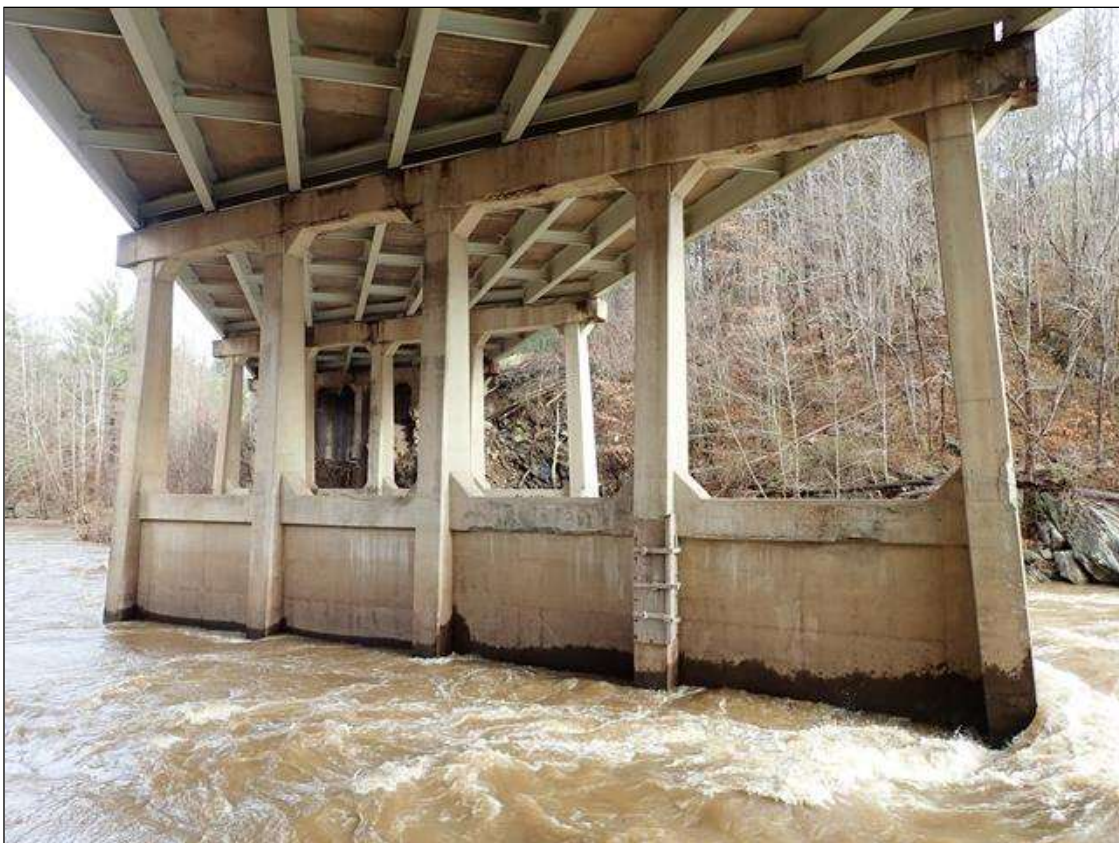
BENT 3 (TYPICAL)

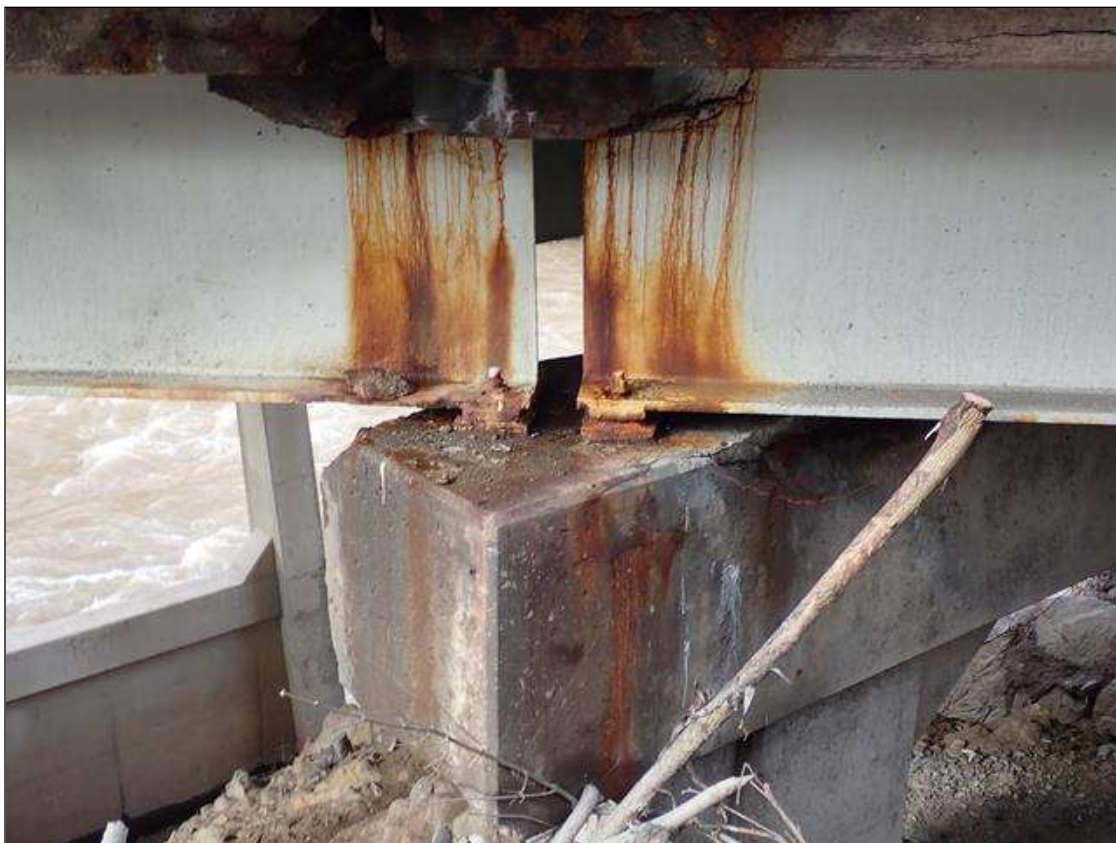
NORTH END OF BENT 4 (TYPICAL)

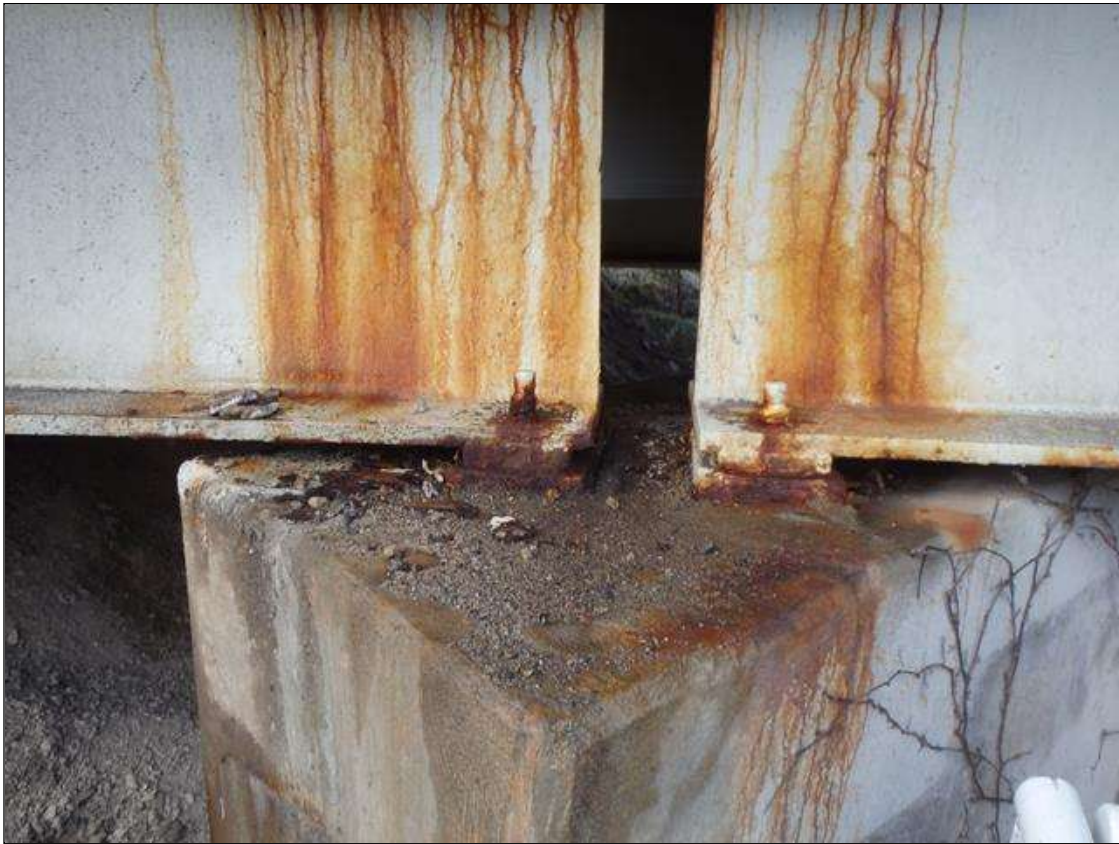
GIRDER 1 BEARING A BENT 4, TYPICAL INTERIOR BENT BEARING.

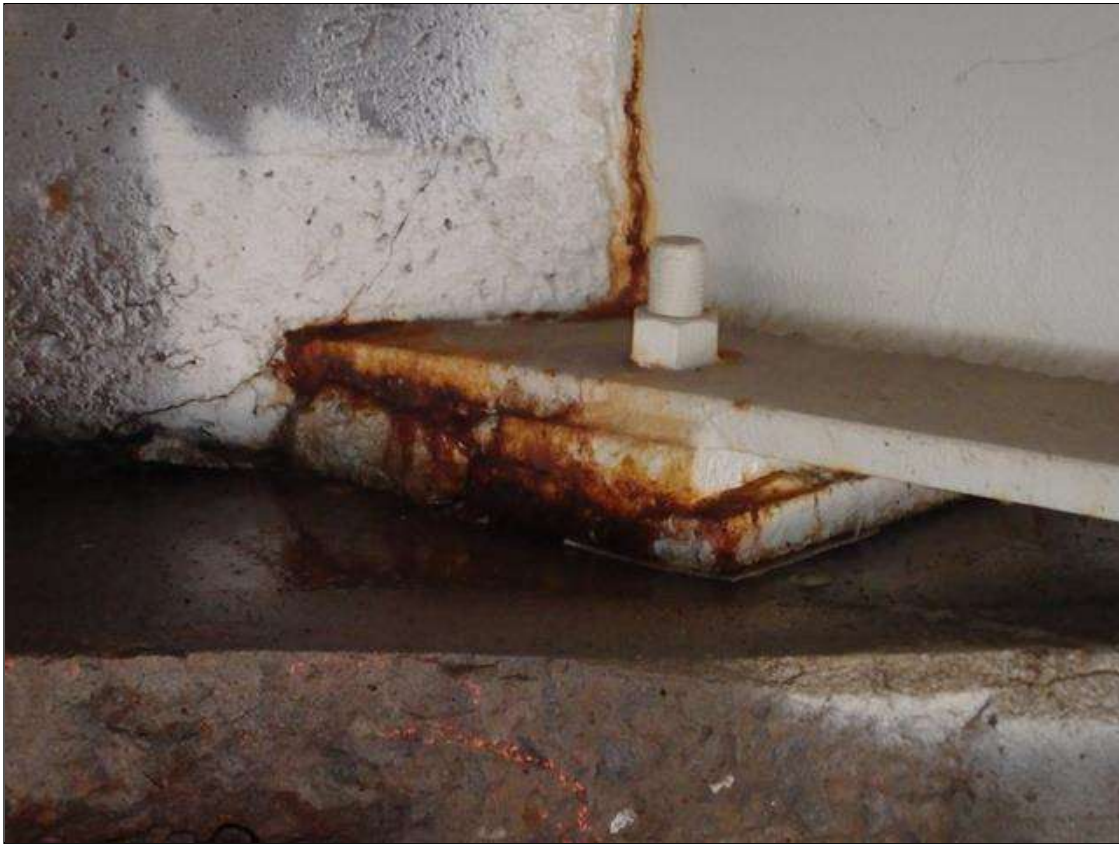
GIRDER 4 AT END BENT 2, TYPICAL END BENT BEARING.

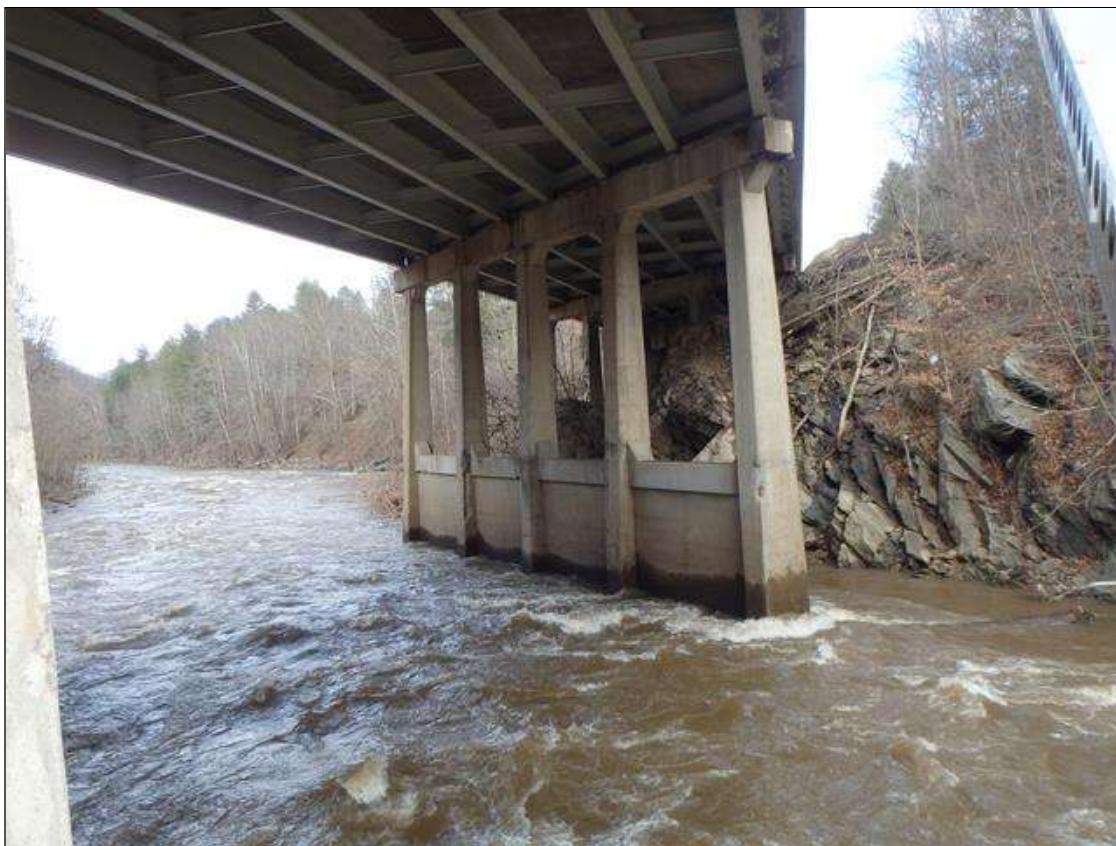
BENT 2. (TYPICAL)
