NC DEPARTMENT OF TRANSPORTATION  
DIVISION OF HIGHWAYS  
STRUCTURE MANAGEMENT UNIT

## Structure Safety Report

### Routine Element Inspection - Contract

DIVISION: 14 COUNTY: HAYWOOD STRUCTURE NUMBER: 430159 FREQUENCY: 24 MONTHS

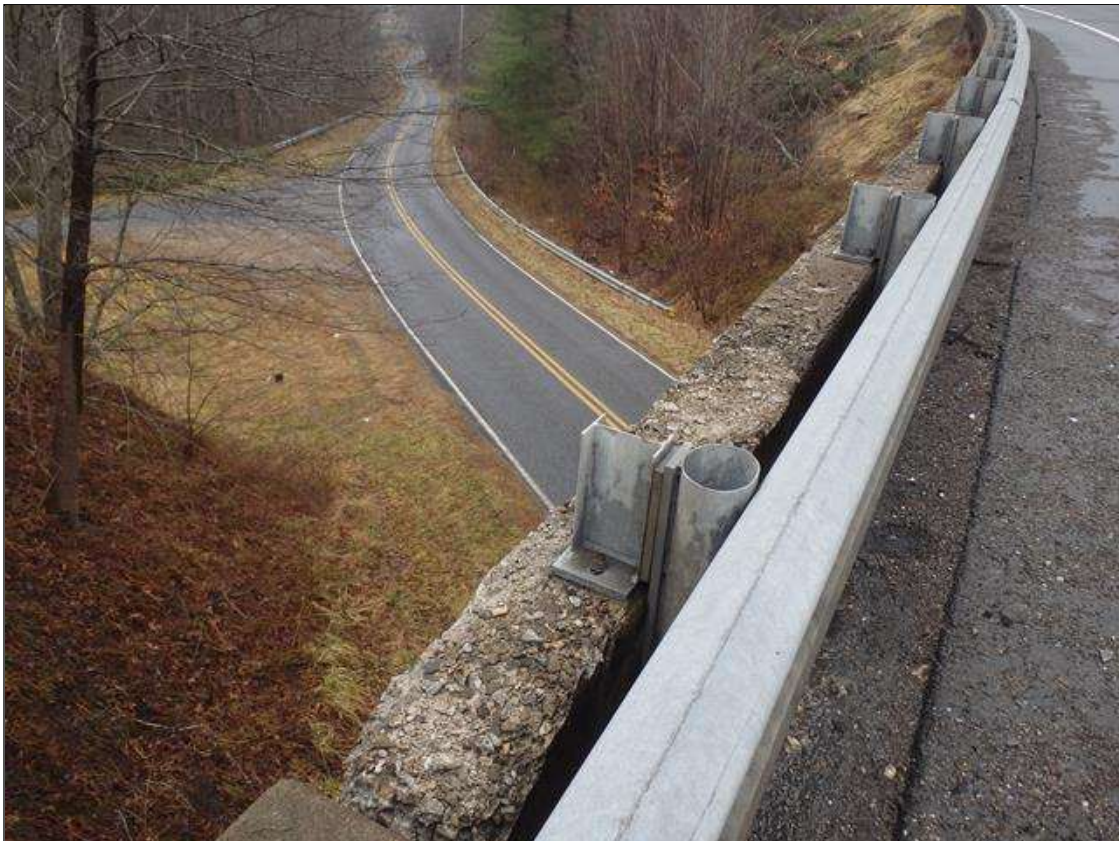
Span 2 Left Bridge Rail: DISINTEGRATING CONCRETE ON ORIGINAL BARRIER RAIL FOR FULL WIDTH X 4" DEEP FOR 50% OF THE SPAN, CONCRETE IS FALLING ONTO TRAFFIC BELOW, PM

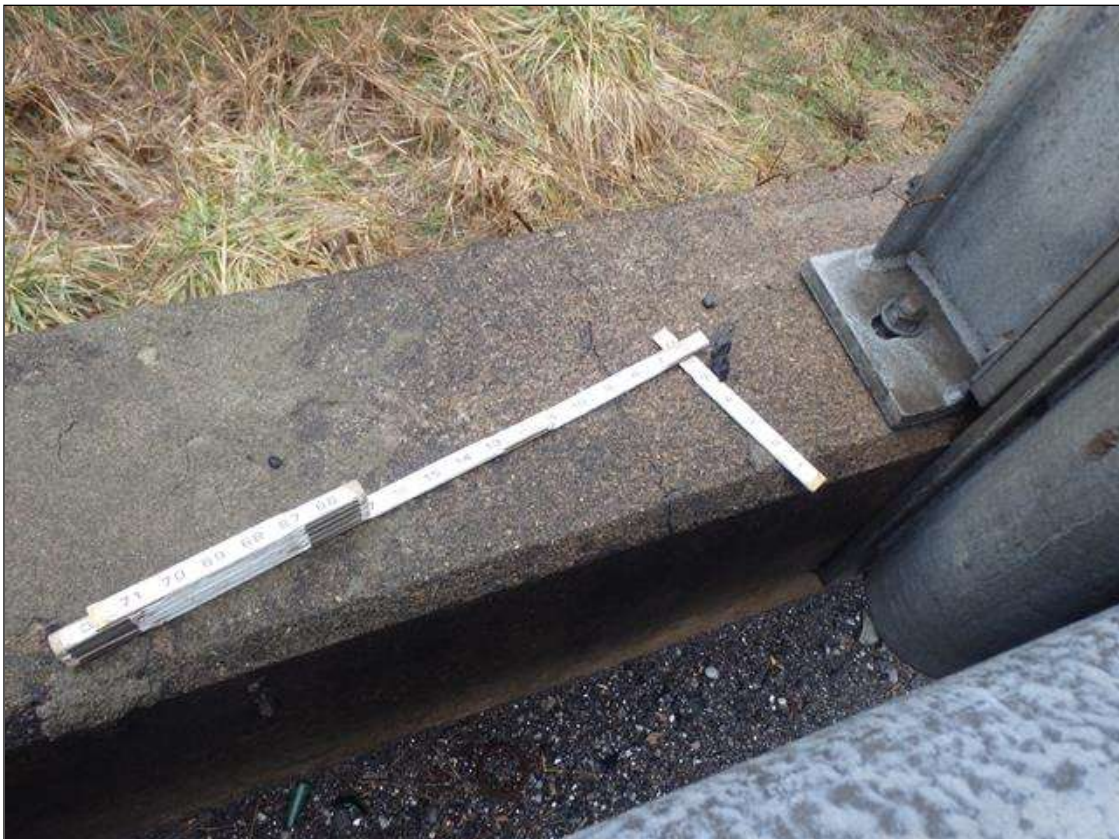
Span 2 Median Rail: UNSOUND PATCH, HONEYCOMBING 3 FT X 2 FT HIGH IN RAIL AT BENT 1

Span 3 Right Bridge Rail: 6 - FULL HEIGHT HAIRLINE VERTICAL CRACKS IN FACE OF RAIL SCATTERED THROUGHOUT

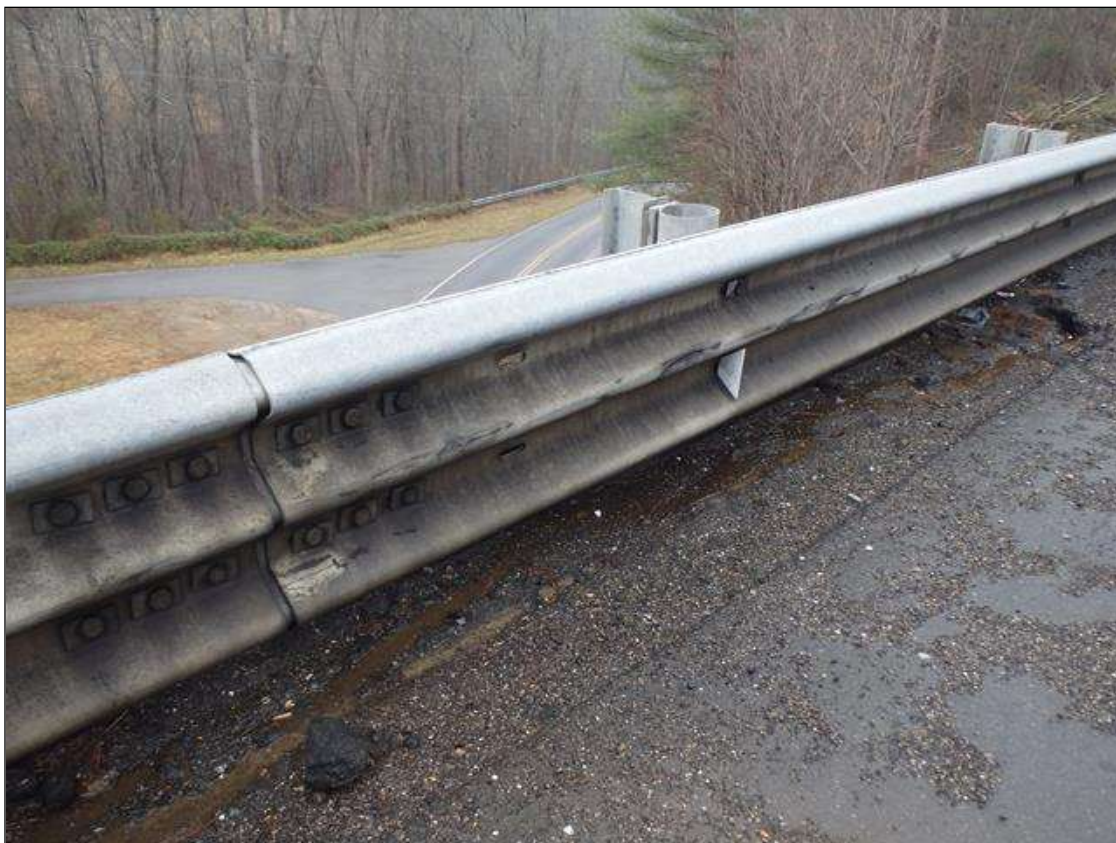
Span 1 Right Bridge Rail: 15 FT OF SCRAPING ON METAL RAIL AT END BENT 1, RAIL STILL FUNCTIONAL

Span 2 Left Bridge Rail: SCRAPING TO METAL RAIL FROM MIDSPAN TO BENT 2, METAL RAIL IS STILL FUNCTIONAL

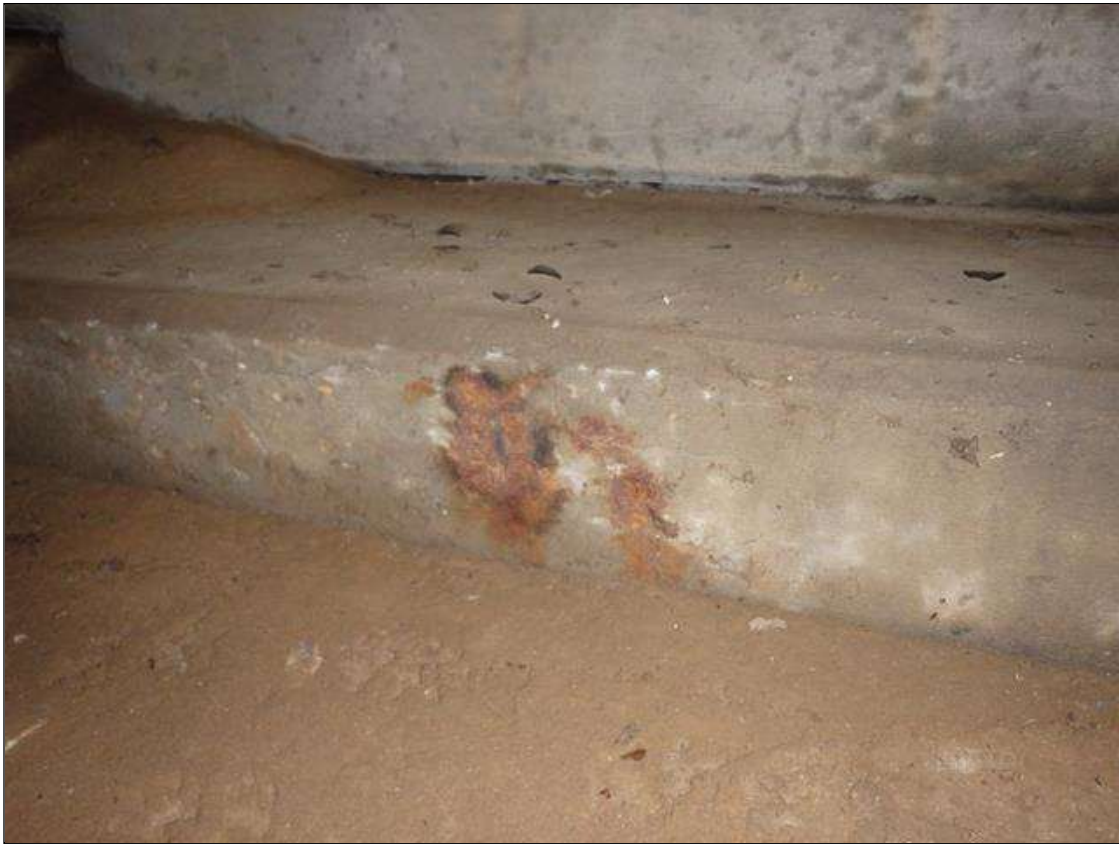
End Bent 1 Cap 1: DELAMINATION, 3 FT X 2" ON FACE OF CAP UNDER BAY 2

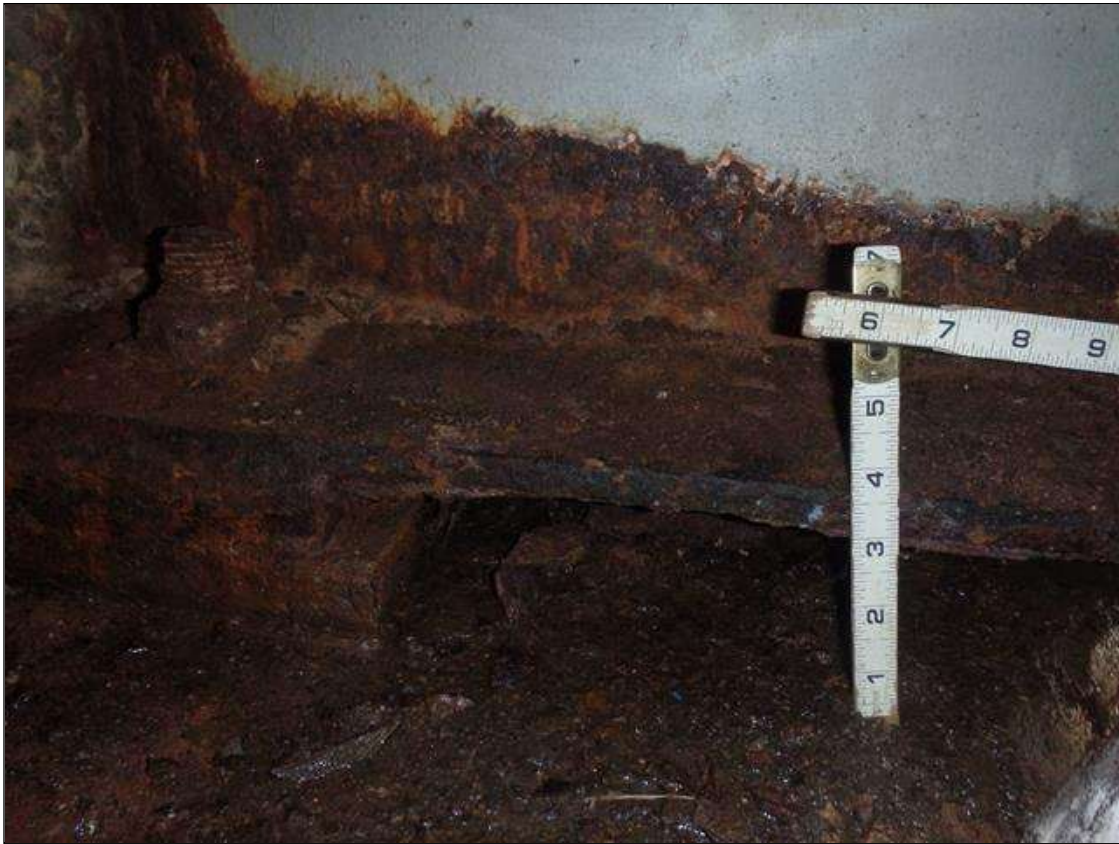
Span 1 Beam 1: SPAN 1 BEAM 1 AT END BENT 1 HAS SECTION LOSS ON THE BOTTOM FLANGES FROM THE BEAM END OUT 3 FT. X FULL WIDTH WITH  $\frac{3}{4}$ " REMAINING AND SECTION LOSS IN THE LOWER WEB FROM THE BEAM END OUT 2 FT. X 4" HIGH WITH  $\frac{11}{16}$ " REMAINING

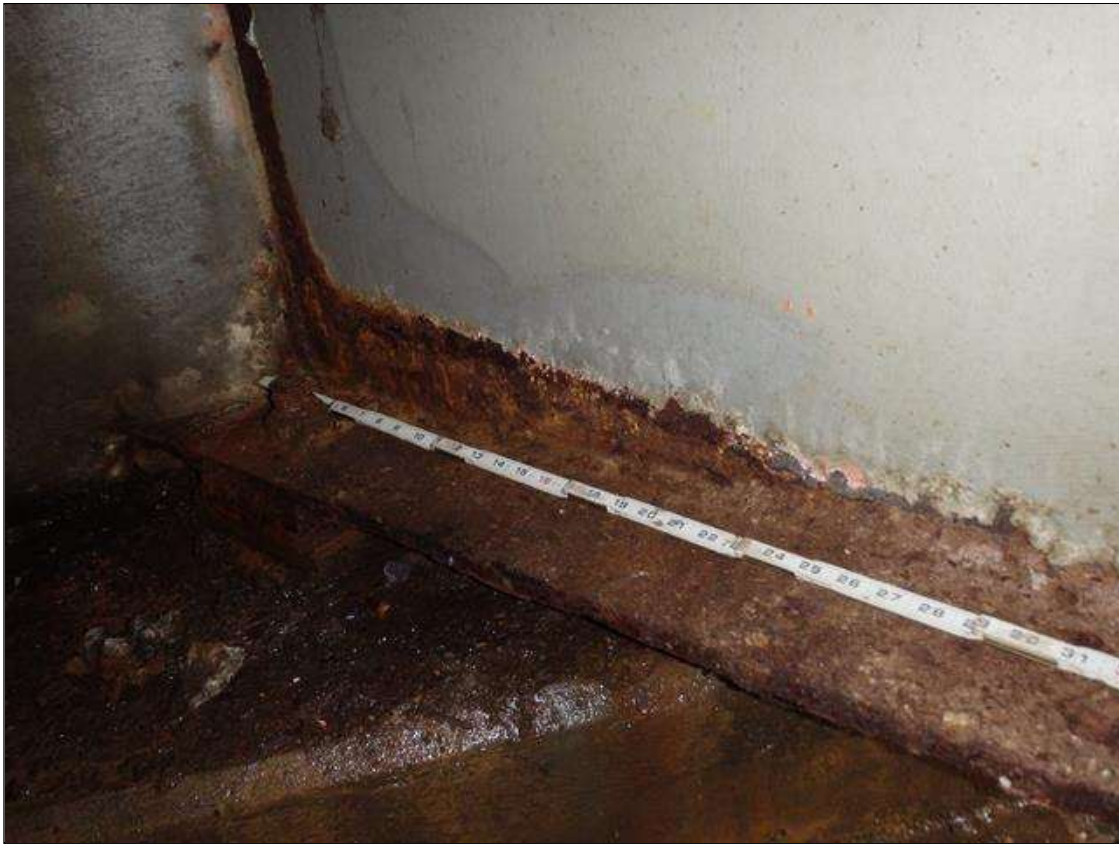
Span 1 Beam 1: SPAN 1 BEAM 1 AT END BENT 1 HAS SECTION LOSS ON THE BOTTOM FLANGES FROM THE BEAM END OUT 3 FT. X FULL WIDTH WITH 3/4" REMAINING AND SECTION LOSS IN THE LOWER WEB FROM THE BEAM END OUT 2 FT. X 4" HIGH WITH 11/16" REMAINING

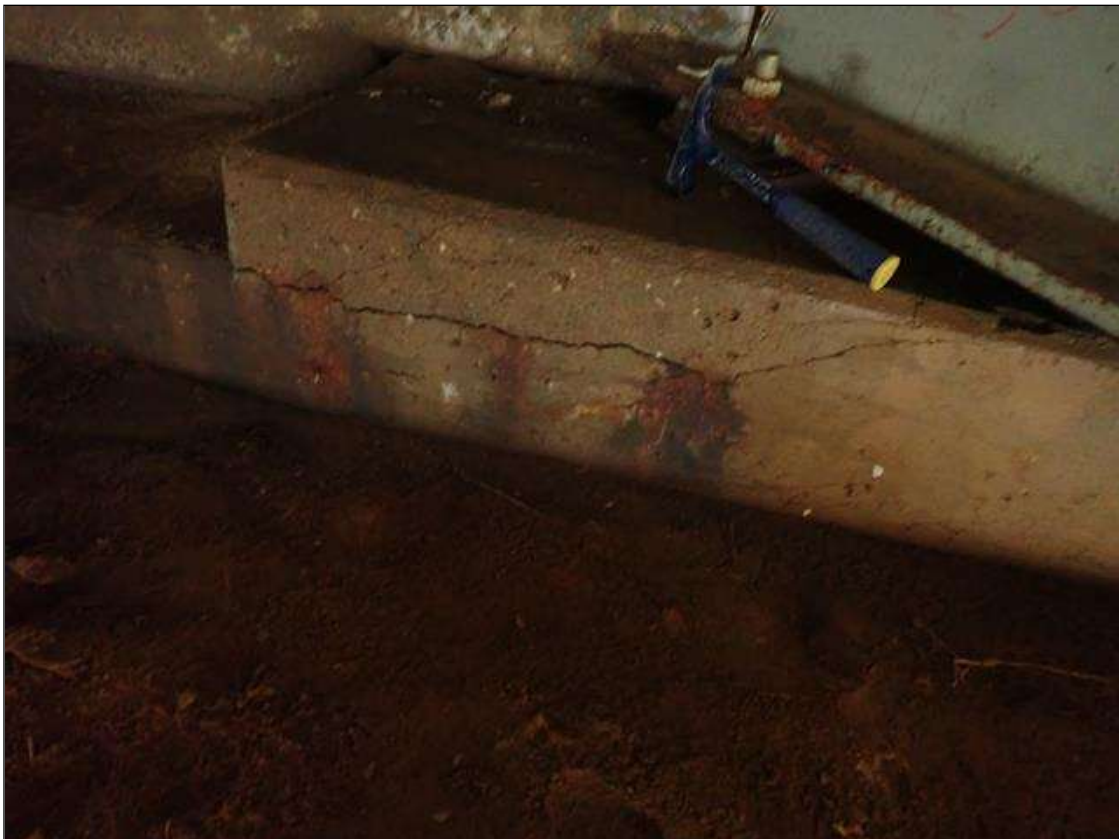
Span 1 Beam 1: PROTECTIVE COATING HAS STARTED TO FAIL DUE TO RUST

End Bent 2 Cap 1: DELAMINATION, 3 FT X FULL HEIGHT X 6" ON FACE OF CAP UNDER BAY 1 AT GIRDER 2, SIMILAR IN BAY 4

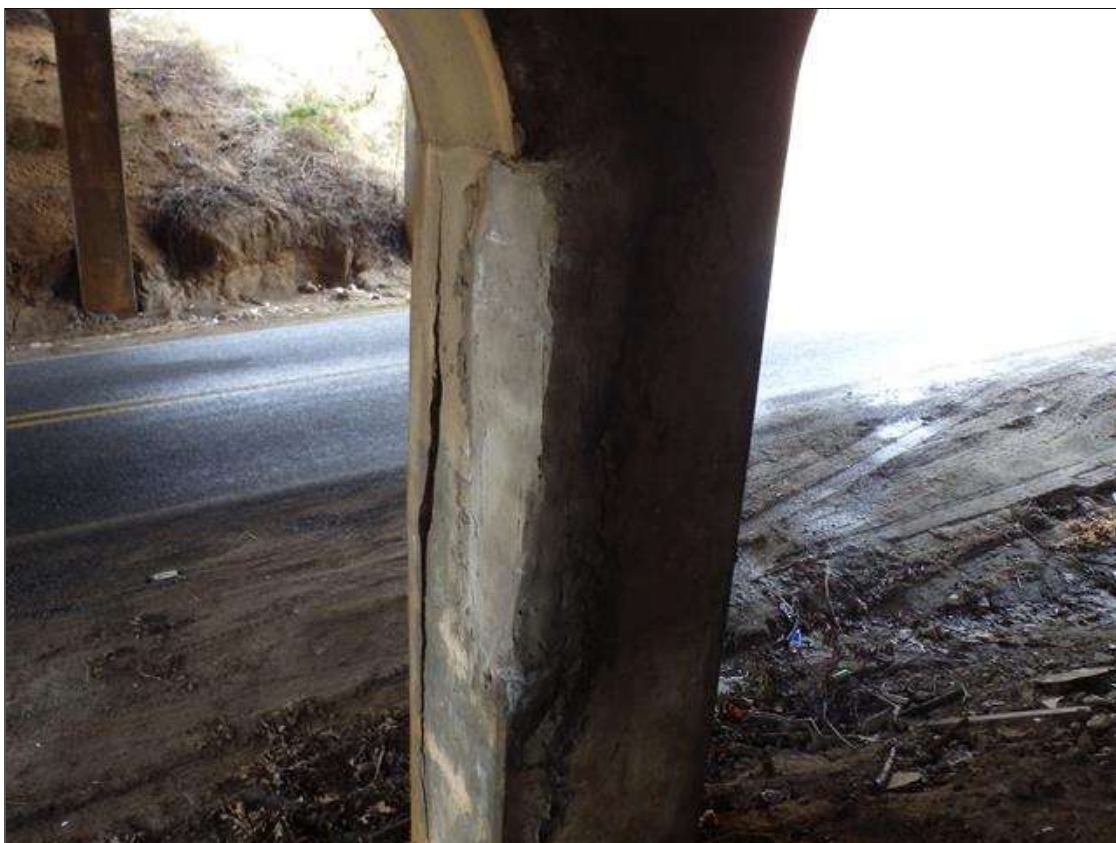
Bent 1 Pile 5: DELAMINATION, 2 FT X 4" X 2 FT ON SOUTHWEST CORNER WITH TWO VERTICAL CRACKS UP TO 1/16" WIDE ON NORTH AND WEST FACES

Bent 1 Pile 3: UNSOUND PATCH, 5 FT X 1 FT X 1 FT ON NORTHWEST CORNER AT TOP THAT IS DELAMINATED

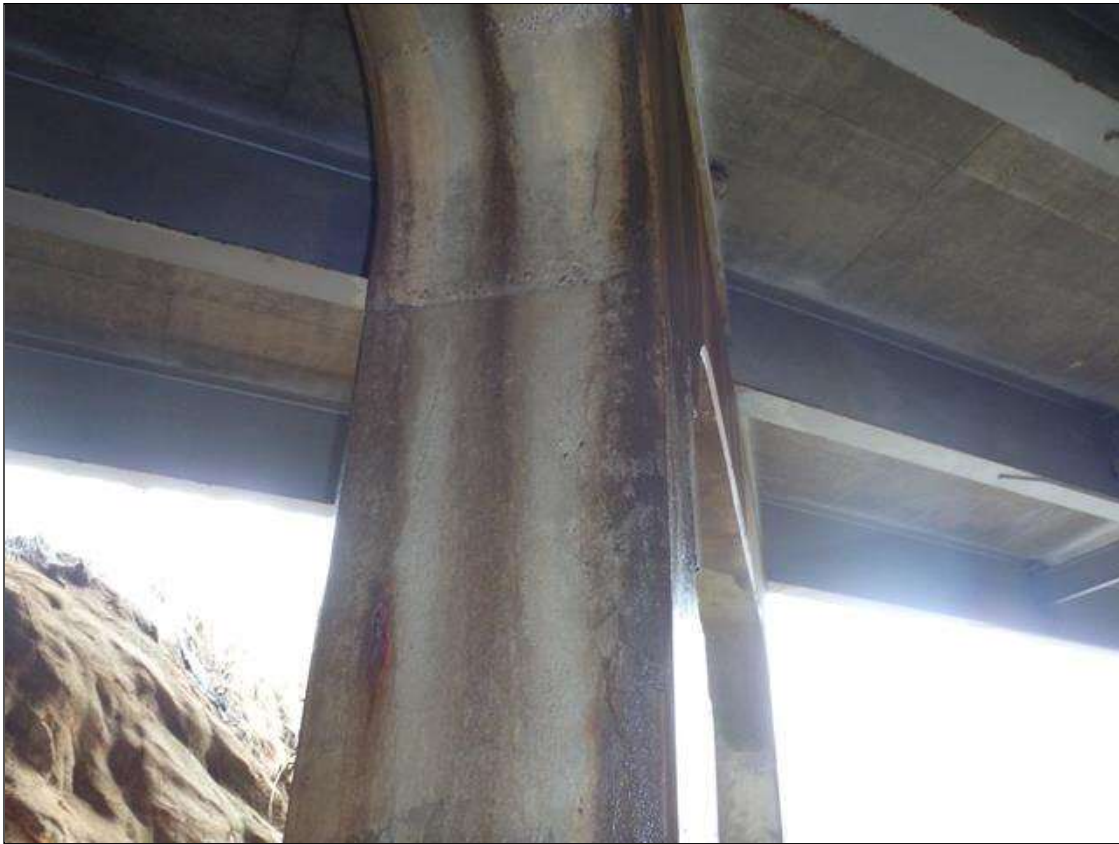
Bent 1 Pile 2: DELAMINATIONS, 2 FT X 4" X 6" ON SOUTHEAST AND SOUTHWEST CORNERS

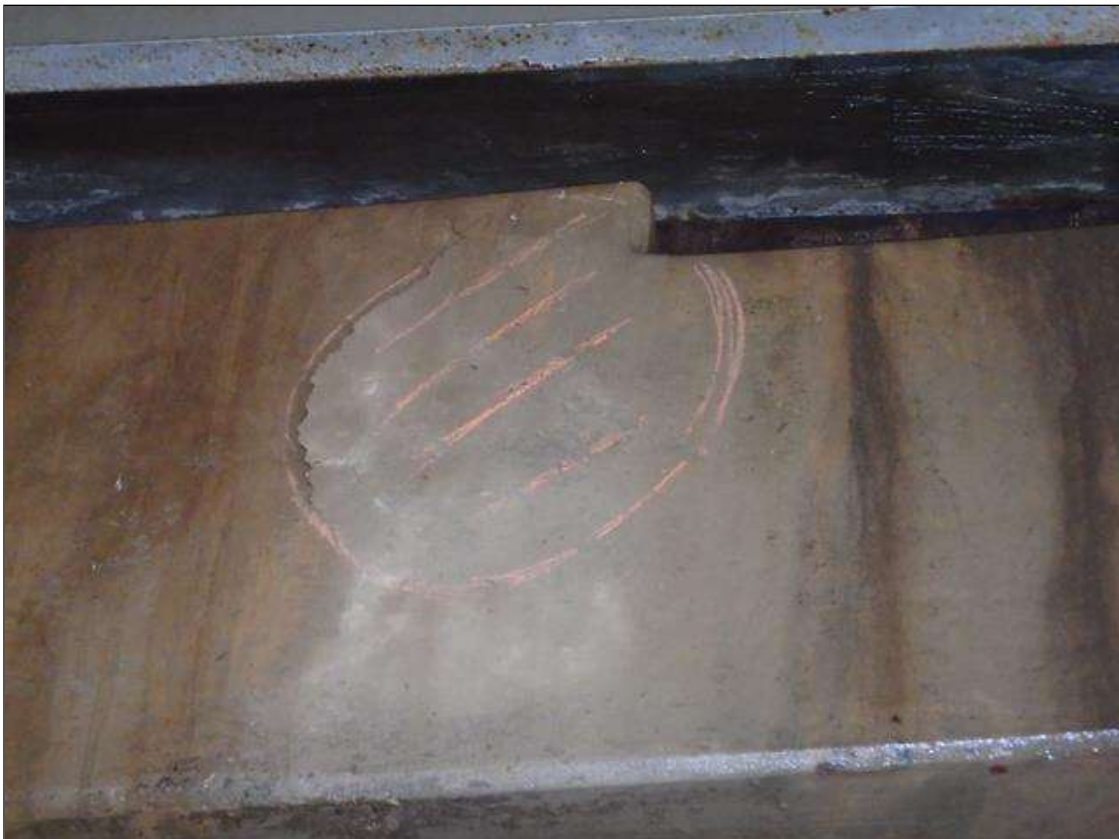
Bent 1 Pile 1: DELAMINATION, 1.5 FT X 1.5 FT ON WEST FACE MIDHEIGHT OF COLUMN. PAR

Bent 1 Cap 1: DELAMINATION, 3 FT DIAMETER ON EAST FACE OF CAP BELOW BAY 3

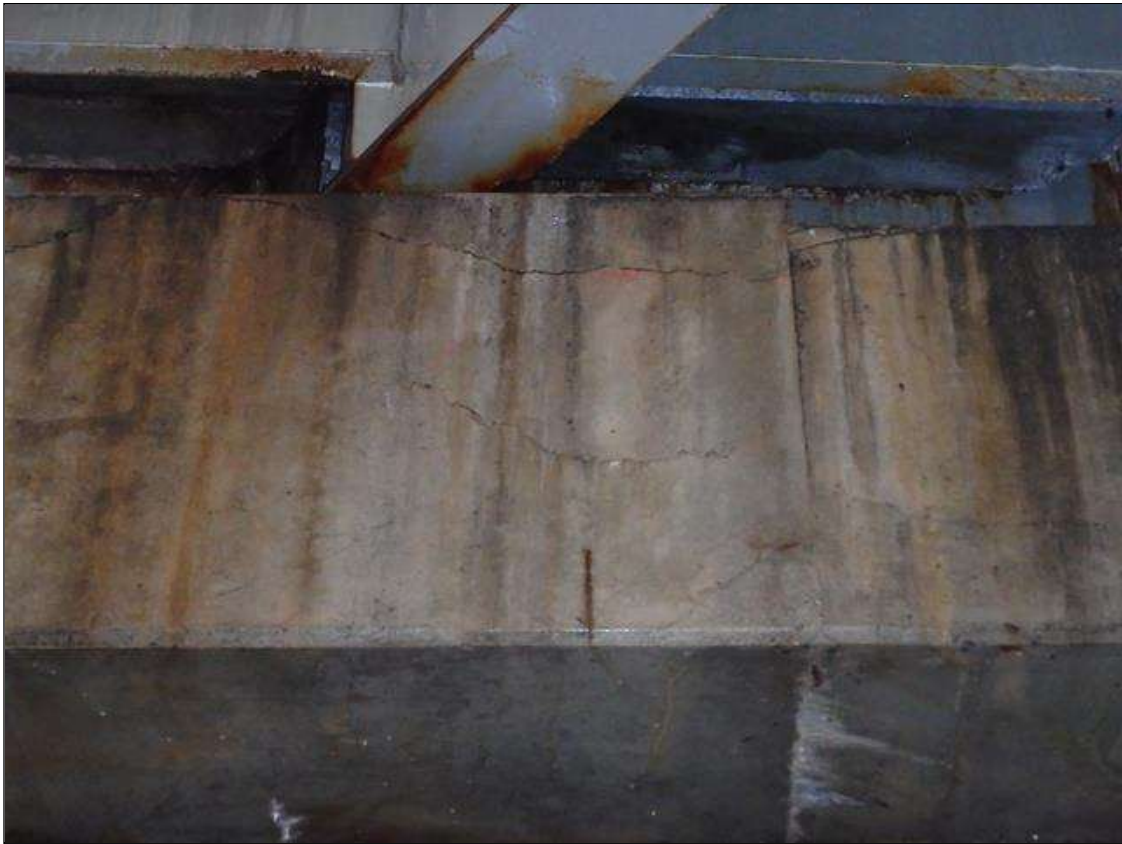
Bent 1 Cap 1: THREE DELAMINATIONS, UP TO 6 FT X 18" ON EAST FACE BELOW GIRDER 6

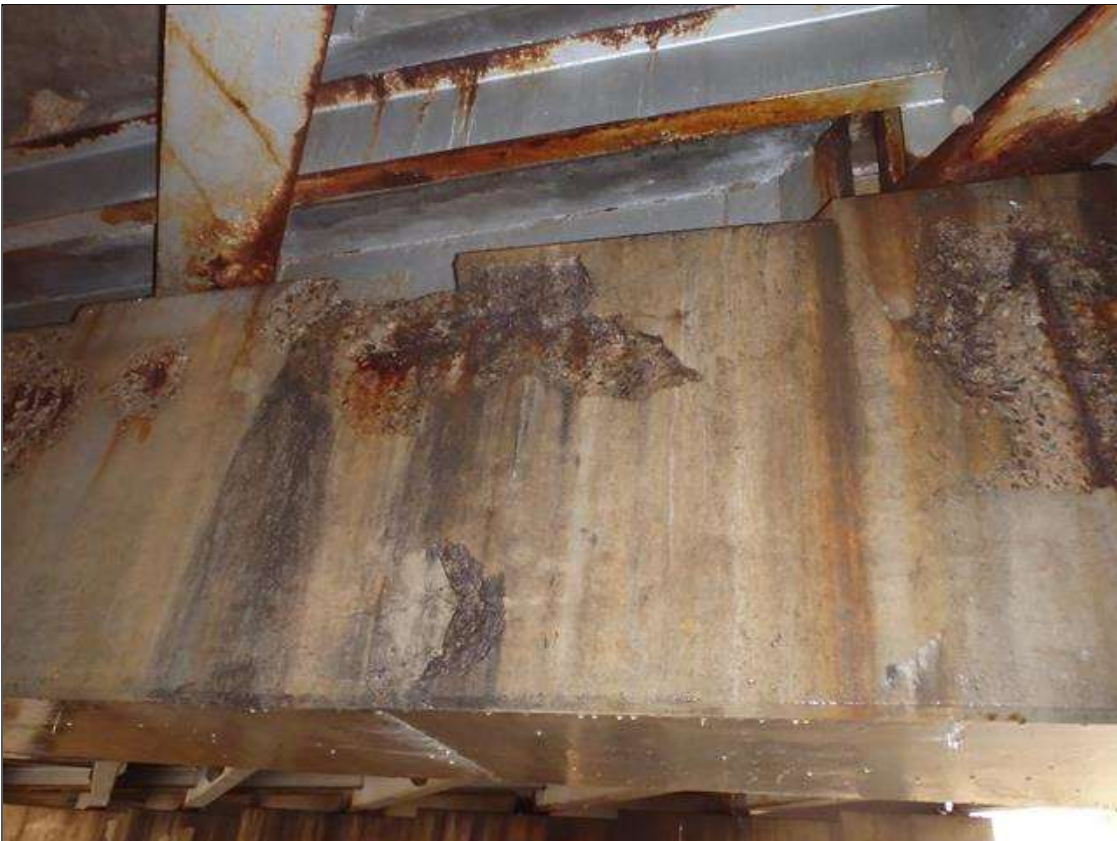
Bent 1 Cap 1: SPALL, 4 FT X 2 FT X 2.5" DEEP ON WEST FACE UNDER GIRDER 3 WITH EXPOSED REBAR, NO SECTION LOSS

Bent 1 Cap 1: SPALL, 4 FT X 2 FT X 3" DEEP ON WEST FACE OF CAP BELOW GIRDER 5 AT TOP WITH EXPOSED REBAR, NO MEASUREABLE SECTION LOSS

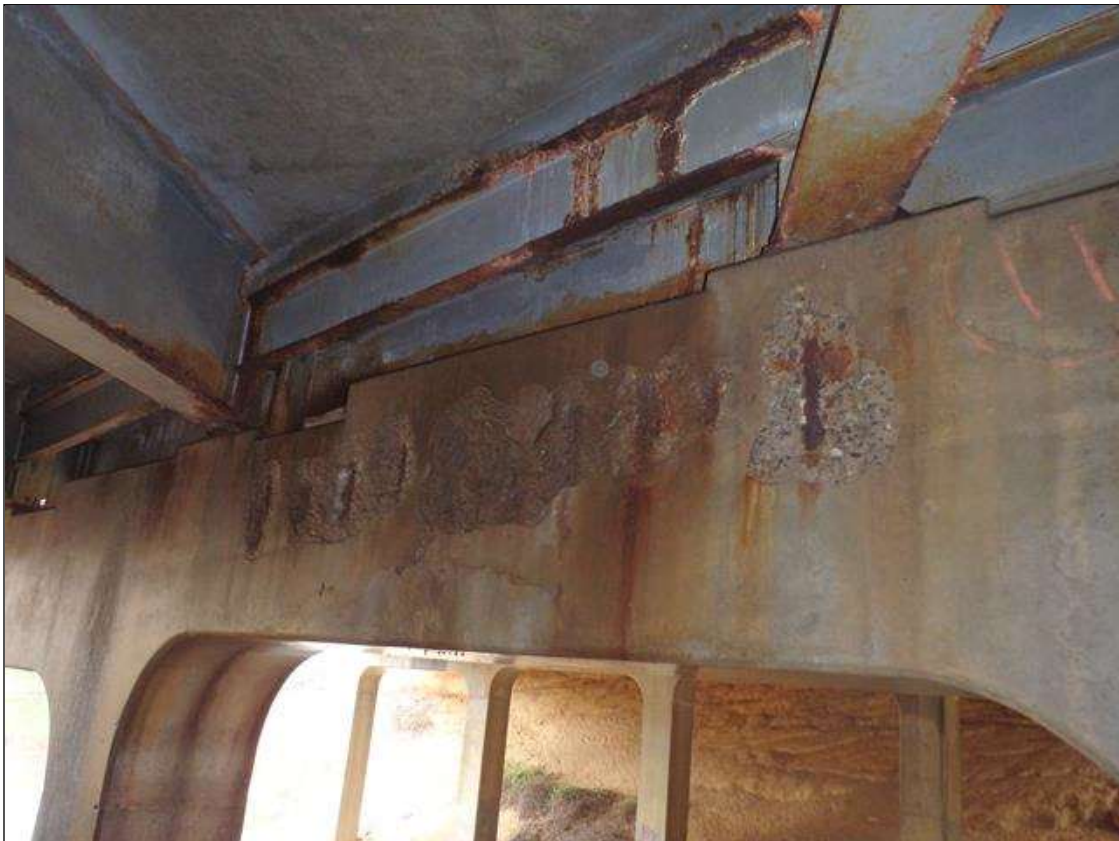
Bent 1 Cap 1: 2 SPALLS, 1 FT DIAMETER X 1/2" DEEP AND 2 FT DIAMETER X 1" DEEP ON WEST FACE OF CAP BELOW GIRDER 5 AND NO MEASUREABLE SECTION LOSS

Bent 1 Cap 1: SPALL, FULL WIDTH X 2 FT HIGH X 2" DEEP ON WEST FACE OF CAP BELOW BAY 3 WITH EXPOSED REBAR, NO SECTION LOSS

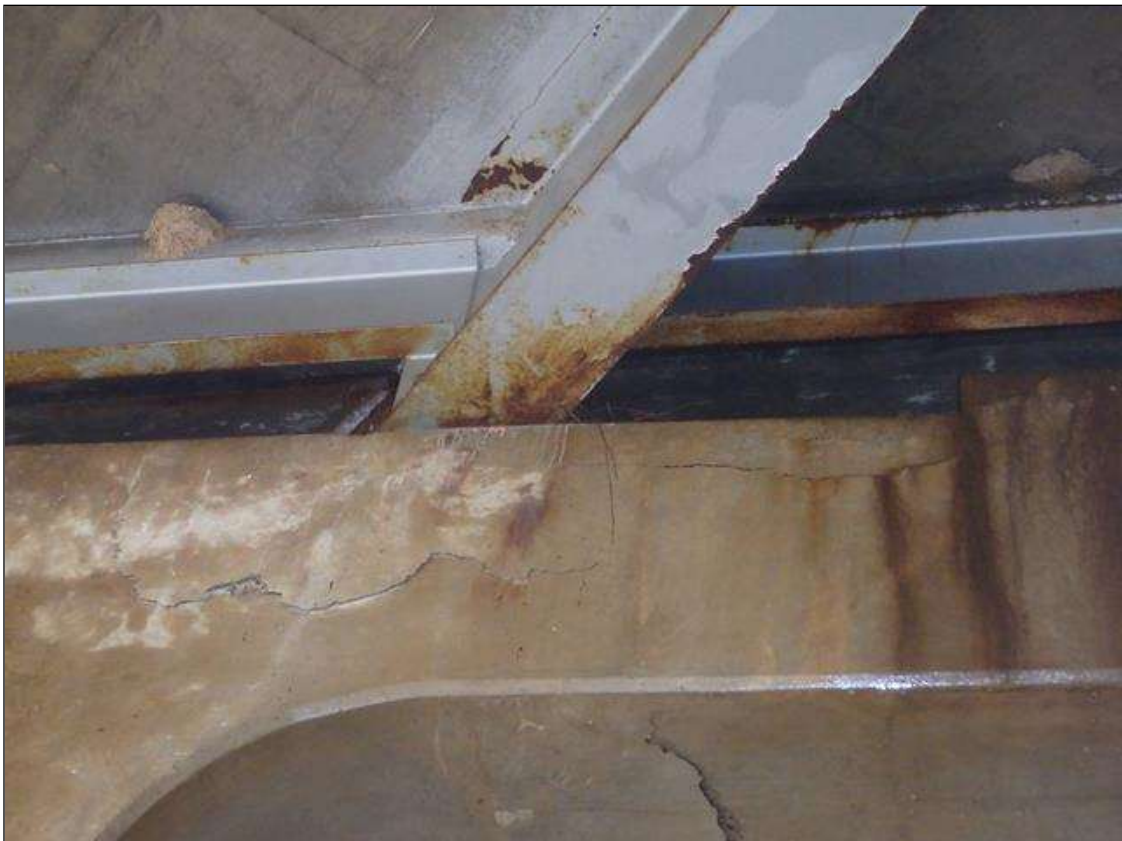
Bent 2 Cap 1: THREE DELAMINATIONS, UP TO 2 FT X 18" ON WEST FACE OF CAP BELOW GIRDER 6

Bent 2 Cap 1: DELAMINATION, 15 FT X 2 FT HIGH ON WEST FACE BELOW GIRDER 3

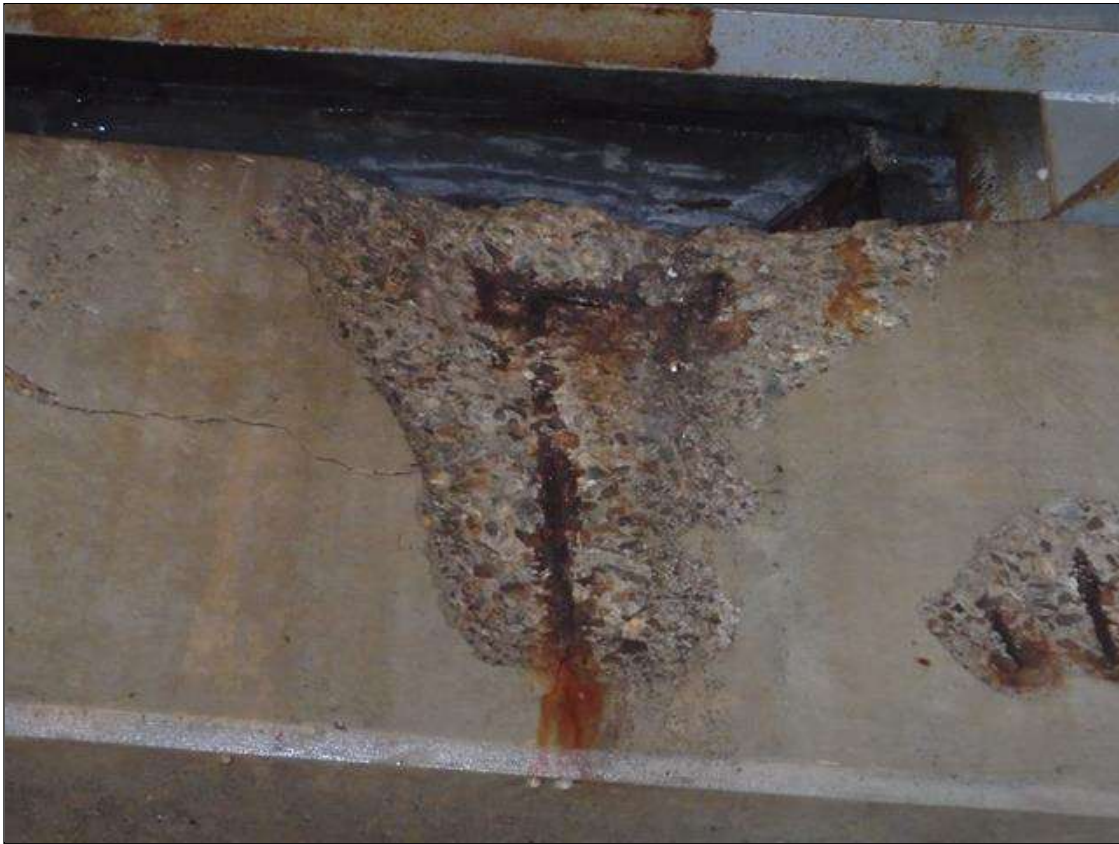
Bent 2 Cap 1: DELAMINATION, 15 FT X 2 FT HIGH ON WEST FACE BELOW GIRDER 3

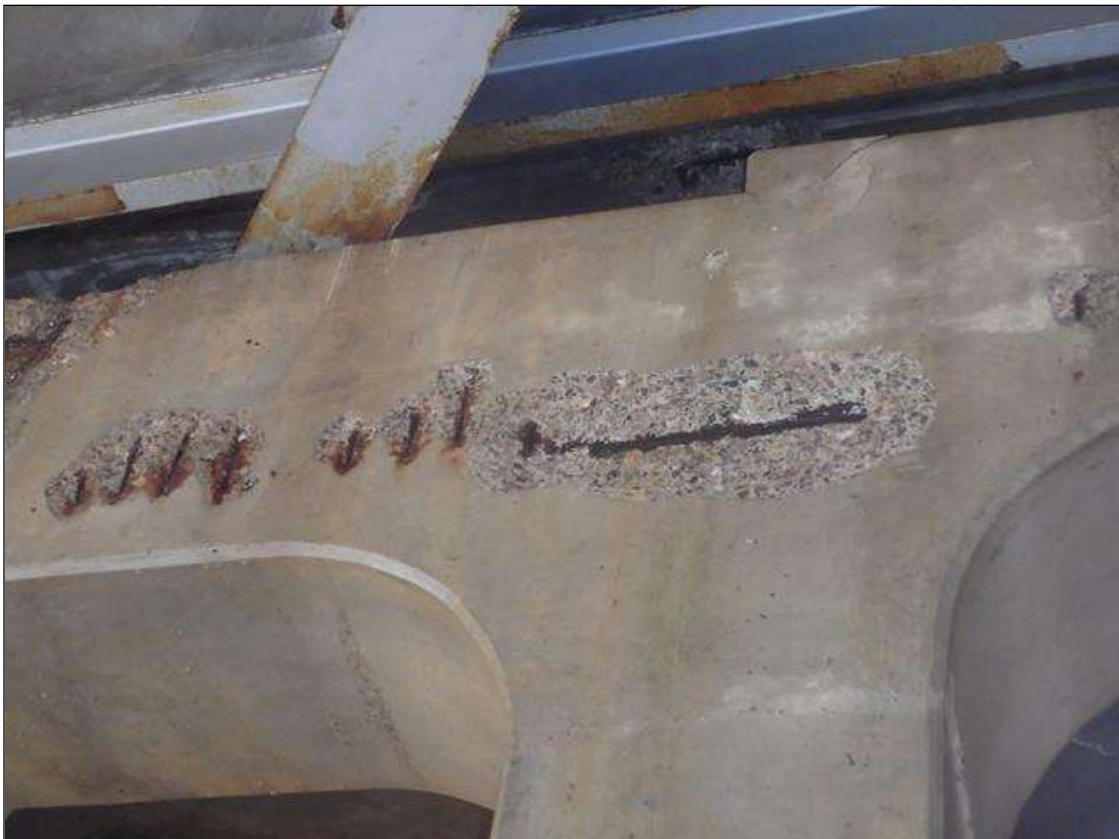
Bent 2 Cap 1: SPALL, 8 FT X 2 FT X 1" DEEP ON WEST FACE OF CAP OVER COLUMN 3 WITH EXPOSED REBAR, NO SECTION LOSS

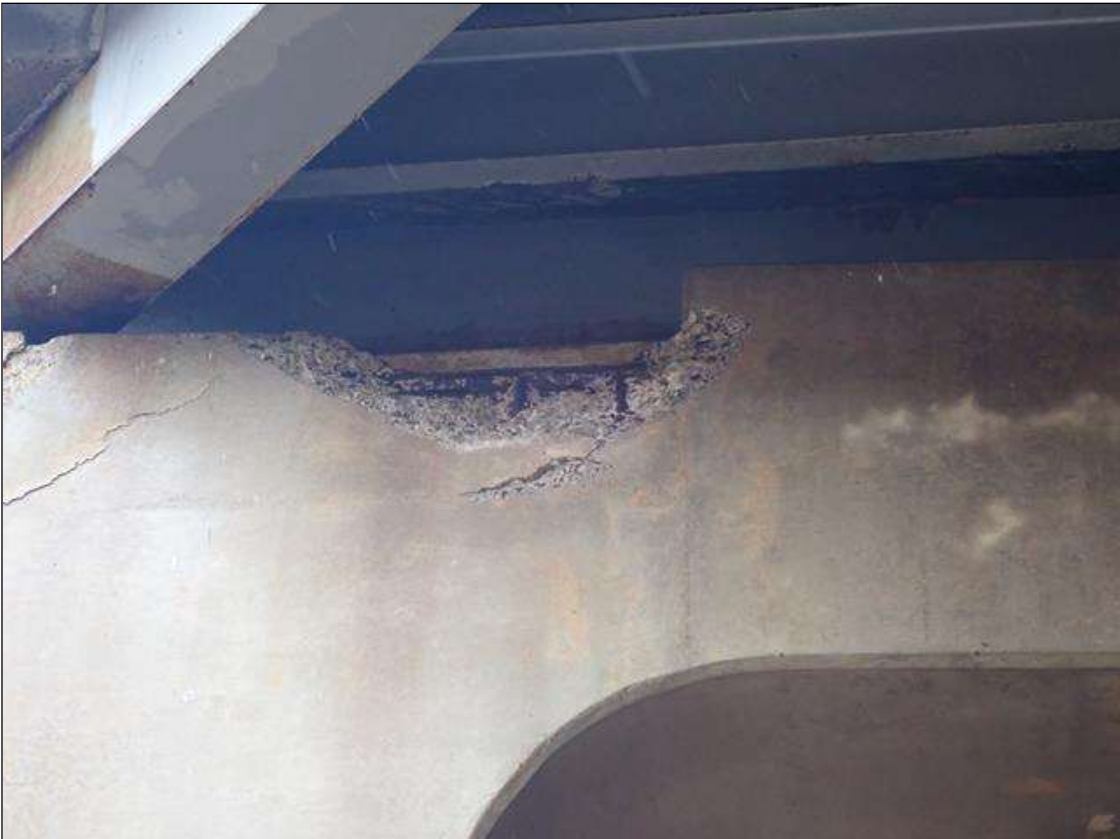
Bent 2 Cap 1: TWO FULL WIDTH HAIRLINE CRACKS IN UNDERSIDE OF CAP BETWEEN COLUMNS 1 AND 2

Bent 2 Cap 1: SPALL, 3 FT X 18" X 1 FT ON WEST FACE OF CAP UNDER BAY 1 WITH EXPOSED REBAR, NO SECTION LOSS. PAR

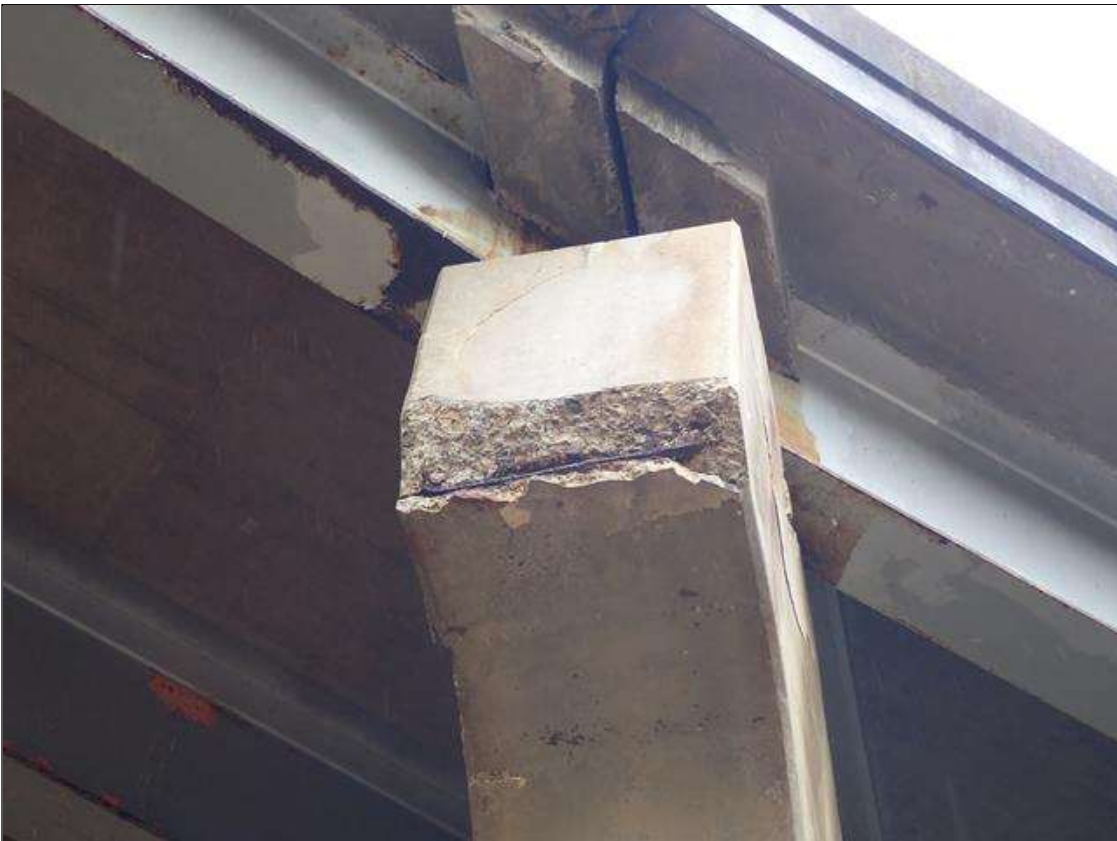
Bent 2 Cap 1: DELAMINATION, 4 FT X 2 FT ON WEST FACE BELOW GIRDER 1 WITH A SPALL, 18" X 1 FT X 2" DEEP WITH EXPOSED REBAR, NO SECTION LOSS

Bent 2 Cap 1: SPALL, FULL WIDTH X 1 FT X 2.5" DEEP ON NORTH END OF CAP WITH EXPOSED REBAR, NO SECTION LOSS

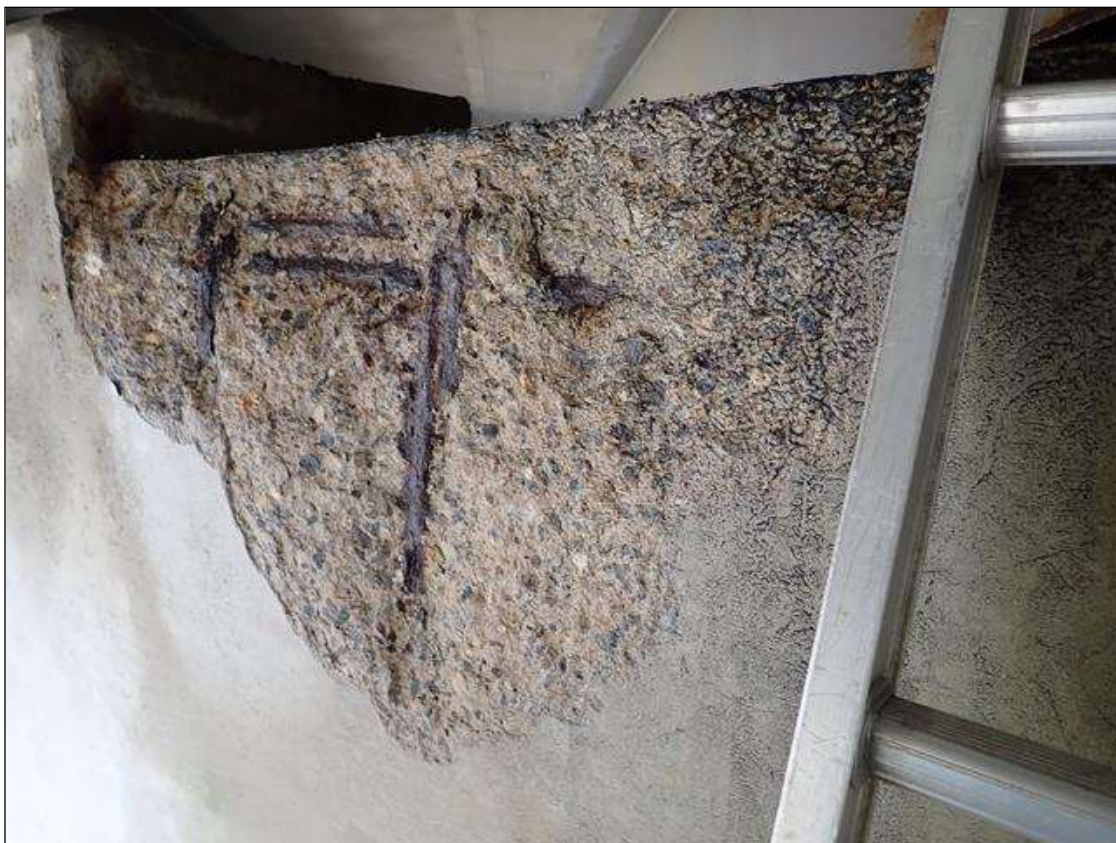
Bent 2 Cap 1: DELAMINATION, 6 FT X 3 FT ON EAST FACE BELOW BAY 3

Bent 1 Cap 1: SPALL, 4 FT X 2.5 FT X 3" DEEP ON EAST FACE BELOW BAY 9 WITH EXPOSED REBAR, NO MEASUREABLE SECTION LOSS. PAR

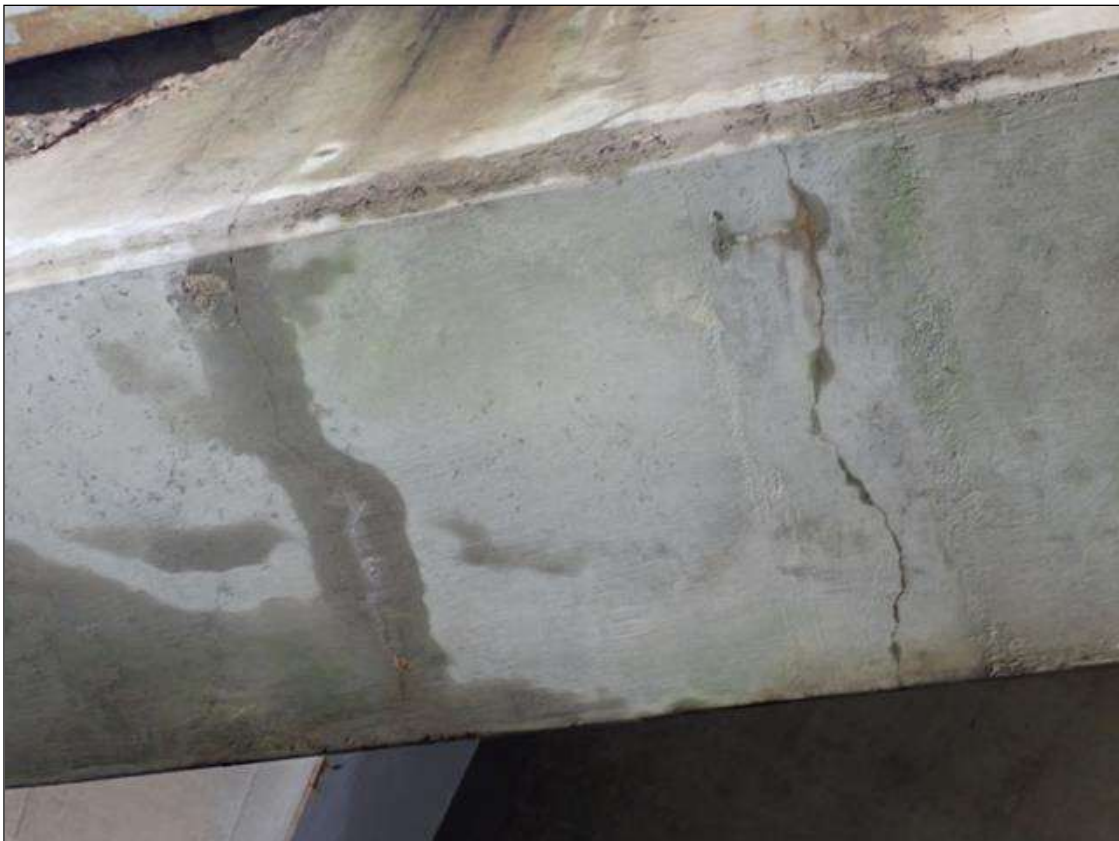
Bent 1 Cap 1: DELAMINATION, 20" X 19" ON EAST FACE UNDER GIRDER 9

Bent 1 Cap 1: FULL WIDTH CRACK ON UNDERSIDE OF CAP UNDER GIRDER 7 UP TO 1/16" WIDE

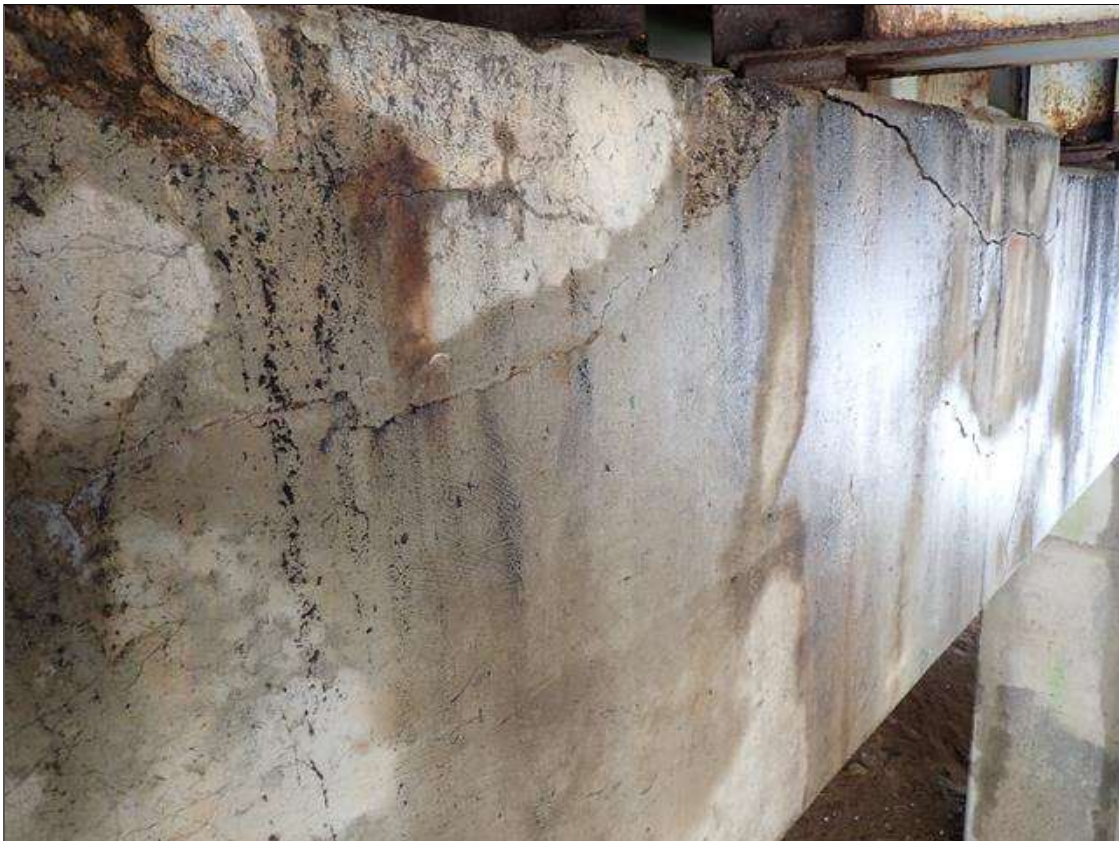
Bent 1 Cap 1: SPALL, 4.5 FT X 20" X 5" ON EAST FACE OF CAP ON UNDER GIRDER 6 WITH EXPOSED REBAR WITH UP TO 5% SECTION LOSS, PM

Bent 1 Cap 1: SPALL AND DELAMINATED AREA, 7 FT X 2 FT X 7" ON EAST FACE OF CAP UNDER GIRDER 6 WITH NO EXPOSED REBAR

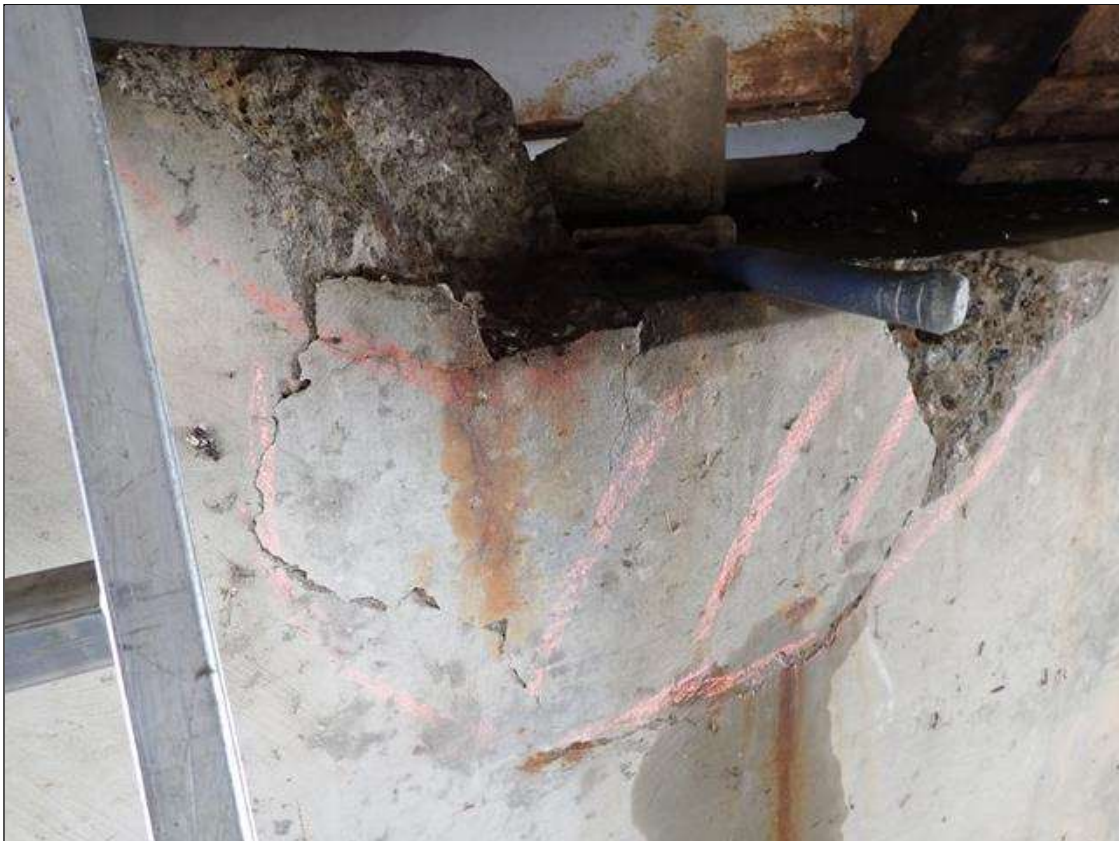
Bent 1 Cap 1: SPALL, 24" X 8" X 6" ON BOTTOM OF EAST FACE OF CAP BELOW GIRDER 5 WITH EXPOSED REBAR, NO SECTION LOSS

Bent 1 Cap 1: SPALLED/DELAMINATED AREA, 24" X 15" X 8" ON EAST FACE UNDER BAY 4 WITH NO EXPOSED REBAR

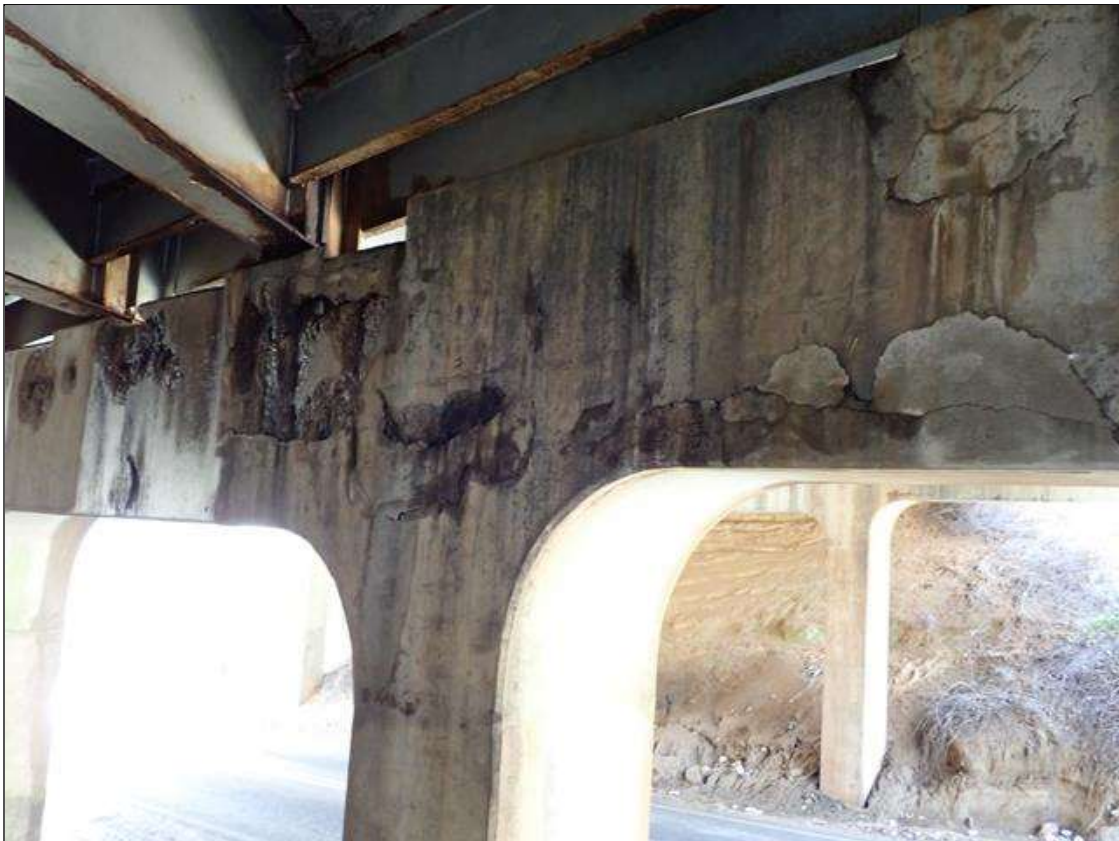
Bent 1 Cap 1: SPALL, 29" X 32" X 2.5" DEEP ON EAST FACE OF CAP UNDER BAY 3 WITH EXPOSED REBAR, NO SECTION LOSS

Bent 1 Cap 1: SPALL AND DELAMINATED AREA, 21 FT X FULL HEIGHT OF CAP X 3" DEEP ON WEST FACE OF CAP UNDER BAYS 5 AND 6 WITH EXPOSED REBAR, NO SECTION LOSS
