NC DEPARTMENT OF TRANSPORTATION  
DIVISION OF HIGHWAYS  
STRUCTURE MANAGEMENT UNIT

## Structure Safety Report

### Routine Element Inspection - Contract

DIVISION: 14 COUNTY: HAYWOOD STRUCTURE NUMBER: 430159 FREQUENCY: 24 MONTHS

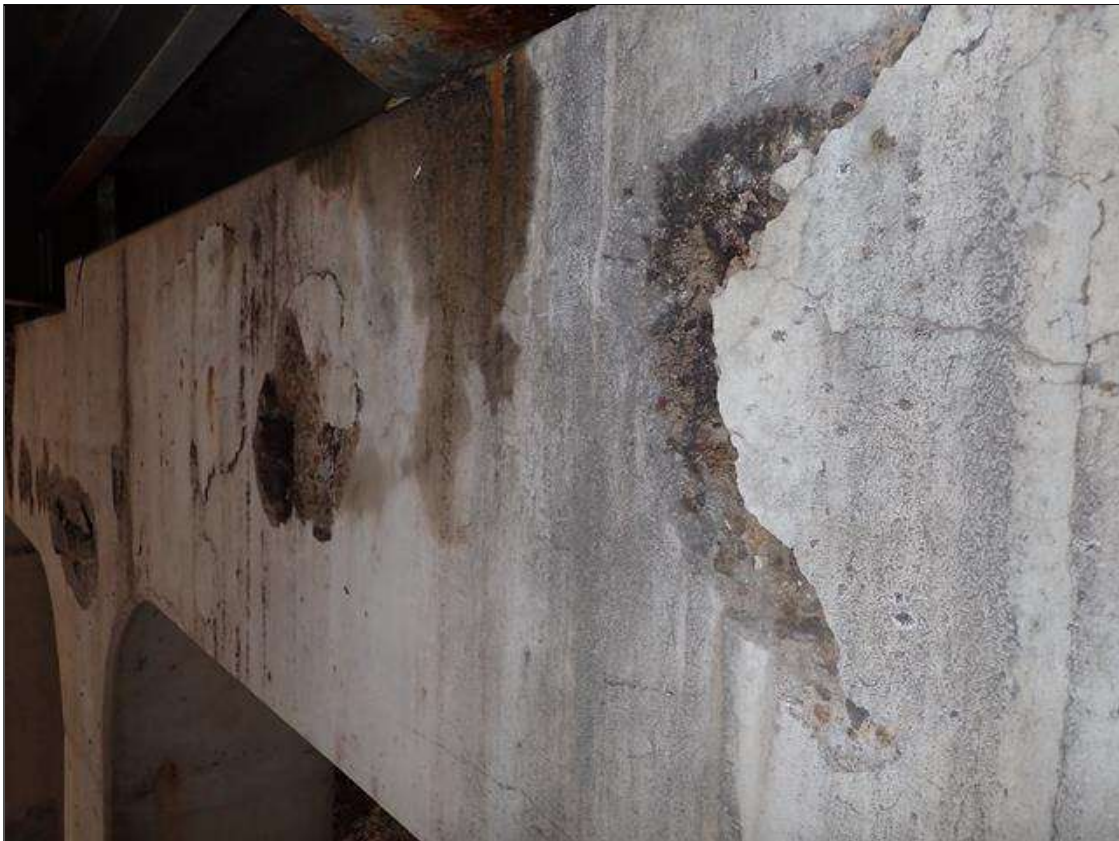
Bent 2 Cap 1: SPALL, FULL HEIGHT X 9 FT X 2" DEEP, ON SPAN 3 SIDE OF CAP UNDER BEAM 1 AND BAY 1 WITH EXPOSED MAIN REINFORCING AND SHEAR REINFORCING WITH SECTION LOSS UP TO 25%, PM

Bent 2 Cap 1: SPALL/DELAMINATED AREA, 4 FT X 2 FT X UP TO 2" DEEP ON WEST FACE OF CAP UNDER BAY 3 WITH EXPOSED REBAR, NO SECTION LOSS

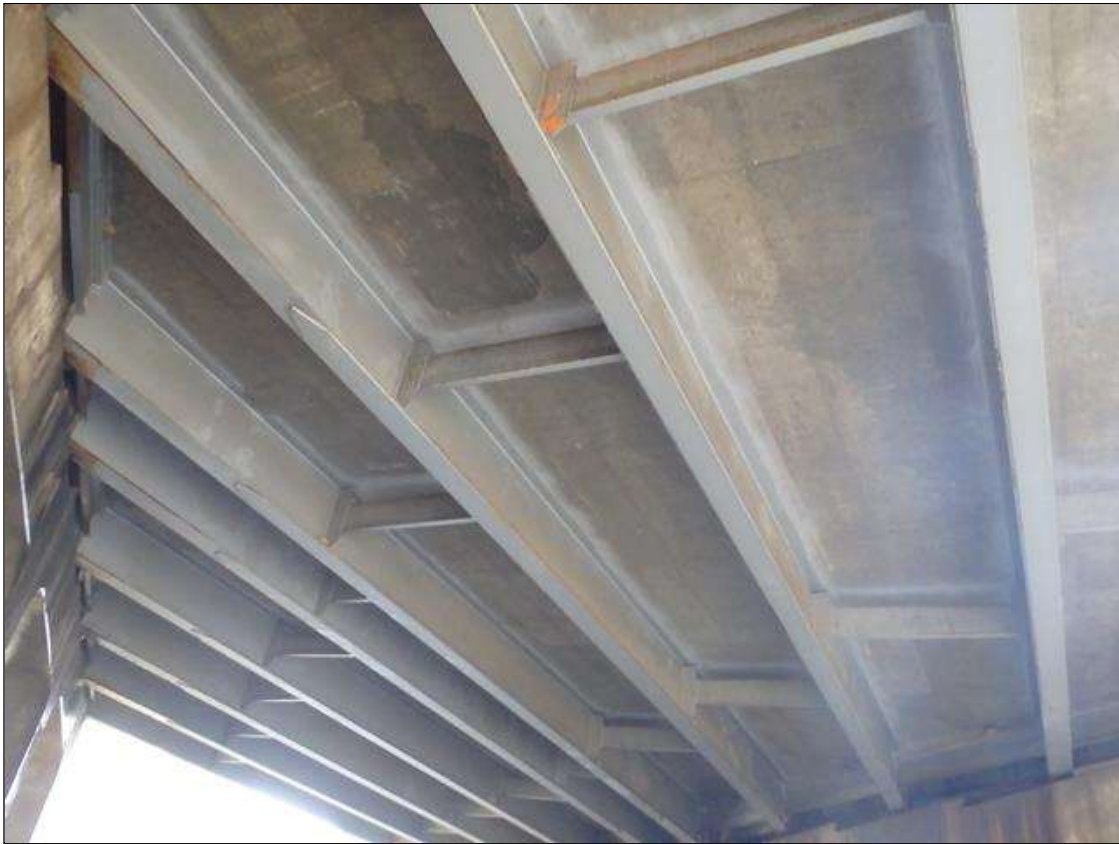
UNDERSIDE OF SUPERSTRUCTURE SPAN 2, OTHERS SIMILAR

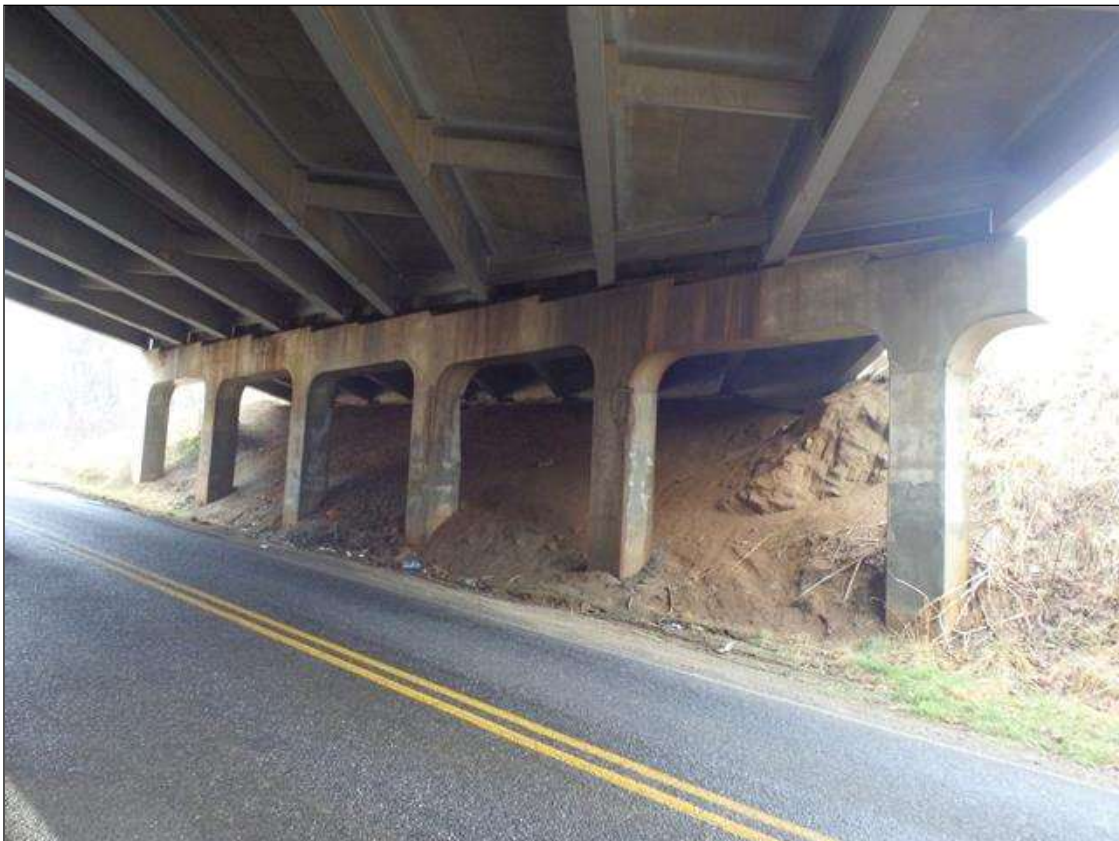
BENT 1, BENT 2 SIMILAR

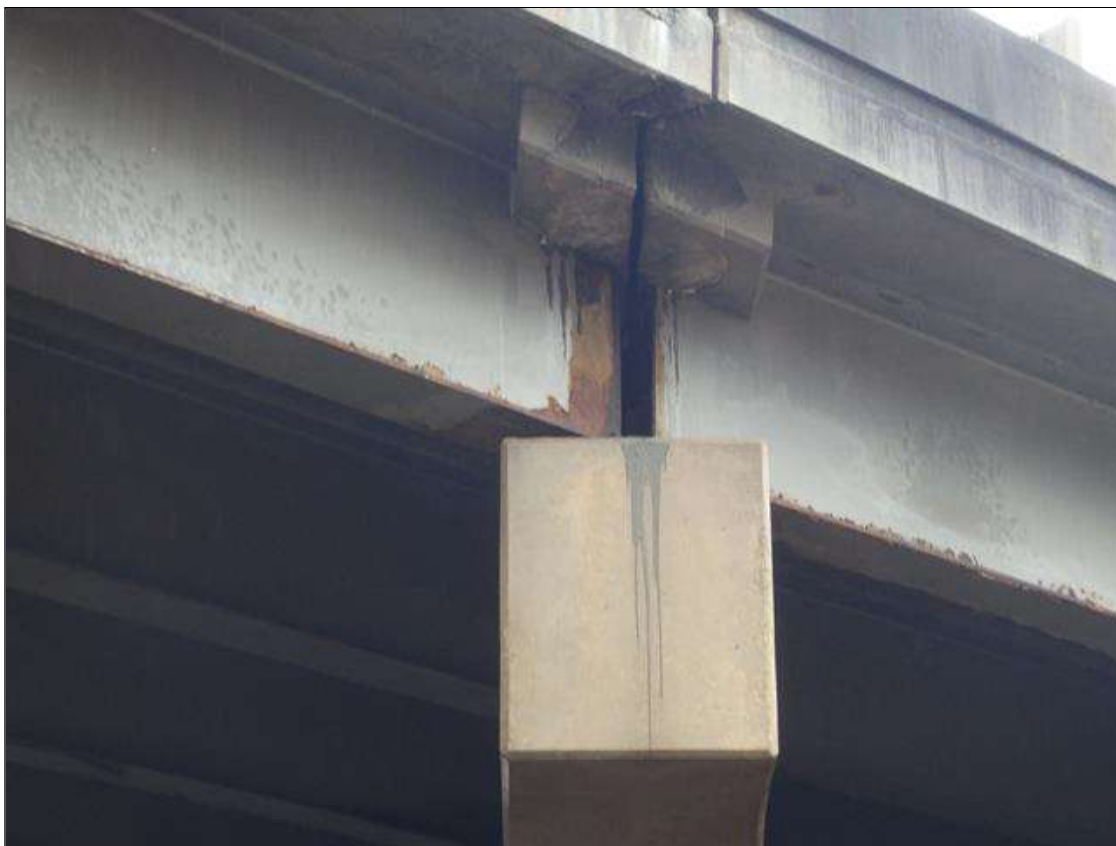
NORTH FACE OF BENT 1 CAP, BENT 2 SIMILAR

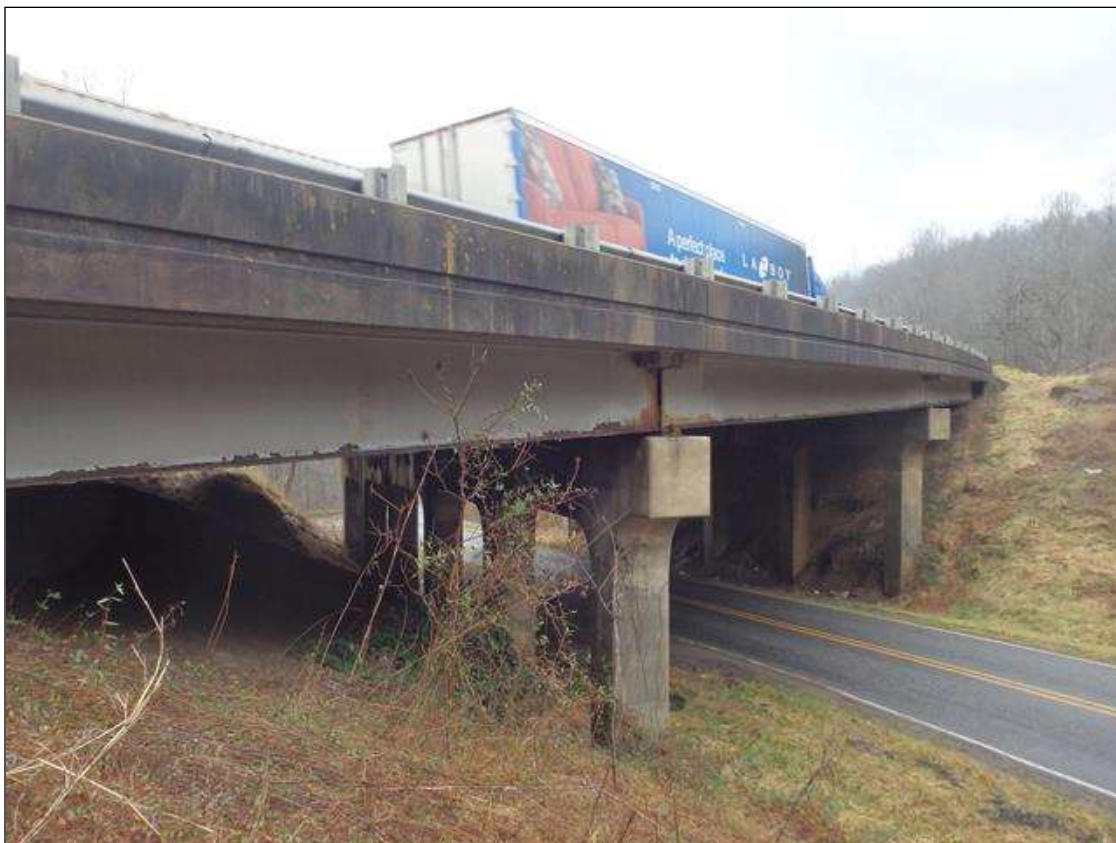
SOUTH PROFILE

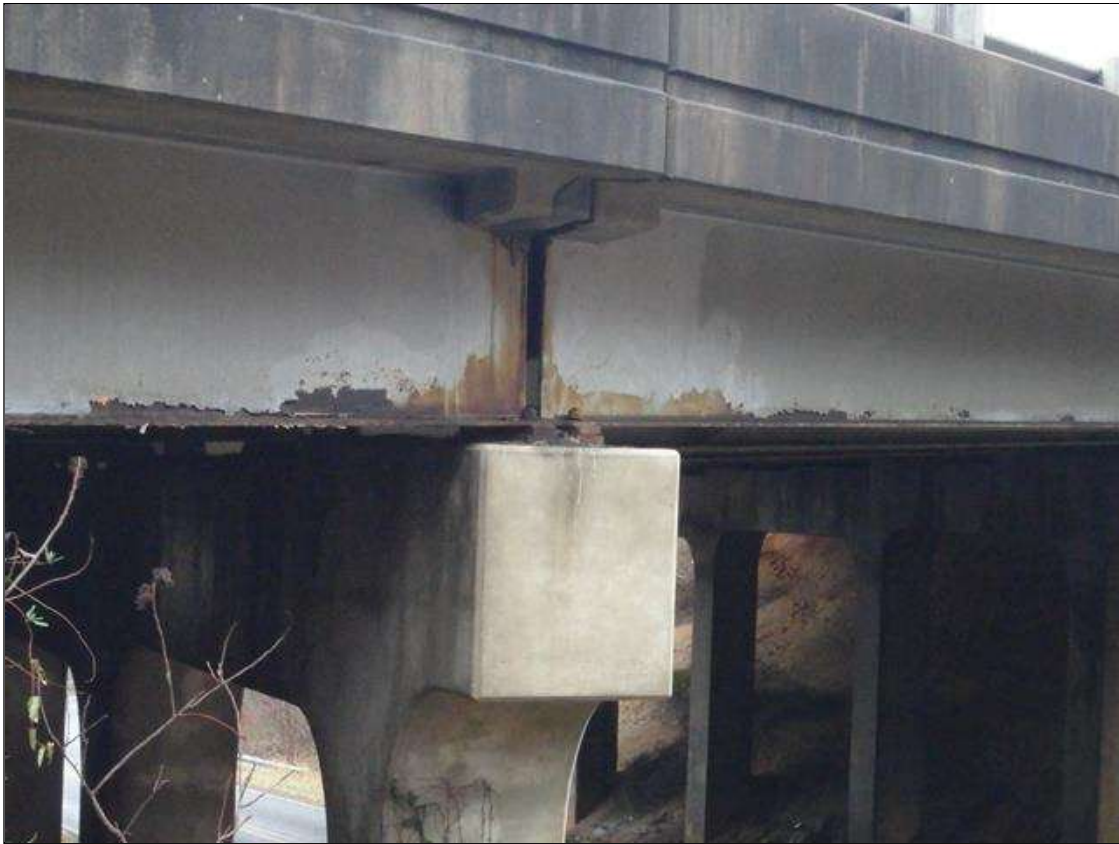
SOUTH FACE OF BENT 1 CAP

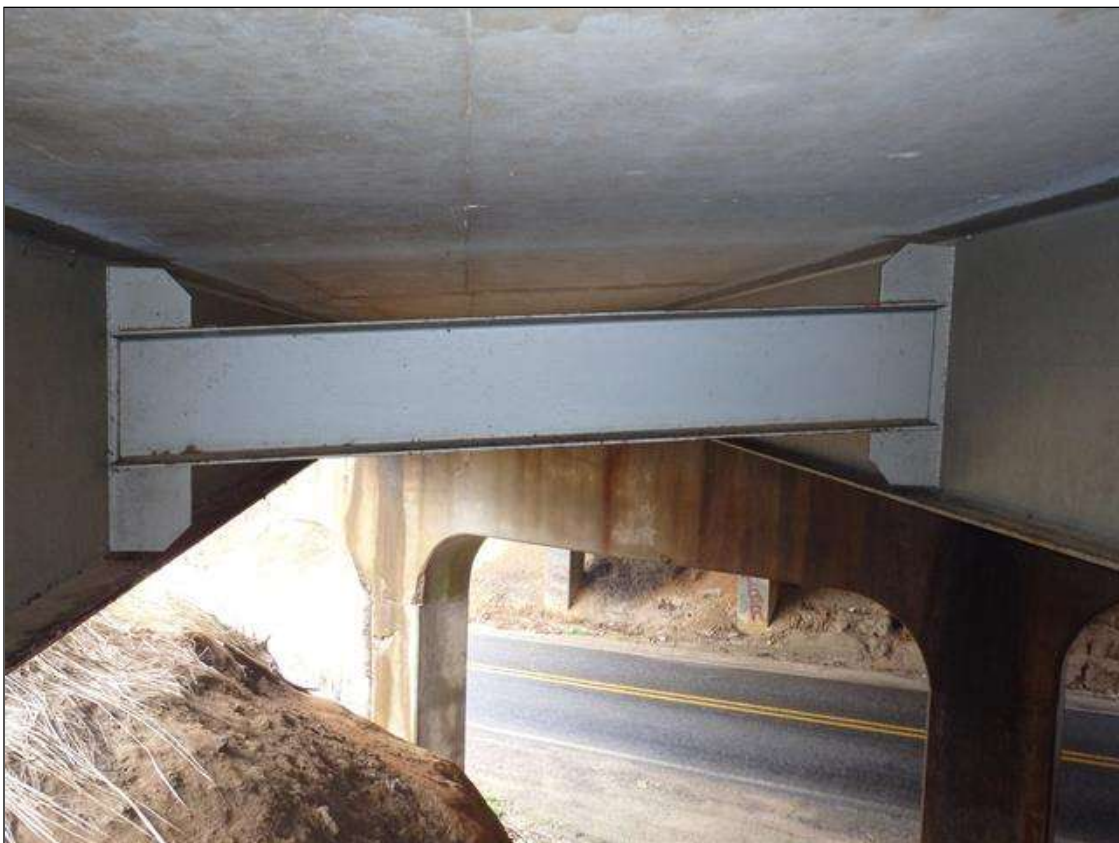
TYPICAL INTERMEDIATE DIAPHRAGM

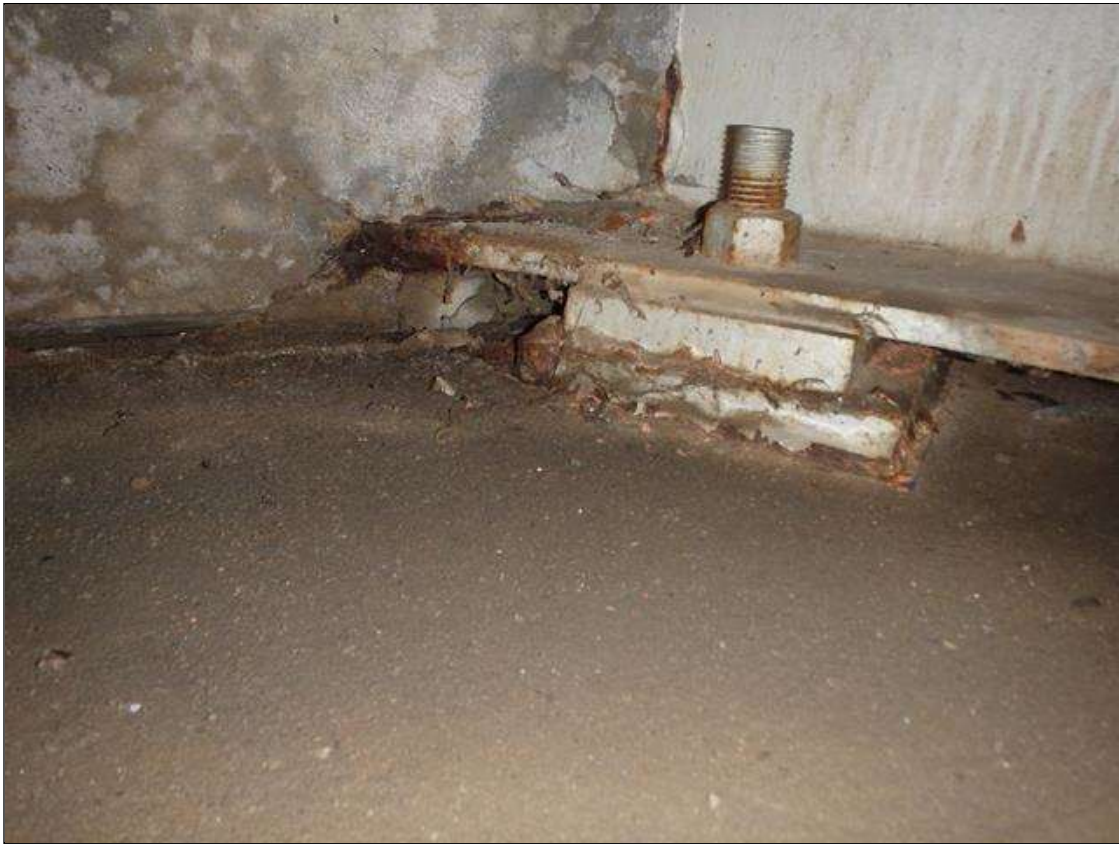
GIRDER 7 BEARING AT END BENT 1, OTHERS AT END BENTS SIMILAR

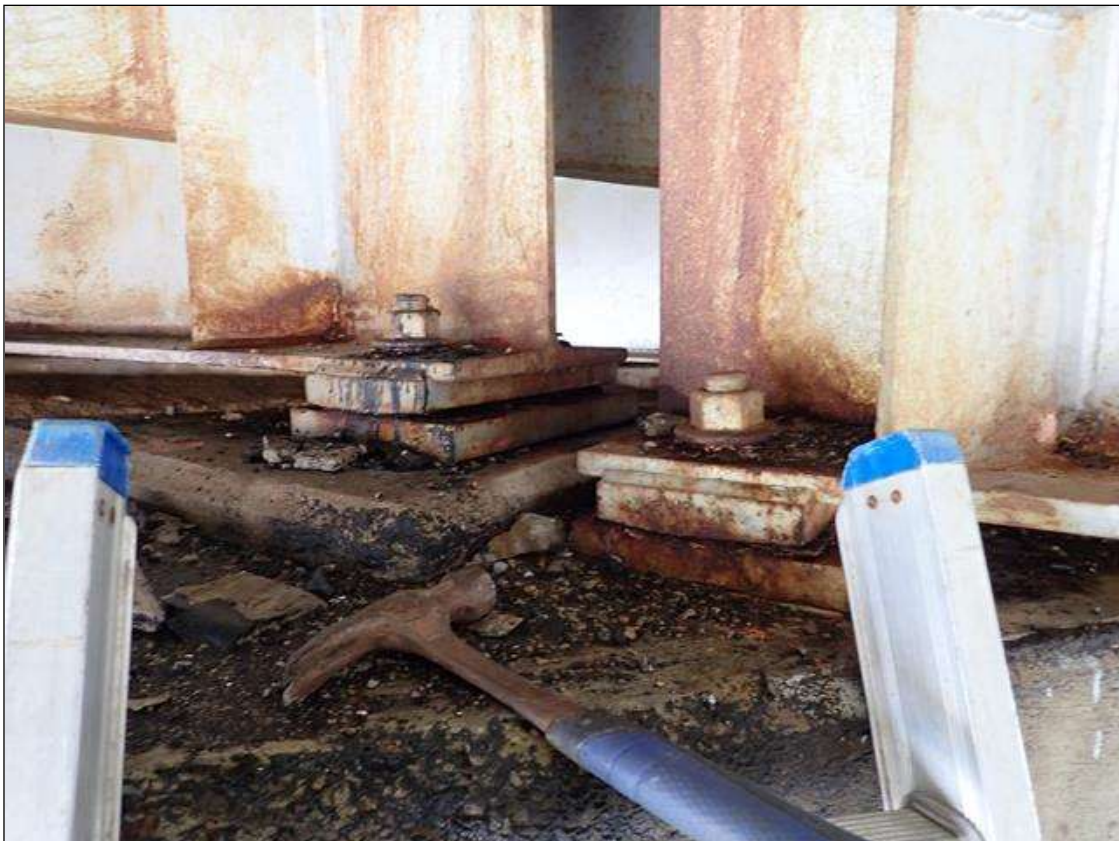
TYPICAL BENT BEARING
