## Structure Safety Report

### Routine Element Inspection - Contract

COUNTY: HAYWOOD STRUCTURE NUMBER: 430142 FREQUENCY: 24 MONTHS

FEATURE INTERSECTED: PIGEON RIVER

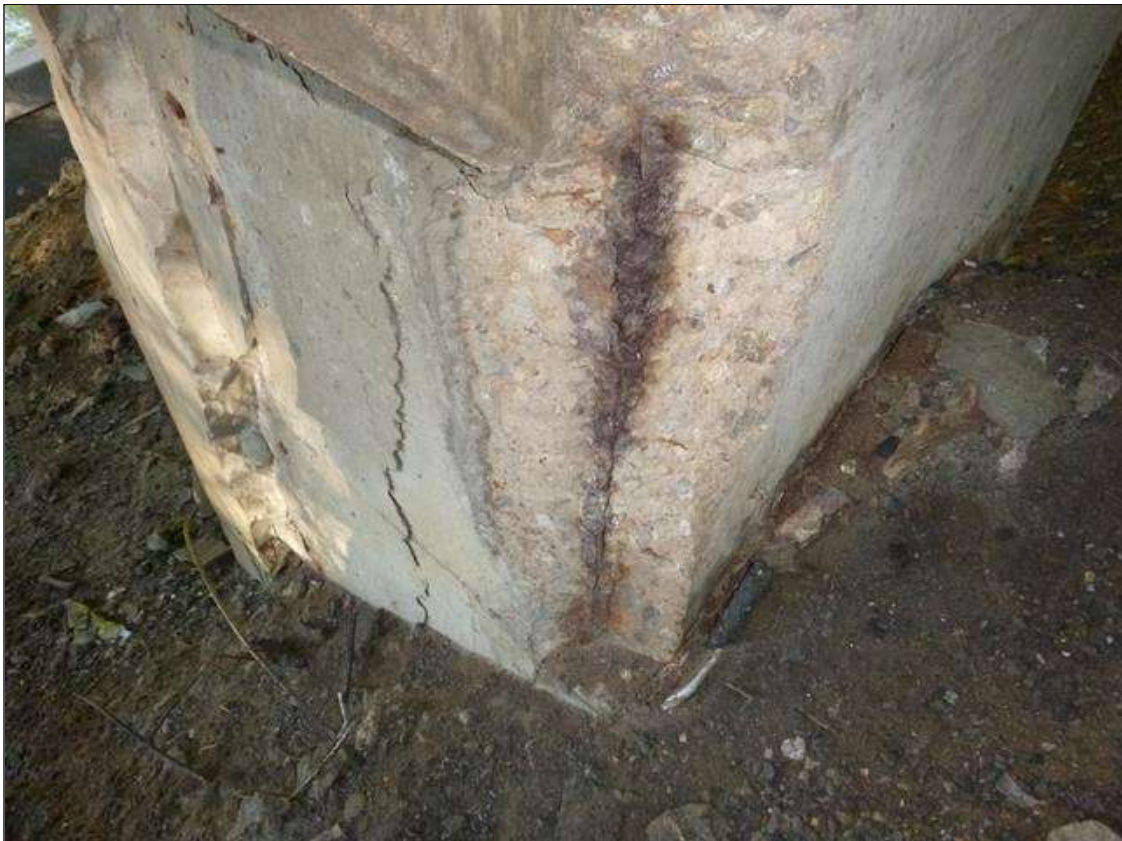
Bent 1 Cap 1: BENT 1 CAP, SPAN 2 SIDE HAS A SPALL, UNDER BEAM 1, 10 INCHES X 30 INCHES X 3 INCHES DEEP WITH EXPOSED REBAR

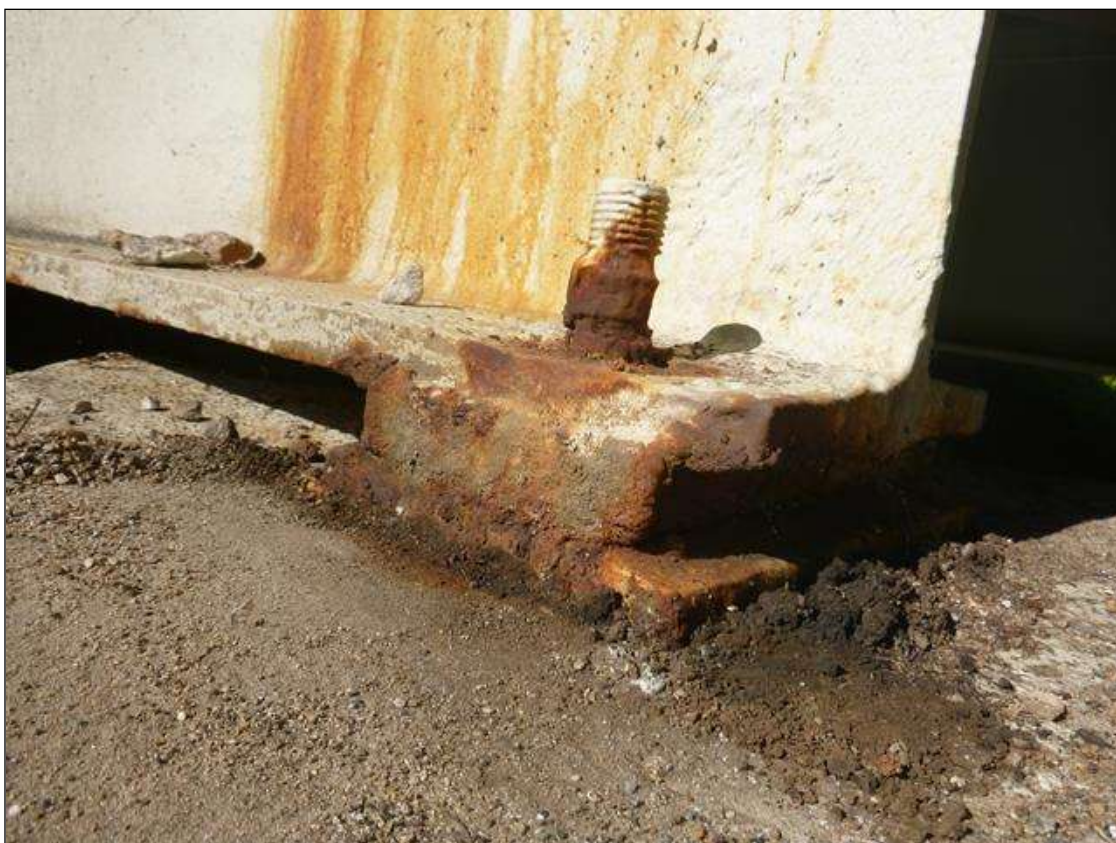
Span 4 Beam 1 Far Bearing: SPAN 4, BEAM 1 FAR BEARING HAS FRECKLED RUST

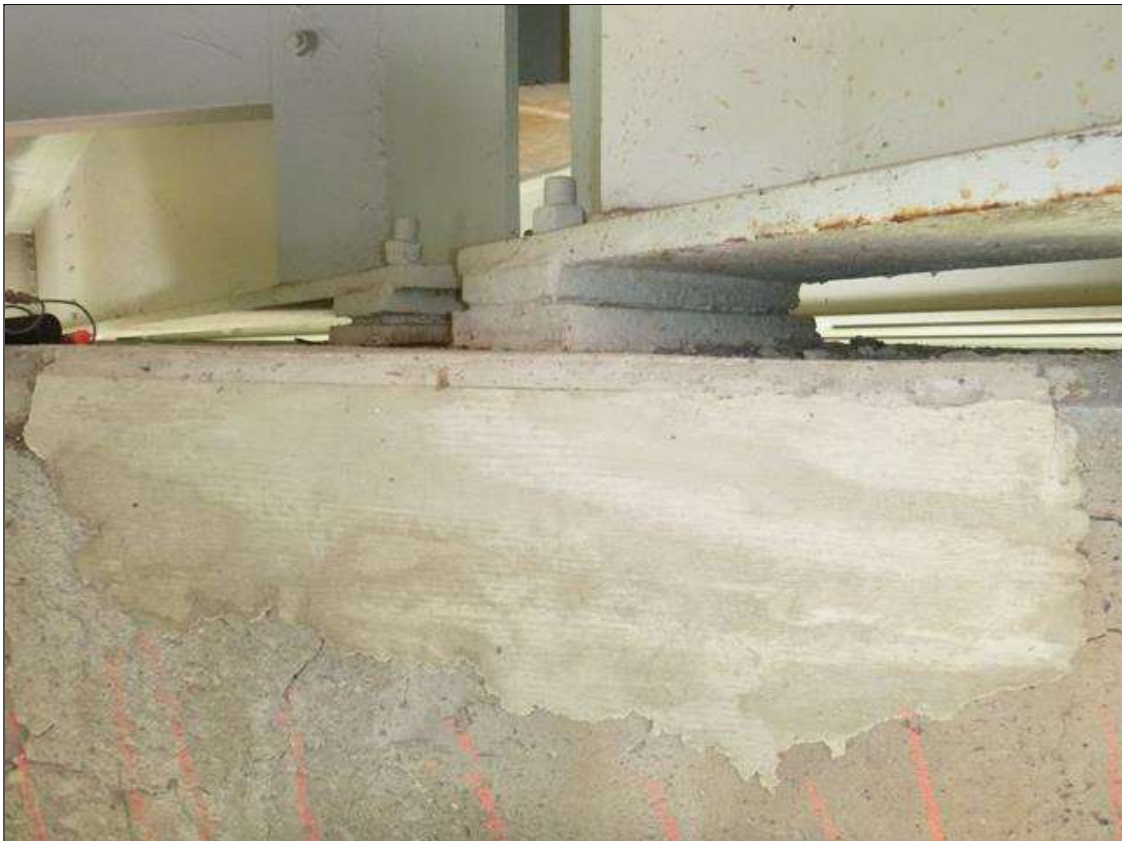
Bent 4 Cap 1: BENT 4 CAP SPAN 4 SIDE HAS AN AREA OF DELAMINATION IN THE FACE OF THE CAP, BAY 2, NEAR BEAM 3, 60 INCHES X 30 INCHES WITH 1/8 INCH SEPARATION X 3 INCHES ACROSS THE TOP

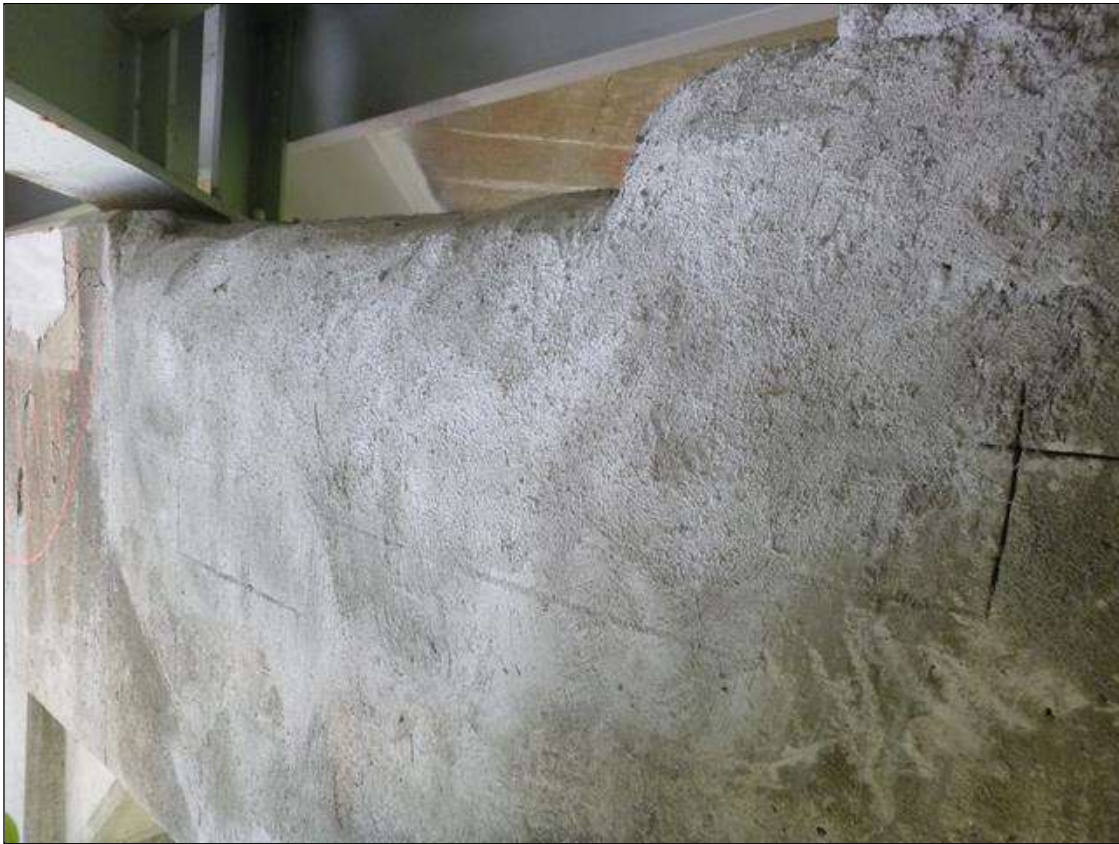
Bent 4 Cap 1: BENT 4 CAP, SPAN 4 SIDE HAS A PATCH IN THE FACE OF THE CAP, NEAR TOP EDGE, 24 INCHES X 9 INCHES X 10 INCHES ACROSS THE TOP, UNDER BEAM 3

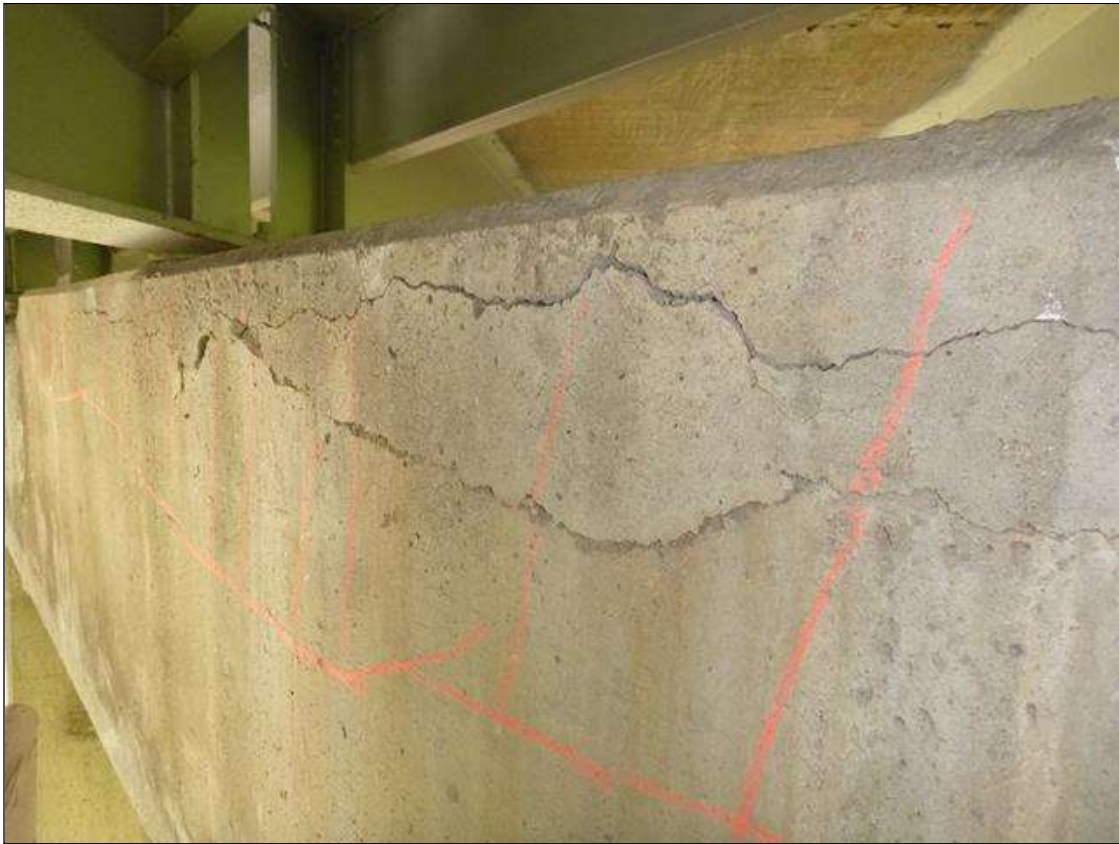
Bent 4 Cap 1: BENT 4 CAP, SPAN 4 SIDE HAS A PATCH IN THE FACE OF THE CAP, 60 INCHES X 24 INCHES IN BAY 3 NEAR BEAM 3, NEAR TOP EDGE

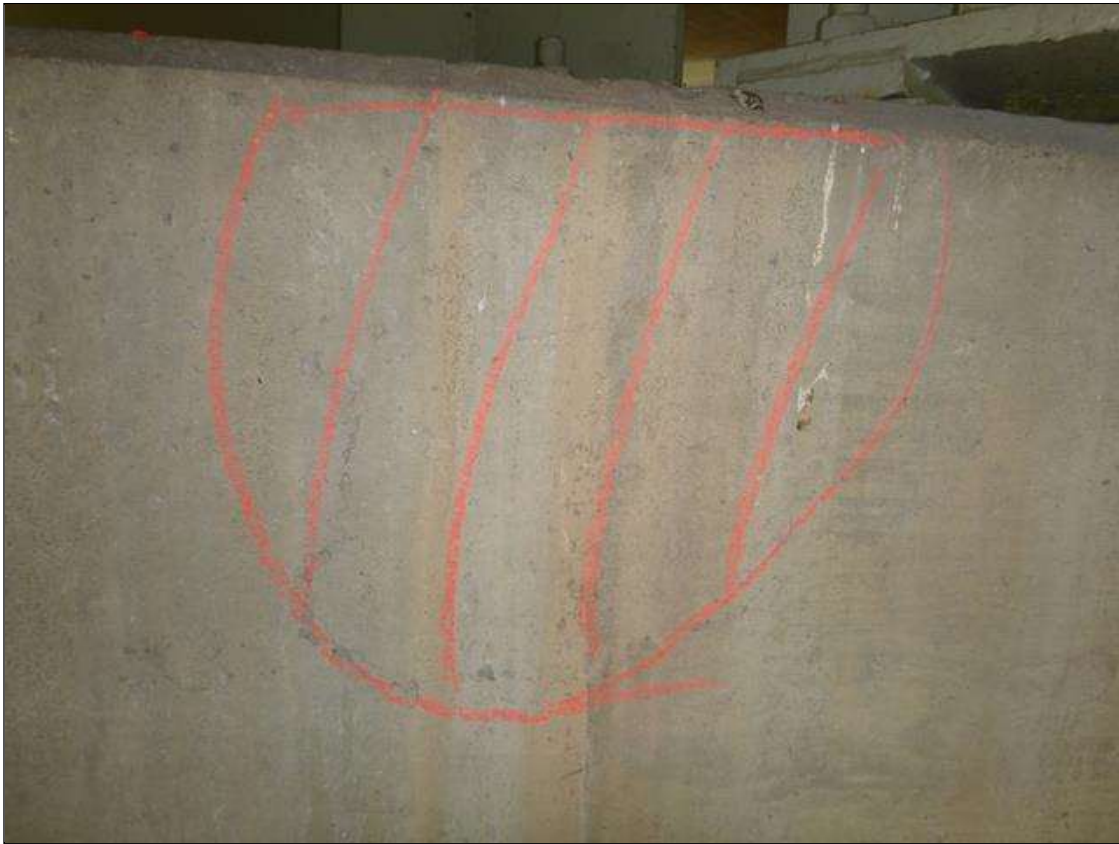
Bent 4 Cap 1: BENT 4 CAP, SPAN 4 SIDE HAS AN AREA OF DELAMINATION IN THE FACE OF THE CAP FROM BAY 3 TO BAY 4, 11 FT. LONG X 16 INCHES HIGH X 3 INCHES ACROSS THE TOP WITH 3/16 INCH SEPARATION

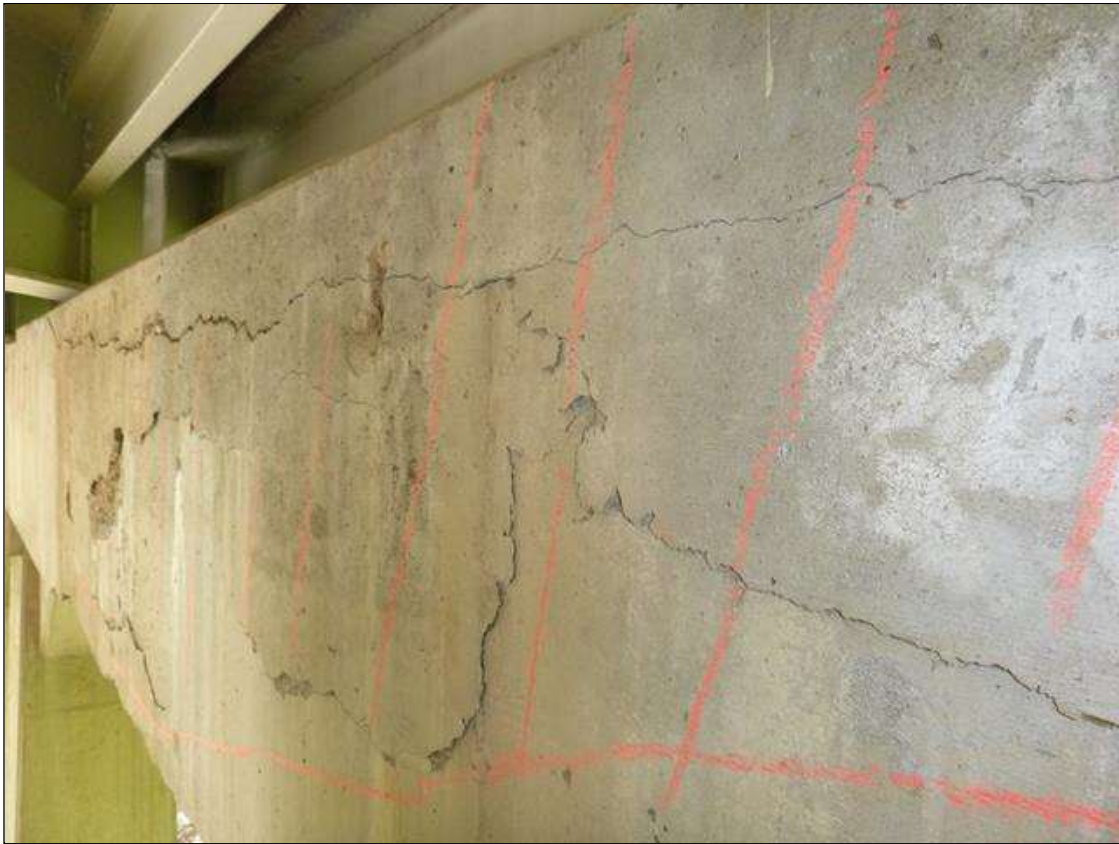
Bent 4 Cap 1: BENT 4 CAP, SPAN 4 SIDE HAS AN AREA OF DELAMINATION IN THE FACE OF THE CAP, 15 INCHES IN DIAMETER IN BAY 4, NEAR BEAM 5

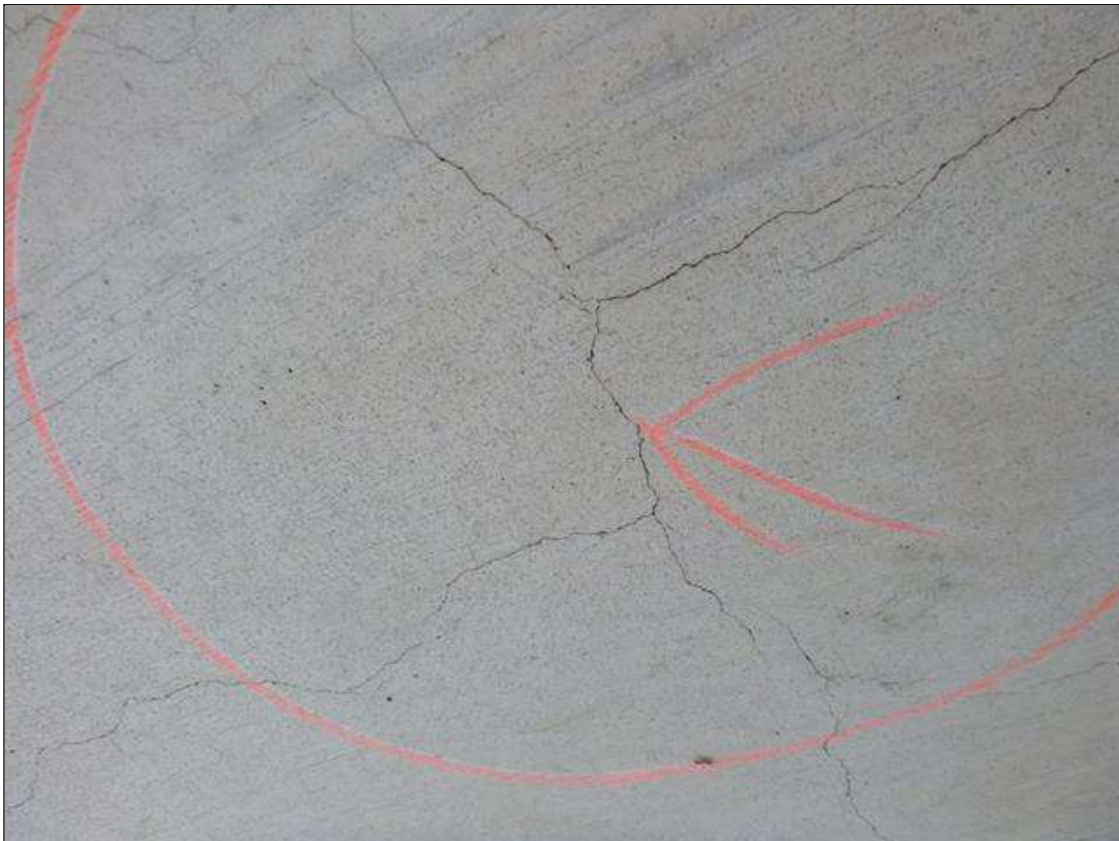
Span 4 Deck: SPAN 4, BOTTOM OF BAY 4 DECK HAS A HAIRLINE TRANSVERSE CRACK WITH EFFLO., 7 FT. LONG AT 3/4 POINT FOR A TOTAL OF 300 SQ. FT. THRU OUT THE BOTTOM OF THE SPAN

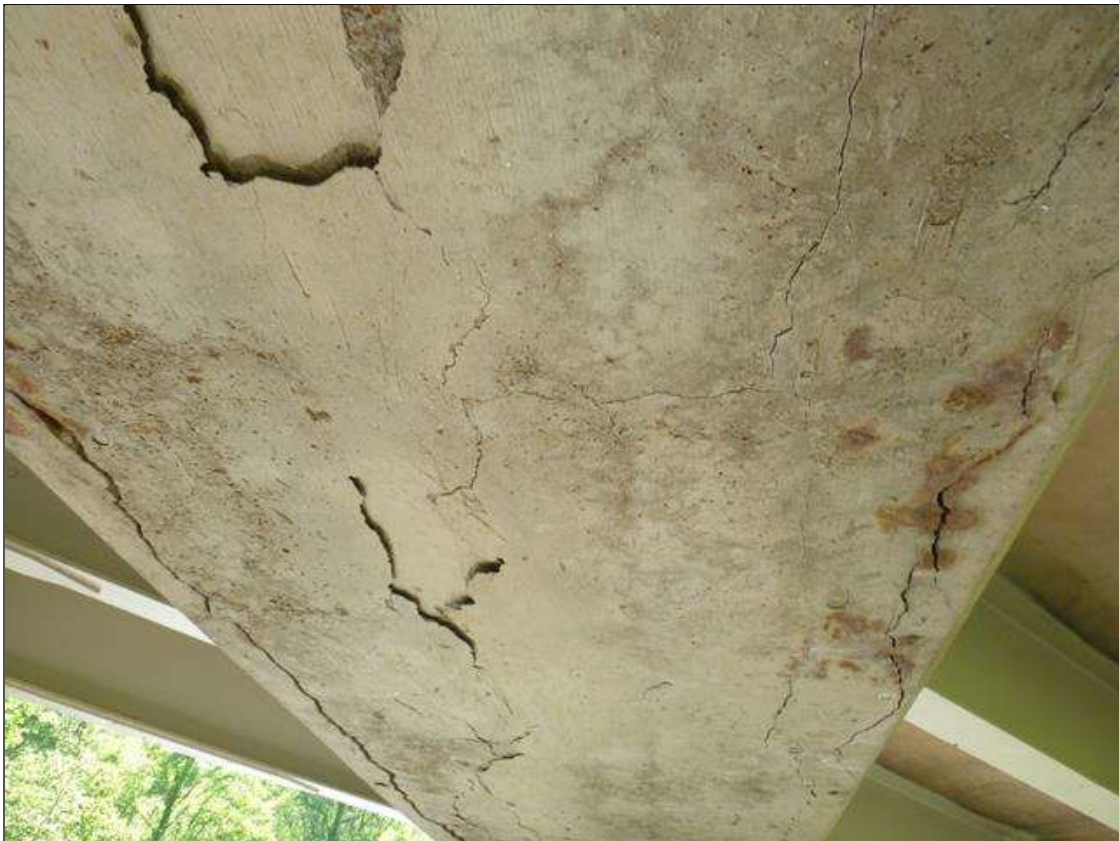
Bent 3 Cap 1: BENT 3, BOTTOM OF CAP HAS A SPALL, 24 INCHES X 12 INCHES X 3 INCHES DEEP WITH EXPOSED REBAR, BETWEEN PILES 2 AND 3

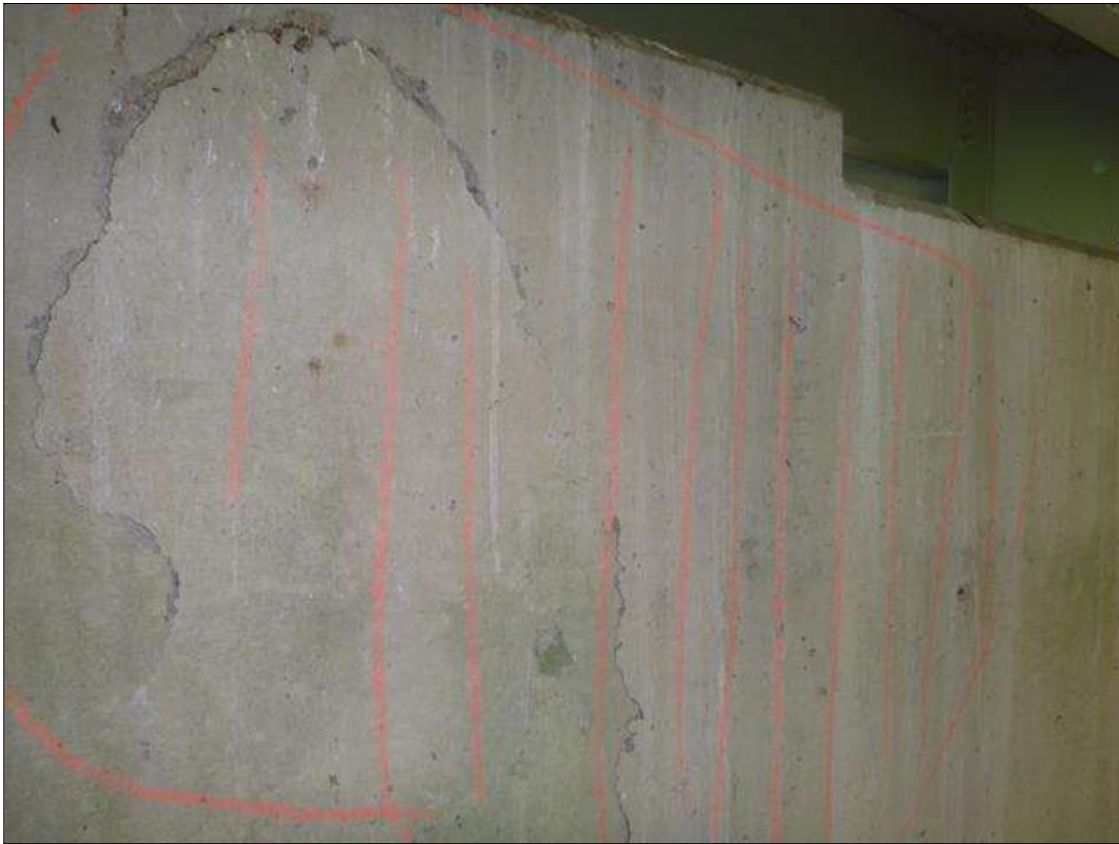
Bent 3 Cap 1: BENT 3, BOTTOM OF CAP HAS AN AREA OF DELAMINATION BETWEEN PILES 2 AND 3, 14 FT. LONG X 36 INCHES WIDE WITH 1/4 INCH SEPARATION

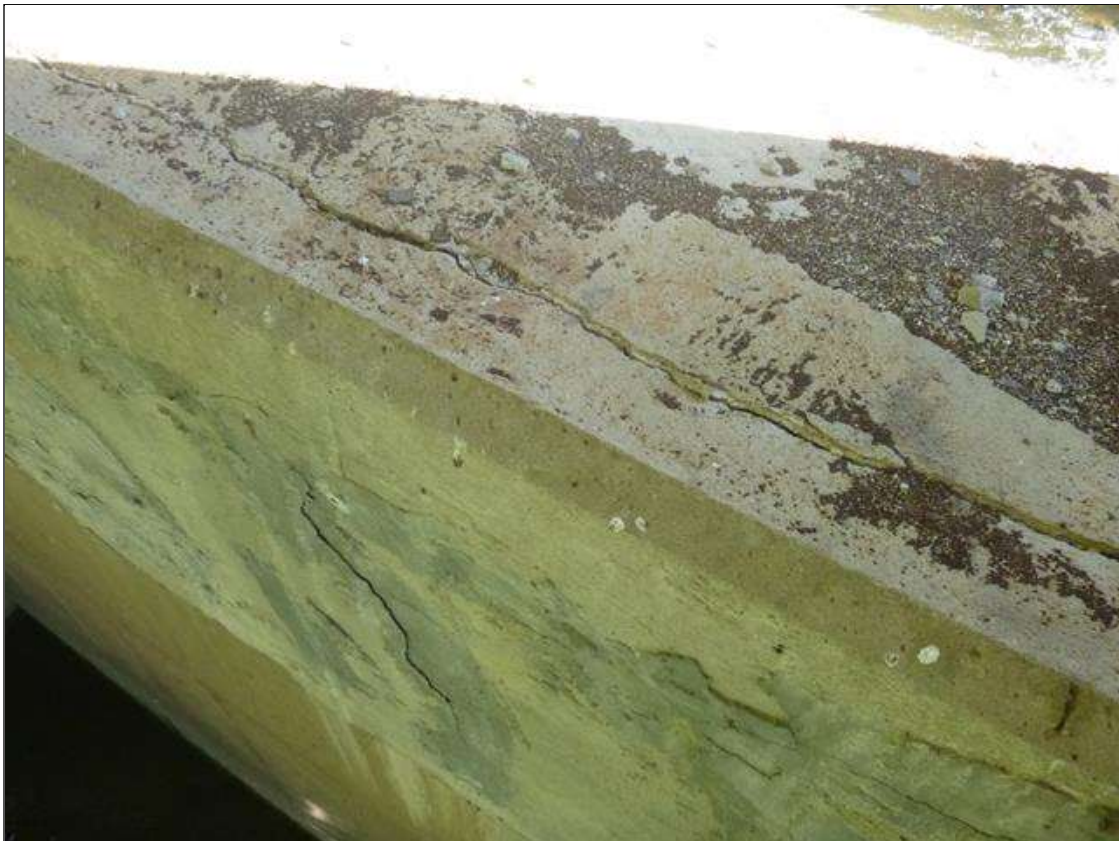
Bent 3 Cap 1: BENT 3 CAP, SPAN 4 SIDE HAS AN AREA OF DELAMINATION IN THE FACE OF THE CAP IN BAY 3, NEAR BEAM 4, 48 INCHES X 30 INCHES, WITH UP TO 1/2 INCH SEPARATION

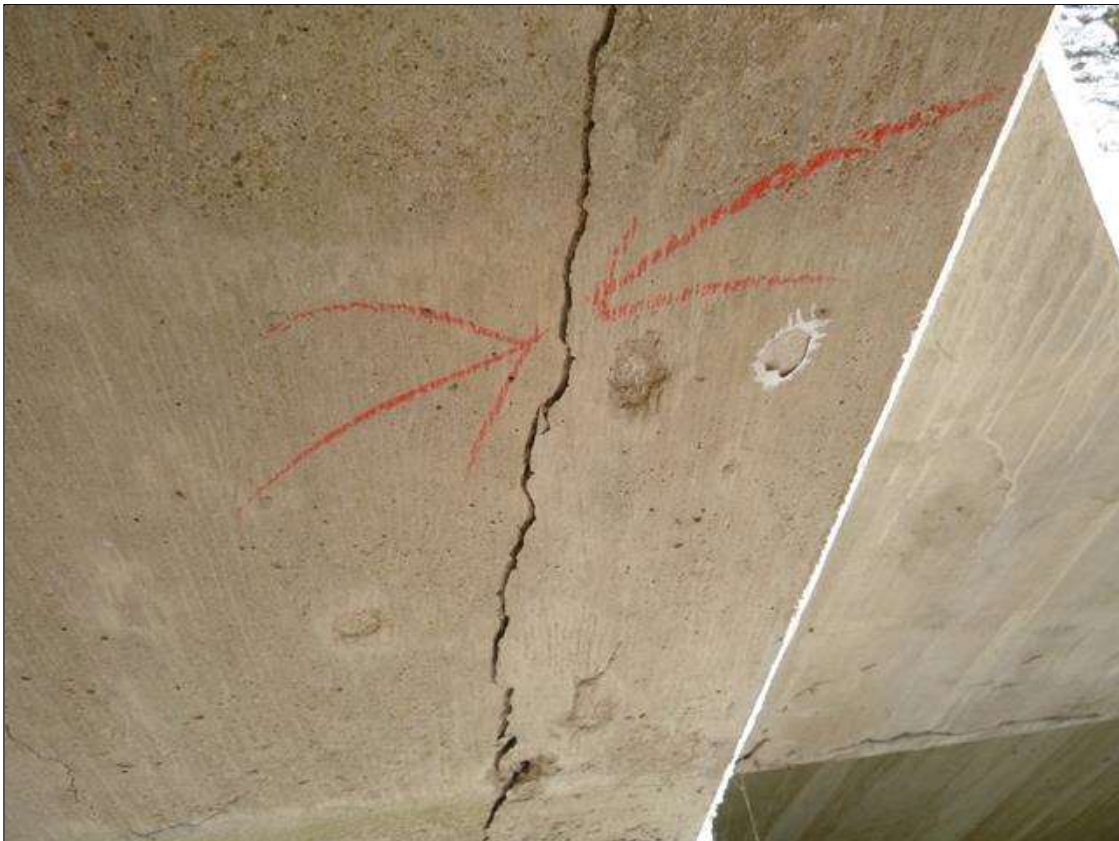
Bent 3 Pile 2: BENT 3, PILE 2 HAS A 3/16 INCH WIDE VERTICAL CRACK, IN THE WEST FACE NEAR THE SOUTHEAST CORNER, 15 FT. HIGH, ADJACENT TO THE STRUT

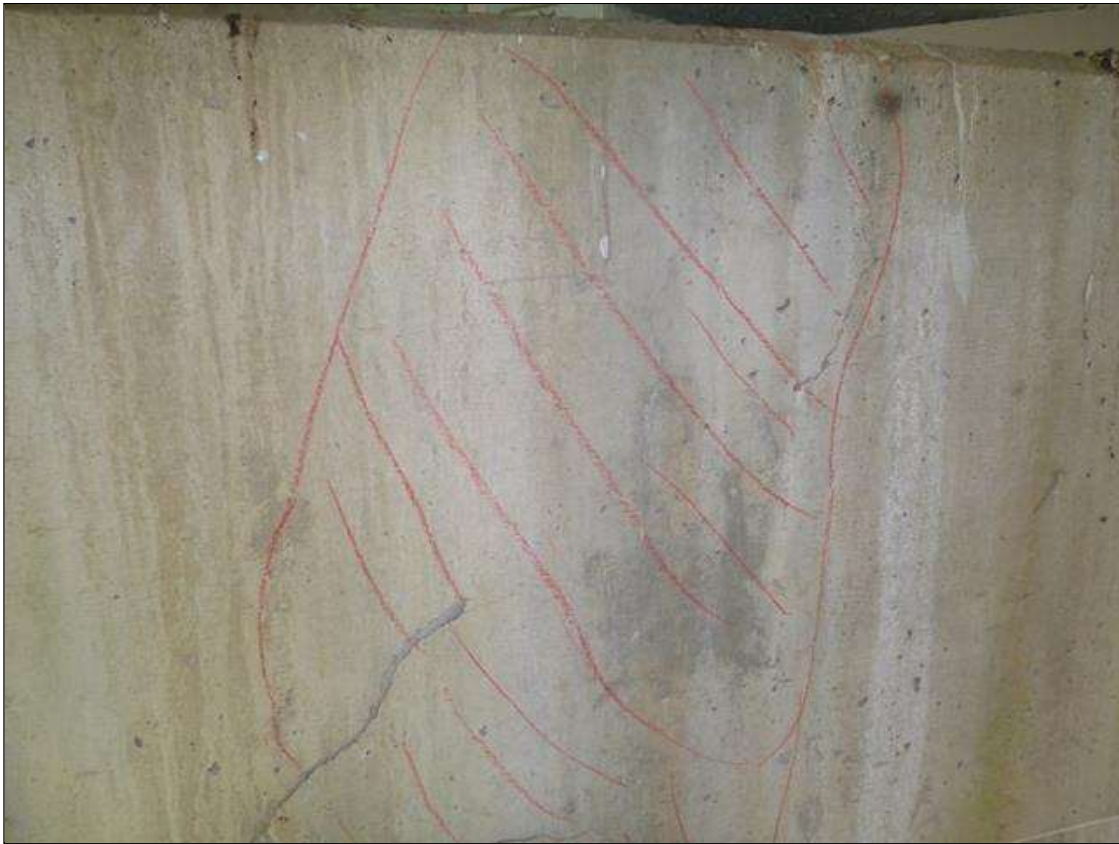
Bent 3 Pile 2: BENT 3, PILE 2 HAS AN AREA OF DELAMINATION ON THE NORTH EAST CORNER, 10 INCHES WIDE X 48 INCHES HIGH ADJACENT TO TOP OF STRUT, WITH 3/16 INCH SEPARATION

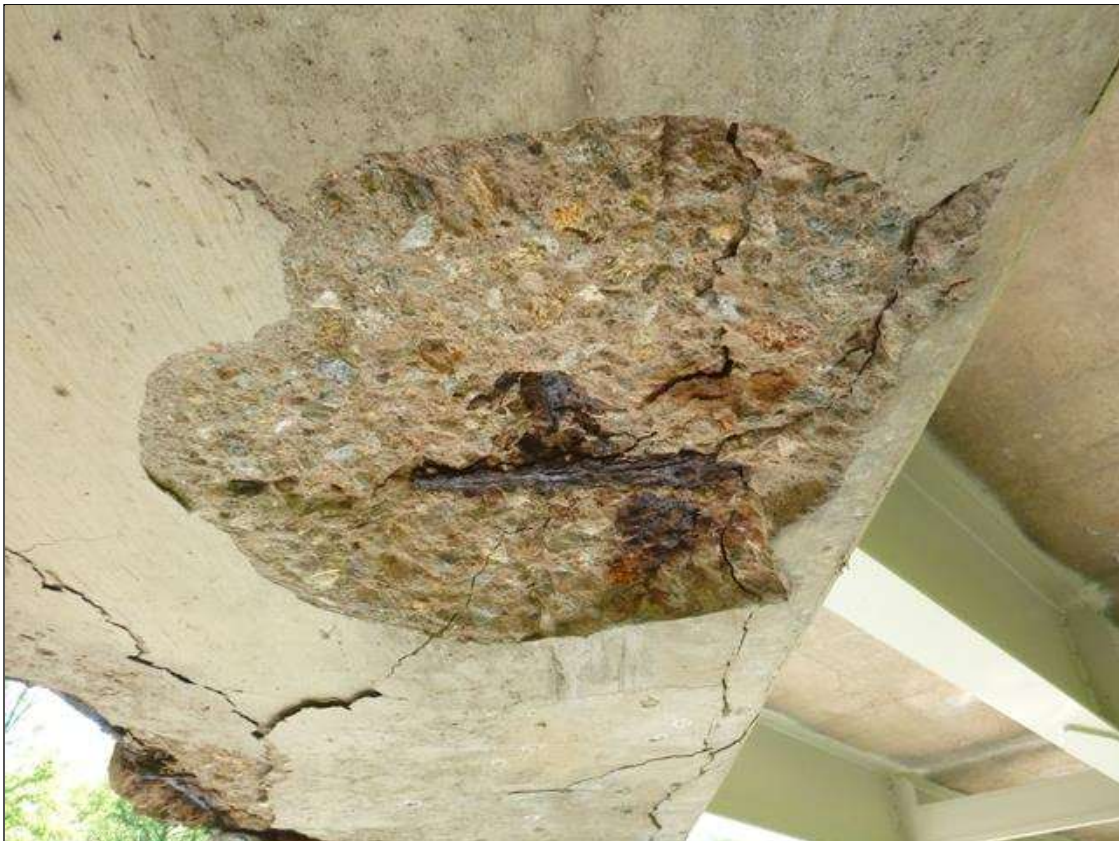
Bent 3 Cap 1: BENT 3 CAP, SPAN 4 SIDE HAS AN AREA OF DELAMINATION IN THE FACE OF THE CAP UNDER BEAM 2, 24 INCHES X 41 INCHES X 2 INCHES ACROSS THE TOP OF THE CAP WITH 3/16 INCH SEPARATION

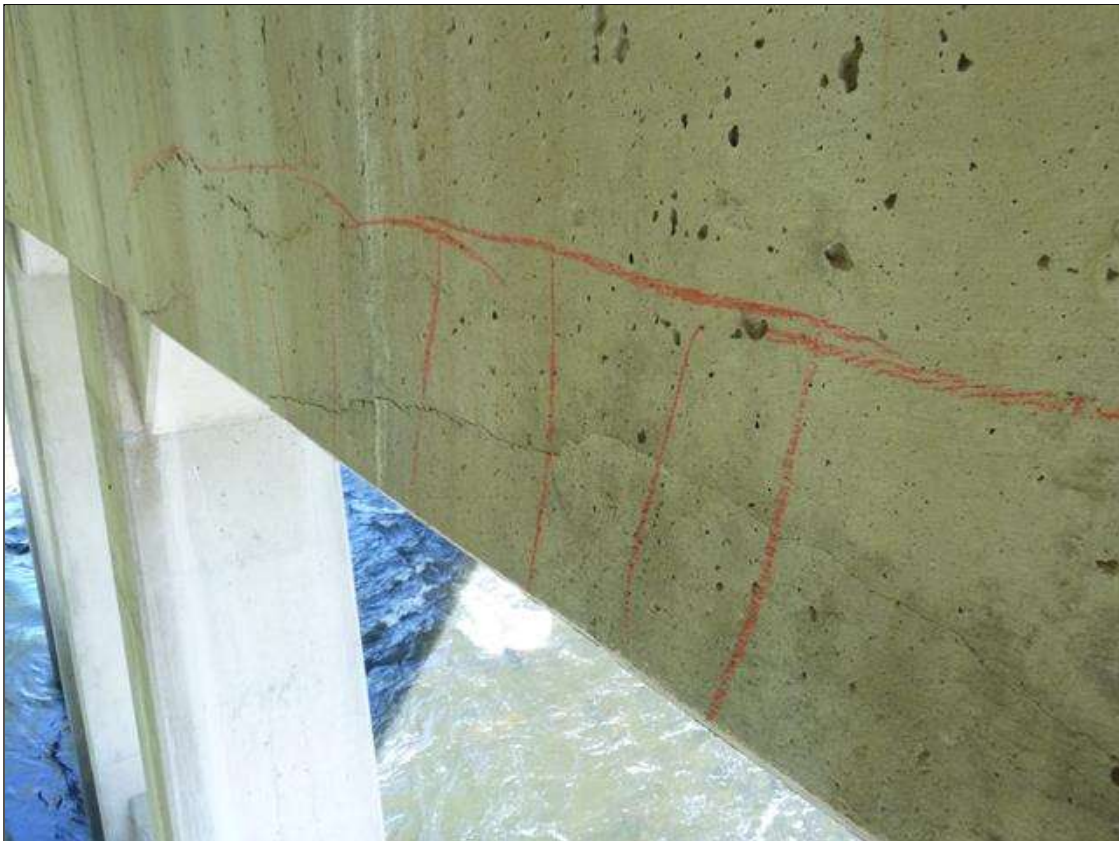
Bent 3 Cap 1: BENT 3 BOTTOM OF THE CAP HAS A SPALLED AREA BETWEEN PILES 1 AND 2', 80 INCHES X 16 INCHES X 3 INCHES DEEP WITH EXPOSED REBAR, NEAR SPAN 3 SIDE

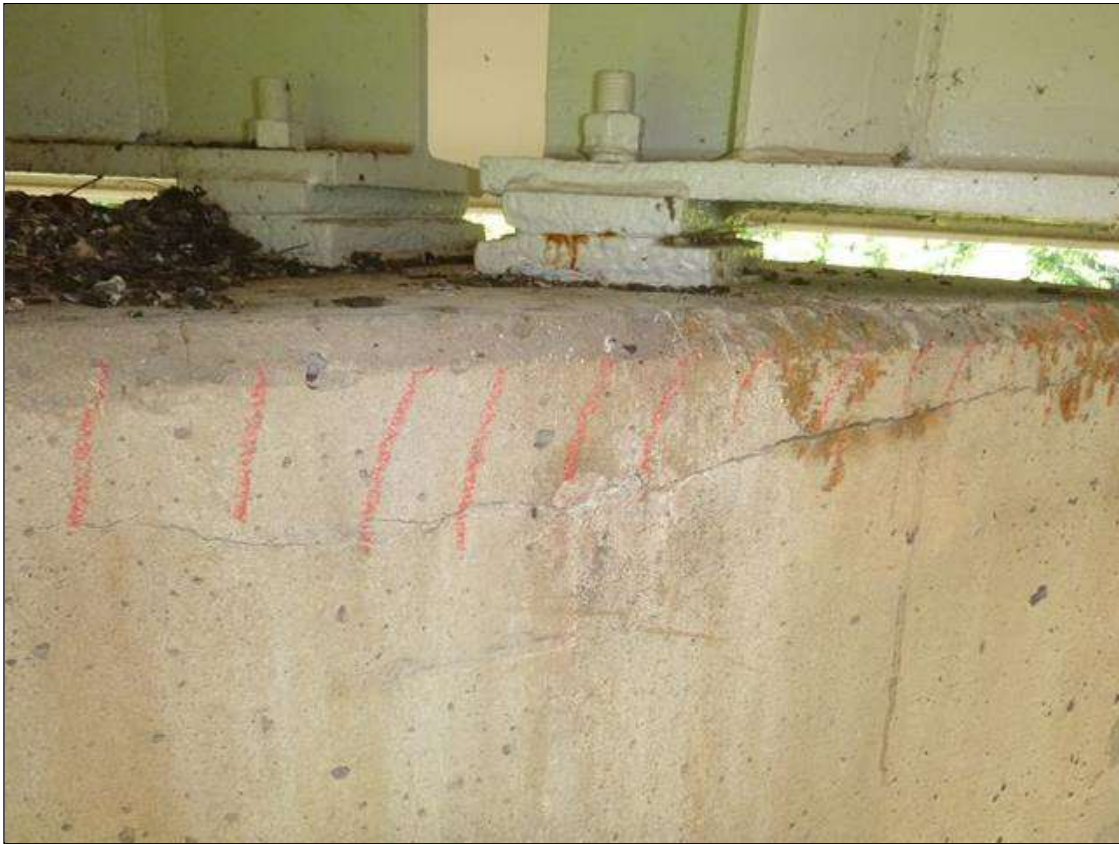
Bent 3 Cap 1: BENT 3 CAP, SPAN 4 SIDE HAS AN AREA OF DELAMINATION IN THE FACE OF THE CAP, NEAR BOTTOM EDGE UNDER BEAM 2, 9 FT. LONG X 10 INCHES HIGH WITH 1/8 INCH SEPARATION

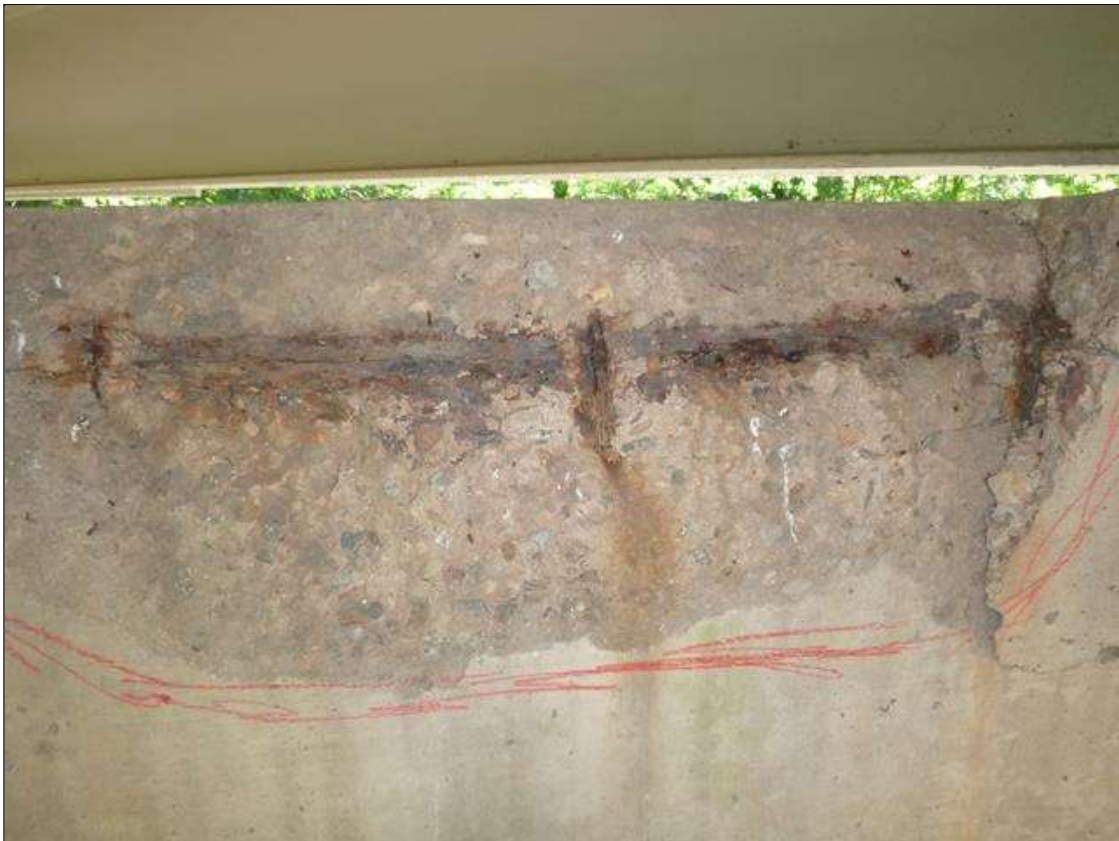
Bent 3 Cap 1: BENT 3 CAP, SPAN 4 SIDE HAS AN AREA OF DELAMINATION IN THE FACE OF THE CAP, 24 INCHES LONG X 4 INCHES WIDE AT TOP EDGE WITH 1/8 INCH SEPARATION, BAY 2, NEAR BEAM 2

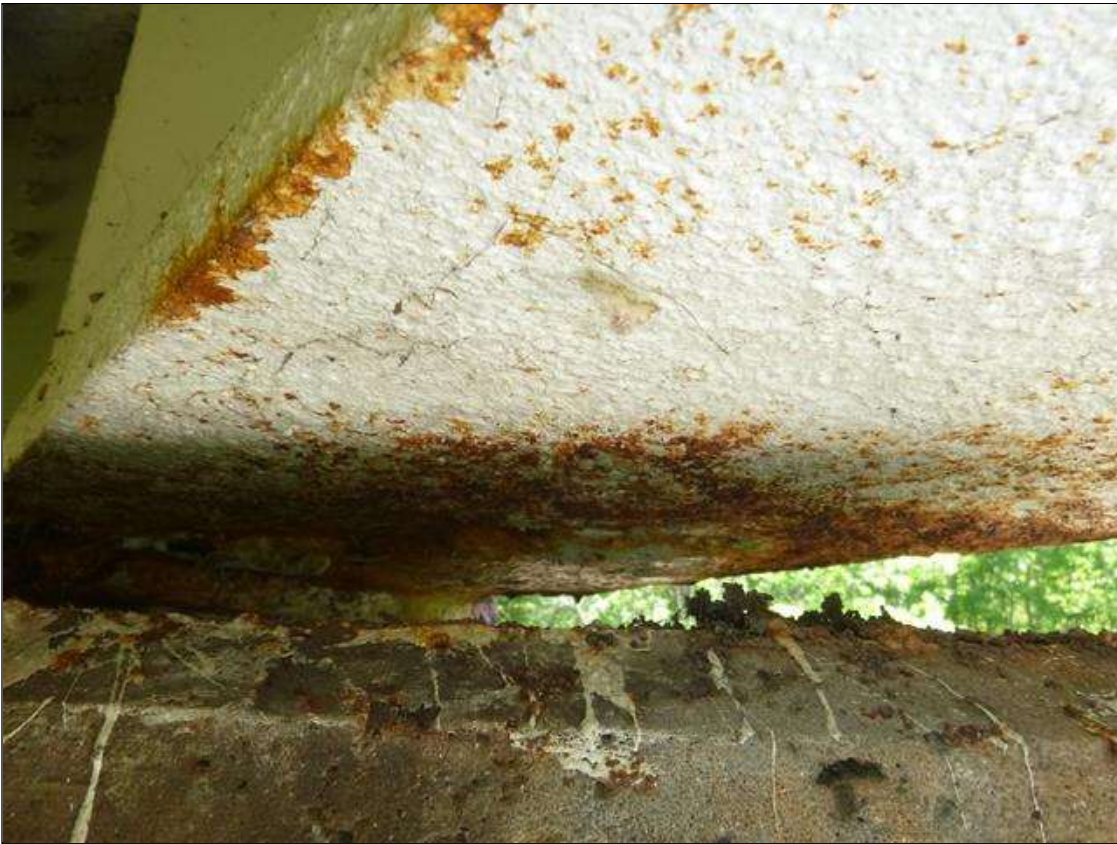
Bent 3 Cap 1: BENT 3 CAP, SPAN 4 SIDE HAS AN AREA OF DELAMINATION IN THE FACE OF THE CAP IN BAY 1 AND UNDER BEAM 1, 72 INCHES LONG X 14 INCHES HIGH WITH 3/16 INCH SEPARATION AND GOES 3 INCHES ACROSS THE TOP OF THE CAP

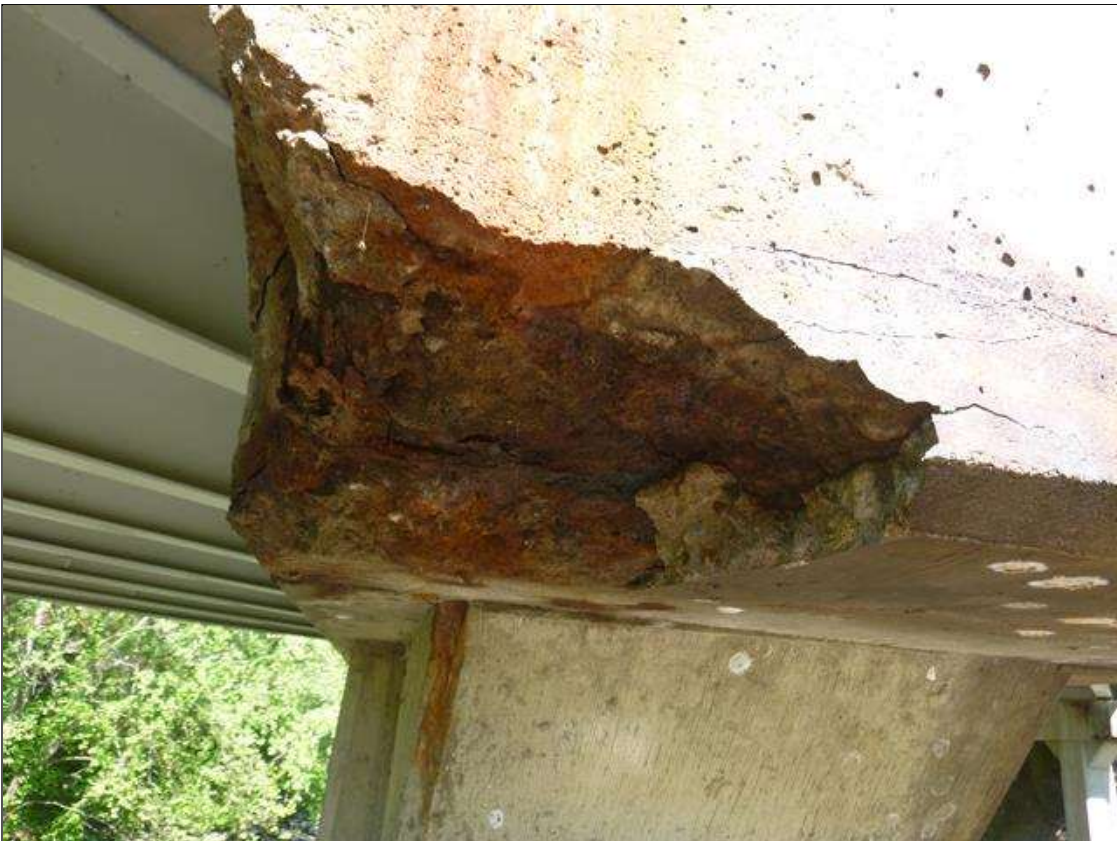
Span 4 Beam 1: SPAN 4 BEAM 1 AT BENT 3 HAS 1/16 INCH SECTION LOSS ON THE BOTTOM OF THE BOTTOM FLANGE X FULL WIDTH FROM THE BEAM END OUT 2 FT. WITH 15/16 INCH REMAINING

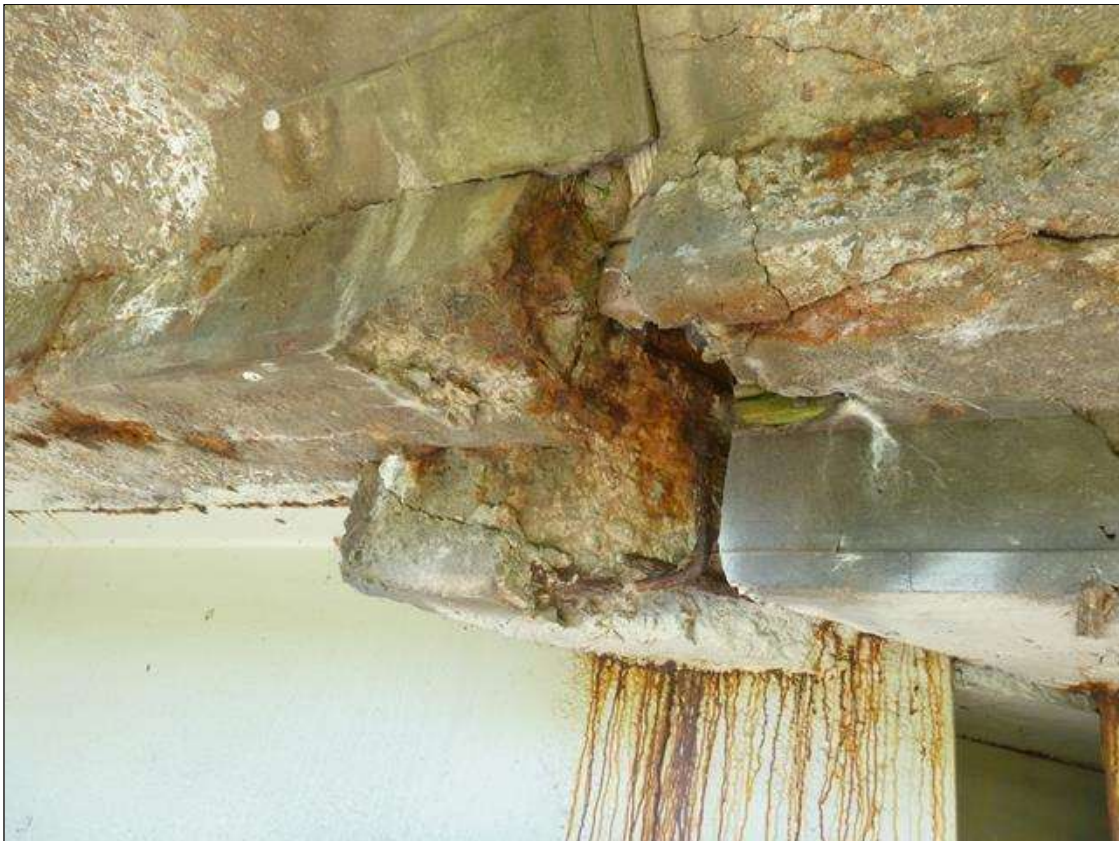
Bent 3 Pile 1: BENT 3, PILE 1 HAS AN AREA OF DELAMINATION ON THE NORTHWEST CORNER, 34 INCHES WIDE X 7 FT. HIGH, STARTING AT THE BOTTOM OF THE CAP, WITH UP TO 1 INCH SEPARATION

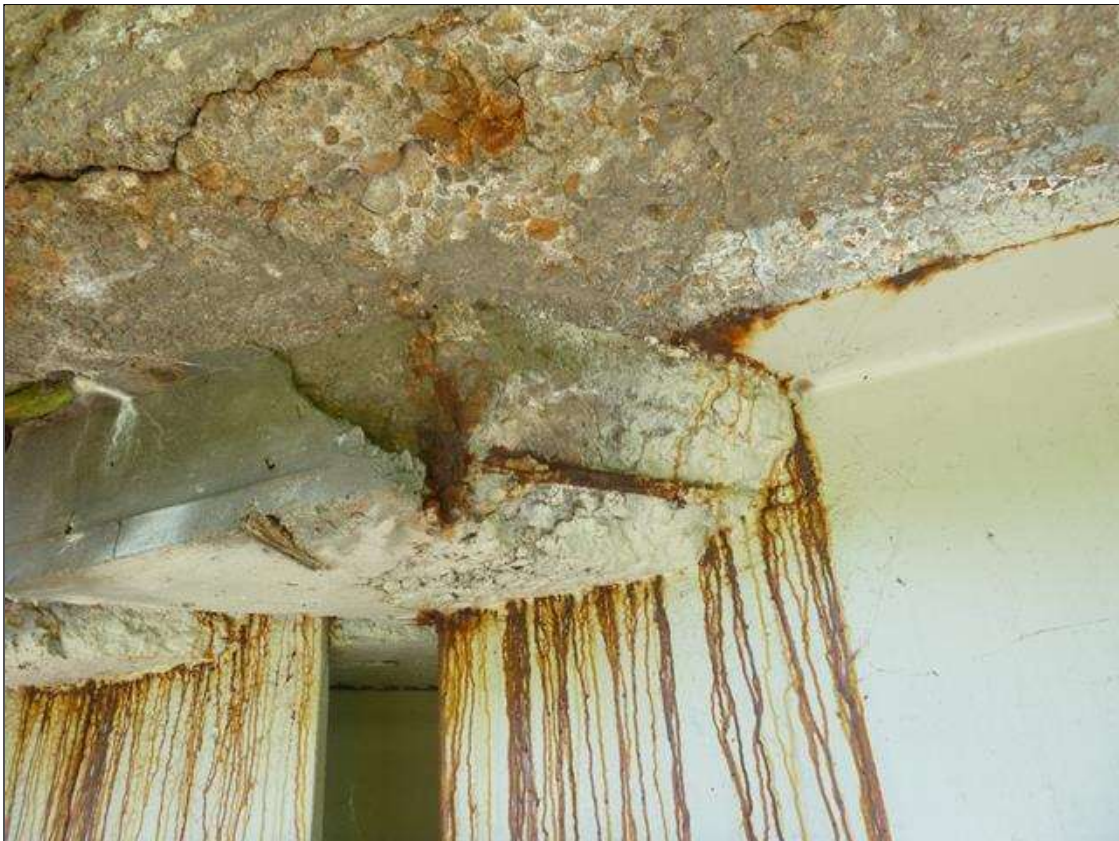
Span 4 Deck: SPAN 4, BOTTOM OF LEFT OVERHANG HAS A SPALL, 11 INCHES X 7 INCHES X 4 INCHES DEEP WITH EXPOSED REBAR

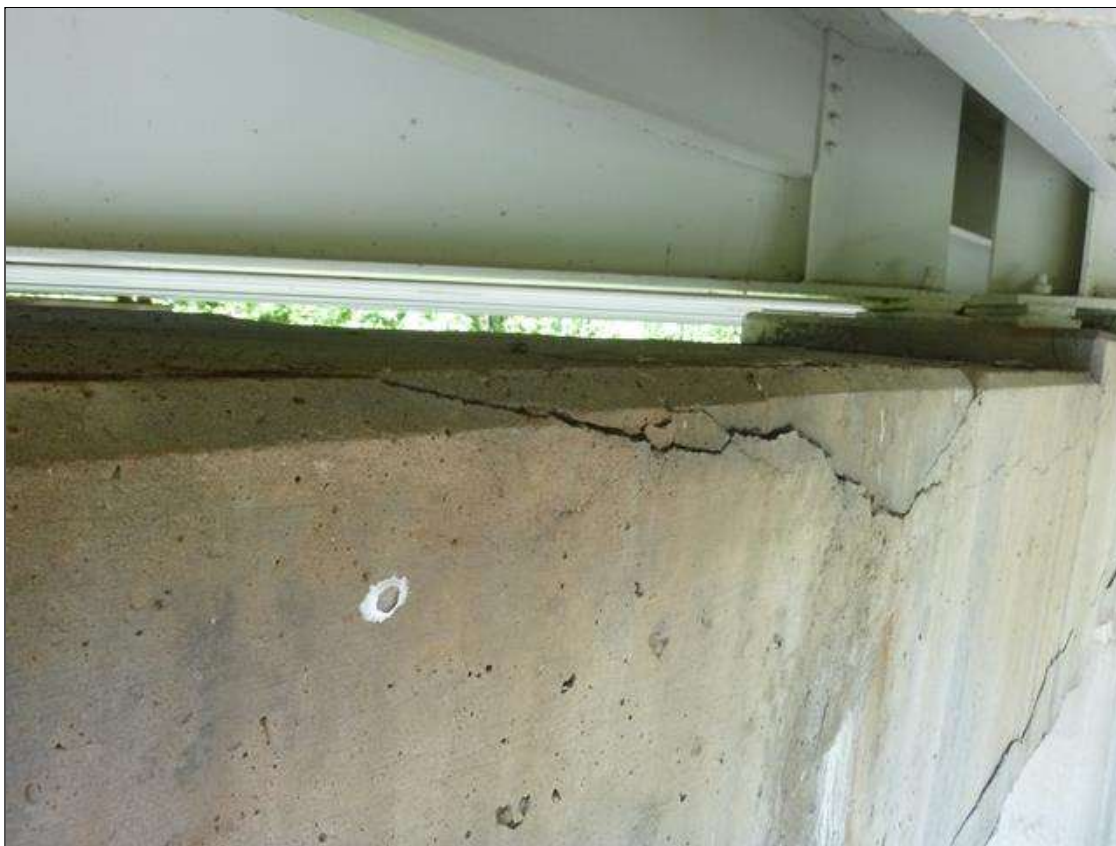
BENT 3, SPAN 3 SIDE BENT DIAPHRAGM UNDER THE LEFT OVERHANG HAS A SPALL WITH EXPOSED REBAR, 9 INCHES X 7 INCHES X 4 INCHES DEEP WITH EXPOSED REBAR

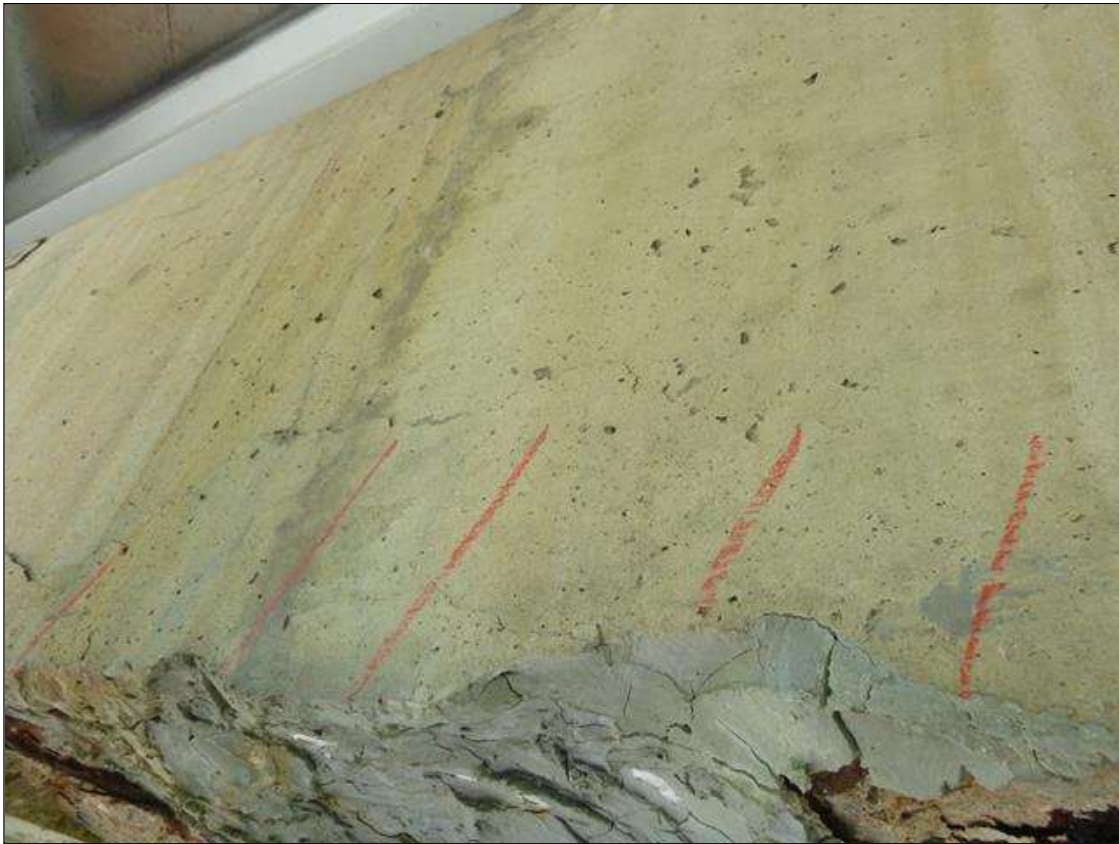
Bent 3 Cap 1: BENT 3 CAP, SPAN 3 SIDE HAS AN AREA OF DELAMINATION IN THE FACE OF THE CAP NEAR TOP EDGE 12 FT. LONG X 8 INCHES WIDE FROM THE LEFT END OF THE CAP TO BEAM 2 WITH UP TO 3/16 INCH SEPARATION
