## Structure Safety Report

### Routine Element Inspection - Contract

COUNTY: HAYWOOD STRUCTURE NUMBER: 430142 FREQUENCY: 24 MONTHS

FEATURE INTERSECTED: PIGEON RIVER

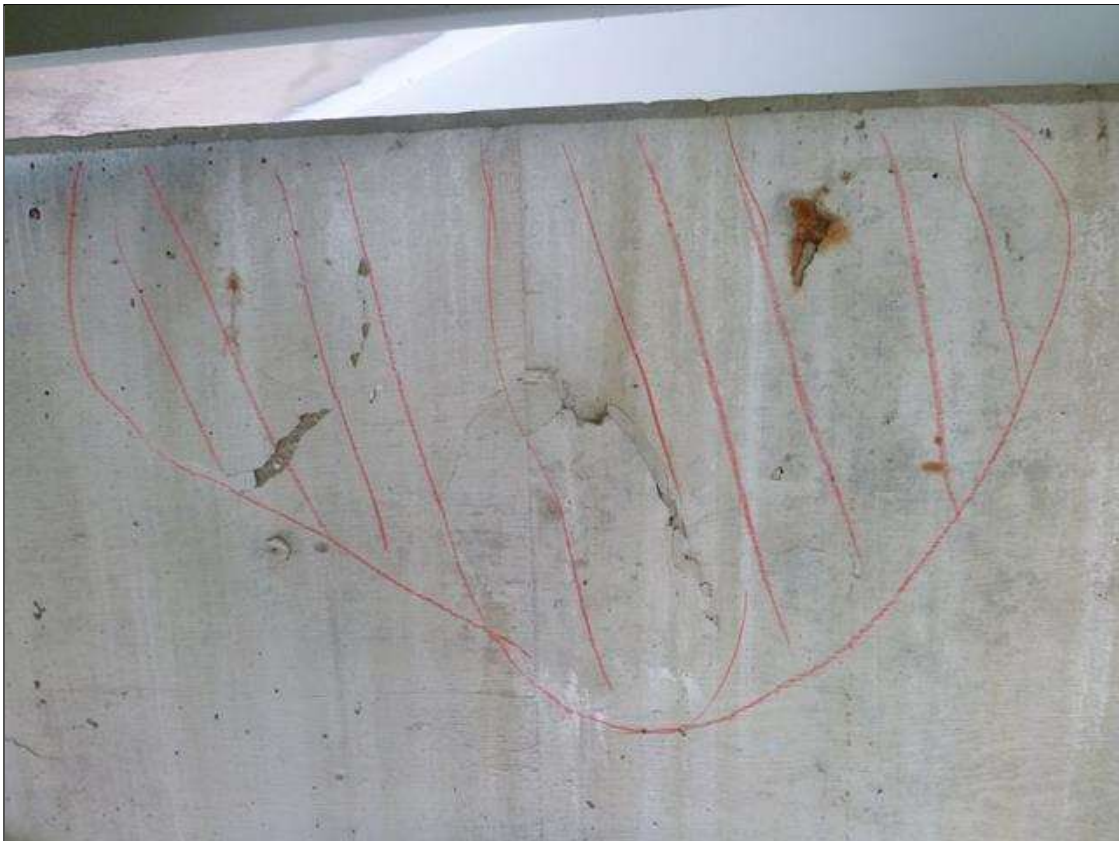
Bent 3 Cap 1: BENT 3 CAP, SPAN 3 SIDE HAS AN AREA OF DELAMINATION IN THE FACE OF THE CAP NEAR THE BOTTOM EDGE, BETWEEN PILES 1 AND 2, 8 INCHES HIGH X 12 FT. LONG

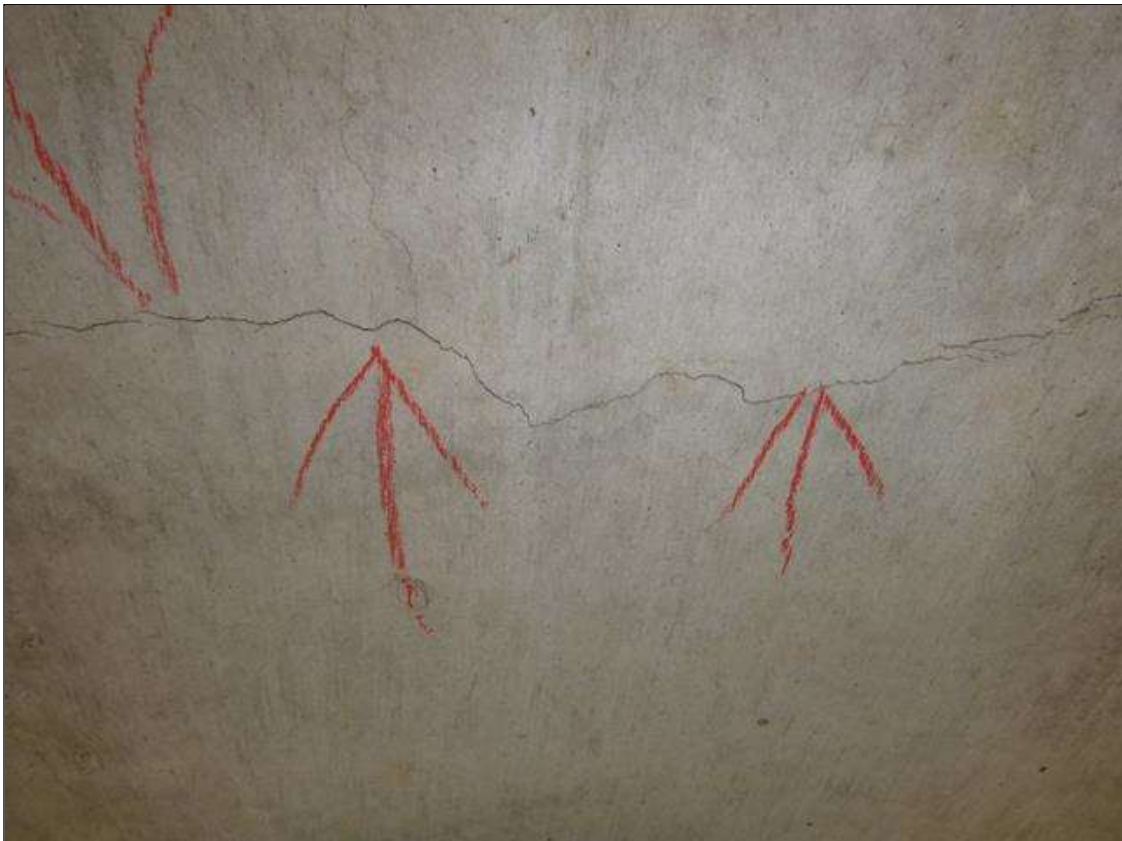
Span 3 Deck: SPAN 3, BOTTOM OF BAY 2 DECK HAS A 1 SQ. FT. AREA OF 1/32 INCH WIDE MAP CRACKING NEAR BENT 3 FOR A TOTAL OF 2100 SQ. FT. THRU OUT THE BOTTOM OF THE SPAN

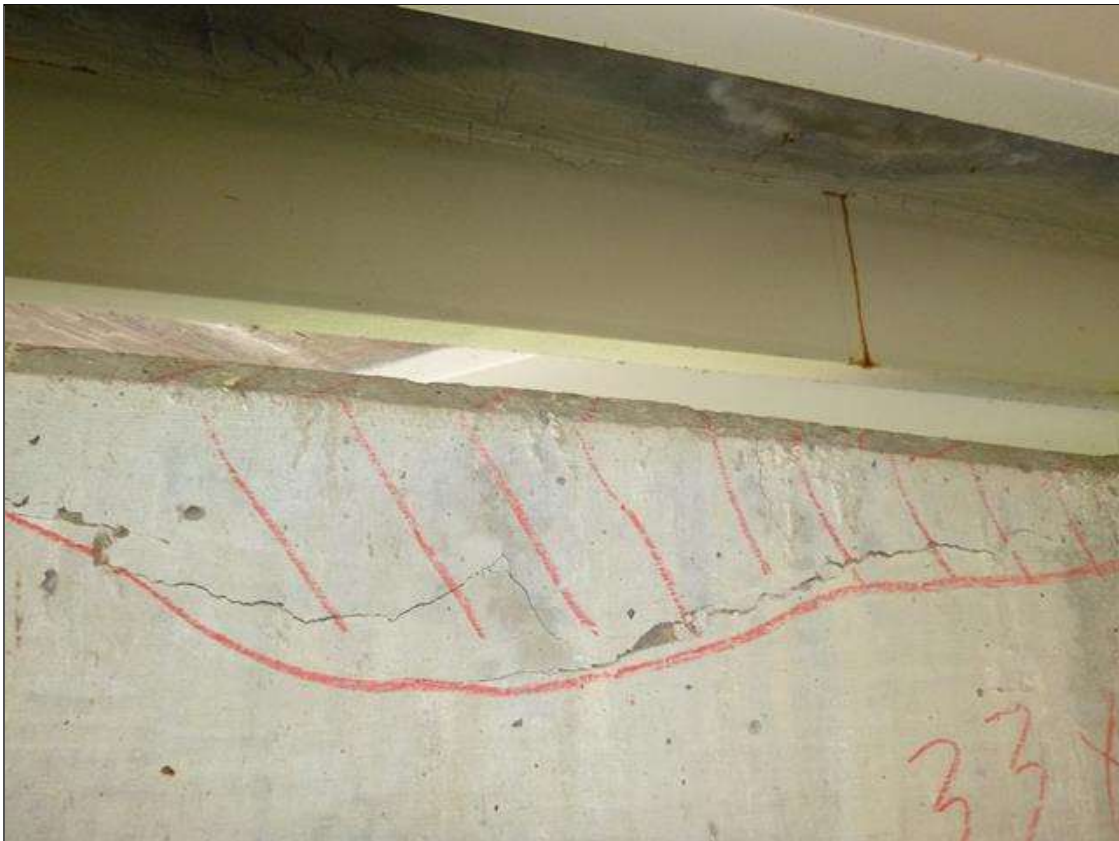
Bent 3 Cap 1: BENT 3 CAP, SPAN 3 SIDE HAS AN AREA OF DELAMINATION IN THE FACE OF THE CAP NEAR BOTTOM EDGE IN BAY 3, 11 FT. LONG X 8 INCHES HIGH WITH 1/4 INCH SEPARATION

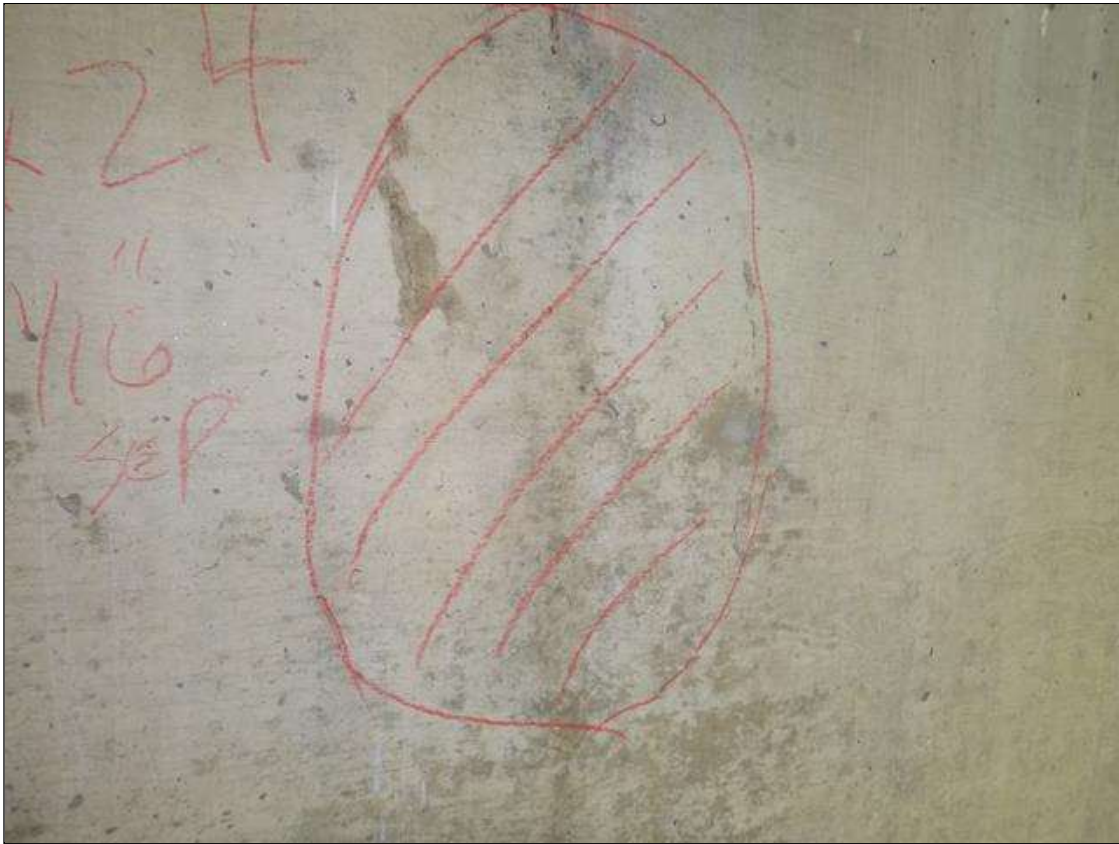
Bent 3 Cap 1: BENT 3 CAP, SPAN 3 SIDE HAS AN AREA OF DELAMINATION IN THE FACE OF THE CAP AT TOP EDGE IN BAY 4, 33 INCHES X 7 INCHES WITH 1/8 INCH SEPARATION

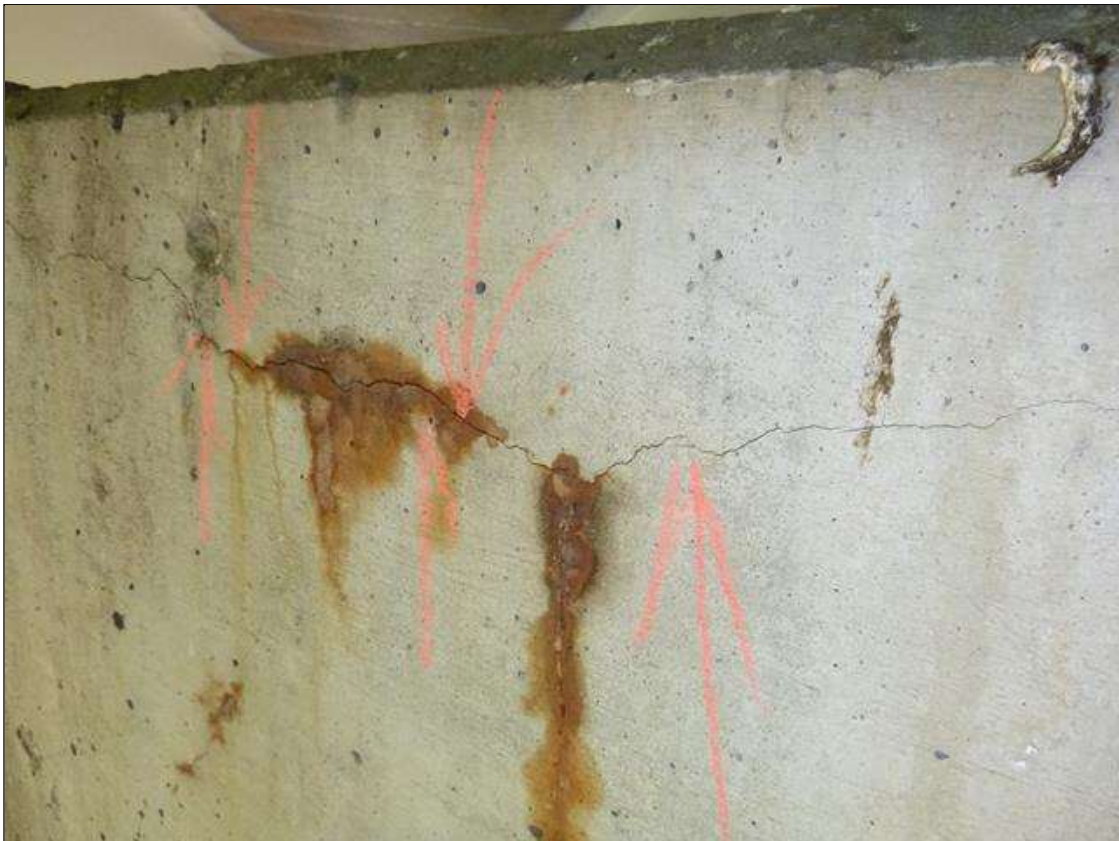
Bent 3 Cap 1: BENT 3 CAP, SPAN 3 SIDE, BOTTOM EDGE, BETWEEN PILES 3 AND 4 HAS AN AREA OF DELAMINATION 60 INCHES X 4 INCHES UP THE FACE X 6 INCHES ACROSS THE BOTTOM, NEAR PILE 4

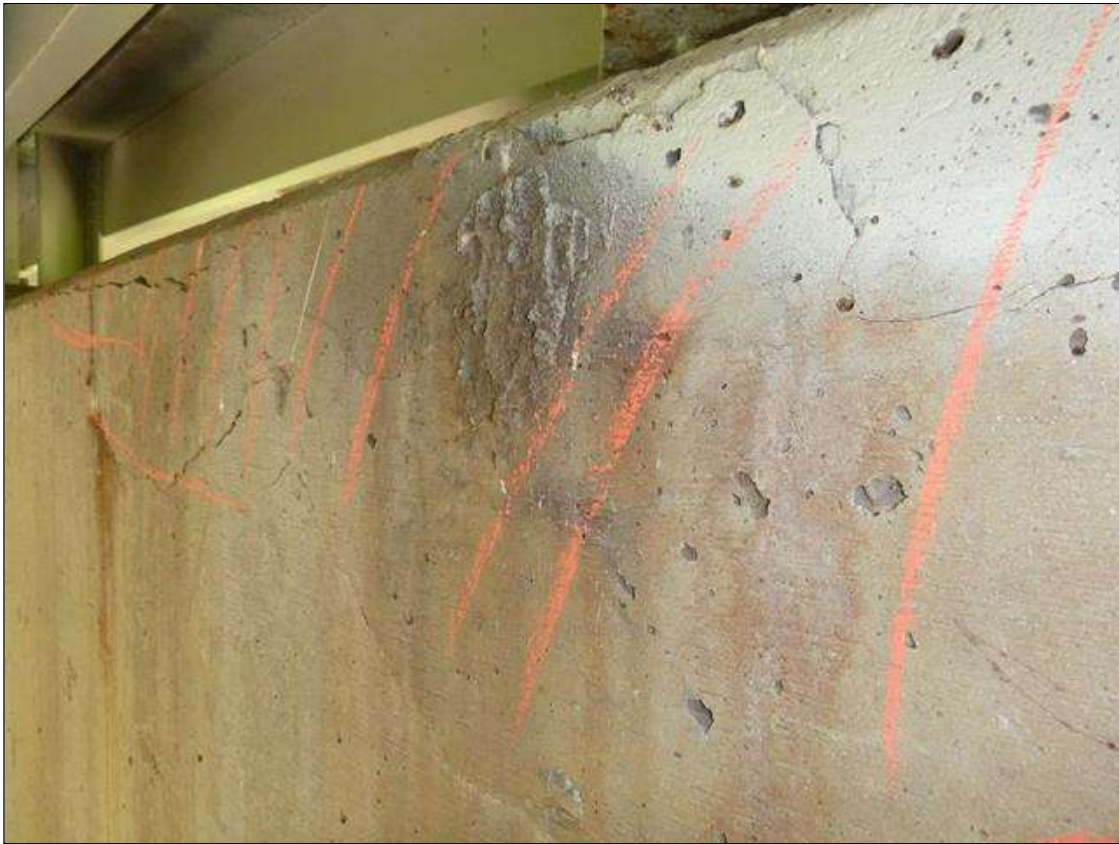
Bent 2 Cap 1: BENT 2 CAP, BETWEEN PILES 2 AND 3 HAS AN AREA OF DELAMINATION IN THE BOTTOM, 12 FT. LONG X 36 INCHES WIDE AND GOES UP ON BOTH FACES UP TO 4 INCHES HIGH WITH 1/4 INCH SEPARATION

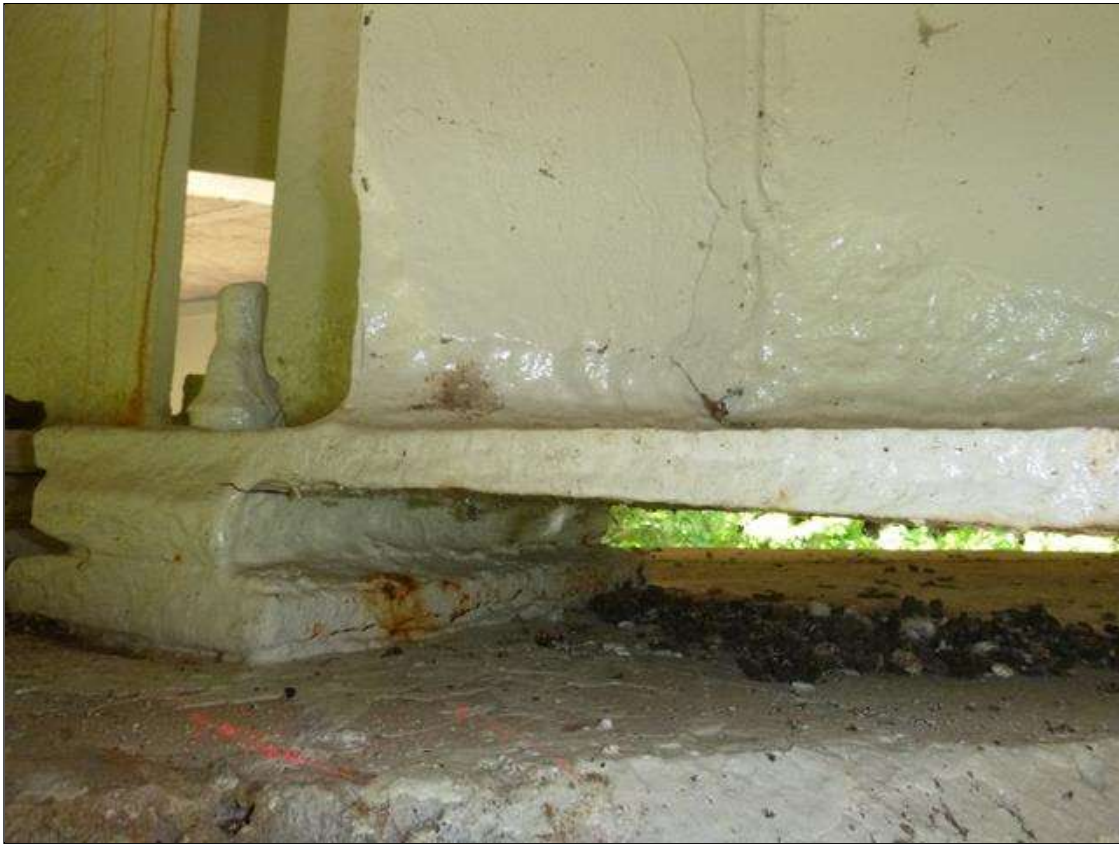
Bent 2 Cap 1: BENT 2 CAP, SPAN 3 SIDE HAS AN AREA OF DELAMINATION IN THE FACE OF THE CAP AT BEAM 3, 60 INCHES X 10 INCHES DOWN THE FACE X 4 INCHES ACROSS THE TOP, WITH 1/8 INCH SEPARATION, BEARING AREA FOR BEAM 3 IS SOUND

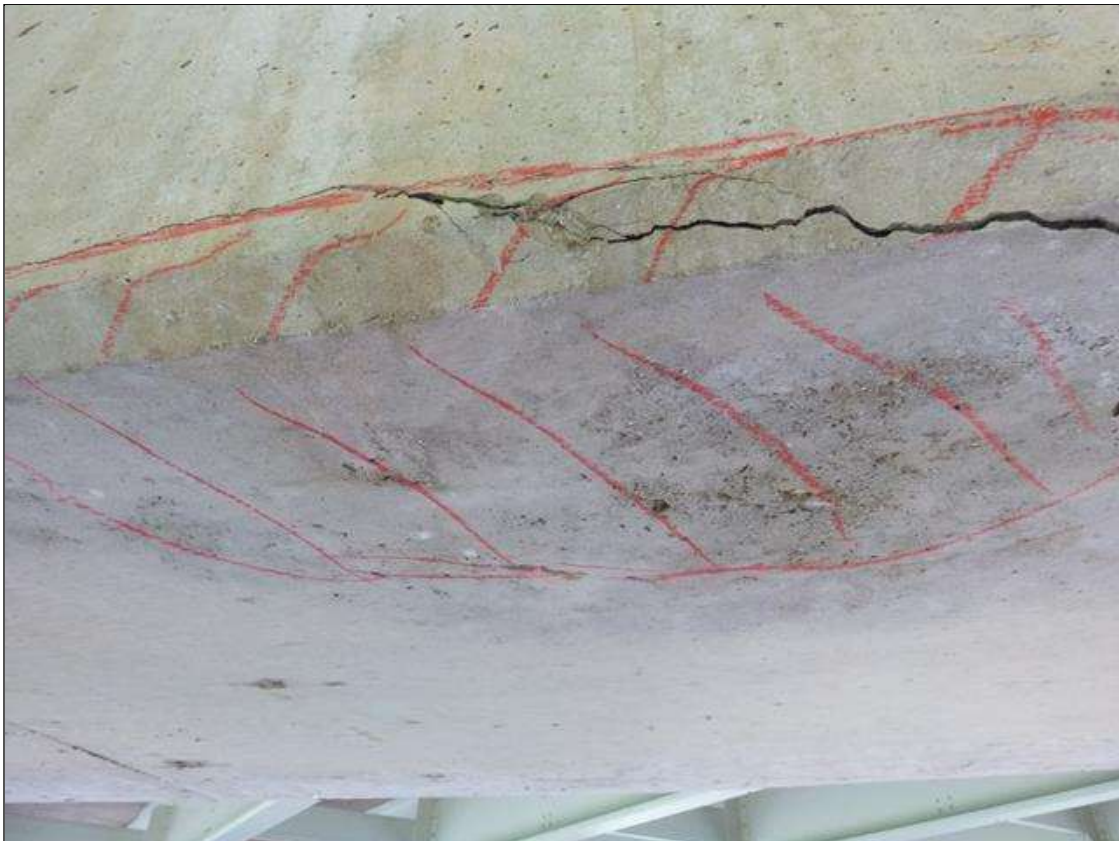
Span 2 Deck: SPAN 2, BOTTOM OF BAY 1 DECK HAS A HAIRLINE TRANSVERSE CRACK, 7 FT. LONG NEAR BENT 2 FOR A TOTAL OF 375 SQ. FT. THRU OUT THE BOTTOM OF THE SPAN

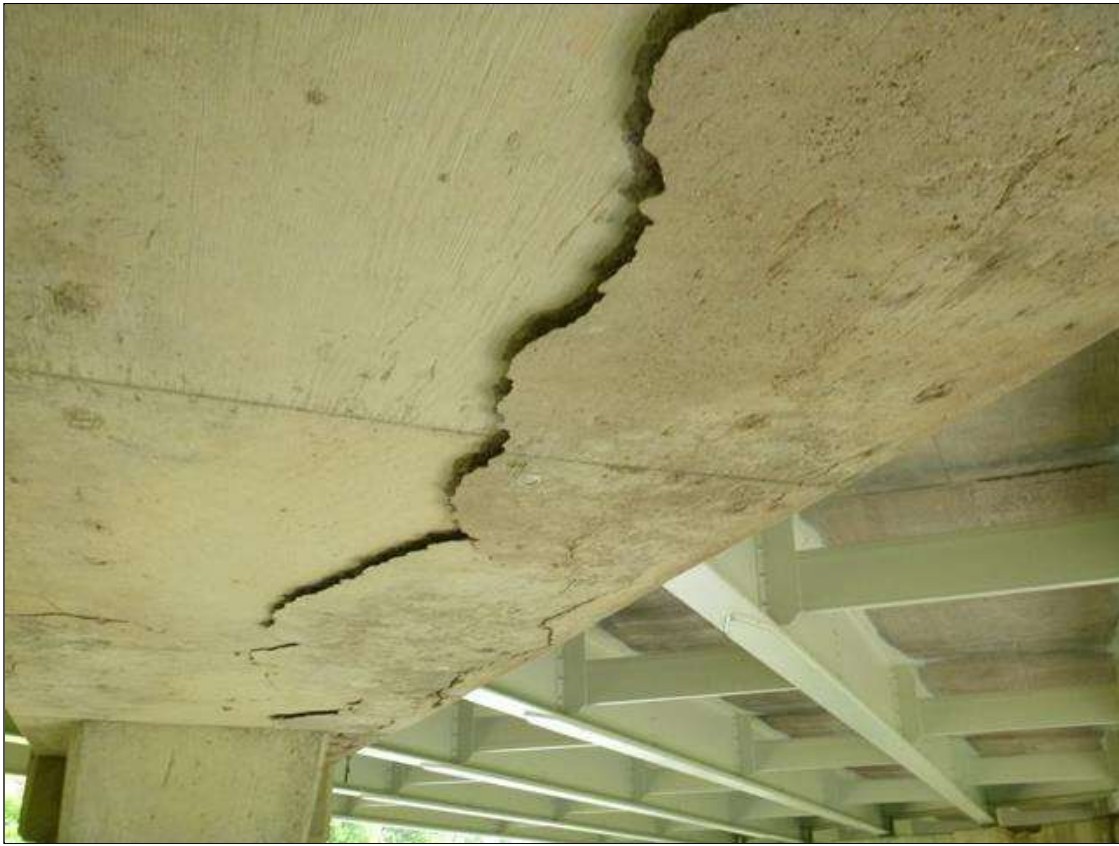
Bent 2 Cap 1: BENT 2 BOTTOM OF CAP HAS AN AREA OF DELAMINATION, 24 INCHES X 12 INCHES, BETWEEN PILES 1 AND 2, NEAR PILE 2, SPAN 2 SIDE WITH 1/8 INCH SEPARATION

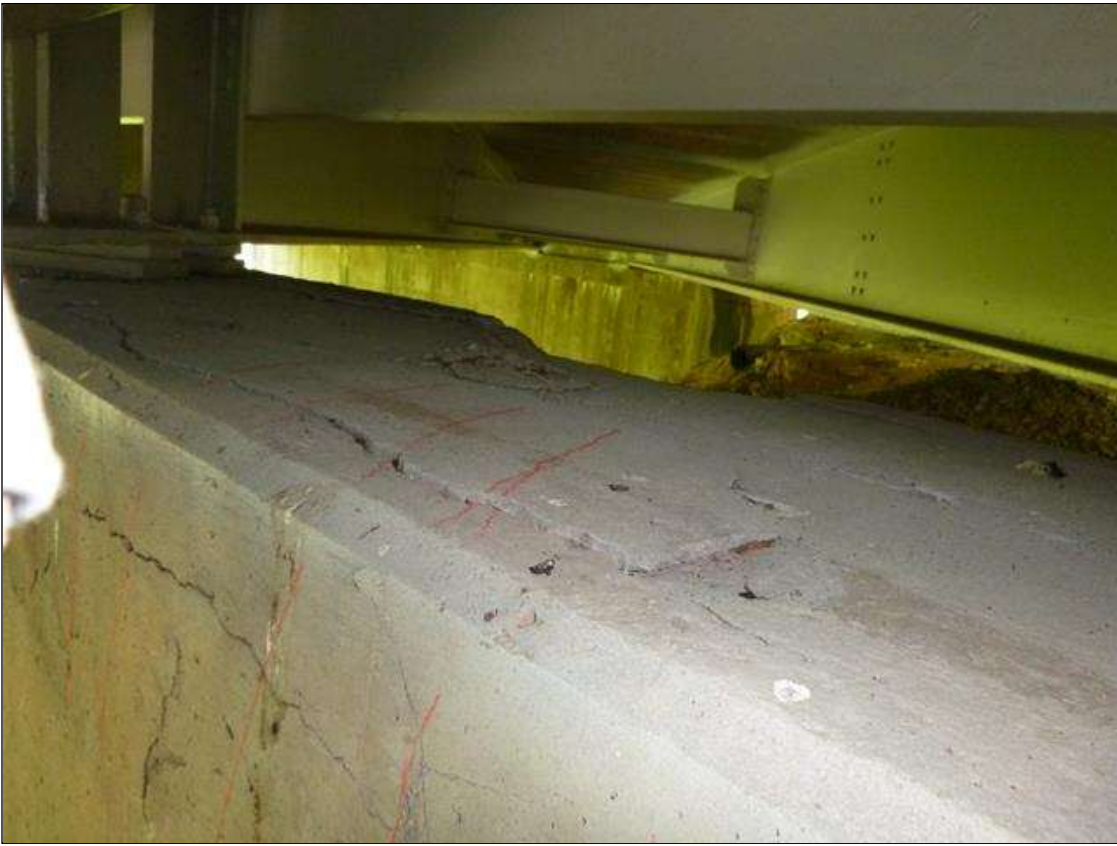
Bent 2 Cap 1: BENT 2 BOTTOM OF CAP BETWEEN PILES 3 AND 4 HAS AN AREA OF DELAMINATION, 12 FT. X 36 INCHES WITH 5/8 INCH SEPARATION

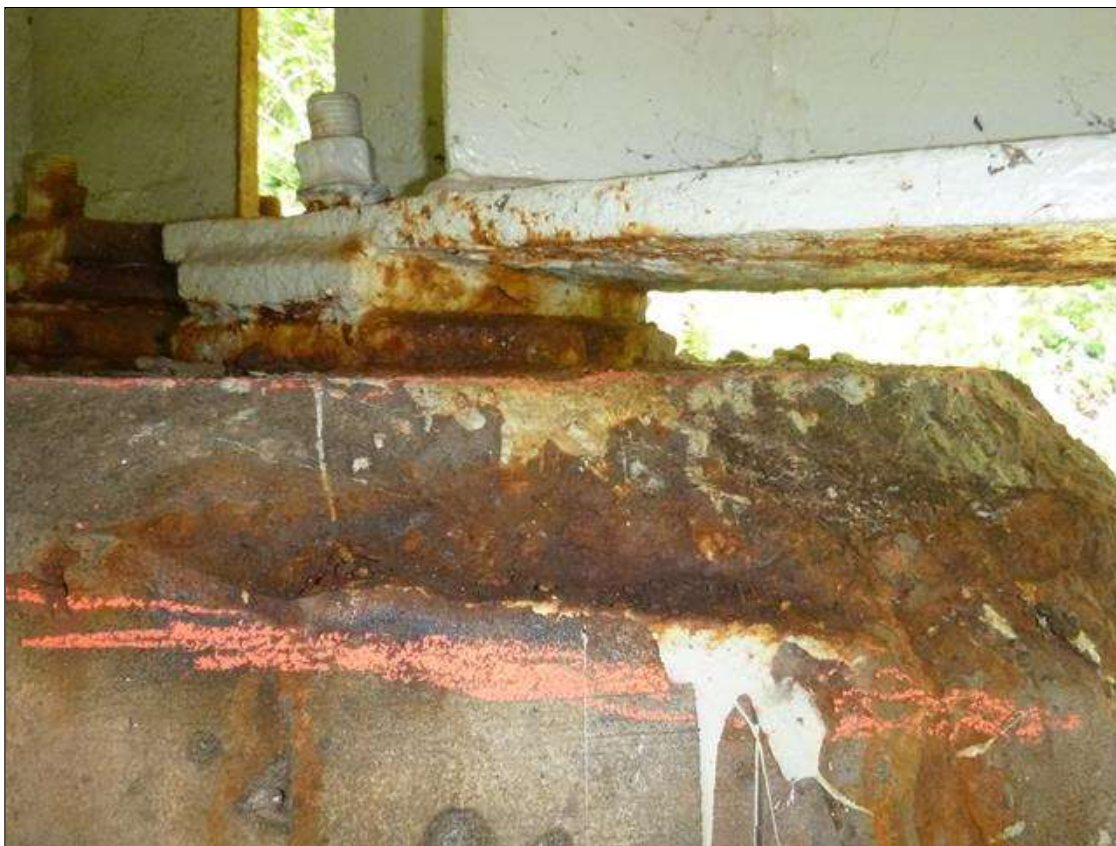
Bent 1 Cap 1: BENT 1 CAP, SPAN 2 SIDE HAS AN AREA OF DELAMINATION IN THE FACE OF THE CAP, NEAR TOP EDGE IN BAY 1, NEAR BEAM 2, 32 INCHES LONG X 9 INCHES DOWN THE FACE X 3 INCHES ACROSS THE TOP

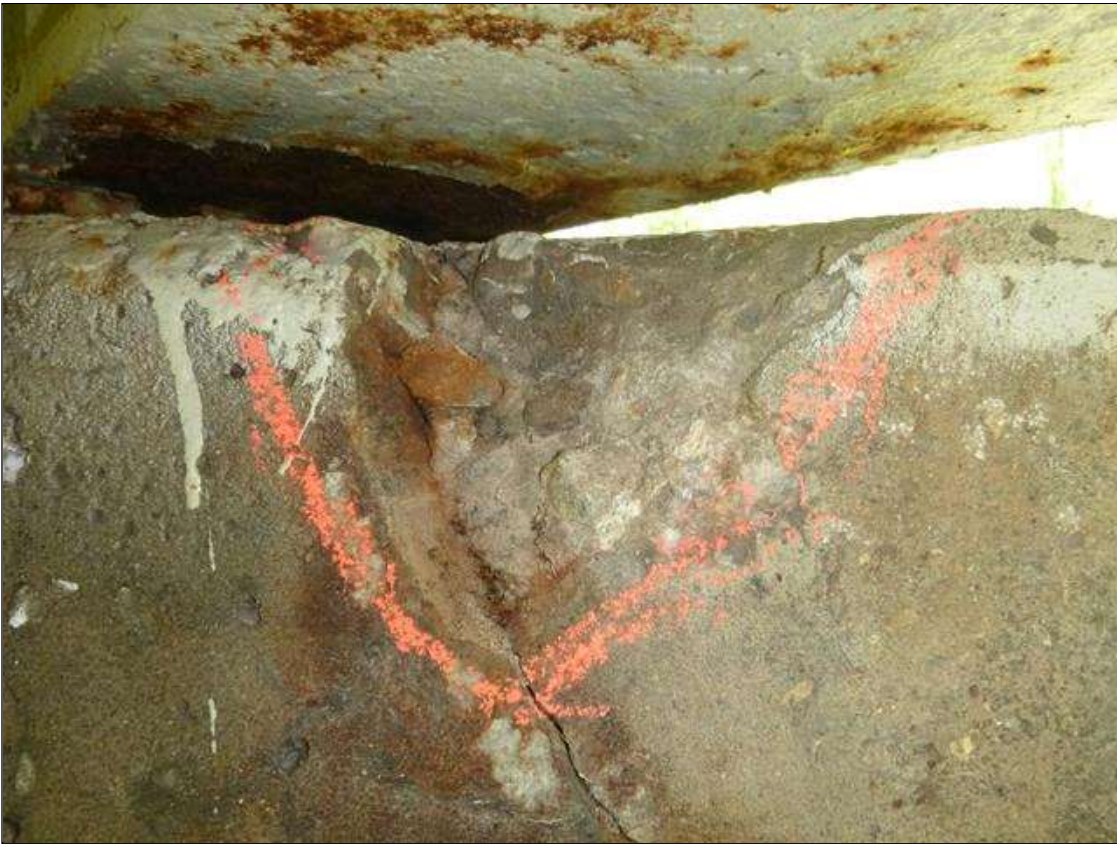
Bent 4 Cap 1: BENT 4 CAP, SPAN 4 SIDE UNDER BEAM 1 HAS A SPALL IN THE FACE OF THE CAP, 7 INCHES X 6 INCHES X 3 INCHES DEEP AT TOP EDGE

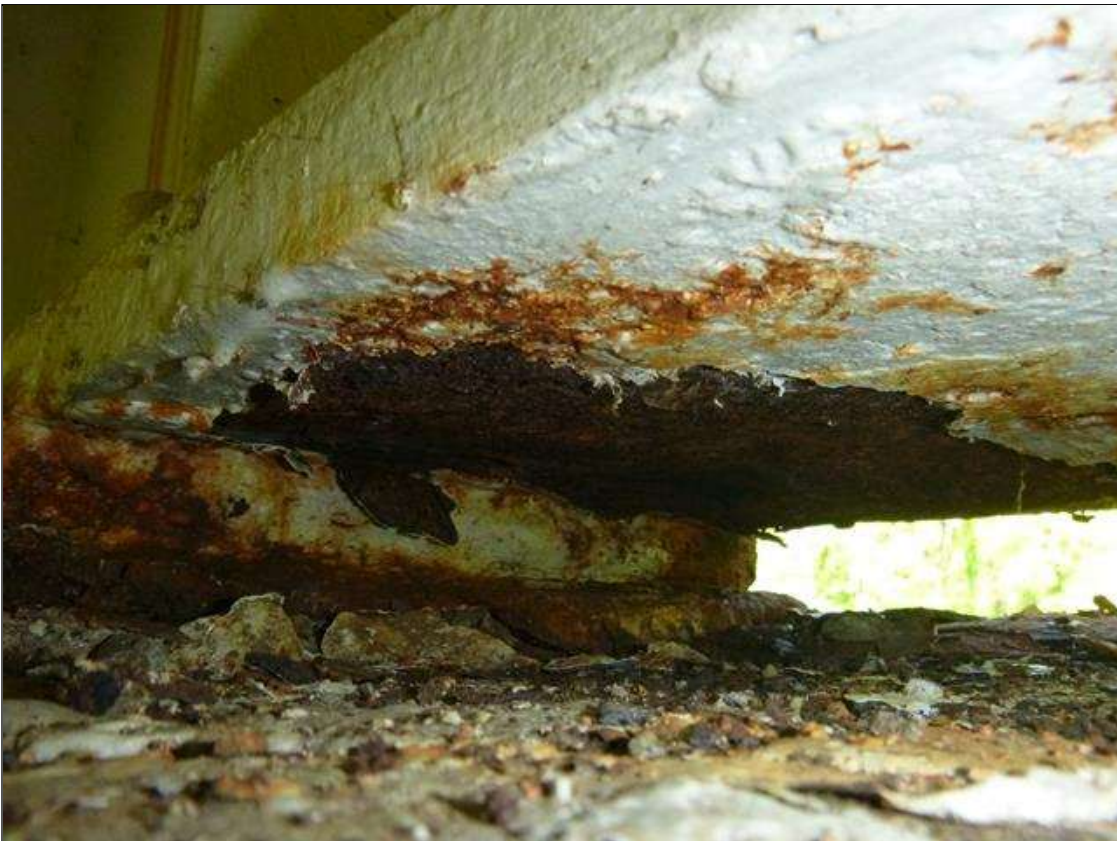
Span 5 Beam 1: SPAN 5, BEAM 1 AT BENT 4 HAS 1/4 INCH SECTION LOSS ON THE BOTTOM OF THE BOTTOM FLANGE, FROM FACE OF BEARING OUT 8 INCHES, X 8 INCHES WIDE WITH 3/4 INCH REMAINING

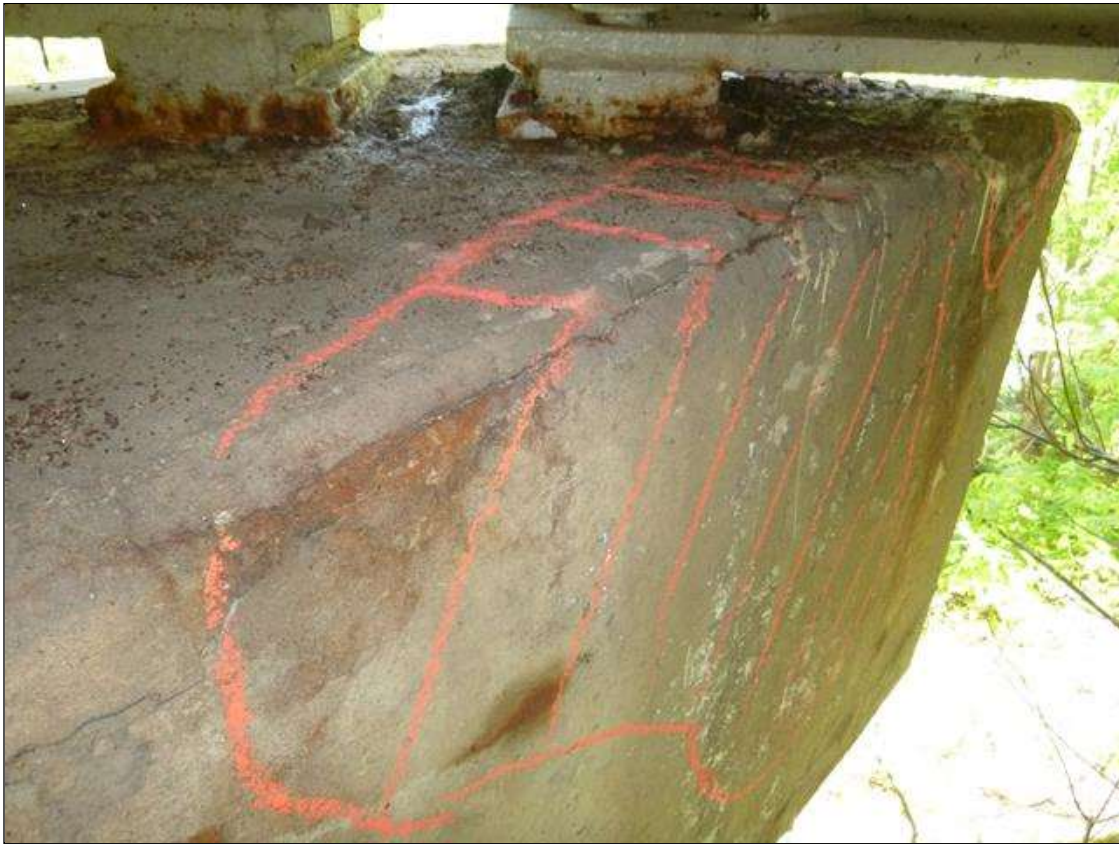
Bent 4 Cap 1: BENT 4 CAP, SPAN 5 SIDE HAS AN AREA OF DELAMINATION IN THE FACE OF THE CAP UNDER BEAM 1, 28 INCHES X 26 INCHES X 7 INCHES ACROSS THE TOP OF THE CAP, ADJACENT TO BEAM 1 BEARING WITH 1/8 INCH SEPARATION

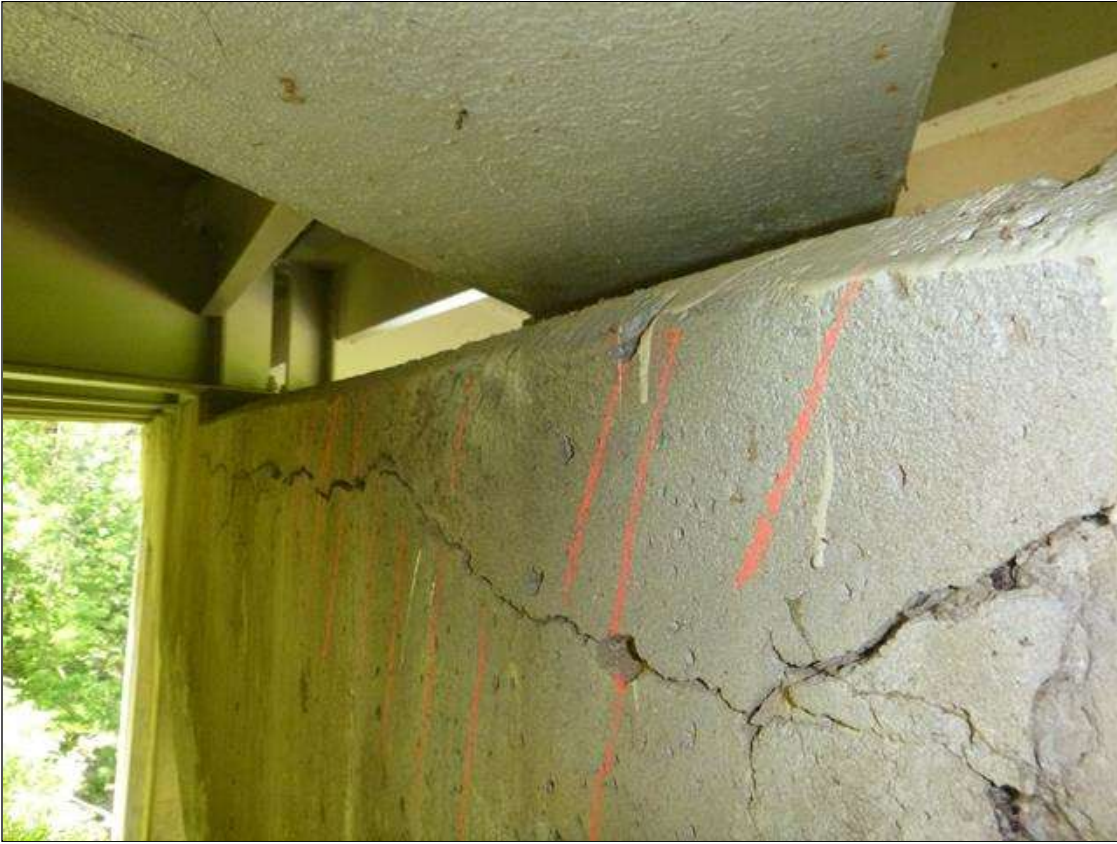
Bent 4 Cap 1: BENT 4 CAP, SPAN 5 SIDE HAS AN AREA OF DELAMINATION IN THE FACE OF THE CAP UNDER BEAM 3 AND BAY 3, 10 FT. LONG X 10 INCHES DOWN THE FACE X 4 INCHES ACROSS THE TOP ADJACENT TO BEAM 3 BEARING WITH 1/4 INCH SEPARATION

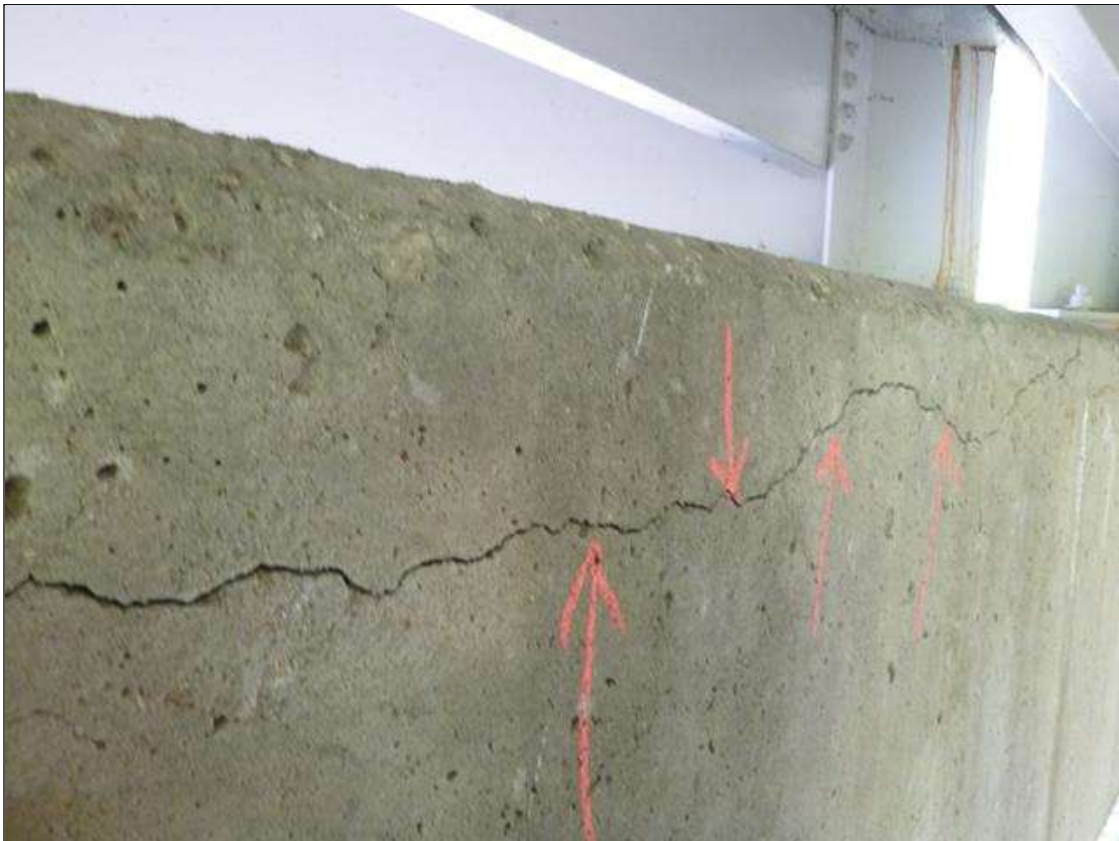
Bent 4 Cap 1: BENT 4 CAP, SPAN 5 SIDE, BAY 1 HAS A 1/16 INCH WIDE LONGITUDINAL CRACK, 7 FT. LONG NEAR TOP EDGE WITH RUST STAINS AND DELAMINATION

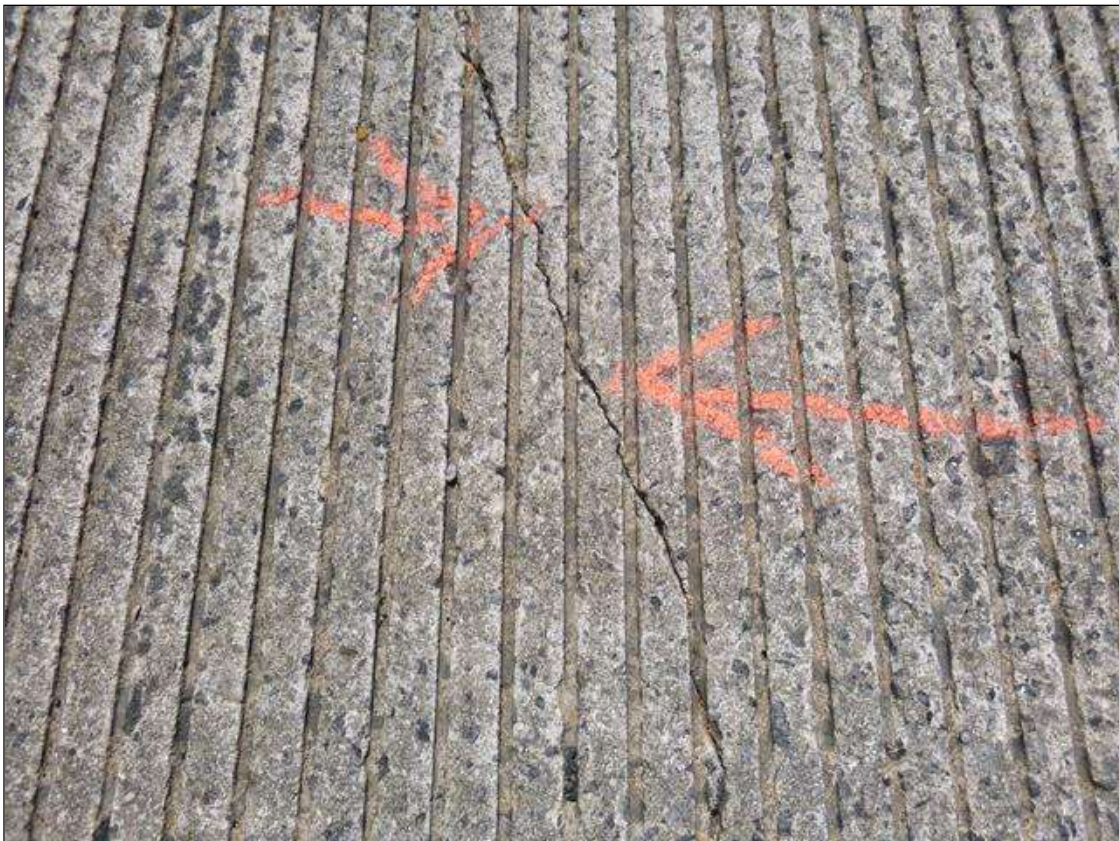
Span 1 Deck: SPAN 1 TOP OF THE DECK HAS A 1/16 INCH WIDE TRANSVERSE CRACK AT THE 3/4 POINT, 12 FT. LONG FOR A TOTAL OF 100 SQ. FT. THRU OUT THE WEST AND EAST BOUND LANES

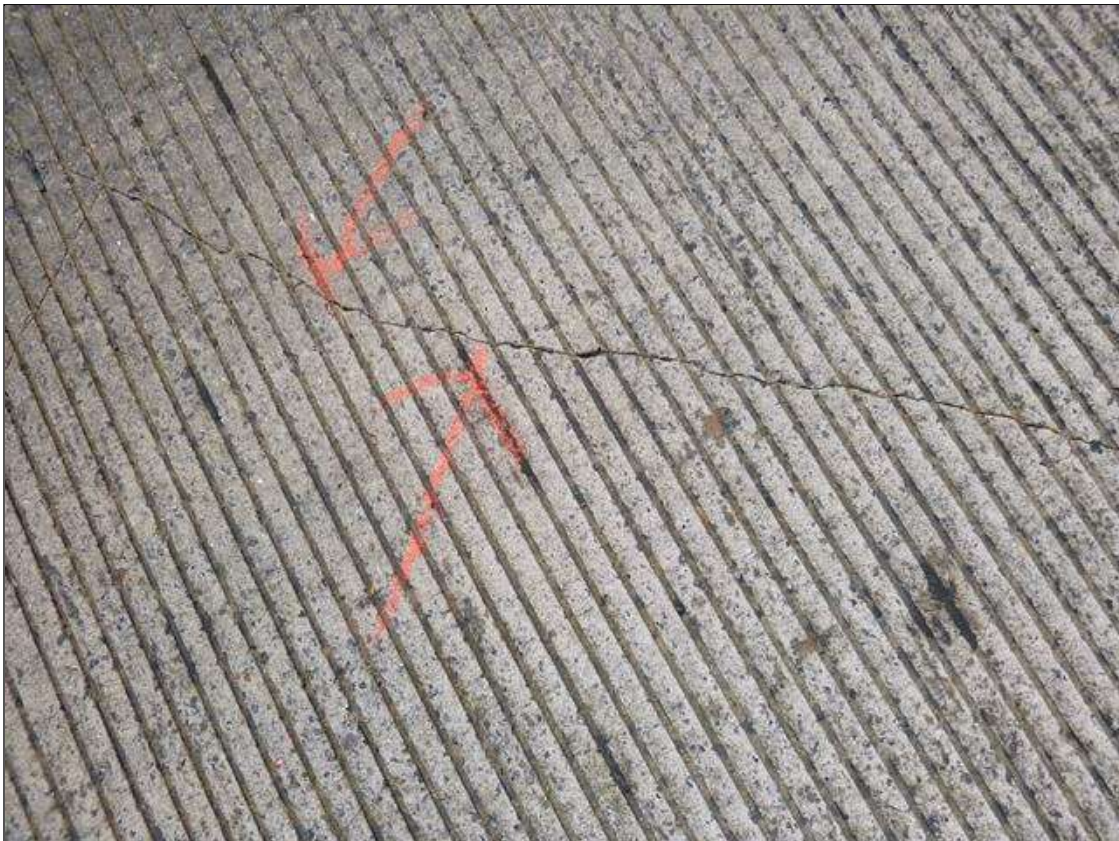
Span 3 Deck: SPAN 3 TOP OF THE DECK HAS A 1/16 INCH WIDE DIAGONAL CRACK, STARTING AT BENT 2, 14 FT. LONG FOR A TOTAL OF 350 SQ. FT. THRU OUT THE SPAN, WEST AND EAST BOUND LANES

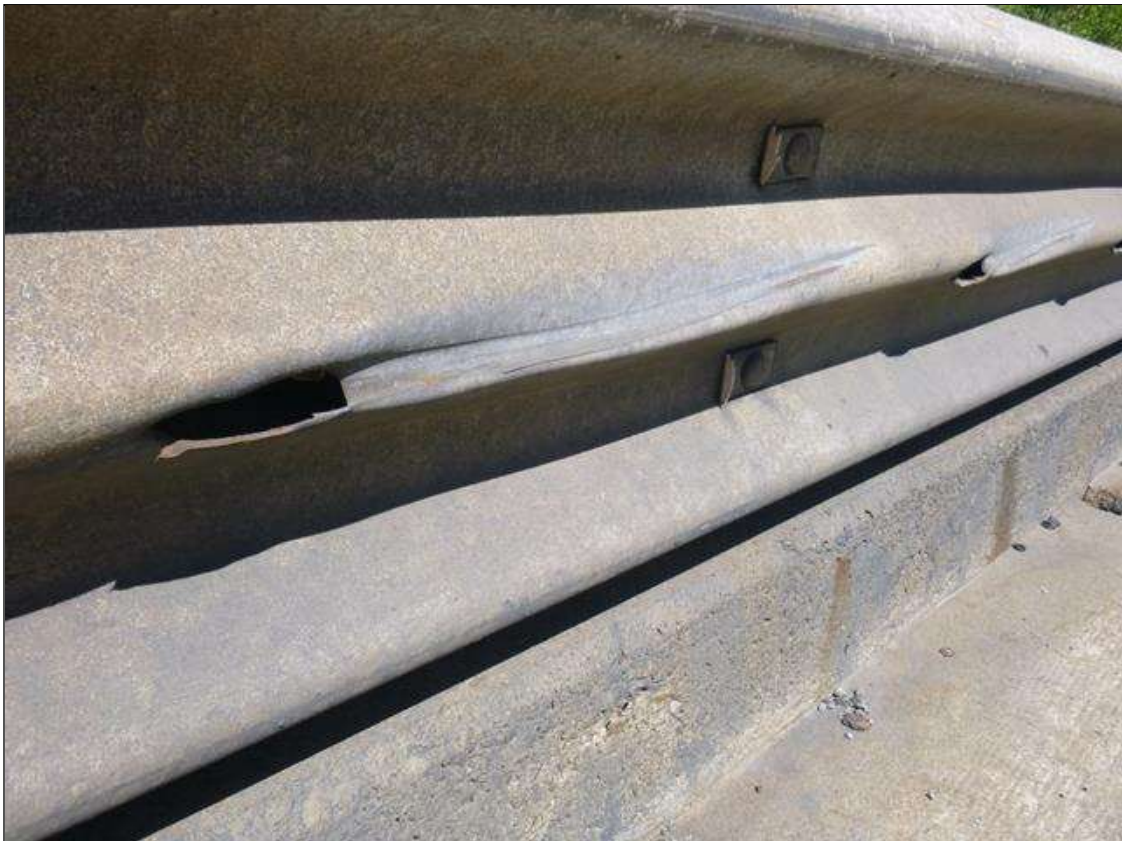
Span 3 Left Bridge Rail: SPAN 3 LEFT RAIL HAS 12 FT. OF 2 INCH WIDE TEARS THRU OUT THE RAIL

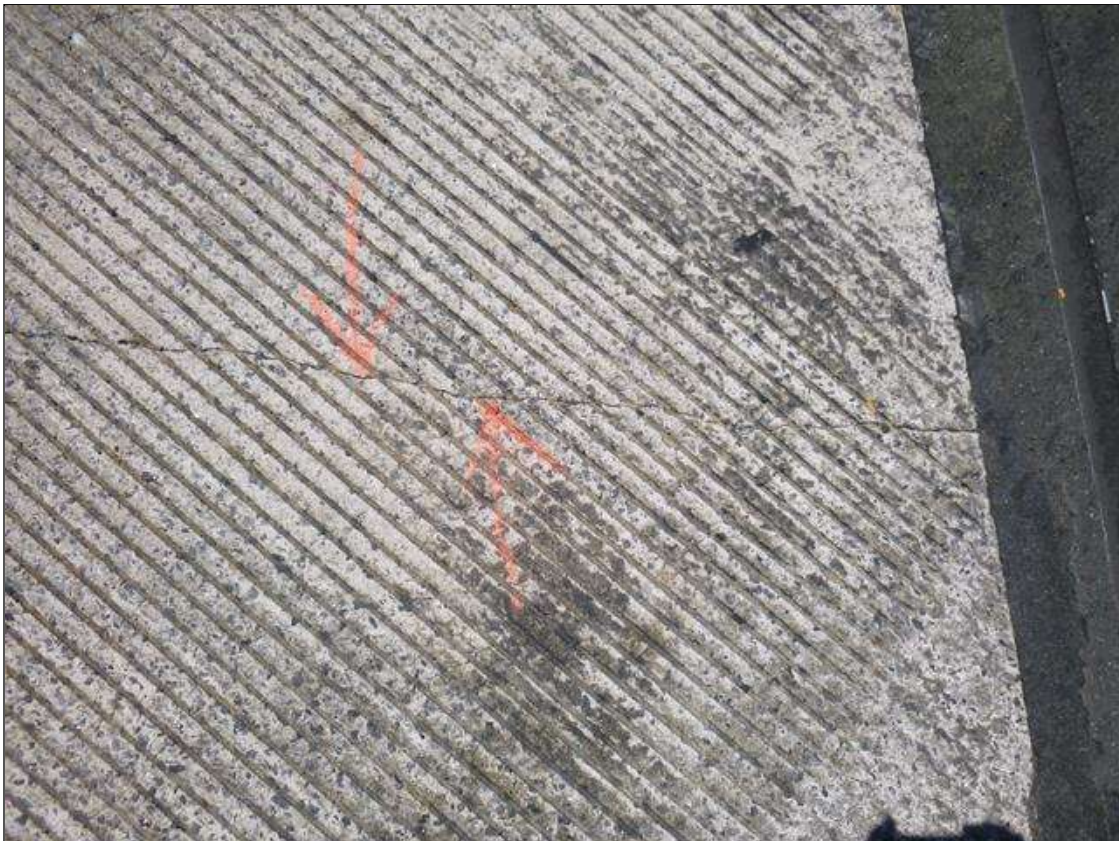
Span 4 Deck: SPAN 4 TOP OF THE DECK HAS A 1/16 INCH WIDE DIAGONAL CRACK, STARTING AT BENT 3, 7 FT. LONG FOR A TOTAL OF 370 SQ. FT. THRU OUT THE TOP OF THE WEST AND EAST BOUND LANES

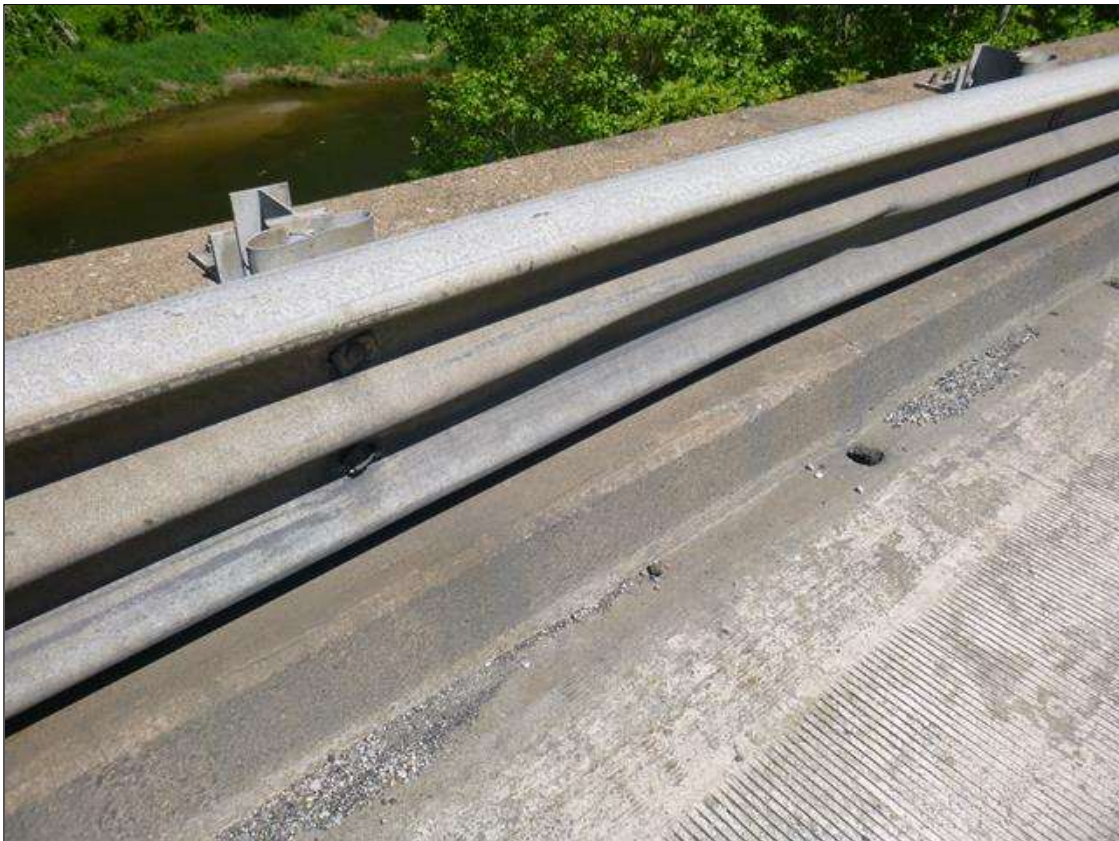
Span 4 Left Bridge Rail: SPAN 4, LEFT RAIL HAS 25 FT. OF IMPACT DAMAGE, RAIL IS PUSHED OUT 3.5 INCHES, STARTING AT BENT 4

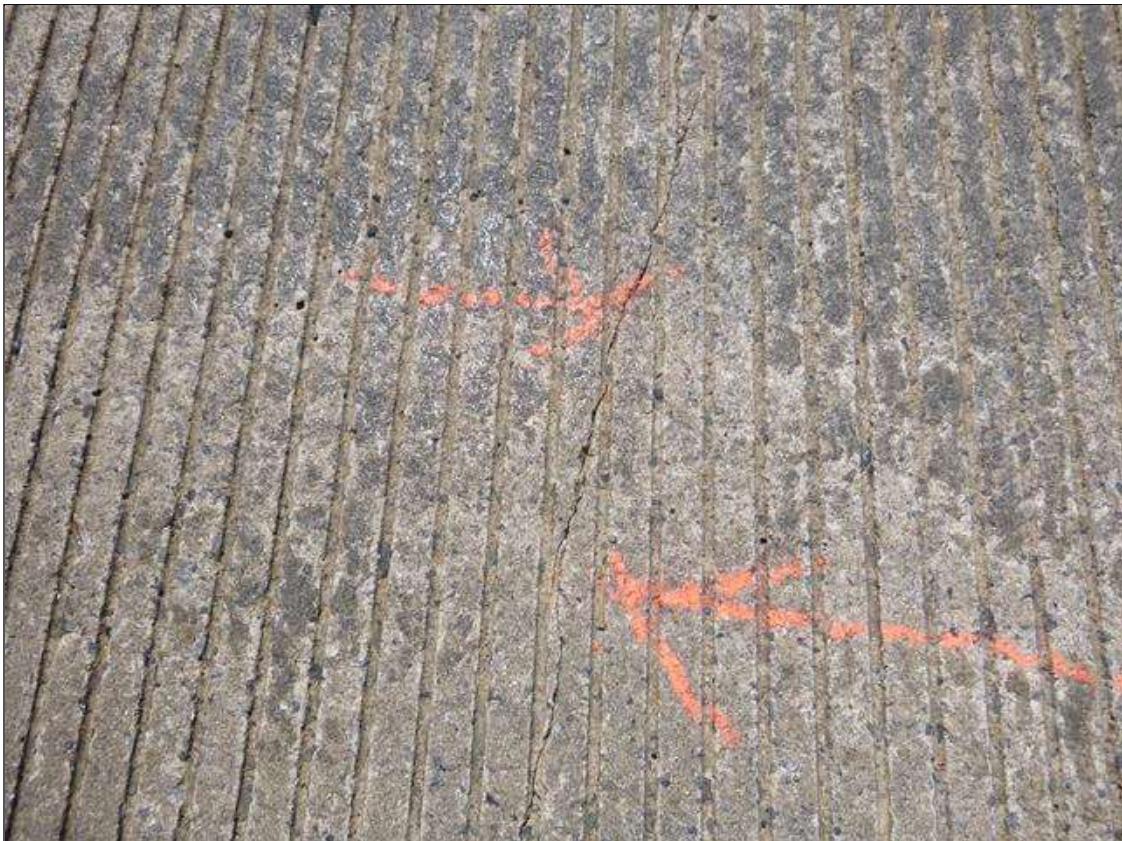
Span 5 Deck: SPAN 5 TOP OF THE DECK HAS A 1/16 INCH WIDE TRANSVERSE CRACK AT 1/3 POINT, 12 FT. LONG FOR A TOTAL OF 580 SQ. FT. THRU OUT THE WEST AND EAST BOUND LANES

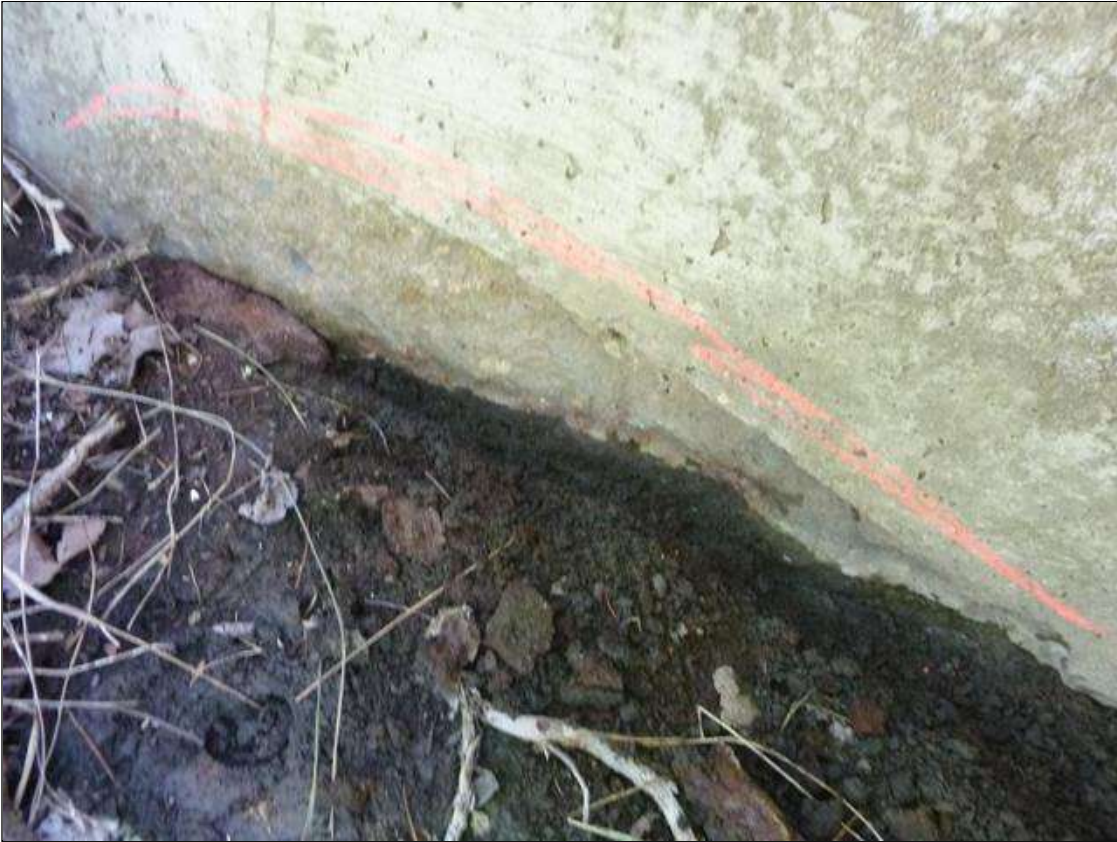
End Bent 2 Abutment/Backwall : END BENT 2 ABUTMENT HAS A SPALL, 32 INCHES LONG X 8 INCHES HIGH X 1 INCH DEEP AT THE LEFT SIDE OF BEAM 1
