## Structure Safety Report

### Routine Element Inspection - Contract

COUNTY: HAYWOOD STRUCTURE NUMBER: 430142 FREQUENCY: 24 MONTHS

FEATURE INTERSECTED: PIGEON RIVER

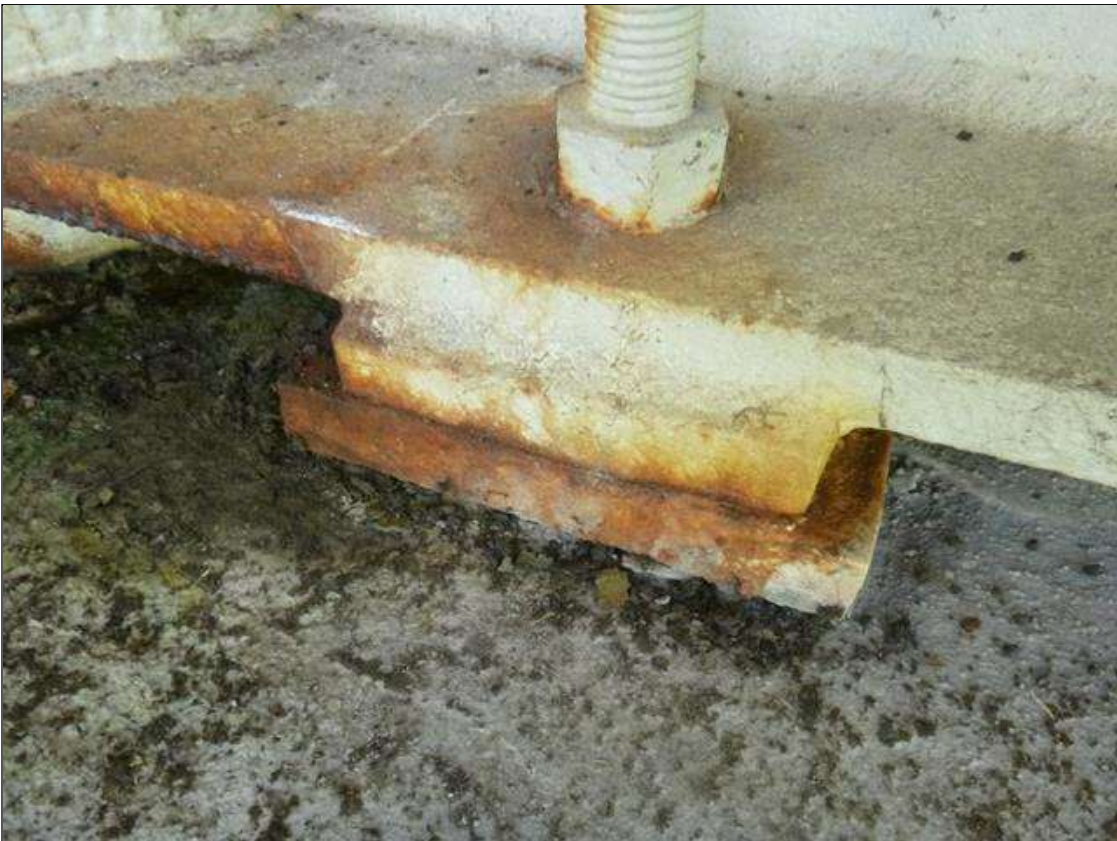
Span 5 Beam 1 Far Bearing: SPAN 5, BEAM 1 FAR BEARING HAS FRECKLED RUST

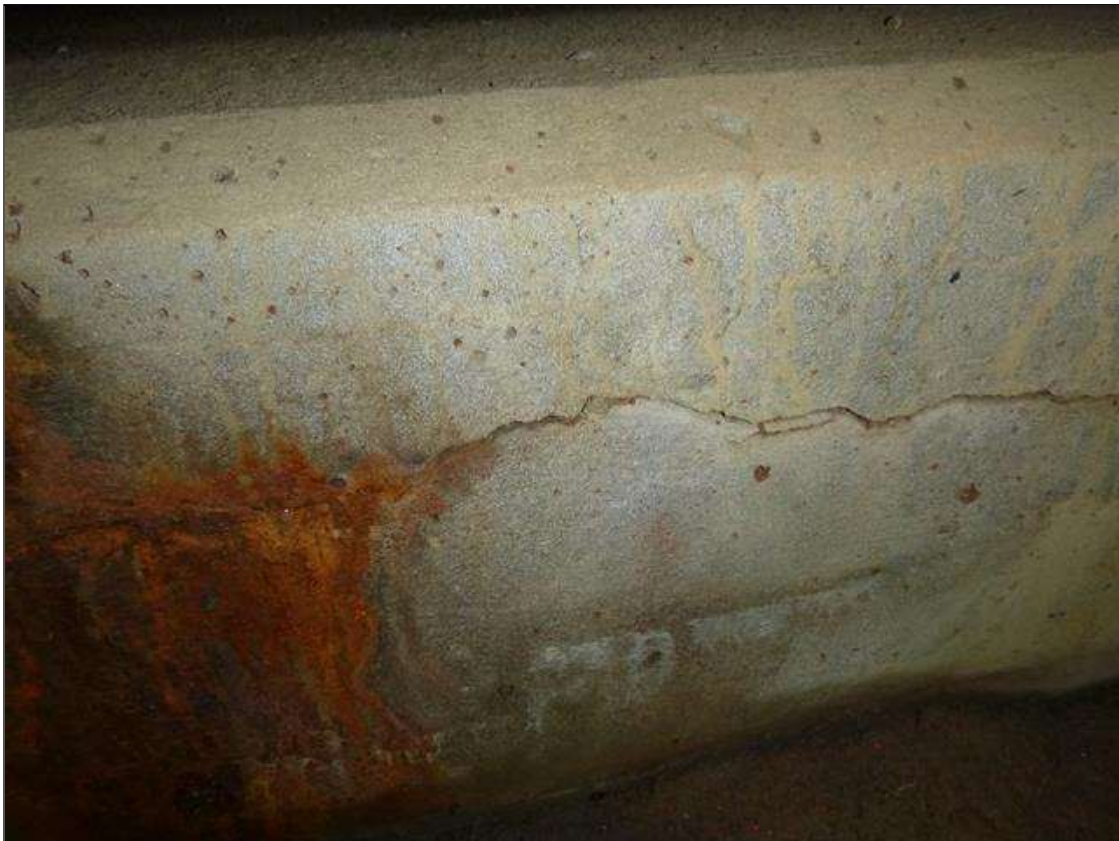
End Bent 2 Cap 1: END BENT 2, BAY 2 CAP HAS A 1/8 INCH WIDE LONGITUDINAL CRACK, 5 FT. LONG NEAR TOP EDGE IN THE FACE OF THE CAP

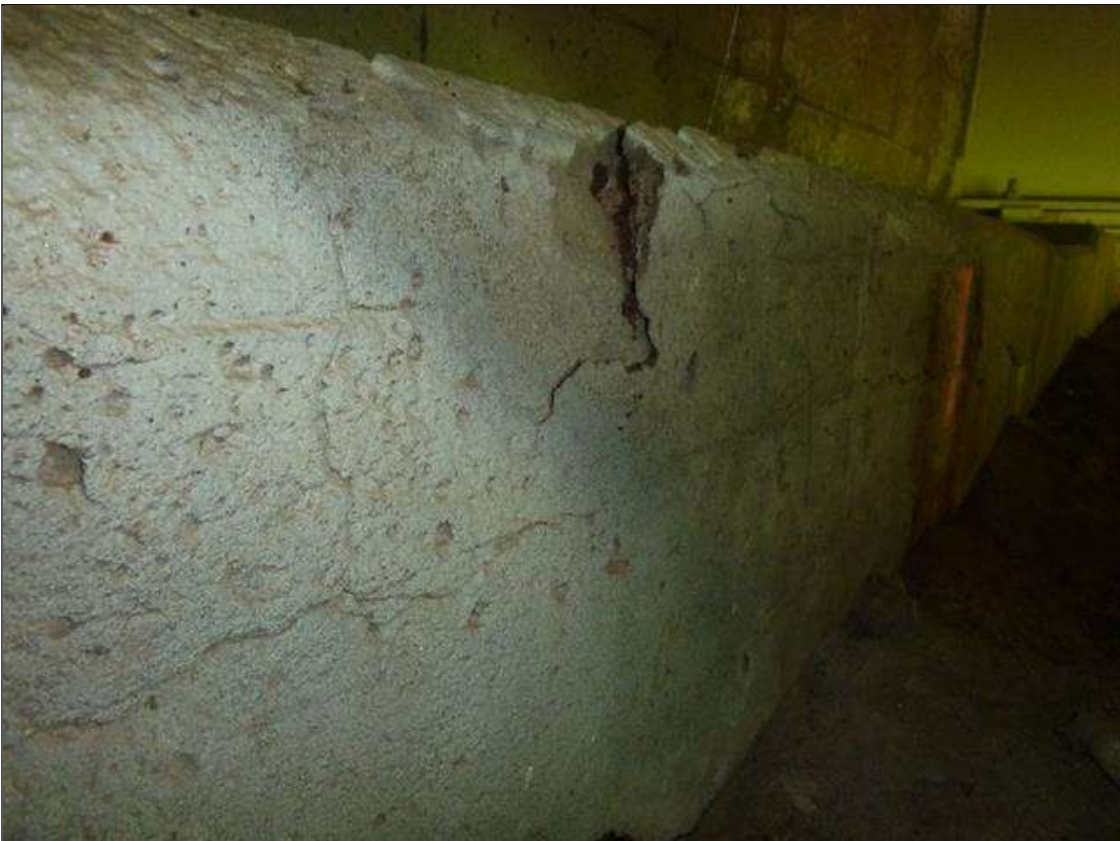
End Bent 2 Cap 1: END BENT 2 FACE OF CAP HAS A 1/16 INCH WIDE LONGITUDINAL CRACK IN BAYS 3 AND 4, 10 FT. LONG WITH RUST STAINS

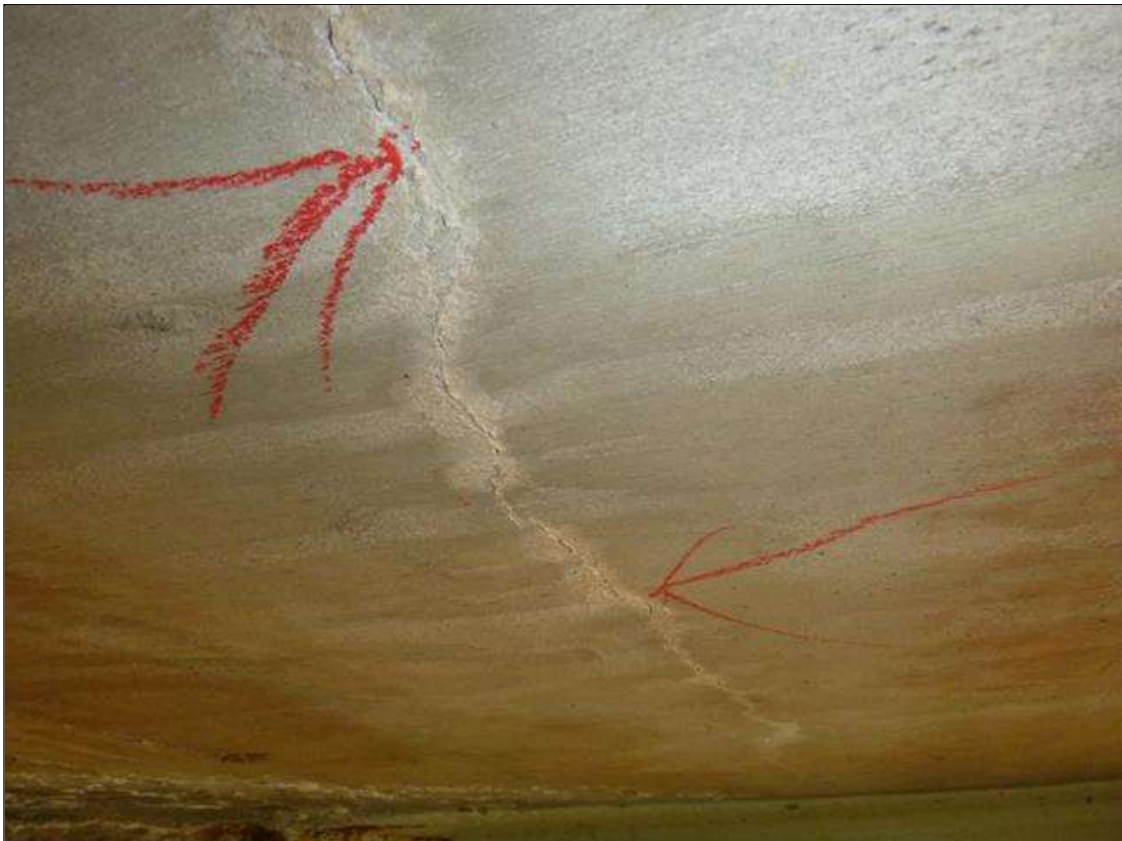
Span 5 Deck: SPAN 5 BOTTOM OF BAY 7 DECK HAS A HAIRLINE TRANSVERSE CRACK, 7 FT. LONG, 3 FT. FROM END BENT 2, FOR A TOTAL OF 200 SQ. FT. THRU OUT THE BOTTOM OF THE SPAN

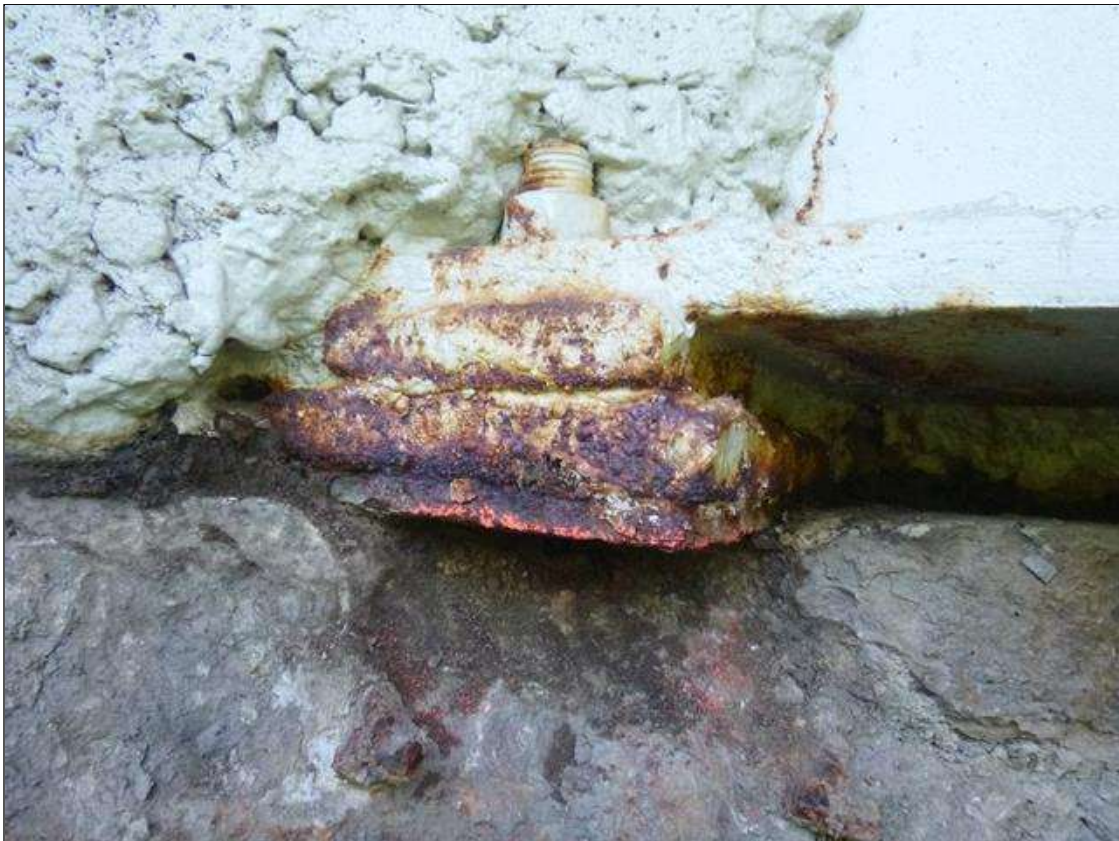
Span 1 Beam 8 Near Bearing: SPAN 1, BEAM 8 NEAR BEARING HAS FRECKLED RUST

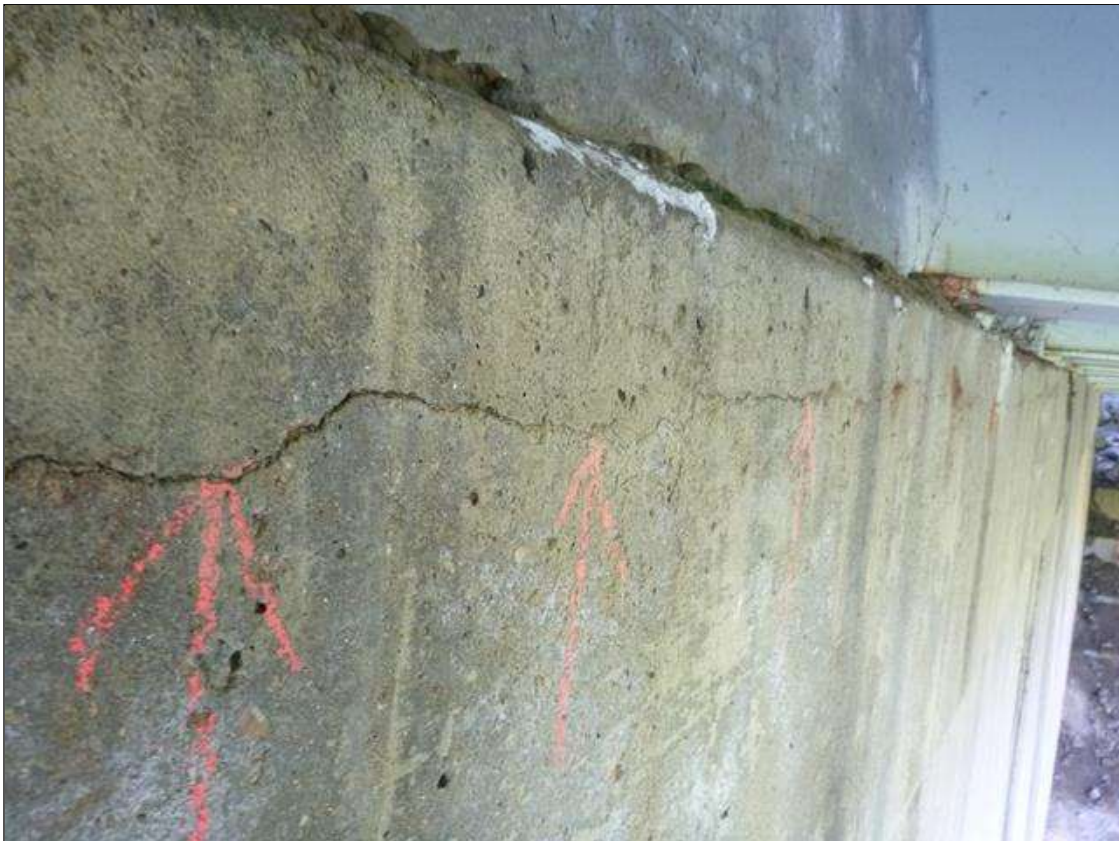
End Bent 1 Abutment/Backwall : END BENT 1 ABUTMENT HAS A 1/8 INCH WIDE LONGITUDINAL CRACK , 36 FT. LONG, 4 INCHES DOWN FROM TOP OF BRIDGE SEAT, FROM BEAM 5 TO BEAM 8 WITH DELAMINATION

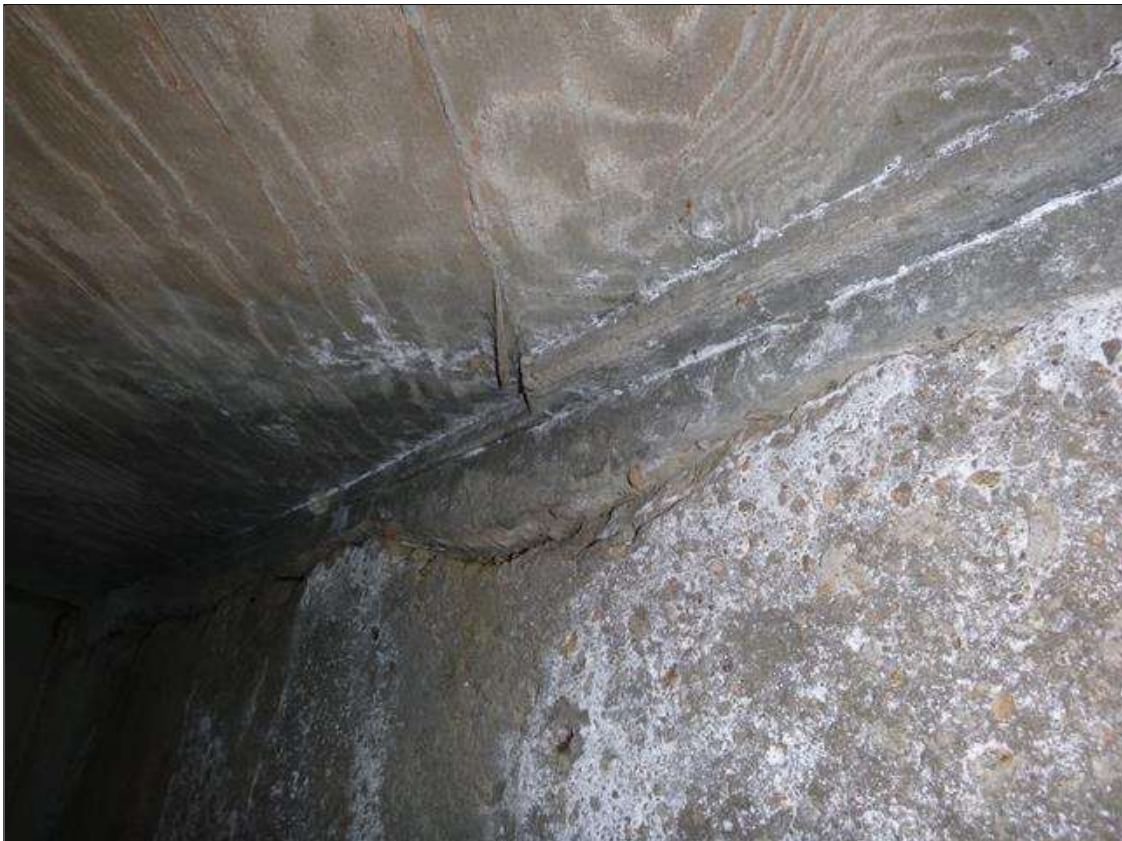
End Bent 1 Abutment/Backwall : END BENT 1 ABUTMENT BACK WALL IN BAY 3 HAS A 1 INCH WIDE LONGITUDINAL CRACK, 10 FT. LONG, 4 INCHES BELOW THE BOTTOM OF THE DECK

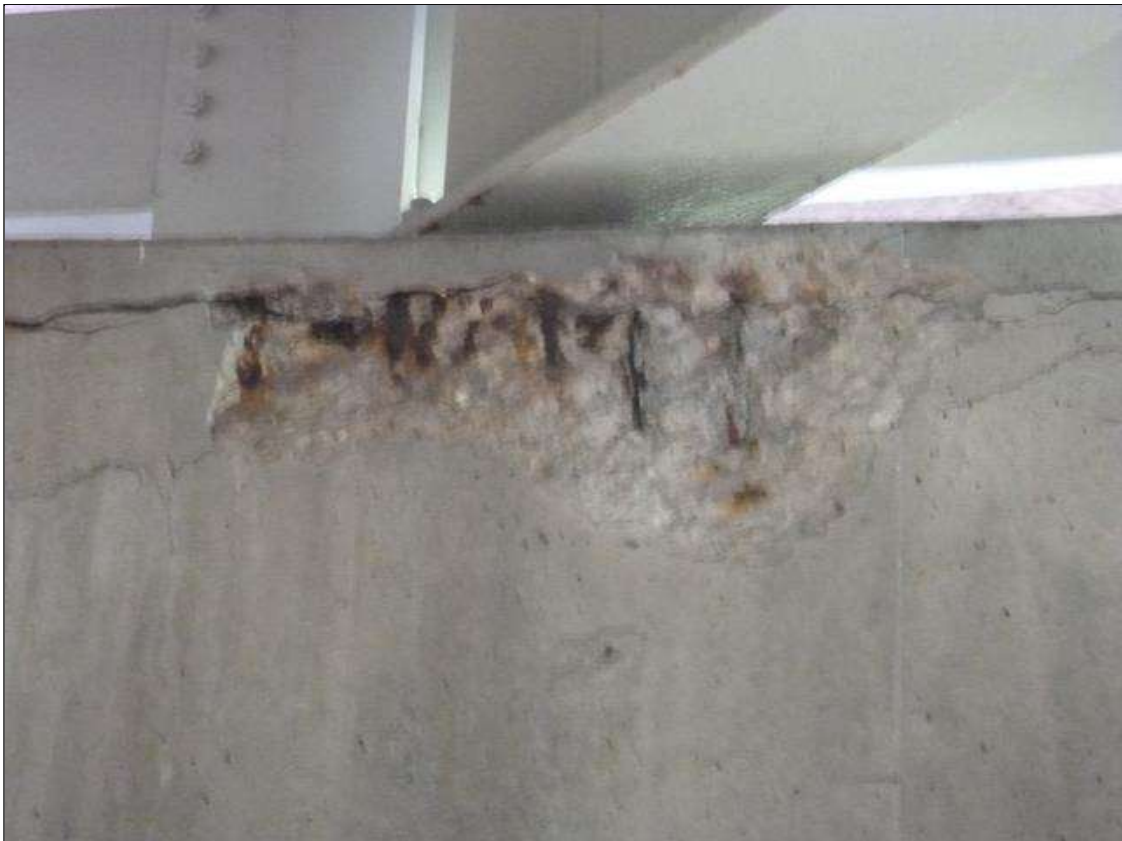
Bent 1 Cap 1: BENT 1 CAP, SPAN 1 SIDE UNDER BEAM 3 HAS A SPALL IN THE FACE OF THE CAP, 38 INCHES LONG X 16 INCHES HIGH X 3 INCHES DEEP WITH REBAR EXPOSED WITH ADJACENT DELAMINATION

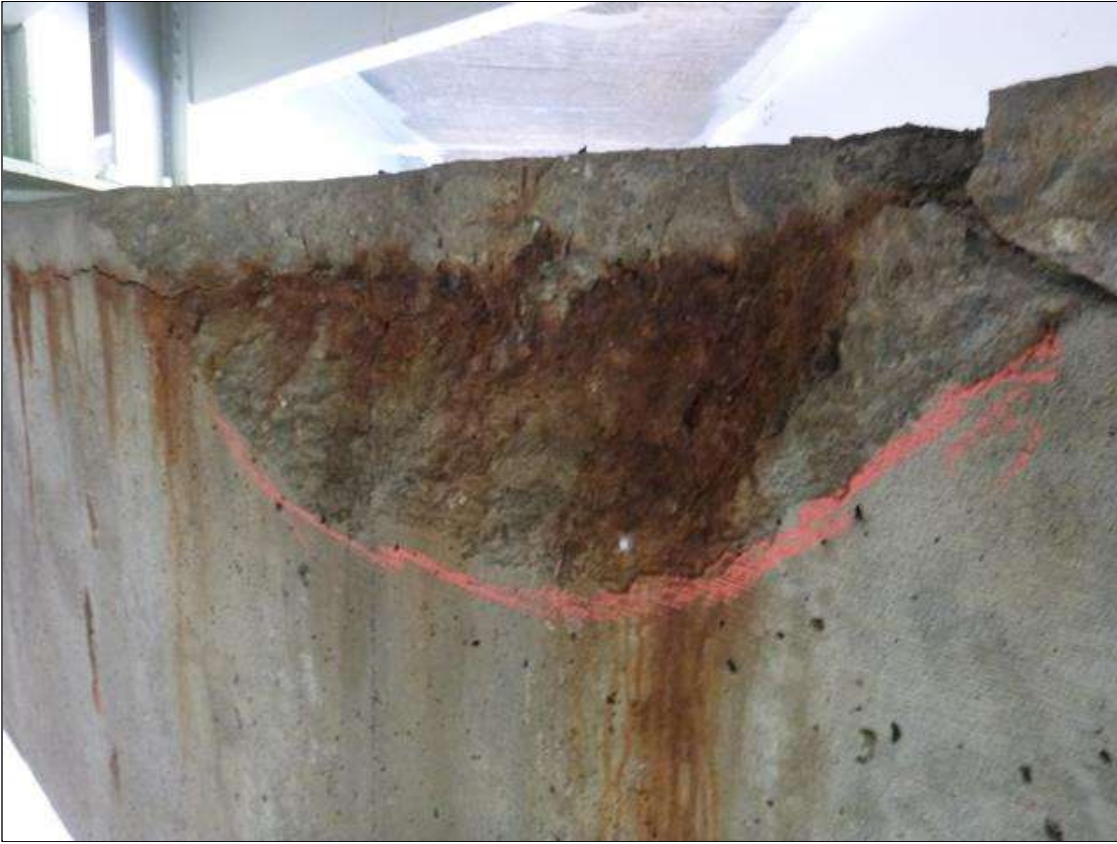
Bent 1 Cap 1: BENT 1 CAP, SPAN 1 SIDE HAS A SPALL IN THE FACE OF THE CAP IN BAY 4, NEAR TOP EDGE, 46 INCHES LONG X 11 INCHES HIGH X 2.5 INCHES DEEP WITH EXPOSED REBAR, WITH ADJACENT DELAMINATION IN THE FACE AND 4 INCHES ACROSS TOP OF CAP

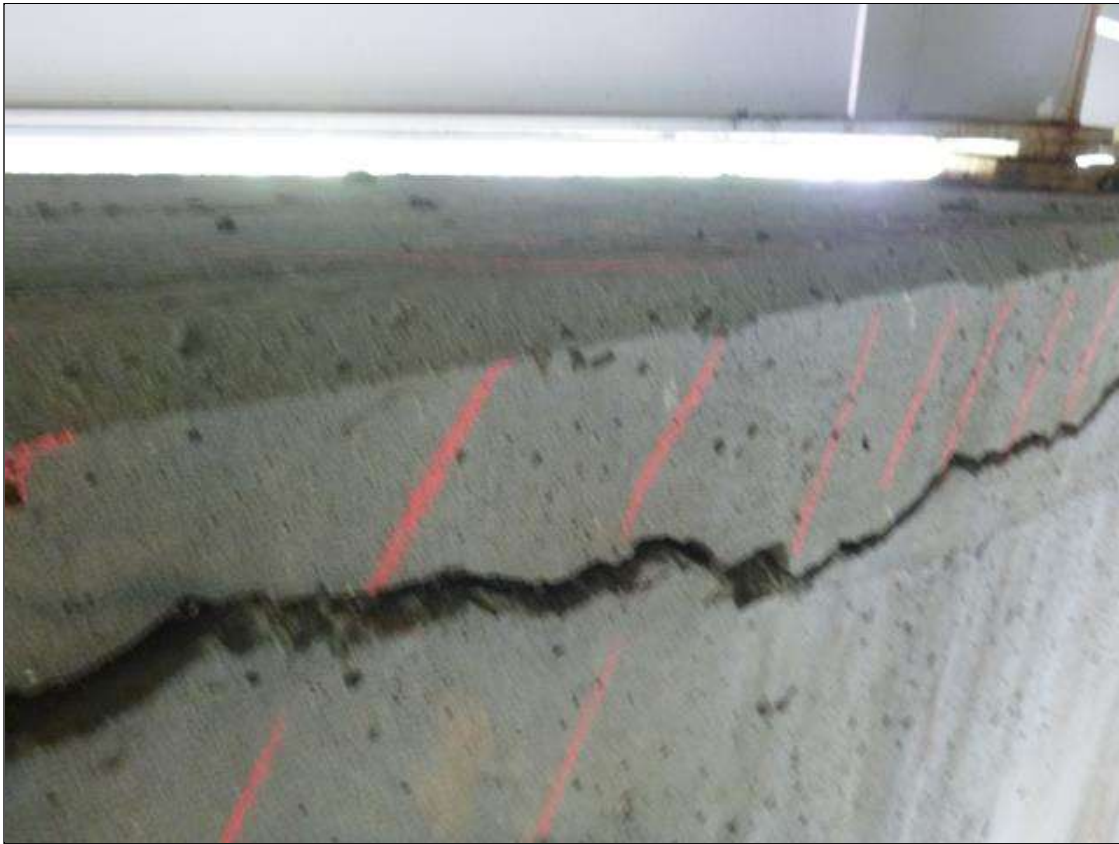
Bent 1 Cap 1: BENT 1 CAP, SPAN 1 SIDE, TOP AND FACE IN BAY 4 HAS AN AREA OF DELAMINATION, 7 FT. LONG X 12 INCHES HIGH ON THE FACE X 17 INCHES ACROSS THE TOP OF THE CAP, WITH 3/4 INCH SEPARATION

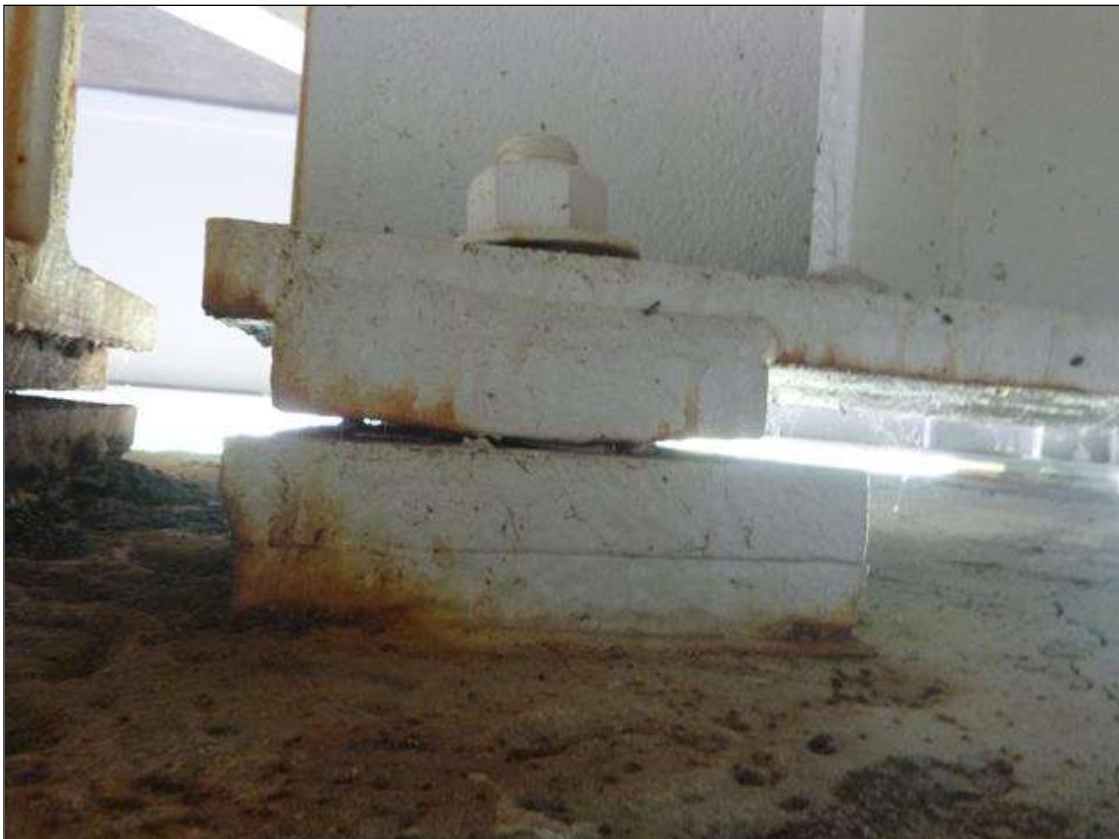
Span 1 Beam 6 Far Bearing: SPAN 1, BEAM 6 FAR BEARING HAS FRECKLED RUST

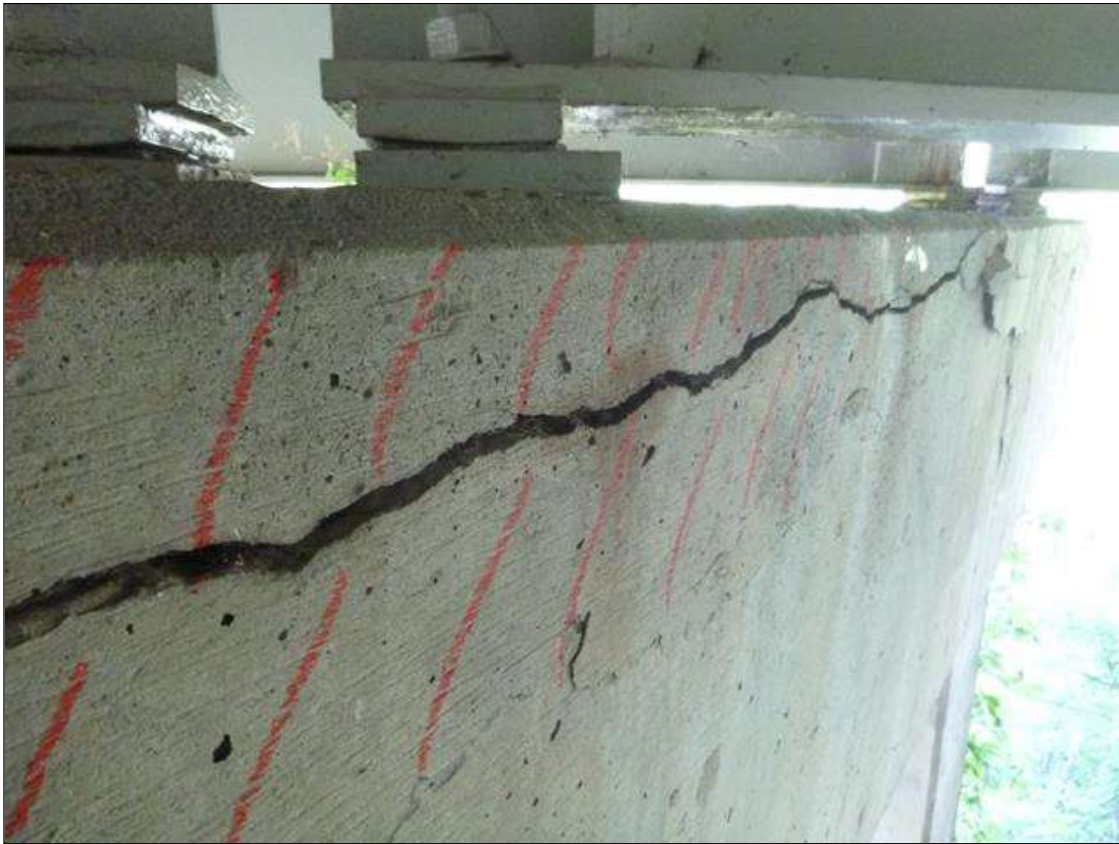
Bent 1 Cap 1: BENT 1 CAP, SPAN 1 SIDE, UNDER BEAMS 7 AND 8, NEAR TOP EDGE HAS AN AREA OF DELAMINATION IN THE FACE OF THE CAP, 15 FT. LONG X UP TO 18 INCHES HIGH X 5 INCHES ACROSS THE TOP WITH 1/2 INCH SEPARATION, BEAM 7 BEARING AREA IS DELAMINATED

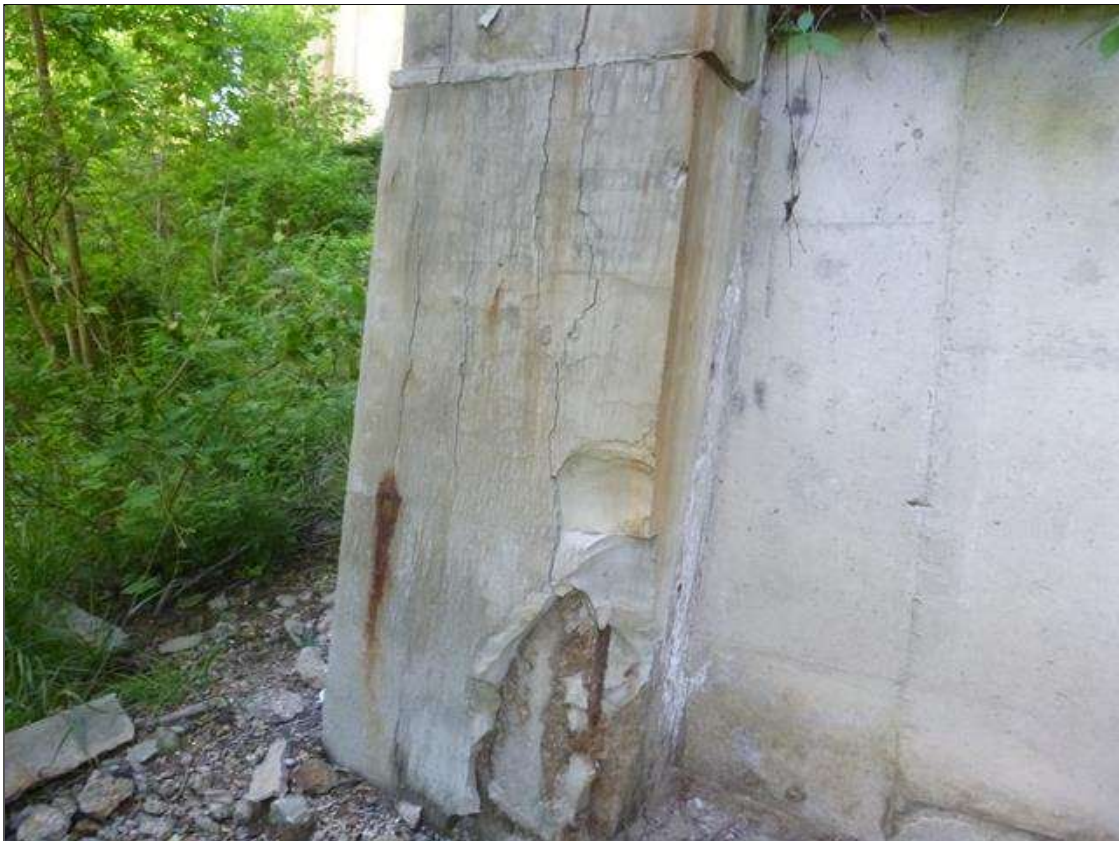
Bent 1 Pile 5: BENT 1, PILE 5 HAS A PATCHED AREA ON THE EAST FACE, 34 INCHES WIDE X 10 FT. HIGH WITH 1 INCH WIDE VERTICAL CRACKS

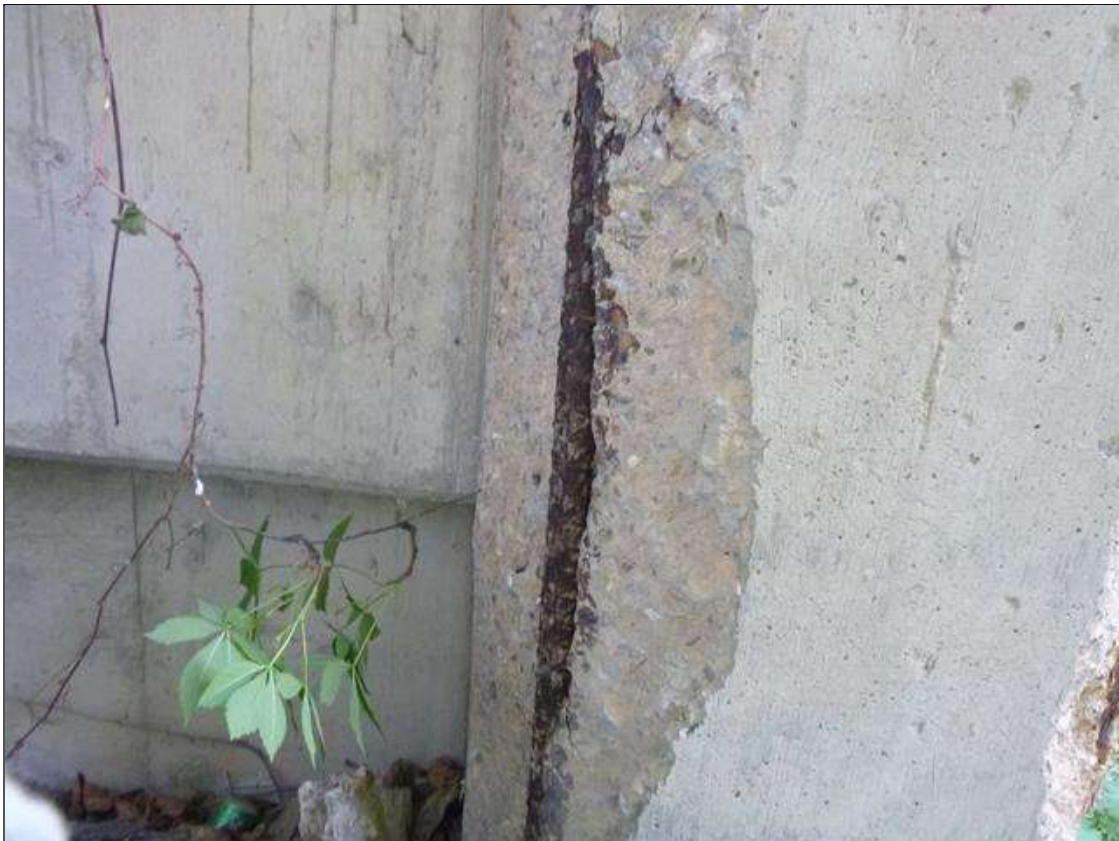
Bent 1 Pile 5: BENT 1, PILE 5 HAS A SPALL ON THE NORTHWEST CORNER, 14 INCHES WIDE X 60 INCHES HIGH X 3 INCHES DEEP WITH EXPOSED REBAR, STARTING AT GROUND LINE

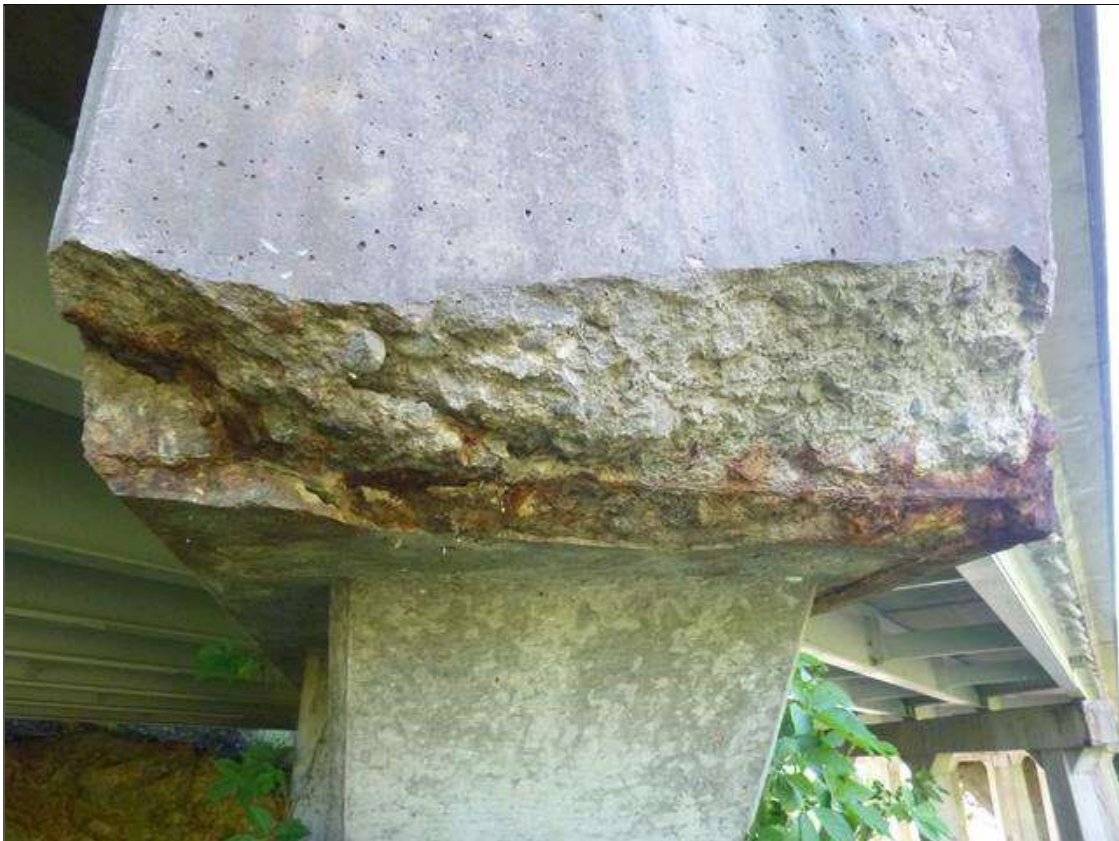
Bent 1 Cap 1: BENT 1 CAP, BOTTOM OF RIGHT END HAS A SPALL, 36 INCHES X 10 INCHES X 6 INCHES VERTICALLY WITH REBAR EXPOSED

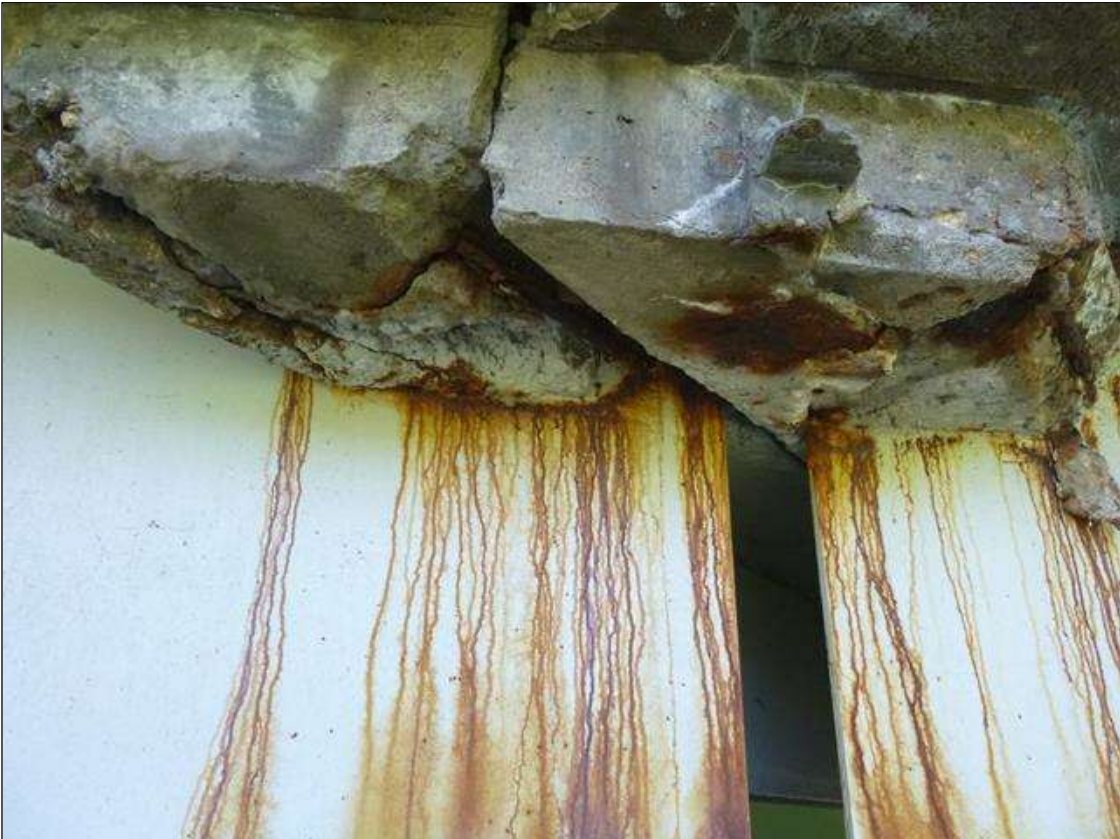
BENT 1, BENT DIAPHRAGMS UNDER RIGHT OVERHANG HAVE UP TO 3 INCH DEEP SPALLING WITH EXPOSED REBAR

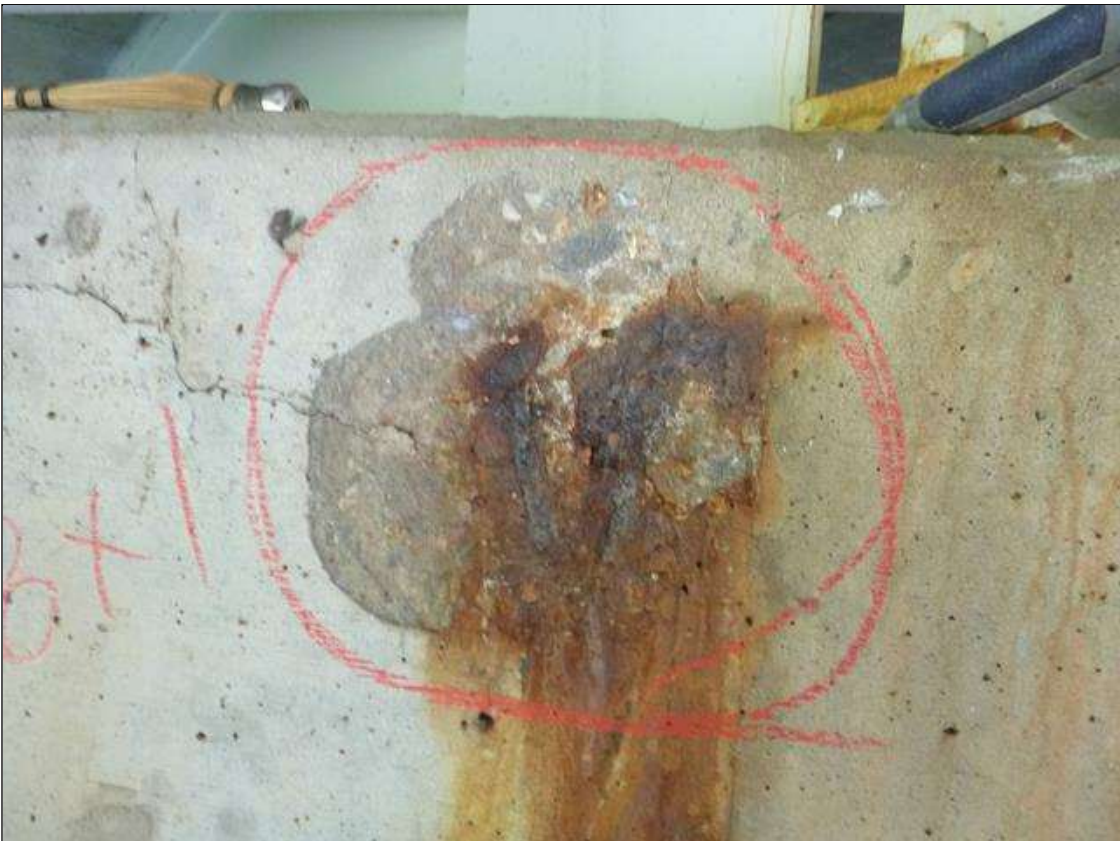
Bent 1 Cap 1: BENT 1 CAP, SPAN 2 SIDE HAS A SPALL ON THE FACE OF THE CAP, NEAR TOP EDGE, NEAR BEAM 6, 9 INCHES X 8 INCHES X 1 INCH DEEP WITH EXPOSED REBAR

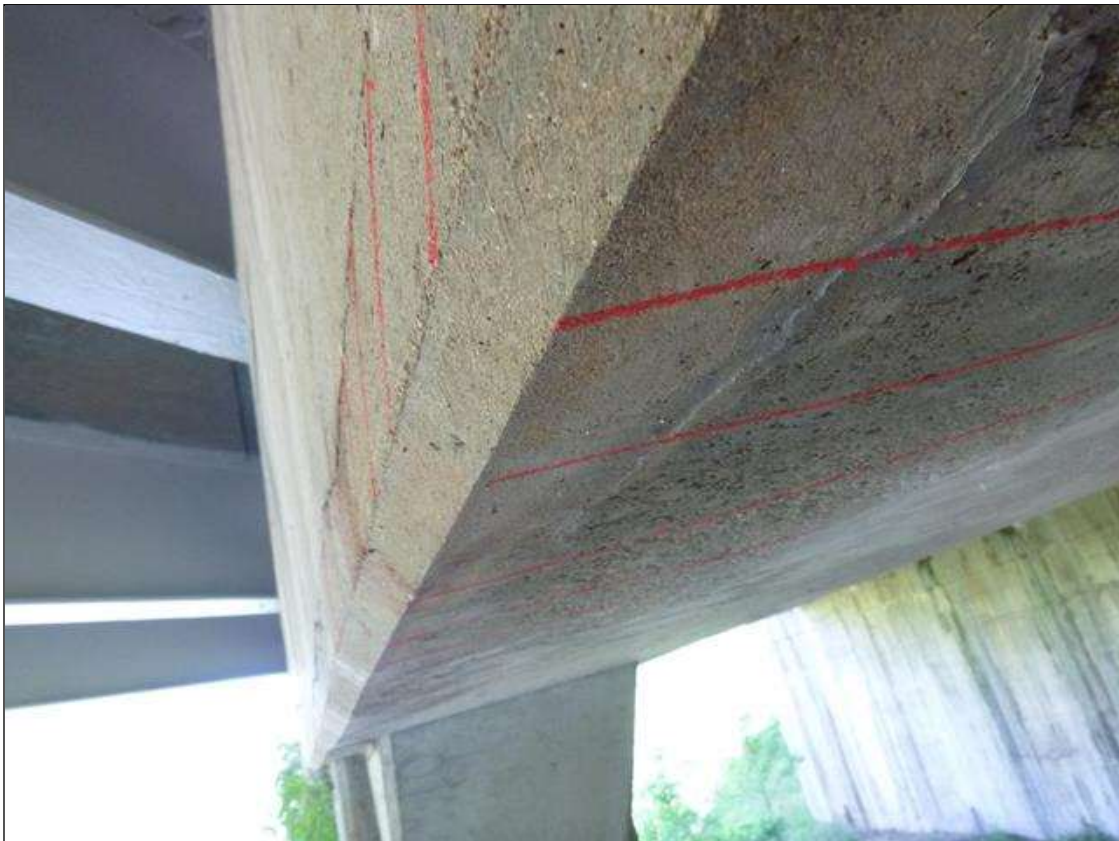
Bent 1 Cap 1: BENT 1 CAP, SPAN 2 SIDE HAS AN AREA OF DELAMINATION IN THE BOTTOM CORNER IN BAY 5, 12 FT. LONG X UP TO 15 INCHES WIDE WITH 1/4 INCH SEPARATION

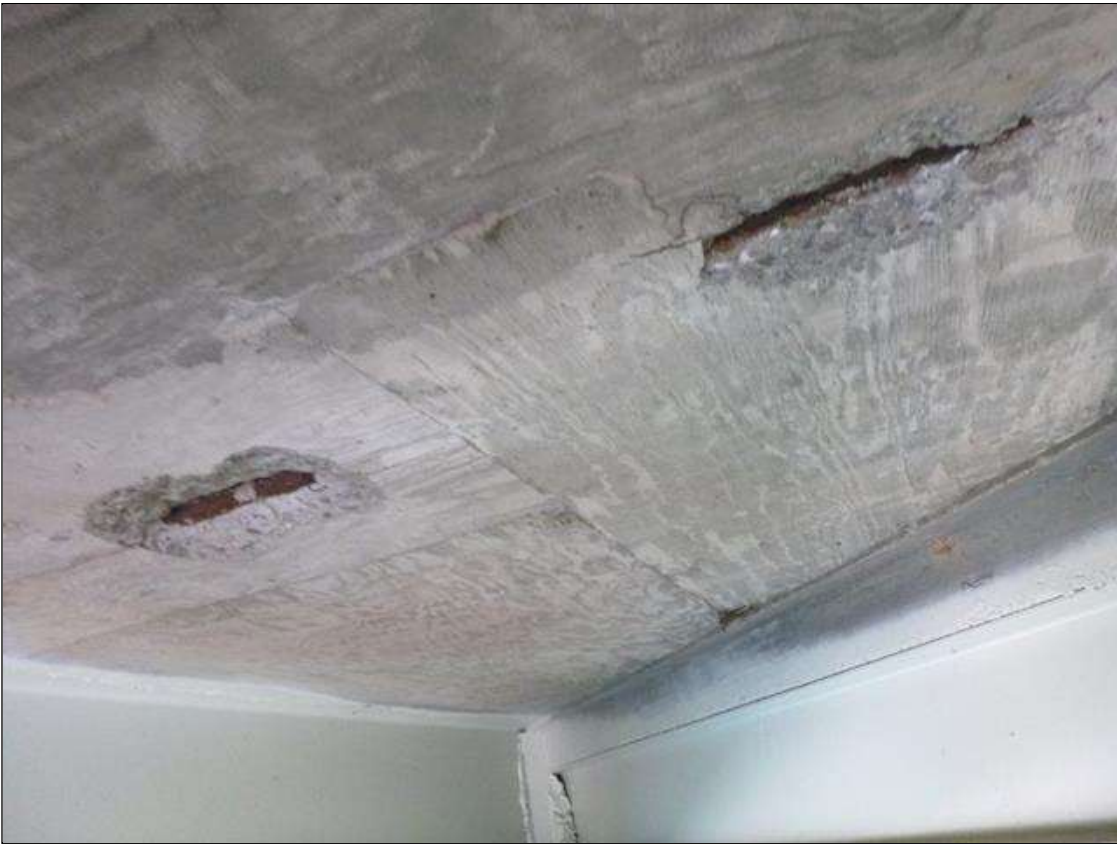
Span 2 Deck: SPAN 2, BOTTOM OF BAY 4 DECK, NEAR BENT 1 HAS 2 SPALLS, 14 INCHES X 10 INCHES X 2 INCHES DEEP WITH EXPOSED REBAR

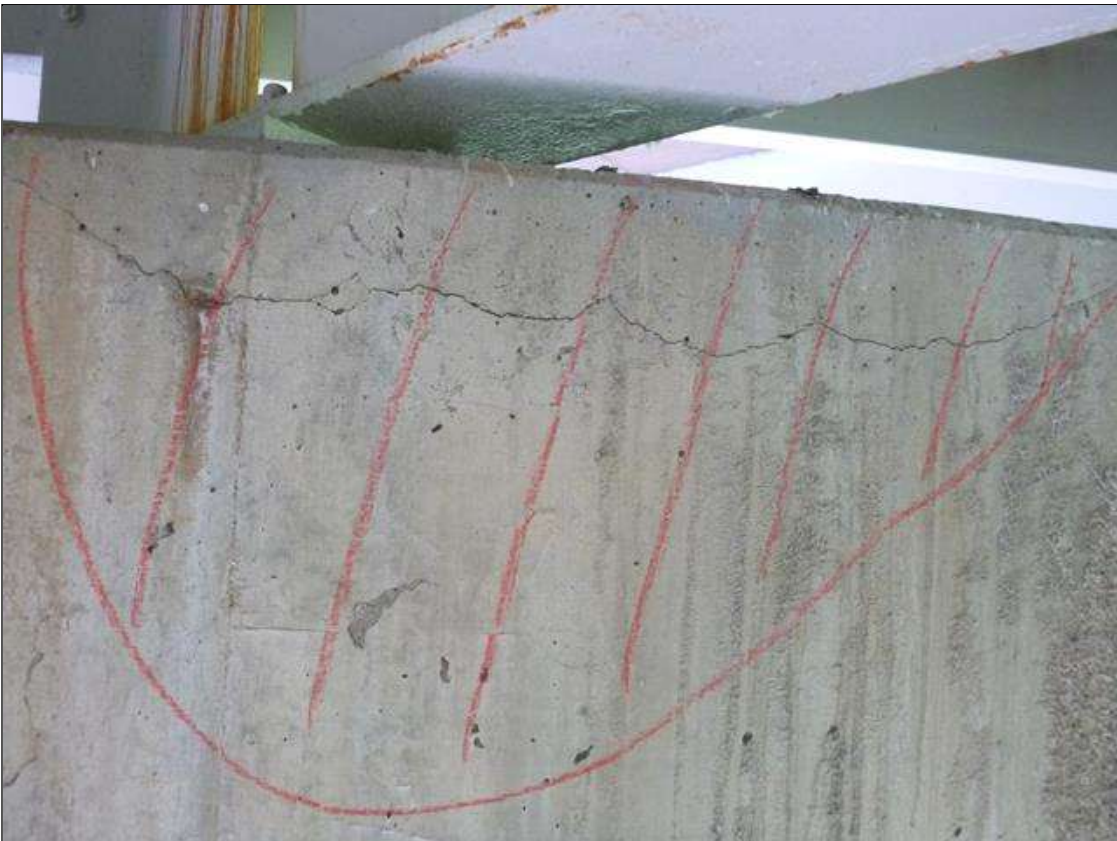
Bent 2 Cap 1: BENT 2 CAP, SPAN 2 SIDE HAS AN AREA OF DELAMINATION IN THE FACE OF THE CAP UNDER BEAM 6, 48 INCHES X 24 INCHES X 4 INCHES ACROSS THE TOP WITH 1/16 INCH SEPARATION

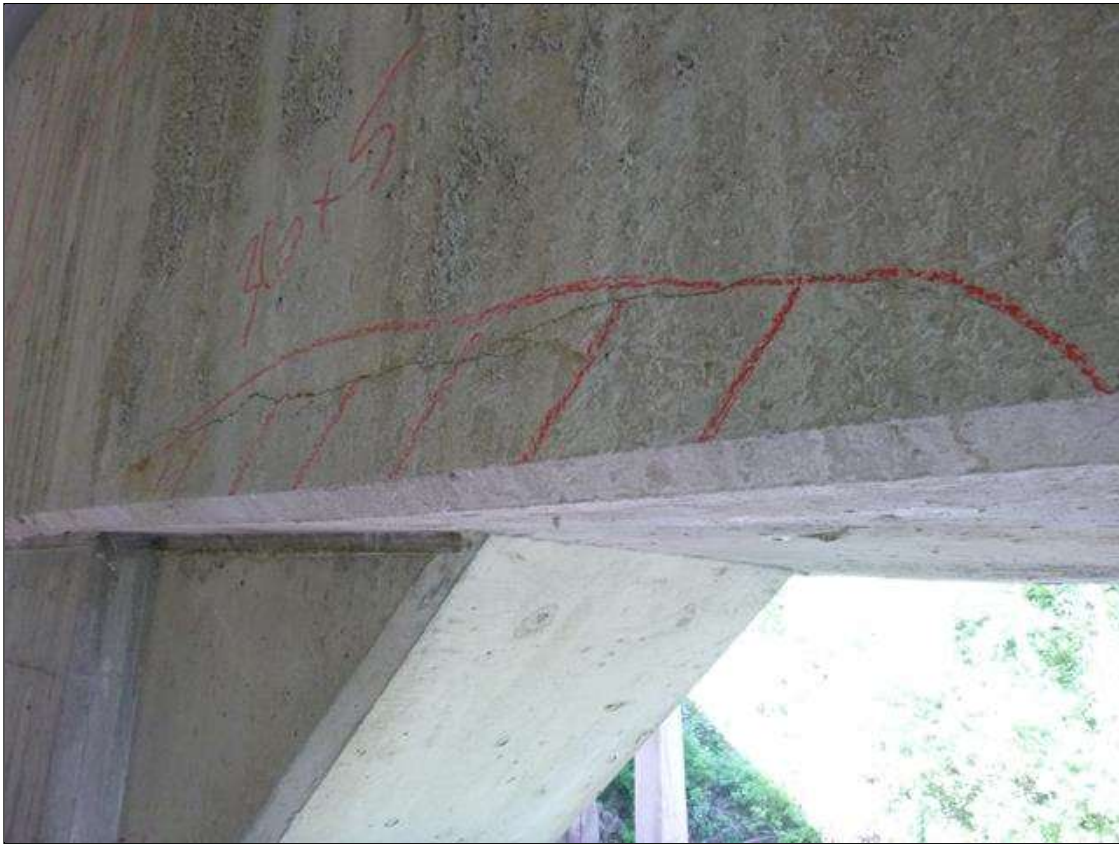
Bent 2 Cap 1: BENT 2 CAP, SPAN 2 SIDE HAS AN AREA OF DELAMINATION IN THE FACE OF THE CAP, NEAR BOTTOM EDGE, IN BAY 6, 36 INCHES X 5 INCHES WITH 1/16 INCH SEPARATION

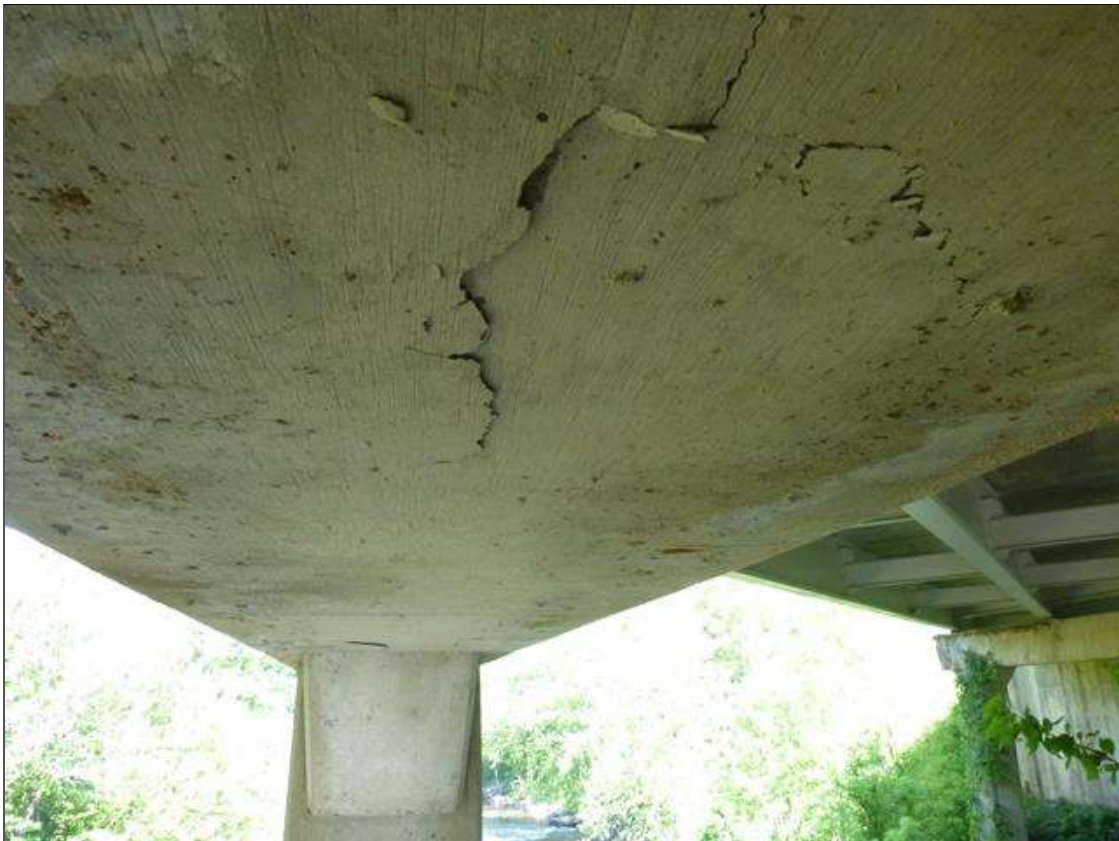
Bent 2 Cap 1: BENT 2 CAP HAS AN AREA OF DELAMINATION IN THE BOTTOM OF THE CAP, BETWEEN PILES 4 AND 5, 8 FT. X 36 INCHES

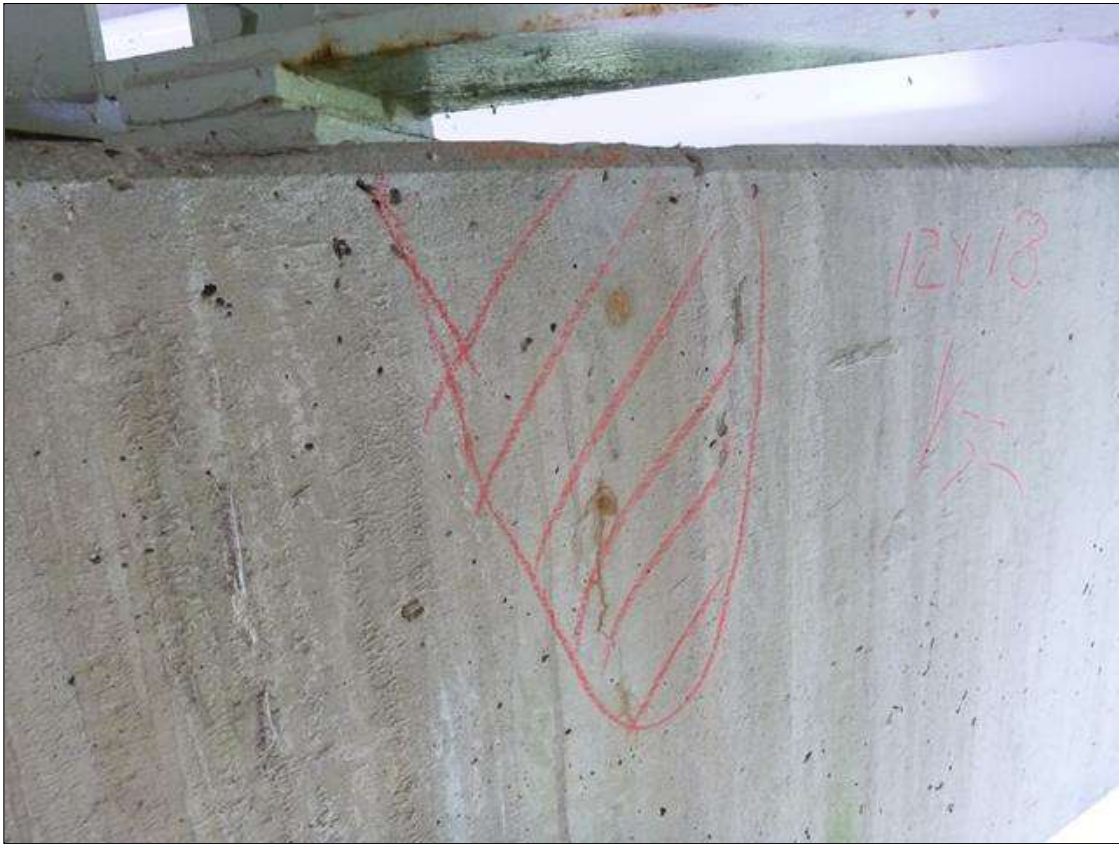
Bent 2 Cap 1: BENT 2 CAP, SPAN 2 SIDE HAS AN AREA OF DELAMINATION IN THE FACE OF THE CAP UNDER BEAM 7, 12 INCHES X 18 INCHES WITH 1/32 INCH SEPARATION
