## Structure Safety Report

### Routine Element Inspection - Contract

COUNTY: HAYWOOD STRUCTURE NUMBER: 430142 FREQUENCY: 24 MONTHS

FEATURE INTERSECTED: PIGEON RIVER

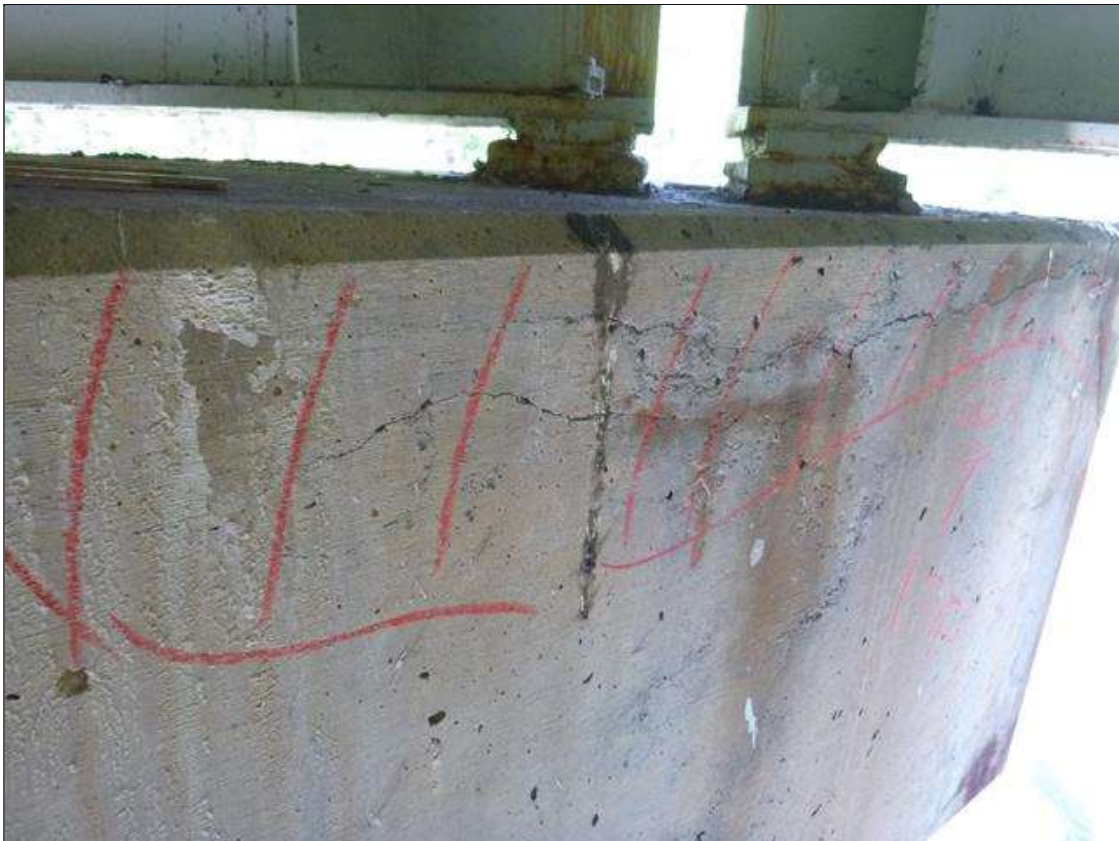
Bent 2 Cap 1: BENT 2 CAP, SPAN 2 SIDE HAS AN AREA OF DELAMINATION IN THE FACE OF THE CAP IN BAY 7 AND UNDER BEAM 8, NEAR TOP EDGE, 60 INCHES X 9 INCHES X 4 INCHES ACROSS THE TOP

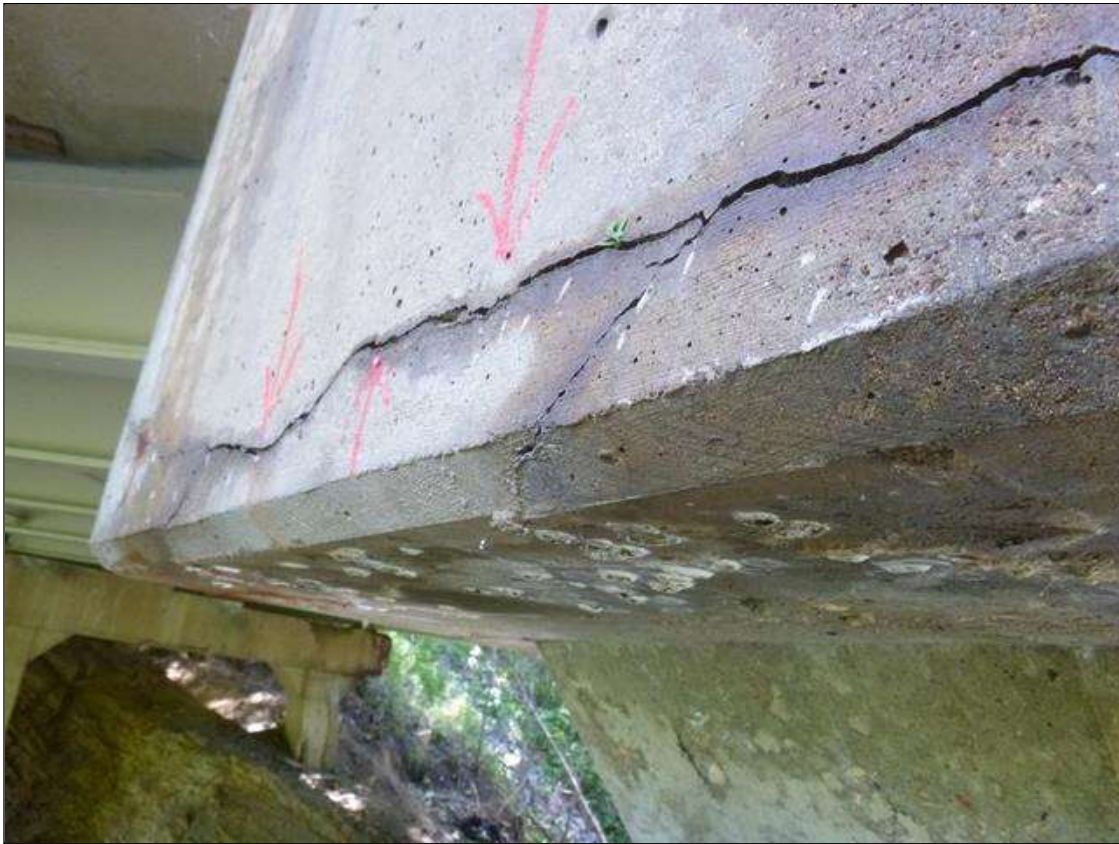
Bent 2 Cap 1: BENT 2 CAP HAS AN AREA OF DELAMINATION ON THE BOTTOM RIGHT END, 36 INCHES X 8 INCHES WITH 1/8 INCH SEPARATION

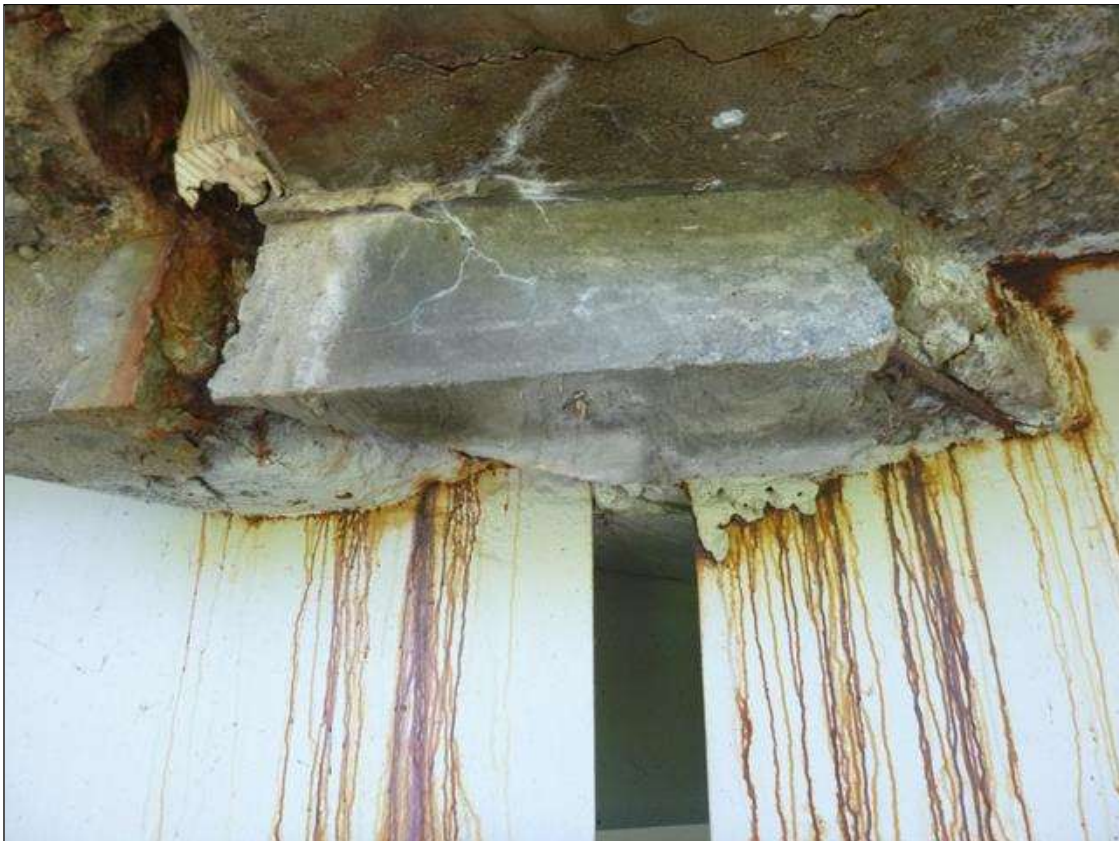
BENT 2, BENT DIAPHRAGMS UNDER RIGHT OVERHANG HAVE UP TO 3 INCH DEEP SPALLING WITH EXPOSED REBAR

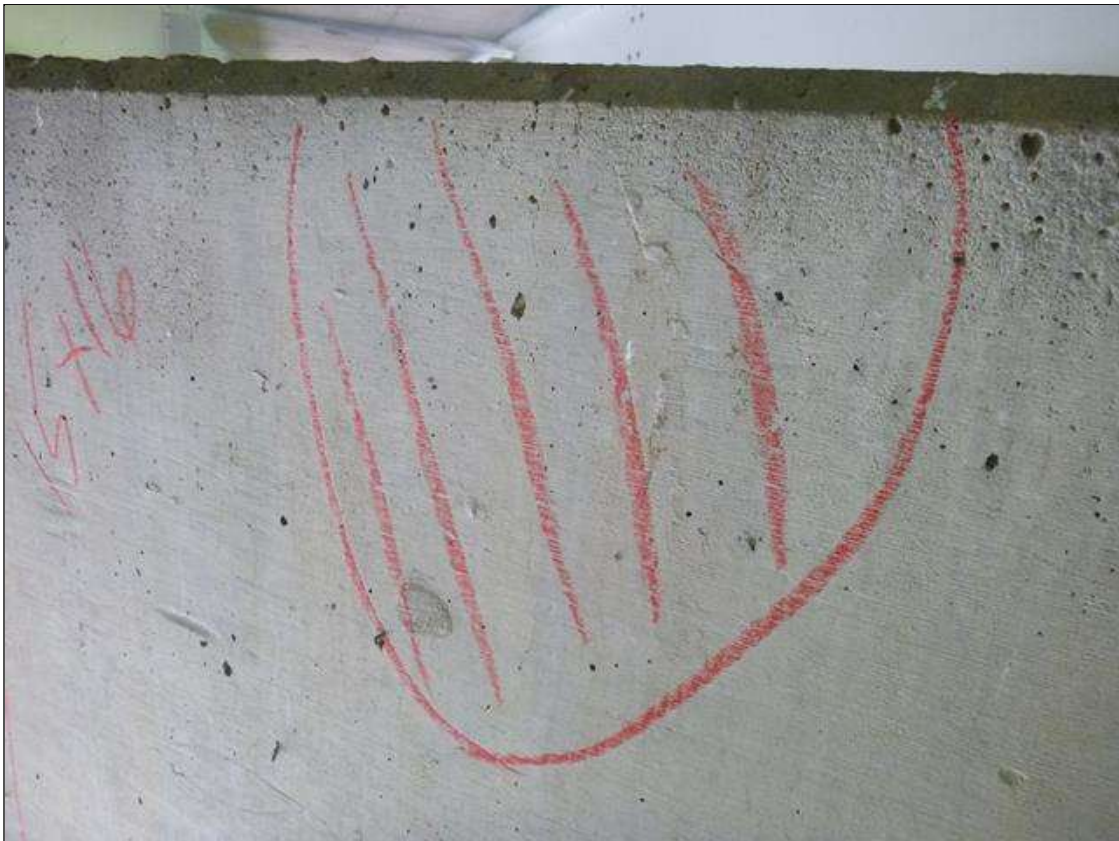
Bent 3 Cap 1: BENT 3 CAP, SPAN 3 SIDE HAS AN AREA OF DELAMINATION IN THE FACE OF THE CAP IN BAY 6, NEAR TOP EDGE, 15 INCHES X 16 INCHES

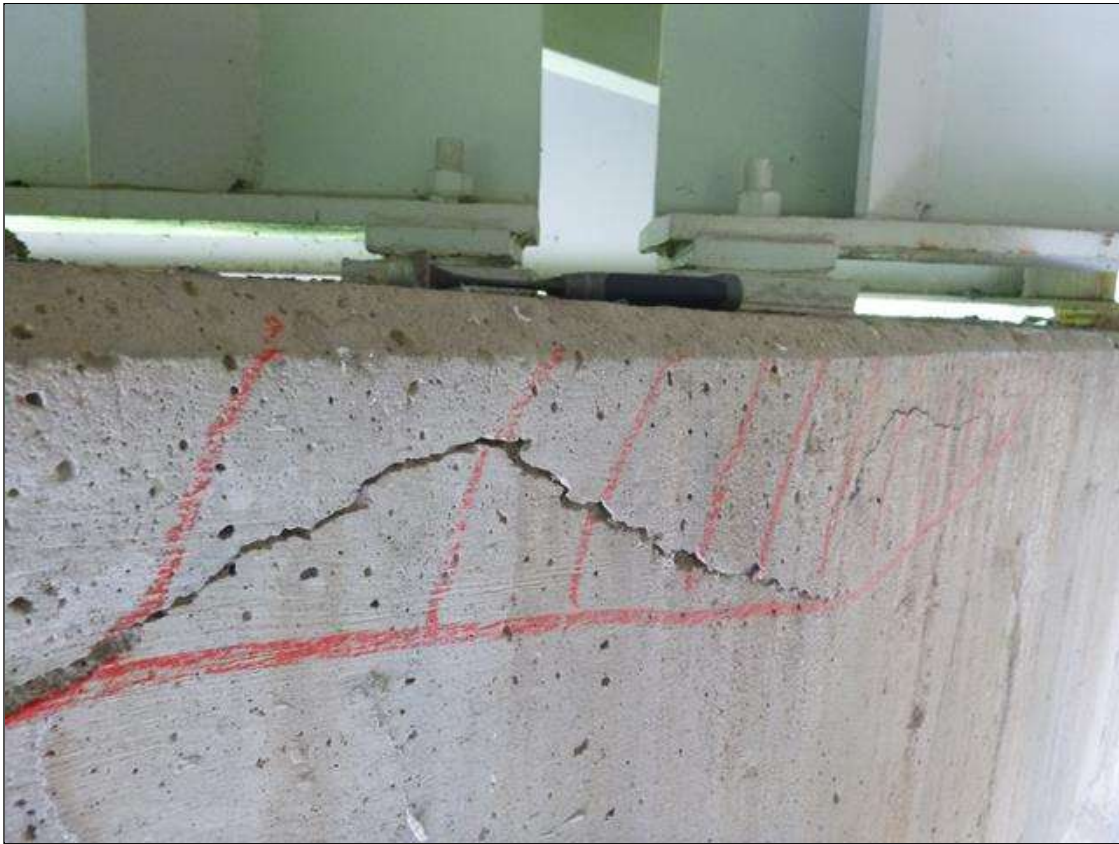
Bent 3 Cap 1: BENT 3 CAP, SPAN 3 SIDE HAS AN AREA OF DELAMINATION IN THE FACE OF THE CAP UNDER BEAM 7, NEAR TOP EDGE, 48 INCHES X 8 INCHES X 2 INCHES ACROSS THE TOP WITH 1/8 INCH SEPARATION

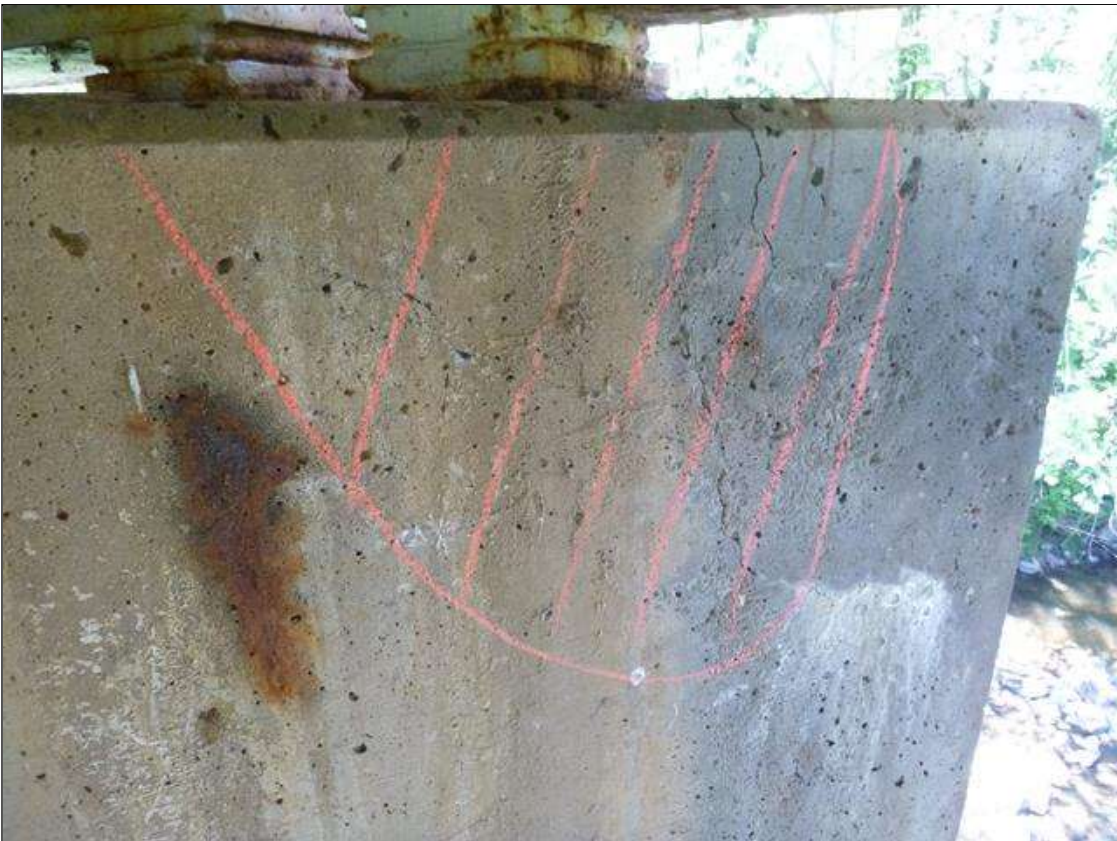
Bent 3 Cap 1: BENT 3 CAP, SPAN 3 SIDE HAS AN AREA OF DELAMINATION IN THE FACE OF THE CAP, UNDER BEAM 7, 12 INCHES X 28 INCHES X 6 INCHES ACROSS THE BOTTOM WITH 1/4 INCH SEPARATION

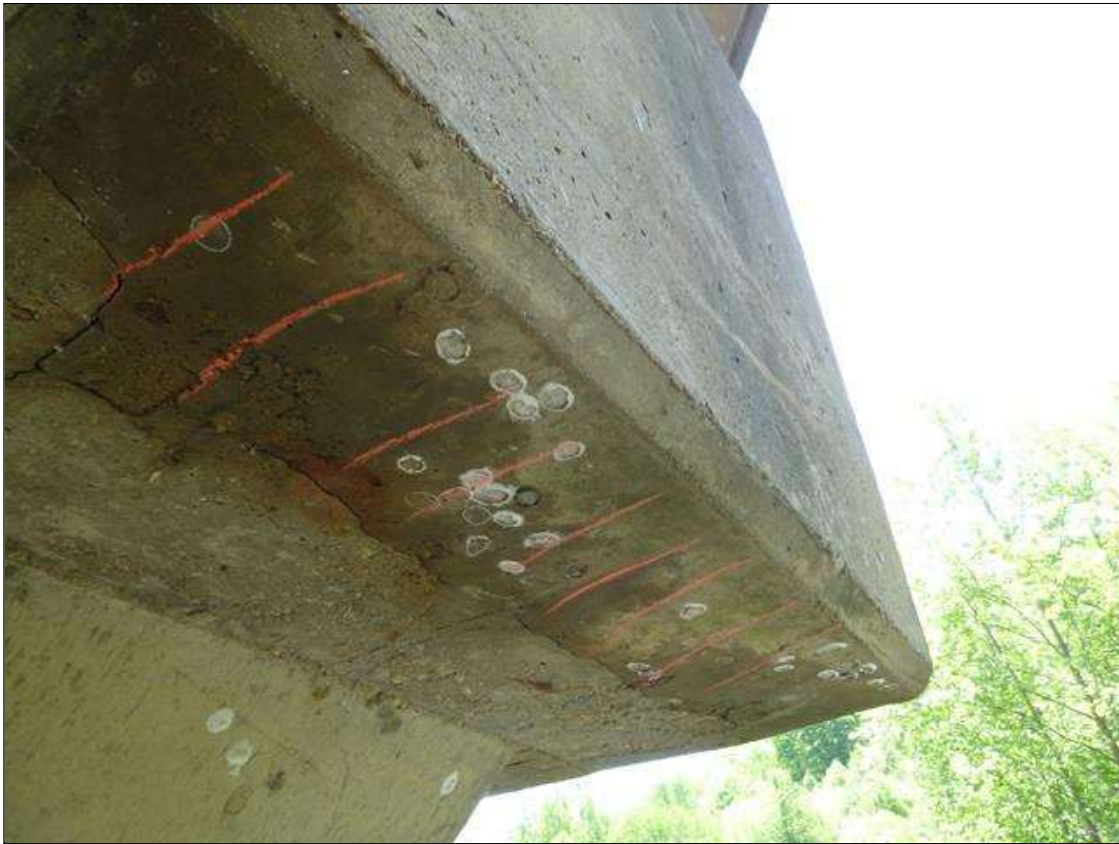
Span 3 Deck: SPAN 3, BOTTOM OF BAY 6 DECK HAS AN AREA OF DELAMINATION AT 1/3 POINT, 24 INCHES X 32 INCHES WITH 1/2 INCH SEPARATION

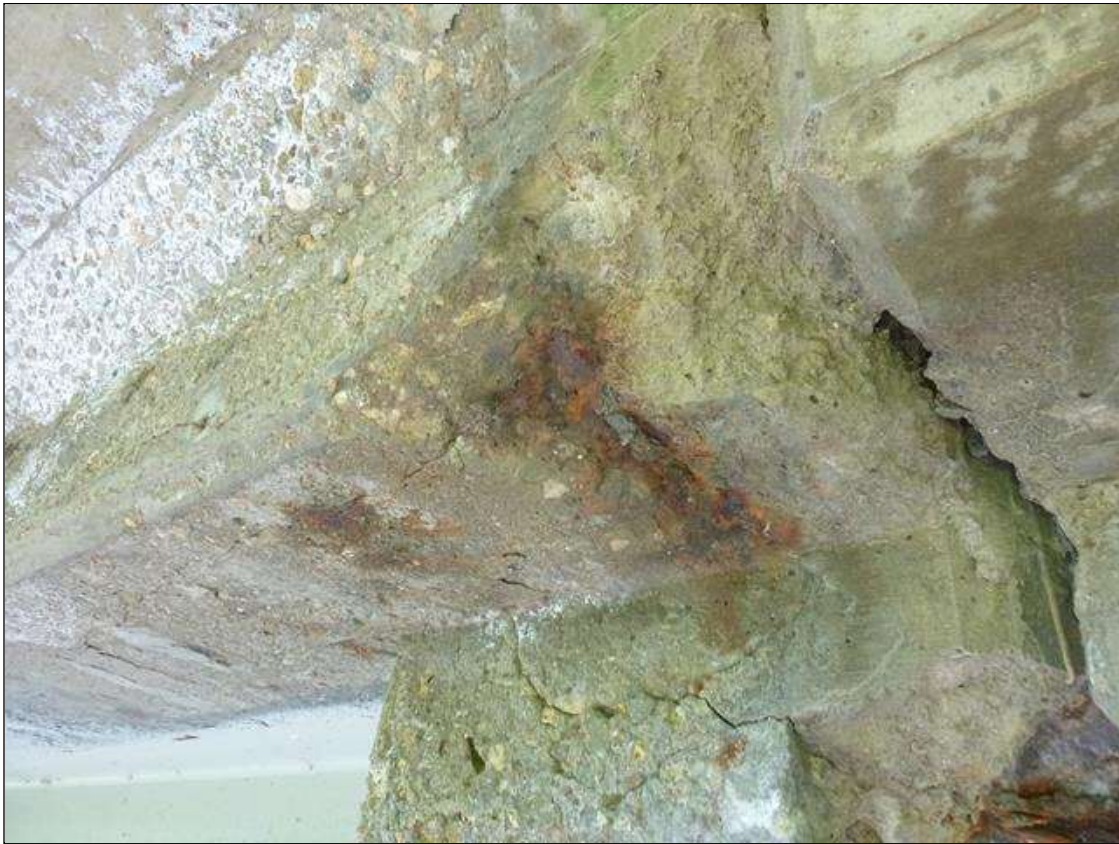
BENT 3, BENT DIAPHRAGMS UNDER RIGHT OVERHANG HAVE UP TO 3 INCH DEEP SPALLING WITH EXPOSED REBAR

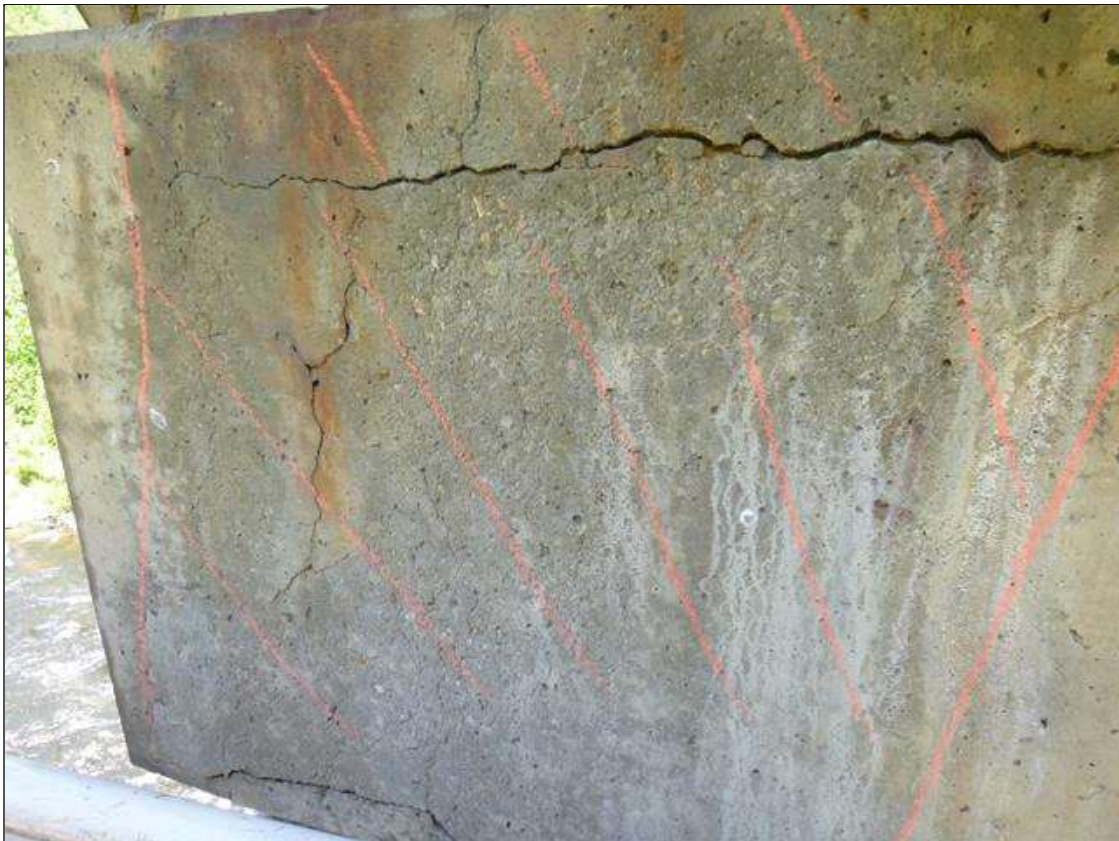
Span 3 Deck: SPAN 3, BOTTOM OF RIGHT OVERHANG AT BENT 3 HAS A SPALL, 7 INCHES X 9 INCHES X 1.5 INCHES DEEP WITH REBAR EXPOSED

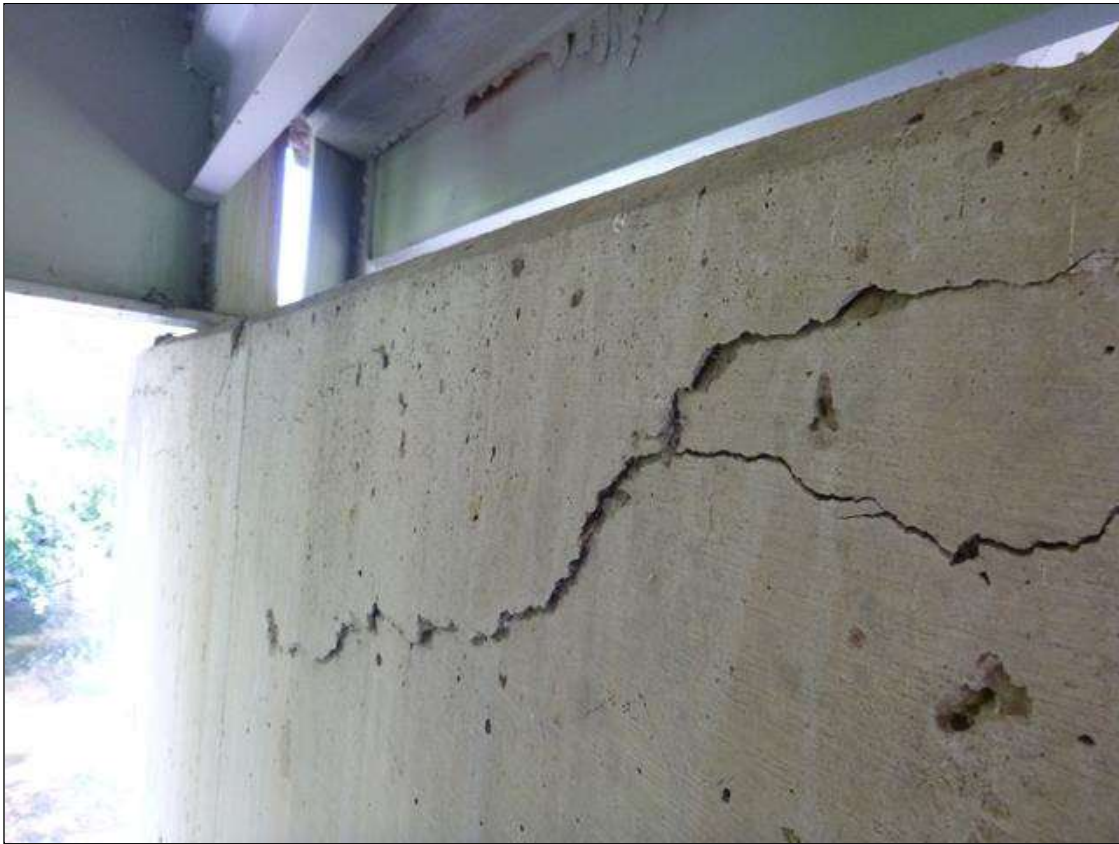
Bent 3 Cap 1: BENT 3 CAP, SPAN 4 SIDE HAS AN AREA OF DELAMINATION IN THE FACE OF THE CAP UNDER BEAM 8, 36 INCHES X 39 INCHES X 3 INCHES ACROSS THE TOP WITH 1/4 INCH SEPARATION

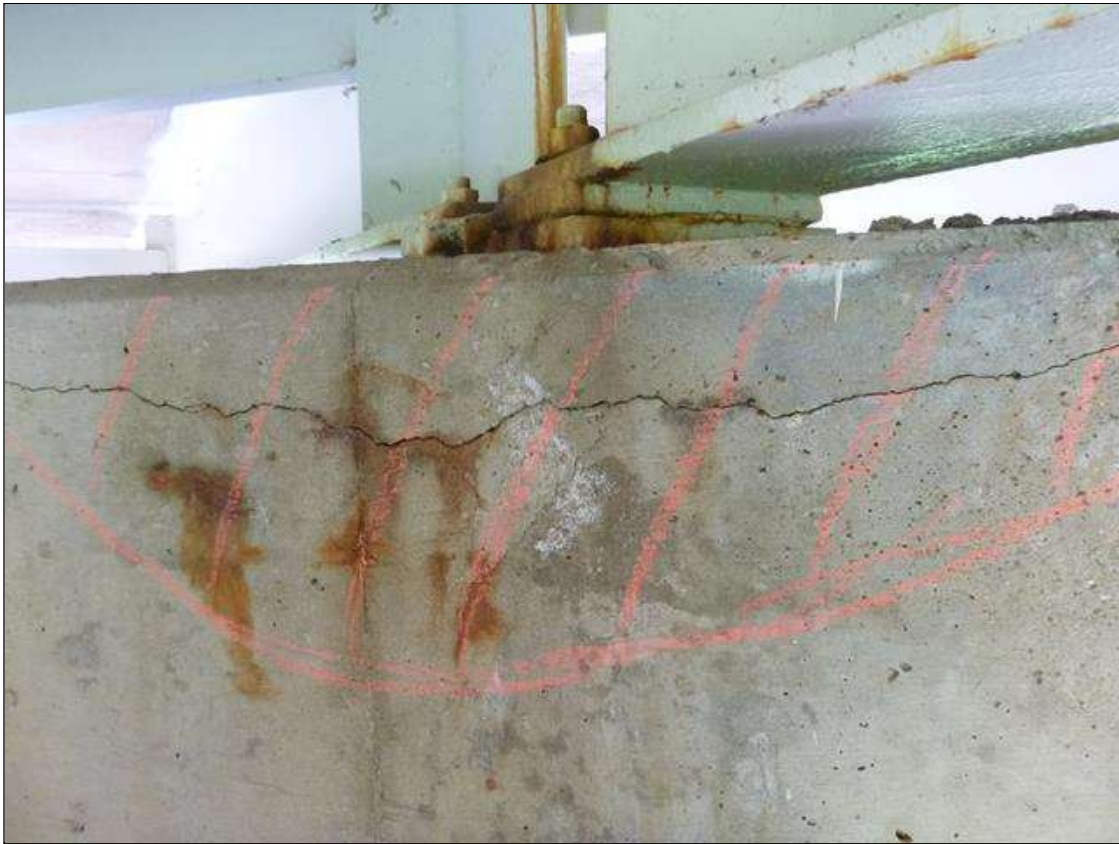
Bent 3 Cap 1: BENT 3 CAP, SPAN 4 SIDE HAS AN AREA OF DELAMINATION IN THE FACE OF THE CAP, NEAR TOP EDGE, IN BAY 7, 9 FT. LONG X 11 INCHES DOWN THE FACE X 4 INCHES ACROSS THE TOP, WITH UP TO 1/4 INCH SEPARATION

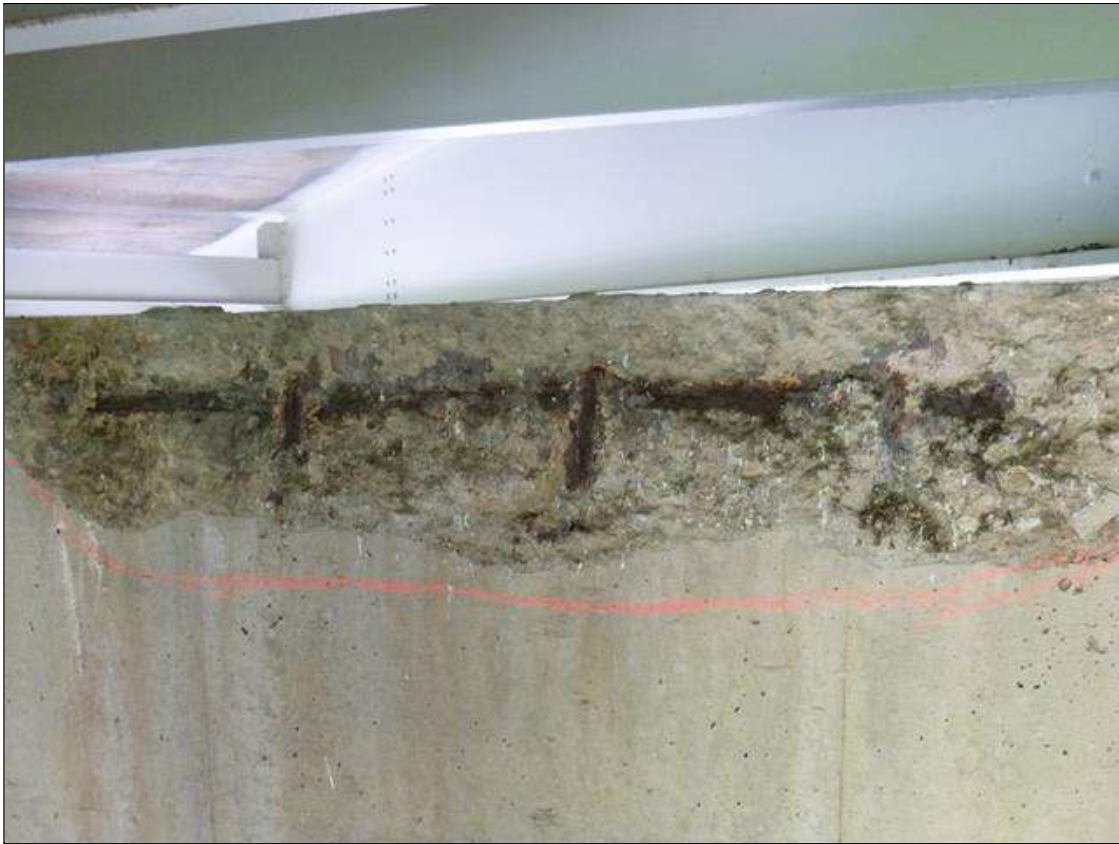
Bent 3 Cap 1: BENT 3 CAP, SPAN 4 SIDE HAS AN AREA OF DELAMINATION IN THE FACE OF THE CAP UNDER BEAM 6, NEAR TOP EDGE, 48 INCHES X 14 INCHES WITH 1/16 INCH WIDE LONGITUDINAL CRACKING WITH RUST STAINS

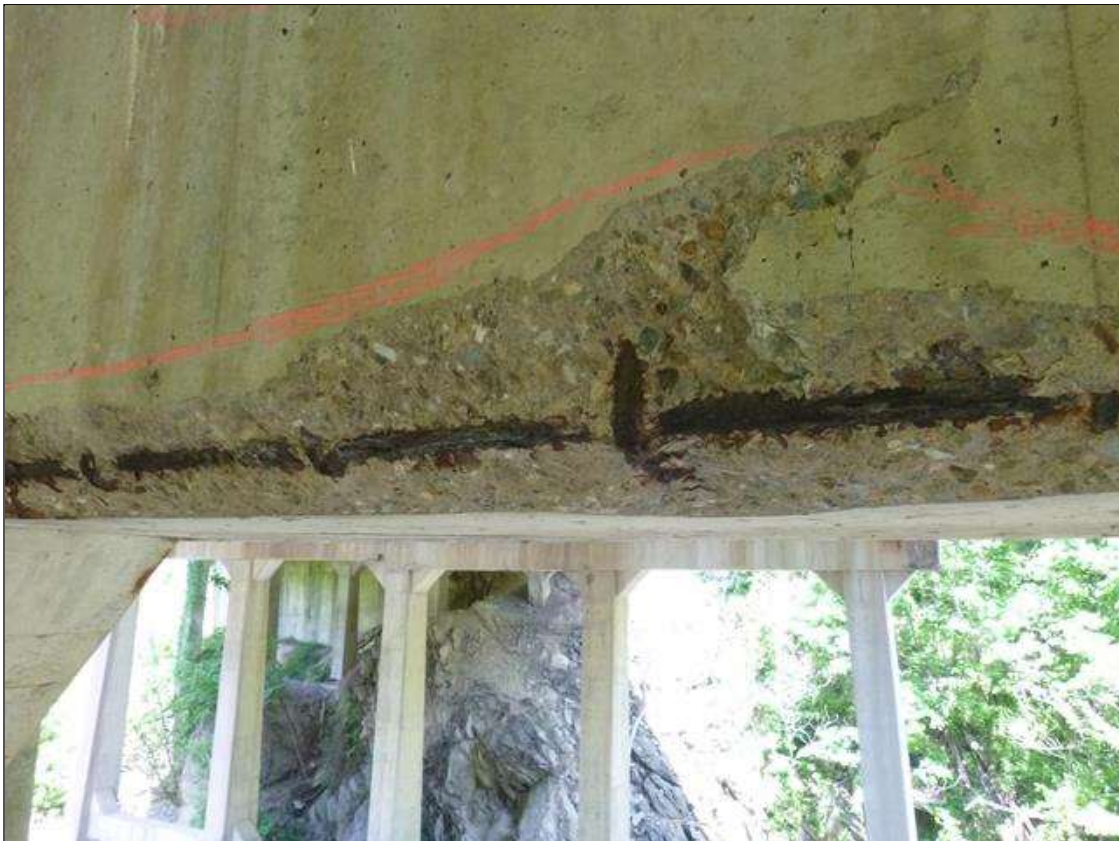
Bent 3 Cap 1: BENT 3 CAP, SPAN 4 SIDE HAS A SPALL ON THE FACE AND TOP OF THE CAP IN BAY 5, 6 FT. LONG X 15 INCHES WIDE X 10 INCHES ACROSS THE TOP WITH REBAR EXPOSED

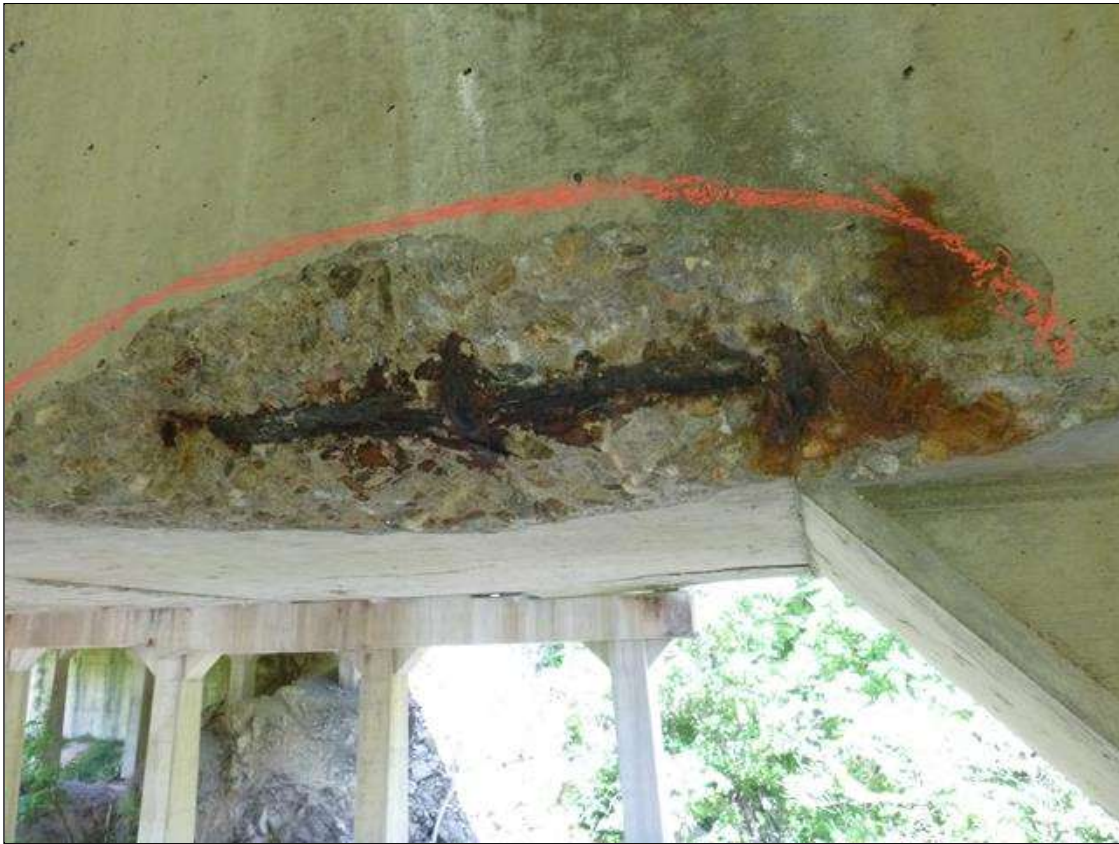
Bent 3 Cap 1: BENT 3 CAP, SPAN 4 SIDE HAS A SPALL ON THE BOTTOM EDGE OF THE CAP IN BAY 5, 5 FT. LONG X 7 INCHES WIDE X 3 INCHES DEEP WITH REBAR EXPOSED

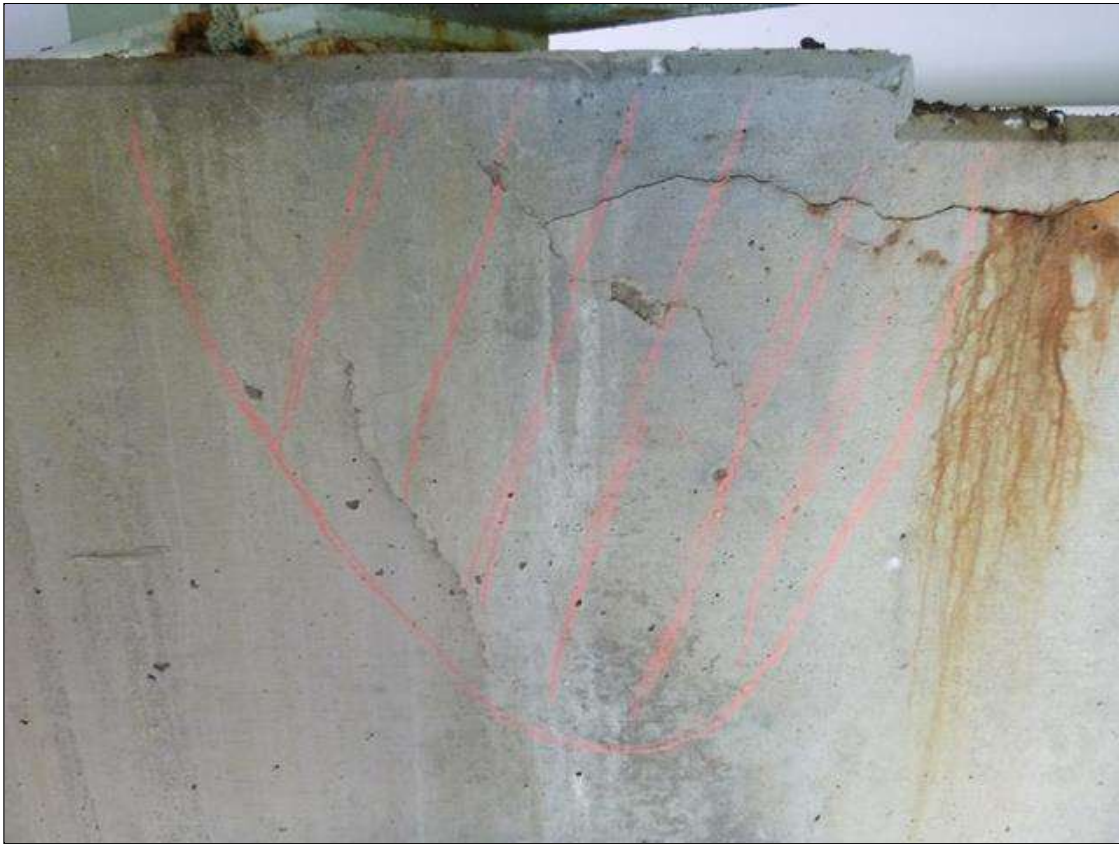
Bent 3 Cap 1: BENT 3 CAP, SPAN 4 SIDE HAS A SPALL ON THE BOTTOM EDGE OF THE CAP IN BAY 5, NEAR BEAM 5, 28 INCHES LONG X 5 INCHES WIDE X 3 INCHES DEEP WITH REBAR EXPOSED

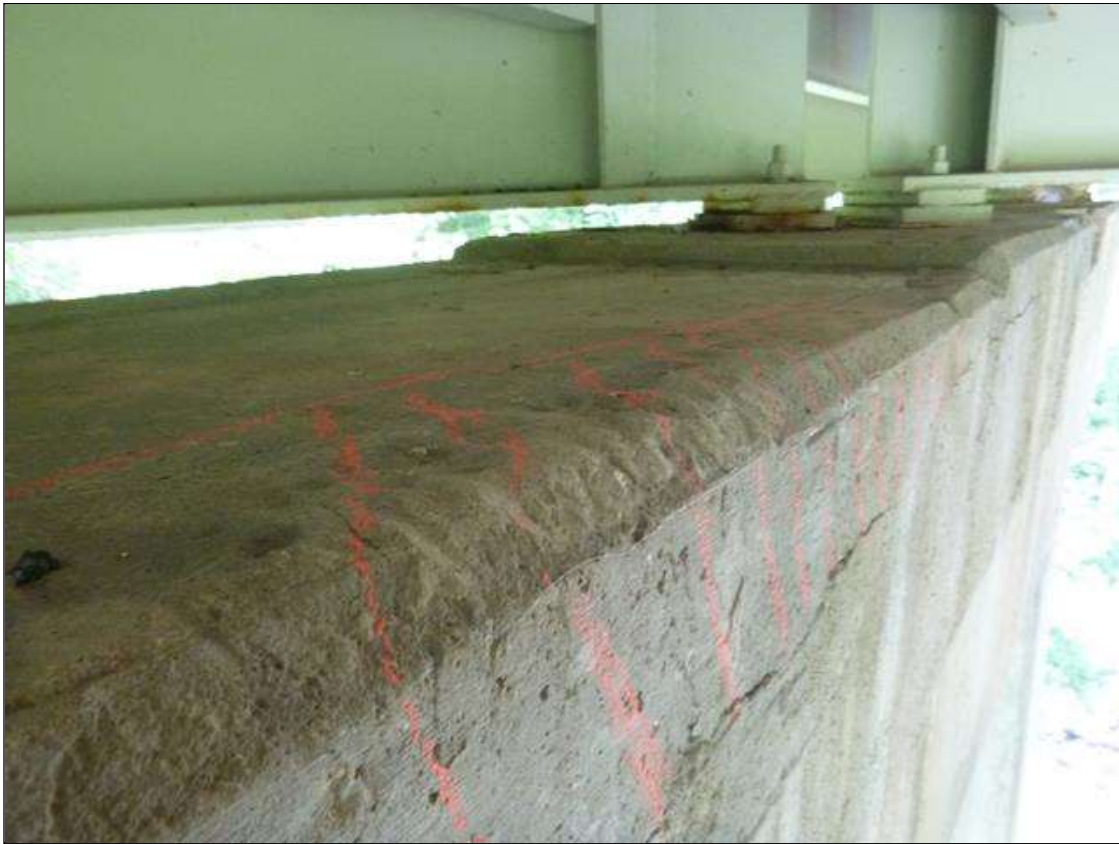
Bent 3 Cap 1: BENT 3 CAP, SPAN 4 SIDE HAS AN AREA OF DELAMINATION IN THE FACE OF THE CAP UNDER BEAM 5, 24 INCHES X 26 INCHES WITH 3/16 INCH SEPARATION, WITH 1/16 INCH WIDE CRACKING WITH RUST STAINS

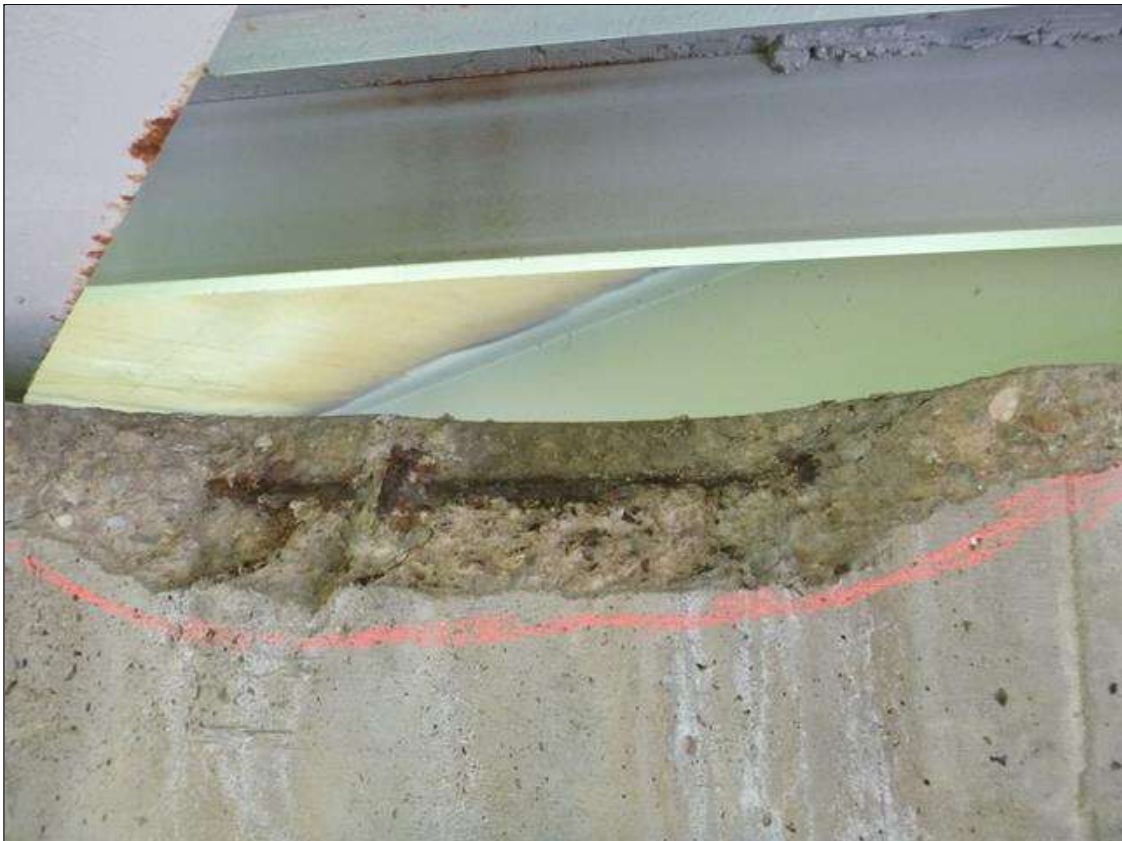
Span 4 Deck: SPAN 4, BOTTOM OF BAY 6 DECK, AT BENT 4 HAS A SPALL, NEAR BEAM 6, 10 INCHES IN DIAMETER X 2.5 INCHES DEEP WITH EXPOSED REBAR

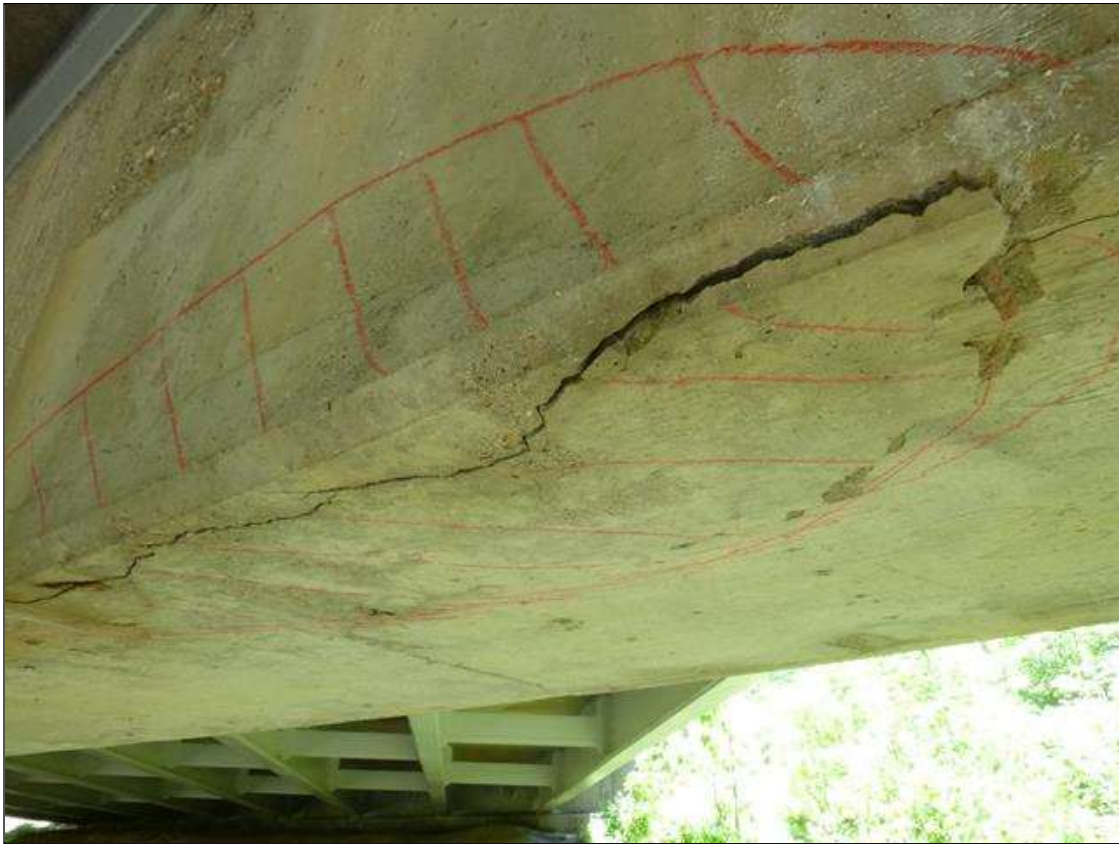
Bent 4 Cap 1: BENT 4 CAP, SPAN 4 SIDE HAS A SPALL ON THE TOP AND FACE OF THE CAP IN BAY 7, 48 INCHES LONG X 12 INCHES HIGH X 3 INCHES DEEP WITH REBAR EXPOSED

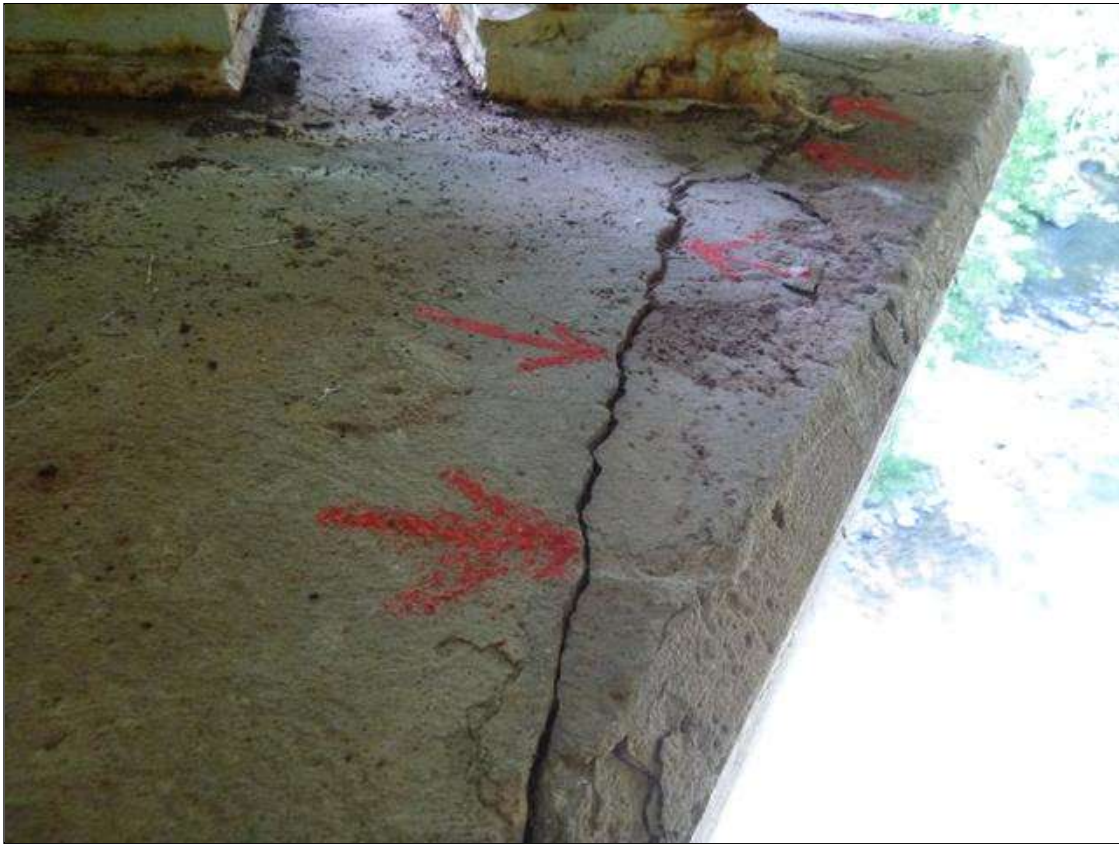
Bent 4 Cap 1: BENT 4 CAP, SPAN 4 SIDE HAS AN AREA OF DELAMINATION IN THE BOTTOM CORNER, UNDER BEAM 7, 56 INCHES LONG X 9 INCHES UP THE FACE X 16 INCHES ACROSS THE BOTTOM, WITH UP TO 1/2 INCH SEPARATION

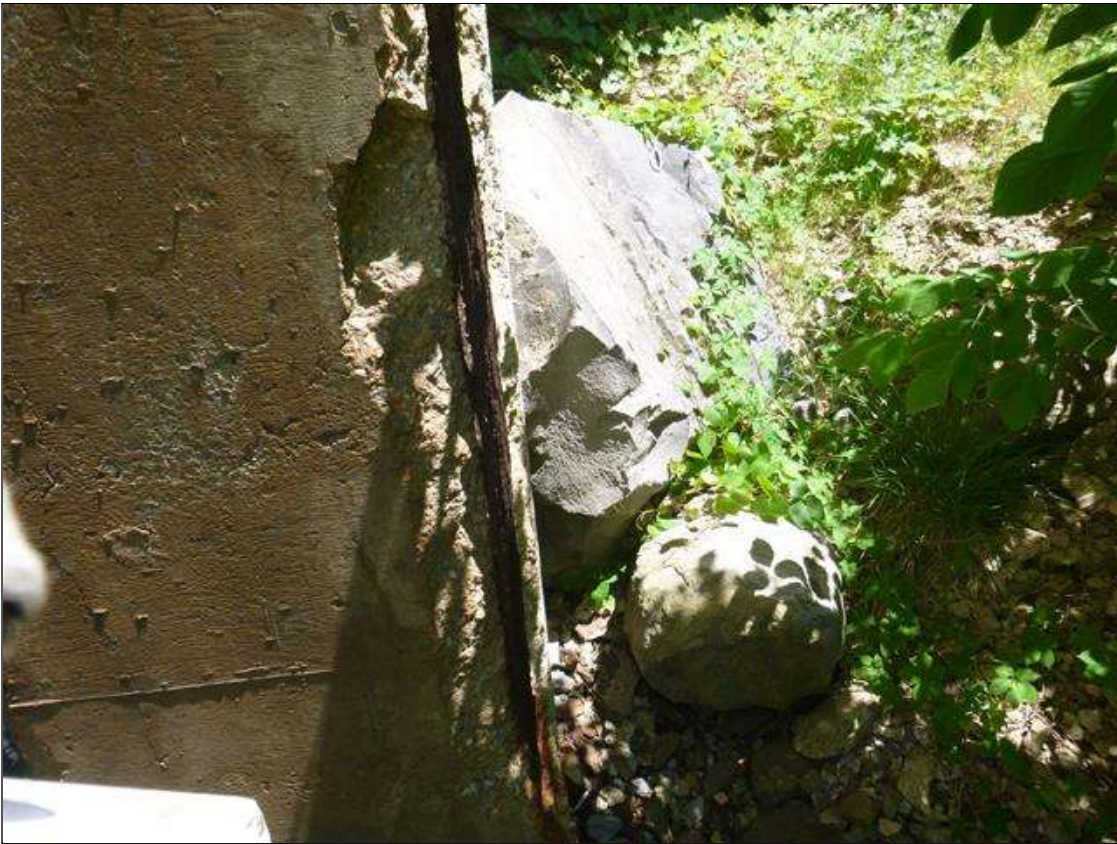
Bent 4 Pile 5: BENT 4, PILE 5 HAS A SPALL ON THE SOUTHWEST CORNER, 1 FT. WIDE X 12 FT. HIGH X 4 INCHES DEEP WITH EXPOSED REBAR, STARTS 3 FT. ABOVE GROUND LINE

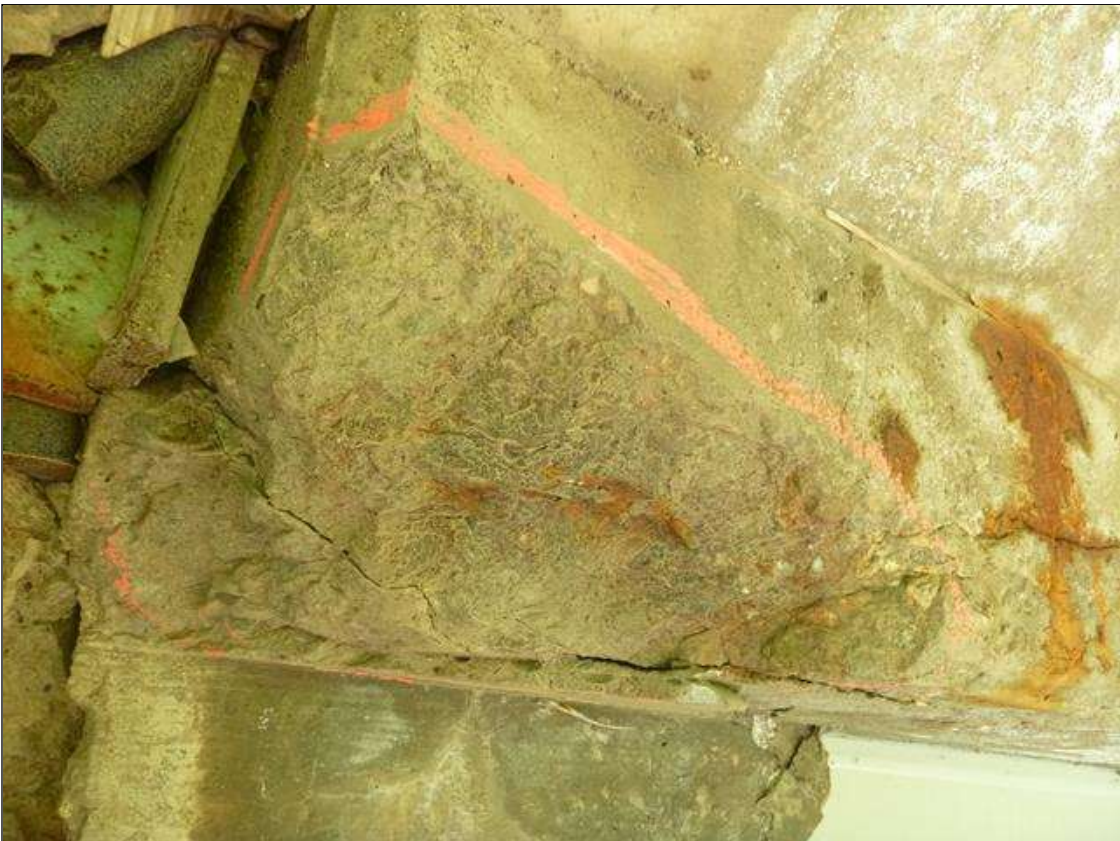
Span 4 Deck: SPAN 4, BOTTOM OF RIGHT OVERHANG AT BENT 4 HAS A SPALL, 9 INCHES X 12 INCHES X 1.5 INCHES DEEP WITH REBAR EXPOSED

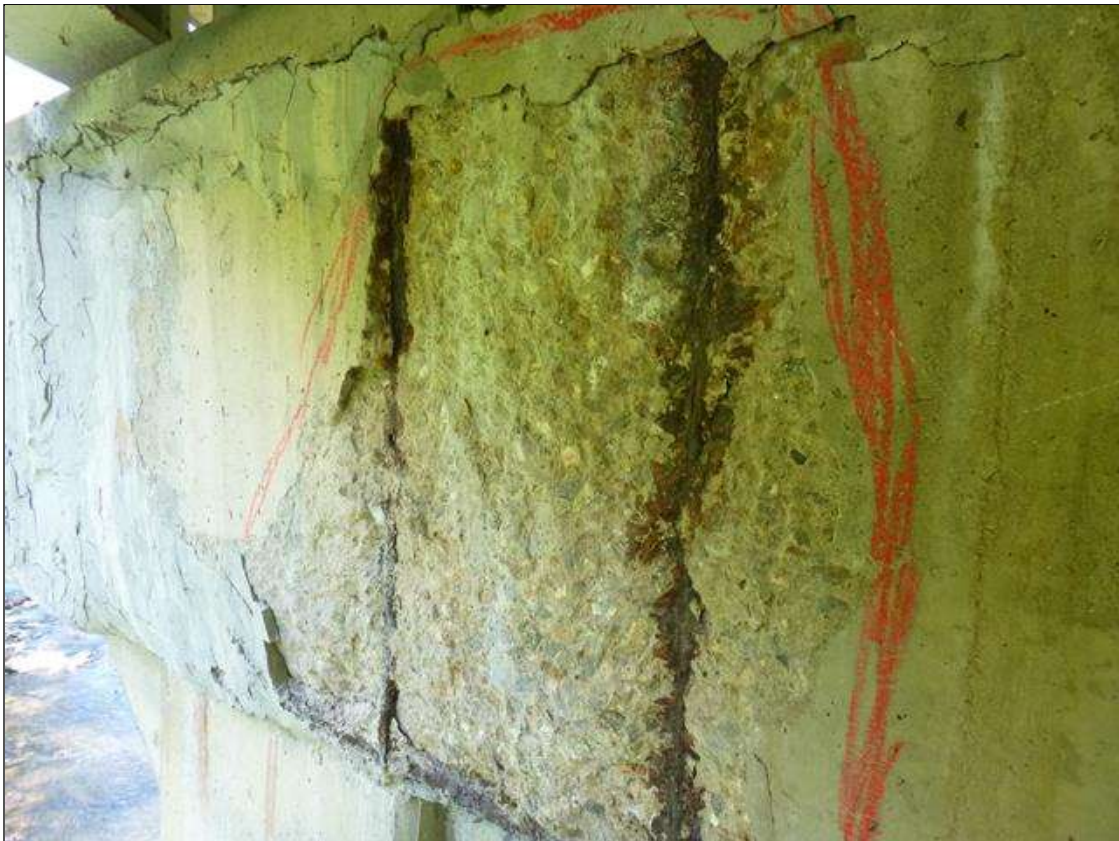
Bent 4 Cap 1: BENT 4 CAP, SPAN 5 SIDE HAS A UNSOUND PATCHED AREA IN THE FACE OF THE CAP UNDER BEAM 8, 5 FT. LONG X 3 FT. WIDE

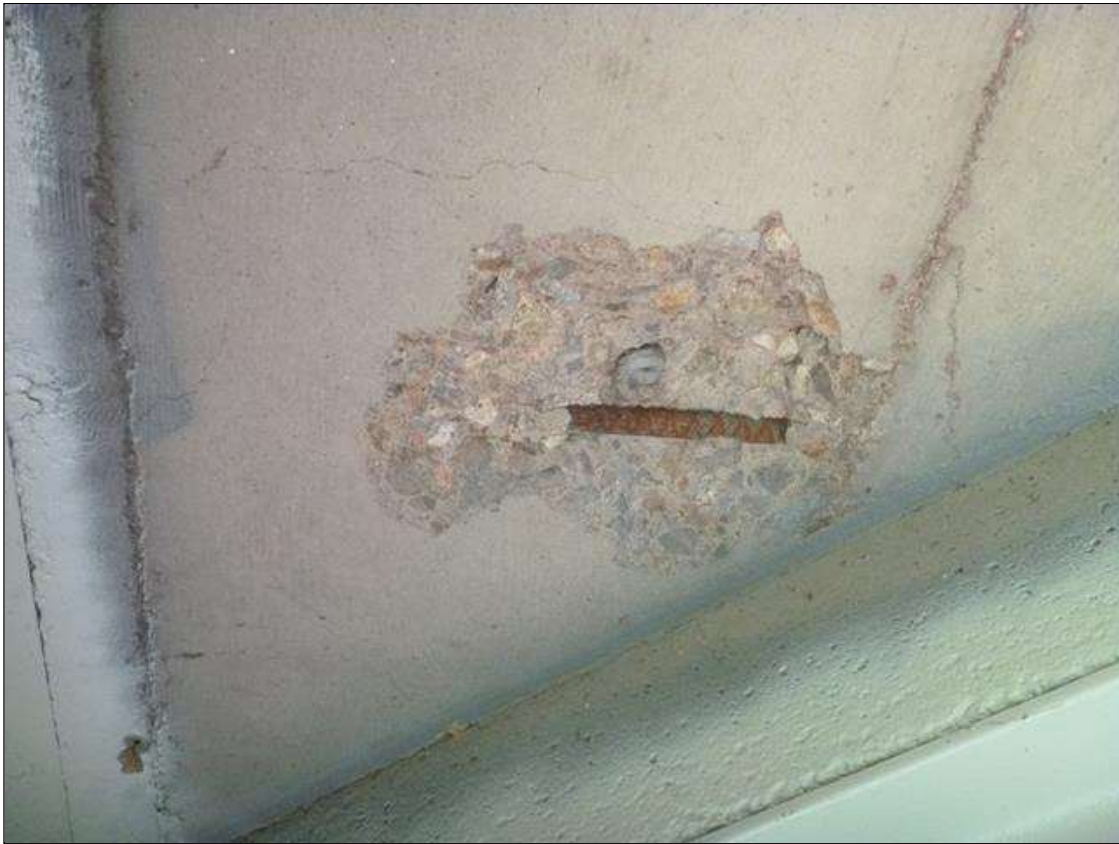
Bent 4 Cap 1: BENT 4 CAP, SPAN 5 SIDE HAS A SPALL ON THE FACE OF THE CAP IN BAY 7, 30 INCHES LONG X 30 INCHES WIDE X 1.5 INCHES DEEP WITH EXPOSED REBAR
