## Structure Safety Report

### Routine Element Inspection - Contract

COUNTY: HAYWOOD STRUCTURE NUMBER: 430142 FREQUENCY: 24 MONTHS

FEATURE INTERSECTED: PIGEON RIVER

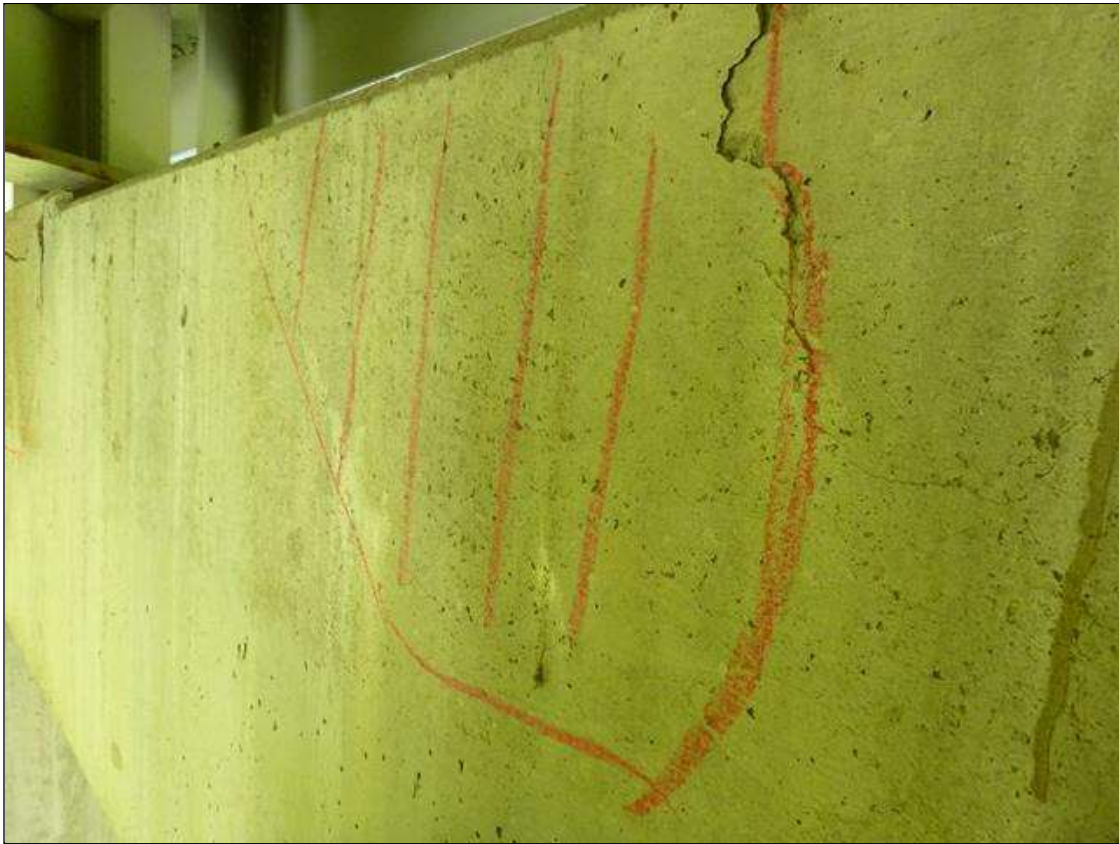
Bent 4 Cap 1: BENT 4 CAP, SPAN 5 SIDE HAS AN AREA OF DELAMINATION IN THE TOP AND FACE, IN BAY 7, 11 FT. LONG X 24 INCHES DOWN THE FACE X 11 INCHES ACROSS THE TOP WITH UP TO 1 INCH SEPARATION

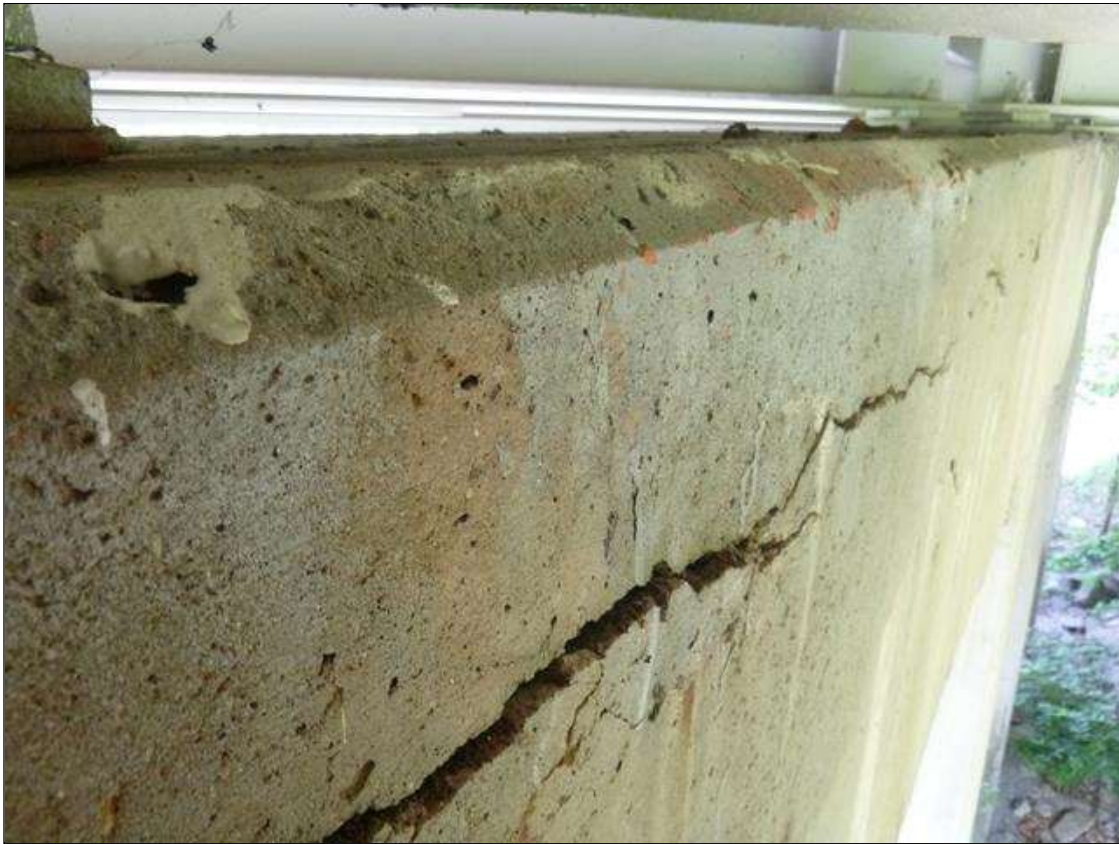
Bent 4 Cap 1: BENT 4 CAP, SPAN 5 SIDE HAS AN AREA OF DELAMINATION IN THE FACE OF THE CAP IN BAY 6, NEAR TOP EDGE, 24 INCHES X 16 INCHES WITH 1/8 INCH SEPARATION

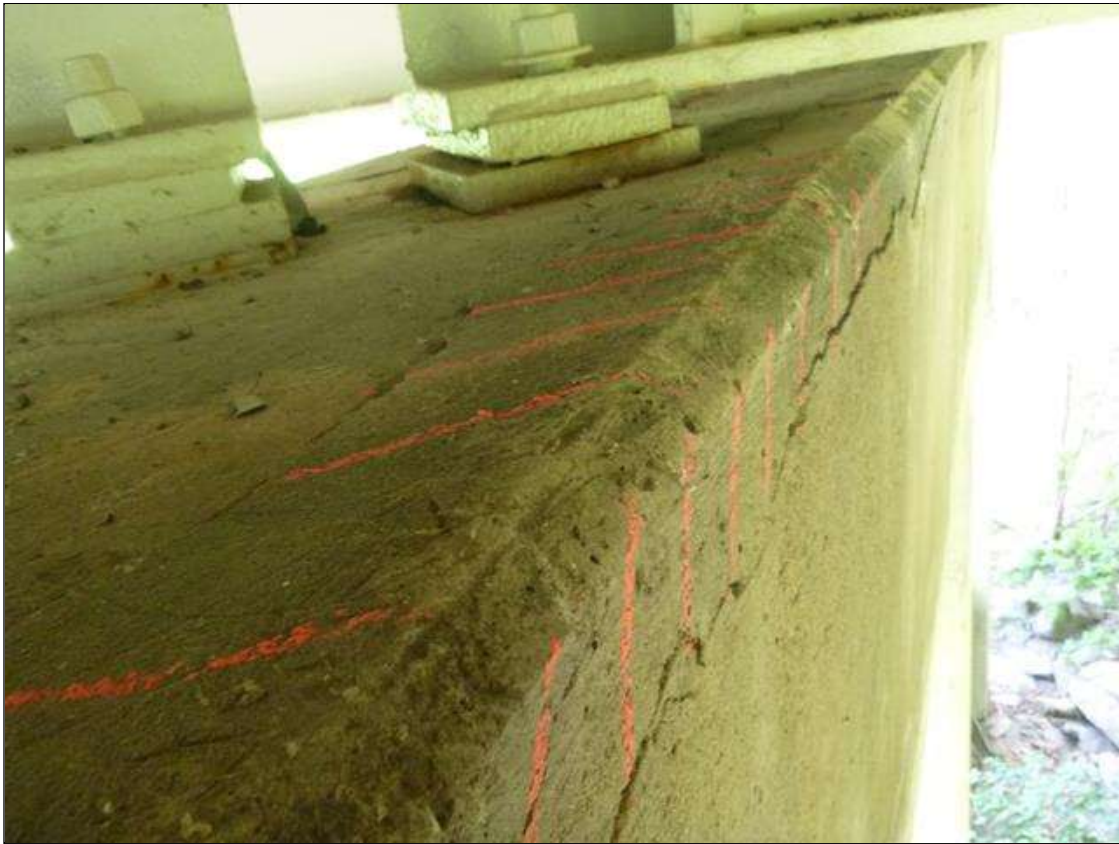
Bent 4 Cap 1: BENT 4 CAP, SPAN 5 SIDE HAS AN AREA OF DELAMINATION IN THE TOP AND FACE OF CAP, FROM BAY 5 TO BAY 6, 12 FT. LONG X 30 INCHES DOWN THE FACE X 6 INCHES ACROSS THE TOP WITH 1/4 INCH SEPARATION

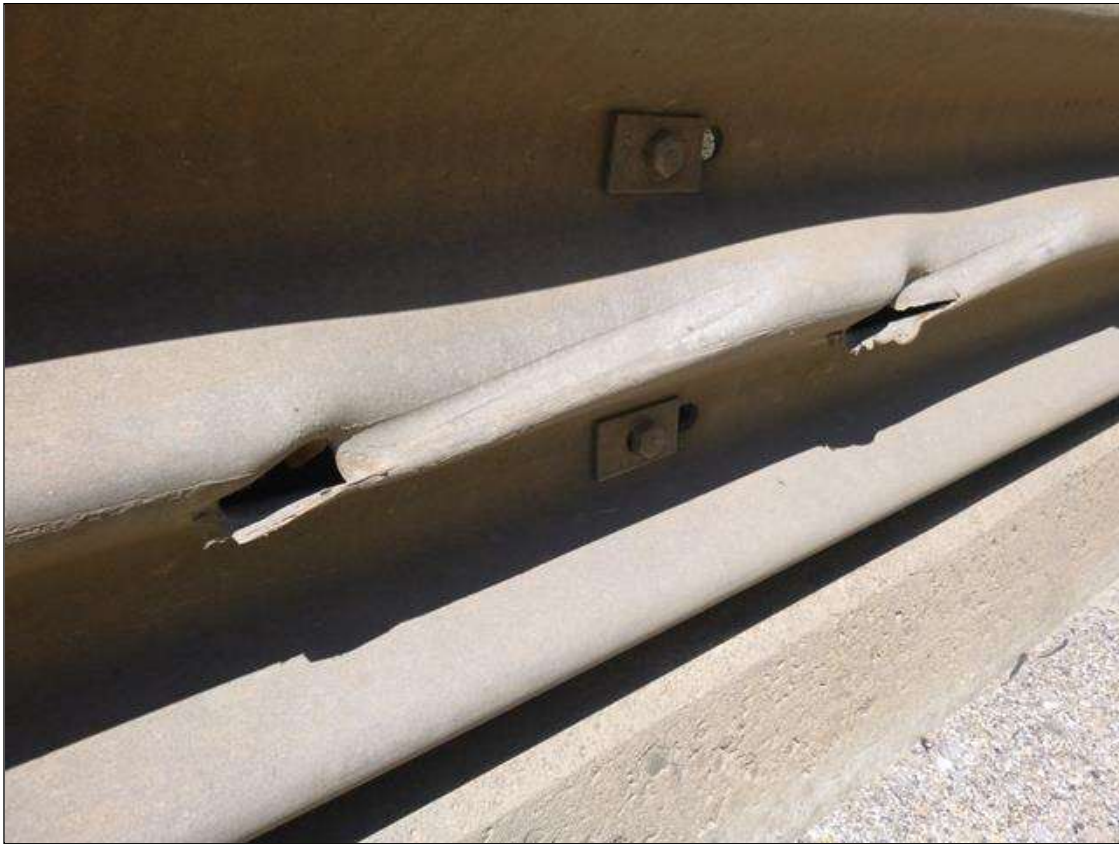
END BENT 1, RIGHT SIDE HAS 25 FT. OF GUARDRAIL DAMAGE

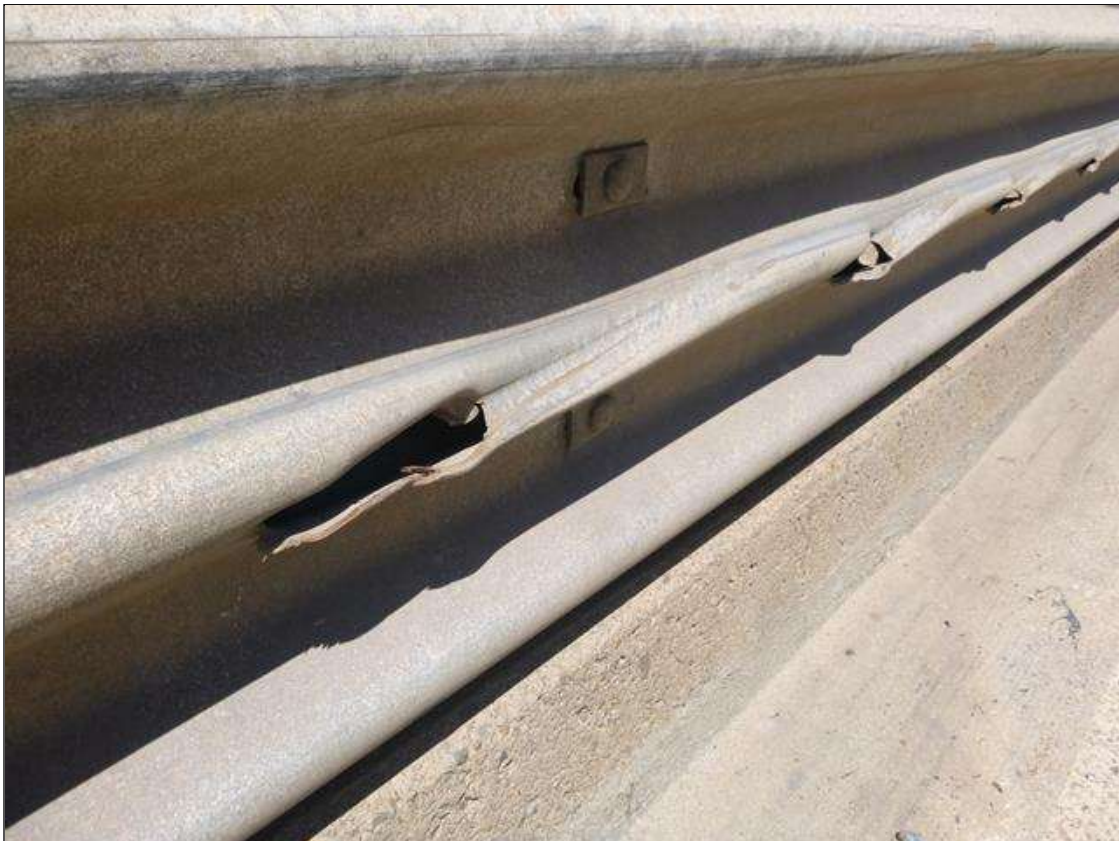
Span 4 Right Bridge Rail: SPAN 4, RIGHT METAL RAIL HAS 10 FT. OF 2 INCH WIDE TEARS THRU OUT THE LENGTH OF THE RAIL

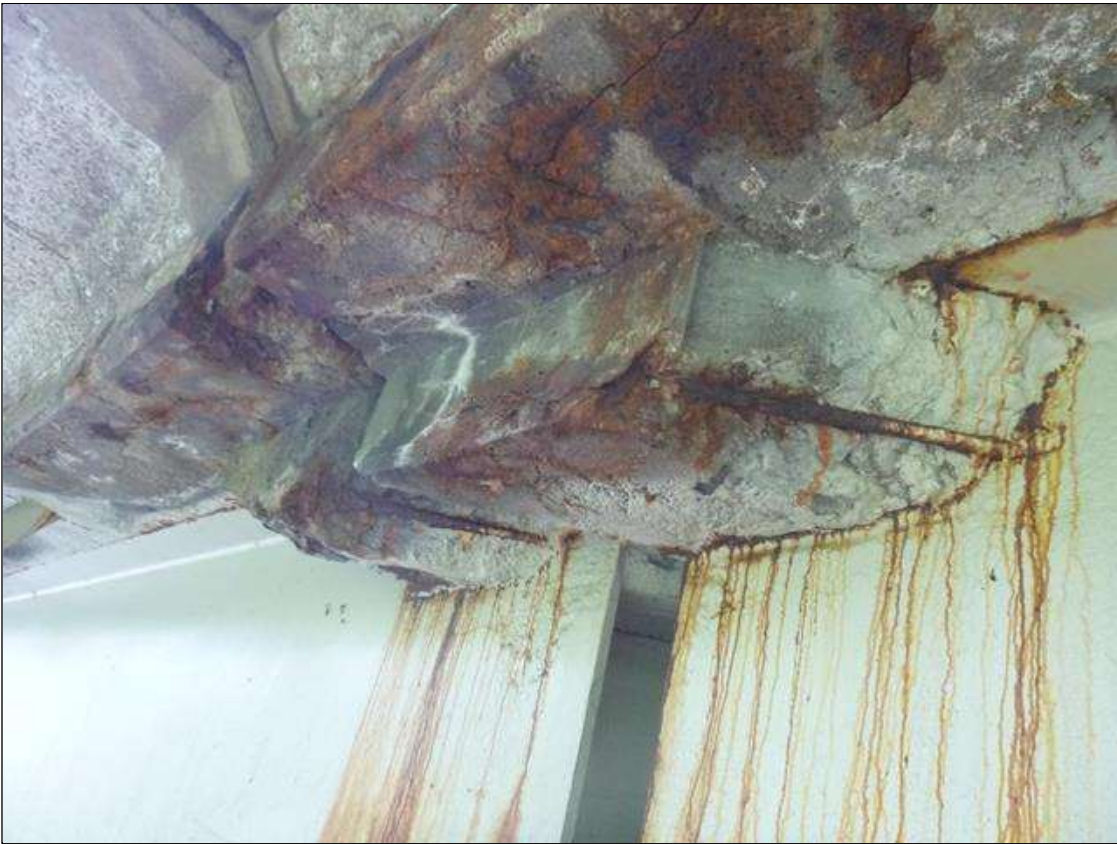
Bent 1 Cap 1: BENT 1 CAP, SPAN 1 SIDE HAS A SPALL ON THE TOP EDGE UNDER BEAM 1, 48 INCHES X 9 INCHES X 4 INCHES DEEP WITH EXPOSED REBAR

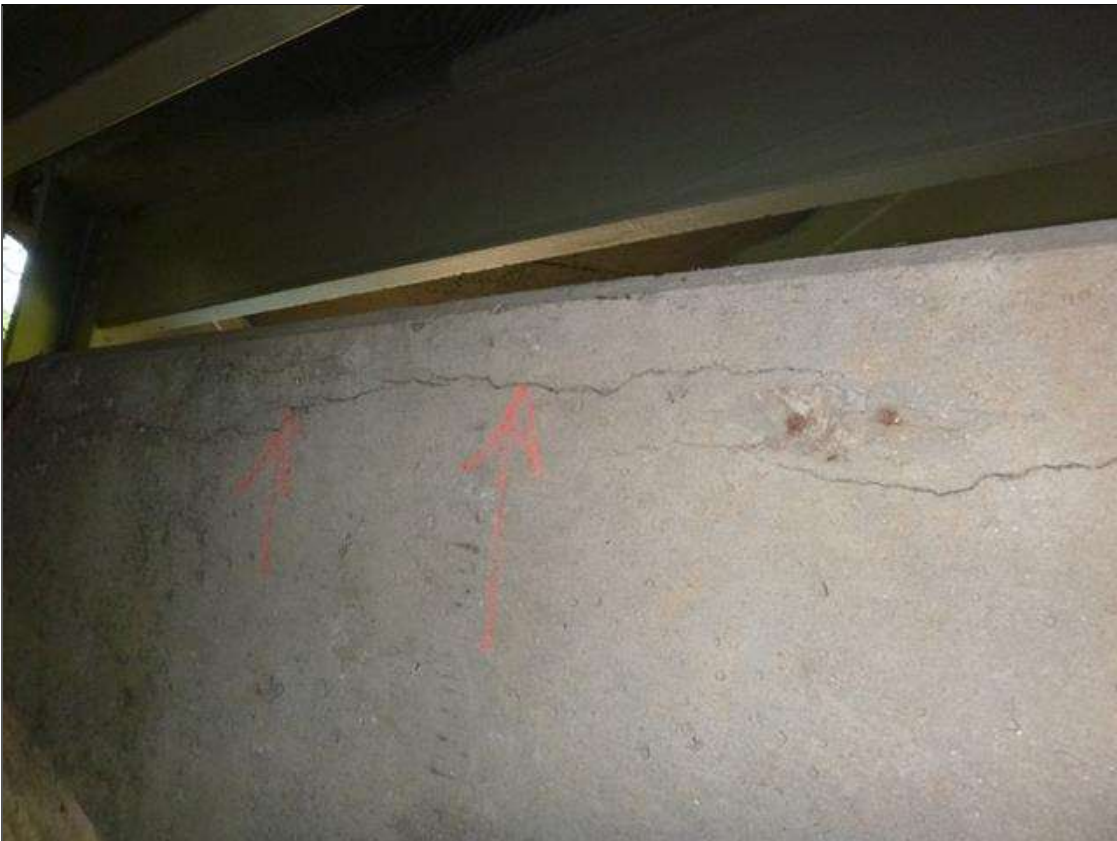
BENT 1, BOTTOM OF LEFT OVERHANG, BENT DIAPHRAGMS FOR SPANS 1 AND 2, SPALLED UP TO 3 INCHES DEEP WITH EXPOSED REBAR

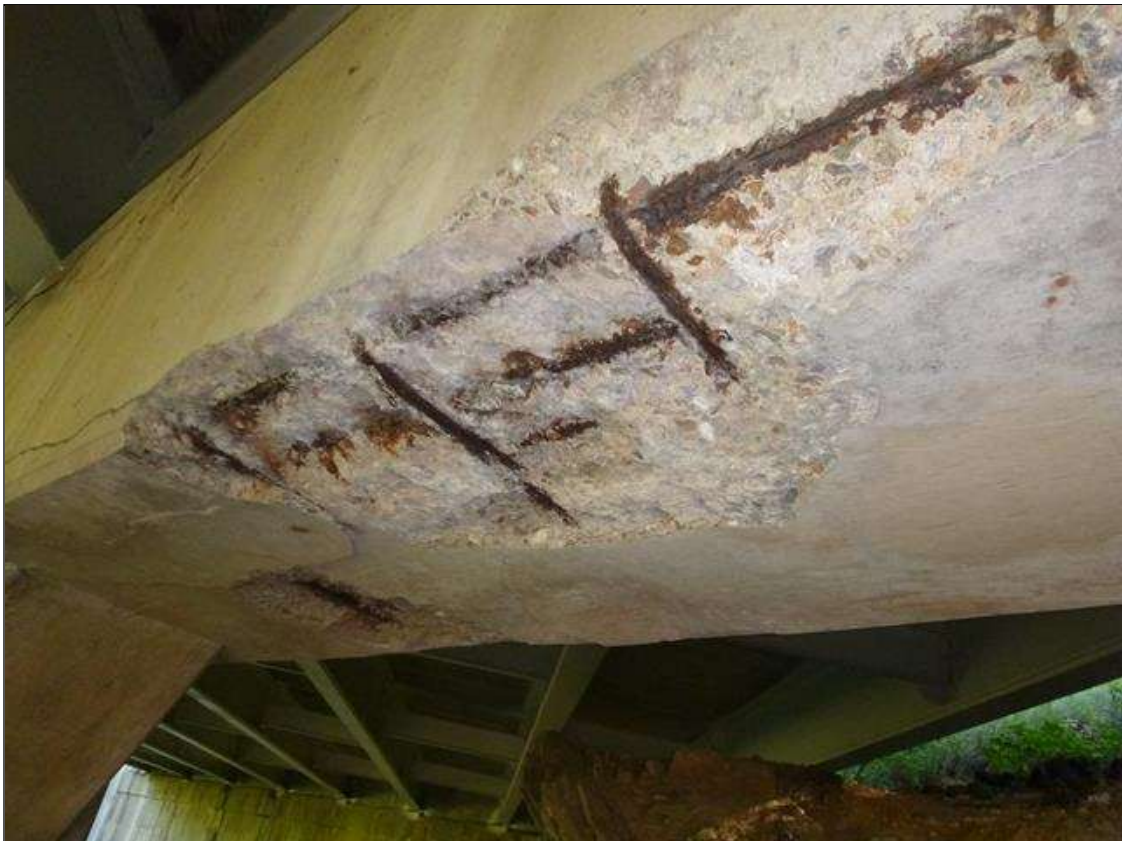
Bent 1 Cap 1: BENT 1 CAP, SPAN 1 SIDE HAS AN AREA OF DELAMINATION IN THE FACE OF THE CAP IN BAY 1, NEAR TOP EDGE, UNDER BEAM 2, 4 FT. LONG X 1 FT. HIGH

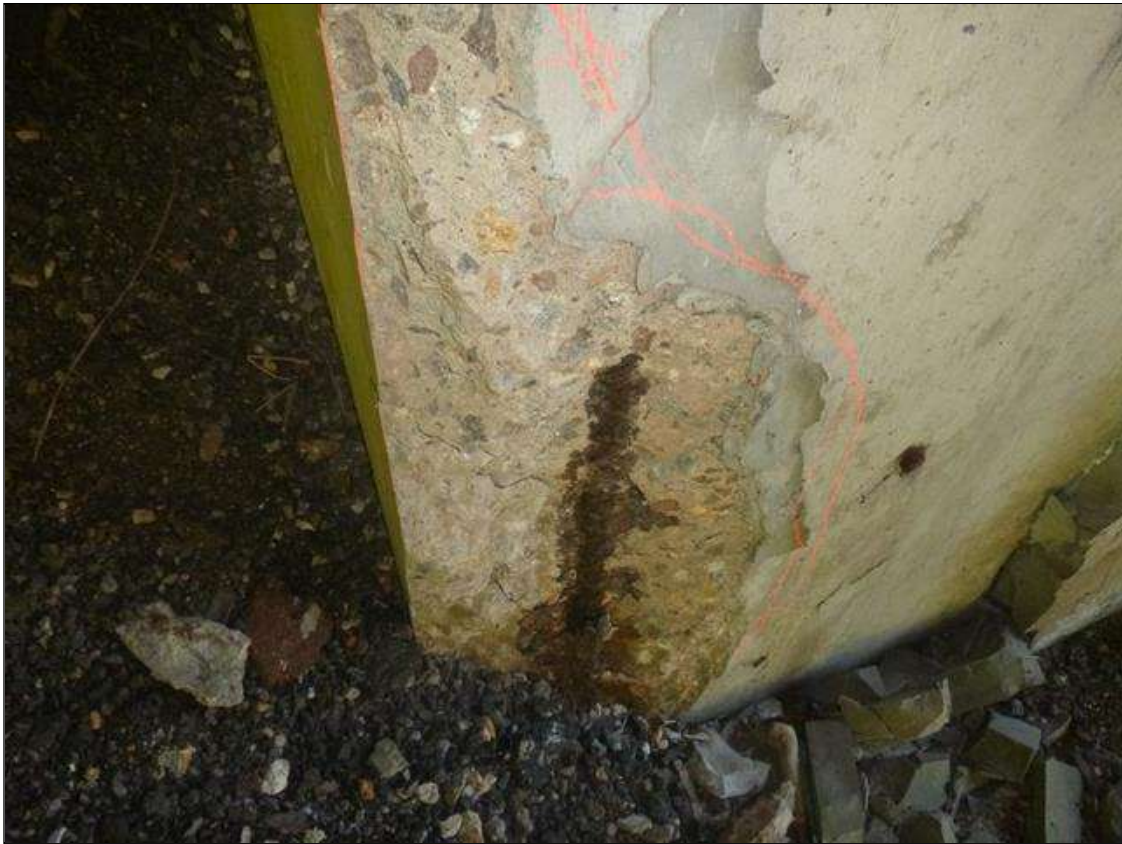
Bent 1 Pile 1: BENT 1, PILE 1 HAS A 12 INCH WIDE X 24 INCH HIGH X 2 INCH DEEP SPALL WITH REBAR EXPOSED ON THE EAST FACE NEAR GROUND LINE

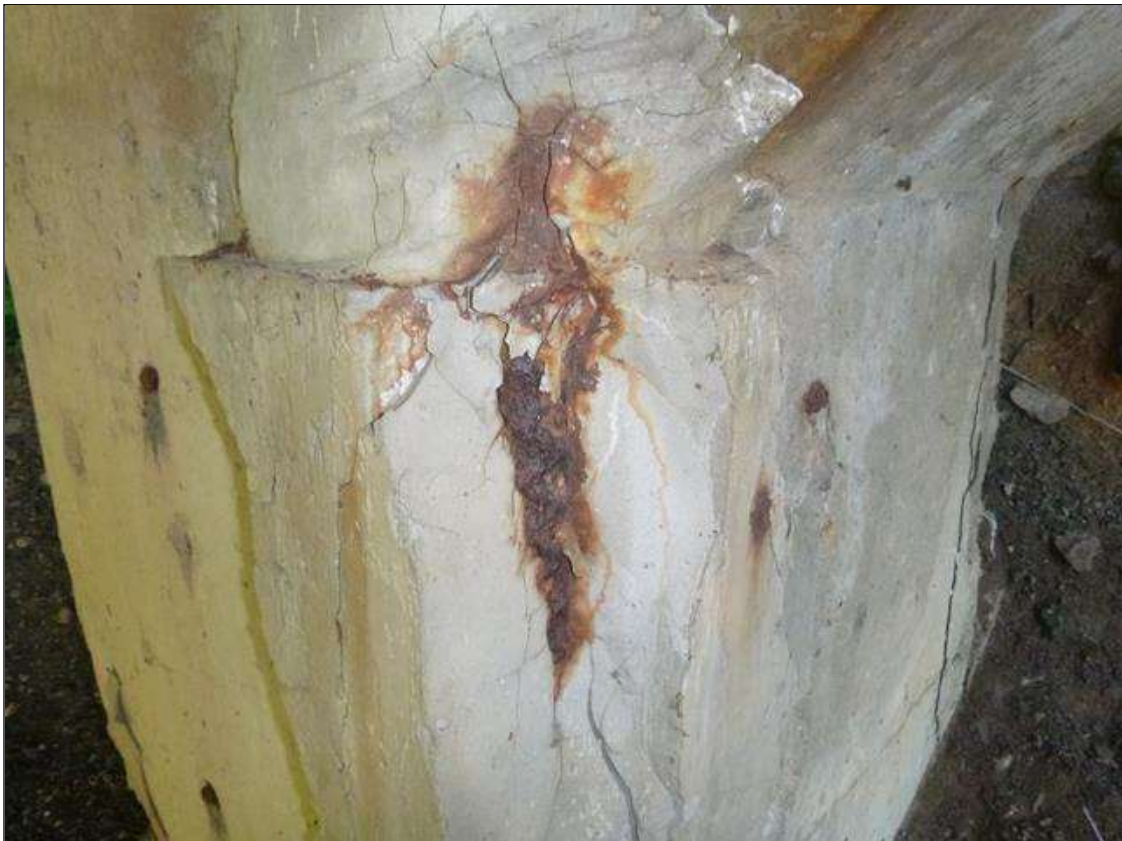
Bent 1 Pile 1: BENT 1, PILE 1 HAS A SPALL ON THE NORTHEAST CORNER, 8 INCHES X 12 INCHES X 2 INCHES DEEP WITH EXPOSED REBAR, 2 FT. BELOW THE BOTTOM OF THE CAP

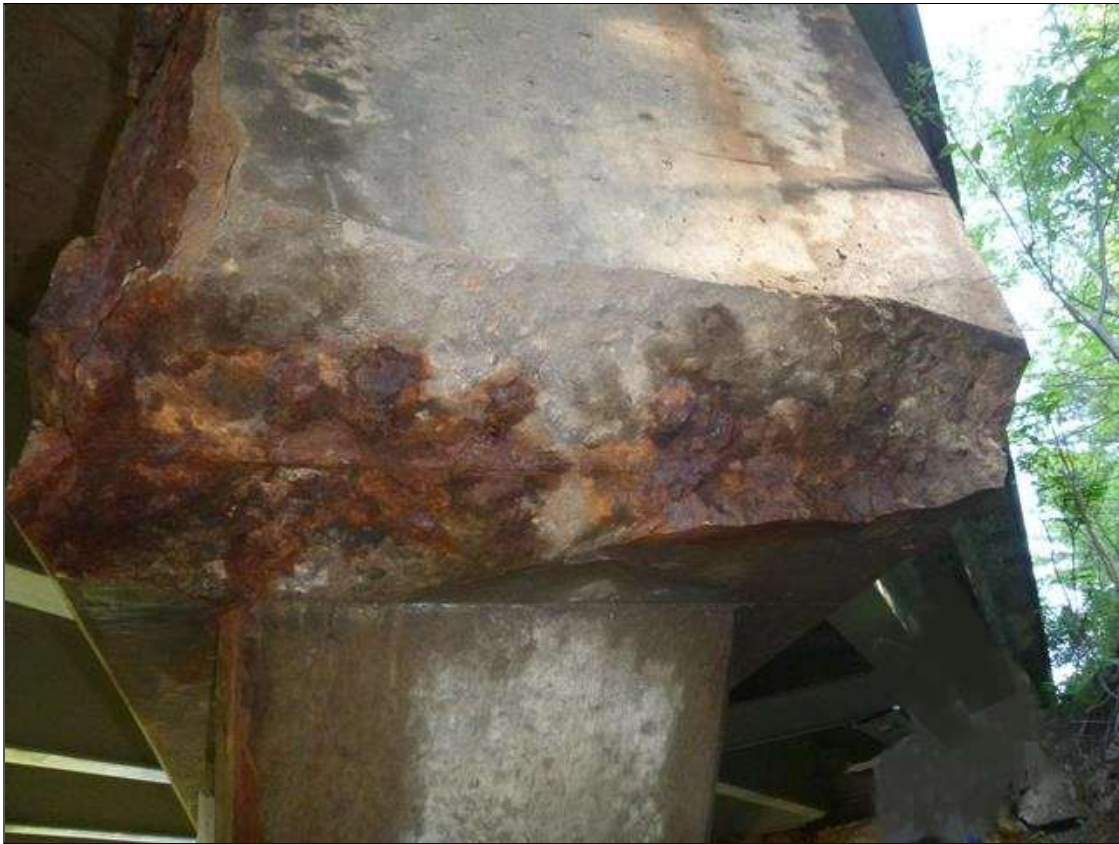
Bent 1 Cap 1: BENT 1 CAP, BOTTOM OF LEFT END HAS A SPALL, 36 INCHES X 8 INCHES X 4 INCHES DEEP  
WITH EXPOSED REBAR

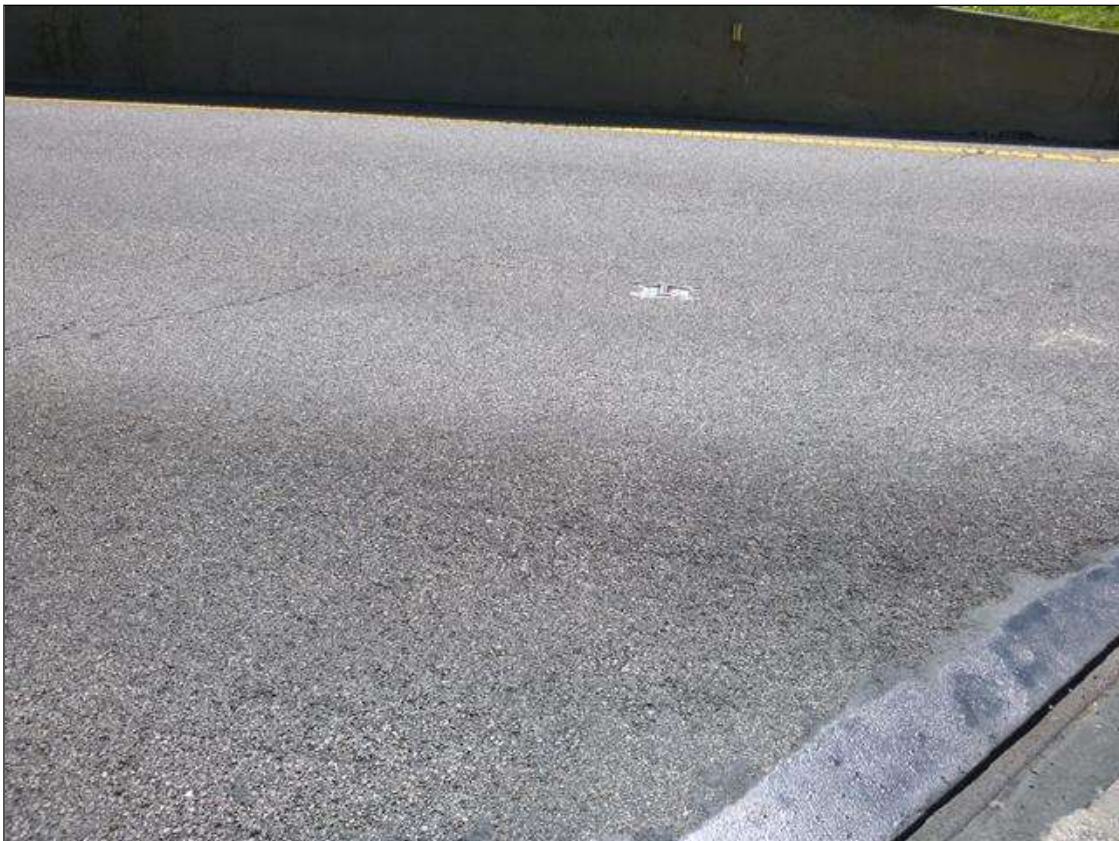
END BENT 2 ASPHALT WEARING SURFACE APPROACH, GOOD CONDITION

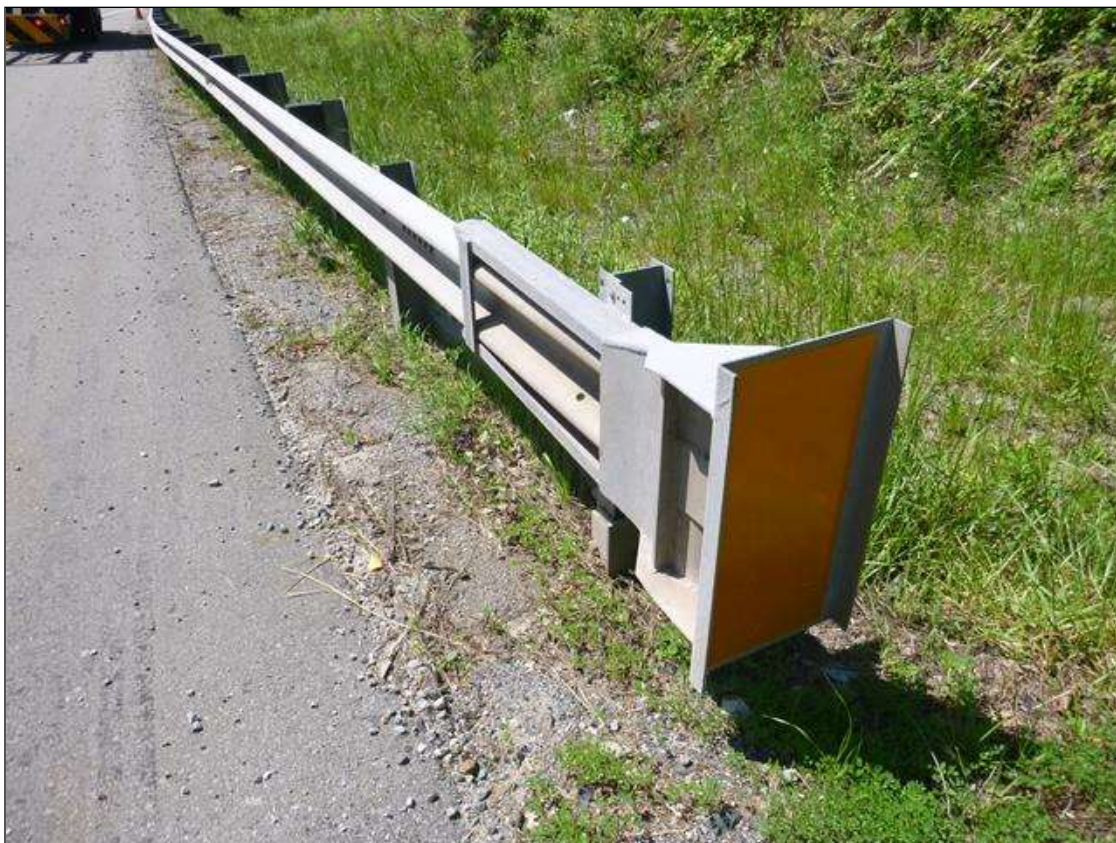
APPROACH GUARD RAIL END AT THE SOUTHWEST CORNER

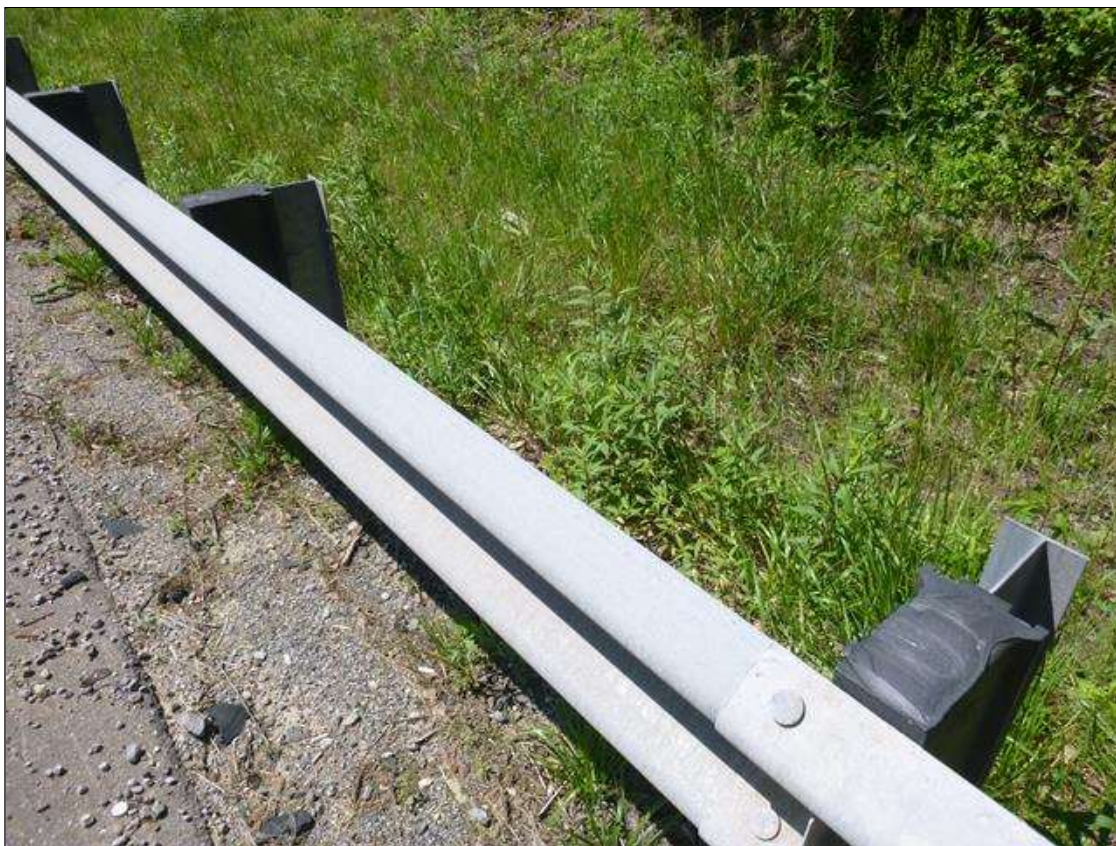
APPROACH GUARDRAIL POST SPACING, 75 INCHES AT THE SOUTHWEST CORNER

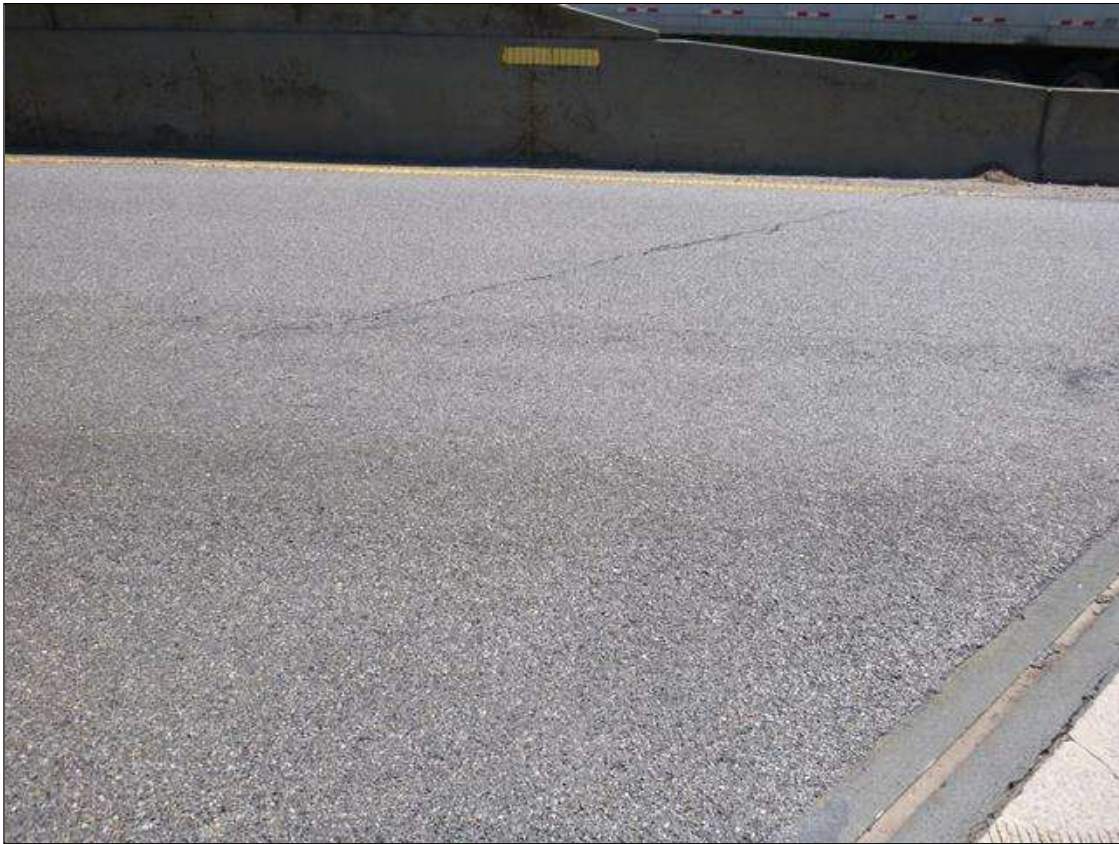
END BENT 1 ASPHALT WEARING SURFACE APPROACH AT EAST BOUND LANES, GOOD CONDITION

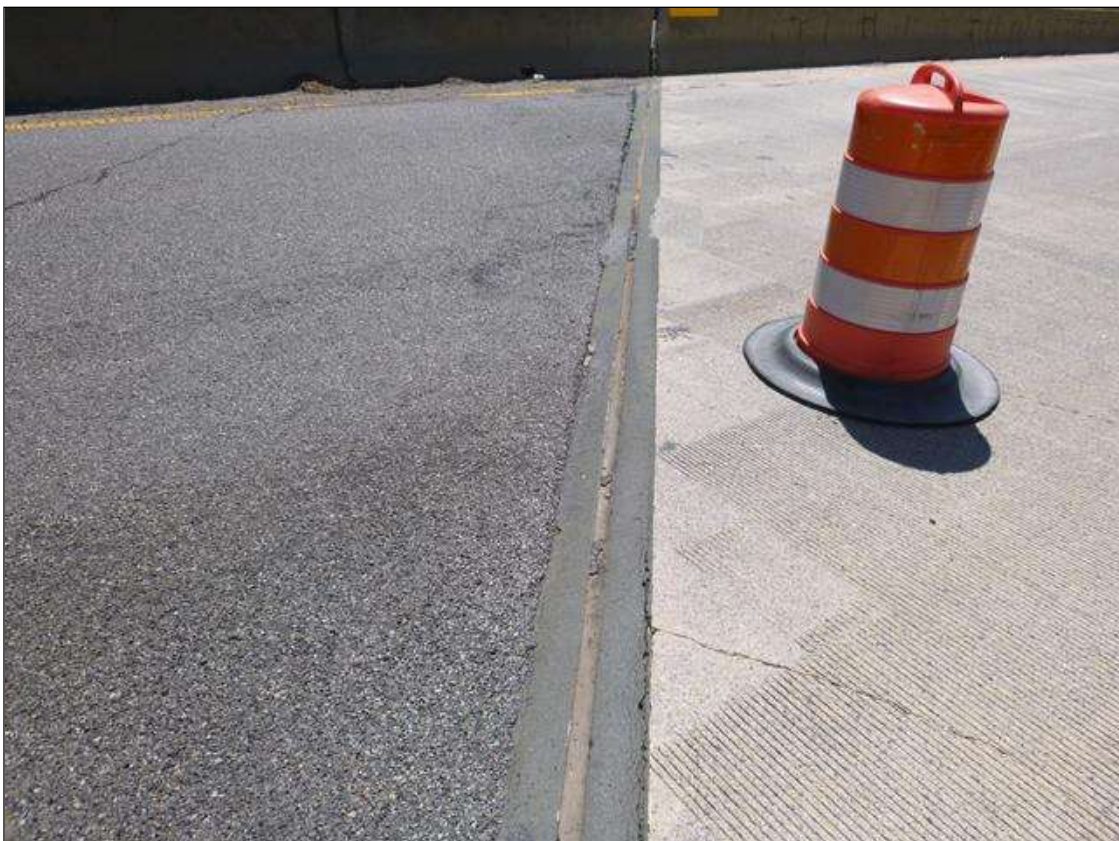
END BENT 1 JOINT, EAST BOUND LANES

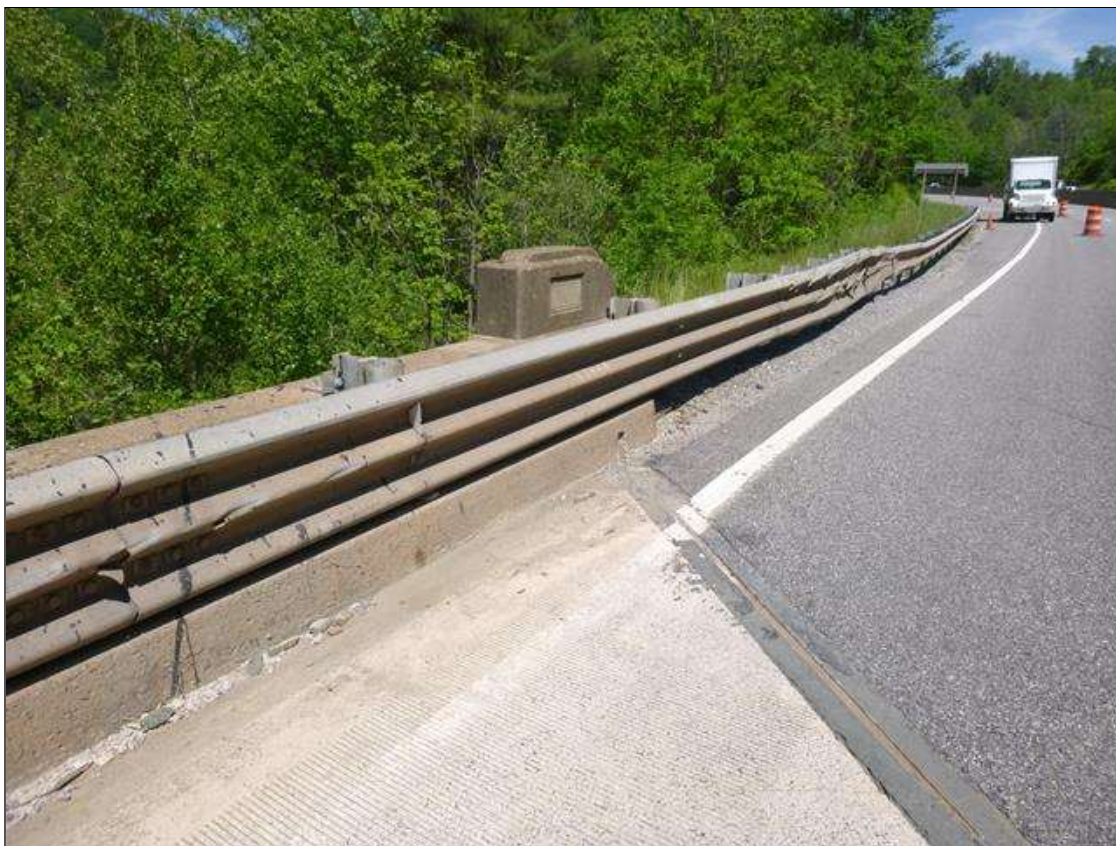
END BENT 1 RIGHT SIDE APPROACH GUARDRAIL TRANSITION

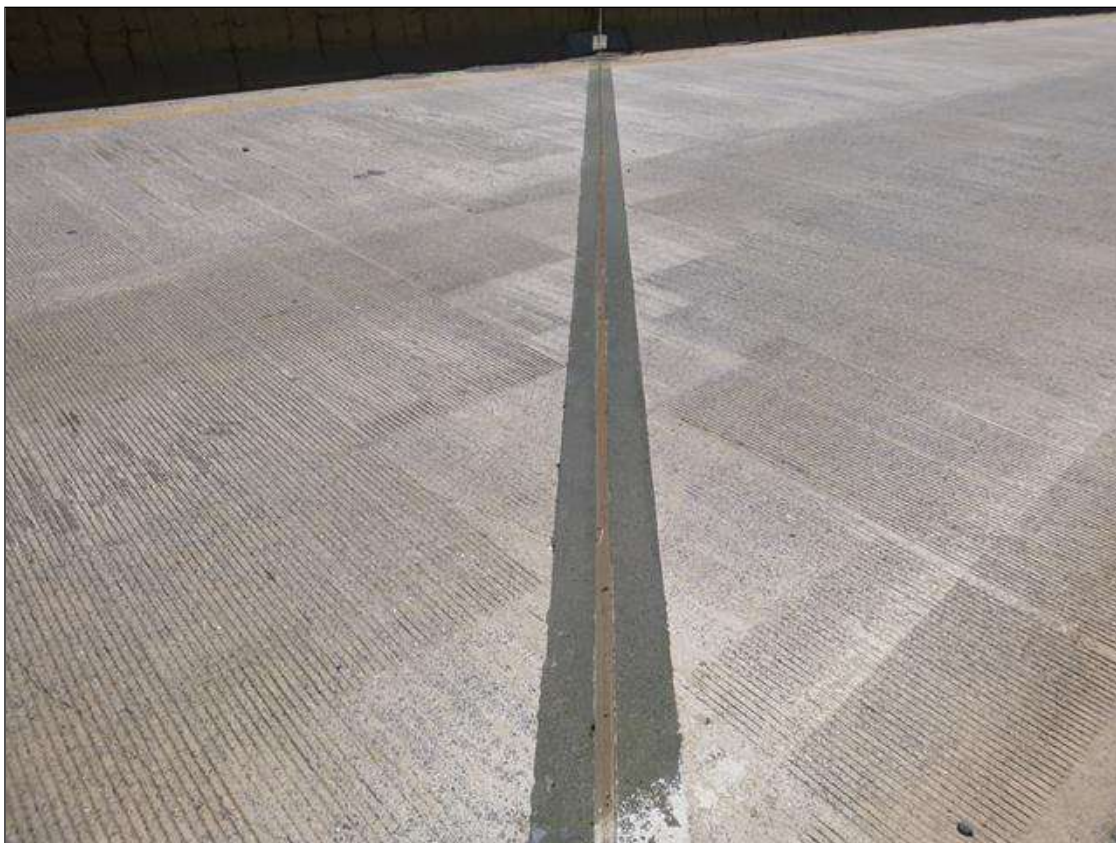
BENT 1 JOINT, EAST BOUND LANES

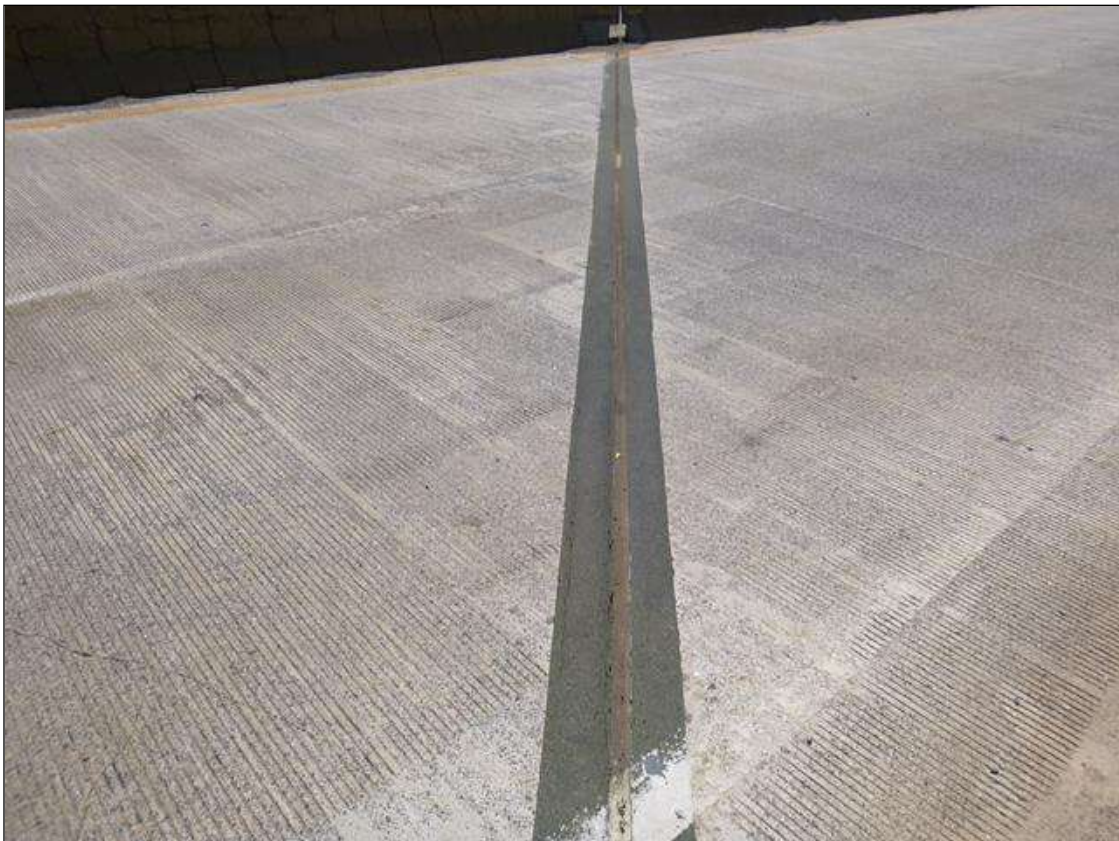
BENT 2 JOINT, EAST BOUND LANES

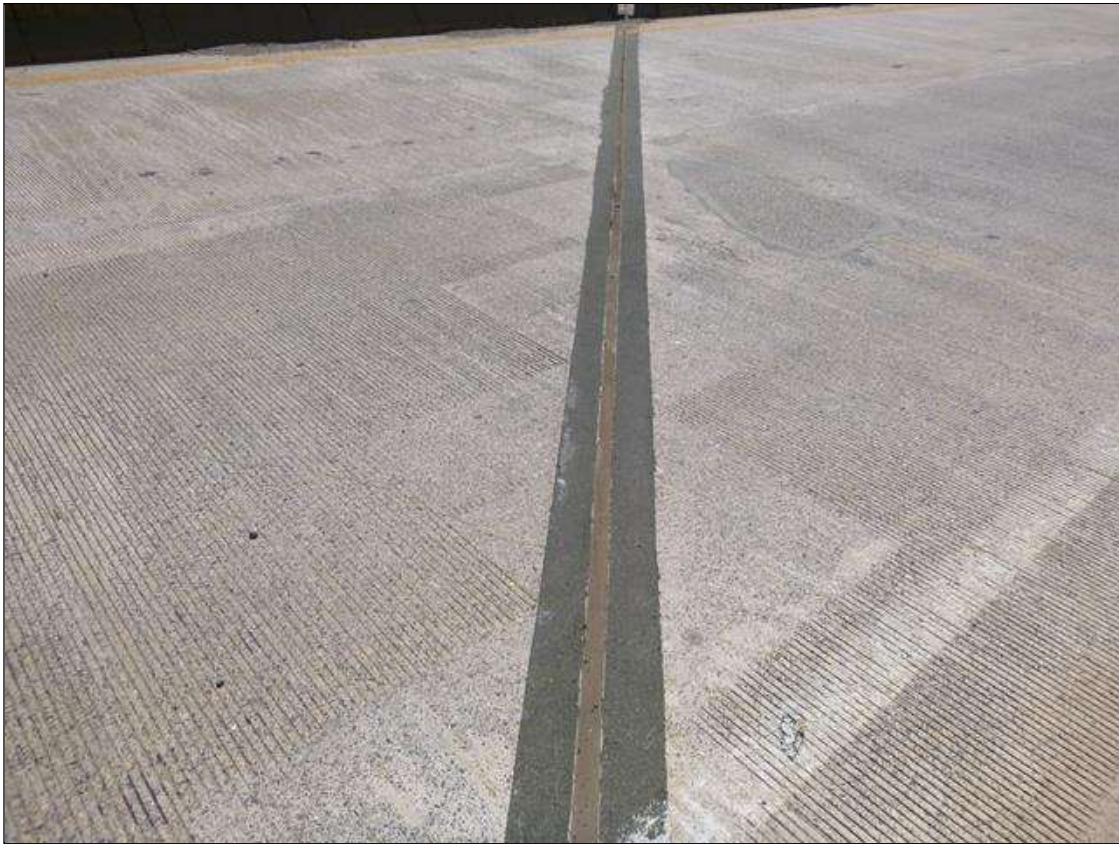
BENT 3 JOINT, EAST BOUND LANES

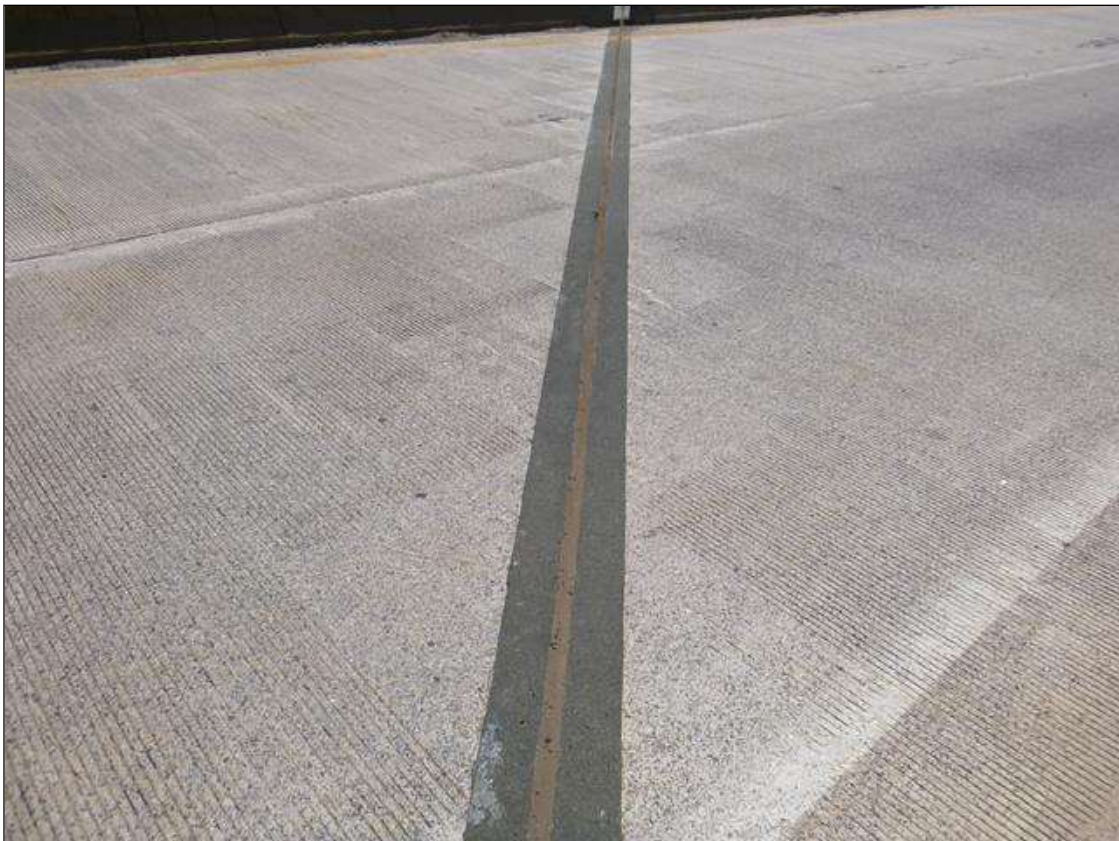
BENT 4 JOINT, EAST BOUND LANES

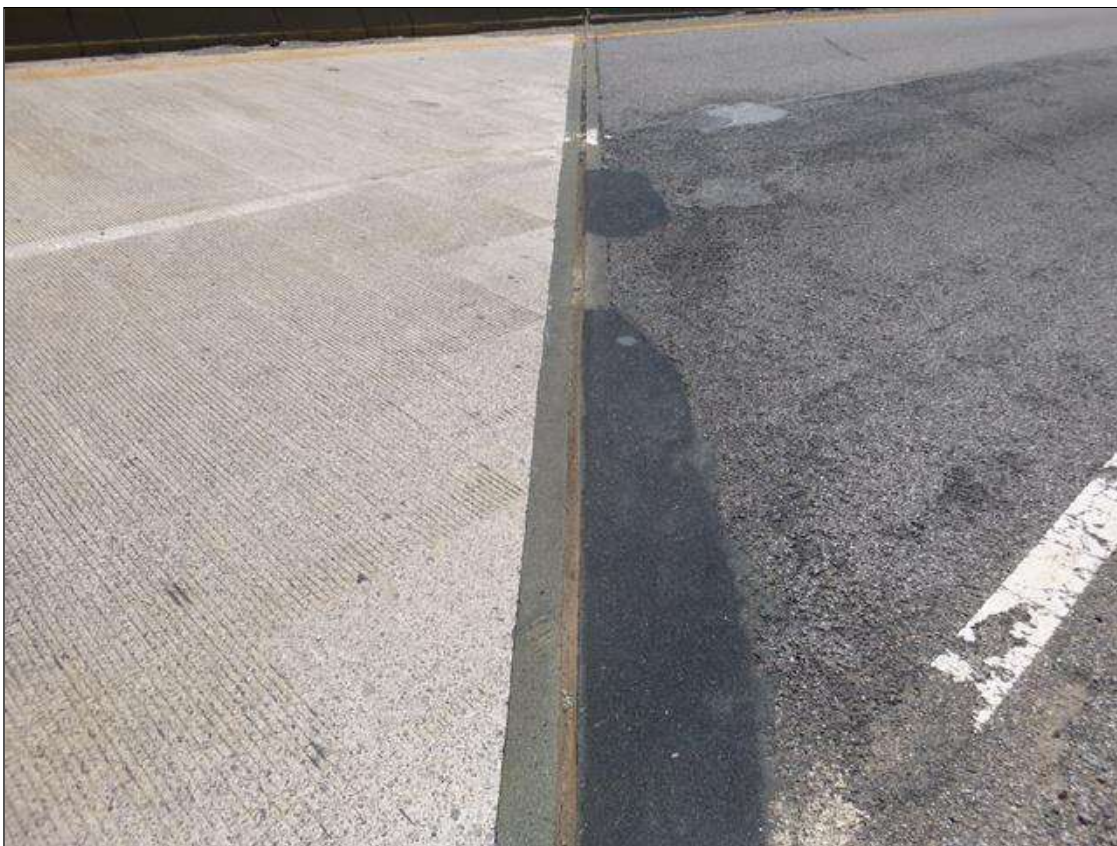
END BENT 2 JOINT, EAST BOUND LANES

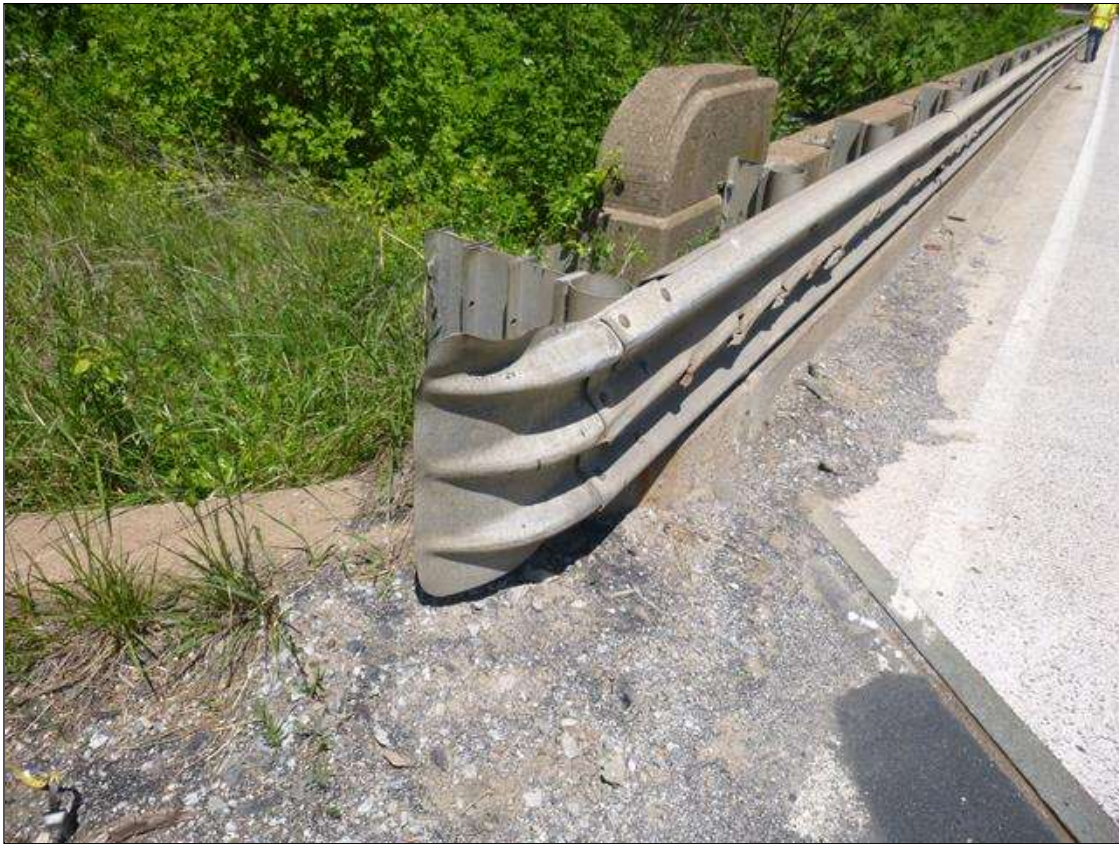
BRIDGE RAIL END AT THE RIGHT SIDE OF END BENT 2

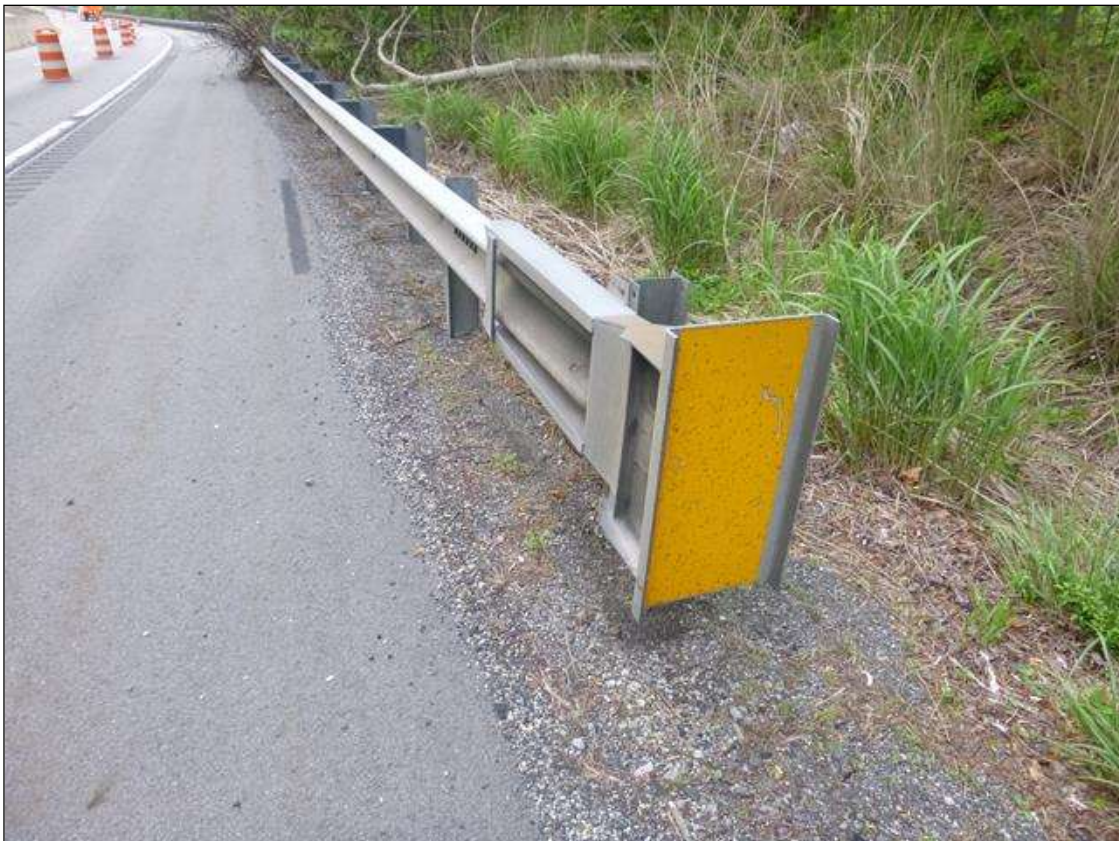
APPROACH GUARDRAIL END AT THE NORTHEAST CORNER
