## Structure Safety Report

### Routine Element Inspection - Contract

COUNTY: HAYWOOD STRUCTURE NUMBER: 430142 FREQUENCY: 24 MONTHS

FEATURE INTERSECTED: PIGEON RIVER

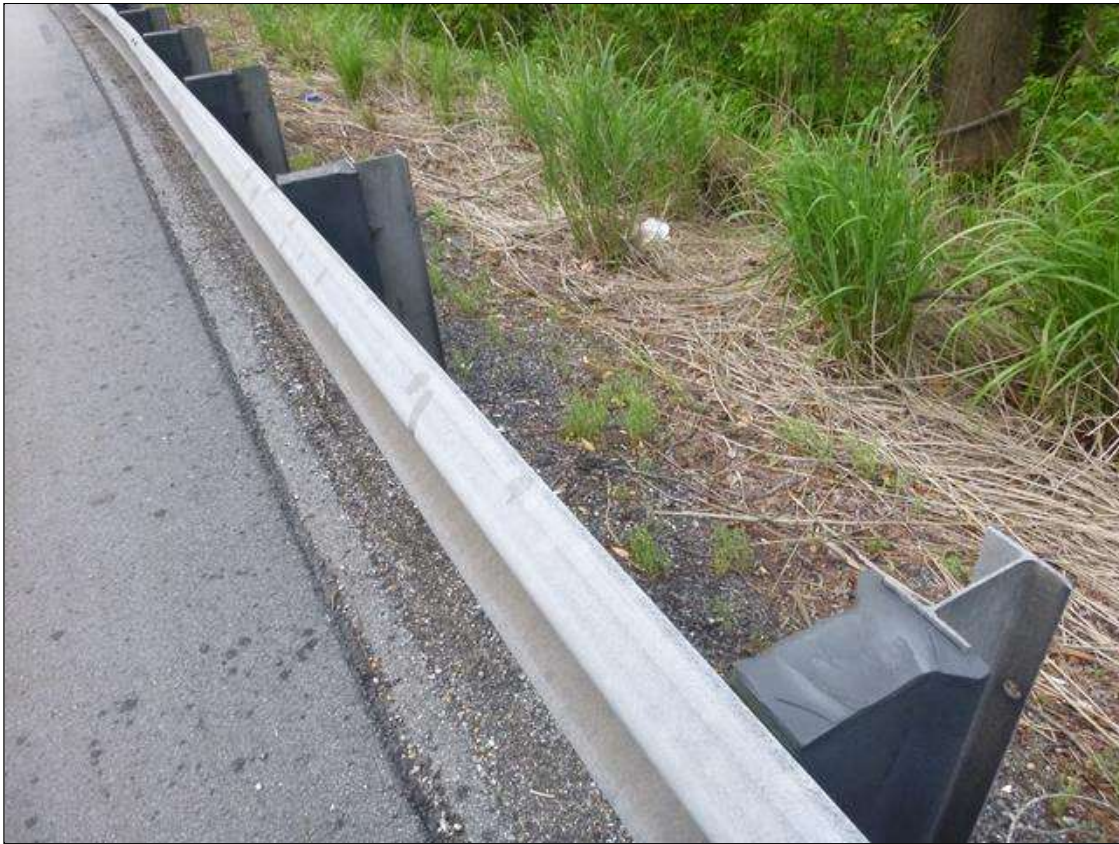
APPROACH GUARDRAIL POST SPACING, 75 INCHES AT THE NORTHEAST CORNER

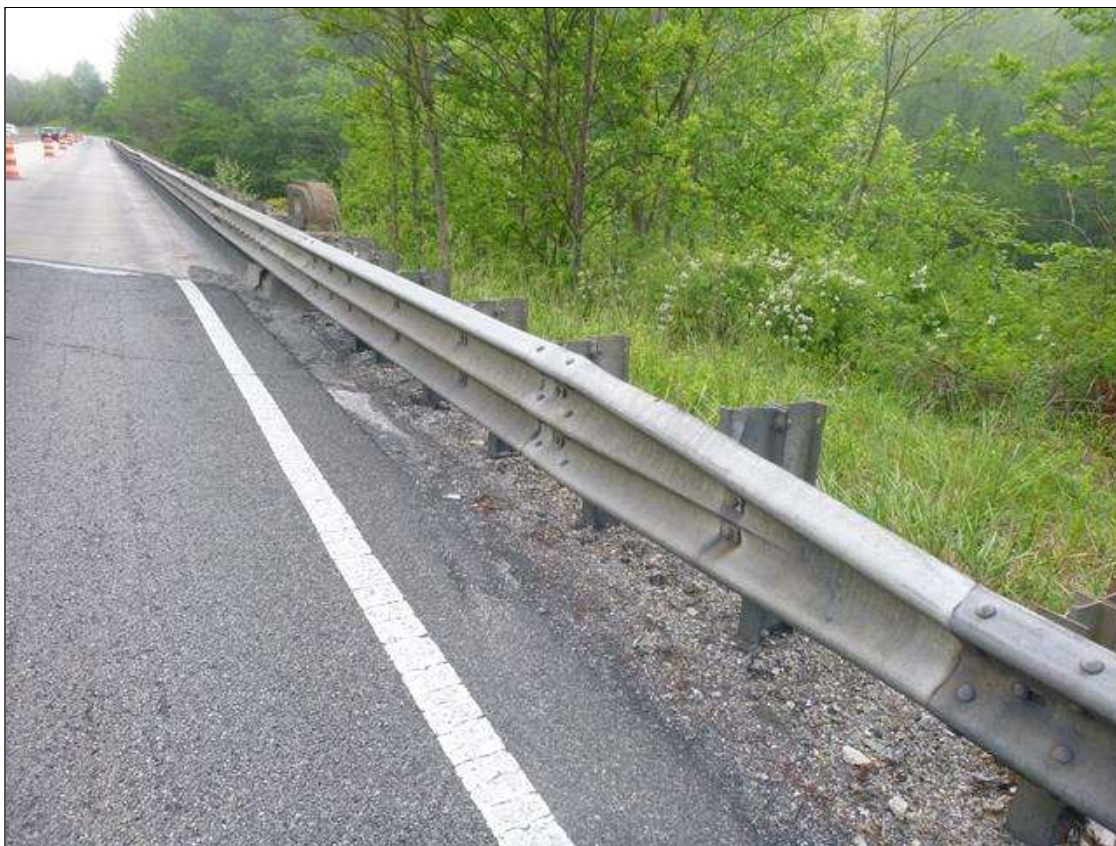
APPROACH GUARDRAIL TRANSITION AT THE LEFT SIDE OF END BENT 2

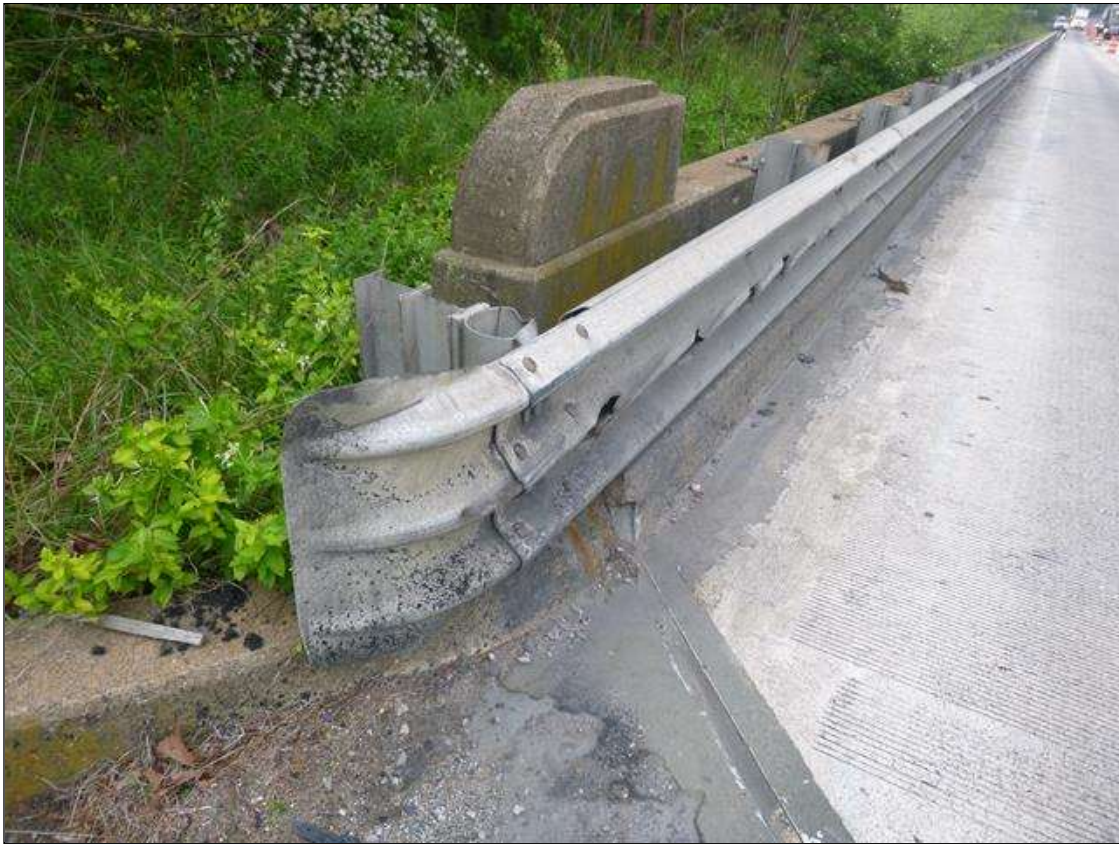
END BENT 1, LEFT SIDE, BRIDGE RAIL END
