NC DEPARTMENT OF TRANSPORTATION  
DIVISION OF HIGHWAYS  
STRUCTURE MANAGEMENT UNIT

## Structure Safety Report

### Routine Element Inspection - Contract

COUNTY: HAYWOOD STRUCTURE NUMBER: 430159 FREQUENCY: 24 MONTHS  
FACILITY CARRIED: I-40 MILE POST: 18.7  
LOCATION: 1.8 MI.W.JCT.US276  
FEATURE INTERSECTED: SR1338  
LATITUDE: 35° 37' 31.64" LONGITUDE: 83° 0' 31.41"  
SUPERSTRUCTURE: REINFORCED CONCRETE FLOOR ON I-BEAMS

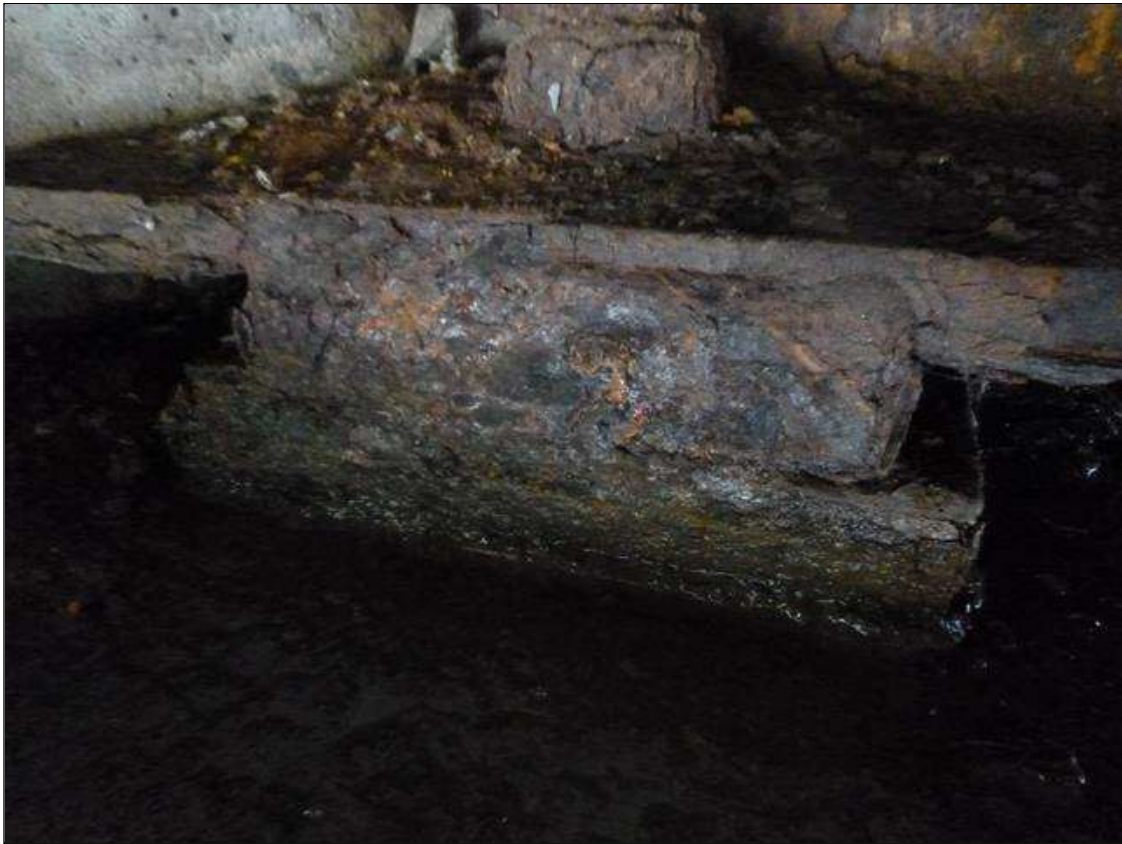
Span 1 Beam 1 Near Bearing: SPAN 1, BEAM 1 NEAR BEARING HAS 1/16 INCH SECTION LOSS

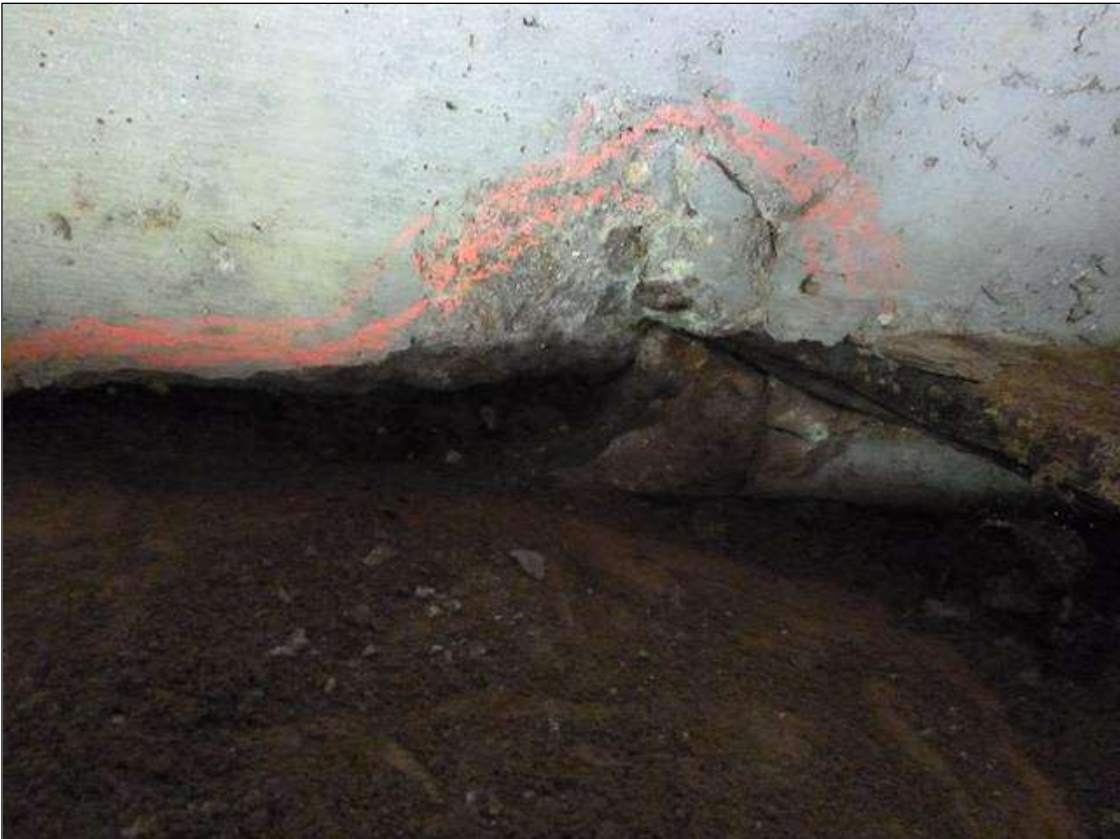
End Bent 1 Abutment/Backwall : END BENT 1 ABUTMENT, BAY 2, ADJACENT TO THE RIGHT BOTTOM FLANGE OF BEAM 2 HAS A SPALL, 12 INCHES LONG X 3 INCHES WIDE X 3 INCHES DEEP

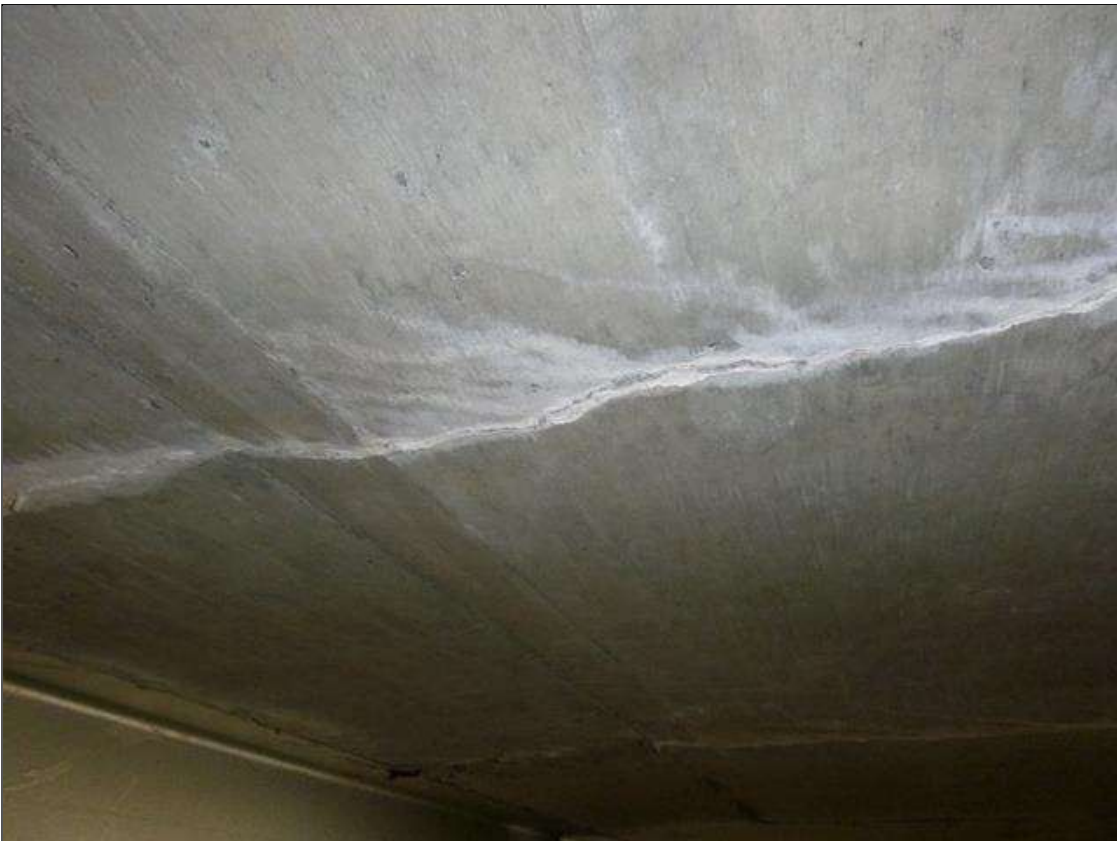
| Element Number | Defect Type | Defect Description | CS | CS Qty | Maint Qty | |
|---|---|---|---|---|---|---|
| 12 | Cracking (RC and Other) | SPAN 1, BOTTOM OF THE DECK, BAY 5 HAS HAIRLINE TRANSVERSE CRACKS WITH EFFLO. X 42 INCHES LONG, FOR A TOTAL OF 24 SQ. FT. IN BAY 5 | 2 | 24 | 24 | Square Feet |

Span 1 Deck: SPAN 1, BOTTOM OF THE DECK, BAY 5 HAS HAIRLINE TRANSVERSE CRACKS WITH EFFLO. X 42 INCHES LONG, FOR A TOTAL OF 24 SQ. FT. IN BAY 5

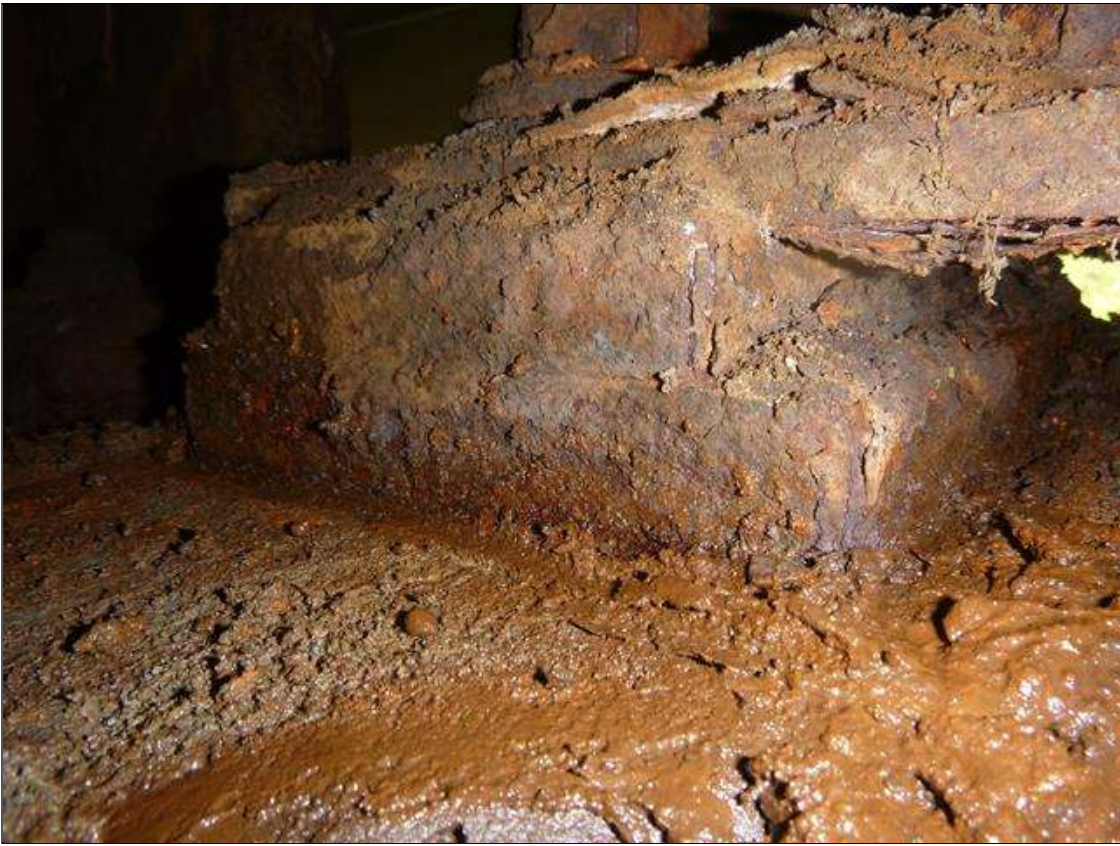
Span 1 Beam 3 Far Bearing: SPAN 1, BEAM 3 FAR BEARING HAS 1/16 INCH SECTION LOSS

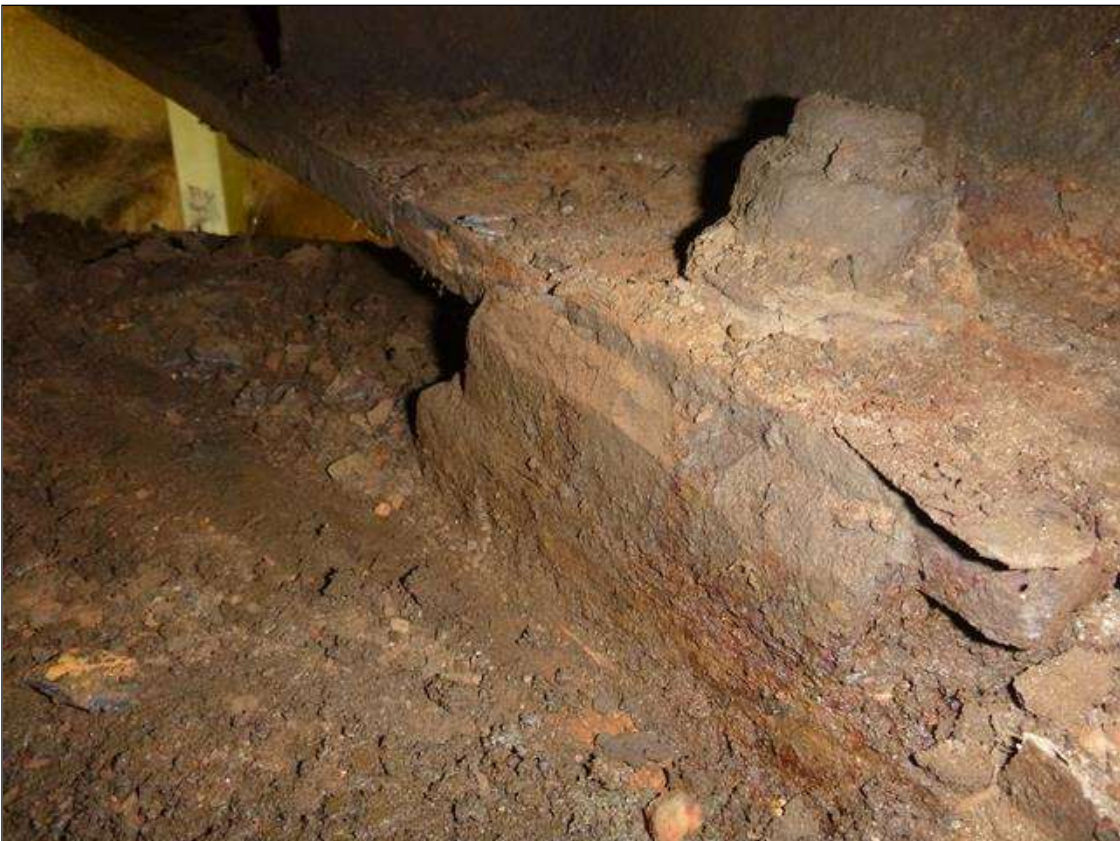
Span 2 Beam 3: SPAN 2, BEAM 3 AT BENT 1 HAS 1/16 INCH SECTION LOSS ON THE BOTTOM FLANGE FROM THE BEAM END OUT 2 FT. X FULL WIDTH WITH 9/16 INCH REMAINING

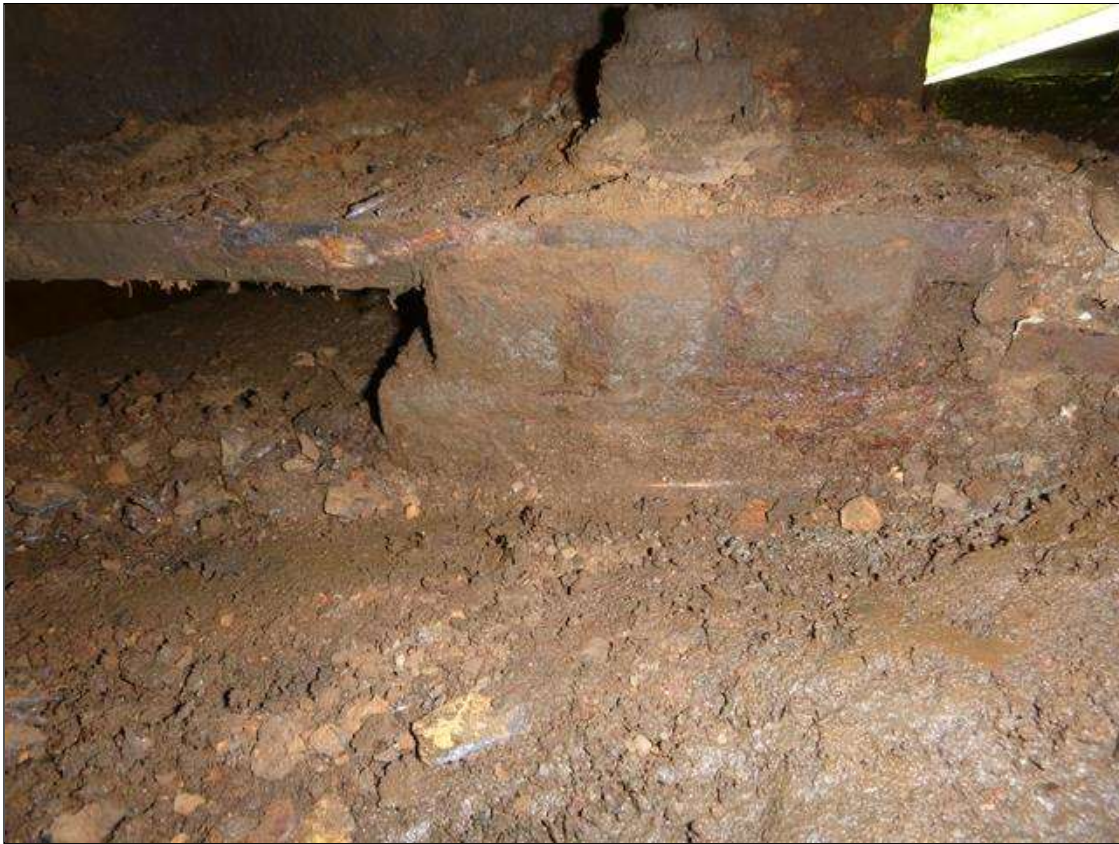
Span 2 Beam 3 Near Bearing: SPAN 2, BEAM 3 NEAR BEARING HAS 1/16 INCH SECTION LOSS

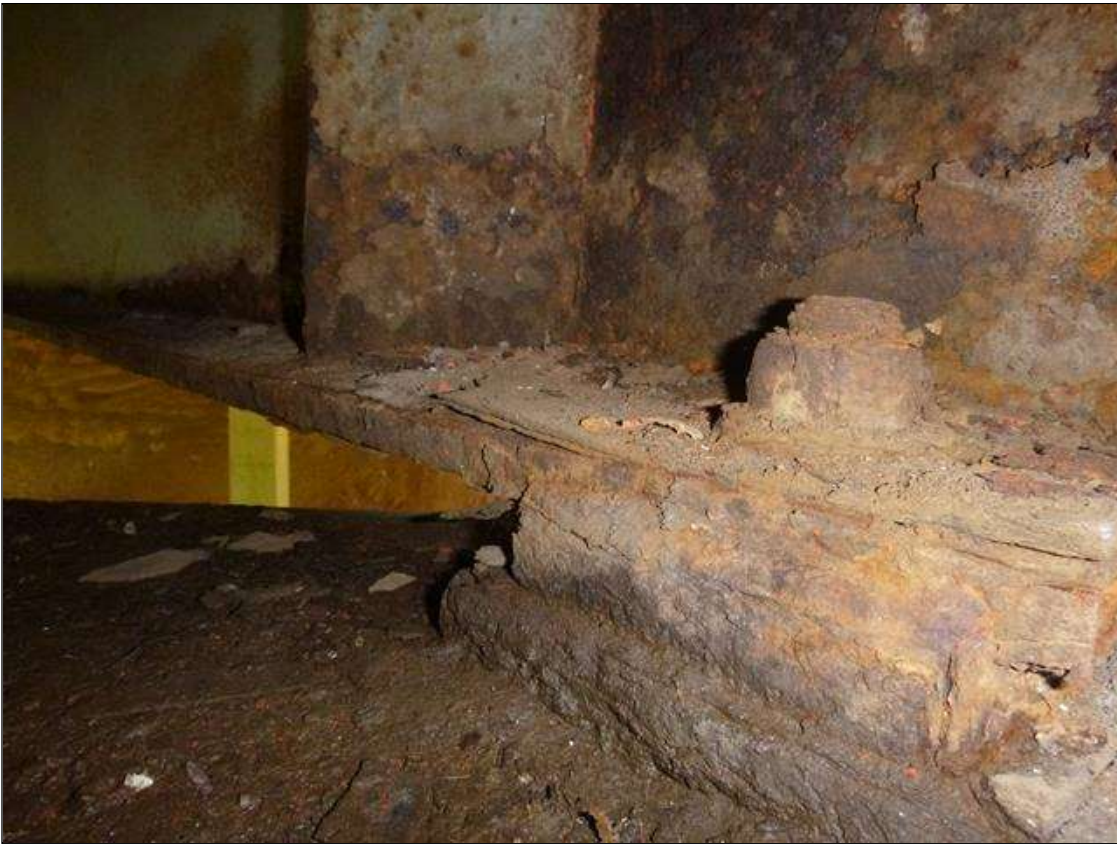
Span 2 Beam 4: SPAN 2, BEAM 4 AT BENT 1 HAS 1/16 INCH SECTION LOSS ON THE BOTTOM FLANGE X FULL WIDTH FROM THE BEAM END OUT 3 FT. WITH 9/16 INCH REMAINING, THE LOWER WEB HAS 1/16 INCH SECTION LOSS FROM THE BEAM END OUT 3 FT X 6 INCHES HIGH WITH 9/16 INCH REMAINING

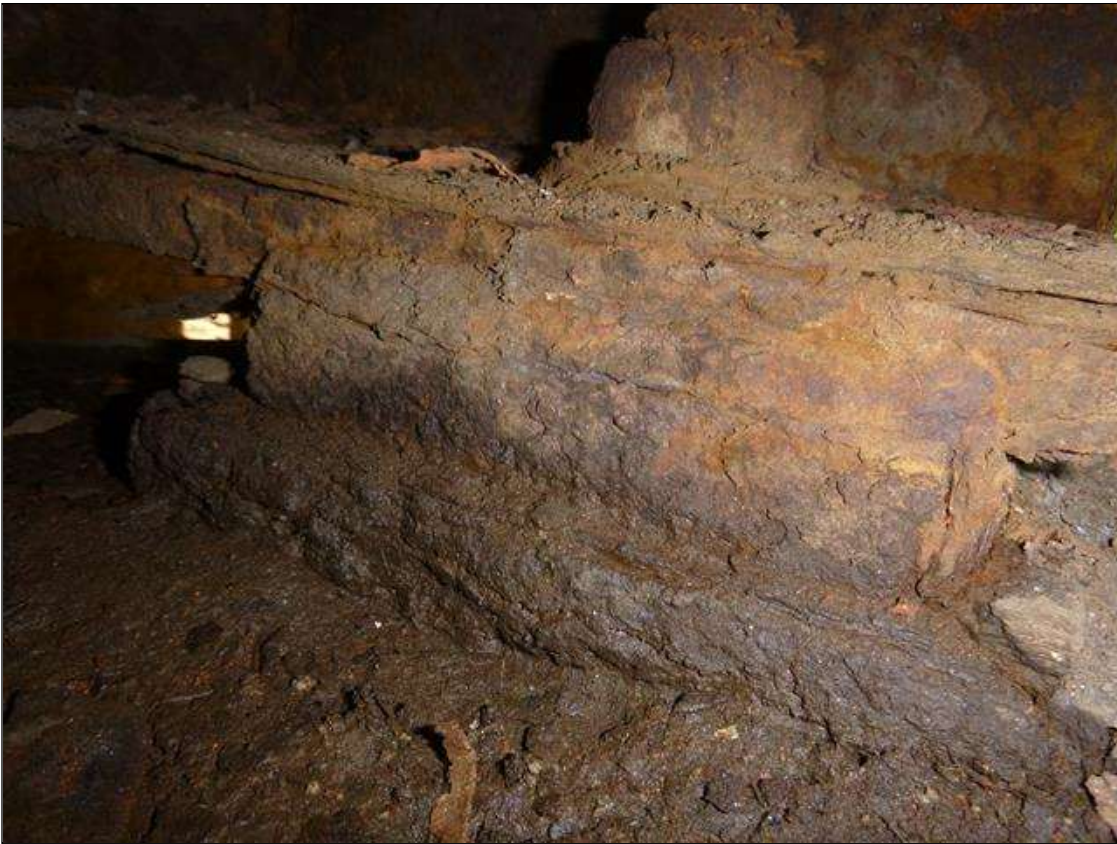
Span 2 Beam 4 Near Bearing: SPAN 2, BEAM 4 NEAR BEARING HAS 1/16 INCH SECTION LOSS

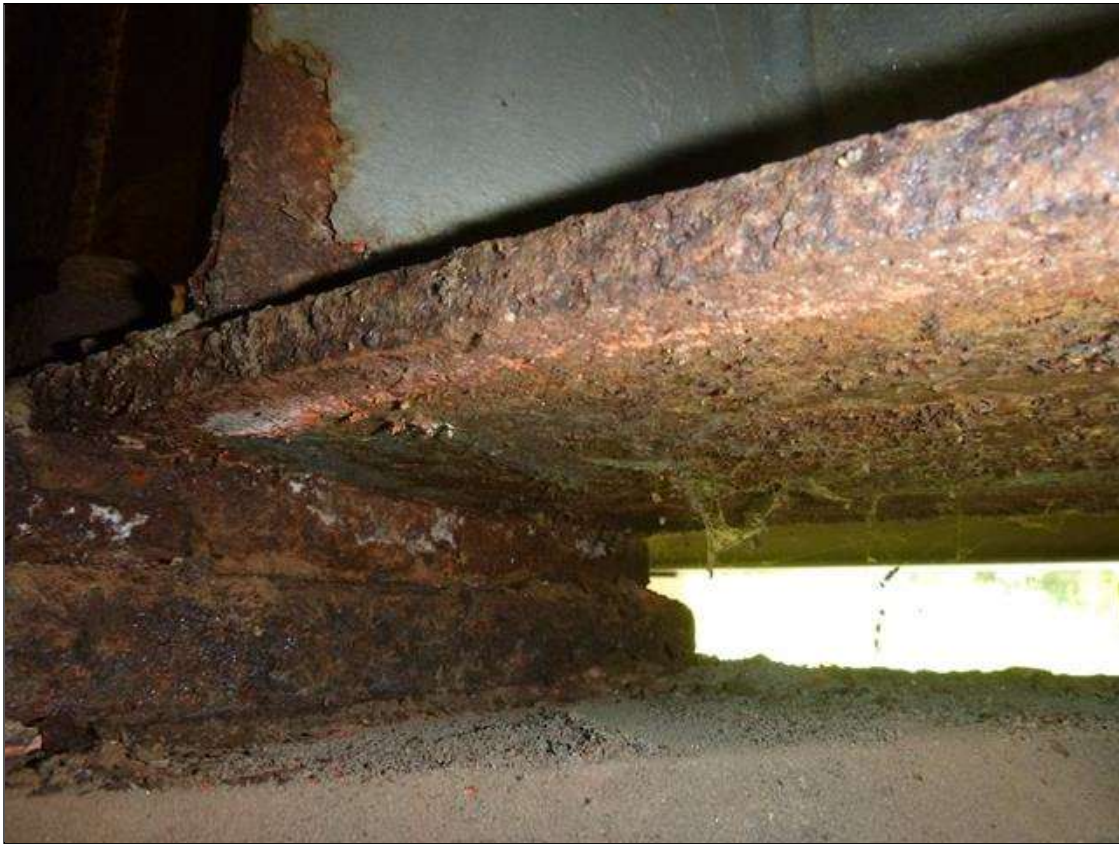
| Element Number | Defect Type | Defect Description | CS | CS Qty | Maint Qty | |
|---|---|---|---|---|---|---|
| 107 | Corrosion | Span 1 Beam 4: SPAN 1, BEAM 4 AT BENT 1 HAS 1/32 INCH SECTION LOSS ON THE BOTTOM FLANGE X FULL WIDTH FROM THE BEAM END OUT 2 FT. WITH 1/2 INCH REMAINING, THE LOWER WEB HAS 1/32 INCH SECTION LOSS FROM THE END OF THE BEAM OUT 2 FT. X 4 INCHES HIGH WITH 15/32 INCH REMAINING | 3 | 2 | 2 | Feet |

Span 1 Beam 4: SPAN 1, BEAM 4 AT BENT 1 HAS 1/32 INCH SECTION LOSS ON THE BOTTOM FLANGE X FULL WIDTH FROM THE BEAM END OUT 2 FT. WITH 1/2 INCH REMAINING, THE LOWER WEB HAS 1/32 INCH LOSS FROM THE END OF THE BEAM OUT 2 FT. X 4 INCHES HIGH WITH 15/32 INCH REMAINING

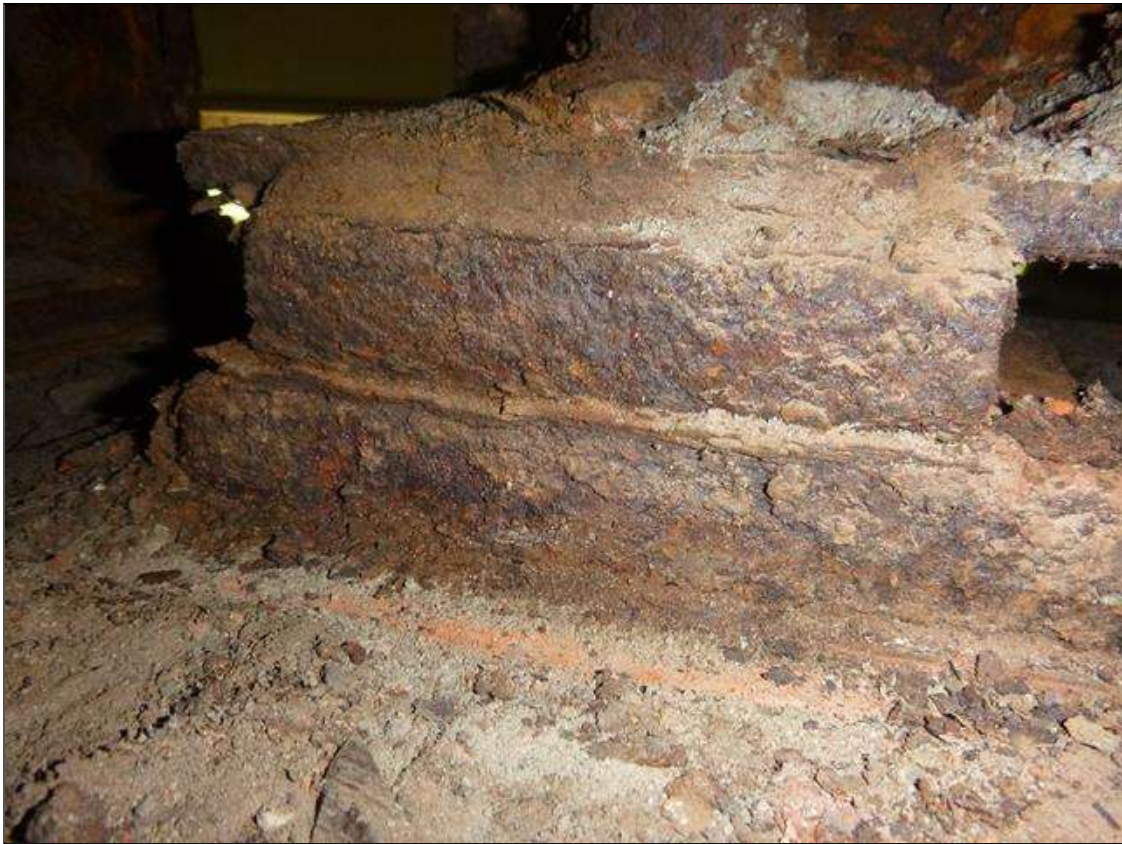
Span 1 Beam 4 Far Bearing: SPAN 1, BEAM 4 FAR BEARING HAS 1/16 INCH SECTION LOSS

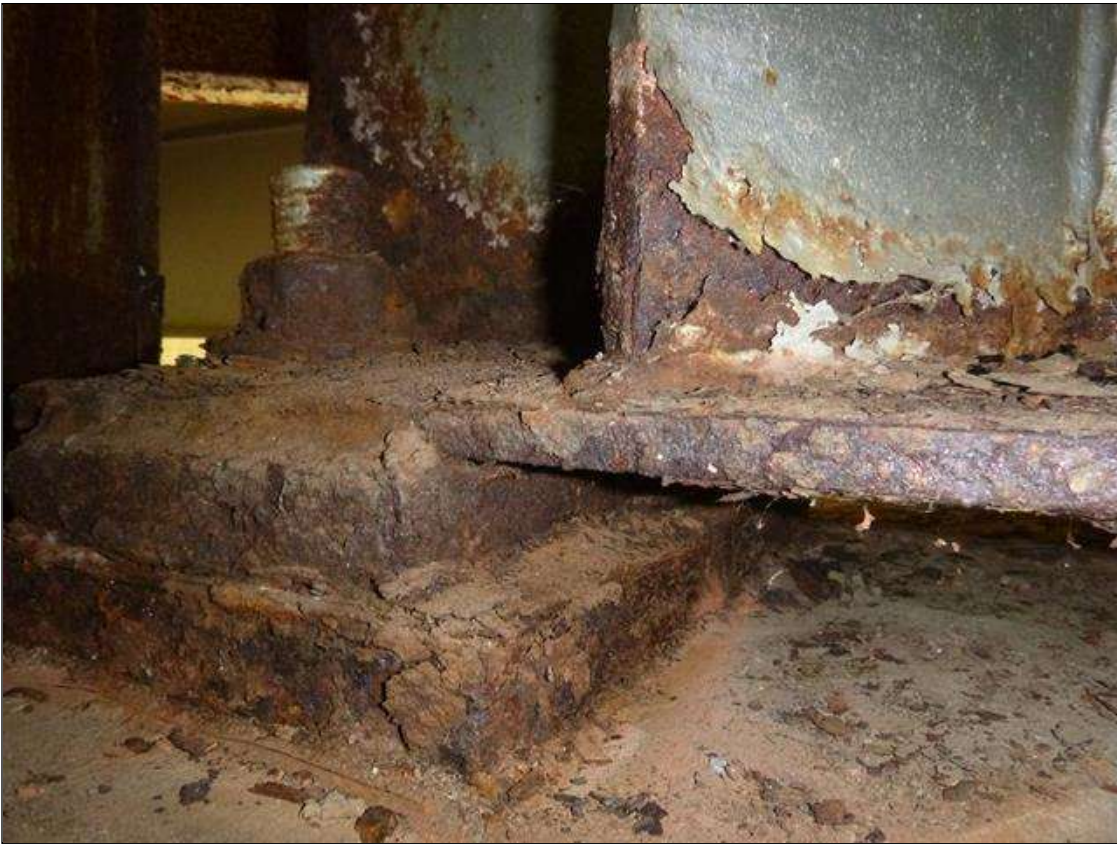
| Element Number | Defect Type | Defect Description | CS | CS Qty | Maint Qty | |
|---|---|---|---|---|---|---|
| 107 | Corrosion | Span 1 Beam 6: SPAN 1, BEAM 6 AT BENT 1 HAS 1/32 INCH SECTION LOSS ON THE BOTTOM FLANGE X FULL WIDTH FROM THE BEAM END OUT 1 FT. WITH 17/32 INCH REMAINING, THE LOWER WEB HAS 1/32 INCH SECTION LOSS FROM THE END OF THE BEAM OUT 10 INCHES X FULL HEIGHT WITH 15/32 INCH REMAINING | 3 | 1 | 1 | Feet |

Span 1 Beam 6: SPAN 1, BEAM 6 AT BENT 1 HAS  $\frac{1}{32}$  INCH SECTION LOSS ON THE BOTTOM FLANGE X FULL WIDTH FROM THE BEAM END OUT 1 FT. WITH  $\frac{17}{32}$  INCH REMAINING, THE LOWER WEB HAS  $\frac{1}{32}$  INCH SECTION LOSS FROM THE END OF THE BEAM OUT 10 INCHES X FULL HEIGHT WITH  $\frac{15}{32}$  INCH REMAINING

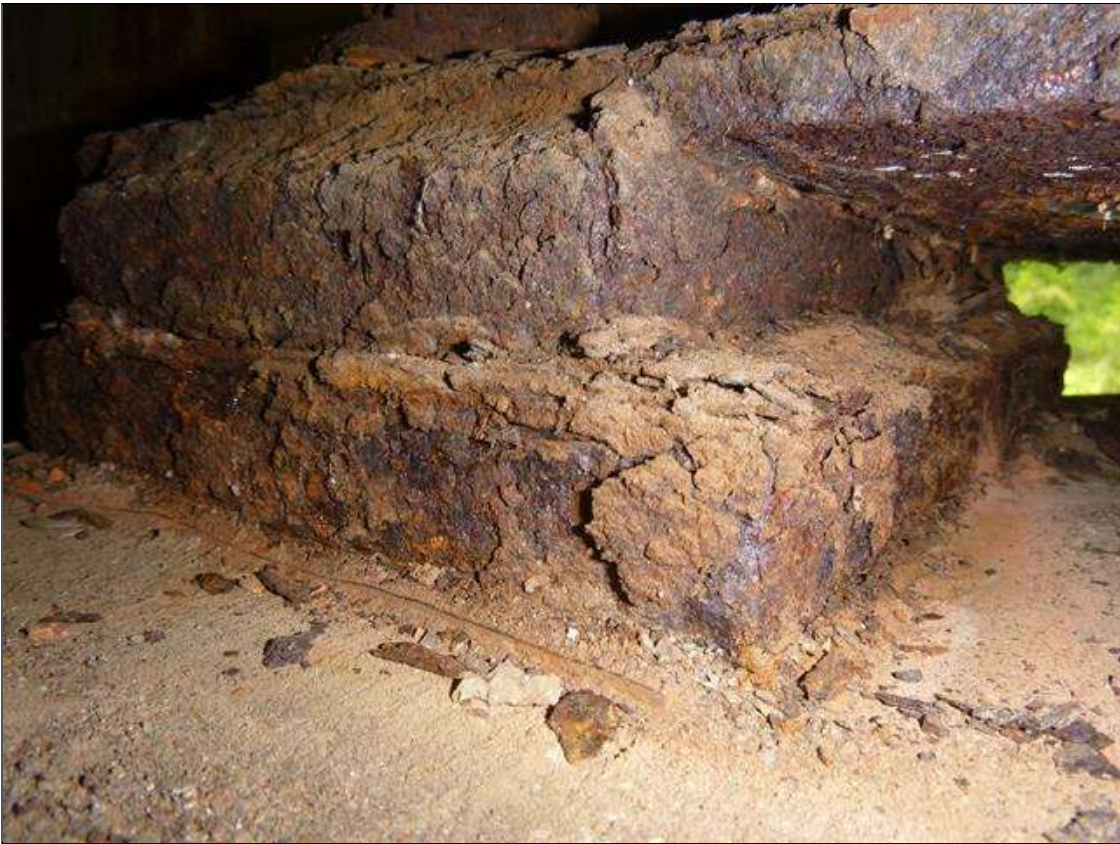
Span 1 Beam 6 Far Bearing: SPAN 1, BEAM 6 FAR BEARING HAS 1/32 INCH SECTION LOSS

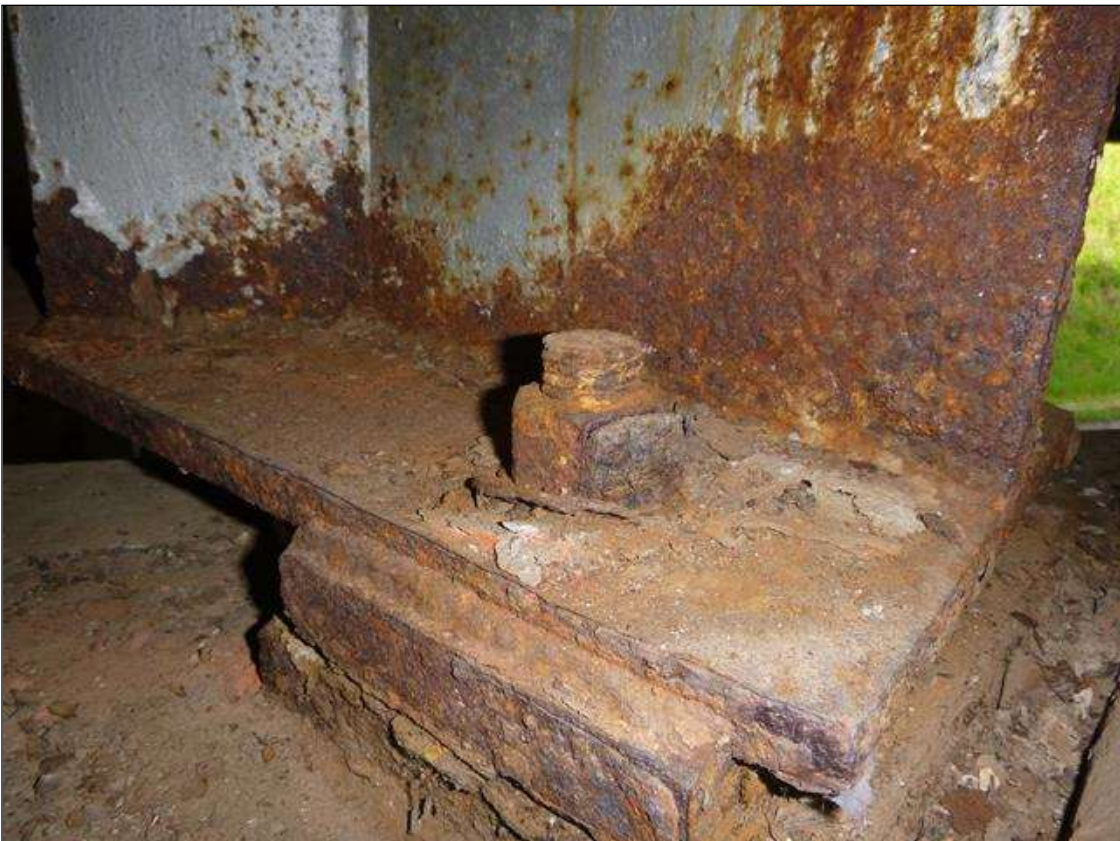
Span 2 Beam 6: SPAN 2, BEAM 6 AT BENT 1 HAS 1/32 INCH SECTION LOSS ON THE BOTTOM FLANGE FROM THE BEAM END OUT 1 FT. X FULL WIDTH WITH 19/32 INCH REMAINING

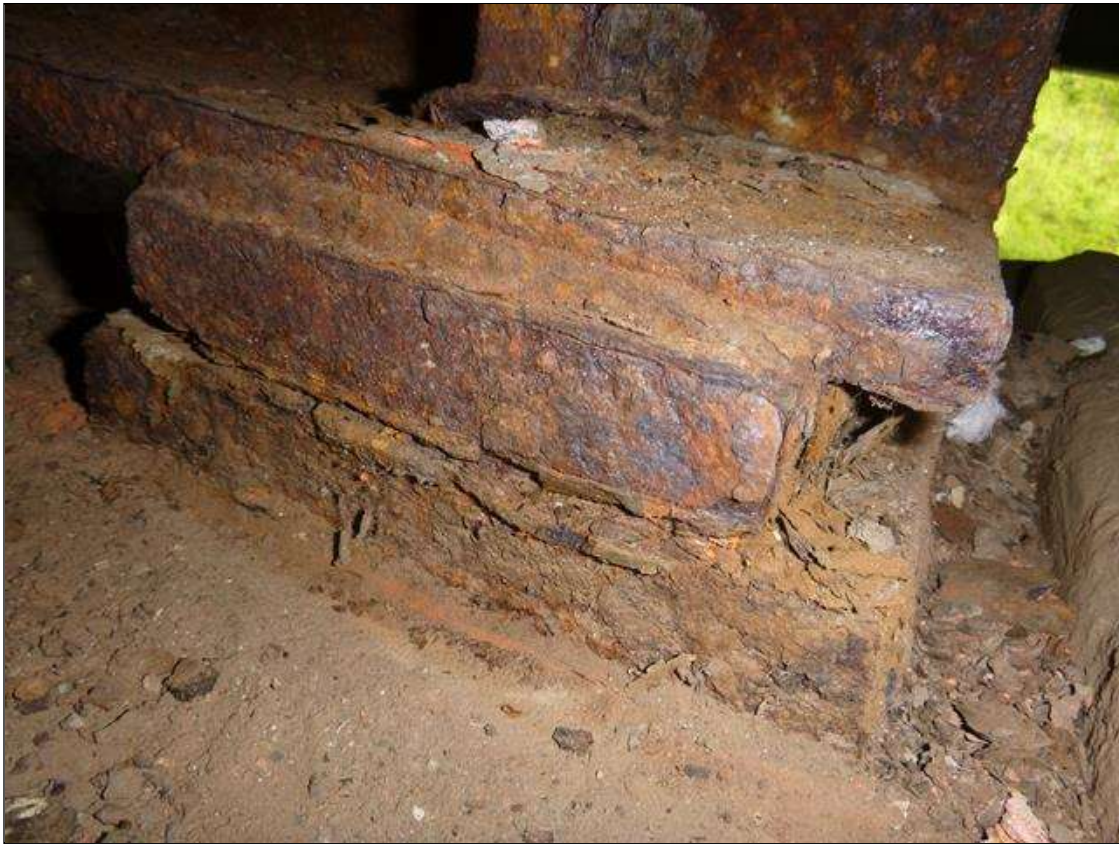
Span 2 Beam 6 Near Bearing: SPAN 2, BEAM 6 NEAR BEARING HAS 1/32 INCH SECTION LOSS

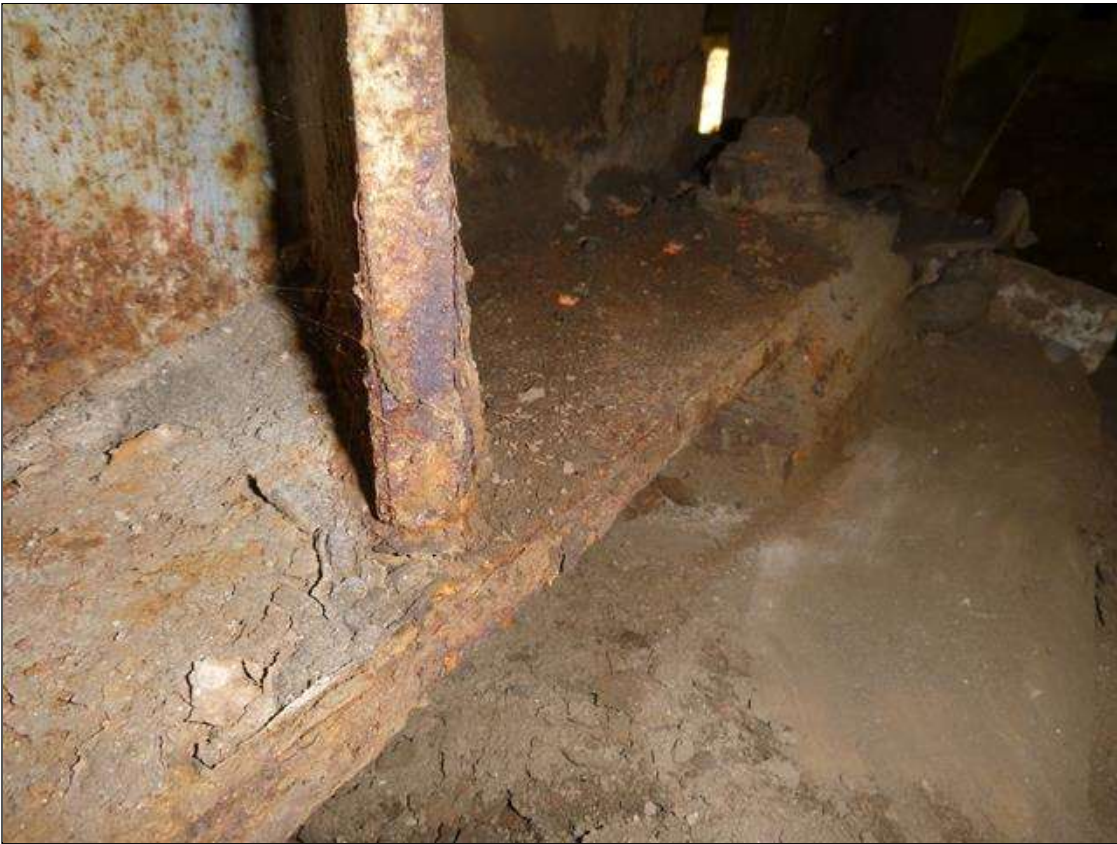
| Element Number | Defect Type | Defect Description | CS | CS Qty | Maint Qty | |
|---|---|---|---|---|---|---|
| 107 | Corrosion | SPAN 1, BEAM 7 AT BENT 1 HAS 1/32 INCH SECTION LOSS ON THE BOTTOM FLANGE FROM THE BEAM END OUT 1 FT. X FULL WIDTH WITH 15/32 INCH REMAINING. THE LOWER WEB HAS 1/32 INCH SECTION LOSS FROM THE BEAM END OUT 1 FT. X 3 INCHES HIGH WITH 15/32 INCH REMAINING | 3 | 1 | 1 | Feet |

Span 1 Beam 7: SPAN 1, BEAM 7 AT BENT 1 HAS 1/32 INCH SECTION LOSS ON THE BOTTOM FLANGE FROM THE BEAM END OUT 1 FT. X FULL WIDTH WITH 15/32 INCH REMAINING. THE LOWER WEB HAS 1/32 INCH SECTION LOSS FROM THE BEAM END OUT 1 FT. X 3 INCHES HIGH WITH 15/32 INCH REMAINING

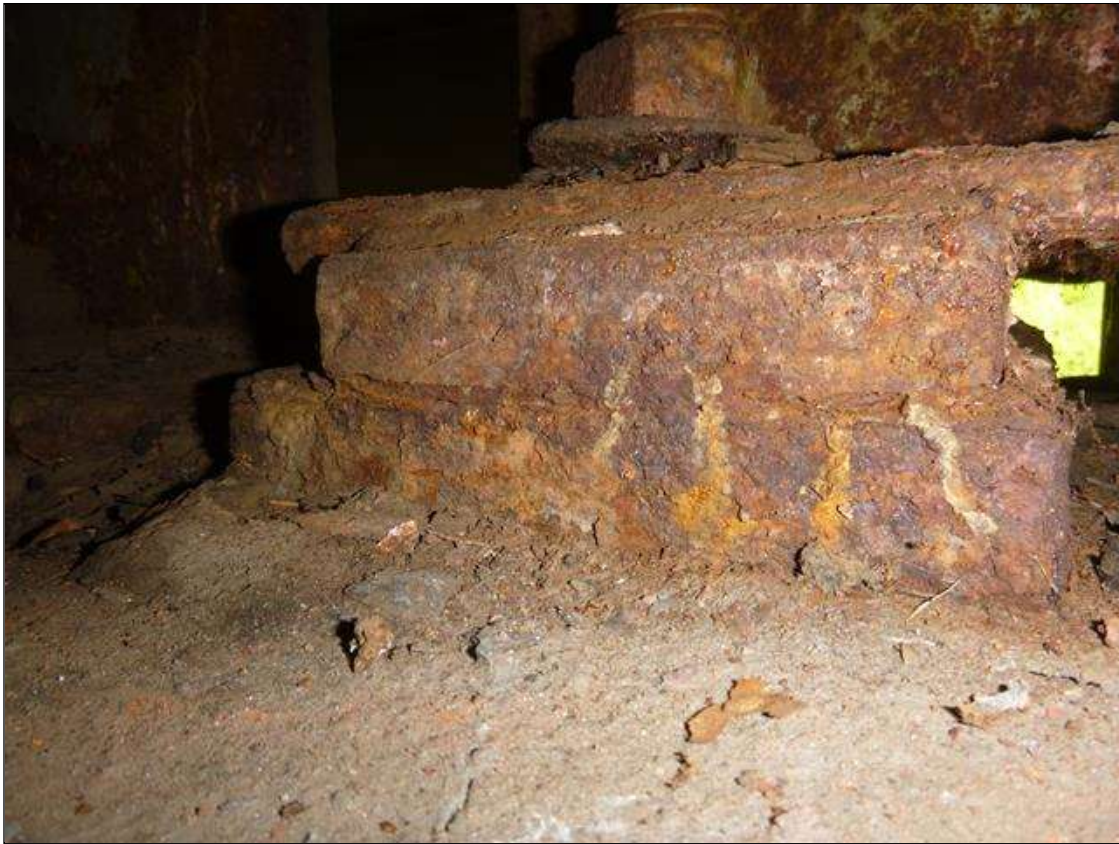
Span 1 Beam 7 Far Bearing: SPAN 1 BEAM 7 FAR BEARING HAS 1/32 INCH SECTION LOSS

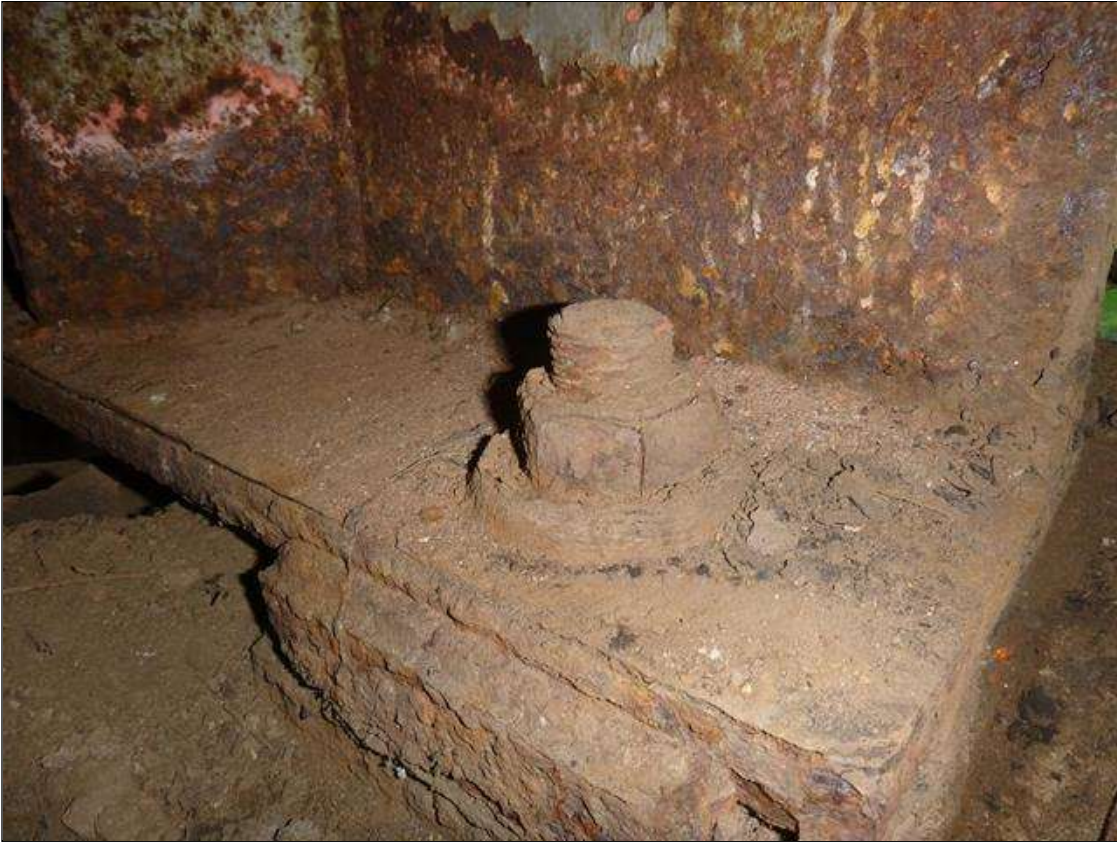
Span 2 Beam 7: SPAN 2, BEAM 7 AT BENT 1 HAS 1/32 INCH SECTION LOSS ON THE BOTTOM FLANGE FROM THE BEAM END OUT 1 FT. X FULL WIDTH WITH 15/32 INCH REMAINING. THE LOWER WEB HAS 1/32 INCH SECTION LOSS FROM THE BEAM END OUT 1 FT. X 3 INCHES HIGH WITH 15/32 INCH REMAINING

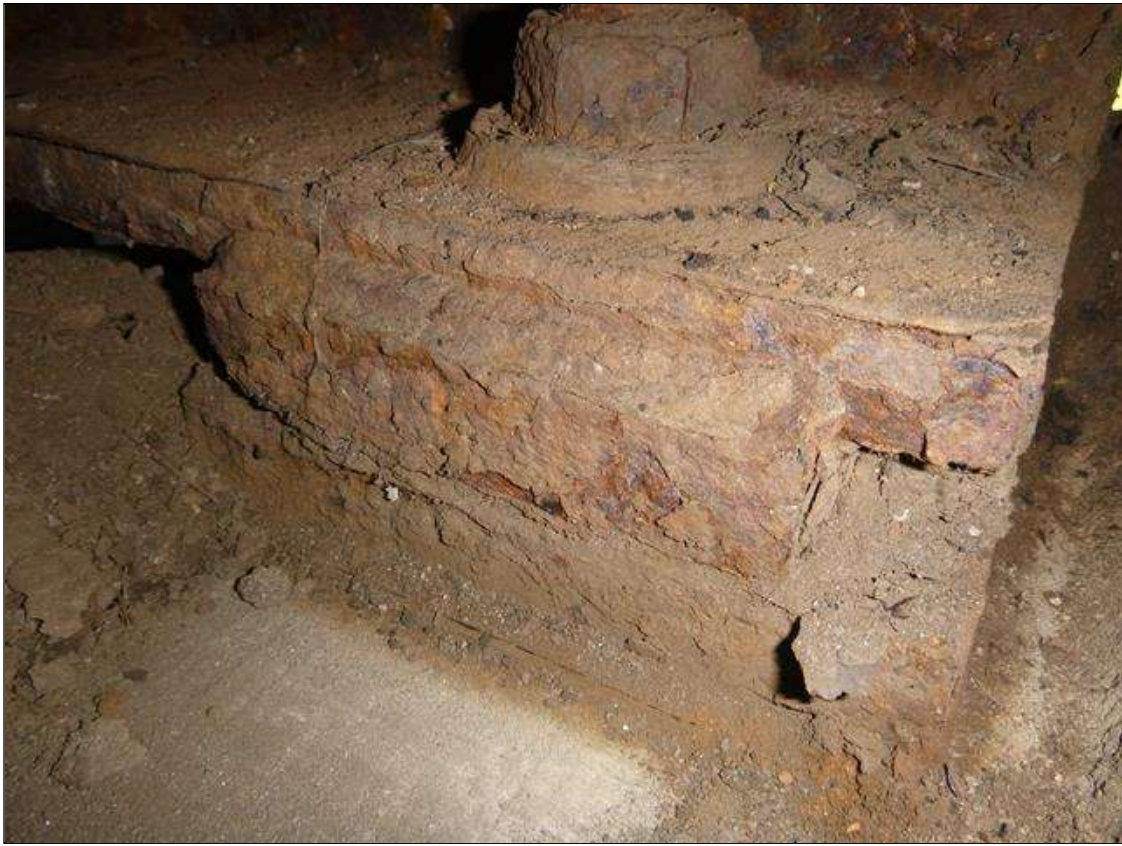
Span 2 Beam 7 Near Bearing: SPAN 2, BEAM 7 NEAR BEARING HAS 1/32 INCH SECTION LOSS

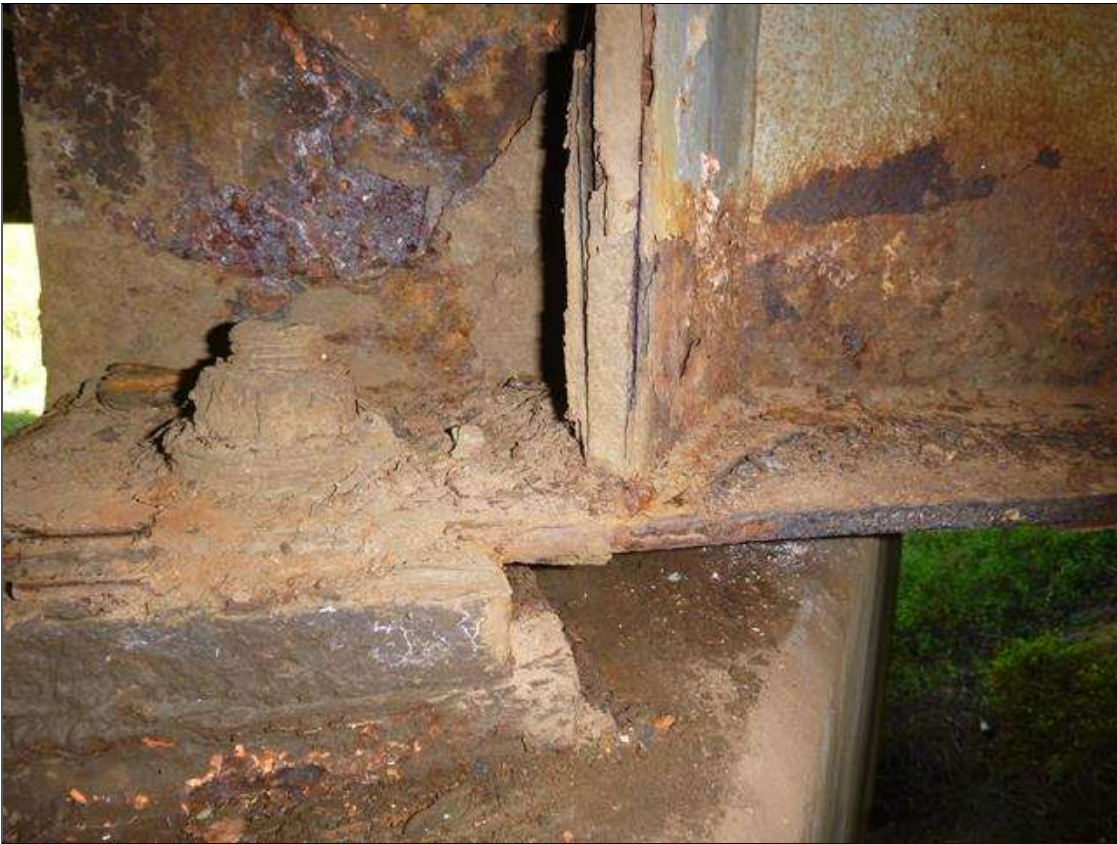
| Element Number | Defect Type | Defect Description | CS | CS Qty | Maint Qty | |
|---|---|---|---|---|---|---|
| 107 | Corrosion | SPAN 1, BEAM 8 AT BENT 1 HAS 1/16 INCH SECTION LOSS ON THE BOTTOM FLANGE FROM THE BEAM END OUT 2 FT. WITH 7/16 INCH REMAINING, THE LOWER WEB HAS 1/16 INCH SECTION LOSS FROM THE BEAM END OUT 2 FT. X 6 INCHES HIGH WITH 7/16 INCH REMAINING | 3 | 2 | 2 | Feet |

Span 1 Beam 8: SPAN 1, BEAM 8 AT BENT 1 HAS 1/16 INCH SECTION LOSS ON THE BOTTOM FLANGE FROM THE BEAM END OUT 2 FT. WITH 7/16 INCH REMAINING, THE LOWER WEB HAS 1/16 INCH SECTION LOSS FROM THE BEAM END OUT 2 FT. X 6 INCHES HIGH WITH 7/16 INCH REMAINING

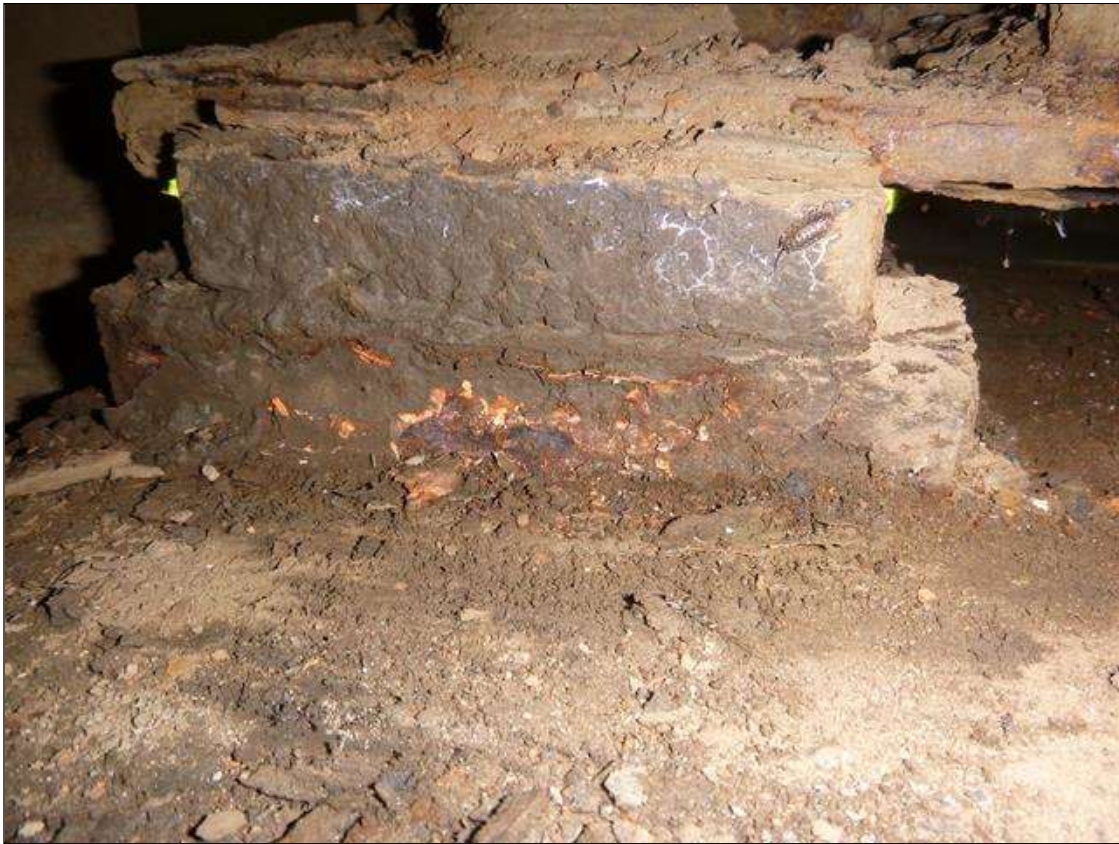
Span 1 Beam 8 Far Bearing: SPAN 1, BEAM 8 FAR BEARING HAS 1/32 INCH SECTION LOSS

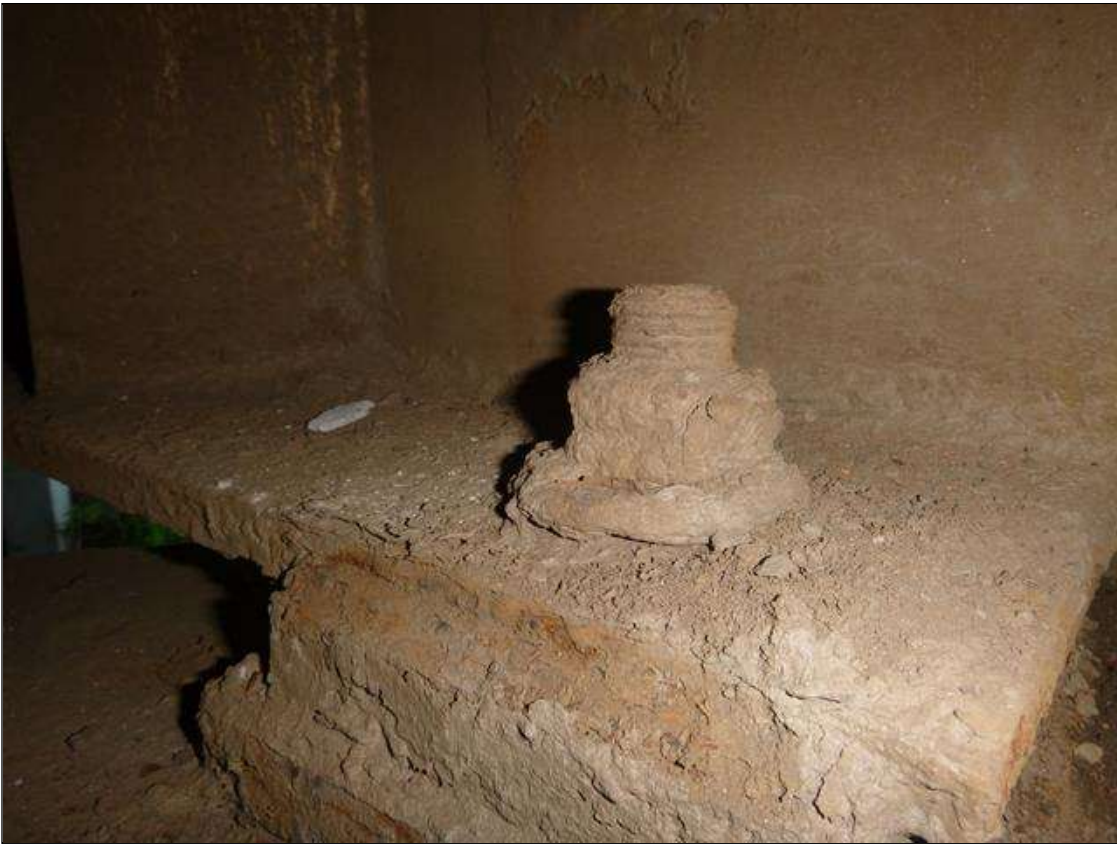
Span 2 Beam 8: SPAN 2, BEAM 8 AT BENT 1 HAS 1/32 INCH SECTION LOSS ON THE BOTTOM FLANGE FROM THE BEAM END OUT 2 FT. WITH 19/32 INCH REMAINING, THE WEB HAS 1/32 INCH SECTION LOSS FROM THE BEAM END OUT FT. X FULL HEIGHT WITH 19/32 INCH REMAINING

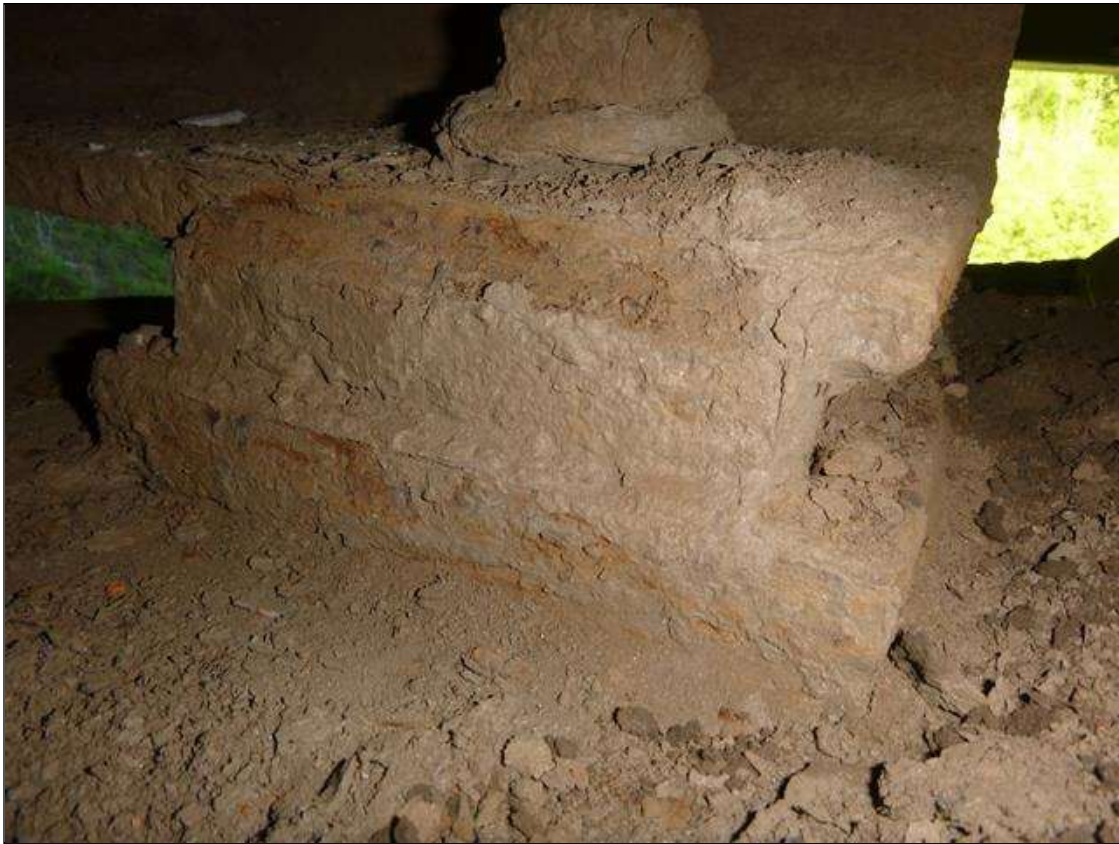
Span 2 Beam 8 Near Bearing: SPAN 2, BEAM 8 NEAR BEARING HAS 1/32 INCH SECTION LOSS
