NC DEPARTMENT OF TRANSPORTATION  
DIVISION OF HIGHWAYS  
STRUCTURE MANAGEMENT UNIT

## Structure Safety Report

### Routine Element Inspection - Contract

COUNTY: HAYWOOD STRUCTURE NUMBER: 430159 FREQUENCY: 24 MONTHS  
FACILITY CARRIED: I-40 MILE POST: 18.7  
LOCATION: 1.8 MI.W.JCT.US276  
FEATURE INTERSECTED: SR1338  
LATITUDE: 35° 37' 31.64" LONGITUDE: 83° 0' 31.41"  
SUPERSTRUCTURE: REINFORCED CONCRETE FLOOR ON I-BEAMS

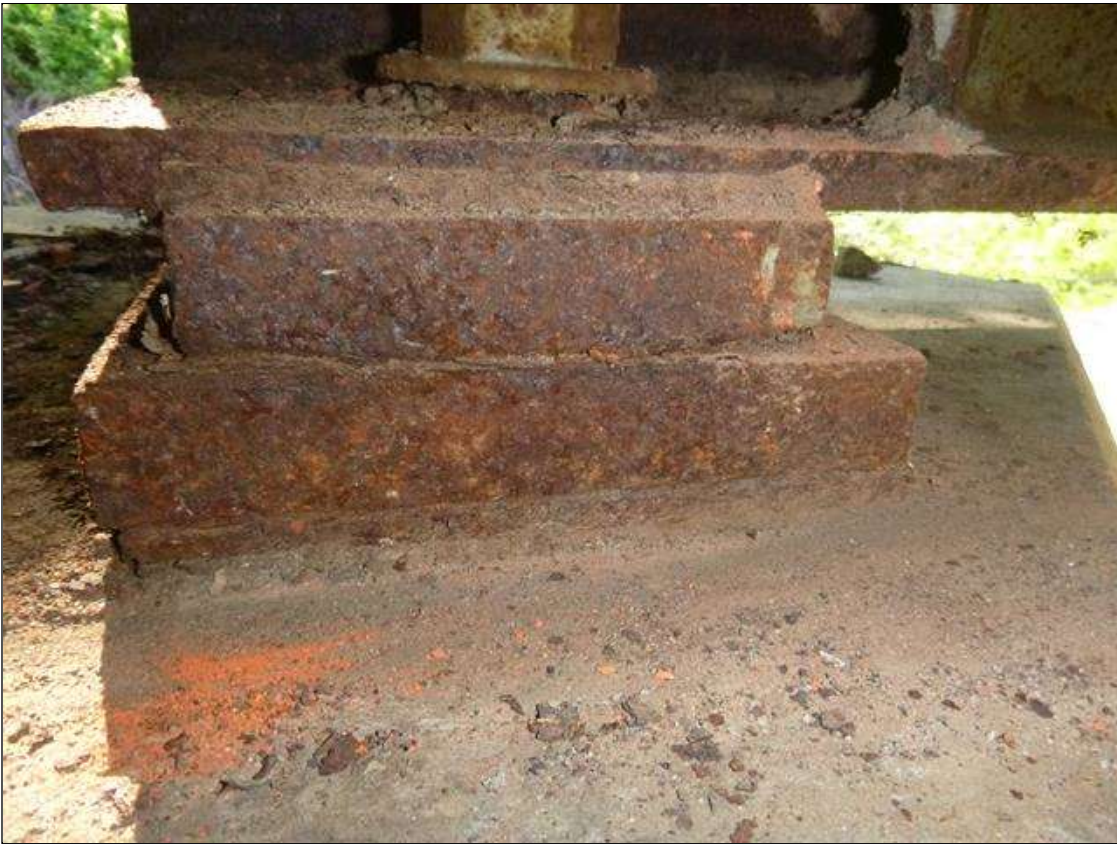
Span 2 Beam 1 Near Bearing: SPAN 2, BEAM 1 NEAR BEARING HAS 1/32 INCH SECTION LOSS

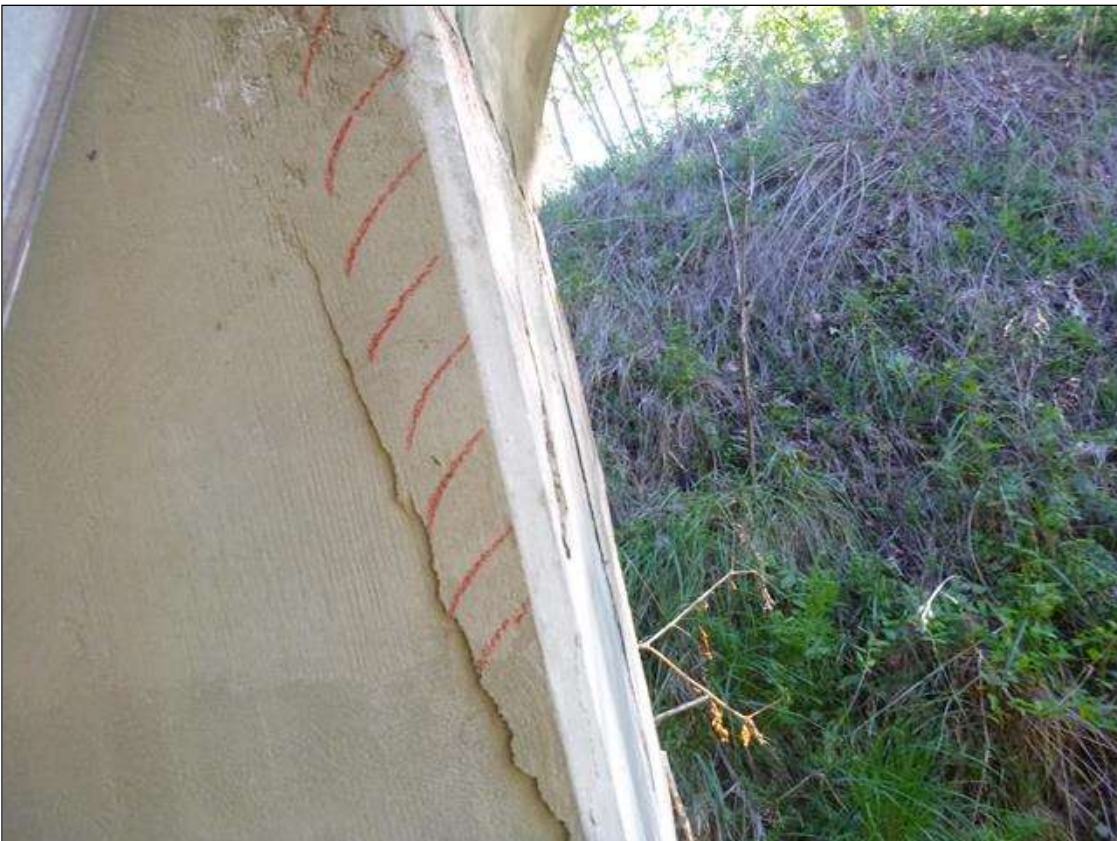
Bent 1 Pile 1: BENT 1, PILE 1 HAS AN AREA OF DELAMINATION ON THE NORTHEAST CORNER, 8 INCHES WIDE X 24 INCHES HIGH WITH 3/16 INCH SEPARATION, 2 FT. BELOW THE BOTTOM OF THE CAP

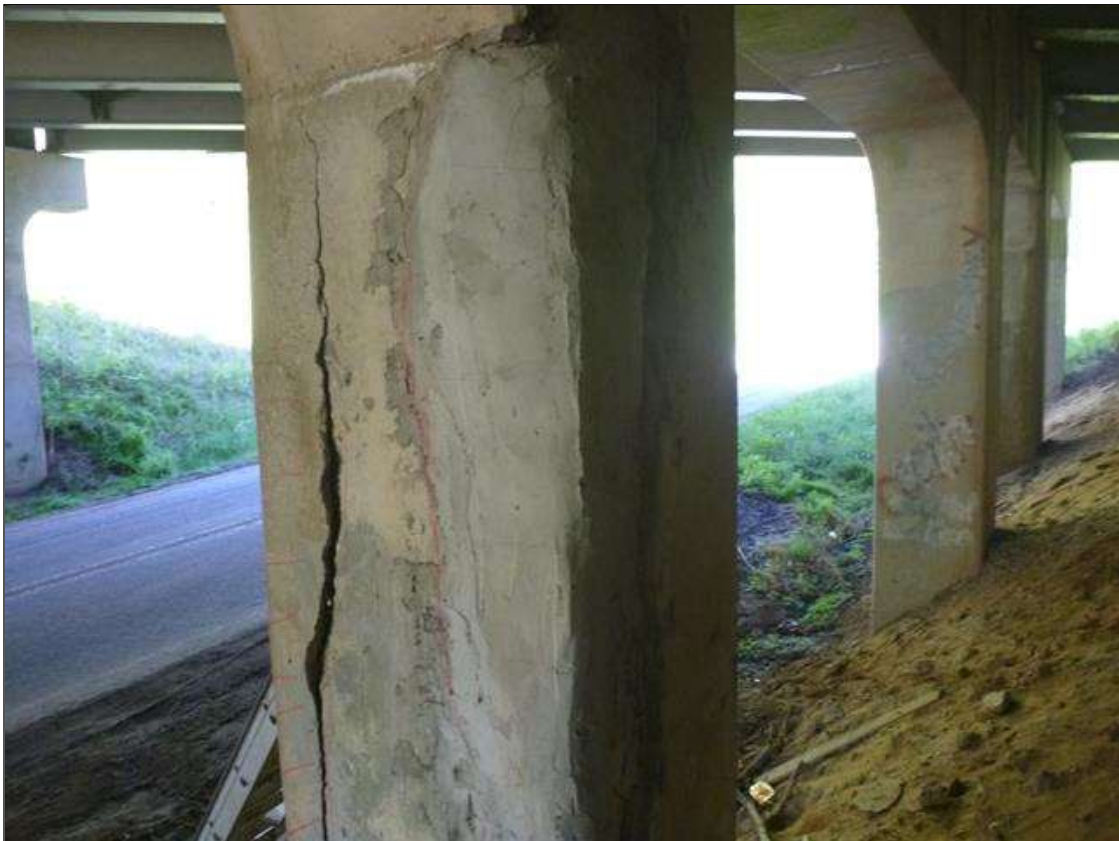
Bent 1 Pile 3: BENT 1, PILE 3 HAS A PATCHED AREA, ON THE NORTHWEST CORNER, 14 INCHES WIDE X 5 FT. HIGH, STARTING 2 FT. BELOW THE BOTTOM OF THE CAP

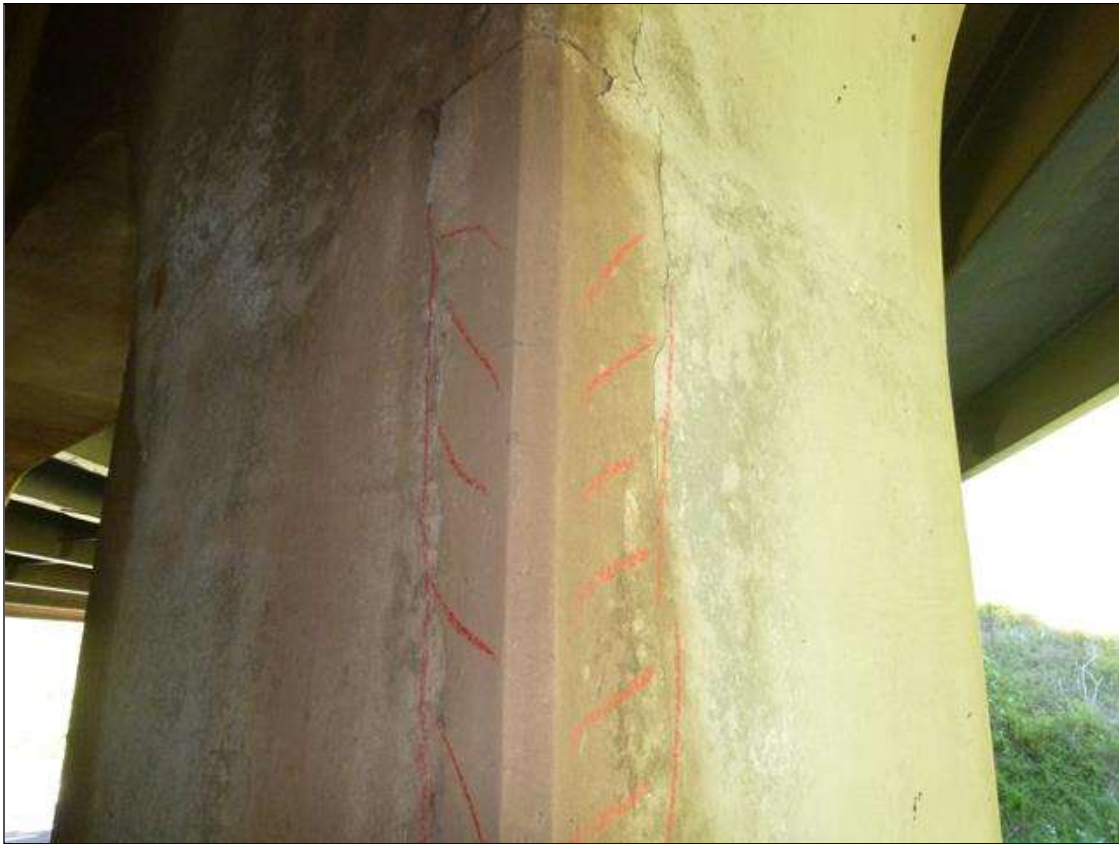
Bent 1 Pile 5: BENT 1, PILE 5 HAS AN AREA OF DELAMINATION ON THE SOUTHWEST CORNER, 7 INCHES WIDE X 24 INCHES HIGH WITH 1/16 INCH SEPARATION, STARTING 2 FT. BELOW THE BOTTOM OF THE CAP

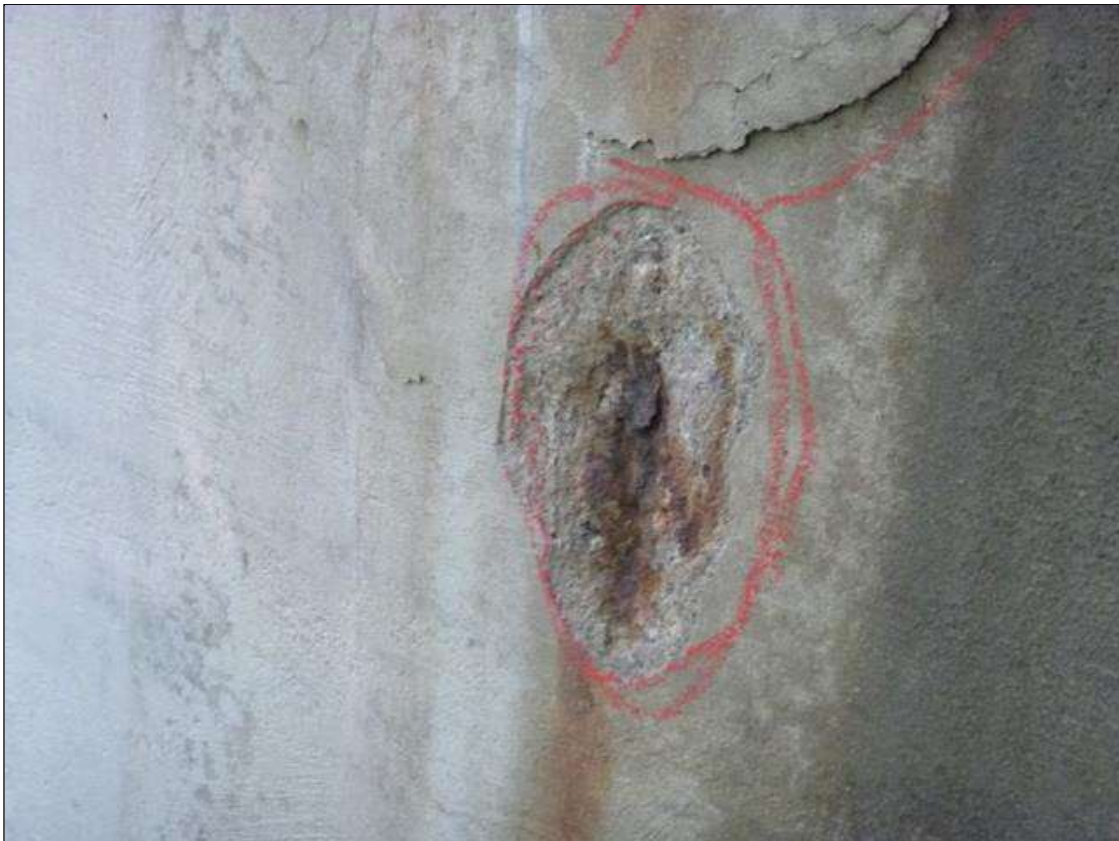
Bent 1 Cap 1: BENT 1 CAP, SPAN 1 SIDE FACE OF CAP HAS A 5 INCH DIAMETER SPALL X 3/4 INCH DEEP WITH EXPOSED REBAR, AT BEAM 1, 15 INCHES BELOW TOP OF CAP

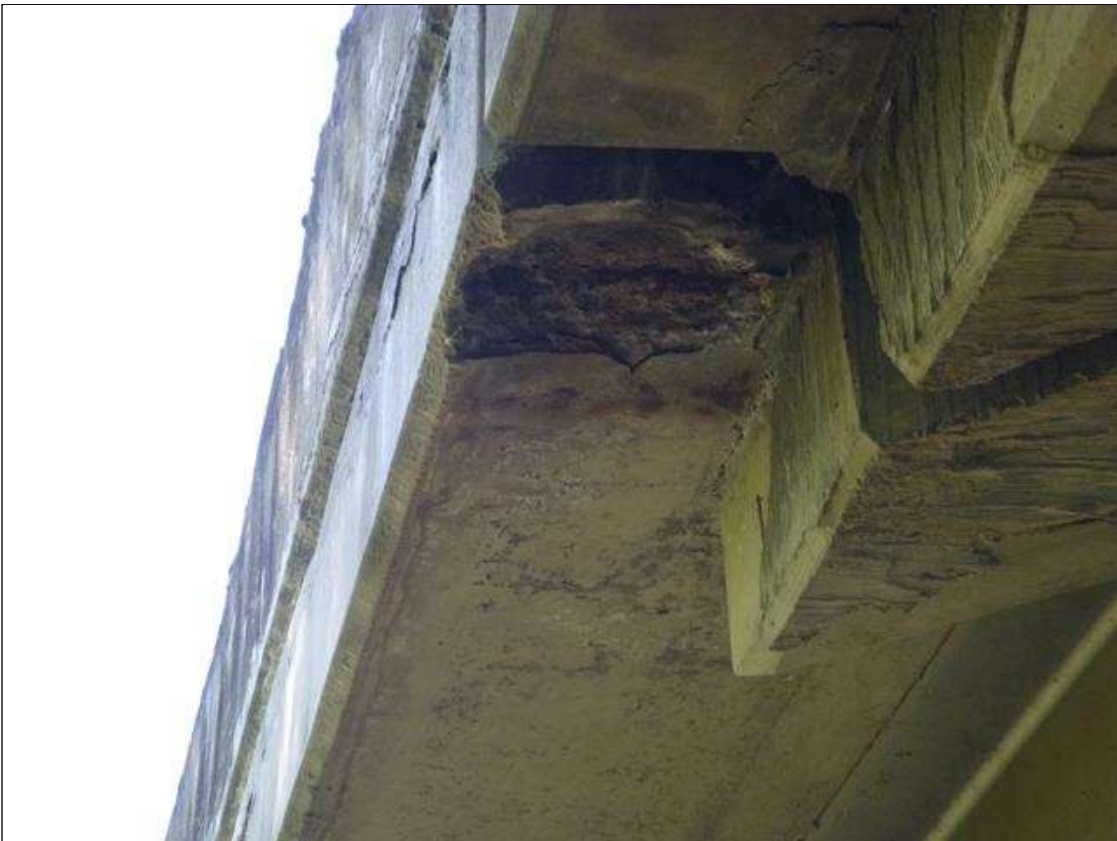
Span 2 Deck: SPAN 2, BOTTOM OF LEFT OVERHANG AT BENT 1 HAS A SPALL, 12 INCHES X 8 INCHES X 1 INCH DEEP WITH EXPOSED REBAR

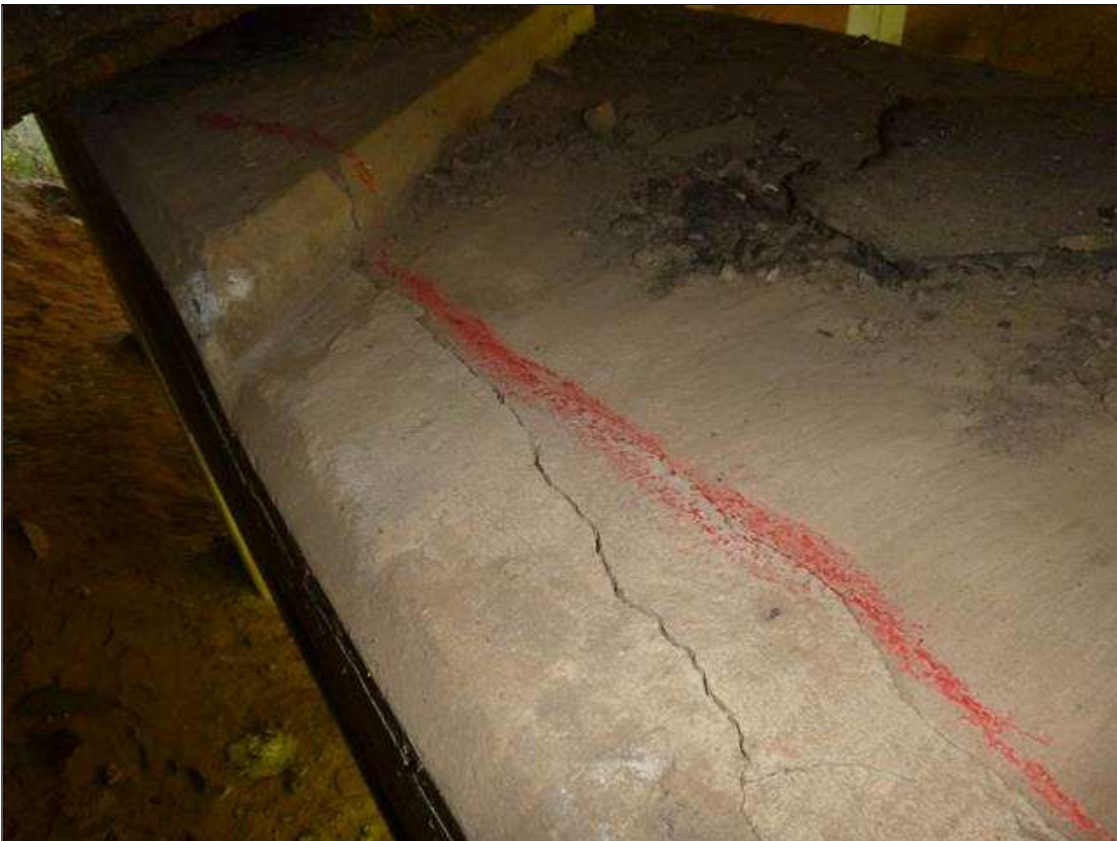
Bent 1 Cap 1: BENT 1 CAP HAS AN AREA OF DELAMINATION ON THE TOP OF THE CAP NEAR TOP EDGE AT SPAN 1 SIDE AT BAY 6 NEAR BEAM 6, 36 INCHES LONG X 5 INCHES WIDE WITH 1/8 INCH WIDE SEPARATION

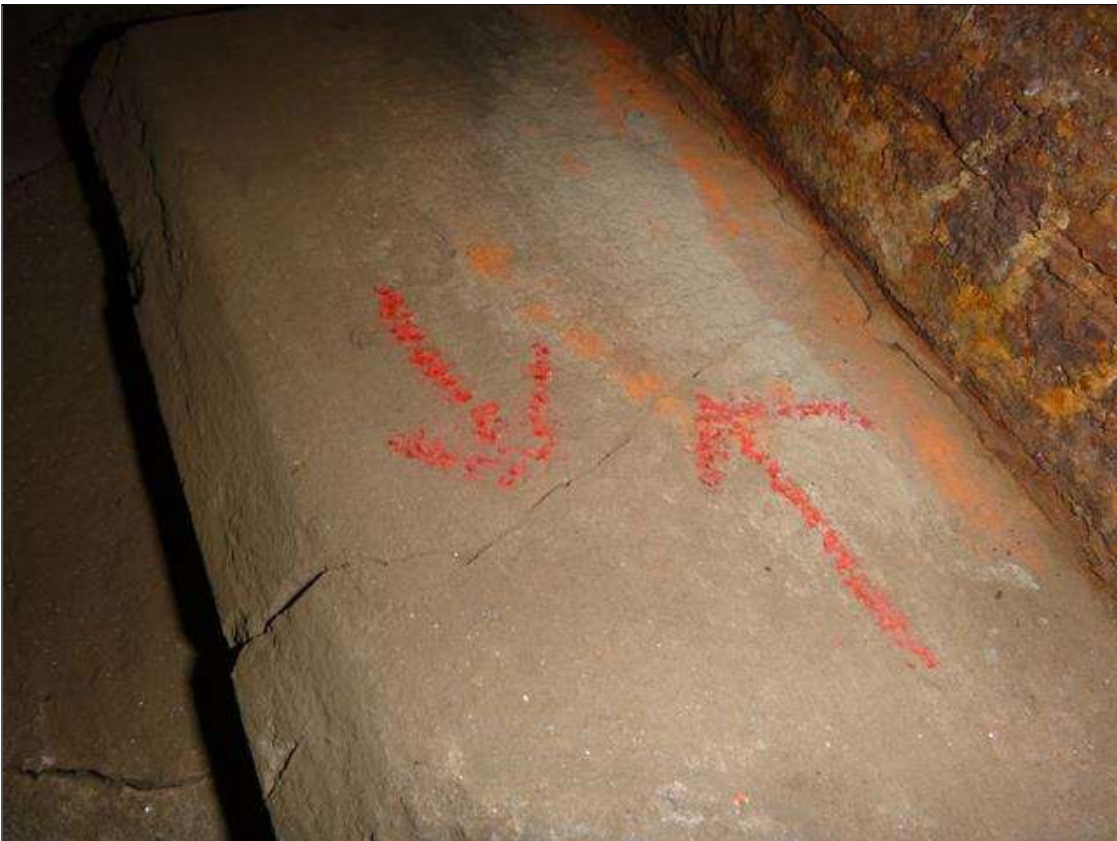
Bent 1 Cap 1: BENT 1 TOP OF CAP HAS A 1/16 INCH WIDE DIAGONAL CRACK, 6 INCHES LONG RUNNING FROM SPAN 1 TOP EDGE TO LEFT SIDE OF BEARING AT BEAM 7

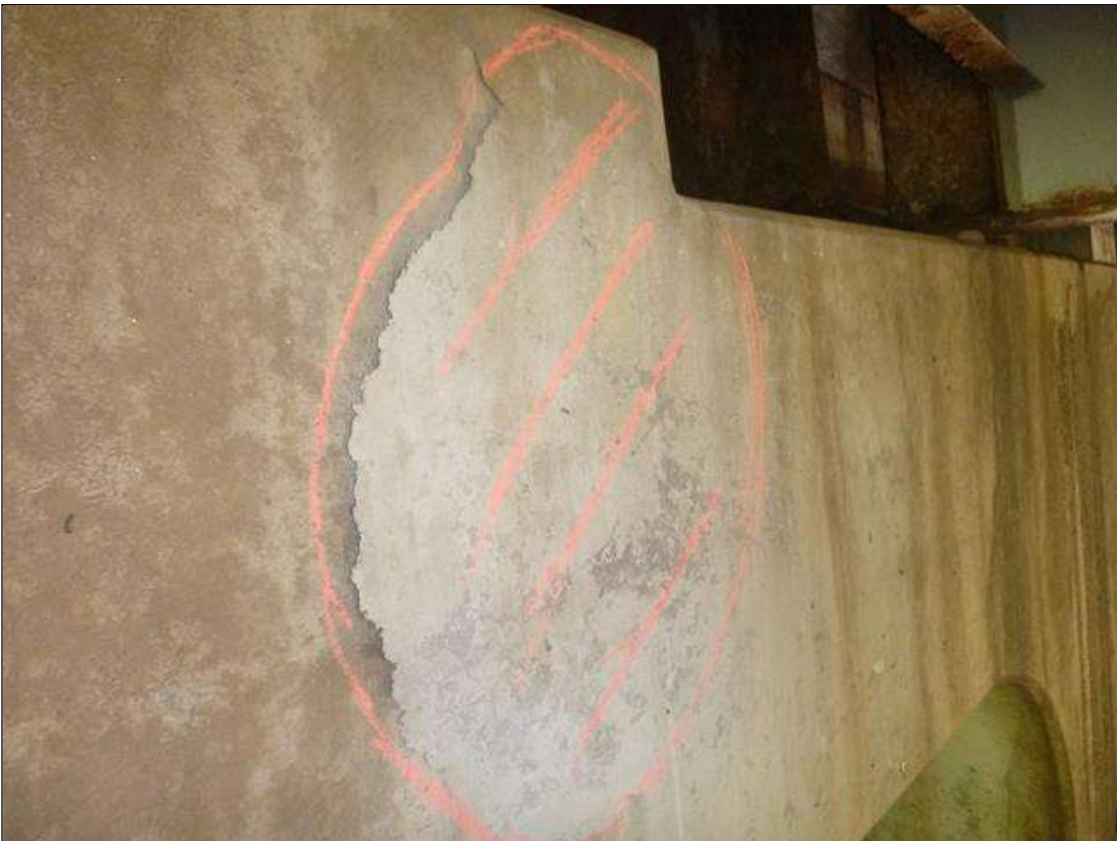
Bent 1 Cap 1: BENT 1 CAP, SPAN 2 SIDE HAS AN AREA OF DELAMINATION IN THE FACE OF THE CAP IN BAY3, 24 INCHES X 29 INCHES WITH 1/4 INCH SEPARATION, NEAR TOP EDGE

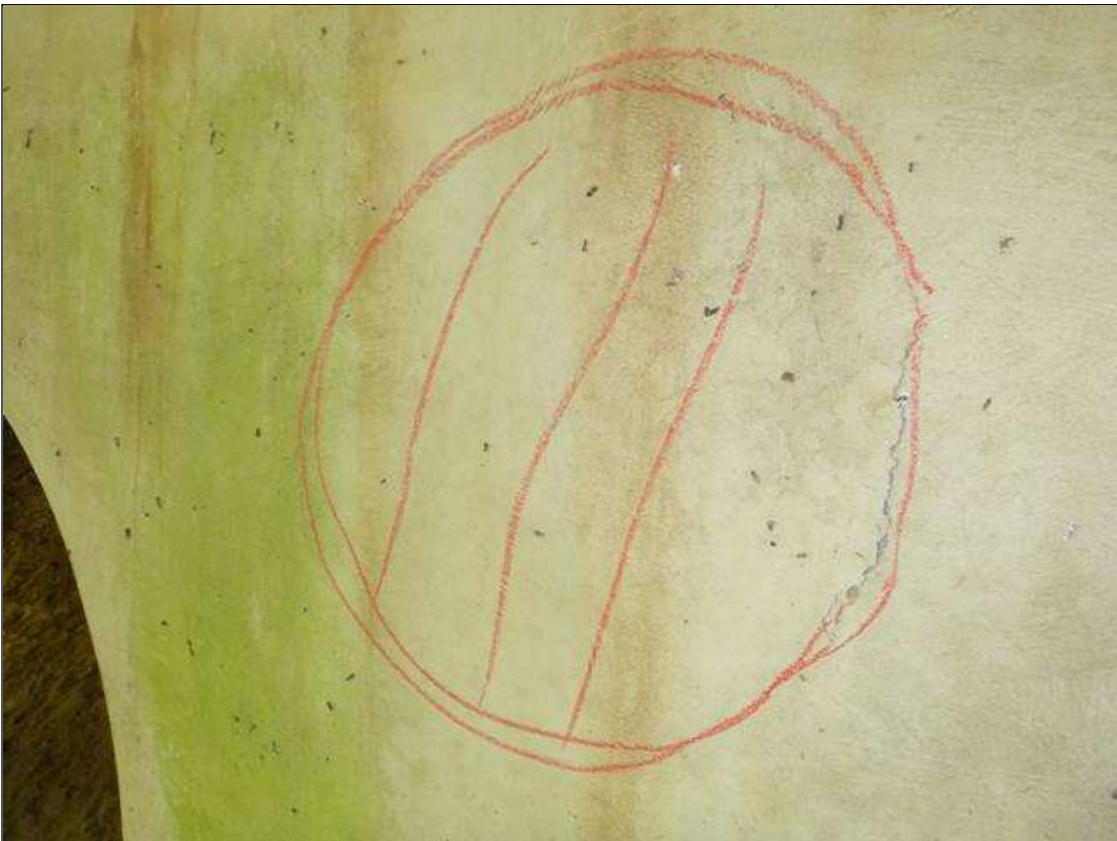
Bent 1 Cap 1: BENT 1 CAP, SPAN 2 SIDE HAS AN AREA OF DELAMINATION IN THE FACE OF THE CAP, ABOVE PILE 4, 2 FT. BELOW TOP OF CAP, 24 INCHES IN DIAMETER WITH 1/8 INCH SEPARATION

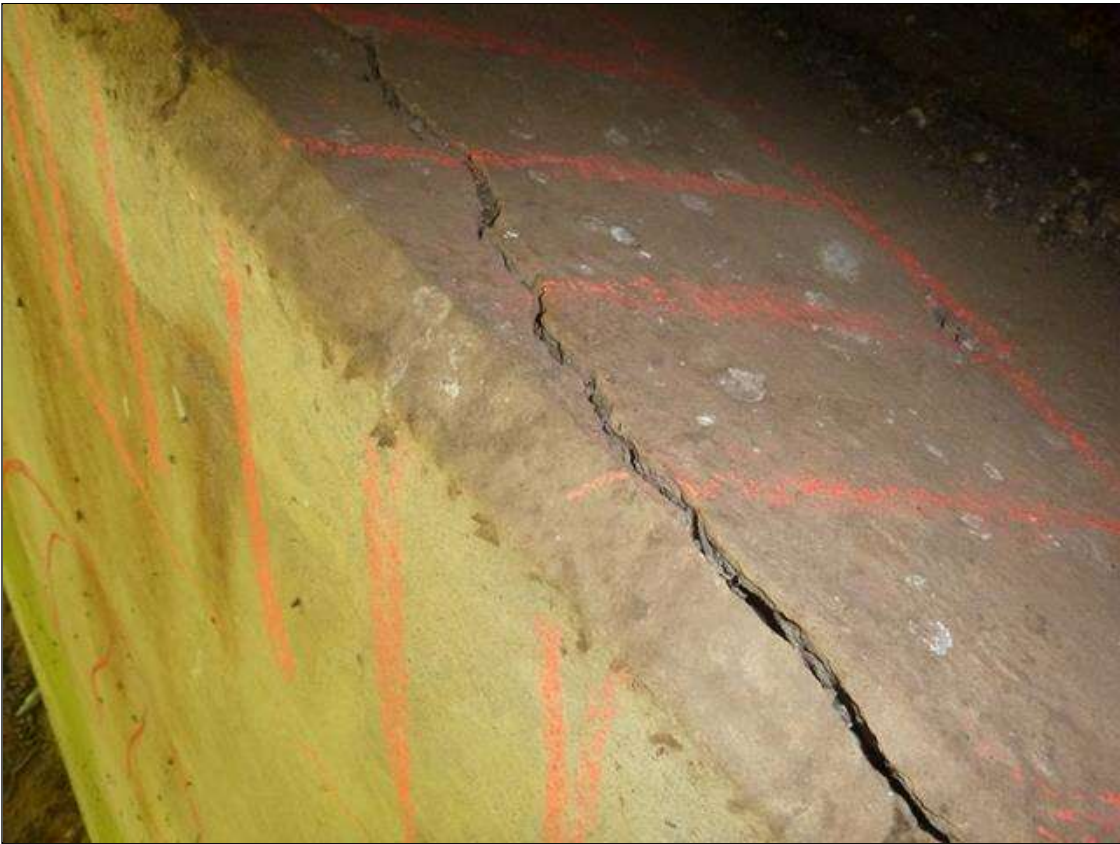
Bent 1 Cap 1: BENT 1 CAP, SPAN 2 SIDE HAS AN AREA OF DELAMINATION IN THE TOP AND FACE IN BAY 6, 36 INCHES LONG X 10 INCHES DOWN THE FACE X 9 INCHES ACROSS THE TOP WITH 1/8 INCH SEPARATION

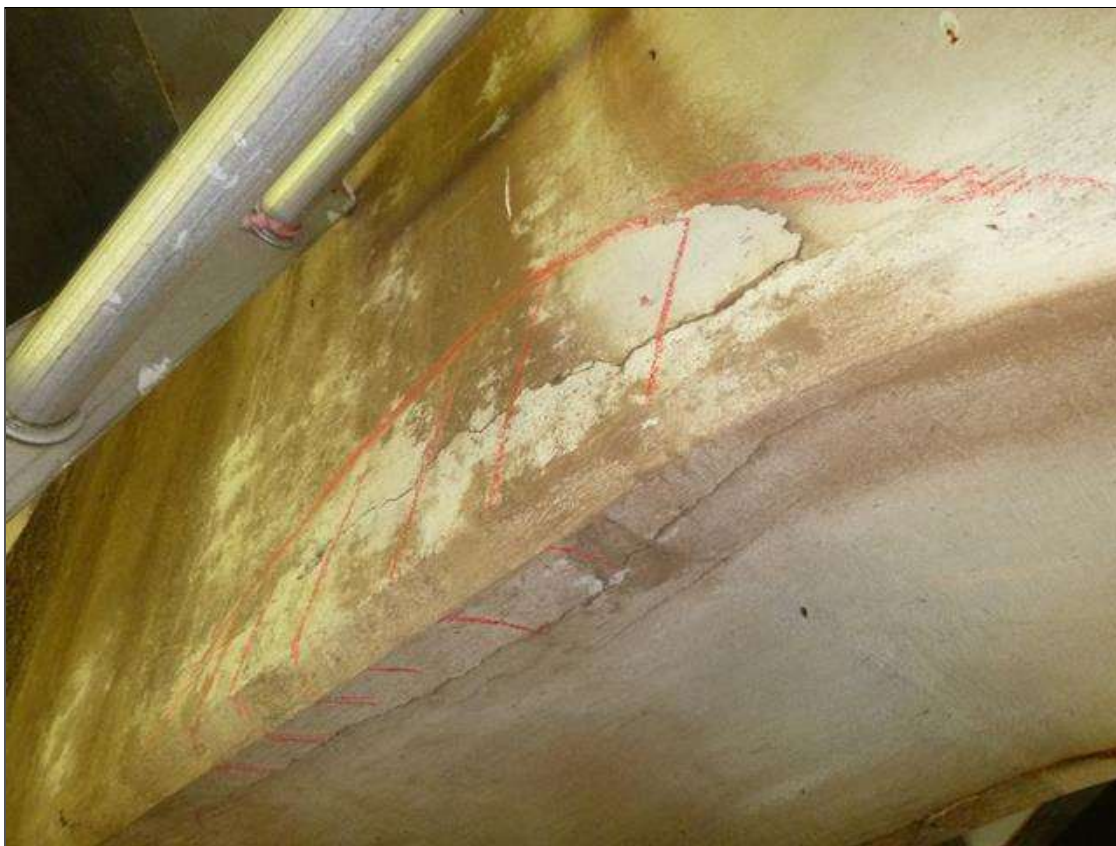
Bent 1 Cap 1: BENT 1 CAP, SPAN 2 SIDE HAS AN AREA OF DELAMINATION IN THE FACE OF THE CAP AT THE BOTTOM EDGE, 24 INCHES LONG X 6 INCHES UP THE FACE X 3 INCHES ACROSS THE BOTTOM WITH 1/16 INCH SEPARATION

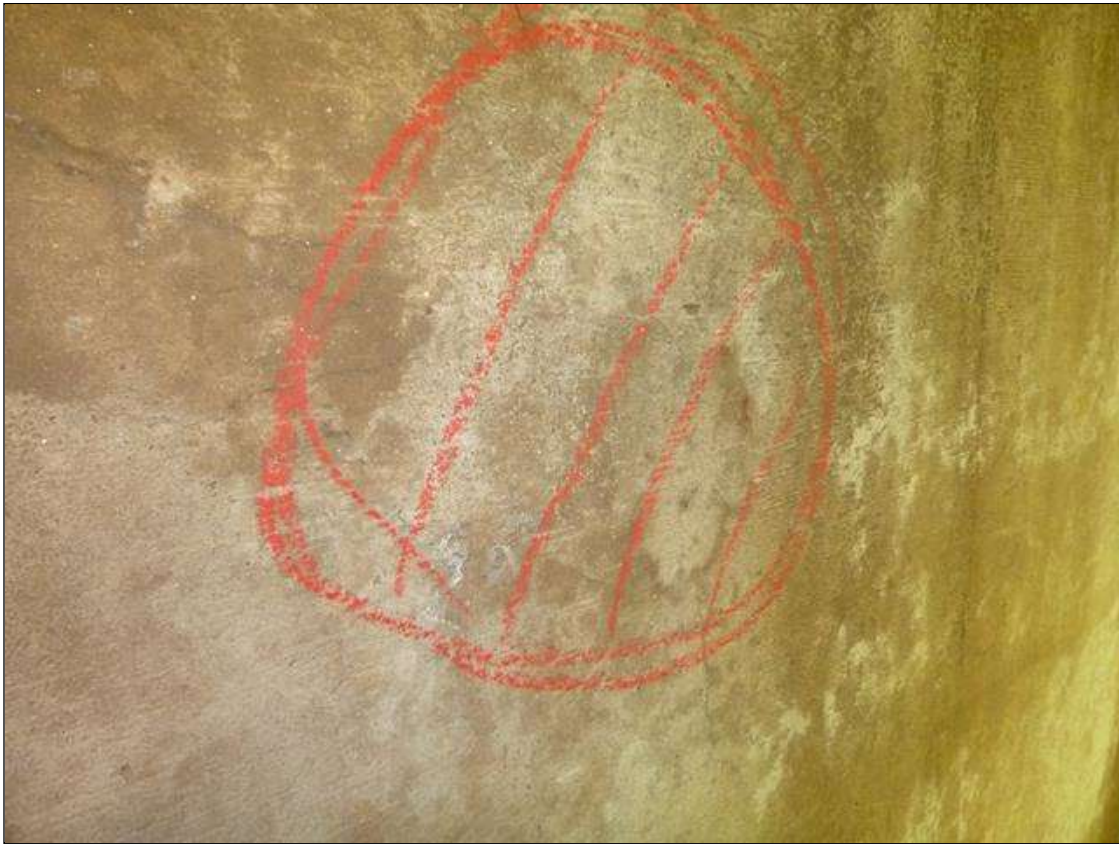
Bent 1 Cap 1: BENT 1 CAP, SPAN 2 SIDE HAS AN AREA OF DELAMINATION IN THE FACE OF THE CAP UNDER BEAM 8 NEAR TOP EDGE, 12 INCHES IN DIAMETER, WITH 1/32 INCH SEPARATION

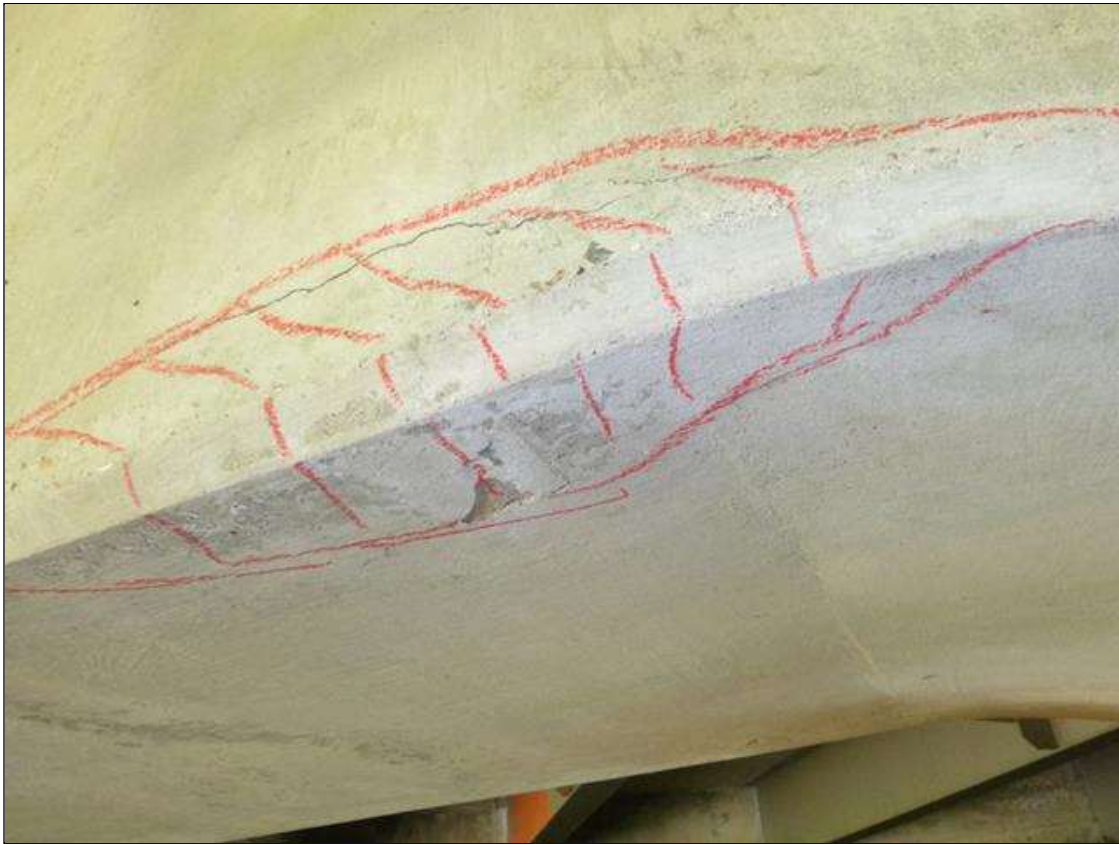
Bent 1 Cap 1: BENT 1 CAP, SPAN 2 SIDE HAS AN AREA OF DELAMINATION IN THE FACE OF THE CAP AT THE BOTTOM EDGE IN BAY 8, 24 INCHES LONG X 3 INCHES UP THE FACE X 3 INCHES ACROSS THE BOTTOM WITH 1/16 INCH SEPARATION

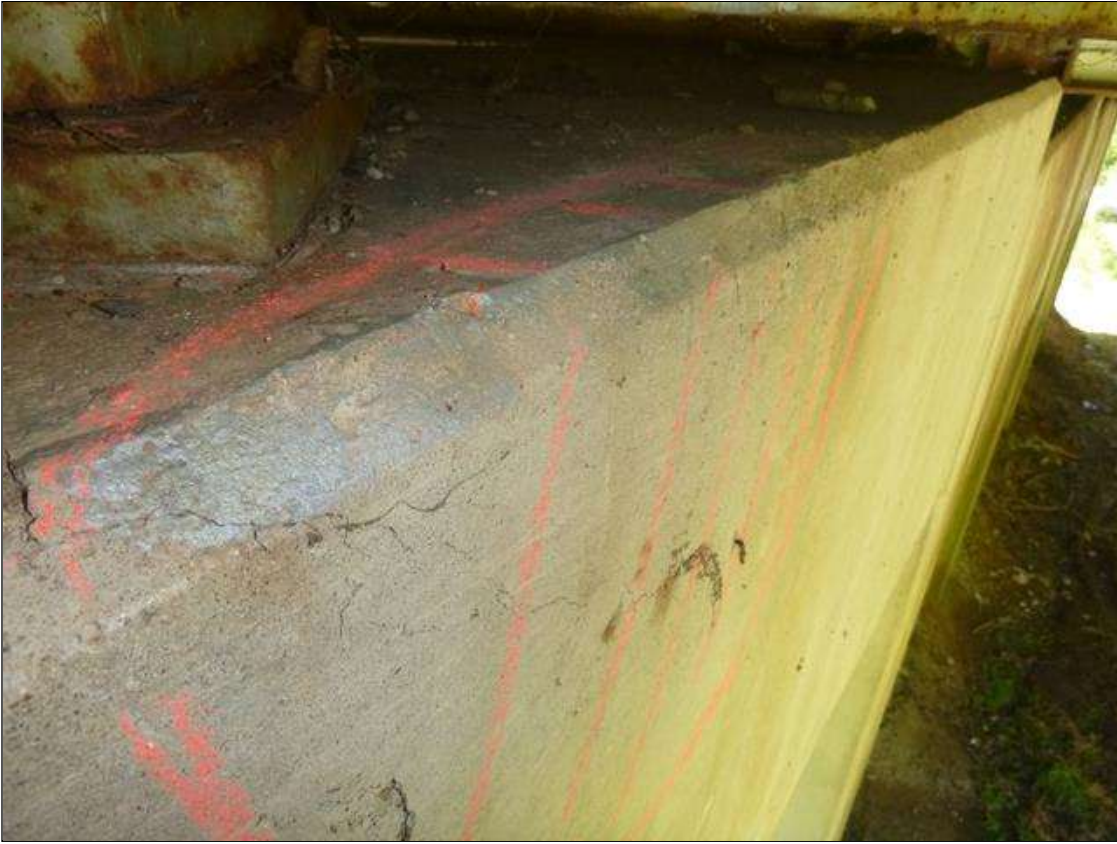
Bent 1 Cap 1: BENT 1 CAP, SPAN 2 SIDE HAS AN AREA OF DELAMINATION IN THE FACE OF THE CAP UNDER BEAM 9, NEAR TOP EDGE, 20 INCHES LONG X 12 INCHES DOWN THE FACE X 3 INCHES ACROSS THE TOP WITH 1/16 INCH SEPARATION

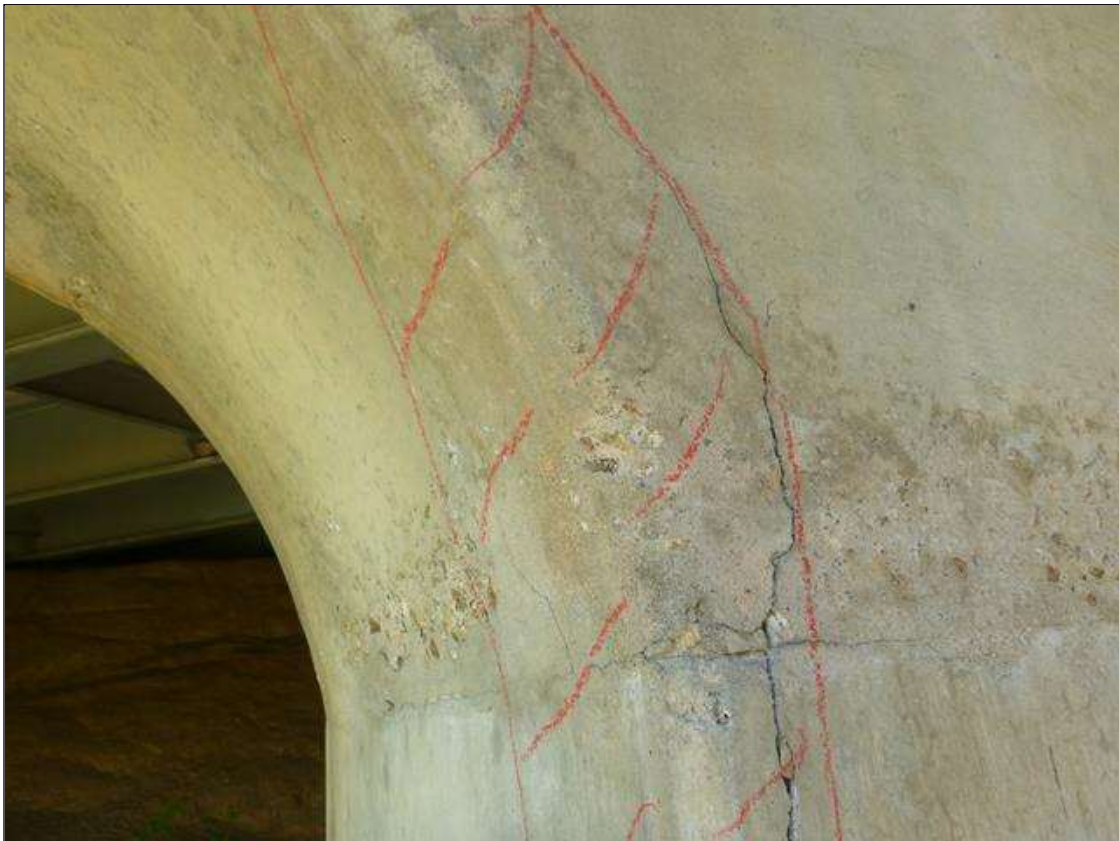
Bent 2 Pile 1: END BENT 2, PILE 1 HAS AN AREA OF DELAMINATION ON THE NORTHWEST CORNER 9 INCHES WIDE X 24 INCHES HIGH WITH 1/16 INCH SEPARATION, STARTING 1 FT. BELOW THE BOTTOM OF THE CAP

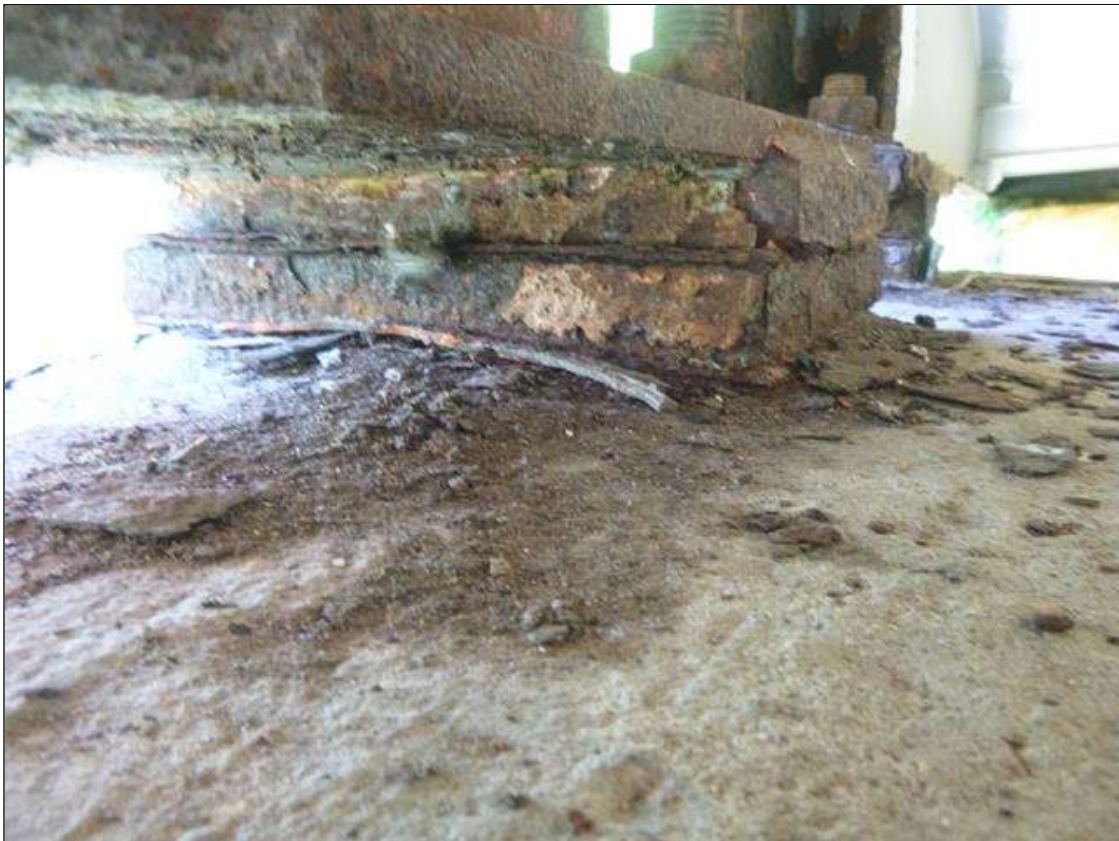
Span 2 Beam 1 Far Bearing: SPAN 2, BEAM 1 FAR BEARING HAS 1/32 INCH SECTION LOSS

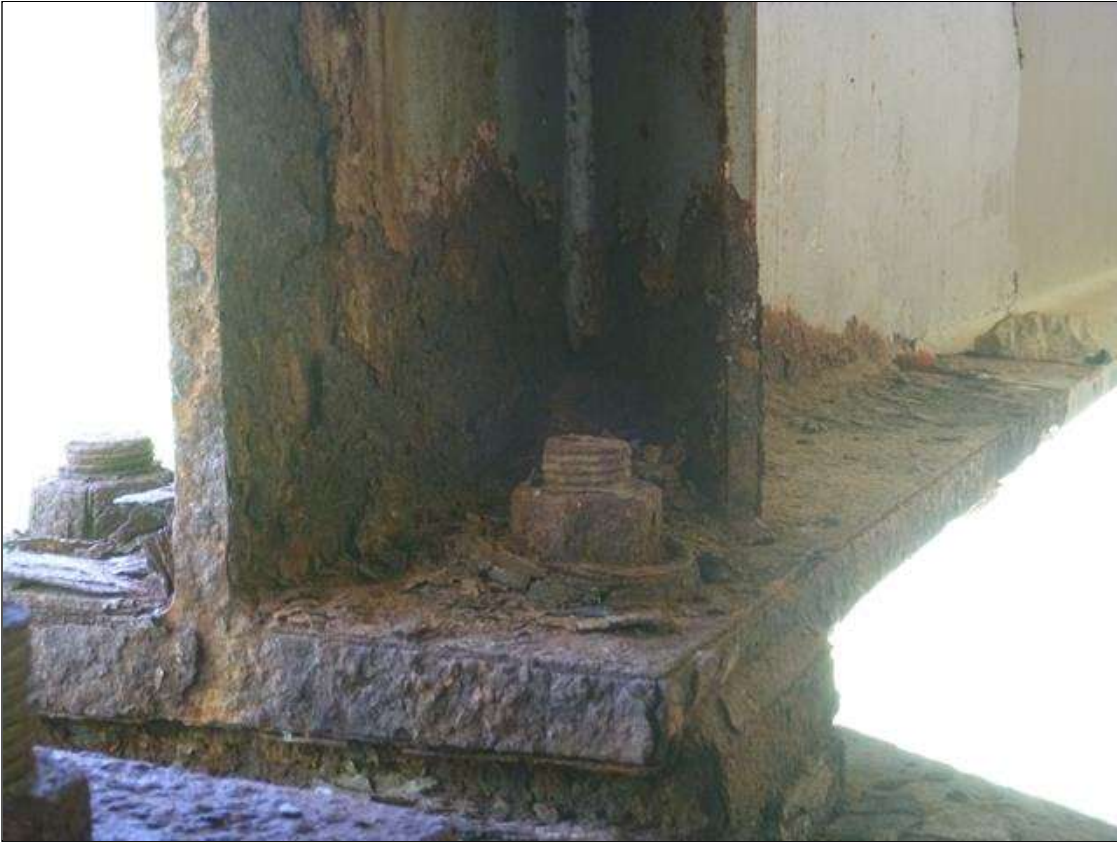
Span 3 Beam 1: SPAN 3, BEAM 1 AT BENT 2 HAS 1/16 INCH SECTION LOSS ON THE BOTTOM FLANGE FROM THE BEAM END OUT 2 FT. WITH 15/16 INCH REMAINING, THE WEB HAS 1/16 INCH SECTION LOSS FROM THE BEAM END OUT 1 FT. X FULL HEIGHT WITH 11/16 INCH REMAINING

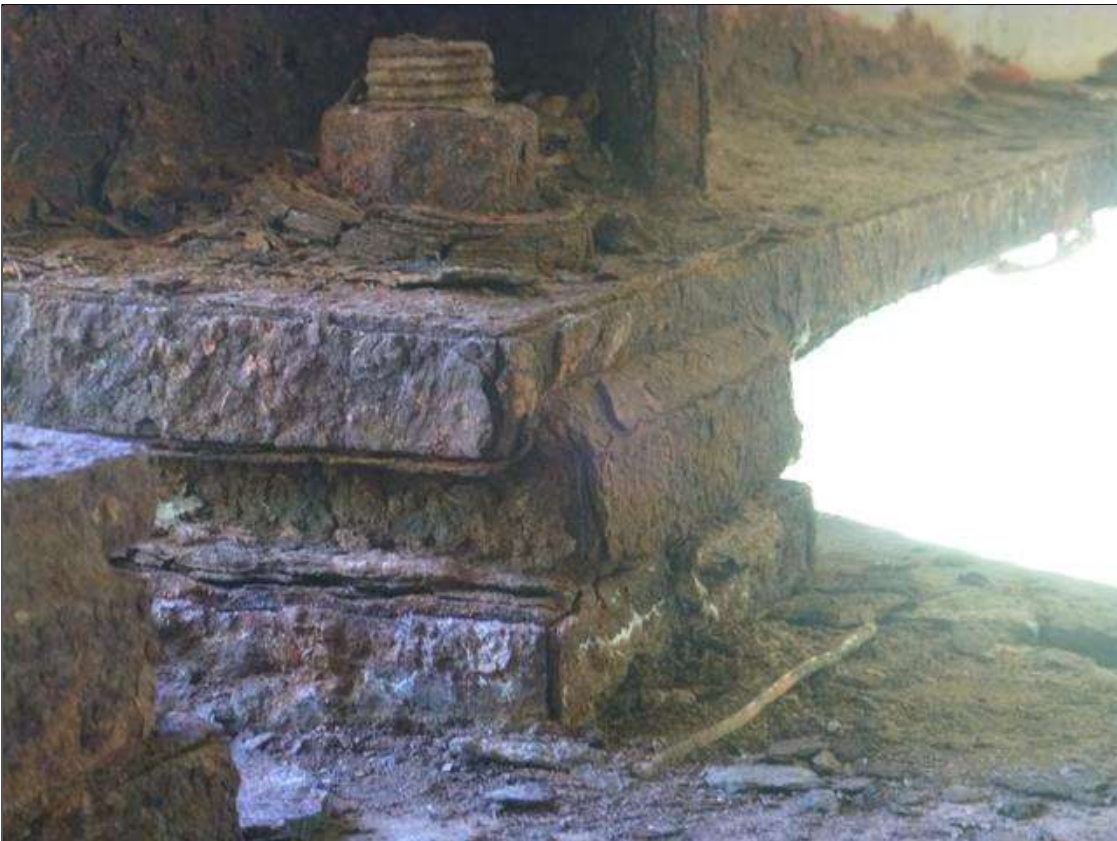
Span 3 Beam 1 Near Bearing: SPAN 3, BEAM 1 NEAR BEARING HAS 1/32 INCH SECTION LOSS

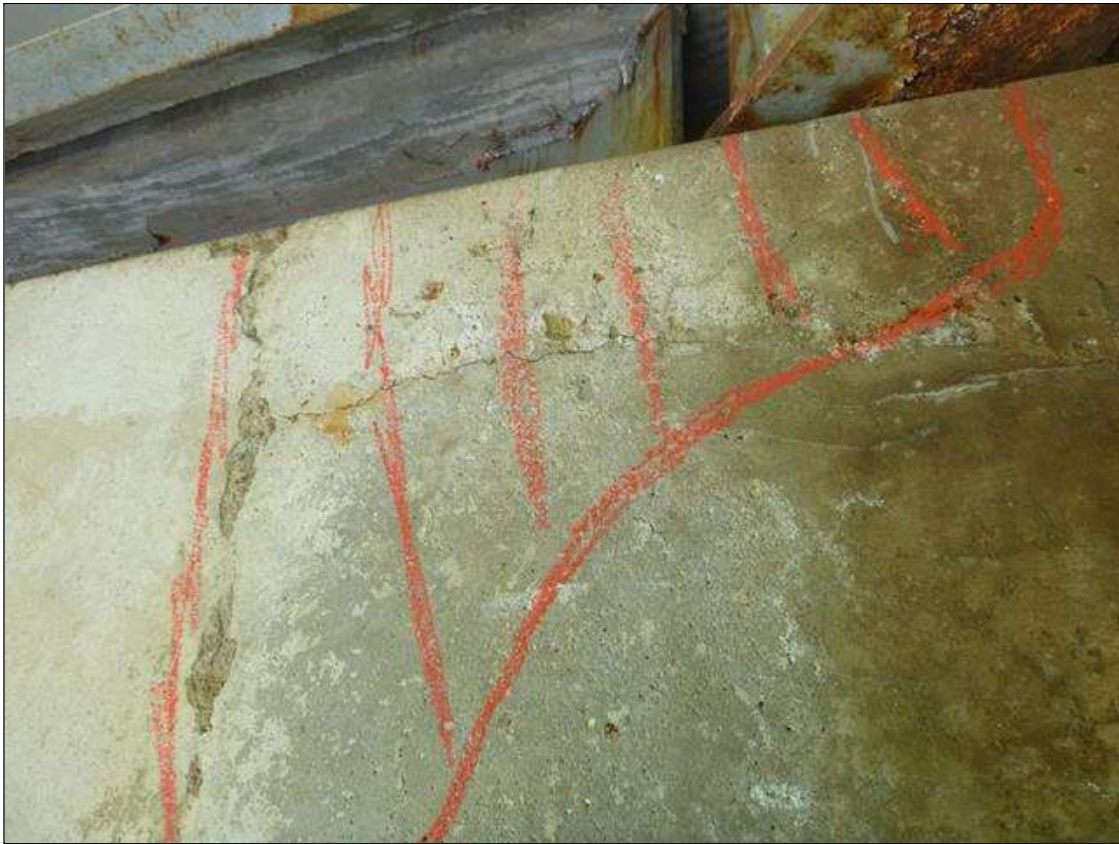
Bent 2 Cap 1: BENT 2 CAP, SPAN 2 SIDE HAS AN AREA OF DELAMINATION IN THE FACE OF THE CAP, BAY 1, NEAR BEAM 2, NEAR TOP EDGE, 22 INCHES X 17 INCHES WITH 3/16 INCH SEPARATION, BEARING AREA IS SOUND

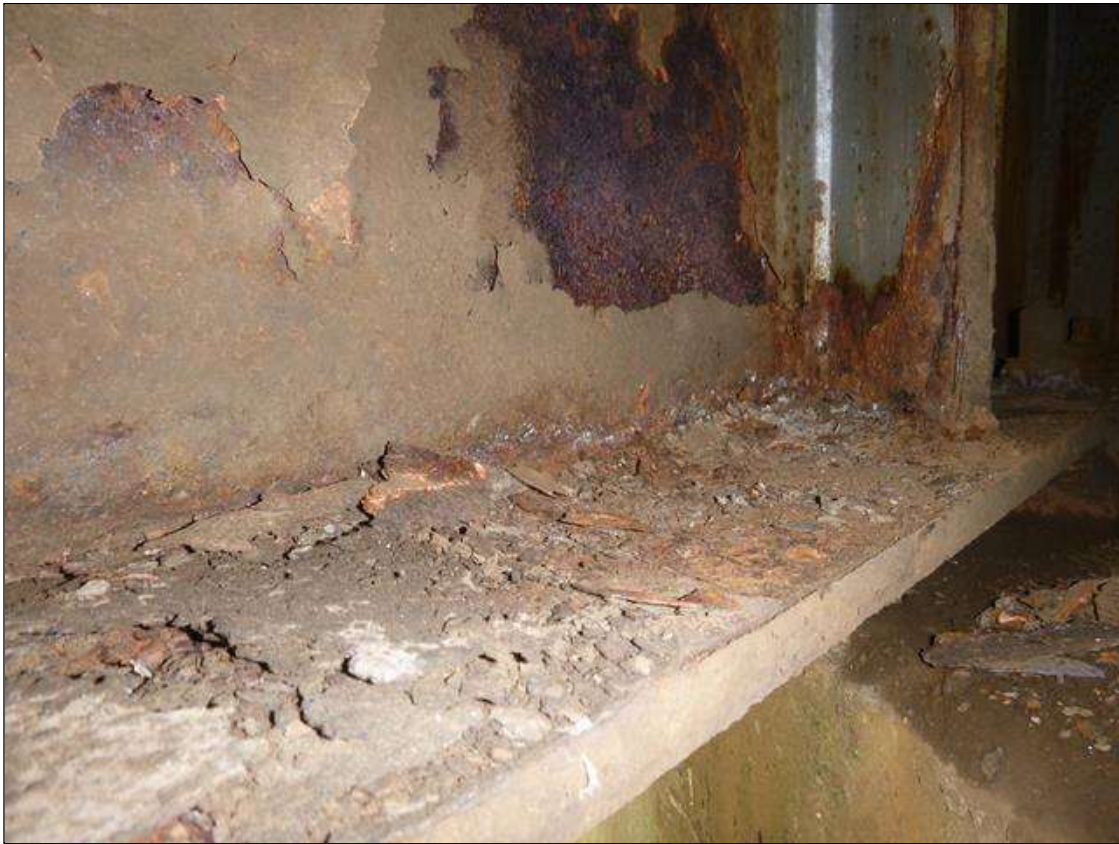
Span 2 Beam 2: SPAN 2, BEAM 2 AT BENT 2 HAS  $\frac{1}{16}$  SECTION LOSS ON THE RIGHT BOTTOM FLANGE FROM THE BEAM END OUT 3 FT. X 6 INCHES WIDE WITH  $\frac{11}{16}$  INCH REMAINING, THE WEB HAS  $\frac{1}{32}$  INCH SECTION FROM THE END OF THE BEAM OUT 3 FT. FROM THE BOTTOM FLANGE UP 10 INCHES HIGH WITH  $\frac{15}{32}$  INCH REMAINING

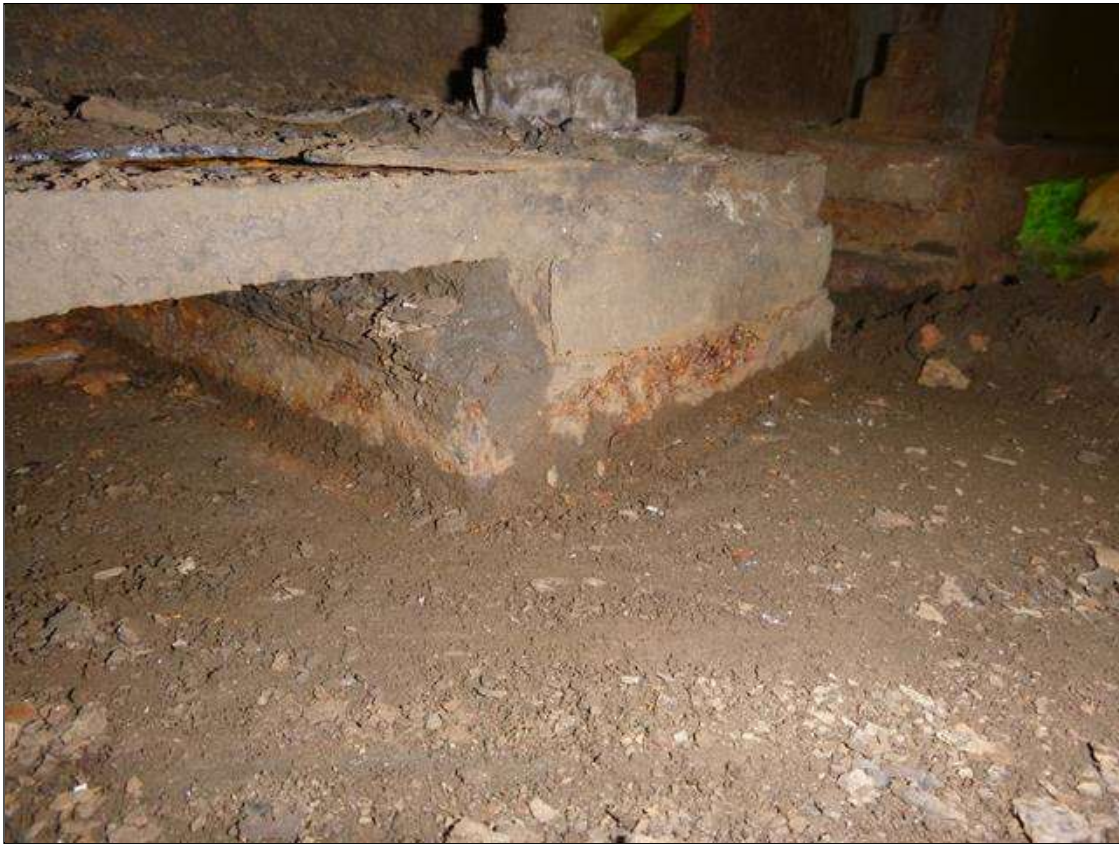
Span 2 Beam 2 Far Bearing: SPAN 2, BEAM 2 FAR BEARING HAS 1/32 INCH SECTION LOSS

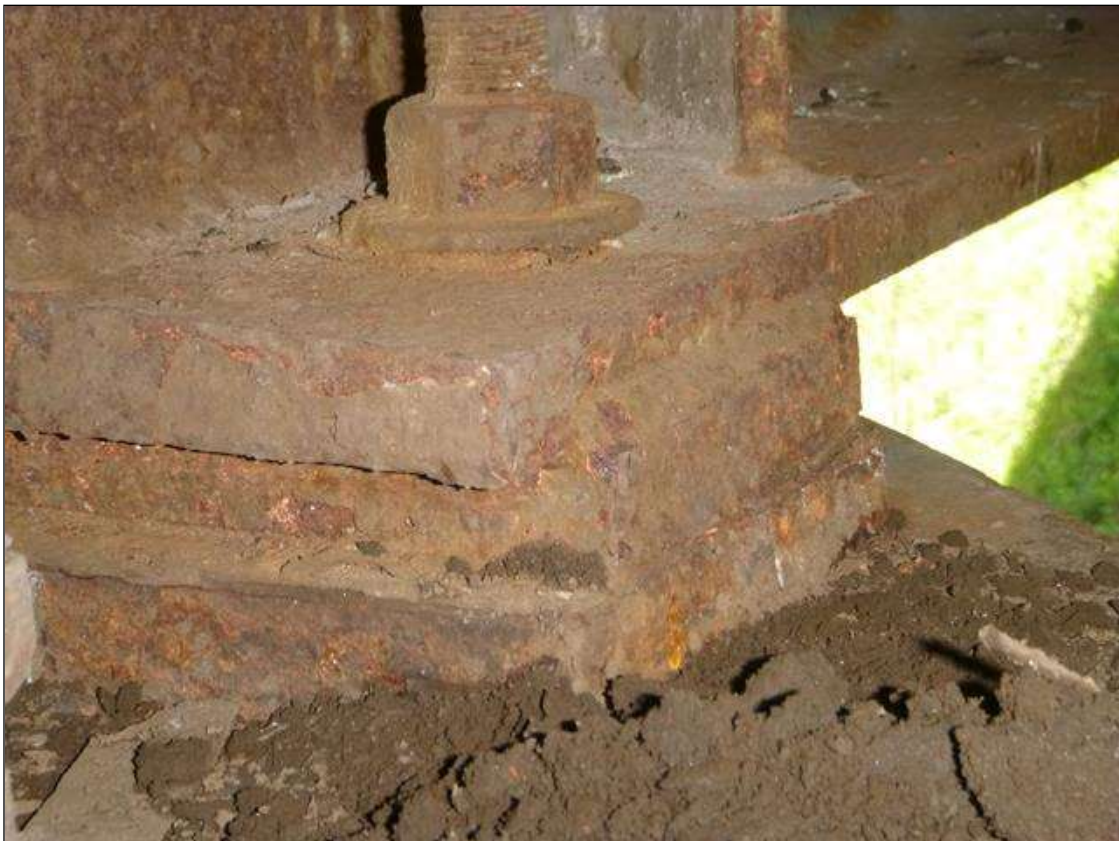
Span 3 Beam 2 Near Bearing: SPAN 3, BEAM 2 NEAR BEARING HAS 1/32 INCH SECTION LOSS
