NC DEPARTMENT OF TRANSPORTATION  
DIVISION OF HIGHWAYS  
STRUCTURE MANAGEMENT UNIT

## Structure Safety Report

### Routine Element Inspection - Contract

COUNTY: HAYWOOD STRUCTURE NUMBER: 430159 FREQUENCY: 24 MONTHS  
FACILITY CARRIED: I-40 MILE POST: 18.7  
LOCATION: 1.8 MI.W.JCT.US276  
FEATURE INTERSECTED: SR1338  
LATITUDE: 35° 37' 31.64" LONGITUDE: 83° 0' 31.41"  
SUPERSTRUCTURE: REINFORCED CONCRETE FLOOR ON I-BEAMS

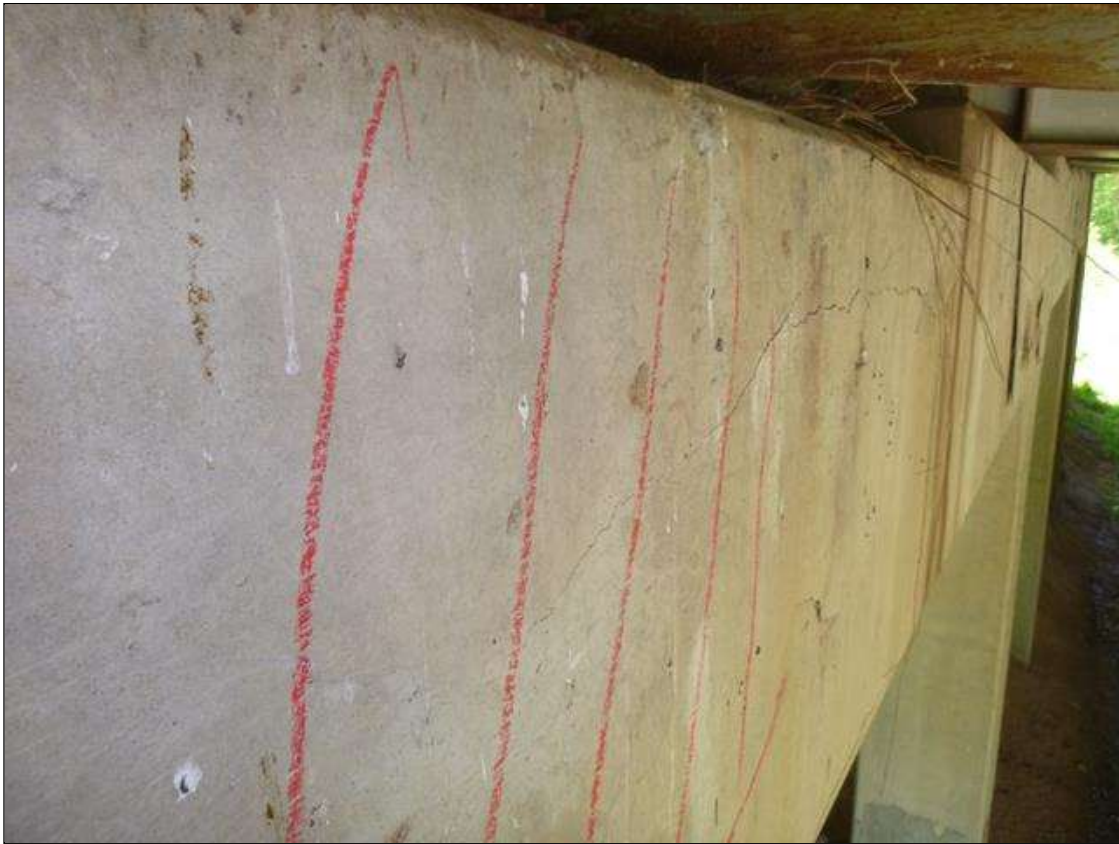
Bent 2 Cap 1: BENT 2 CAP, SPAN 2 SIDE HAS AN AREA OF DELAMINATION IN THE FACE OF THE CAP UNDER BEAM 3, IN BAYS 2 AND 3, 6 FT. LONG X 2 FT. HIGH AND 3 INCHES ACROSS THE TOP OF THE CAP WITH 1/4 INCH SEPARATION

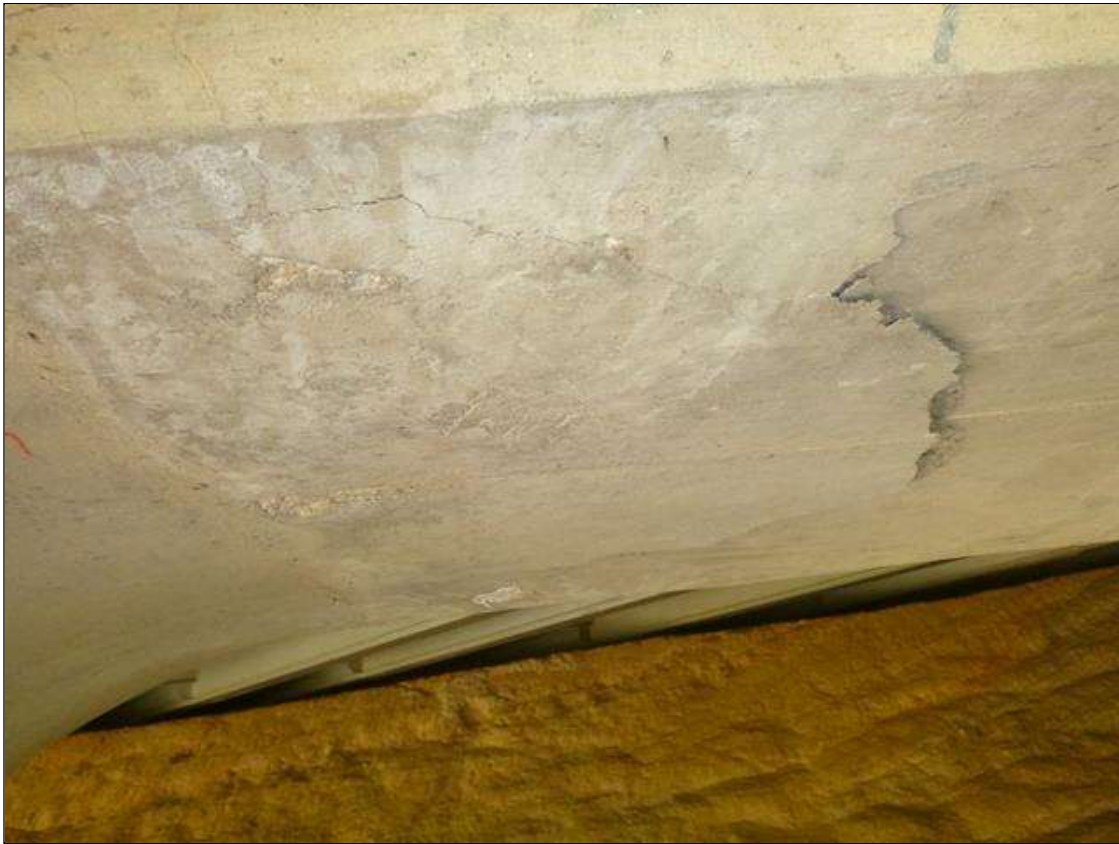
Bent 2 Cap 1: BENT 2 BOTTOM OF CAP, UNDER BEAM 3 HAS AN AREA OF DELAMINATION, 22 INCHES X 20 INCHES WITH 1/2 INCH SEPARATION

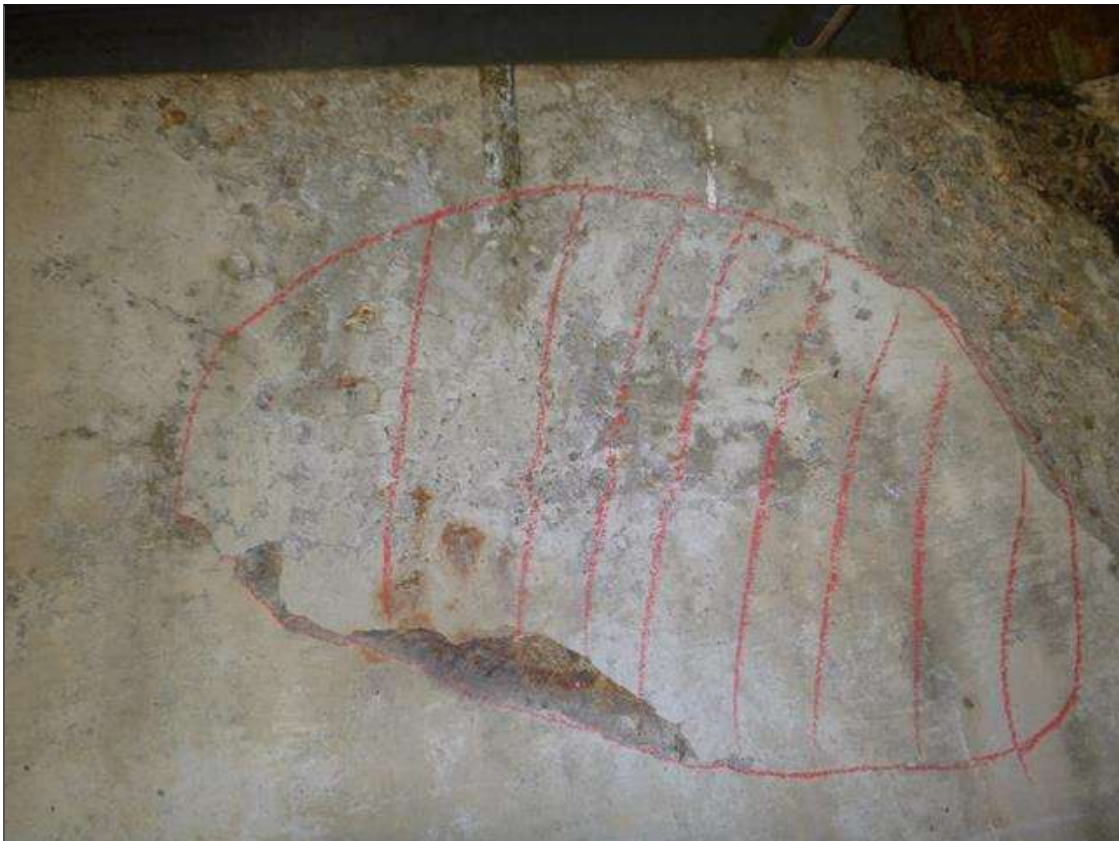
Bent 2 Cap 1: BENT 2 CAP, SPAN 2 SIDE HAS AN AREA OF DELAMINATION IN THE FACE OF THE CAP IN BAY 3, 24 INCHES X 15 INCHES WITH 1/8 INCH SEPARATION

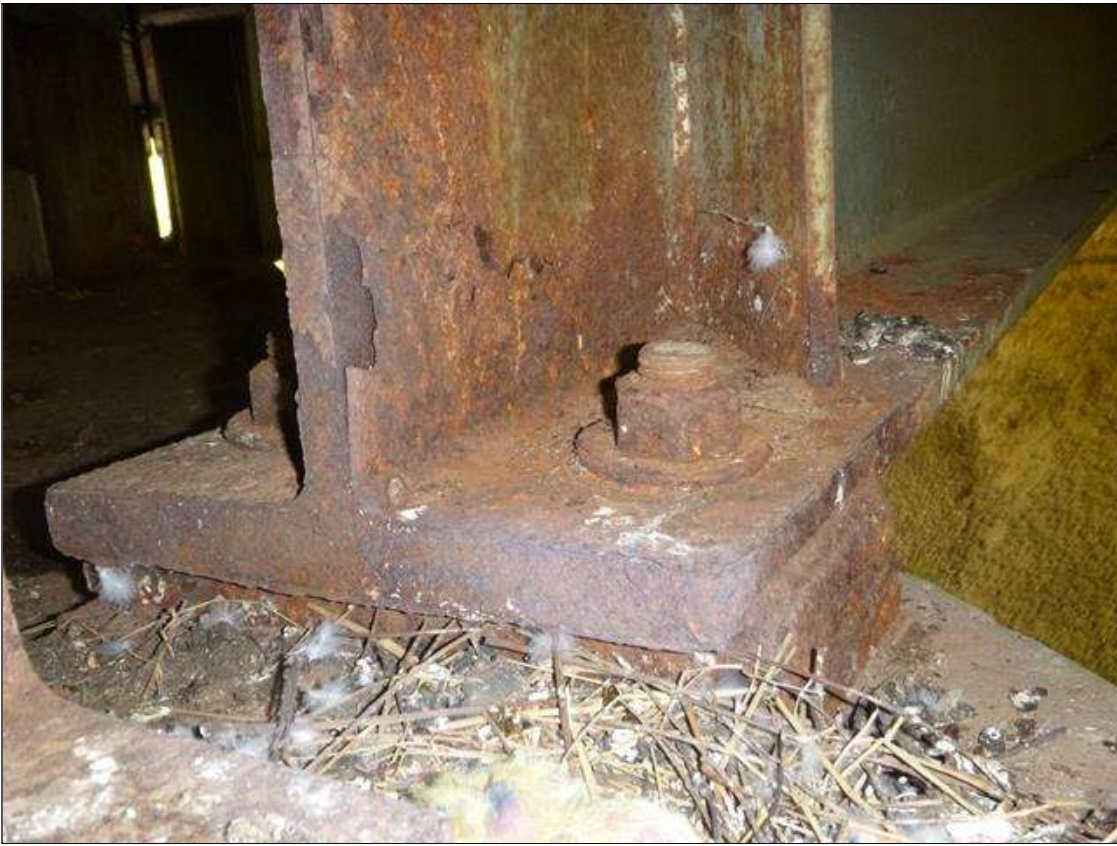
Span 3 Beam 4: SPAN 3, BEAM 4 AT BENT 2 HAS  $\frac{1}{32}$  INCH SECTION ON THE BOTTOM FLANGE FROM THE BEAM END OUT 1 FT. X FULL WIDTH WITH  $\frac{31}{32}$  INCH REMAINING, THE WEB HAS  $\frac{1}{32}$  INCH SECTION LOSS FROM THE END OF THE BEAM OUT 1 FT. X FULL HEIGHT WITH  $\frac{23}{32}$  INCH REMAINING

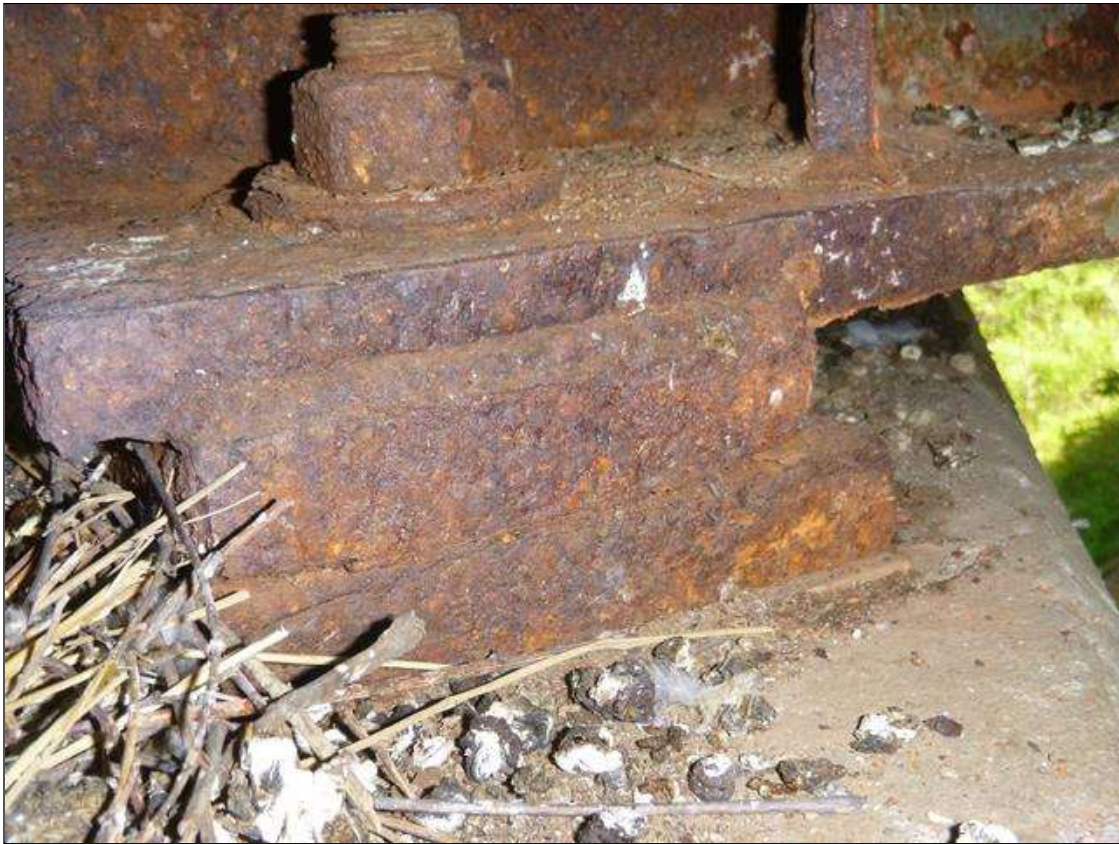
Span 3 Beam 4 Near Bearing: SPAN 3, BEAM 4 NEAR BEARING HAS 1/32 INCH SECTION LOSS

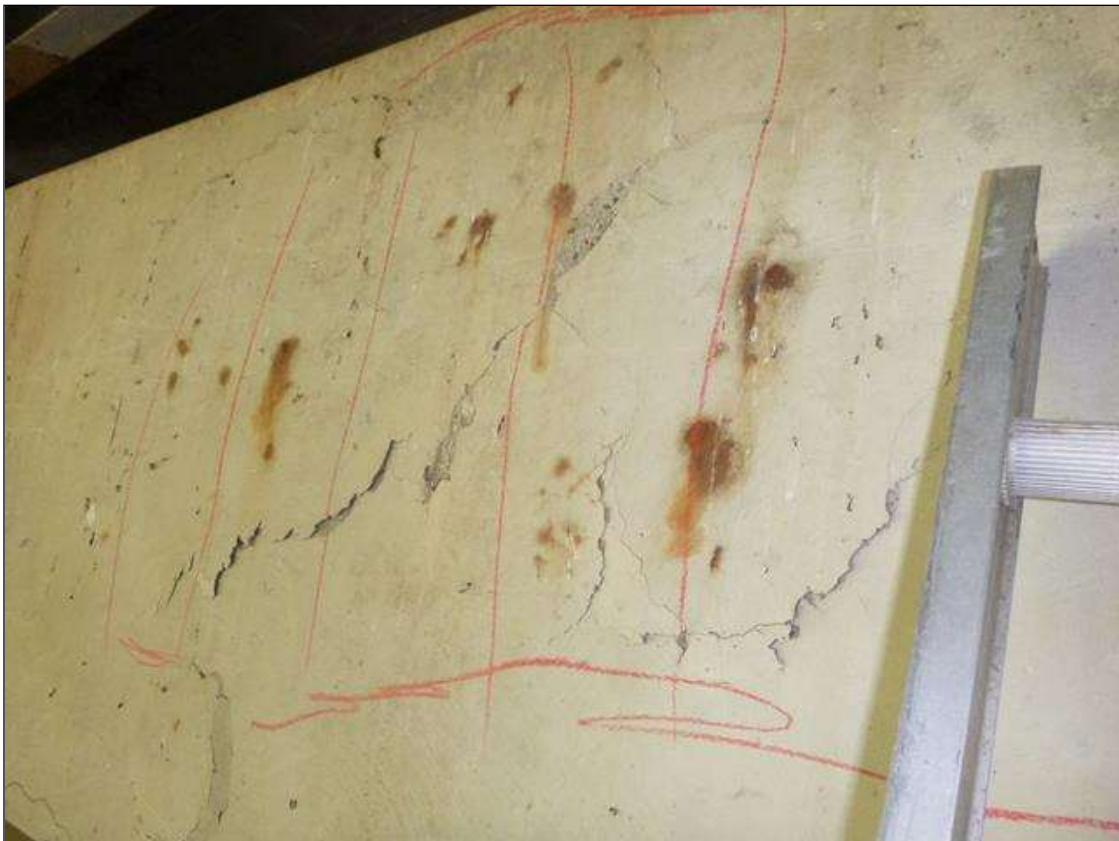
Bent 2 Cap 1: BENT 2 CAP, SPAN 2 SIDE HAS AN AREA OF DECAY IN THE FACE OF THE CAP IN BAYS 4 AND 5, 6 FT. LONG X 2 FT. HIGH WITH 3/16 INCH SEPARATION

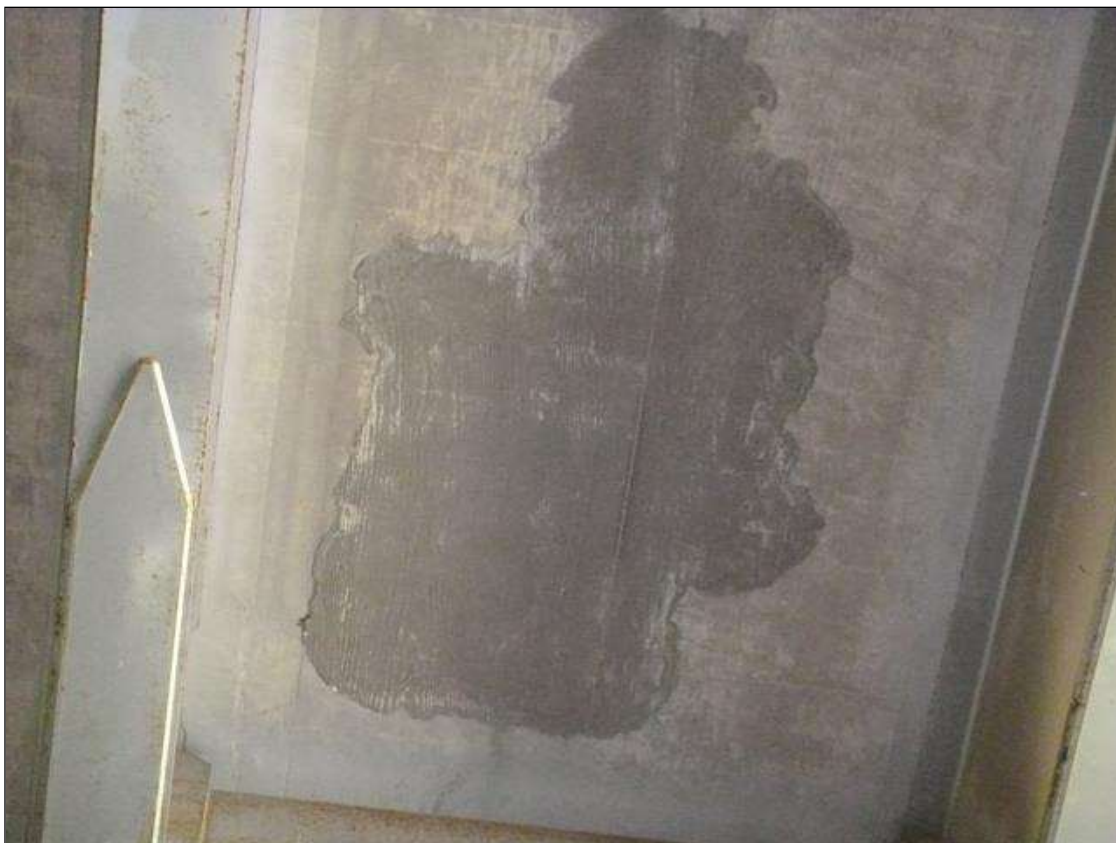
Span 2 Deck: SPAN 2 BAY 3 BOTTOM OF DECK, 8 FT. FROM BENT 2 HAS A PATCH, 4 FT. X 7 FT.

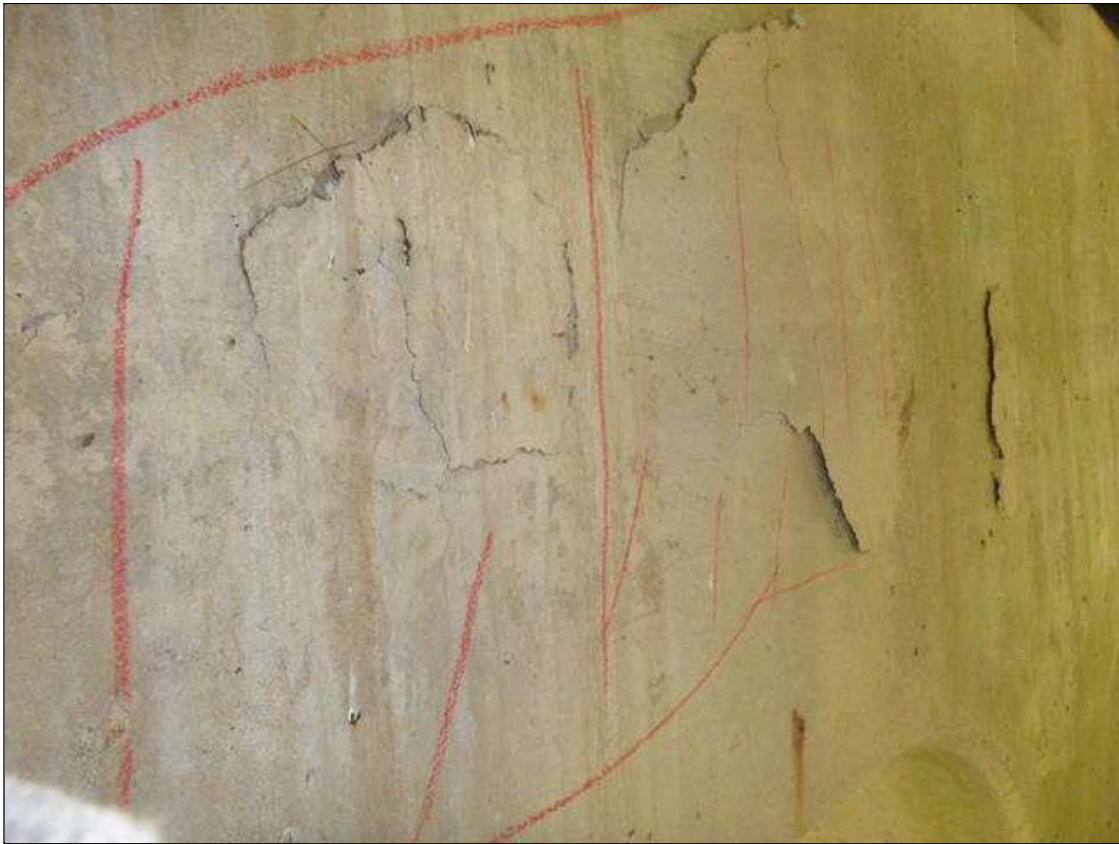
Bent 2 Cap 1: BENT 2 CAP, SPAN 2 SIDE HAS AN AREA OF DELAMINATION IN THE FACE OF THE CAP UNDER BEAM 6, 5 FT. X 20 INCHES WITH 1/2 INCH SEPARATION

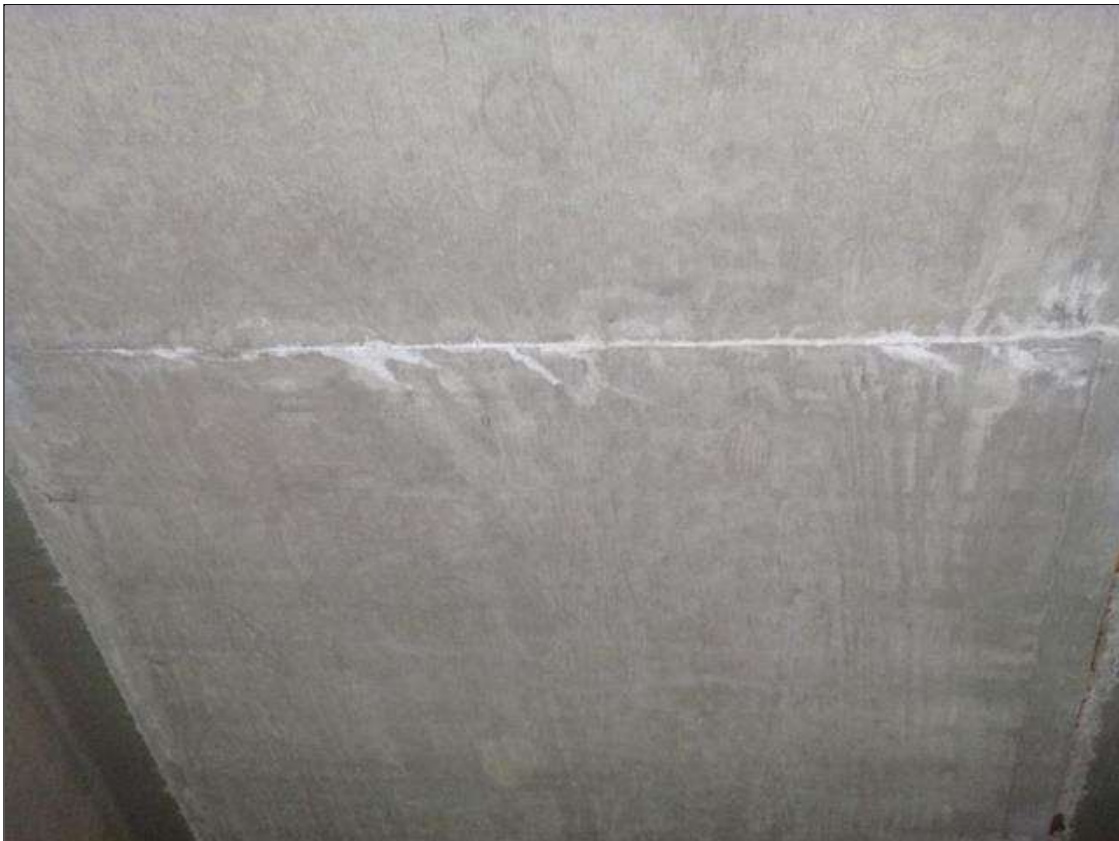
Span 2 Deck: SPAN 2, BOTTOM OF THE DECK IN BAY 5 HAS A HAIRLINE 4 FT. LONG TRANSVERSE CRACK WITH EFFLO. 8 FT. FROM BENT 2 FOR A TOTAL OF 80 SQ. FT. THRU OUT THE SPAN

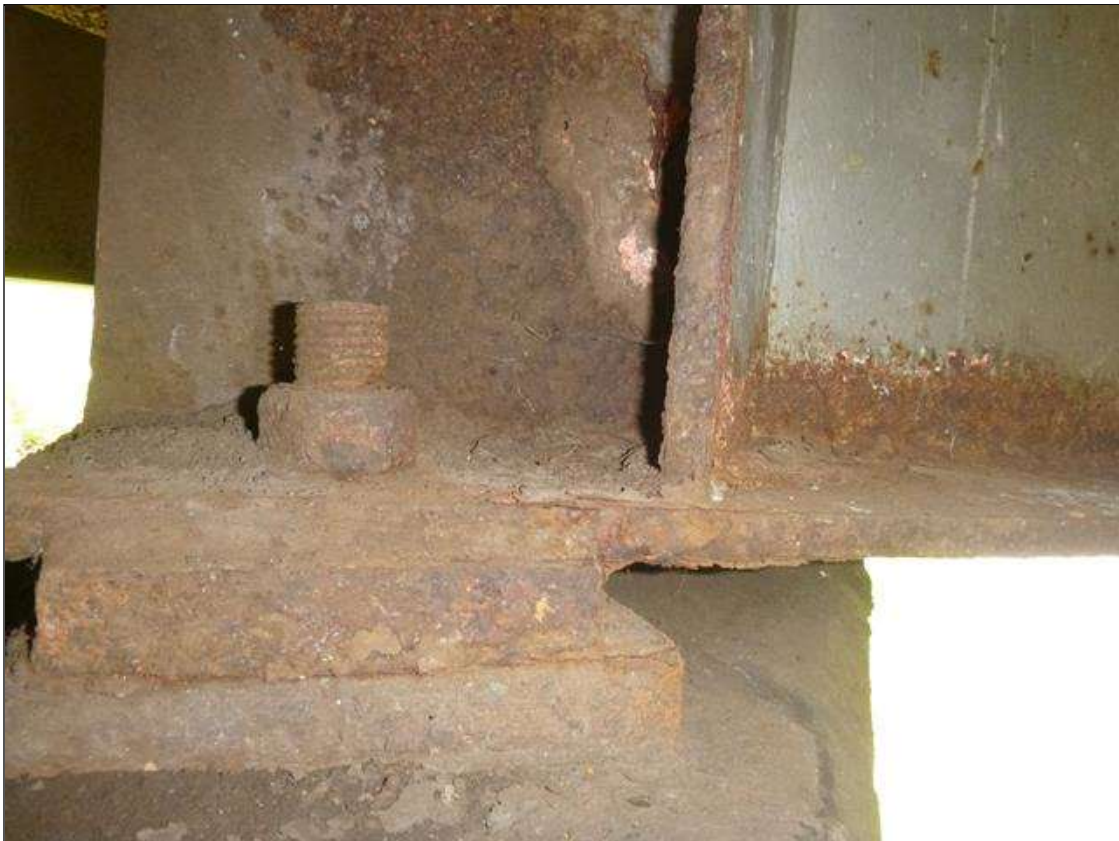
Span 2 Beam 8: SPAN 2, BEAM 8 AT BENT 2 HAS 1/32 INCH SECTION LOSS ON THE BOTTOM FLANGE FROM THE BEAM END OUT 2 FT. X FULL WIDTH WITH 19/32 INCH REMAINING,

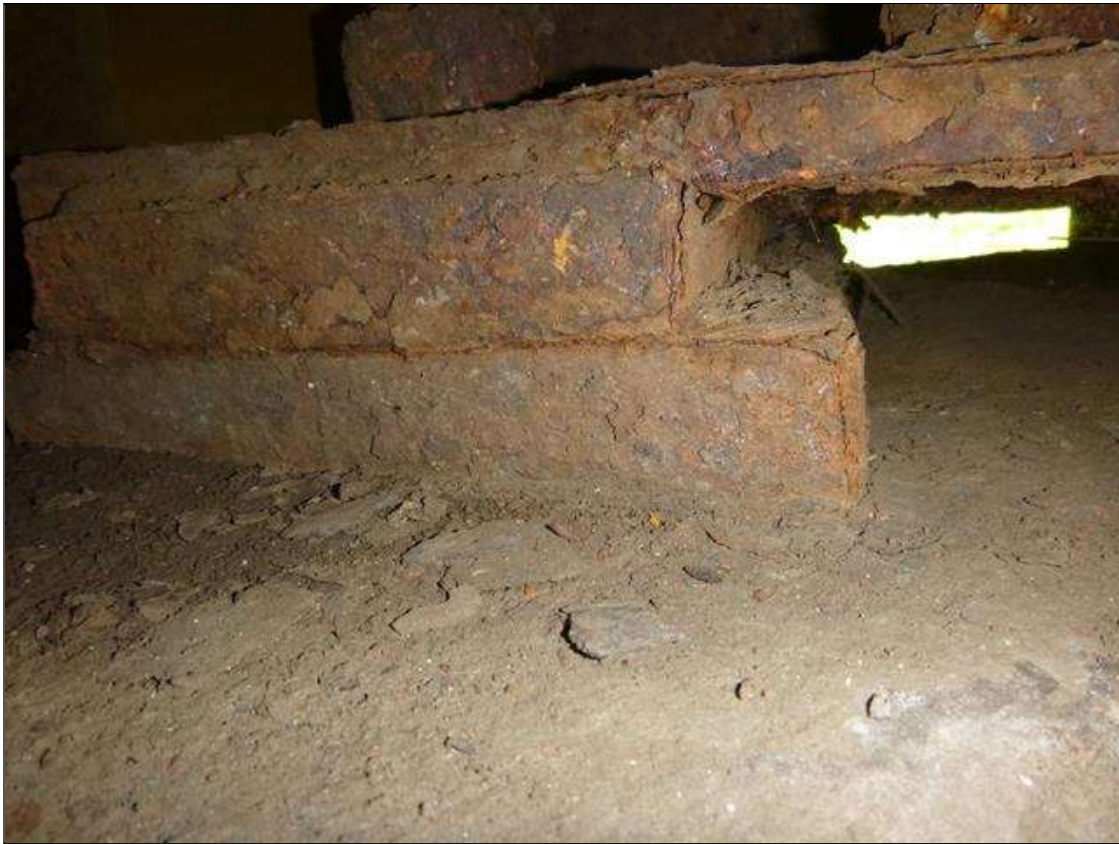
Span 2 Beam 8 Far Bearing: SPAN 2, BEAM 8 FAR BEARING HAS 1/32 INCH SECTION LOSS

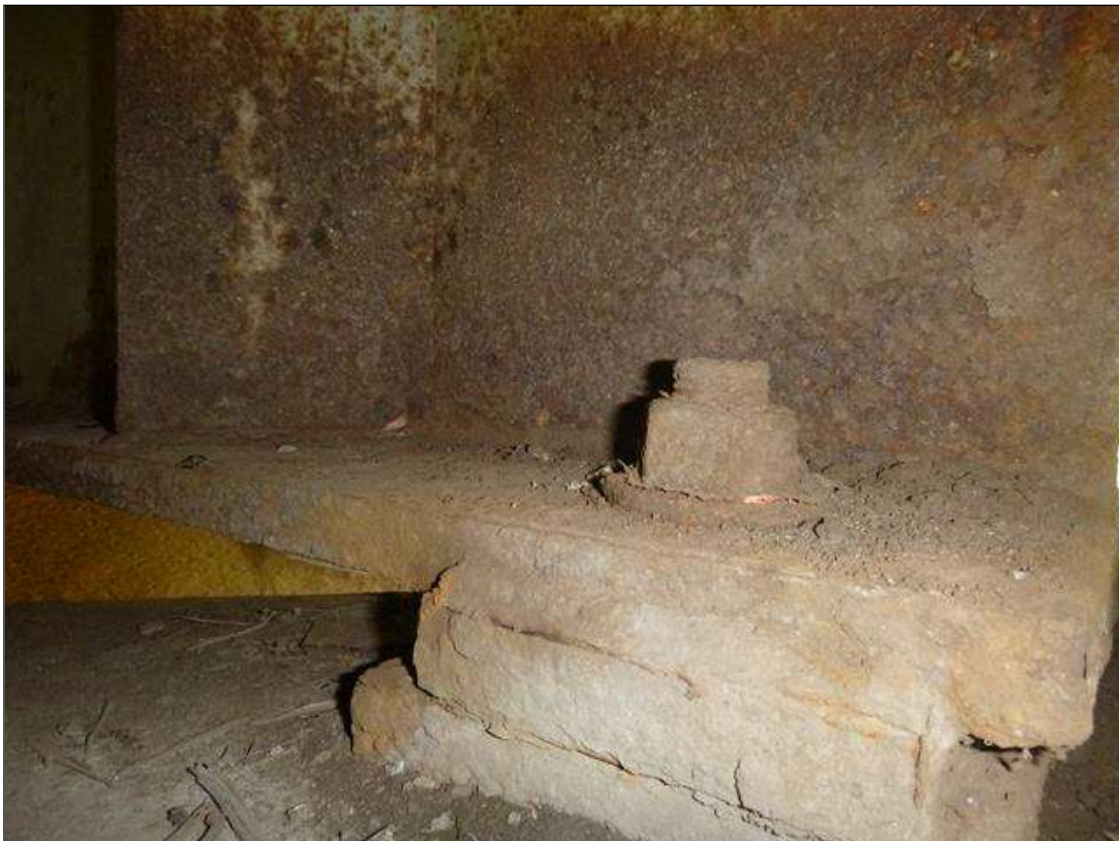
Span 3 Beam 8: SPAN 3, BEAM 8 AT BENT 2 HAS 1/32 INCH SECTION LOSS ON THE BOTTOM FLANGE FROM THE BEAM END OUT 2 FT. WITH 31/32 INCH REMAINING

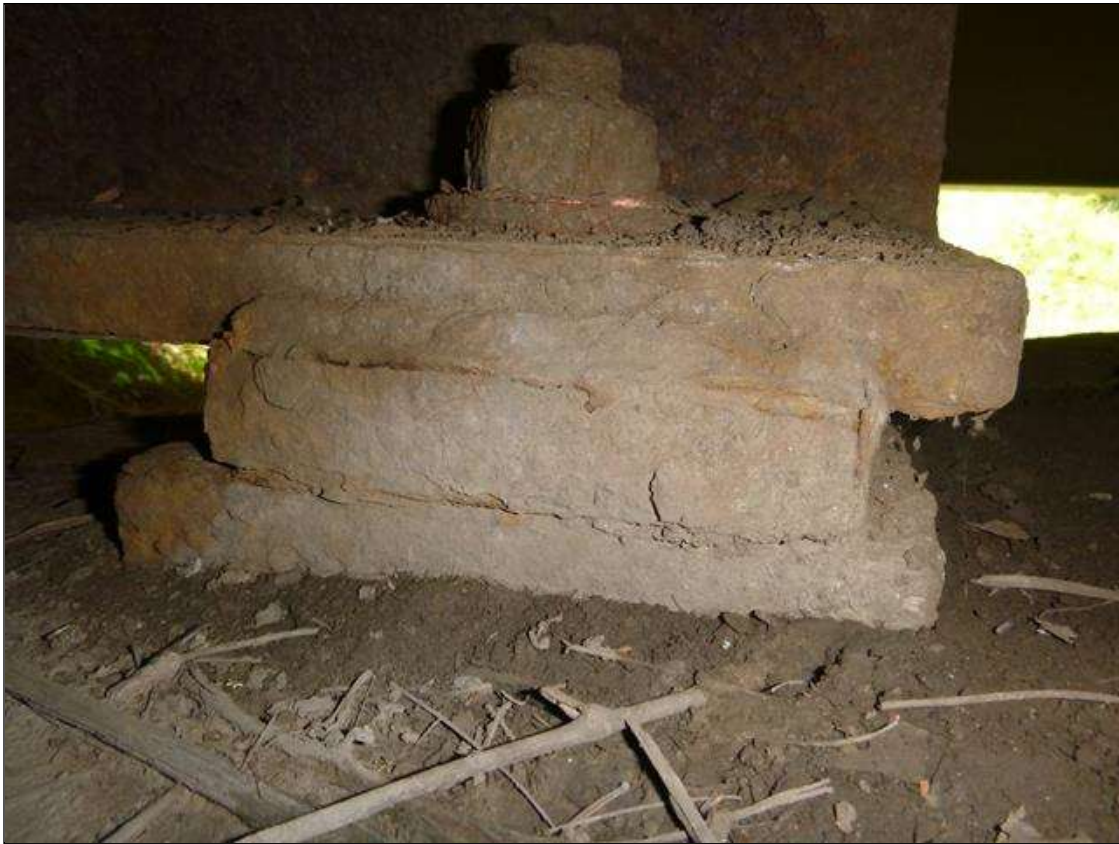
Span 3 Beam 8 Near Bearing: SPAN 3 BEAM 8 NEAR BEARING HAS 1/32 INCH SECTION LOSS

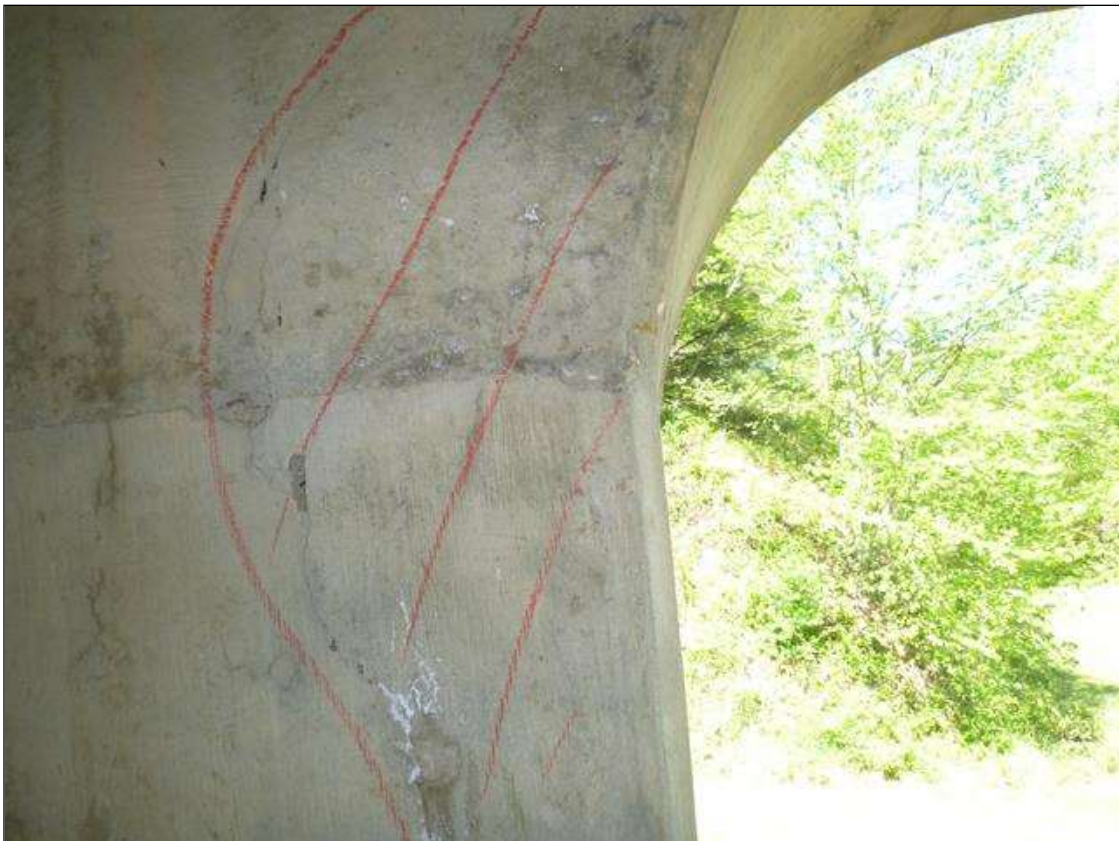
Bent 2 Pile 1: BENT 2, PILE 1 HAS AN AREA OF DELAMINATION ON THE NORTHEAST CORNER, 16 INCHES WIDE X 32 INCHES HIGH WITH 1/4 INCH SEPARATION

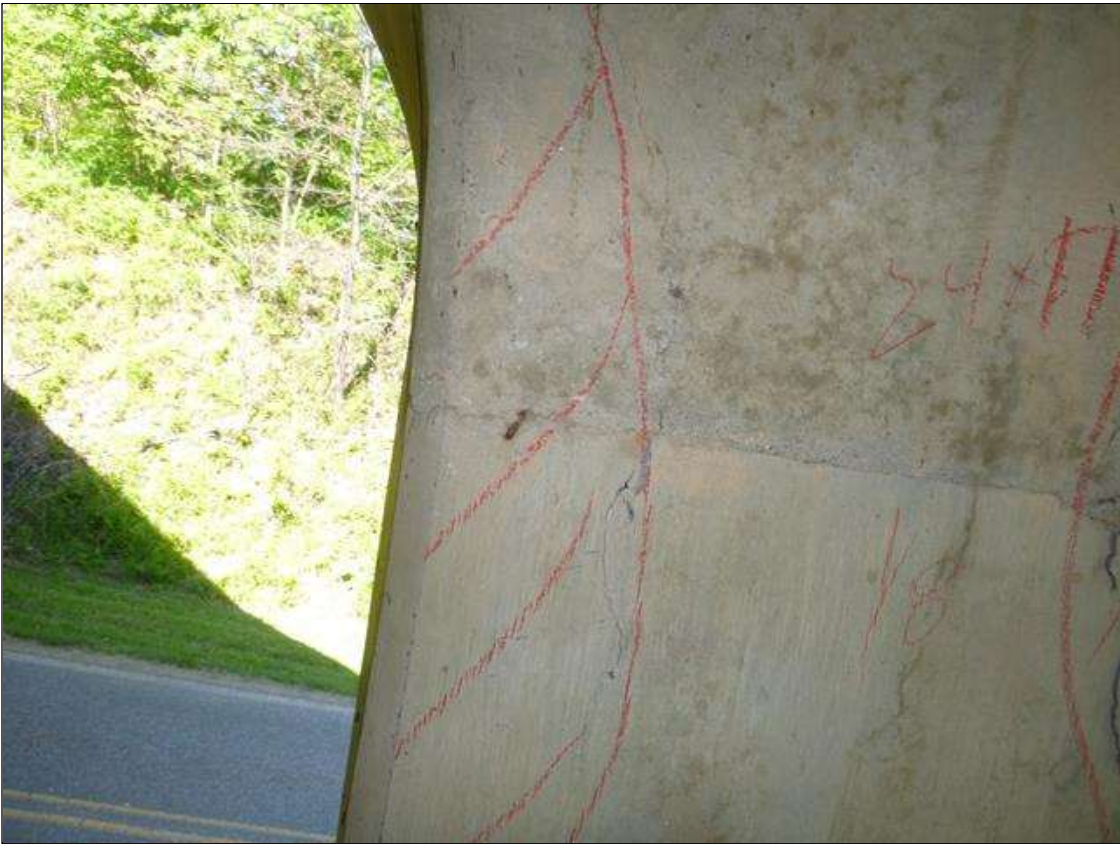
Bent 2 Pile 1: BENT 2, PILE 1 HAS AN AREA OF DELAMINATION ON THE SOUTHEAST CORNER, 11 INCHES WIDE X 24 INCHES HIGH WITH 1/8 INCH SEPARATION, 1 FT. BELOW THE BOTTOM OF THE CAP

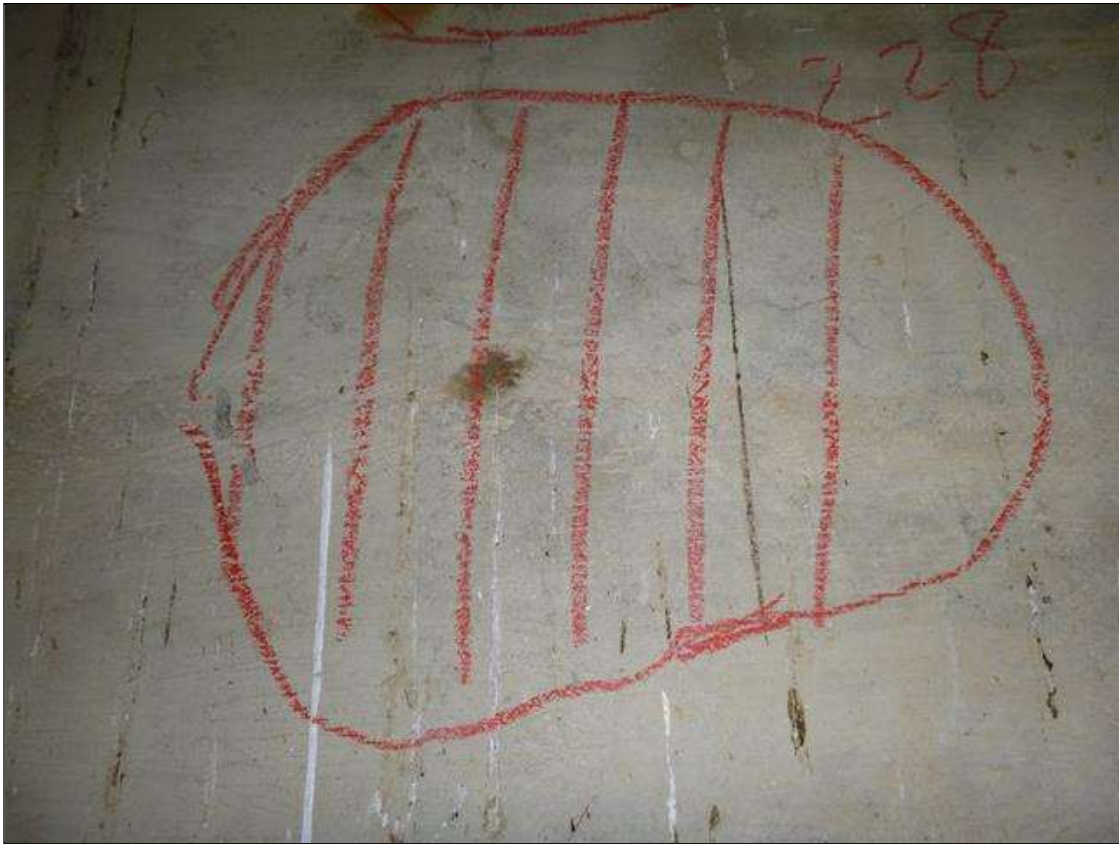
Bent 2 Cap 1: BENT 2 CAP, SPAN 3 SIDE HAS AN AREA OF DELAMINATION IN THE FACE OF THE CAP IN BAY 4, 16 INCHES X 12 INCHES

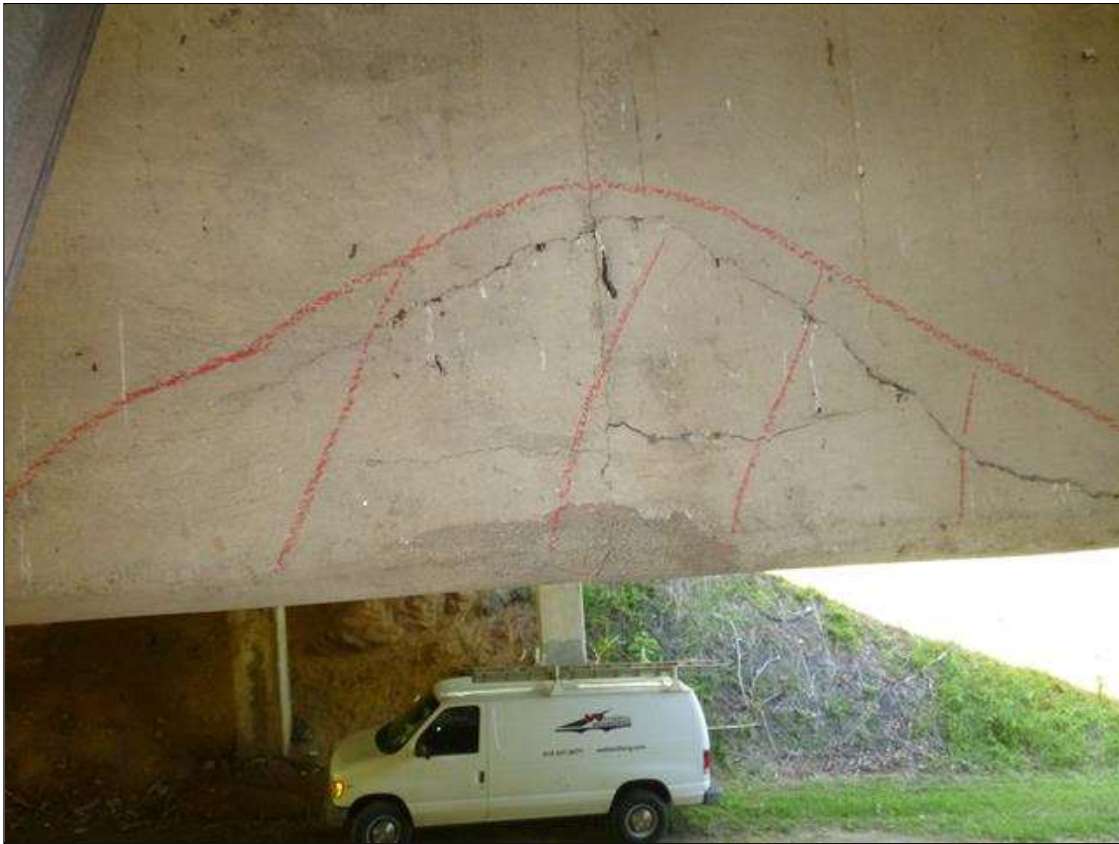
Bent 2 Cap 1: BENT 2 CAP, SPAN 3 SIDE HAS AN AREA OF DELAMINATION IN THE FACE OF THE CAP, IN BAY 5, NEAR BOTTOM EDGE, 36 INCHES X 9 INCHES X 6 INCHES ACROSS THE BOTTOM WITH 3/16 INCH SEPARATION

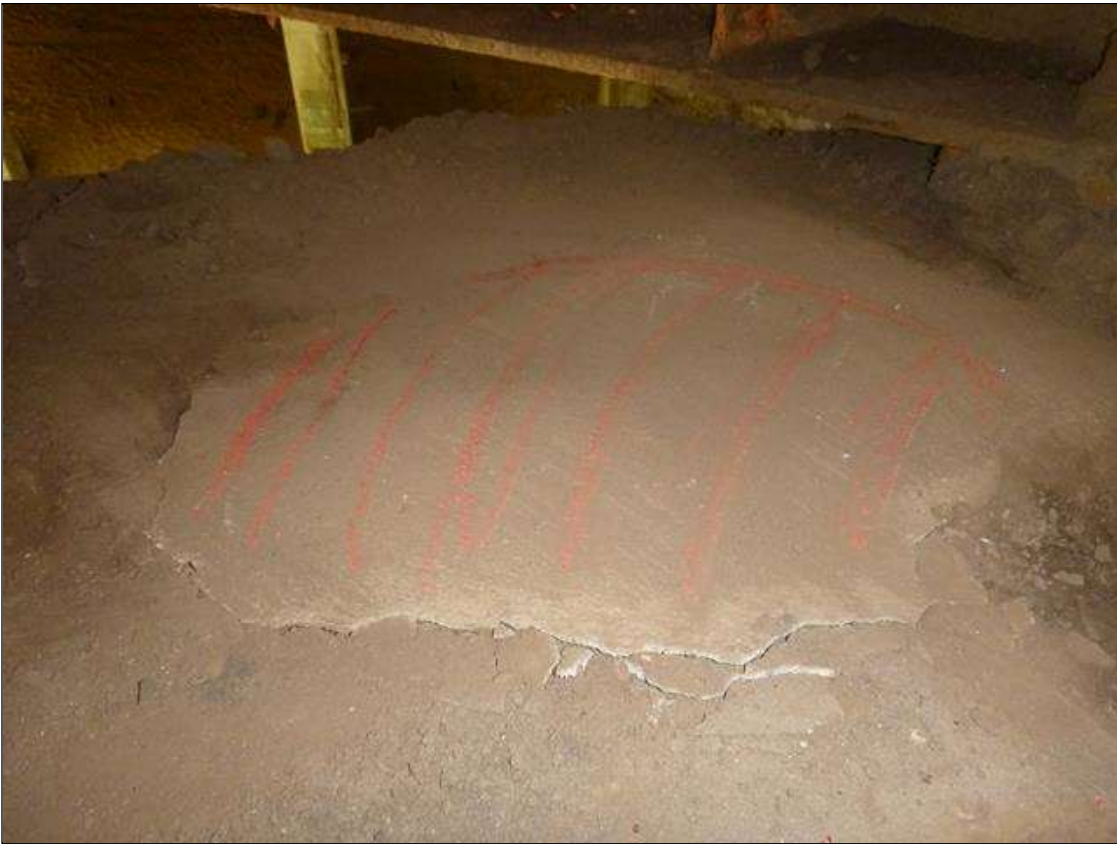
Bent 2 Cap 1: BENT 2 TOP OF CAP IN BAY 8 HAS AN AREA OF DELAMINATION, 14 INCHES X 17 INCHES NEAR BEAM 8 WITH 1/8 INCH SEPARATION

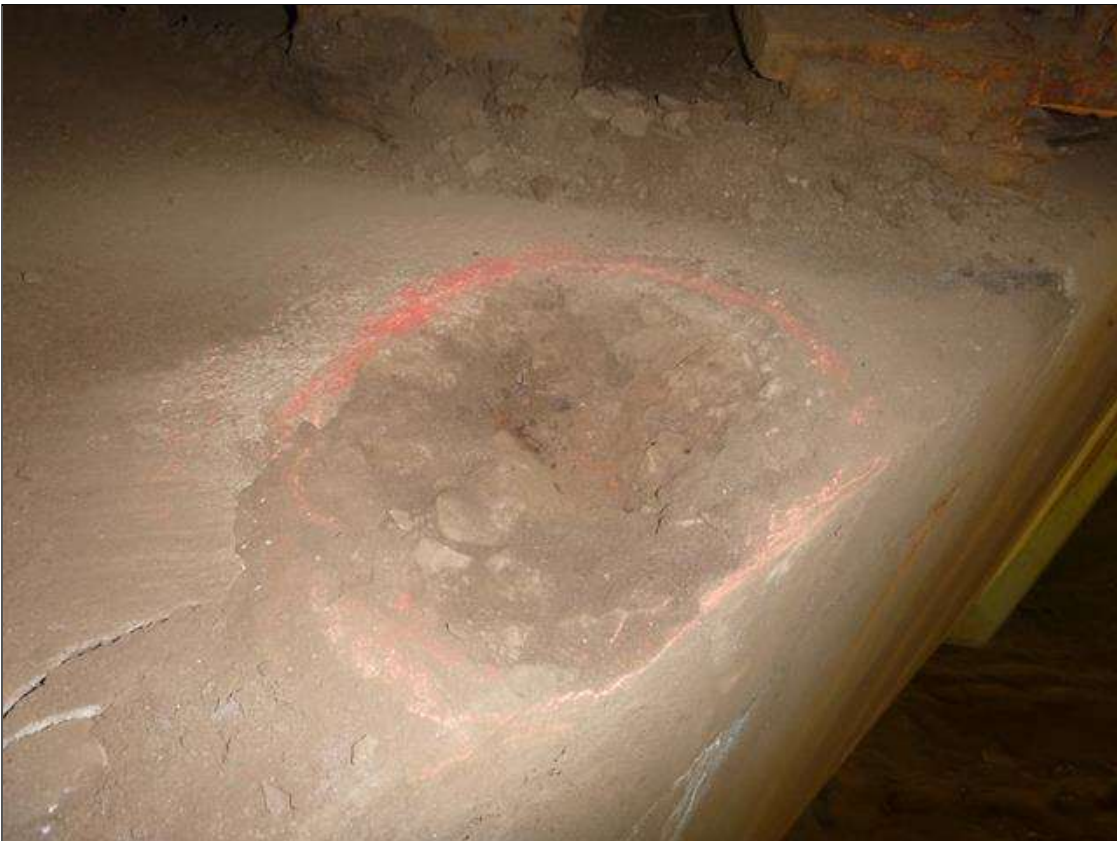
Bent 2 Cap 1: BENT 2 TOP OF CAP, BAY 8 NEAR BEAM 8 HAS A SPALL 8 INCHES X 12 INCHES X 1.5 INCHES DEEP, NEAR SPAN 3 SIDE

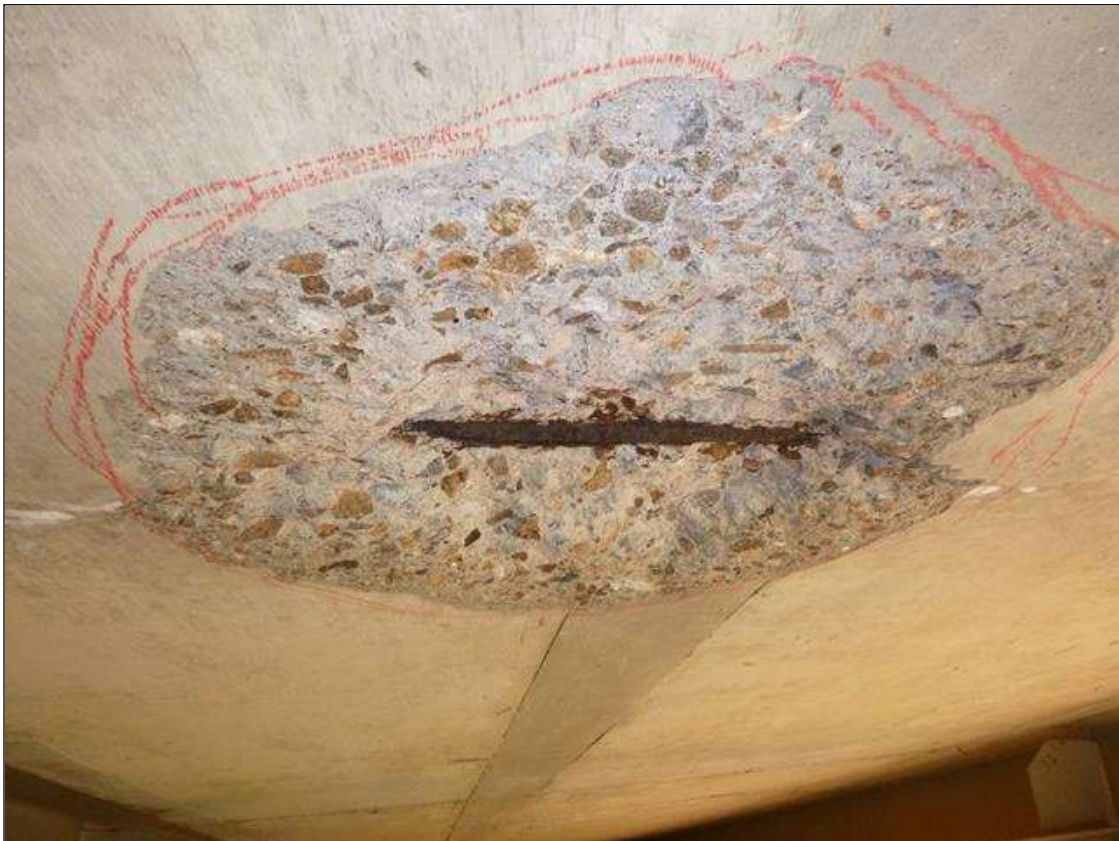
Span 3 Deck: SPAN 3 BOTTOM OF BAY 9 DECK HAS A SPALL, 22 INCHES IN DIAMETER X 1.5 INCHES DEEP WITH EXPOSED REBAR AT 2/3 POINT

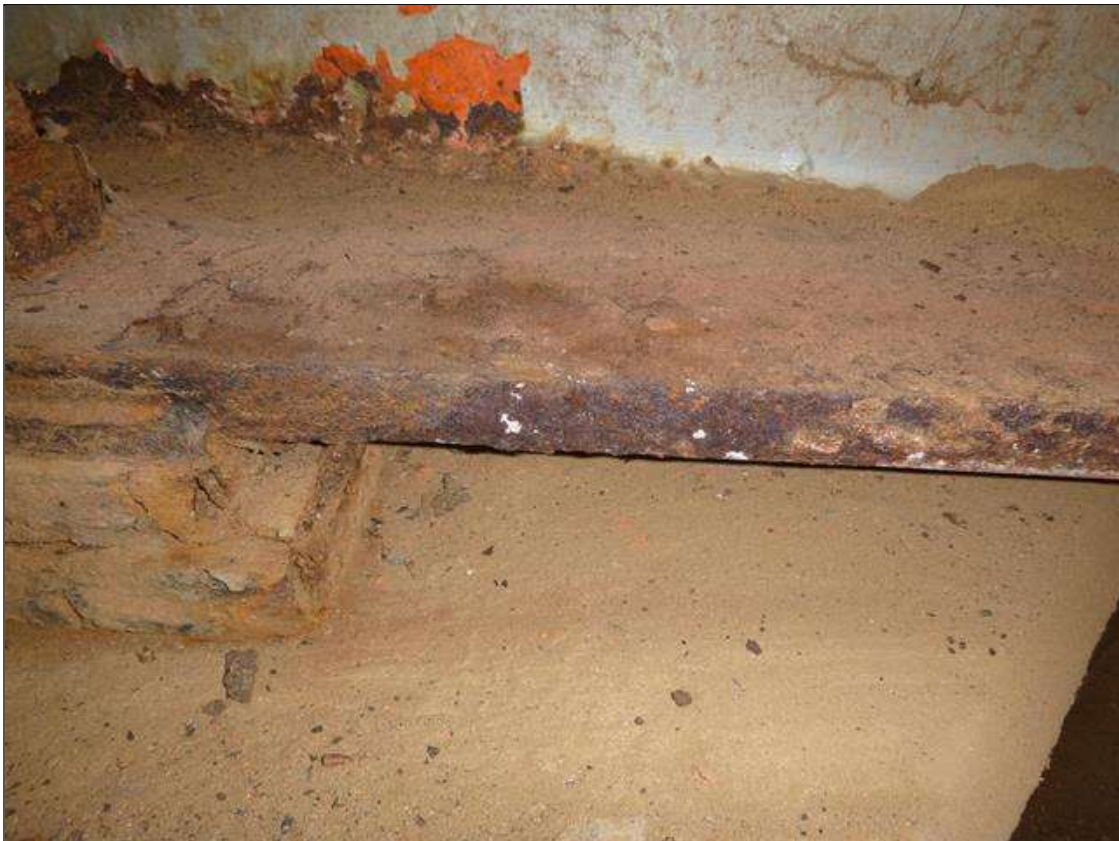
Span 3 Beam 10: SPAN 3, BEAM 10 AT END BENT 2 HAS 1/32 INCH SECTION LOSS ON THE BOTTOM FLANGE FROM CENTERLINE OF BEARING OUT 1 FT. X FULL WIDTH WITH 31/32 INCH REMAINING

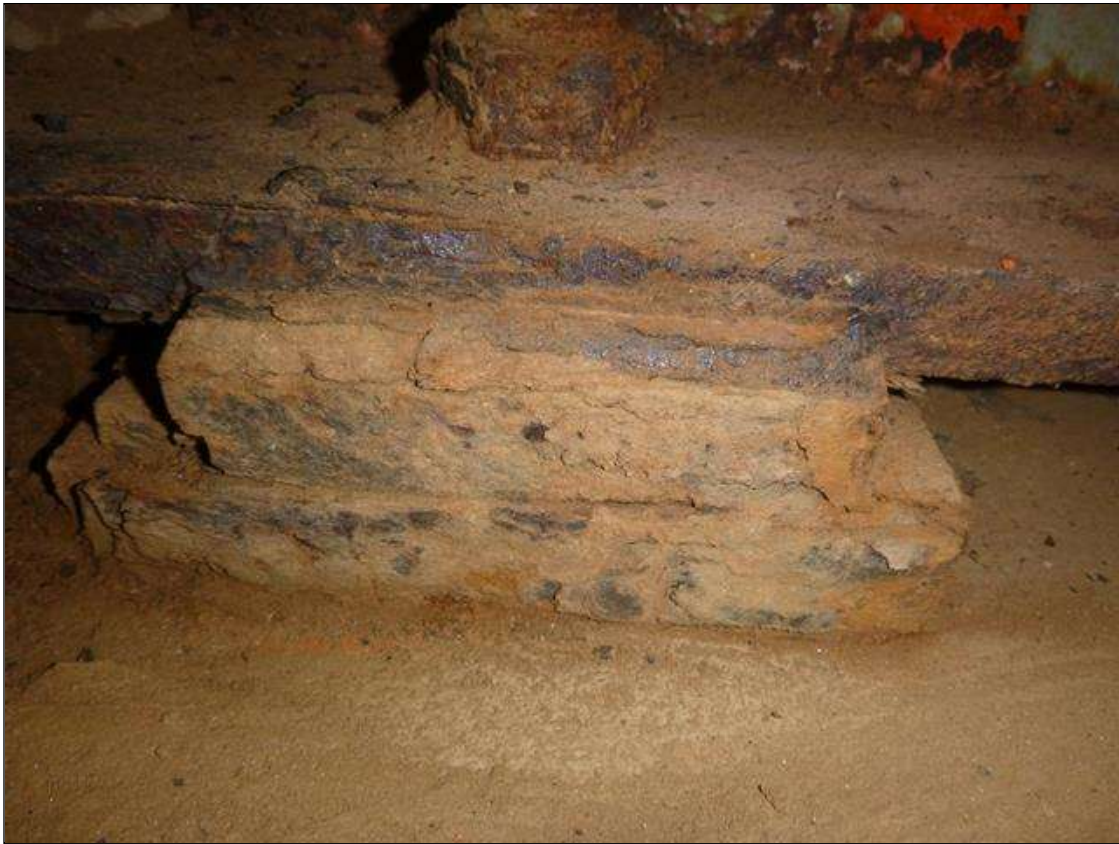
Span 3 Beam 10 Far Bearing: SPAN 3, BEAM 10 FAR BEARING HAS 1/32 INCH SECTION LOSS

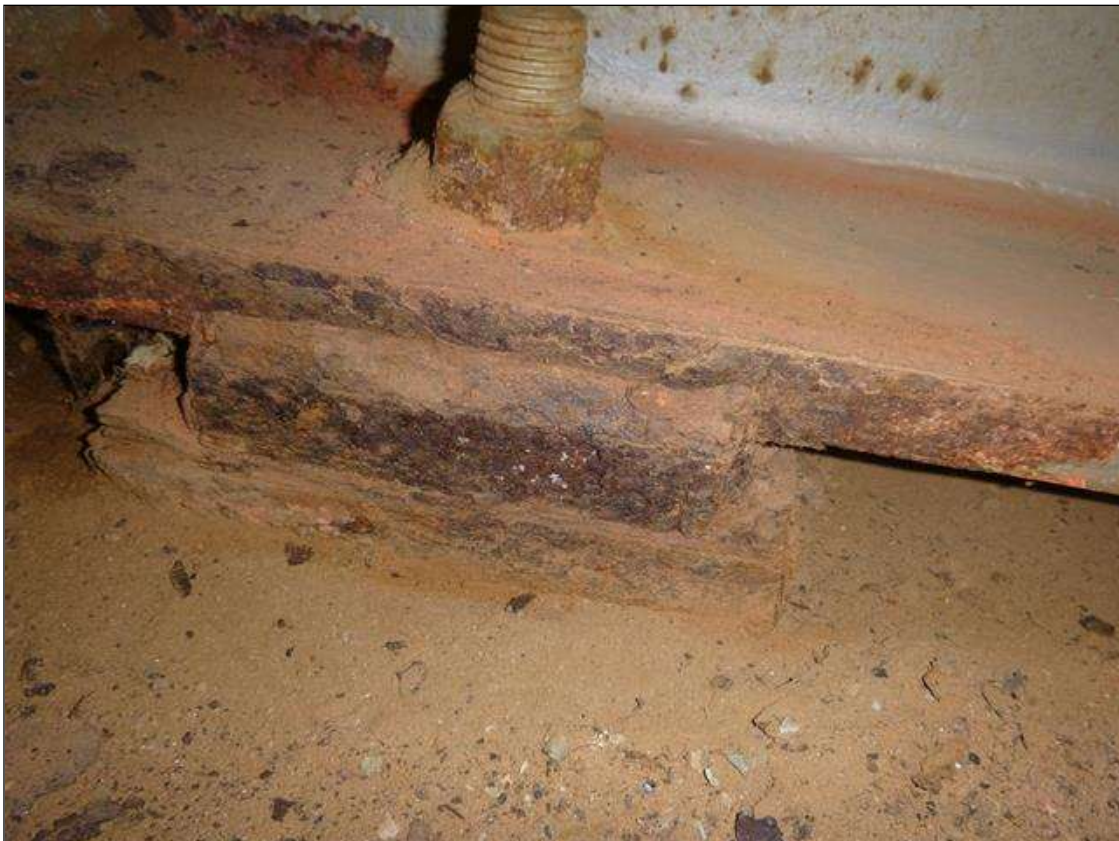
Span 3 Beam 9 Far Bearing: SPAN 3, BEAM 9 FAR BEARING HAS 1/32 INCH SECTION LOSS
