NC DEPARTMENT OF TRANSPORTATION  
DIVISION OF HIGHWAYS  
STRUCTURE MANAGEMENT UNIT

## Structure Safety Report

### Routine Element Inspection - Contract

COUNTY: HAYWOOD STRUCTURE NUMBER: 430159 FREQUENCY: 24 MONTHS  
FACILITY CARRIED: I-40 MILE POST: 18.7  
LOCATION: 1.8 MI.W.JCT.US276  
FEATURE INTERSECTED: SR1338  
LATITUDE: 35° 37' 31.64" LONGITUDE: 83° 0' 31.41"  
SUPERSTRUCTURE: REINFORCED CONCRETE FLOOR ON I-BEAMS

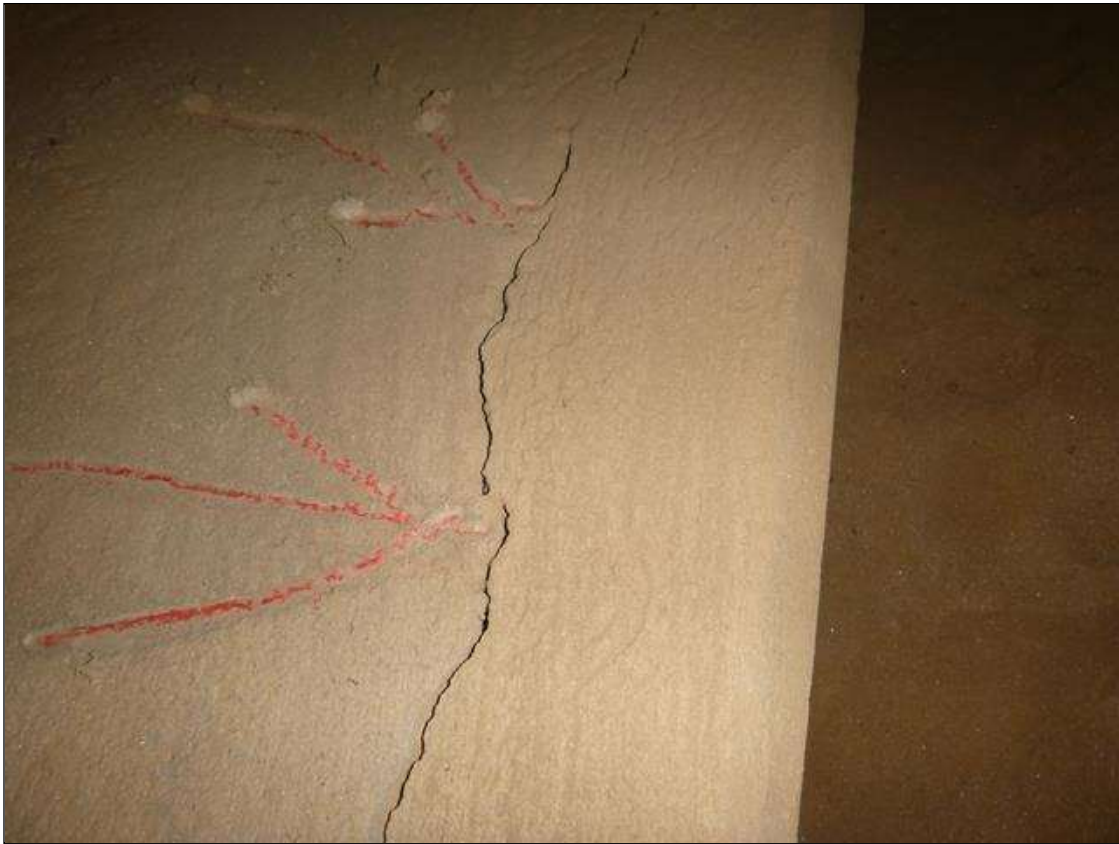
End Bent 2 Cap 1: END BENT 2 CAP IN BAY 8 HAS AN AREA OF DELAMINATION, 5 FT. LONG X 4 INCHES DOWN THE FACE X 5 INCHES ACROSS THE TOP WITH 3/16 INCH SEPARATION, PHOTO LOOKING AT TOP OF CAP

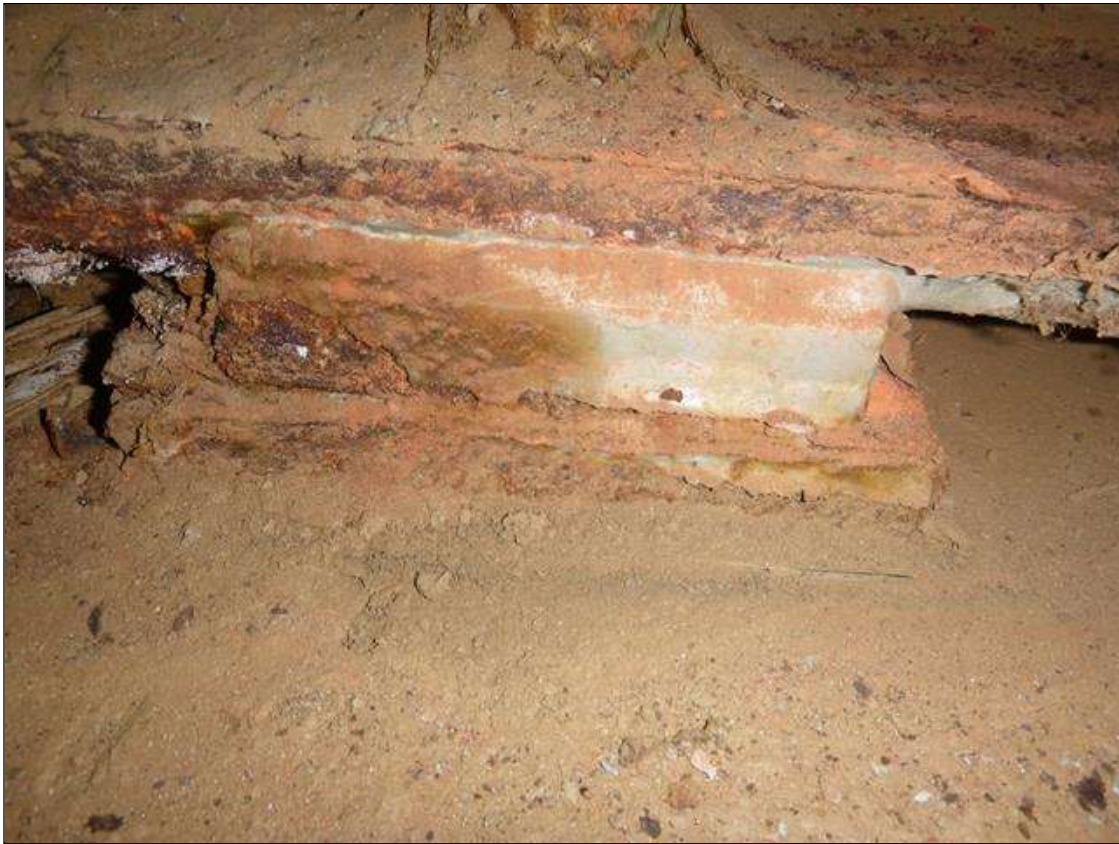
Span 3 Beam 8 Far Bearing: SPAN 3, BEAM 8 FAR BEARING HAS 1/32 INCH SECTION LOSS

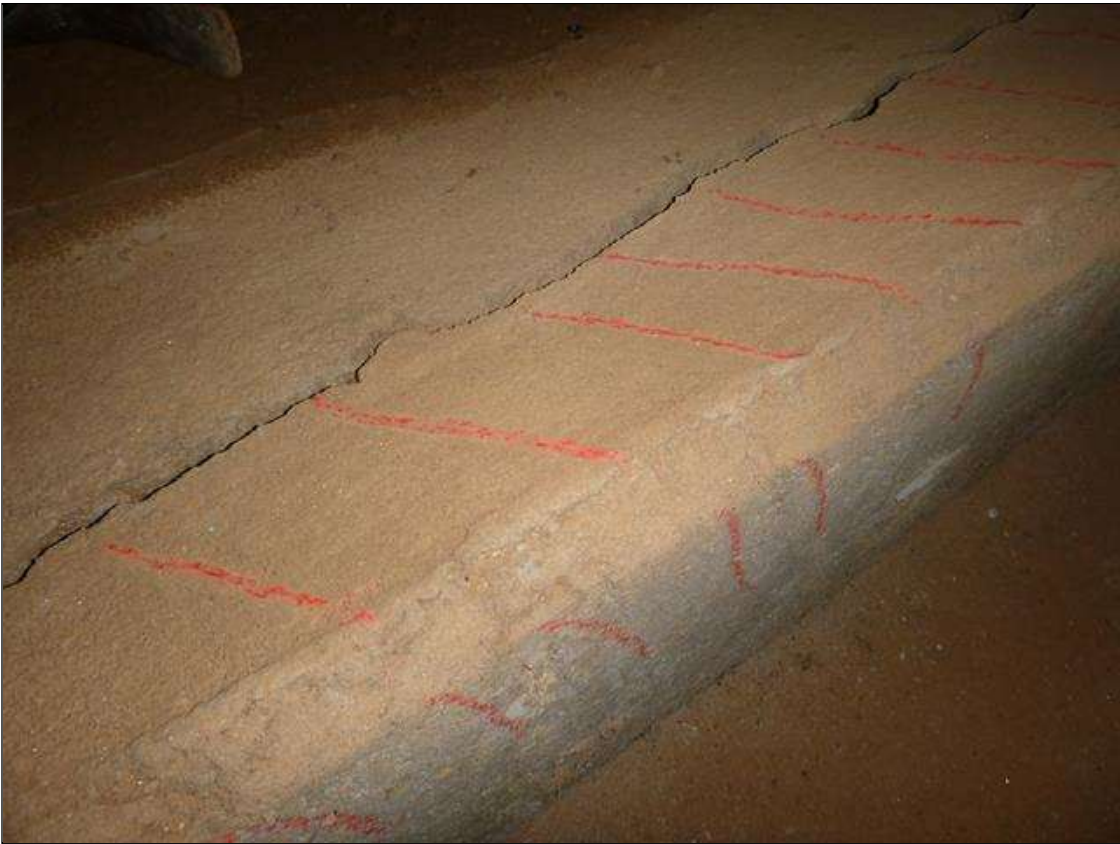
End Bent 2 Cap 1: END BENT 2 CAP IN BAY 4 HAS AN AREA OF DELAMINATION, 9 FT. LONG X 4 INCHES DOWN THE FACE X 4 INCHES ACROSS THE TOP WITH 3/8 INCH SEPARATION

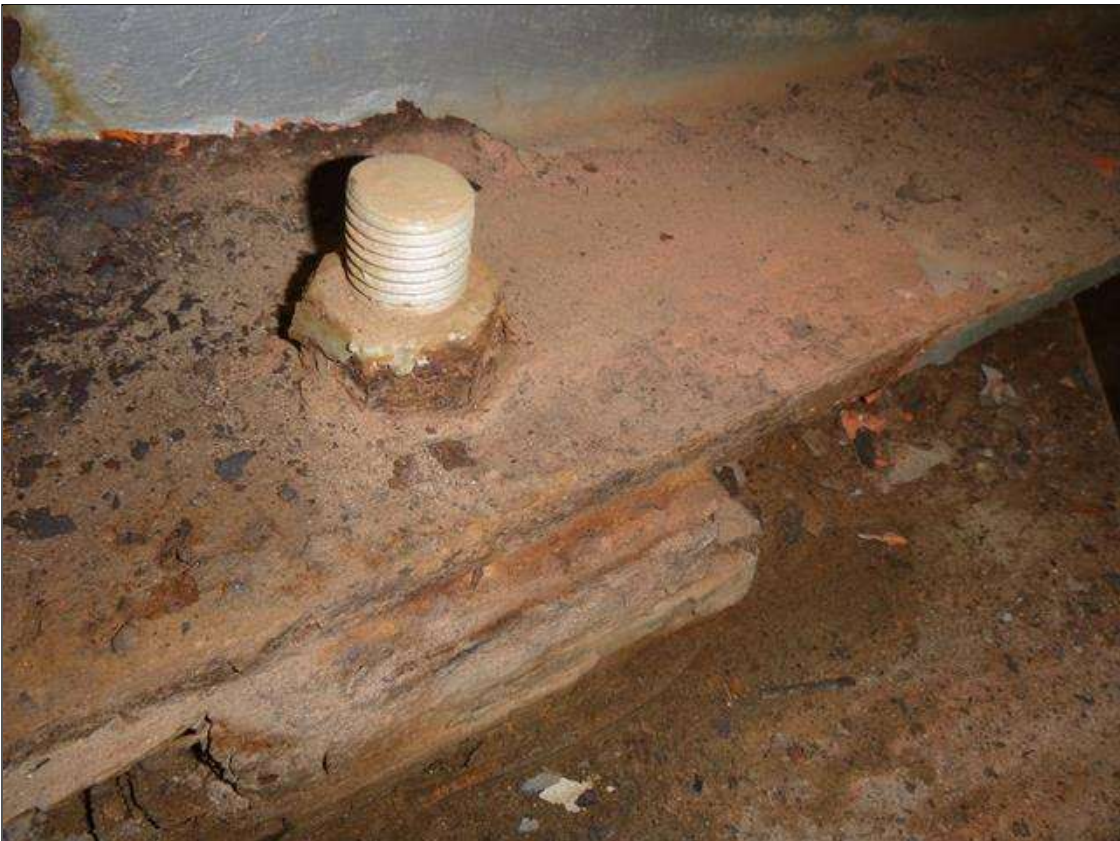
Span 3 Beam 4: SPAN 3, BEAM 4 AT END BENT 2 HAS 1/32 INCH SECTION LOSS ON THE BOTTOM FLANGE FROM THE CENTERLINE OF BEARING OUT 1 FT. X FULL WIDTH WITH 31/32 INCH REMAINING

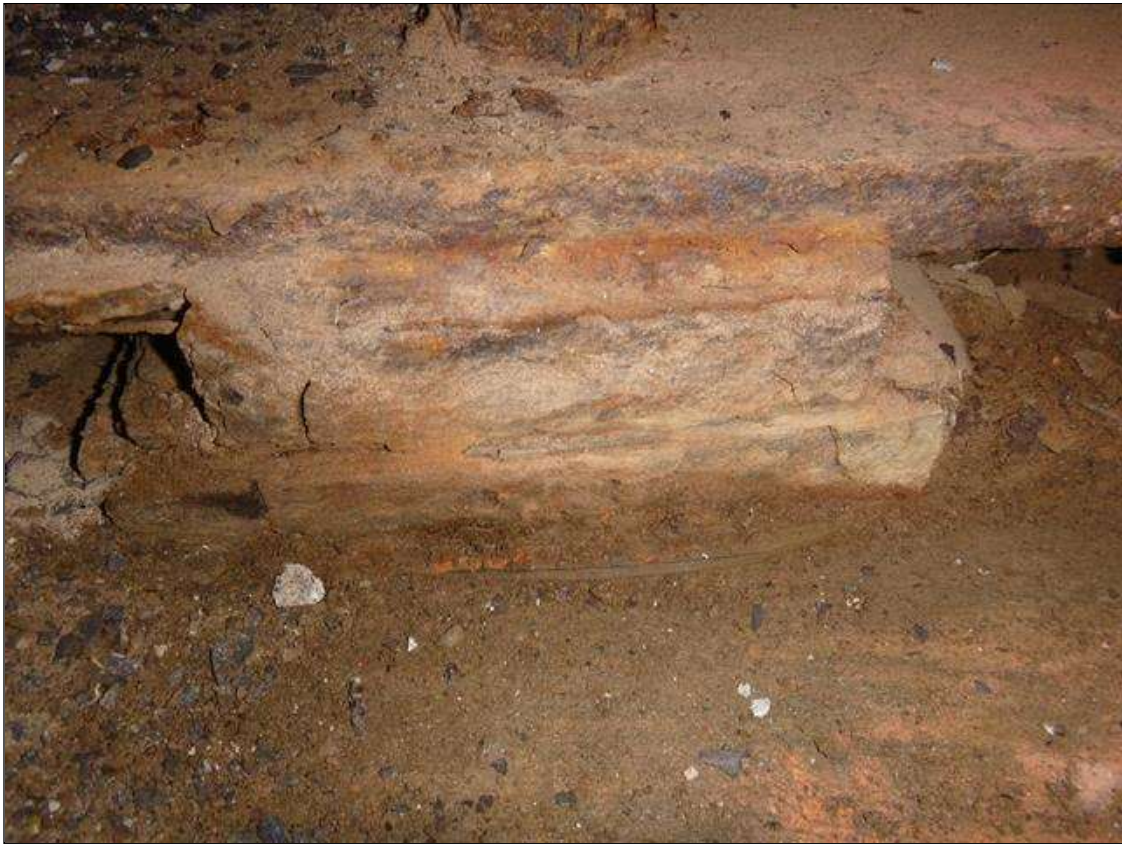
Span 3 Beam 4 Far Bearing: SPAN 3, BEAM 4 FAR BEARING HAS 1/32 INCH SECTION LOSS

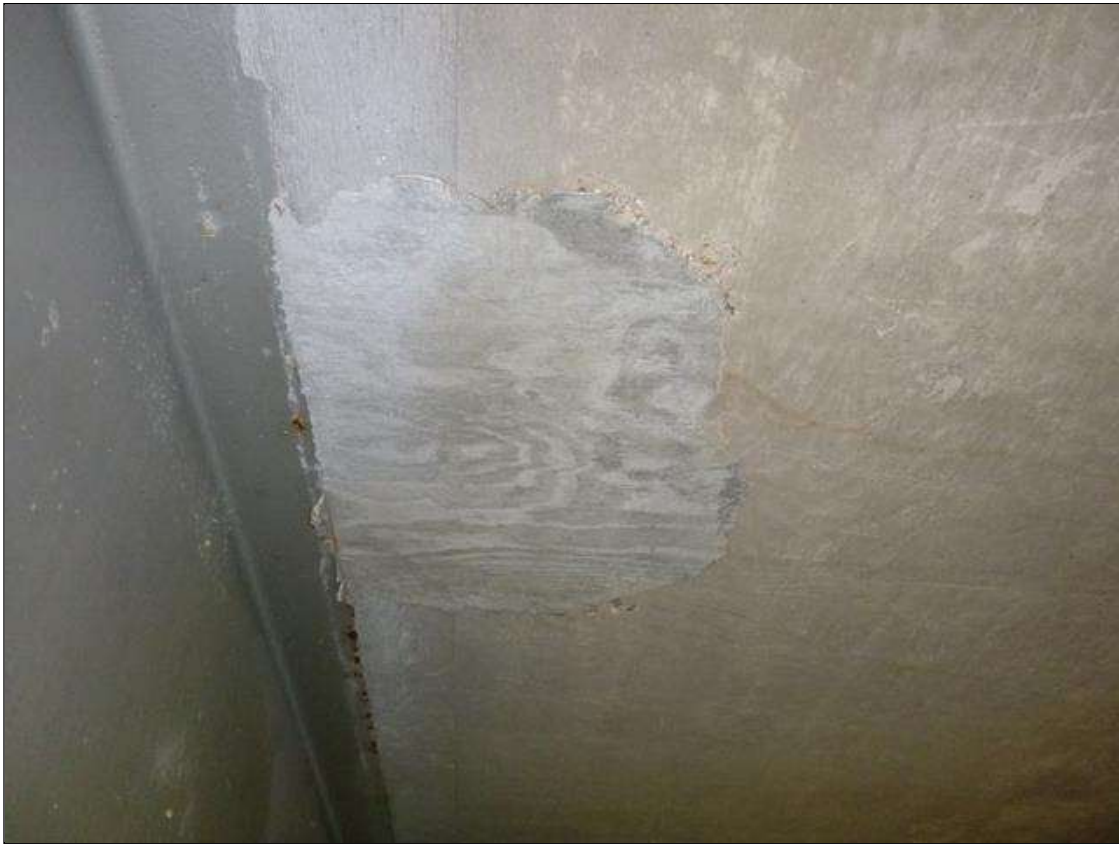
Span 3 Deck: SPAN 3 BOTTOM OF BAY 2 DECK HAS A 16 INCH X 24 INCH PATCHED AREA AT MID-SPAN FOR A TOTAL OF 100 SQ. FT. OF PATCHES THRU OUT THE BOTTOM OF THE SPAN

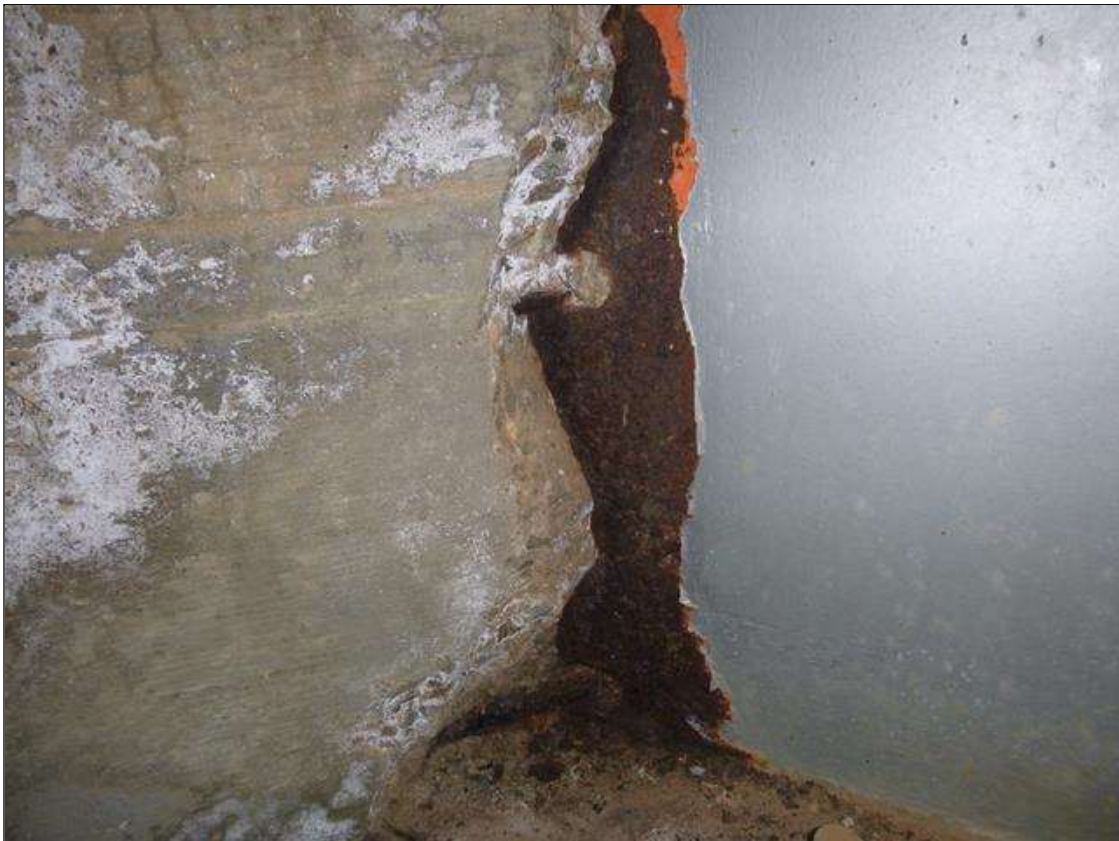
End Bent 2 Abutment/Backwall : END BENT 2 ABUTMENT HAS A SPALL ADJACENT TO BEAM 3, 24 INCHES HIGH X 7 INCHES WIDE X 4 INCHES DEEP IN BAY 2

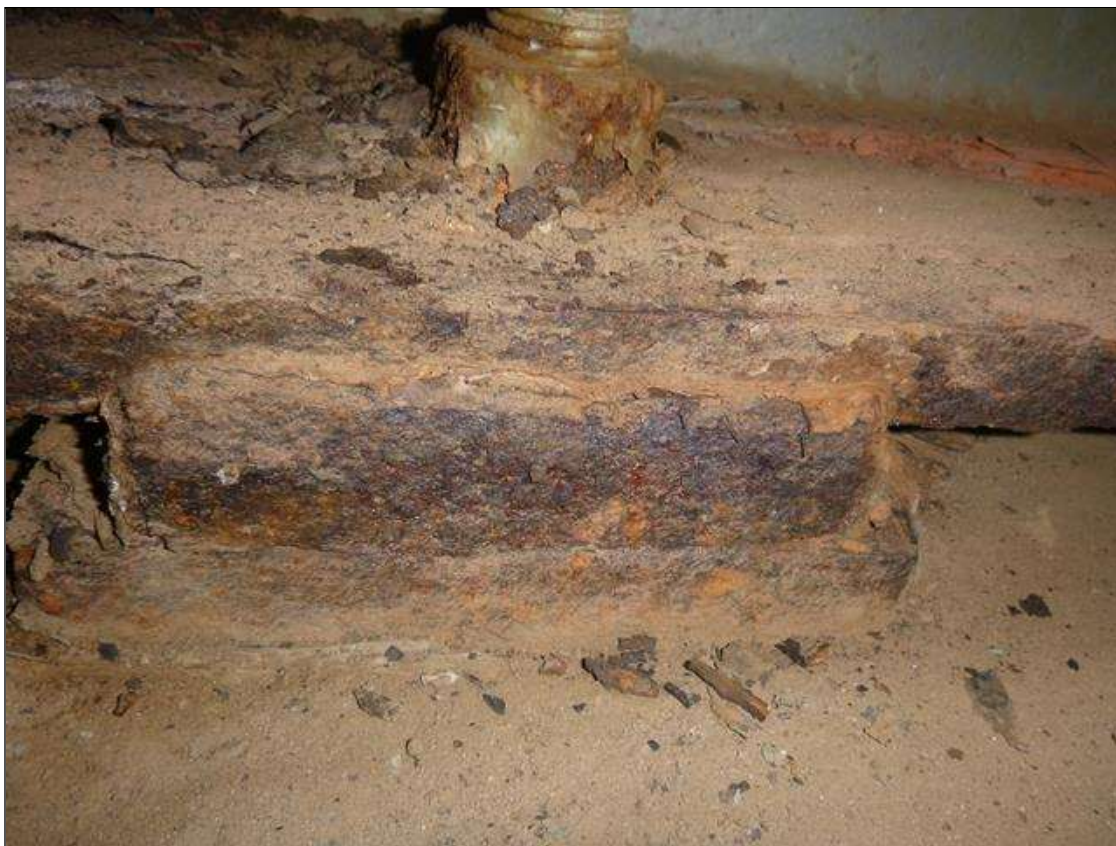
Span 3 Beam 3 Far Bearing: SPAN 3, BEAM 3 FAR BEARING HAS 1/32 INCH SECTION LOSS

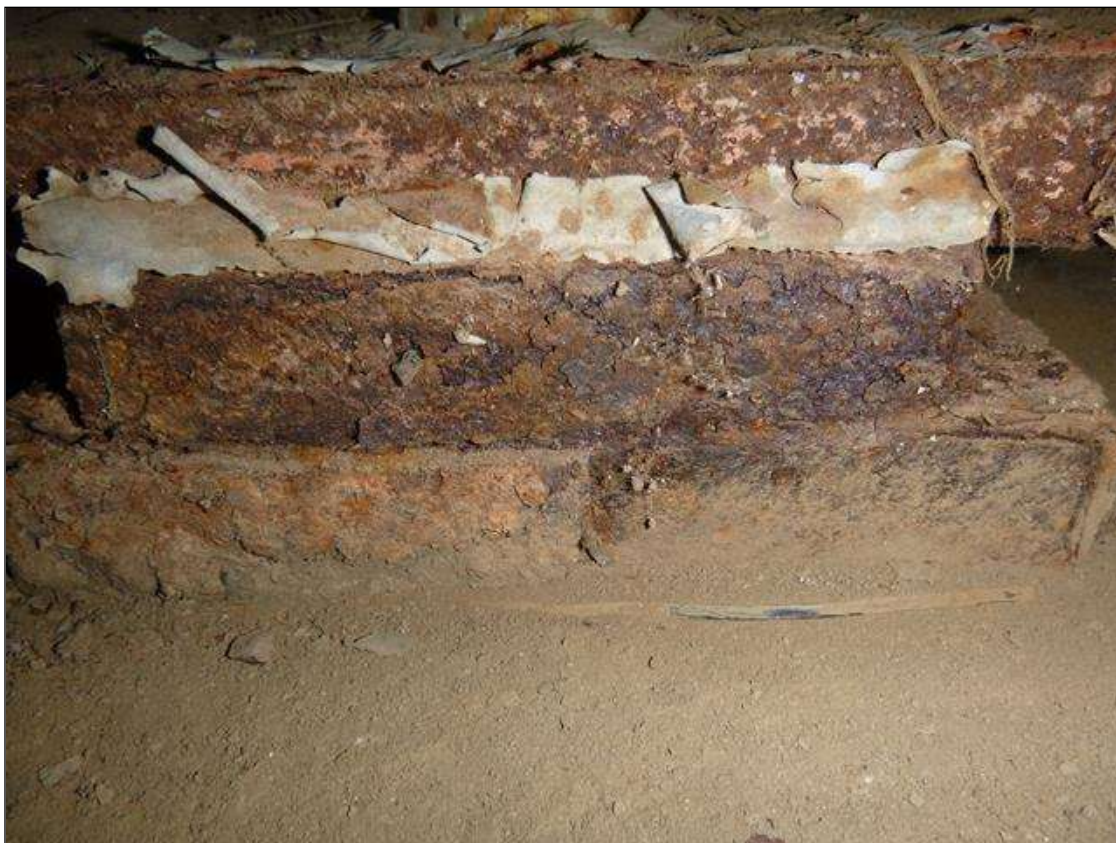
Span 3 Beam 2 Far Bearing: SPAN 3, BEAM 2 FAR BEARING HAS 1/32 INCH SECTION LOSS

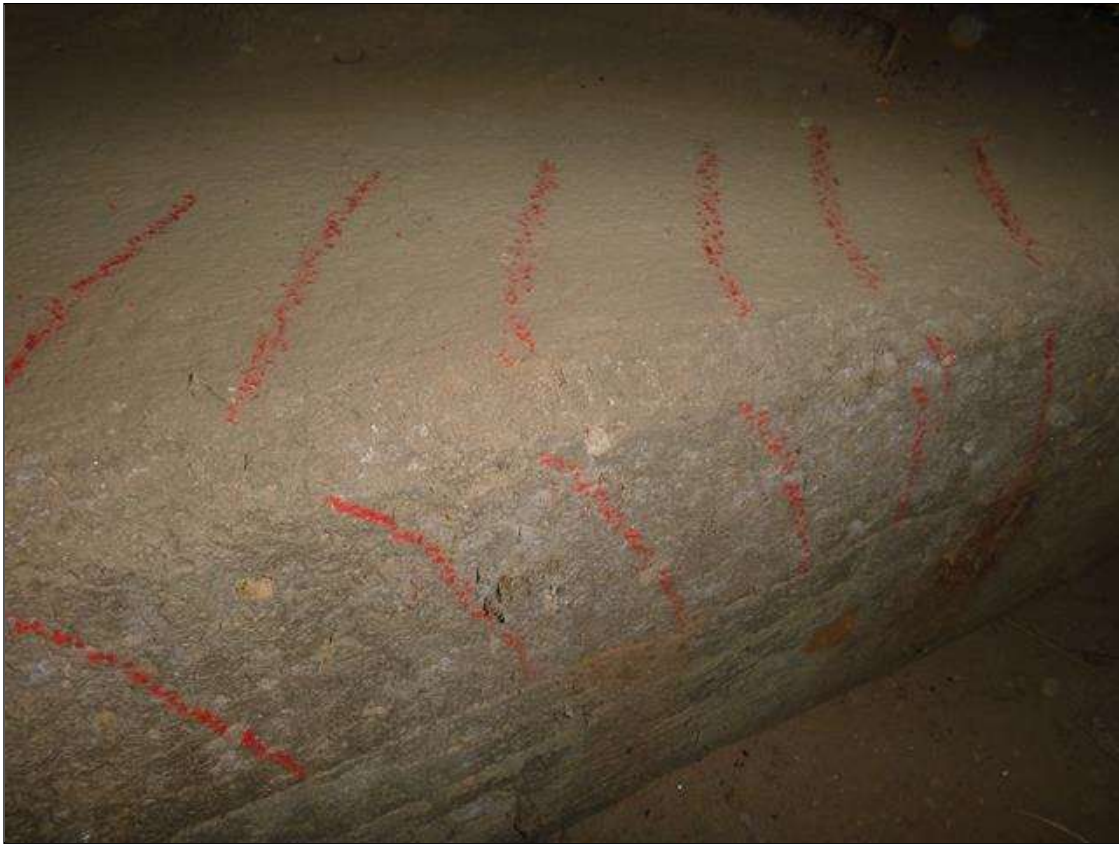
End Bent 2 Cap 1: END BENT 2 CAP HAS AN AREA OF DELAMINATION IN THE TOP AND FACE IN BAY 1, NEAR BEAM 2, 3FT. LONG X 5 INCHES DOWN THE FACE AND 5 INCHES ACROSS THE TOP WITH 1/8 INCH SEPARATION

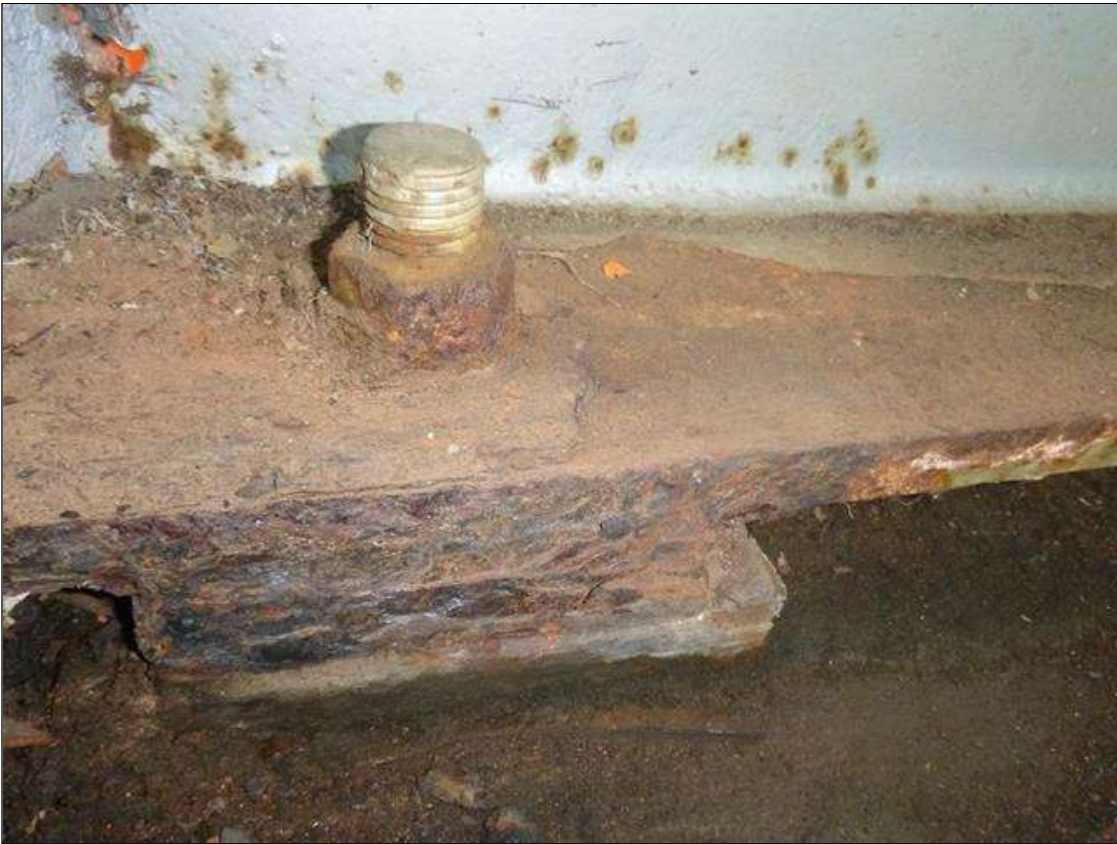
Span 3 Beam 1: SPAN 3, BEAM 1 AT END BENT 2 HAS 1/32 INCH SECTION LOSS ON THE BOTTOM FLANGE FROM THE CENTERLINE OF BEARING OUT 1 FT. X FULL WIDTH WITH 31/32 INCH REMAINING

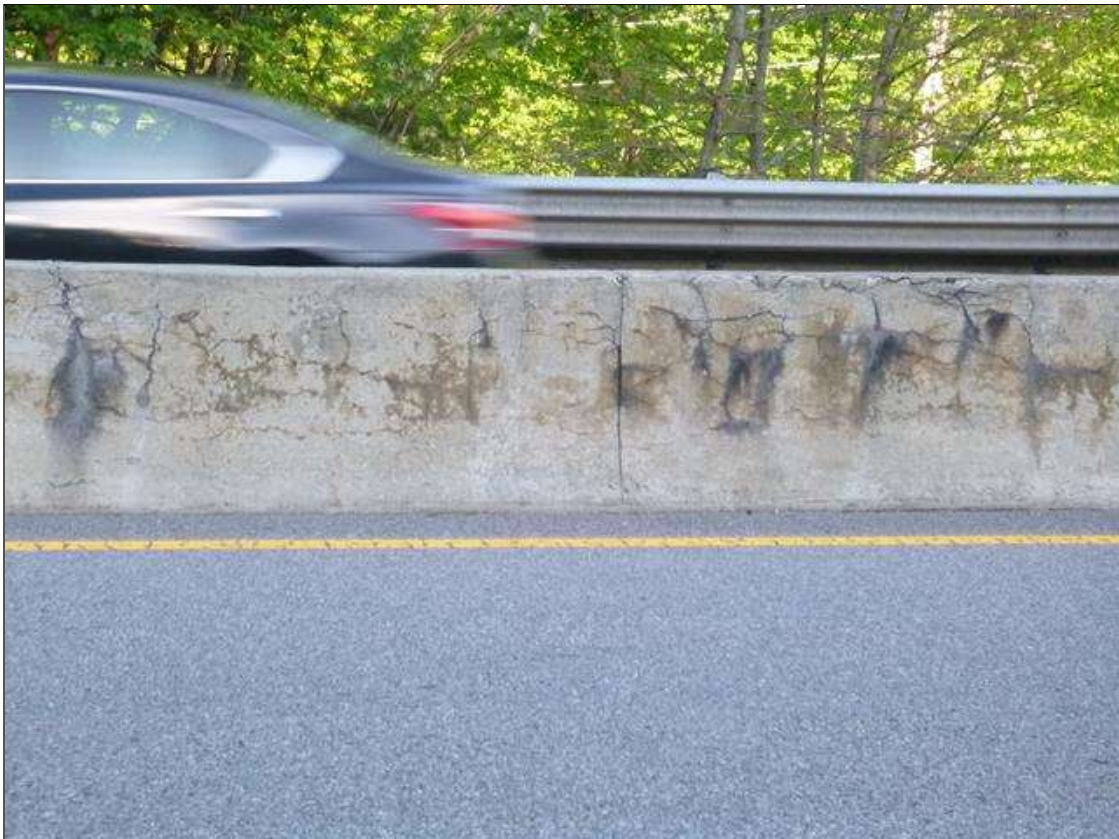
Span 1 Median Rail: SPAN 1 MEDIAN RAIL HAS 38 FT. OF HAIRLINE TO 1/16 INCH WIDE MAP CRACKING THRU OUT RAIL

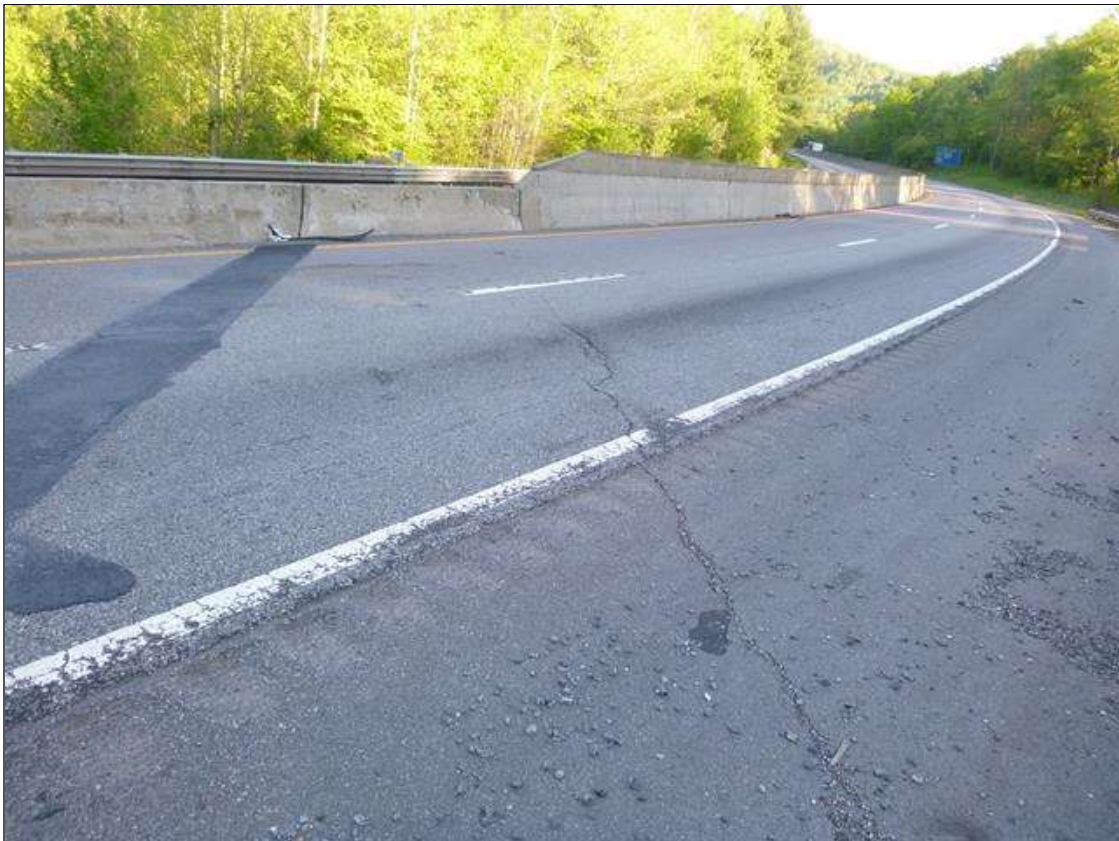
Span 3 Median Rail: SPAN 3 MEDIAN RAIL HAS 75 FT. OF HAIRLINE TO 1/16 INCH WIDE MAP CRACKING THRU OUT RAIL

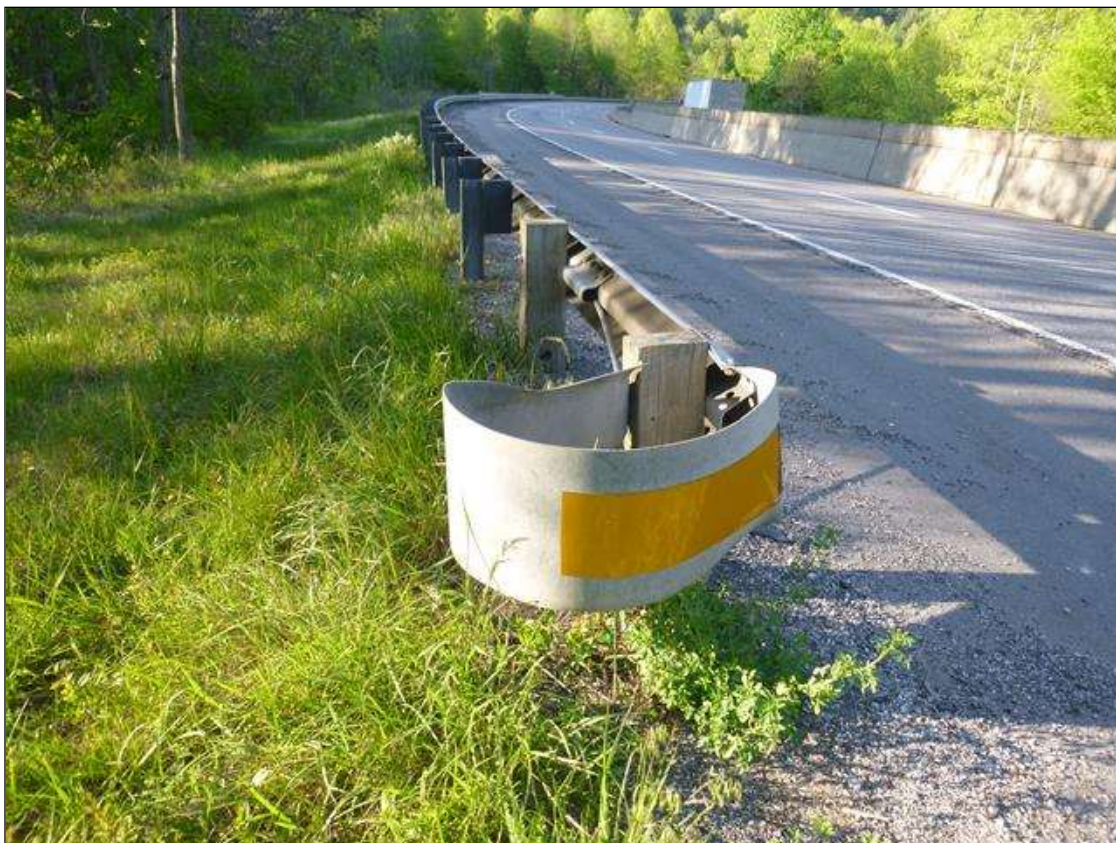
APPROACH GUARDRAIL END AT THE SOUTHWEST CORNER

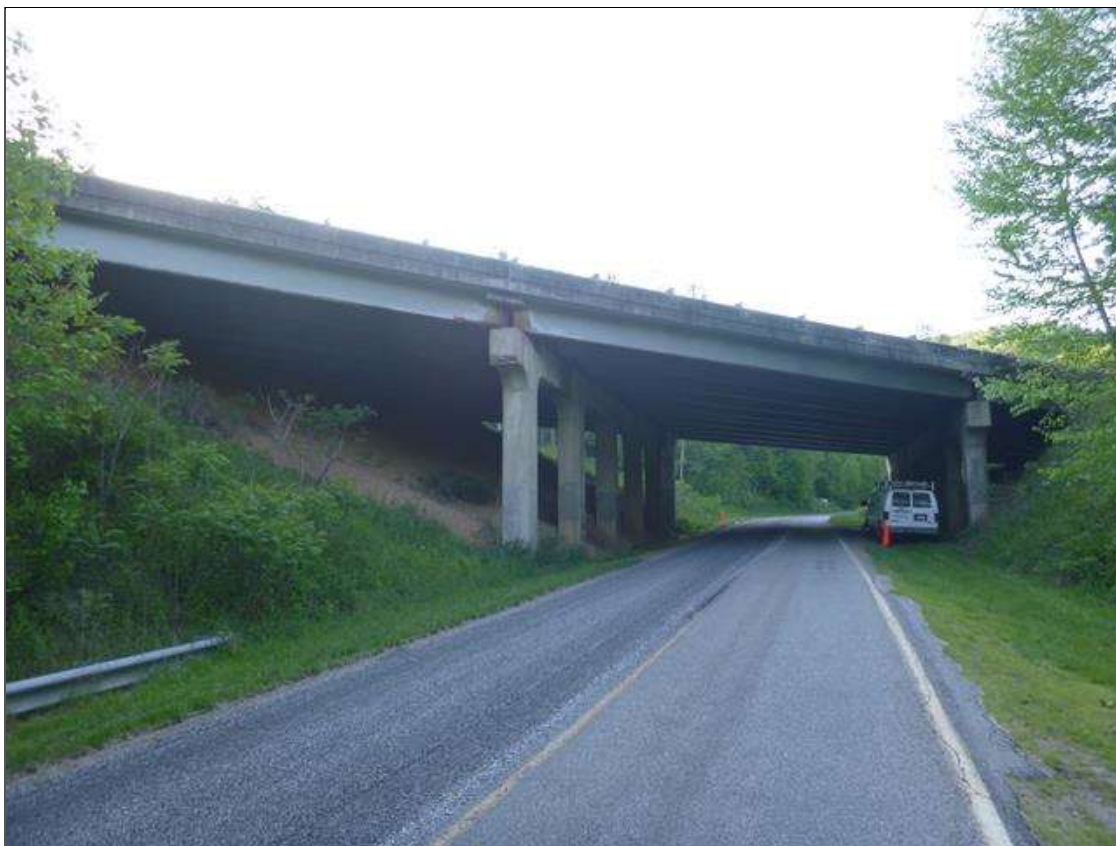
LEFT SIDE OF BRIDGE LOOKING SOUTH

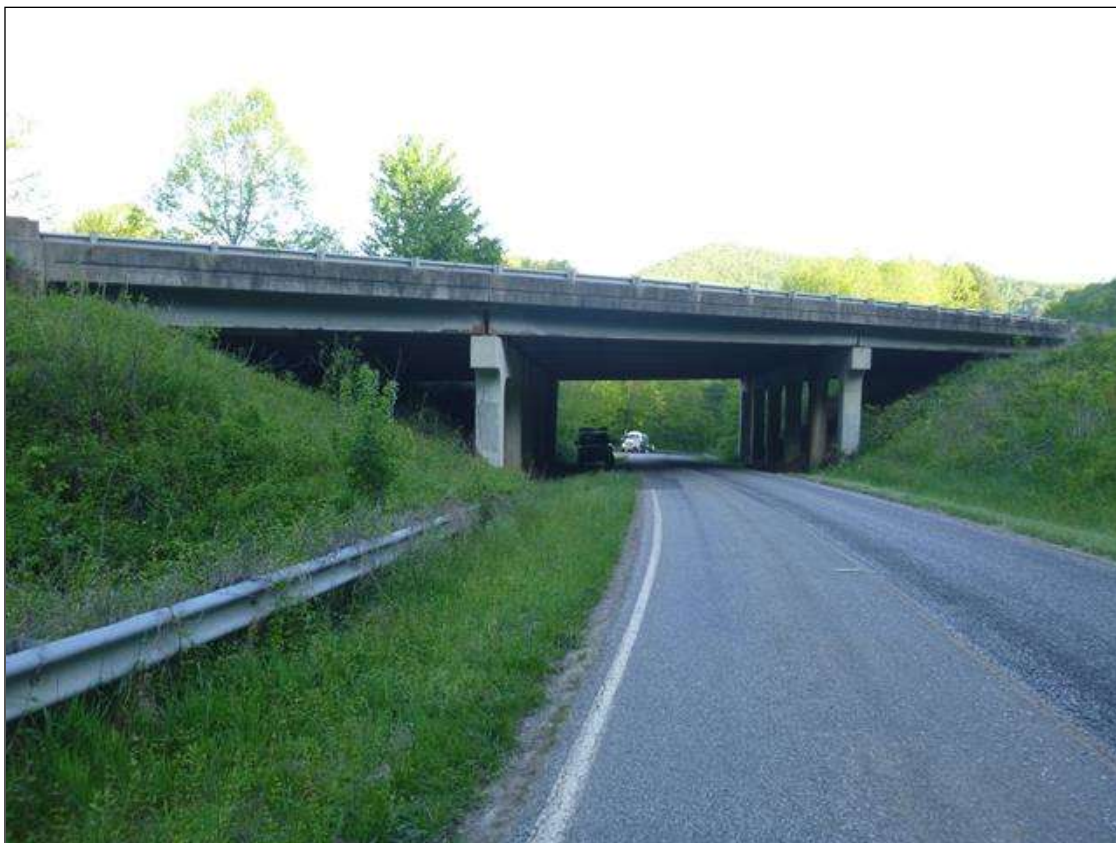
RIGHT SIDE OF BRIDGE LOOKING NORTH
