NC DEPARTMENT OF TRANSPORTATION  
DIVISION OF HIGHWAYS  
STRUCTURE MANAGEMENT UNIT

# Structure Safety Report

## Municipal Routine Element Inspection - Contract

DIVISION: 6 COUNTY: CUMBERLAND STRUCTURE NUMBER: 250211 FREQUENCY: 24 MONTHS

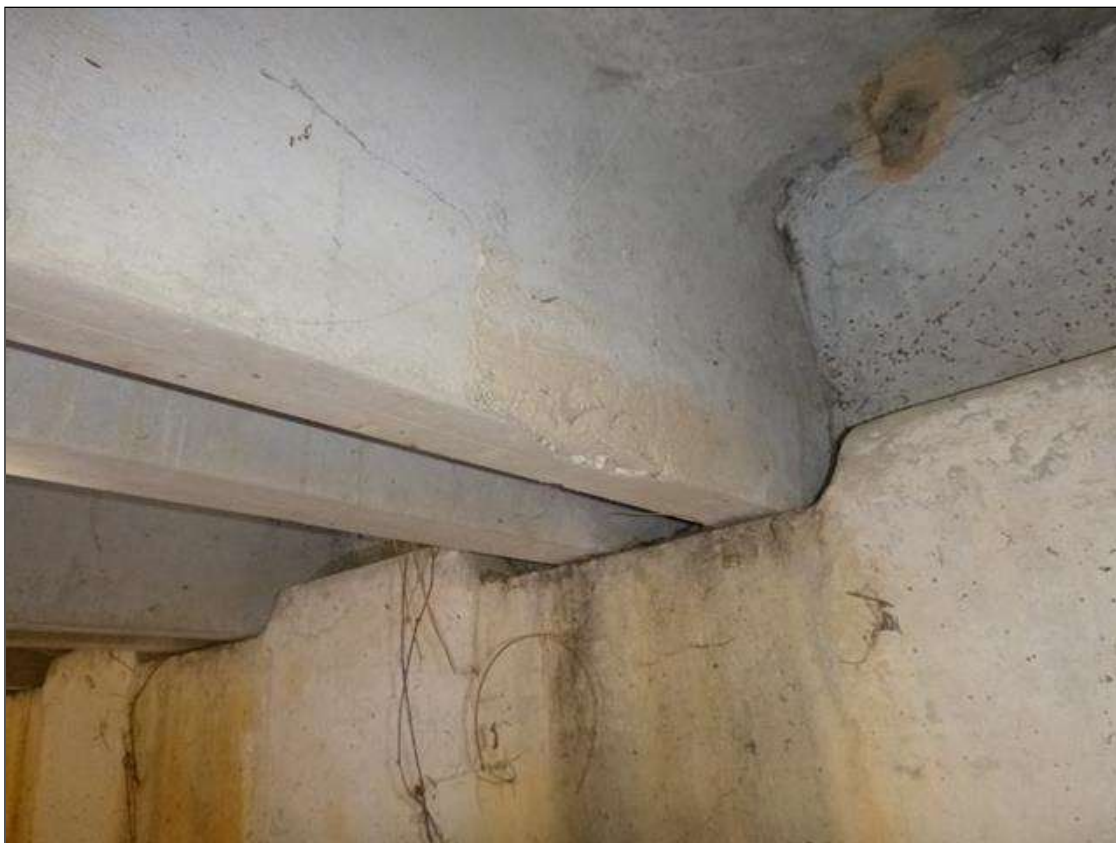
Span 1 Slab 7: 6" X 2" X 1" PATCHED AREA ALONG BOTTOM INSIDE FACE OF LEG 2, AT END BENT 1.

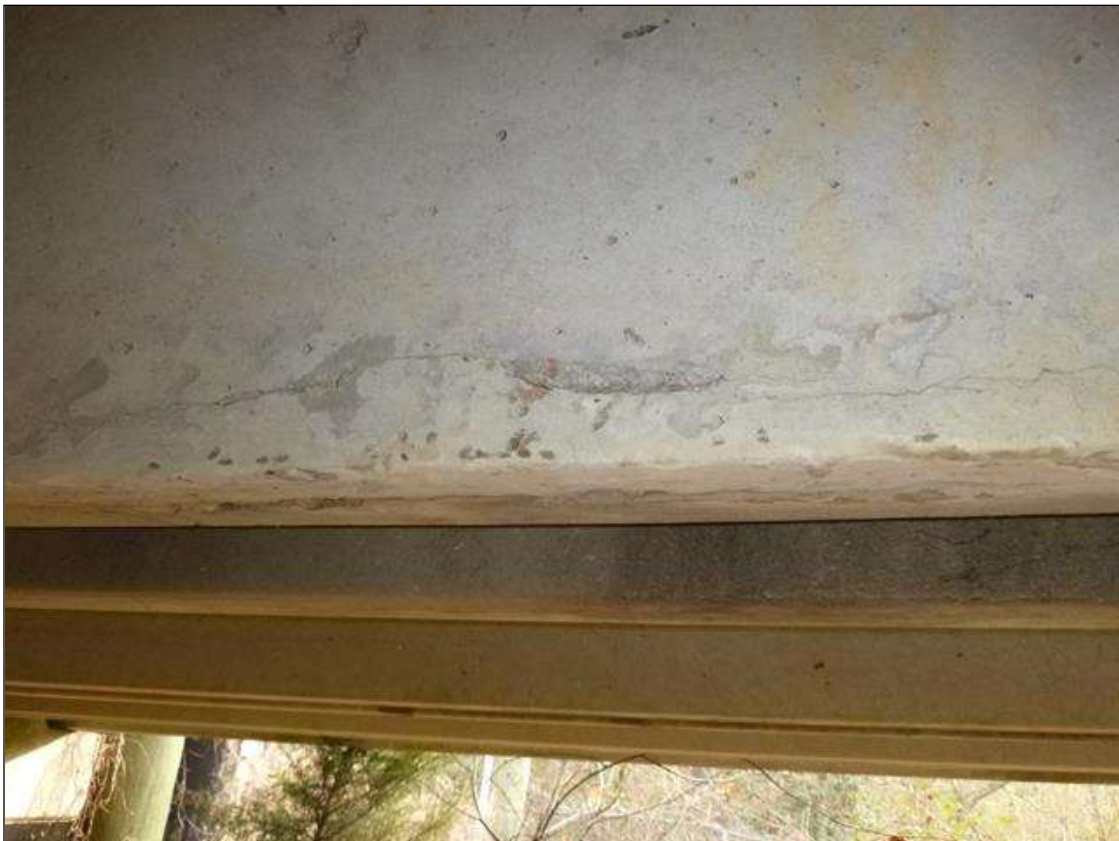
Span 3 Slab 9: 16" X 2" X 2" DELAMINATION, BOTTOM OF LEG 2, 7' FROM END BENT 2.

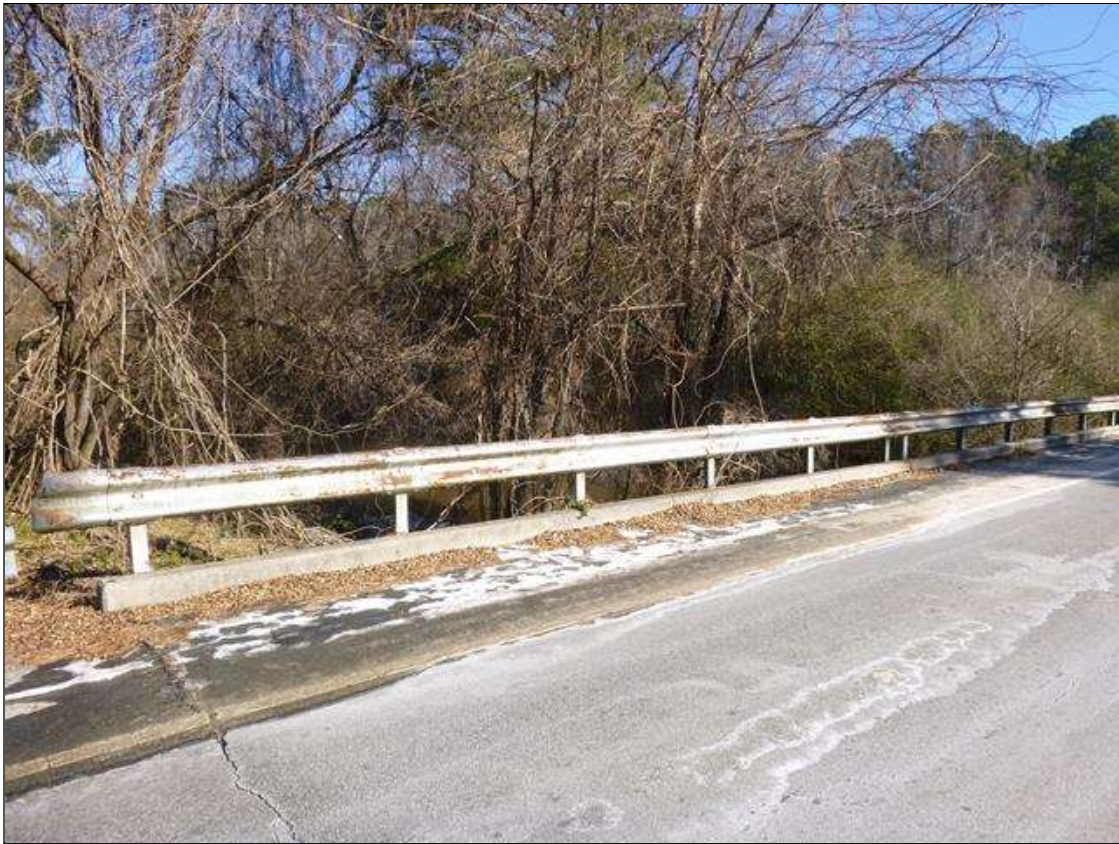
NORTH BRIDGE RAIL

| Element Number | Defect Type | Defect Description | CS | CS Qty | Maint Qty | |
|---|---|---|---|---|---|---|
| 330 | Corrosion | 31' OF SURFACE RUST ALONG RAIL. | 2 | 31 | | Square Feet |

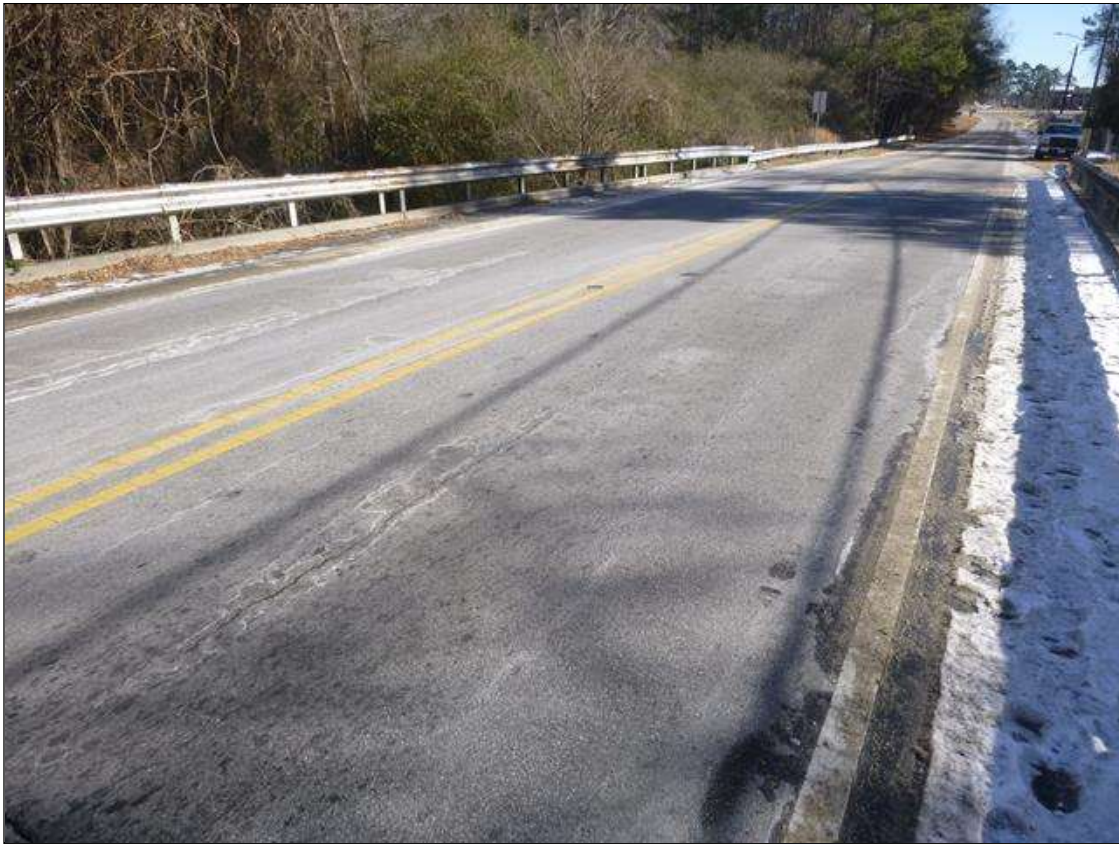
ASPHALT WEARING SURFACE, SPAN 1, LOOKING EAST

| Element Number | Defect Type | Defect Description | CS | CS Qty | Maint Qty | |
|---|---|---|---|---|---|---|
| 510 | Crack (Wearing Surface) | (8) 31' REFLECTIVE LONGITUDINAL CRACKS UP TO 1/8", THROUGHOUT TRAVEL LANES. | 3 | 248 | 248 | Square Feet |
| 510 | Crack (Wearing Surface) | 30' TRANSVERSE CRACK UP TO 1/4", OVER END BENT 1. | 3 | 30 | 30 | Square Feet |

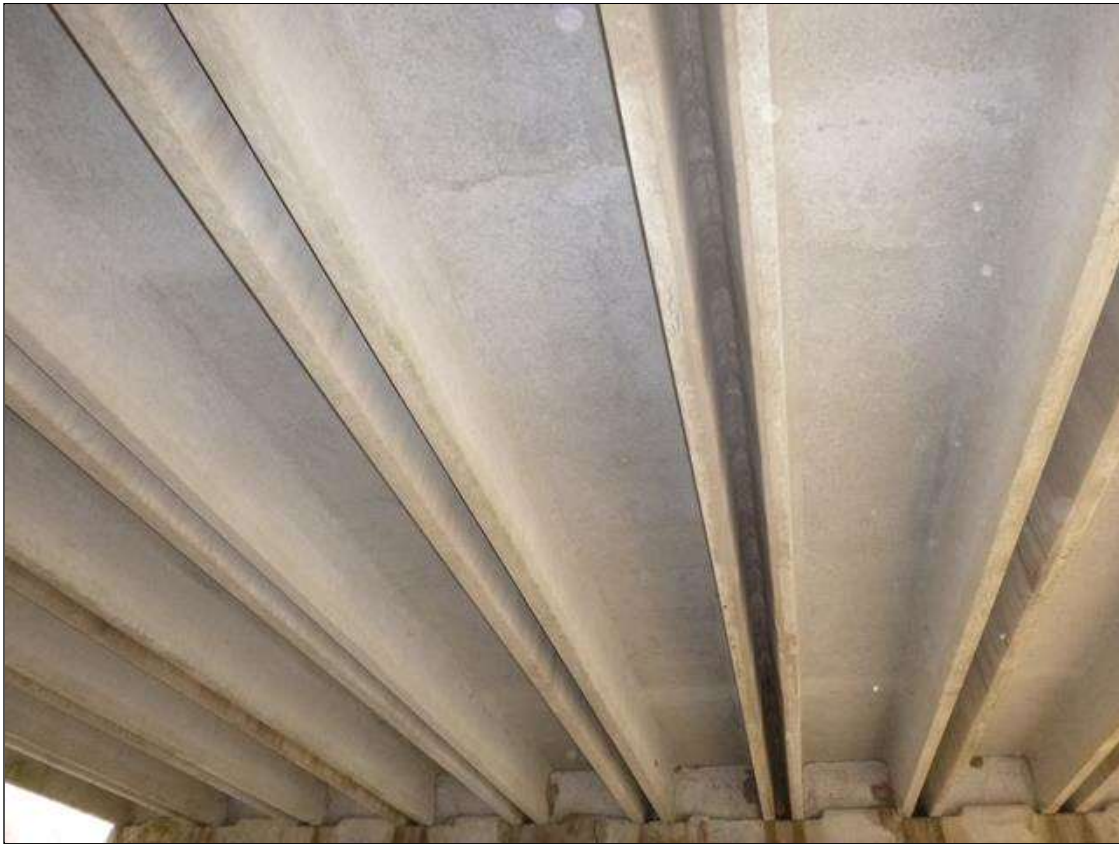
SUPERSTRUCTURE UNDERSIDE, SPAN 1, LOOKING EAST

| Element Number | Defect Type | Defect Description | CS | CS Qty | Maint Qty | |
|---|---|---|---|---|---|---|
| 109 | Delamination/Spall | (9) 2" X UP TO 10" X 1/4" SPALLS WITH EXPOSED REINFORCING, AT RANDOM ALONG UNDERSIDE OF TOP SLAB. | 2 | 9 | 9 | Feet |
