NC DEPARTMENT OF TRANSPORTATION  
DIVISION OF HIGHWAYS  
STRUCTURE MANAGEMENT UNIT

## Structure Safety Report

### Routine Element Inspection - Contract

COUNTY: YADKIN STRUCTURE NUMBER: 980010 FREQUENCY: 24 MONTHS

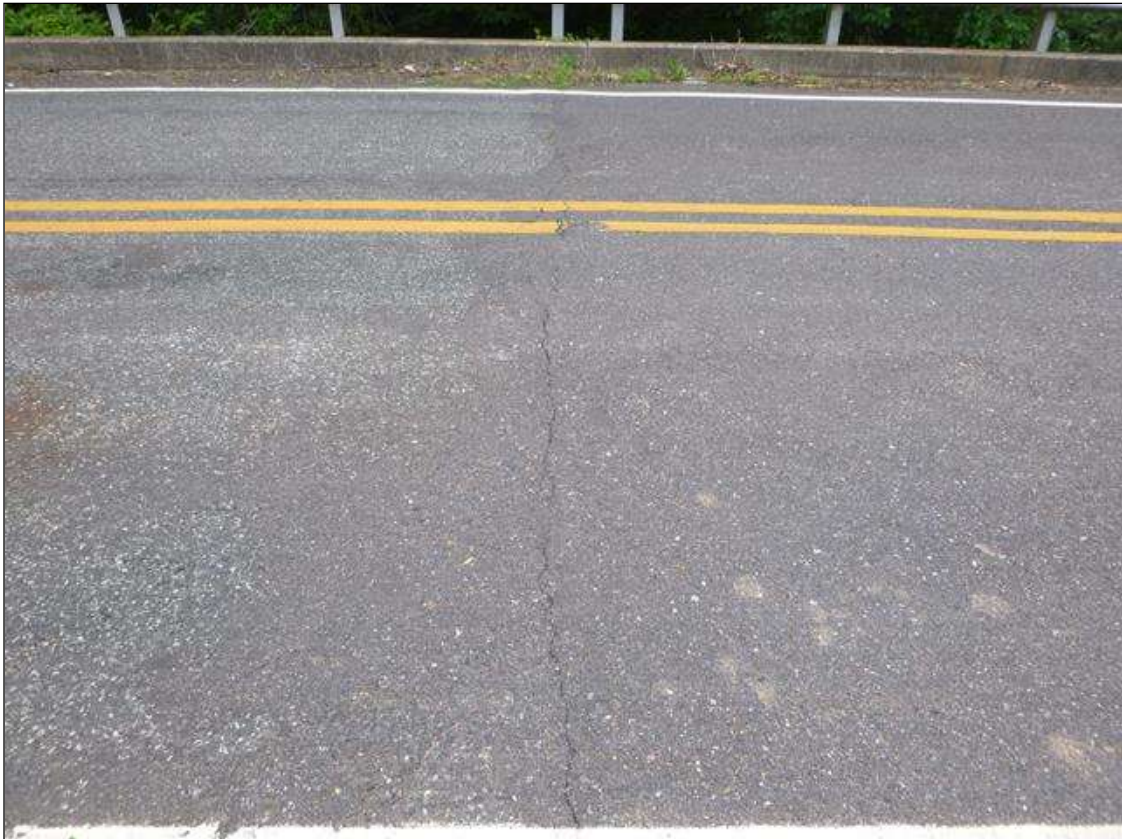
Span 4 Wearing Surface: 20 Square Feet of Crack (Wearing Surface): Width of more than 0.05 in. or spacing of less than 1.0 ft. Transverse crack at bent 4.

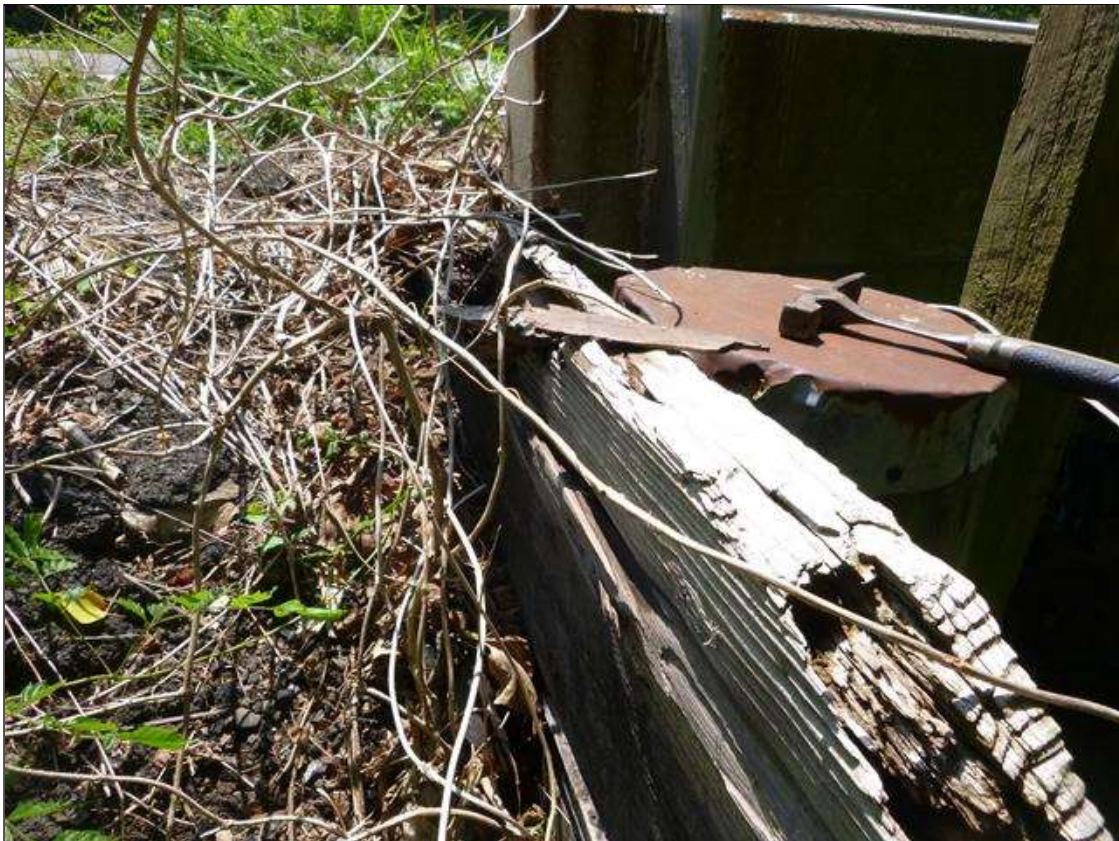
End Bent 1 Abutment/Backwall : 4 Feet of Decay/Section Loss: Affects 10% or more of the member but does not warrant structural review. Top bulkhead board decayed on right side end bent 1.

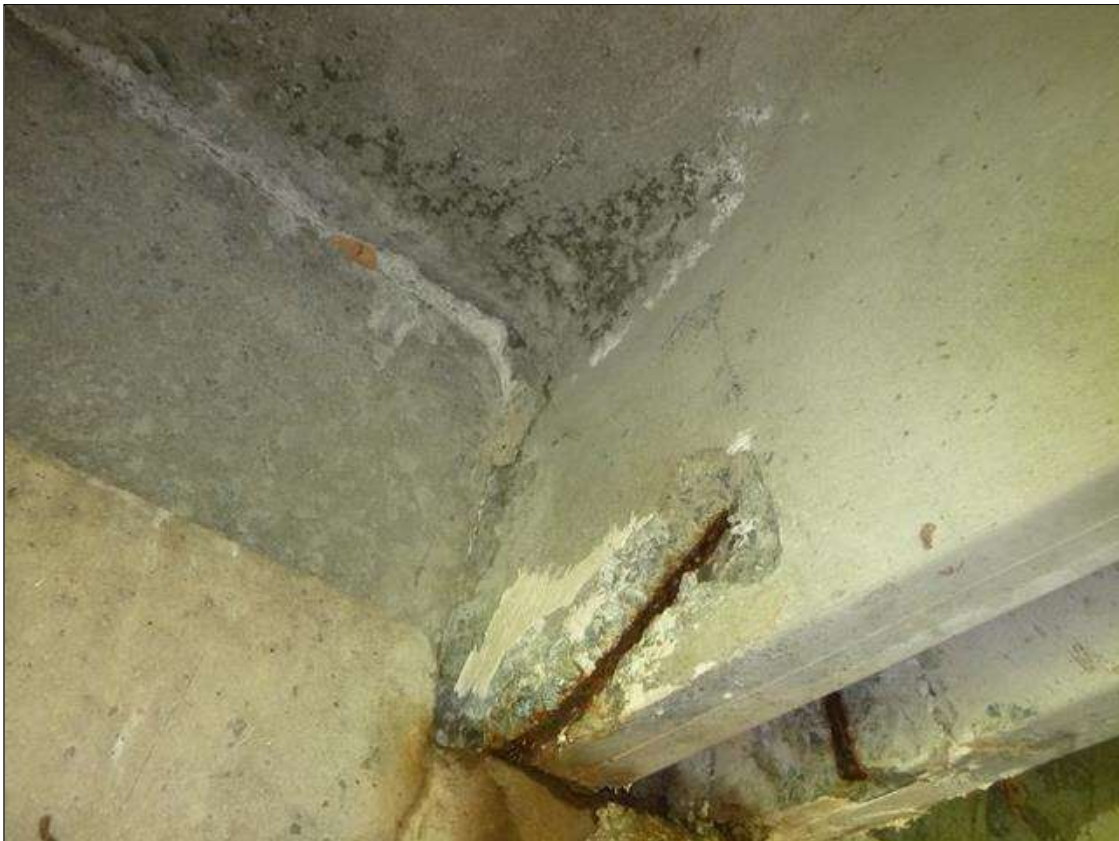
1 Feet of Delamination/Spall/Patched Area: Delaminated. Spall 1 in. or less deep or 6 in. or less in diameter. 8" x 2" x 1/2" deep with exposed rebar in bottom of right leg at bent 1.

Span 1 Channel/Slab 4: 1 Feet of Delamination/Spall/Patched Area: Delaminated. Spall 1 in. or less deep or 6 in. or less in diameter. 8" x 2" x 1/2" deep with exposed rebar in bottom of right leg at bent 1.

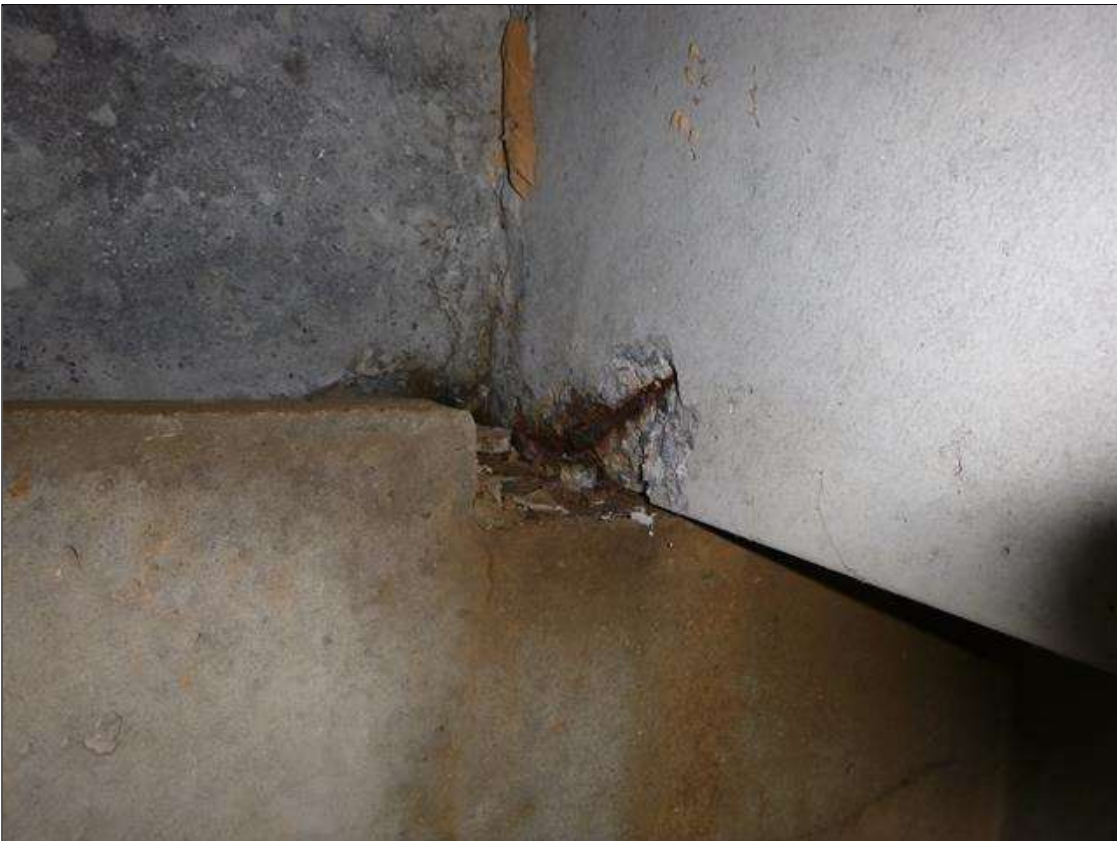
1 Feet of Delamination/Spall/Patched Area: Delaminated. Spall 1 in. or less deep or 6 in. or less in diameter. 5" x 3" x 1/2" deep spall in bottom of left leg at end bent 1.

Span 1 Channel/Slab 6: 1 Feet of Delamination/Spall/Patched Area: Delaminated. Spall 1 in. or less deep or 6 in. or less in diameter. 5" x 3" x 1/2" deep spall in bottom of left leg at end bent 1.

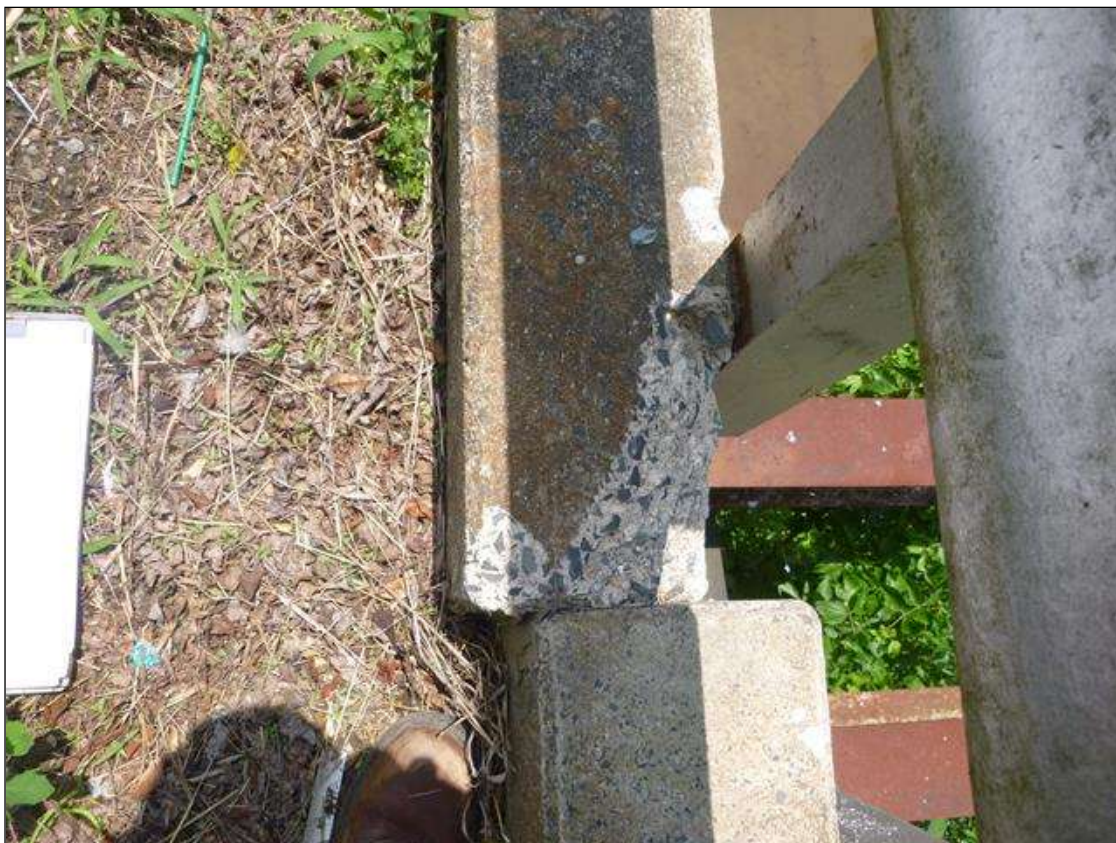
Span 3 : 6" x 9" x 3" deep spall on left curb at bent 3

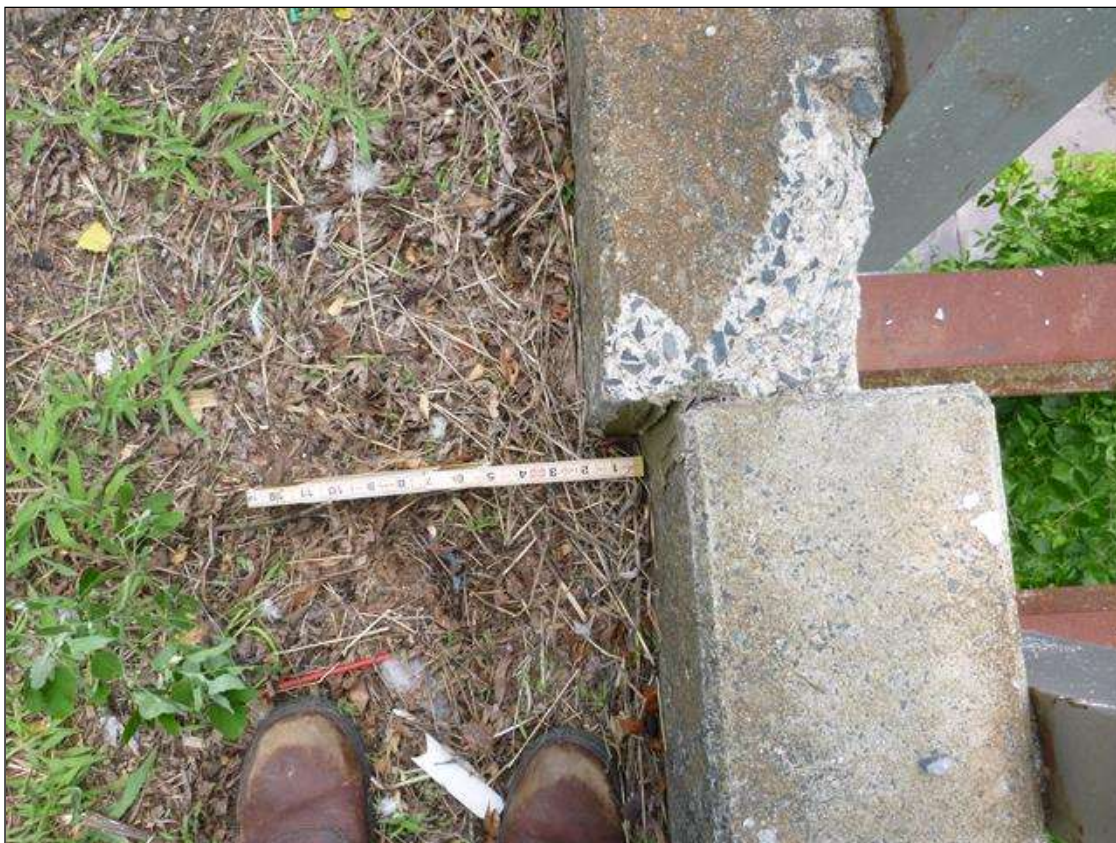
Span 4 : Curb misaligned 1 3/4" towards to west at left curb at bent 3

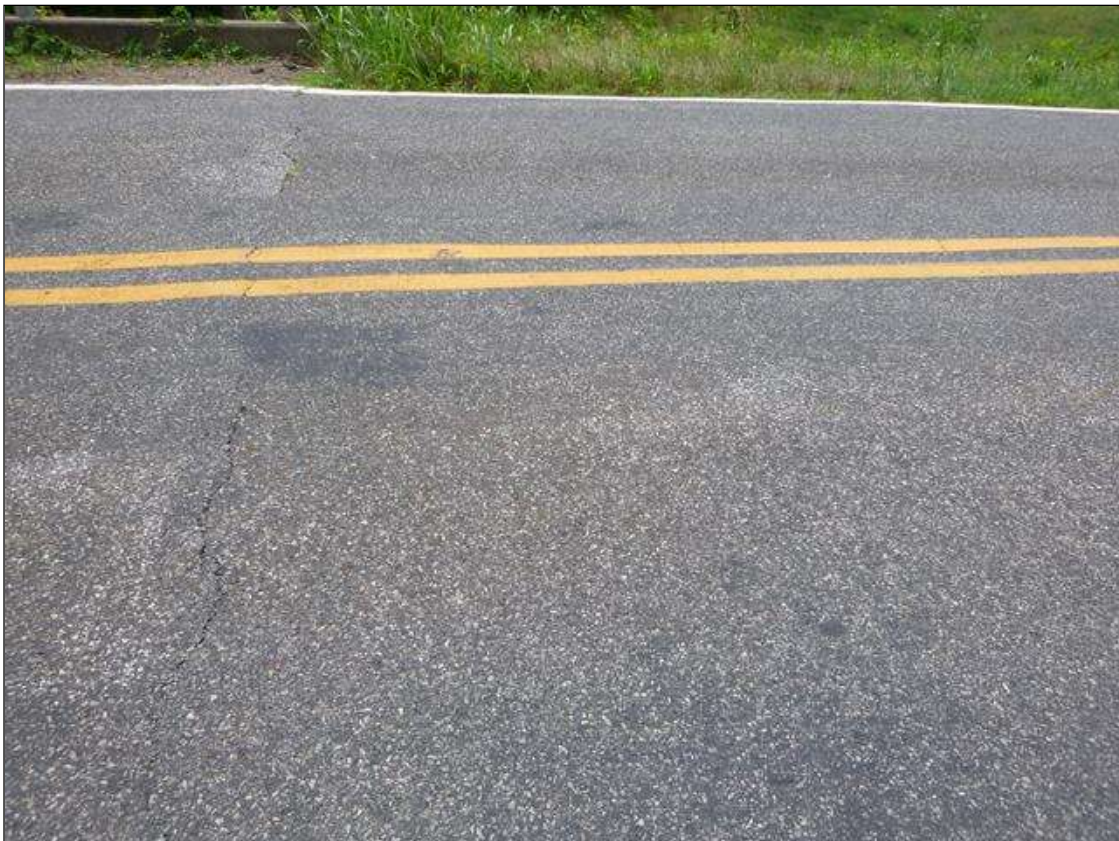
ASPHALT WEARING SURFACE SETTLED 3/8" AT NORTH APPROACH

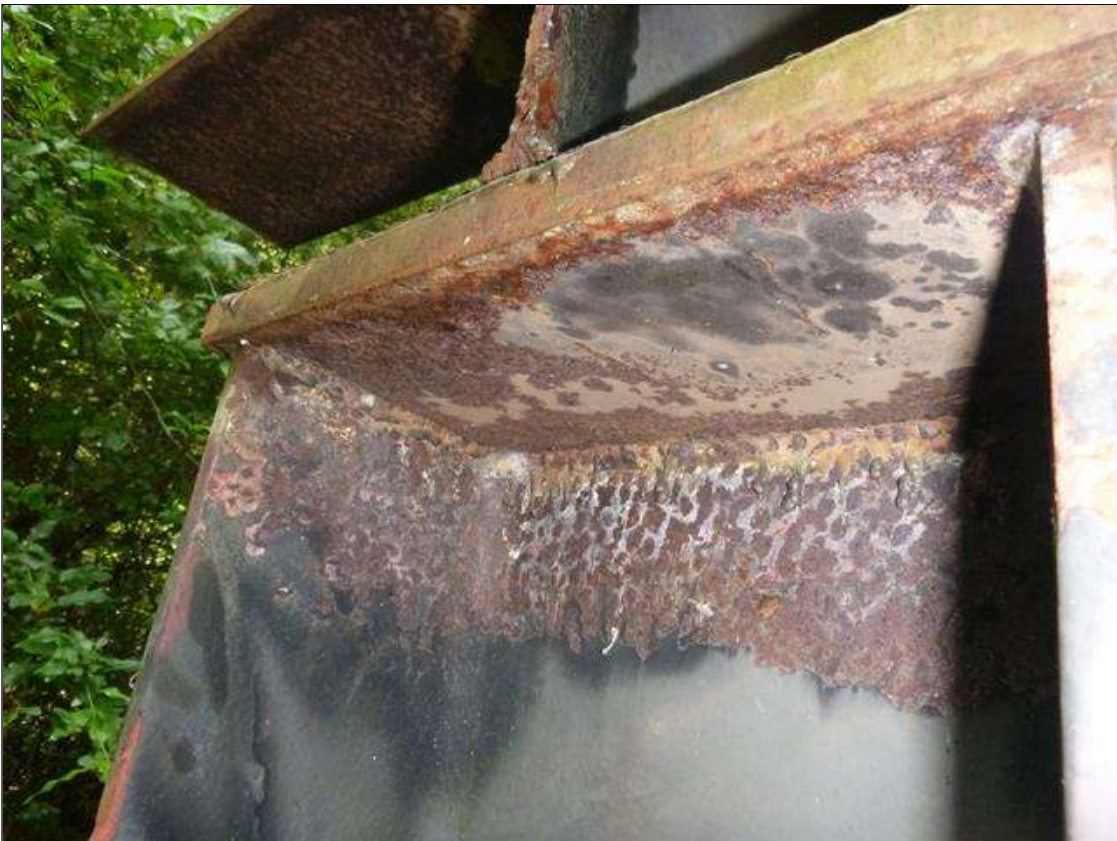
Bent 1 Pile 2: 1 Each of Corrosion: Freckled Rust. Corrosion of the steel has initiated. Surface rust at top 4" of pile.

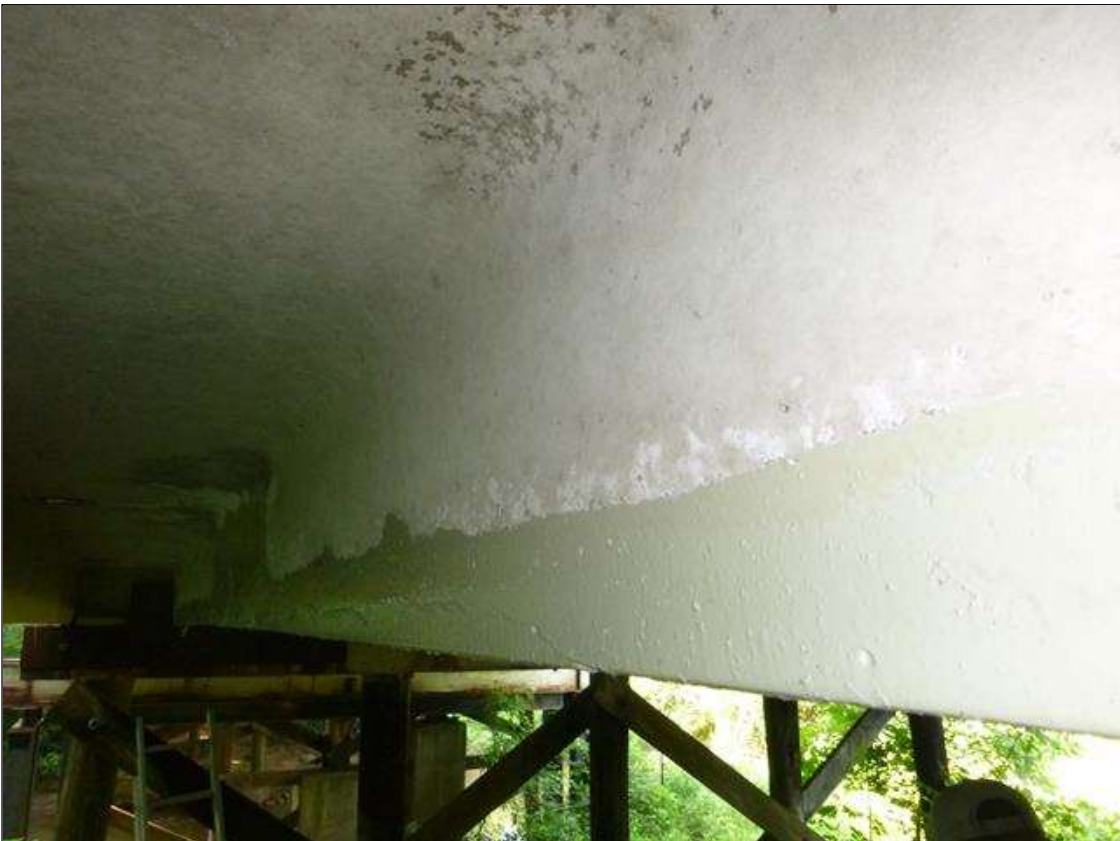
Span 5 Channel/Slab 10: 25 Feet of Delamination/Spall/Patched Area: Delaminated. Spall 1 in. or less deep or 6 in. or less in diameter. Patched area that is sound along most of left leg along span.

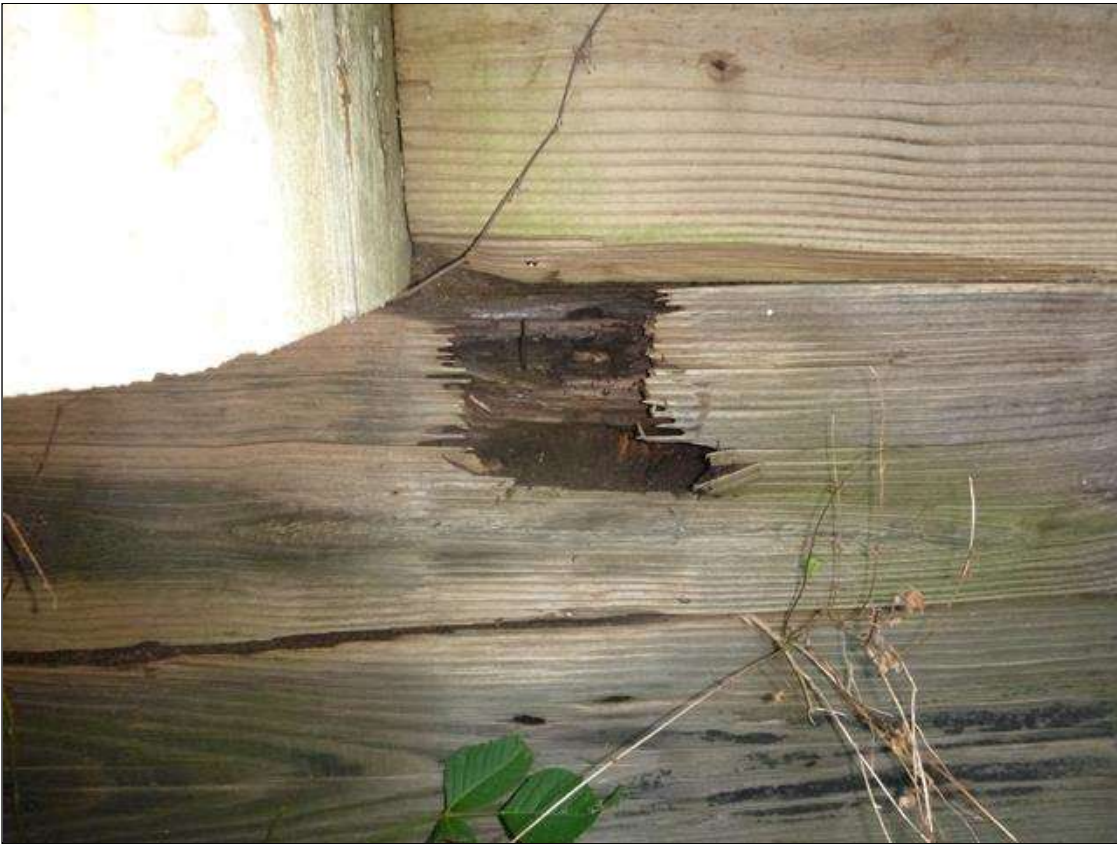
End Bent 2 Abutment/Backwall : 1 Feet of Decay/Section Loss: Affects 10% or more of the member but does not warrant structural review. 7" x 5" x 2.5" deep on abutment board at EAST end of end bent 2 cap.

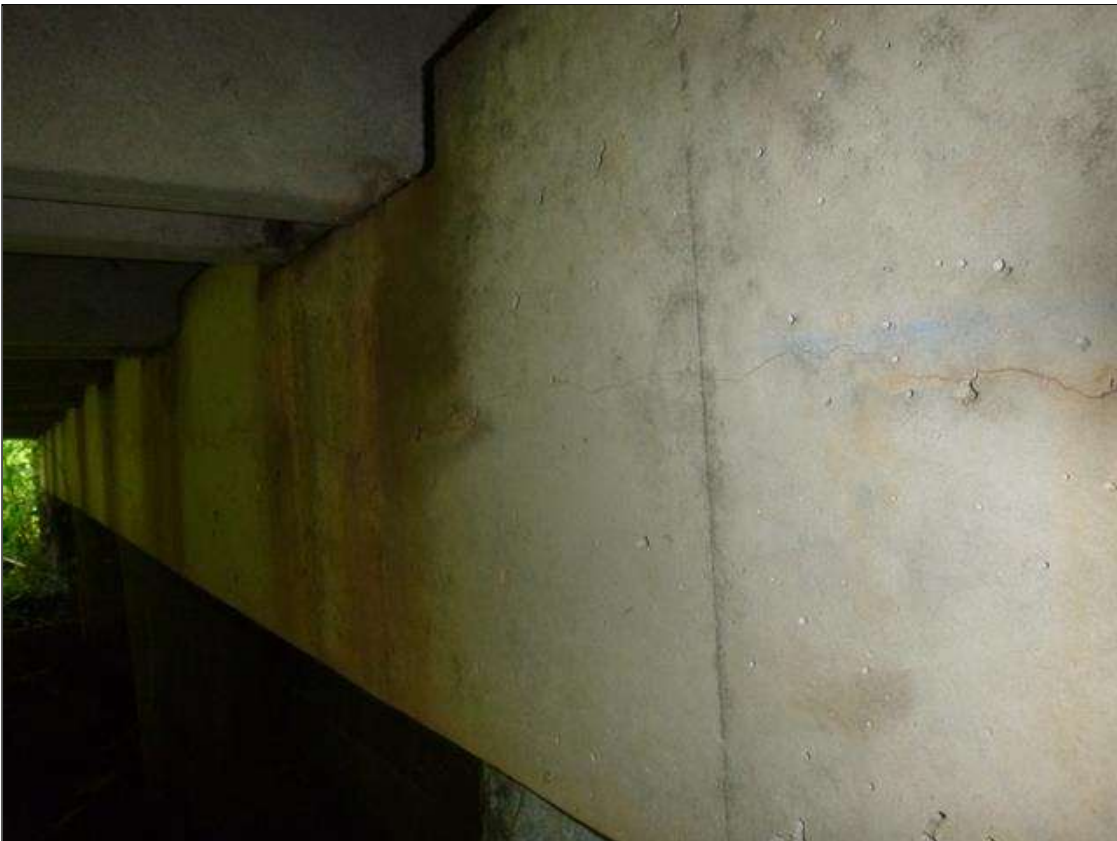
End Bent 2 Cap : 20 Feet of Cracking (PSC): Width 0.004-0.009 in. or spacing 1.0-3.0 ft. Horizontal crack from channel 1 to channel 8 8" from bottom of cap on SOUTH face.

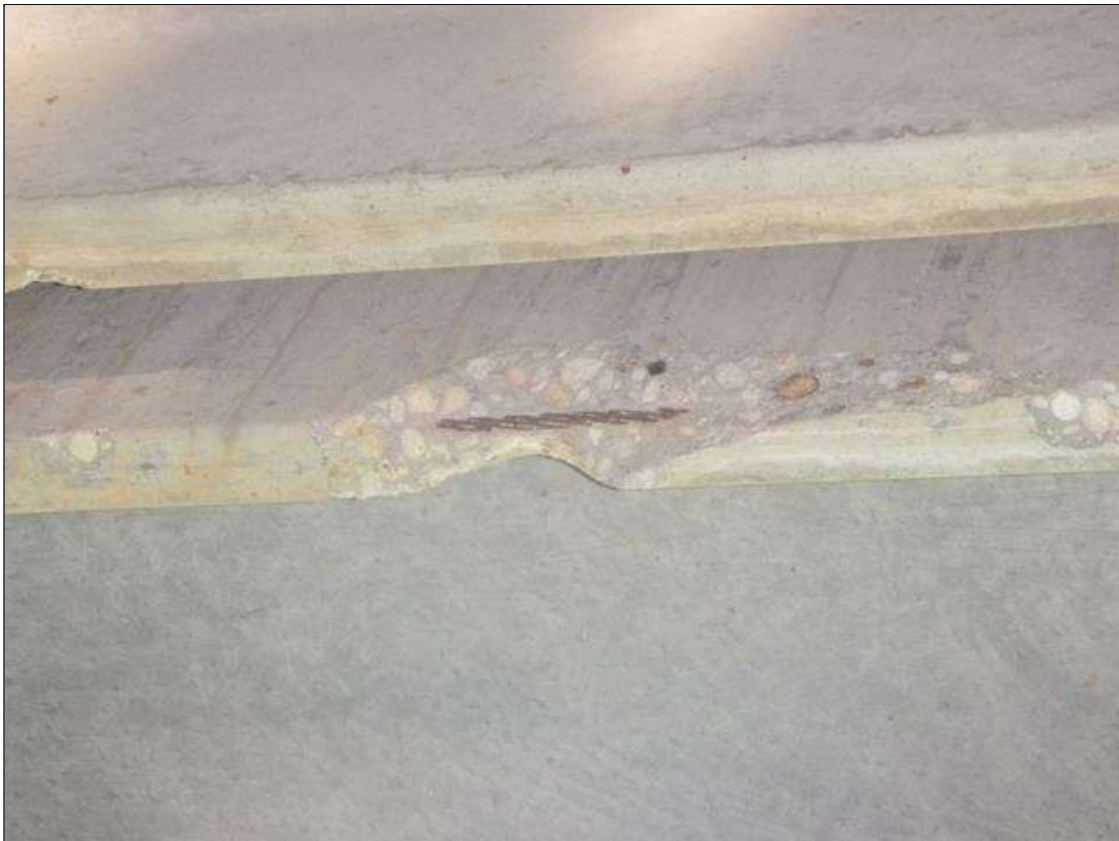
Span 4 Channel / Slab 2 : 1 Feet of Exposed Prestressing: Present without section loss. 12" spall with exposed cable on bottom of right leg 9 ft. from bent 3.

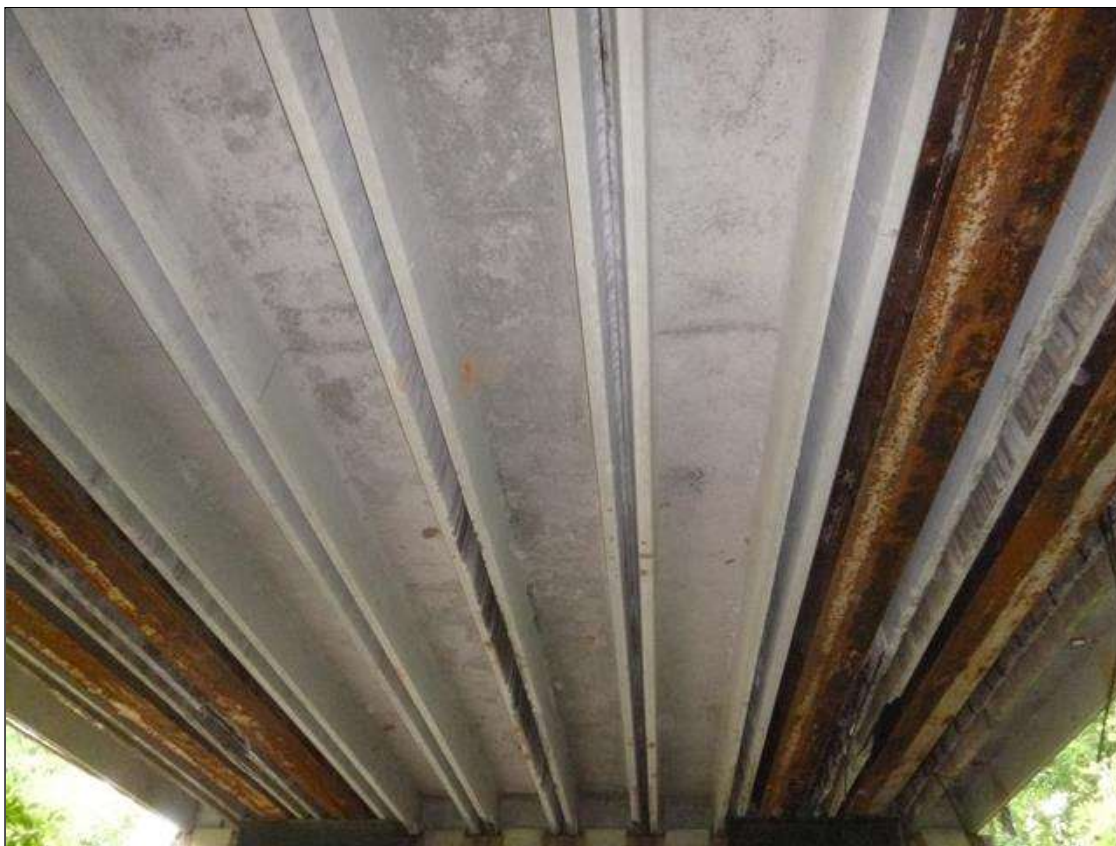
UNDERSIDE OF SPAN 2 WITH STEEL BEAMS UNDER CHANNELS 2,3, 8,AND 9

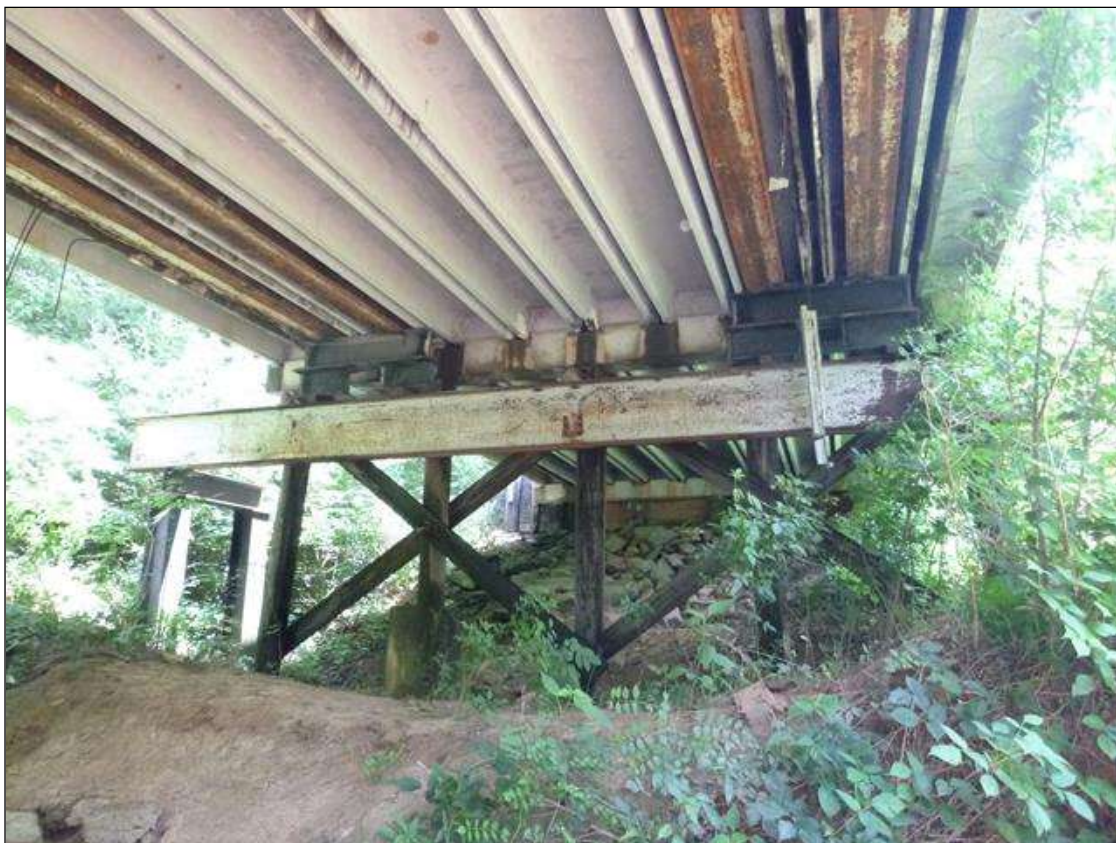
BENT 1 WITH CRUTCH BENT LOOKING SOUTH

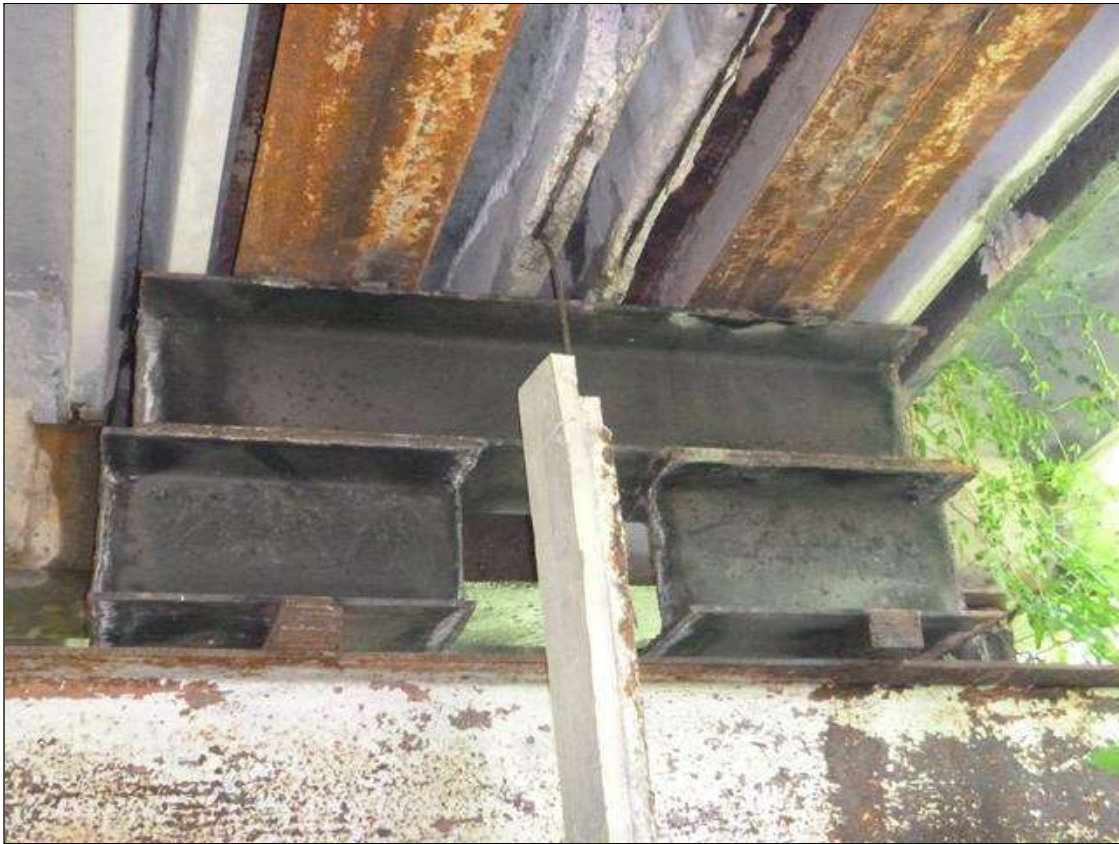
CRUTCH BENT 1 SPAN 2 SUPPORT FOR CHANNELS 2 AND 3

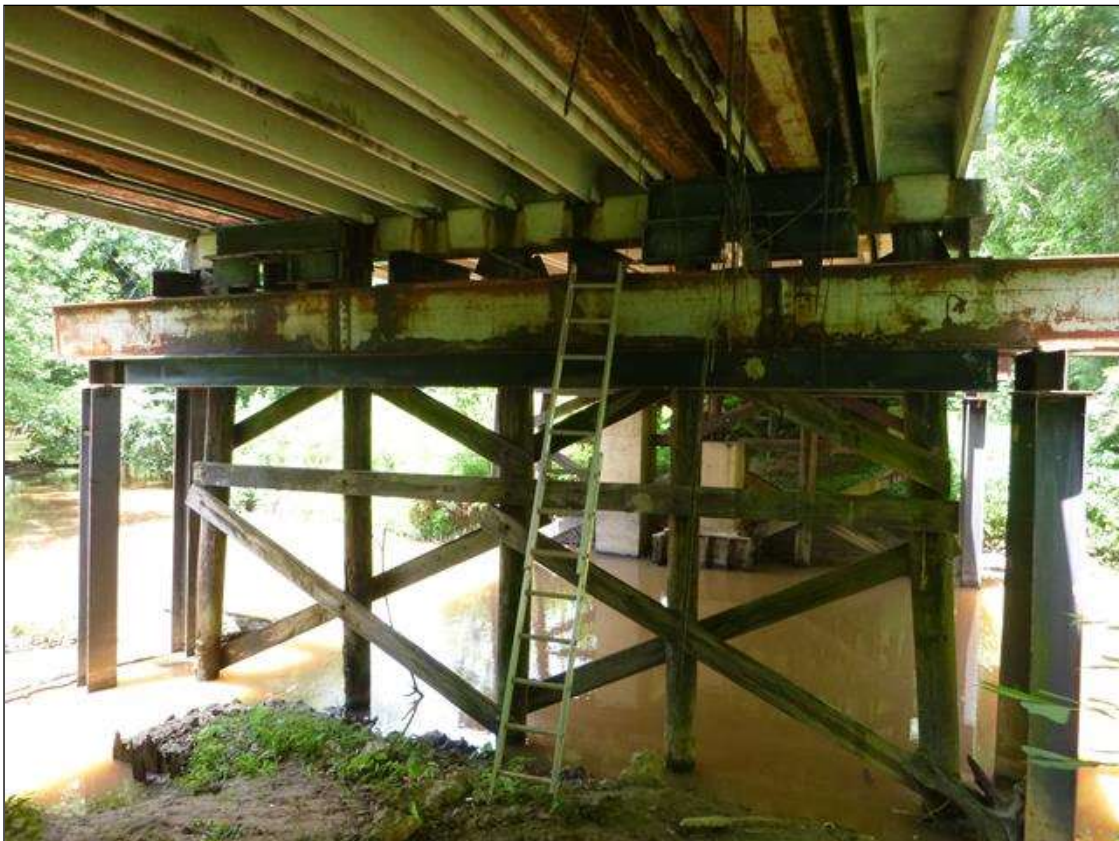
BENT 2 WITH CRUTCH BENTS

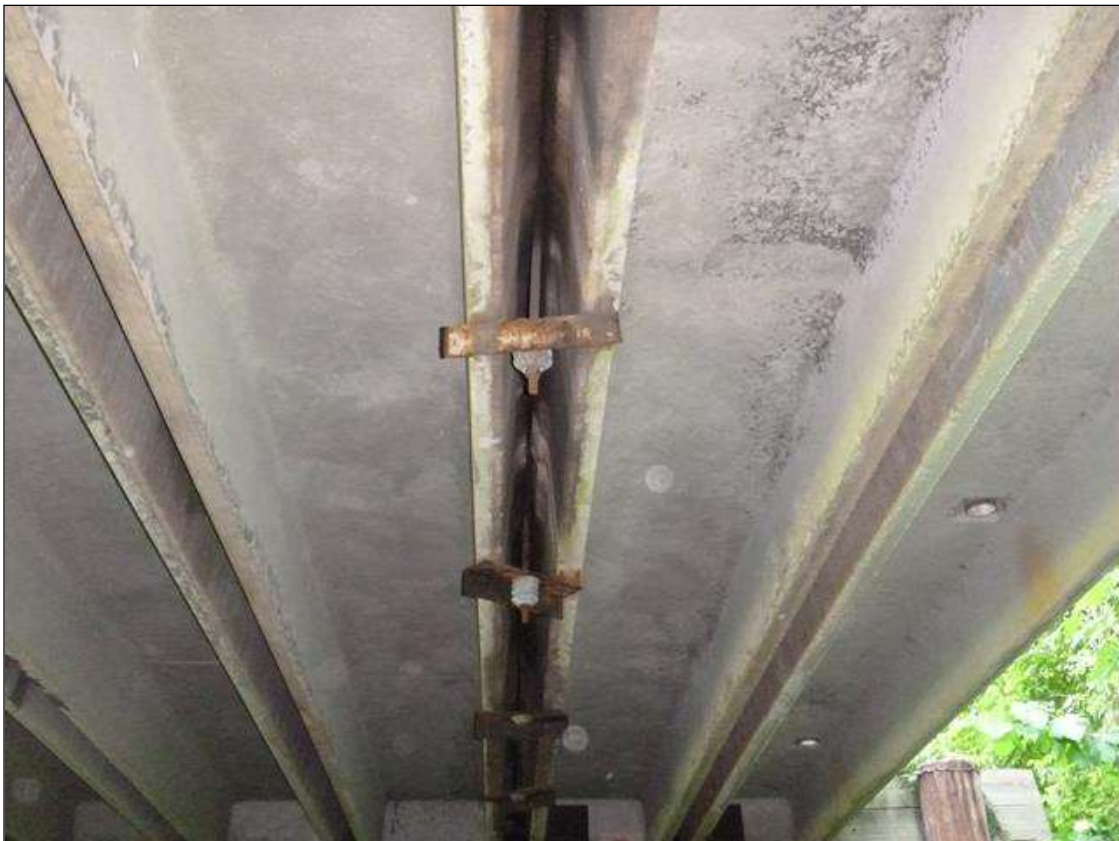
BOLT AND STEEL ANGLE SUPPORTS BETWEEN CHANNELS 8 AND 9 SPACED OUT IN SPAN 5

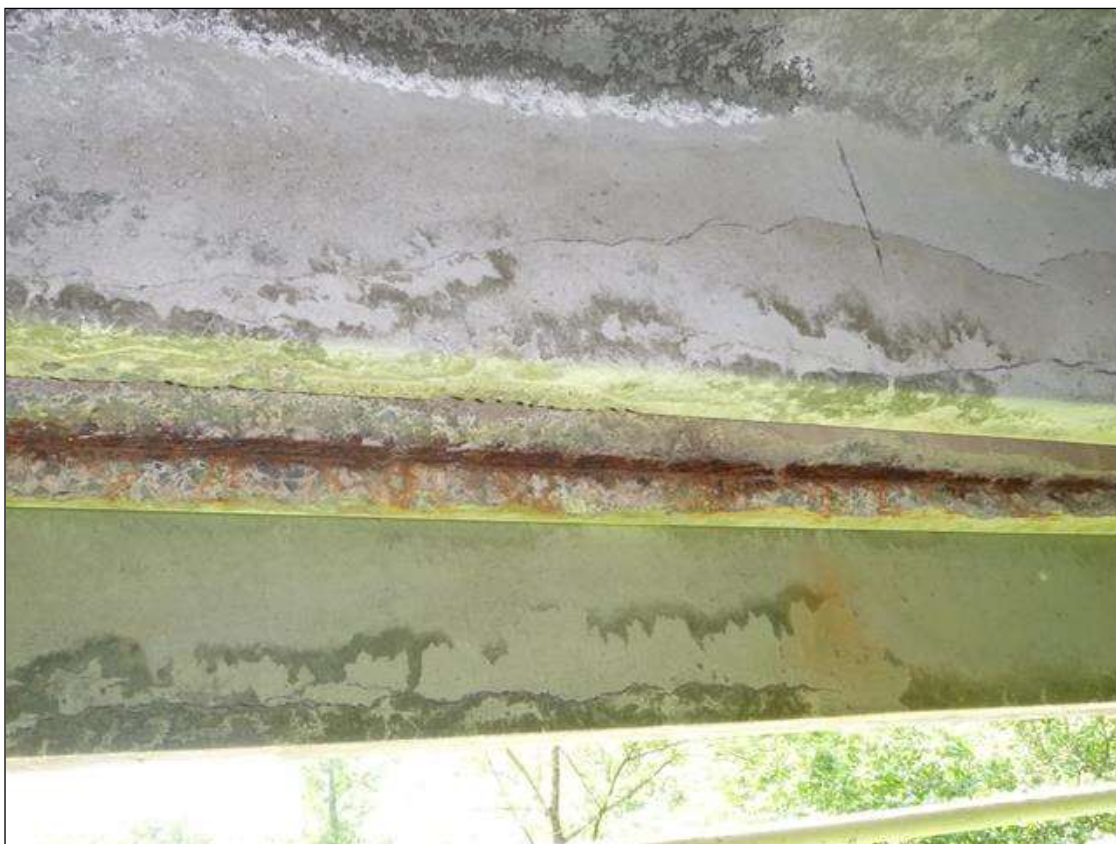
5 Feet of Exposed Prestressing: The condition warrants a structural review to determine the effect on strength or serviceability of the element or bridge; OR a structural review has been completed and the defects impact strength or serviceability of the element or bridge. 3" x 1.5" x 5' spall on bottom of right leg of channel near midspan.

SPAN 1 CHANNEL/SLAB 1: 5 FEET OF EXPOSED PRESTRESSING: 3" X 1.5" DEEP X 5' SPALL ON BOTTOM OF RIGHT LEG OF CHANNEL NEAR MIDSPAN WITH EXPOSED CABLE.

PRIORITY MAINTENANCE FOR EXPOSED  
PRESTRESSING CABLES. SHORING OF BOTH  
SUBSTRUCTURE AND SUPERSTRUCTURE

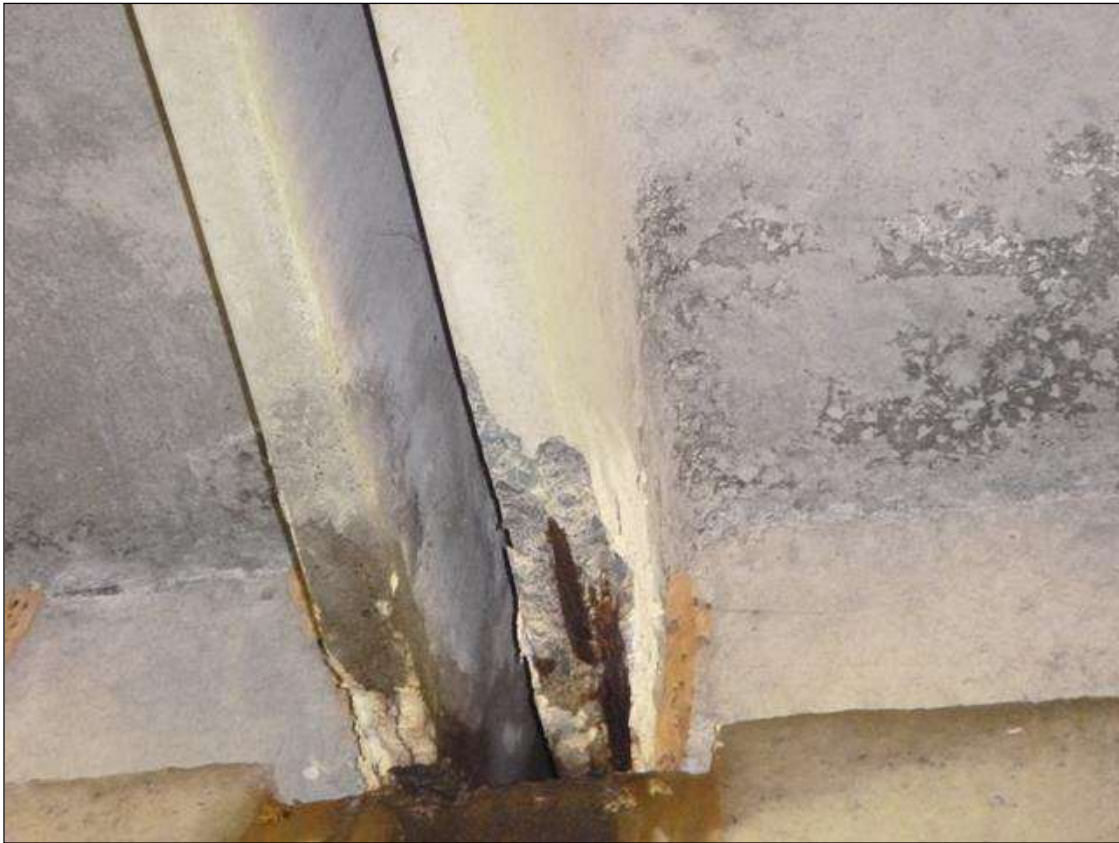
SPAN 2 CHANNEL/SLAB 5: 2 FEET OF EXPOSED PRESTRESSING: 15" SPALL WITH EXPOSED CABLE ON RIGHT LEG AT BENT 1

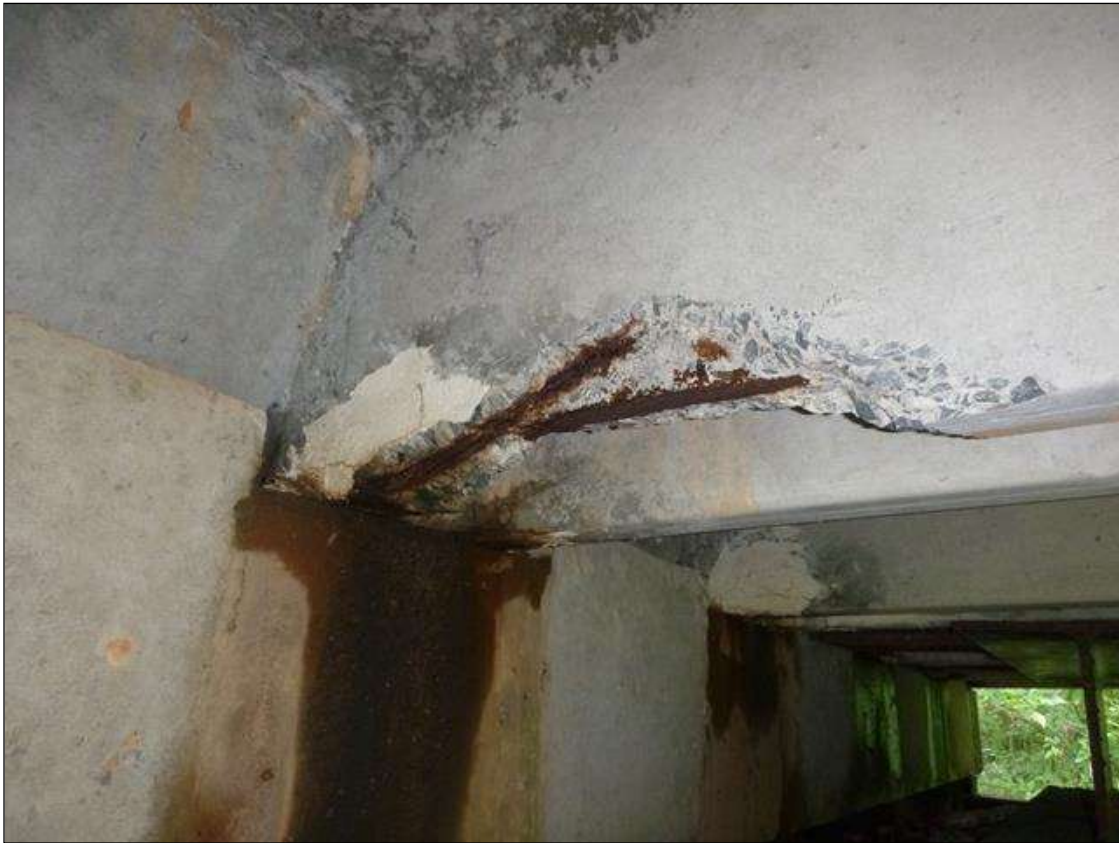
SPAN 2 CHANNEL/SLAB 6: 2 FEET OF EXPOSED PRESTRESSING: 18" SPALL WITH EXPOSED CABLE IN BOTTOM OF RIGHT LEG AT BENT 2.

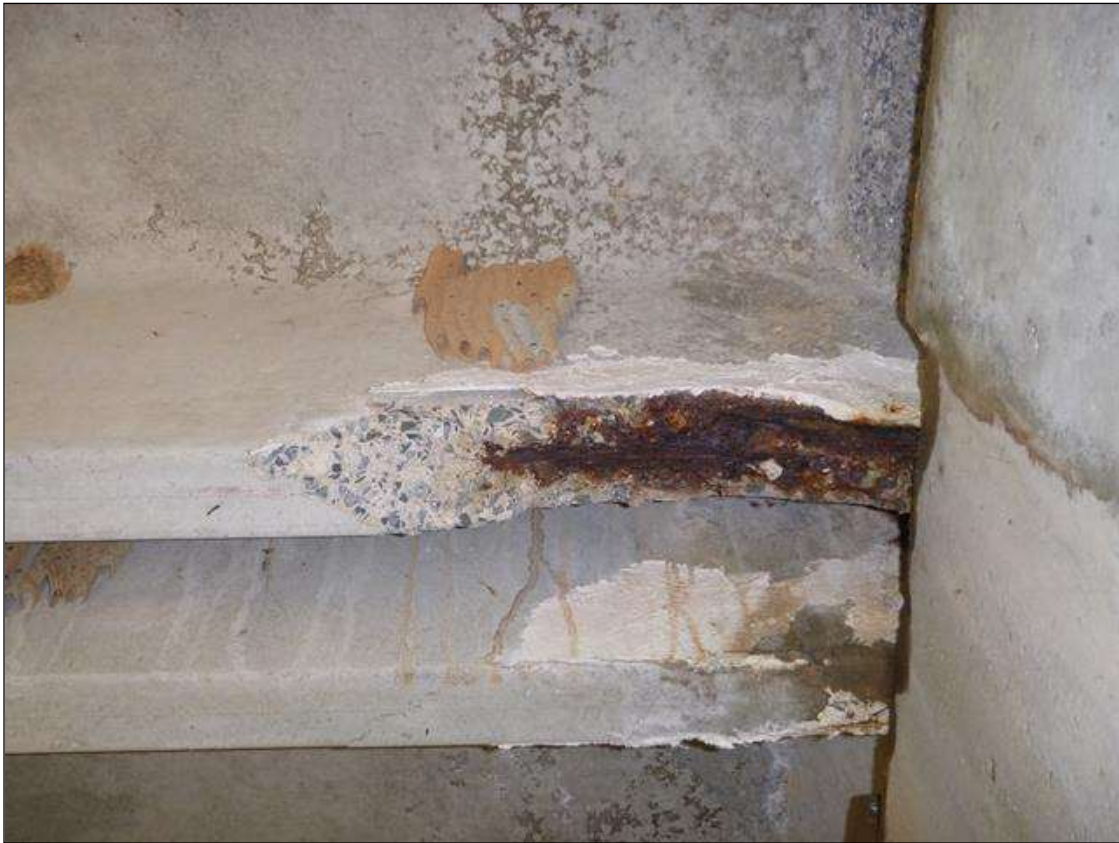
SPAN 3 CHANNEL/SLAB 5: 2 FEET OF EXPOSED PRESTRESSING: 16" SPALL WITH EXPOSED AND BROKEN CABLE IN RIGHT LEG AT BENT 2.

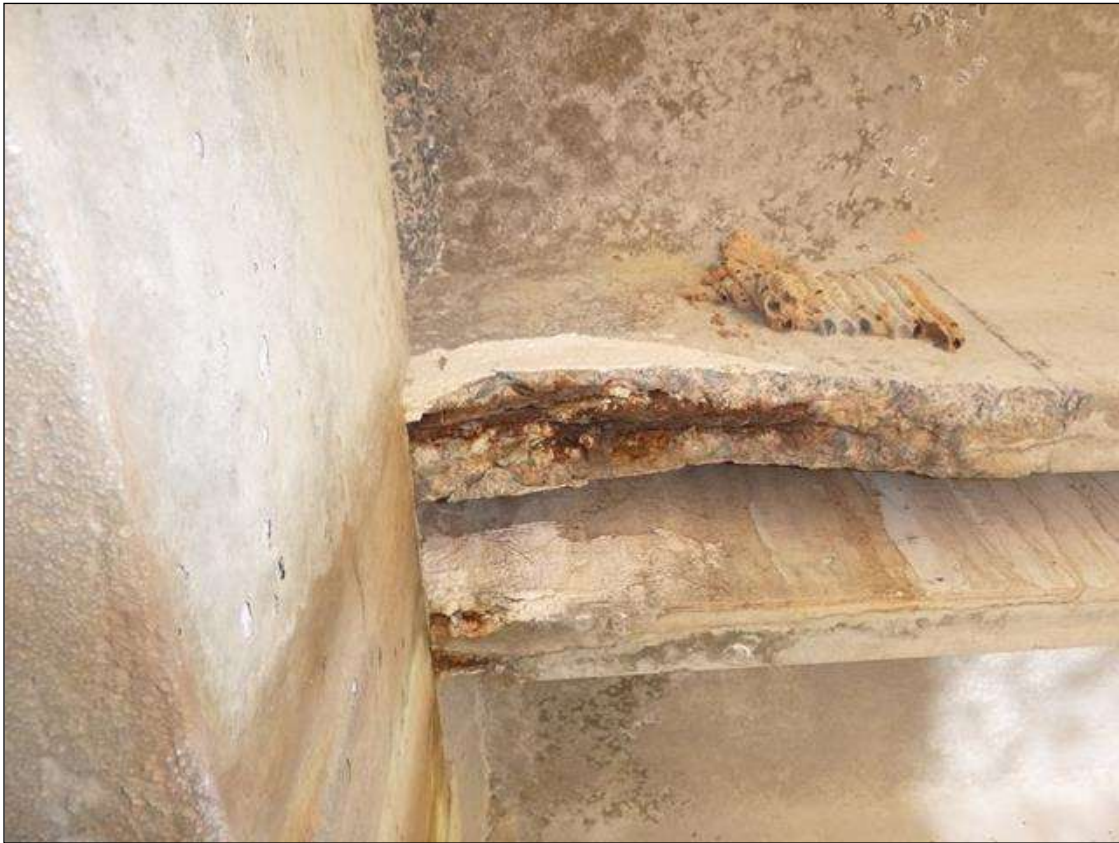
SPAN 3 CHANNEL/SLAB 6: 2 FEET OF EXPOSED PRESTRESSING: 18" SPALL WITH EXPOSED PRESTRESSING CABLE IN BOTTOM OF RIGHT LEG AT BENT 3.

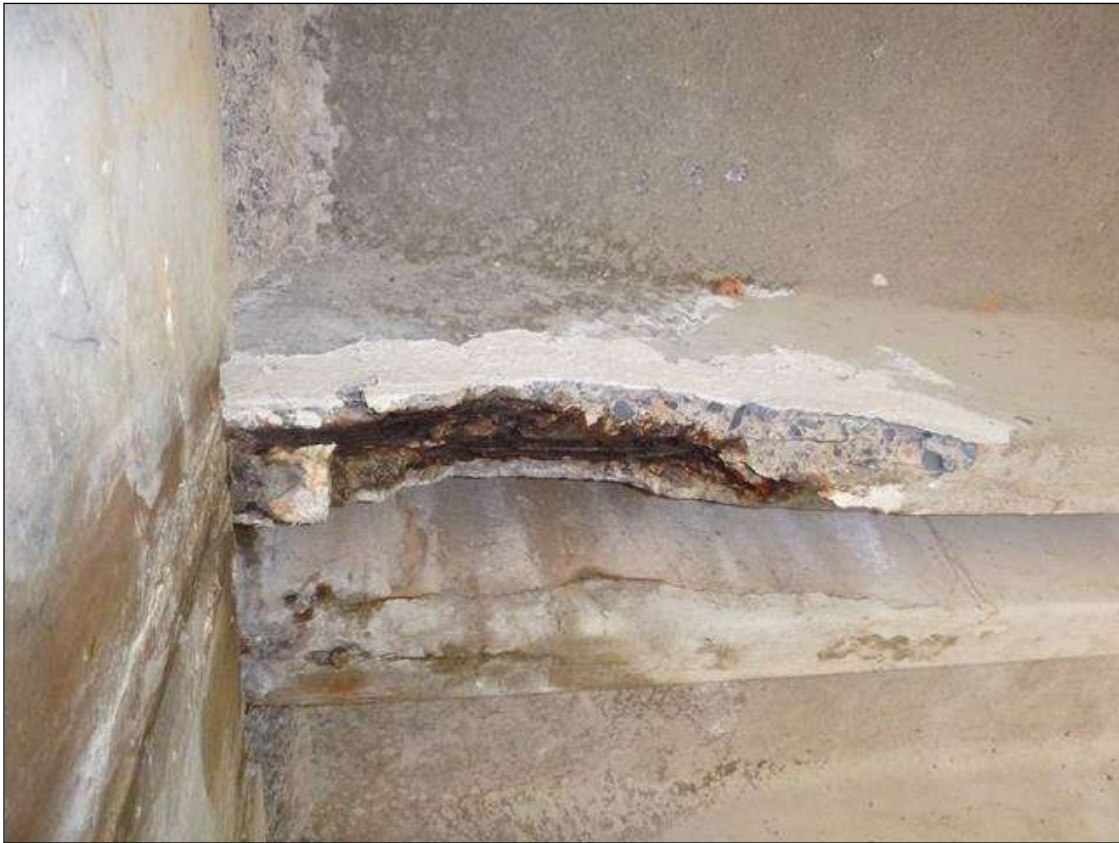
SPAN 3 CHANNEL/SLAB 4: 2 FEET OF EXPOSED PRESTRESSING: 18" LONG SPALL WITH EXPOSED CABLE  
IN RIGHT LEG AT BENT 3.
