NC DEPARTMENT OF TRANSPORTATION  
DIVISION OF HIGHWAYS  
STRUCTURE MANAGEMENT UNIT

## Structure Safety Report

### Routine Element Inspection - Contract

COUNTY: YADKIN STRUCTURE NUMBER: 980010 FREQUENCY: 24 MONTHS

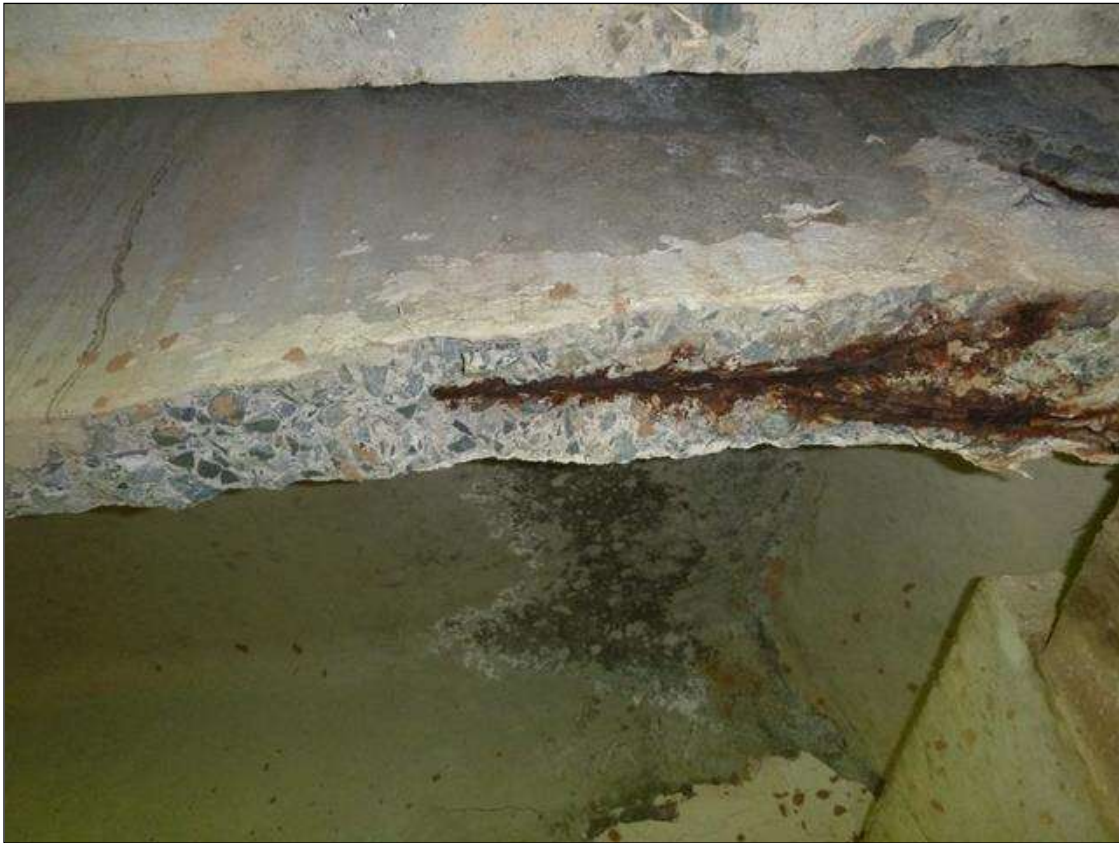
SPAN 4 CHANNEL/SLAB 7: 2 FEET OF EXPOSED PRESTRESSING: 20" SPALL WITH EXPOSED CABLE IN BOTTOM OF LEFT LEG AT BENT 3.

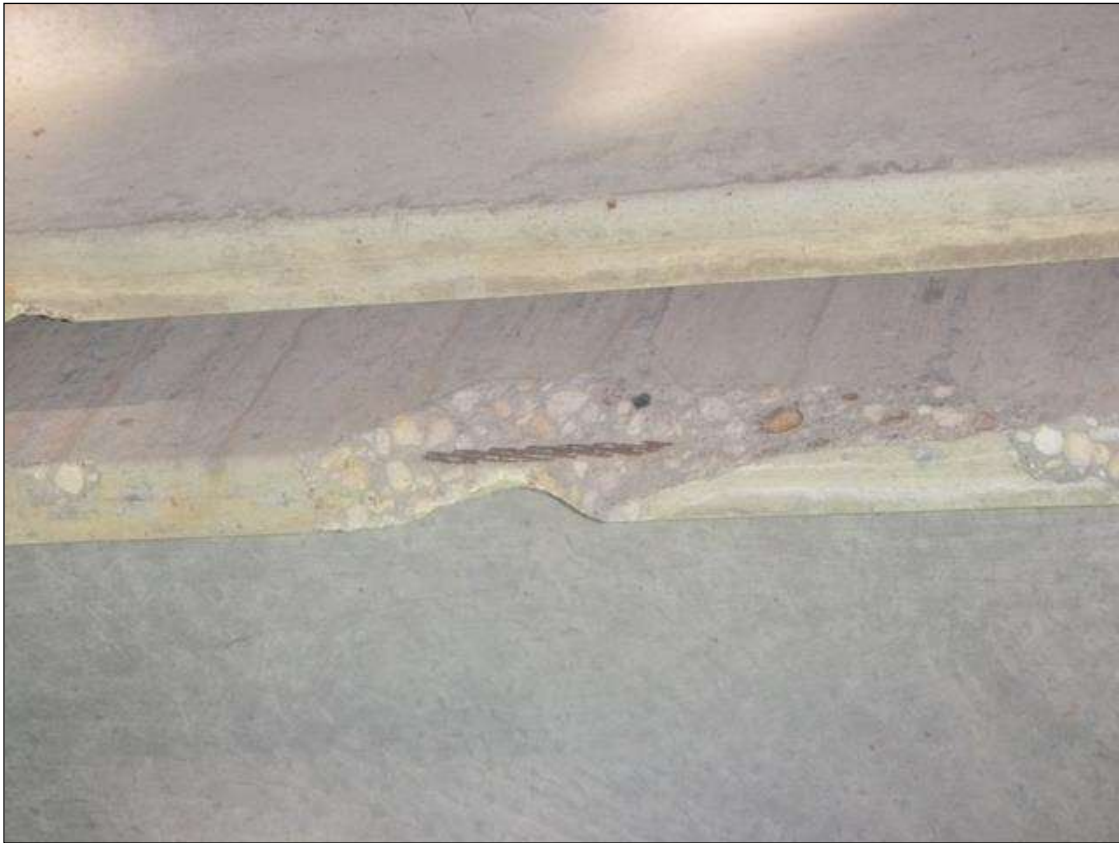
SPAN 4 CHANNEL / SLAB 2 : 1 FEET OF EXPOSED PRESTRESSING: PRESENT WITHOUT SECTION LOSS. 12"  
SPALL WITH EXPOSED CABLE ON BOTTOM OF RIGHT LEG 9 FT. FRO

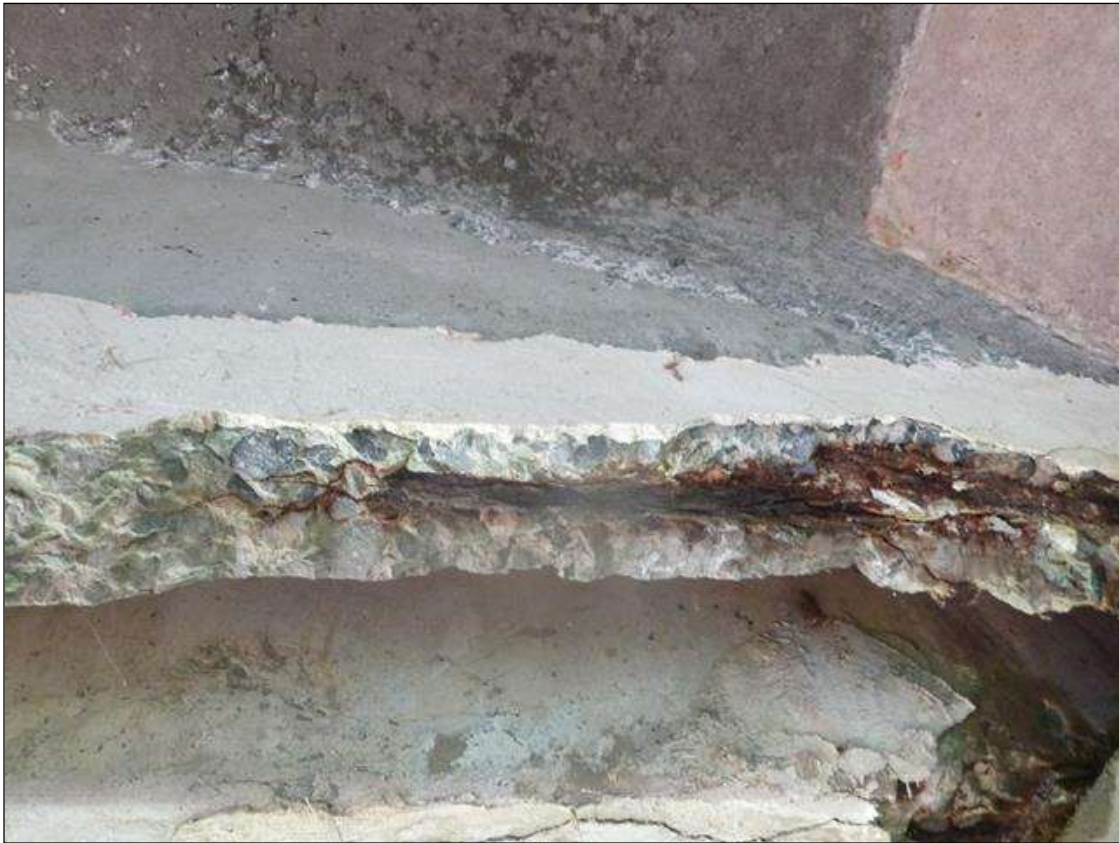
SPAN 4 CHANNEL/SLAB 6: 2 FEET OF EXPOSED PRESTRESSING: . 20" LONG SPALL WITH EXPOSED CABLE ON BOTTOM OF LEFT LEG AT BENT 4. .

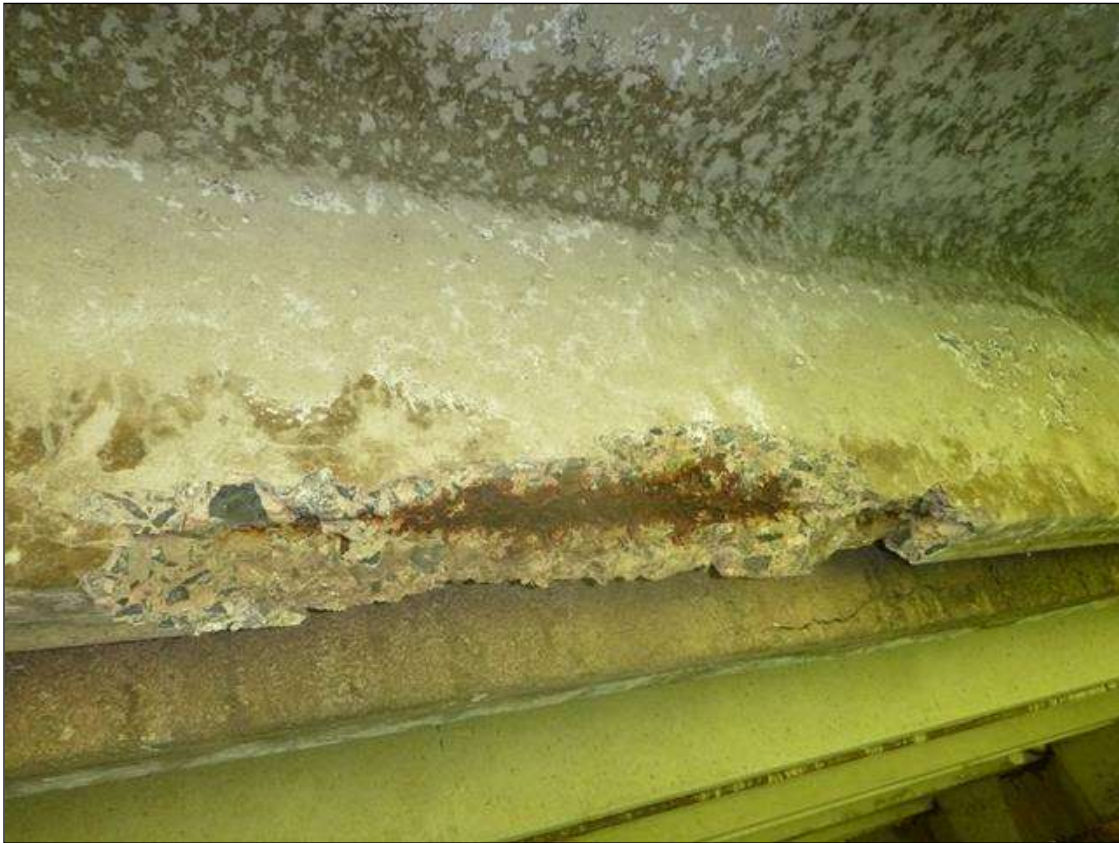
| MMS Code | MMS Description | Quantity |
|---|---|---|
| Span 4 Channel/Slab 6: 2 Feet of Exposed Prestressing: The condition warrants a structural review to determine the effect on strength or serviceability of the element or bridge; OR a structural review has been completed and the defects impact strength or serviceability of the element or bridge. 20" long spall with exposed cable on bottom of left leg at bent 4.. . | | |

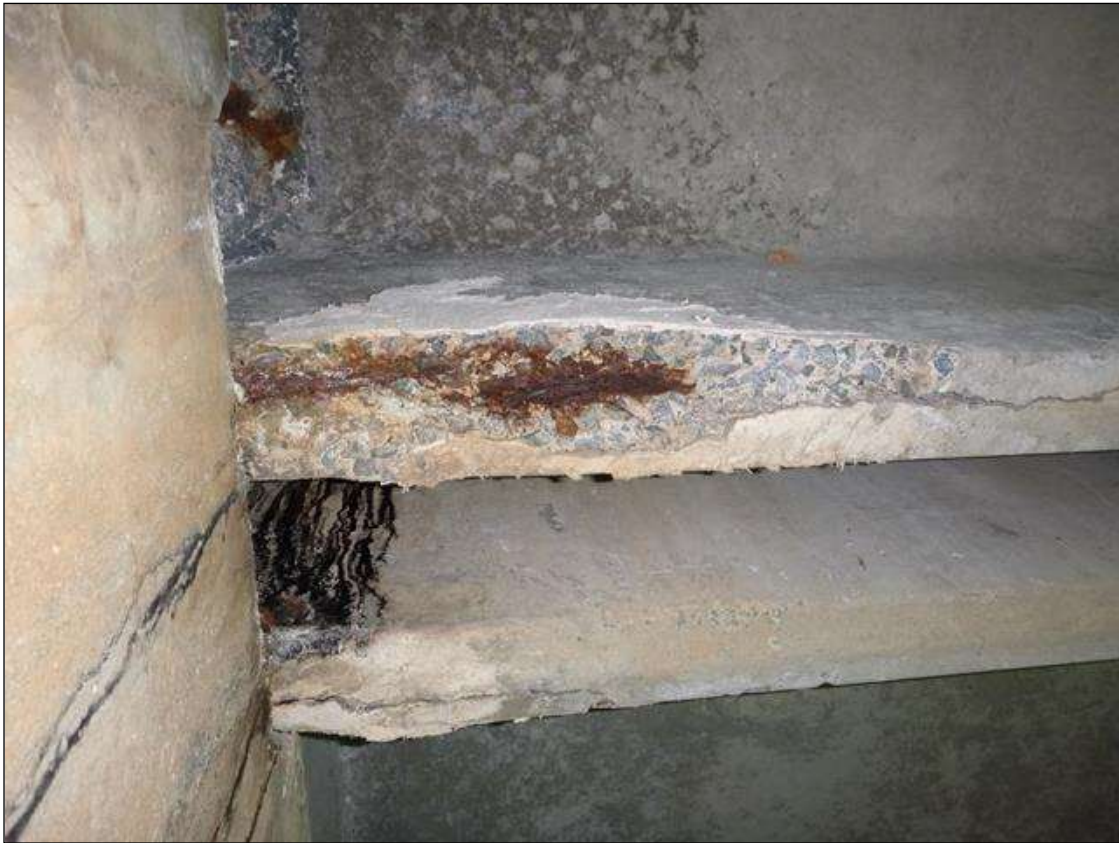
| MMS Code | MMS Description | Quantity |
|---|---|---|
| <p>Span 5 Channel/Slab 2: 2 Feet of Exposed Prestressing: The condition warrants a structural review to determine the effect on strength or serviceability of the element or bridge; OR a structural review has been completed and the defects impact strength or serviceability of the element or bridge. 22" spall with exposed strands in bottom of right leg at midspan.</p> | | |

SPAN 5 CHANNEL/SLAB 2: 2 FEET OF EXPOSED PRESTRESSING: 22" SPALL WITH EXPOSED CABLE IN BOTTOM OF RIGHT LEG AT MIDSPAN.

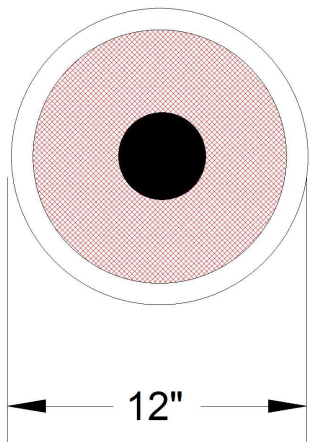
PILE # 1 & 2 @ PIER # 2 HAVE APPROX 85% DECAY  
DECAY EXTENDS FROM STREAMBED UP APPROX. 6'

PILE # 1  
1/2" SHELL' 4" CORE

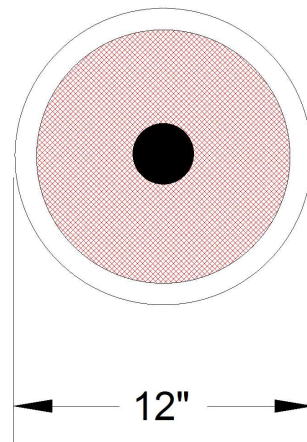
PILE # 2  
1/2" SHELL' 2" CORE

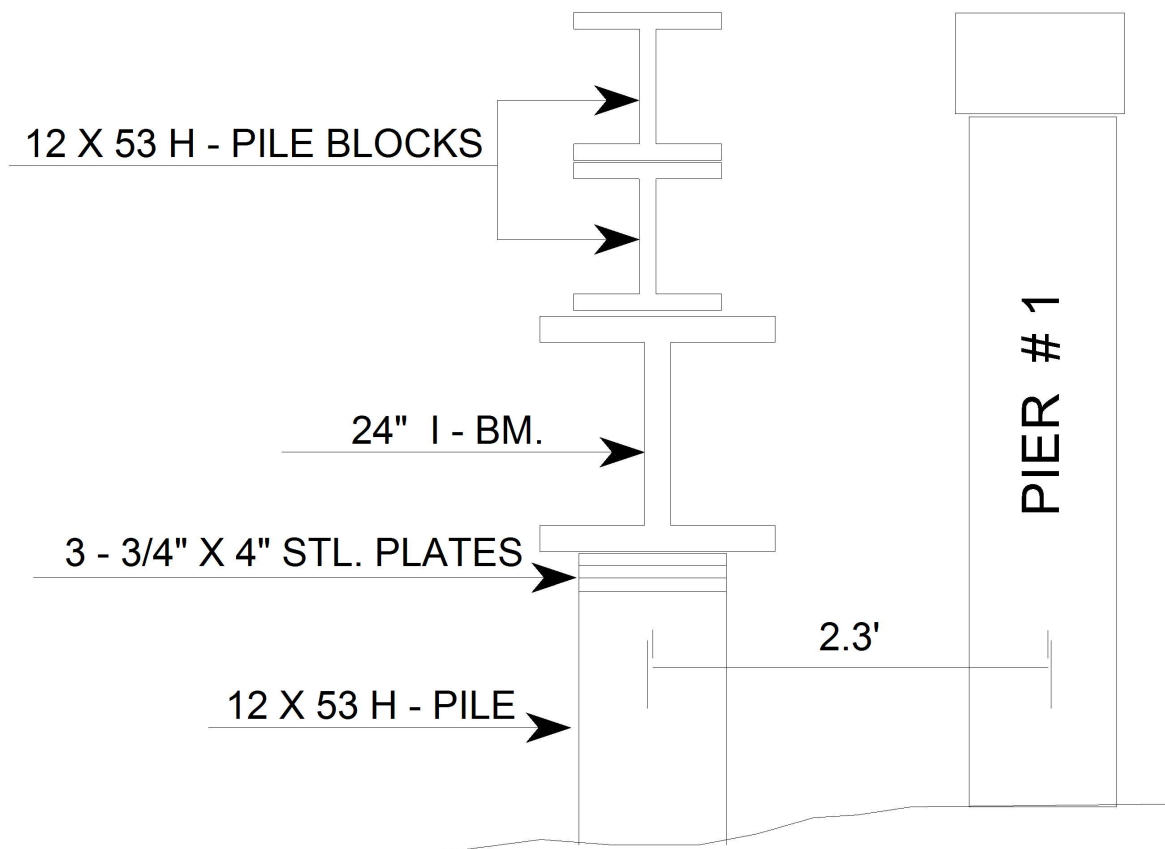
END VIEW OF SHORING @ PIER # 1

12 X 53 H - PILE BLOCKS PLACED UNDER CHANNEL # 2,3,8,9 IN SPAN # 2

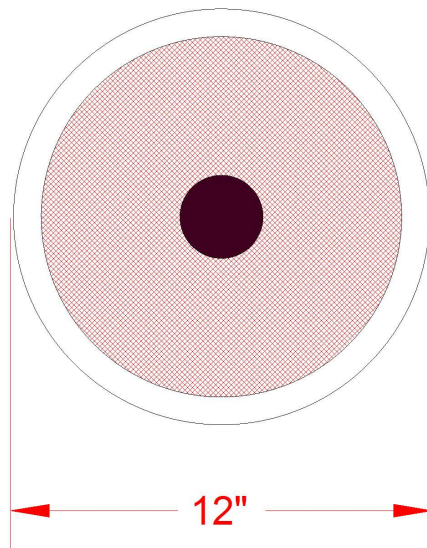
| Title | | Description | |
|---|---|---|---|
| PILE DECAY @ PIER # 4 | | PILE # 5 | |

APPROX. 85% DECAY IN PILE # 5 @ PIER # 4

DECAY EXTENDS FROM GROUNDLINE UP APPROX. 3'

1/2" SHELL; 2" CORE

PILE REPAIRED W/CONC. ENCASEMENT 6/17/13
