# BRIDGE INSPECTION REPORT

INSPECTION TYPE: Routine Inspection

COUNTY WAKE BRIDGE NUMBER 910091 INSPECTION CYCLE 2 YRS

ROUTE US70 ACROSS CRABTREE CREEK M.P. 0

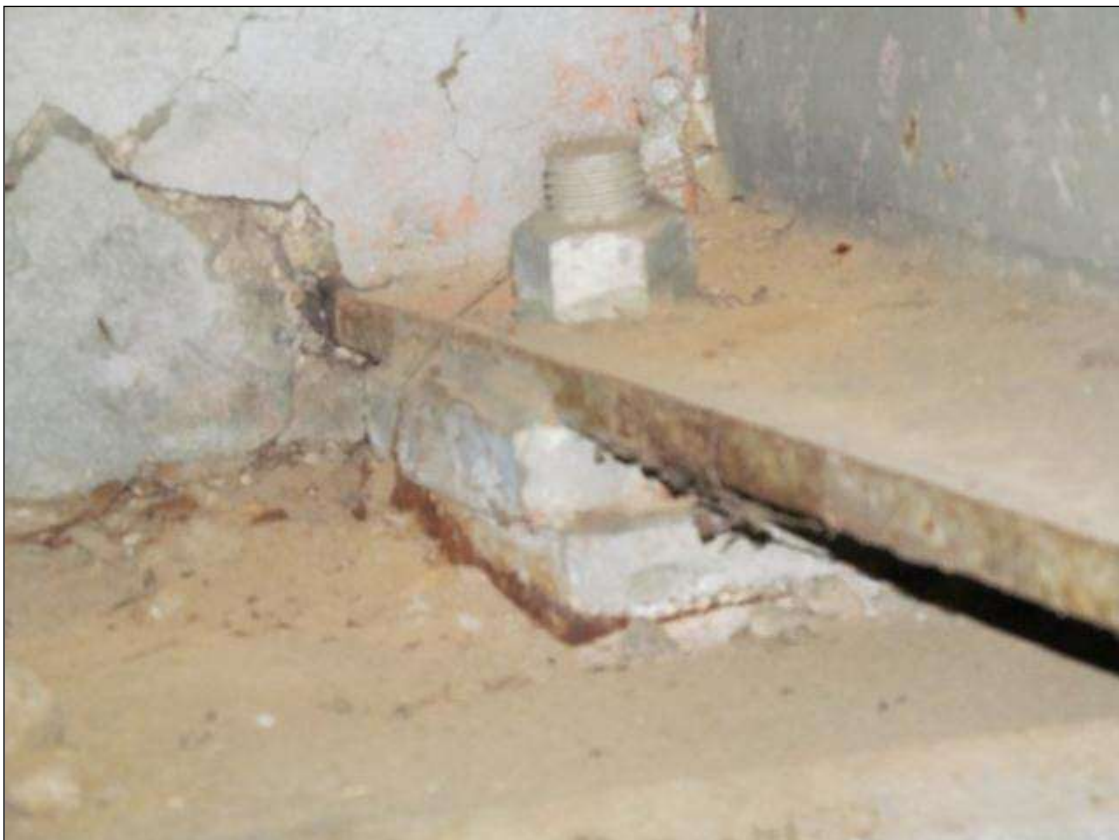
BEARING (OTHERS SIMILAR)

| Bridge I&A Form 1(82)H<br>State of North Carolina<br>Dept. of Transportation<br>Division of Highways | | <h1 style="text-align: center;">FIELD INSPECTION REPORT</h1> <p style="text-align: center;"><u>Bridge Inspection &amp; Analysis</u></p> | |
|---|---|---|--|
| 15 | G | BEARING ASSEMBLIES:<br>- BEAMS 12 AT BENT 1 SPANS 1 AND 2 HAS ( 3 ) ANCHOR BOLTS MISSING NUTS BETWEEN THE TWO BEAMS. | |

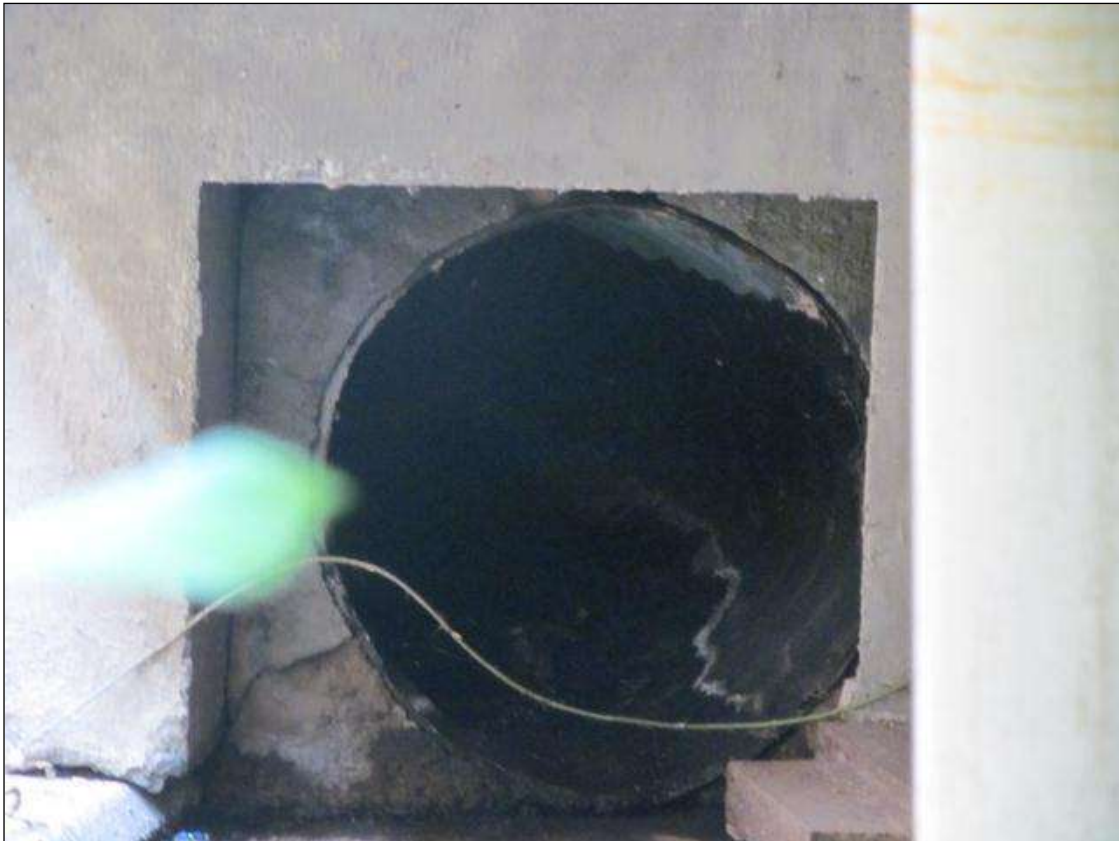
UTILITY HOLE RIGHT SIDE OF GIRDER 14 END BENT 1 (PHOTO 1 OF 2)

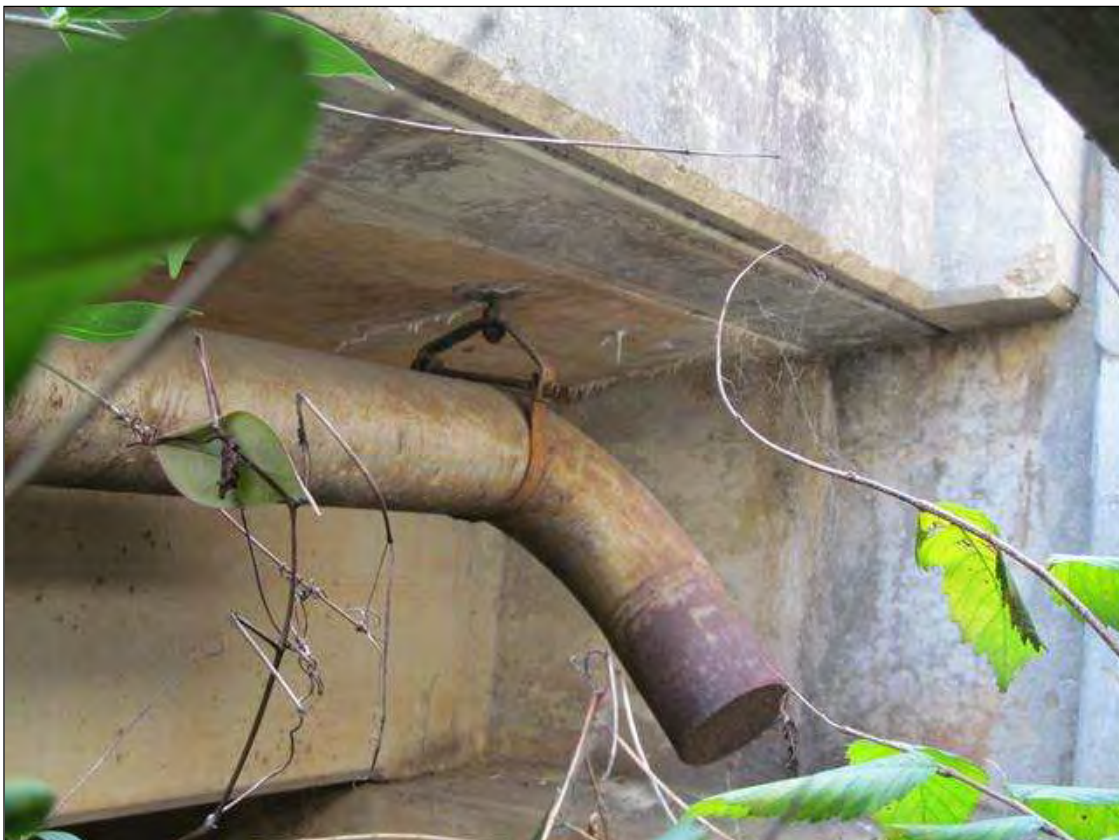
CAPPED OFF UTILITY PIPE FROM ADJACENT BRIDGE (PHOTO 2 OF 2)

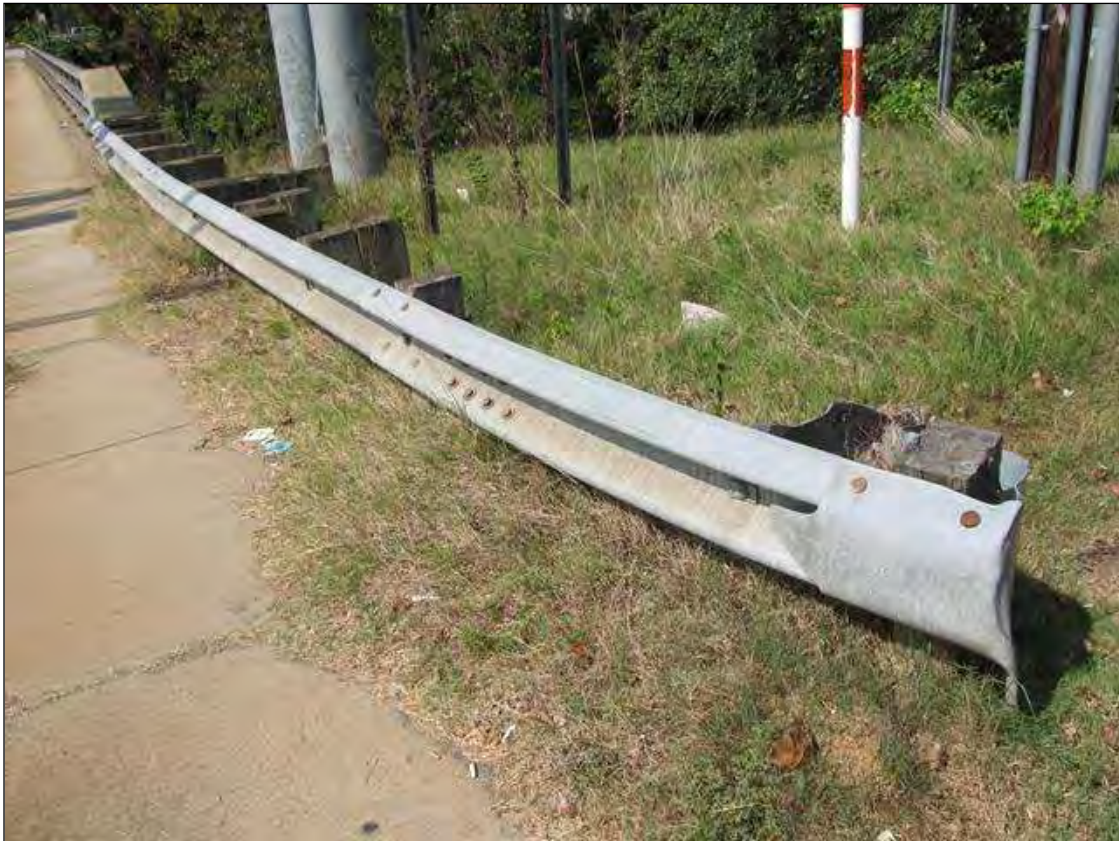
GUARDRAIL NORTHEAST CORNER

| Bridge I&A Form 1(82)H<br>State of North Carolina<br>Dept. of Transportation<br>Division of Highways | | <h1 style="text-align: center;">FIELD INSPECTION REPORT</h1> <p style="text-align: center;"><u>Bridge Inspection &amp; Analysis</u></p> | |
|---|---|---|--|
| 50 | F | APPROACH ROADWAY:<br>- WEST APPROACH CRACKING AND BREAKING UP ALONG END OF DECK.<br>- SOUTH APPROACH CRACKING AND BREAKING UP IN SPOTS NEAR END OF SPAN 4 DECK.<br>- GUARD RAIL TERMINAL END AT NE CORNER DAMAGED. | |

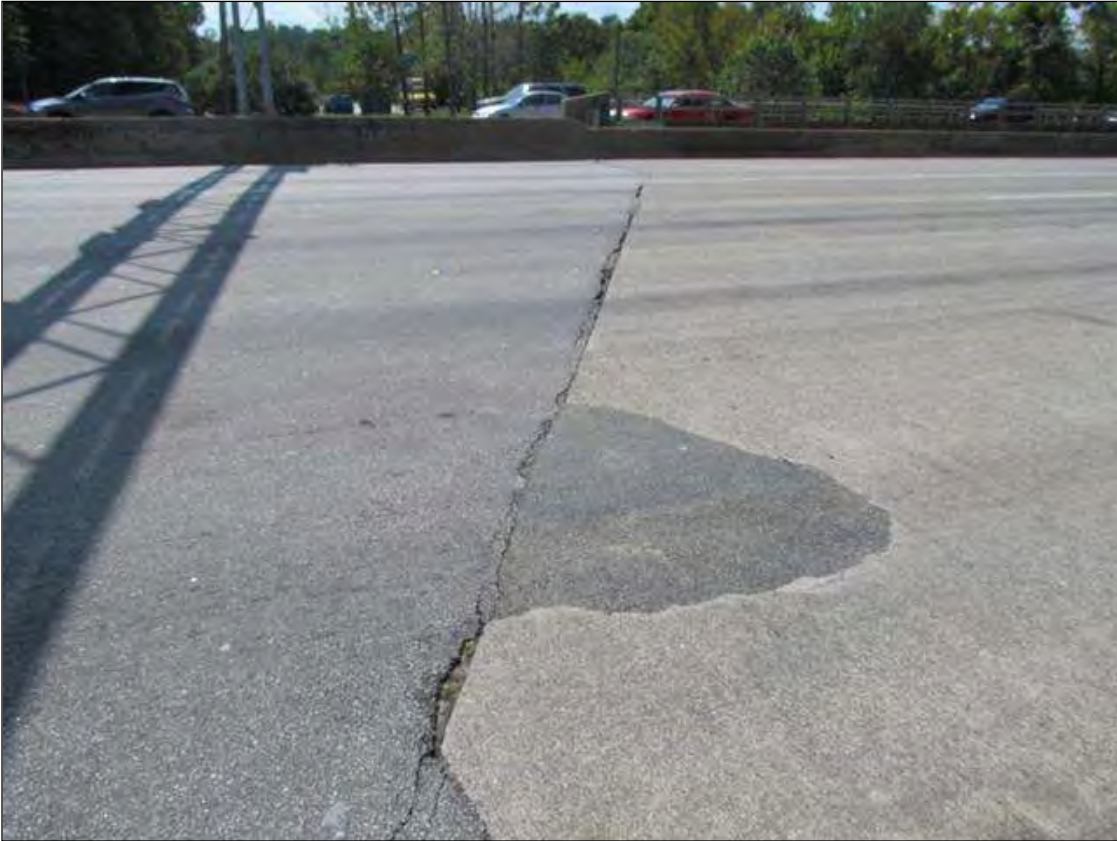
END BENT 2 JOINT (END BENT 1 SIMILAR)

| Bridge I&A Form 1(82)H<br>State of North Carolina<br>Dept. of Transportation<br>Division of Highways | | <h1 style="text-align: center;">FIELD INSPECTION REPORT</h1> <p style="text-align: center;"><u>Bridge Inspection &amp; Analysis</u></p> | |
|---|---|---|--|
| 6d | F | STANDARD JOINTS:<br>- EXPANSION JOINTS ARE DETERIORATED AND ARE ALLOWING DRAINAGE ON TO THE SUBSTRUCTURE.<br>- EXPANSION JOINT AT END BENT 2 IS COVERED WITH AWS, CRACKING AND BREAKING UP OVER JOINT. | |

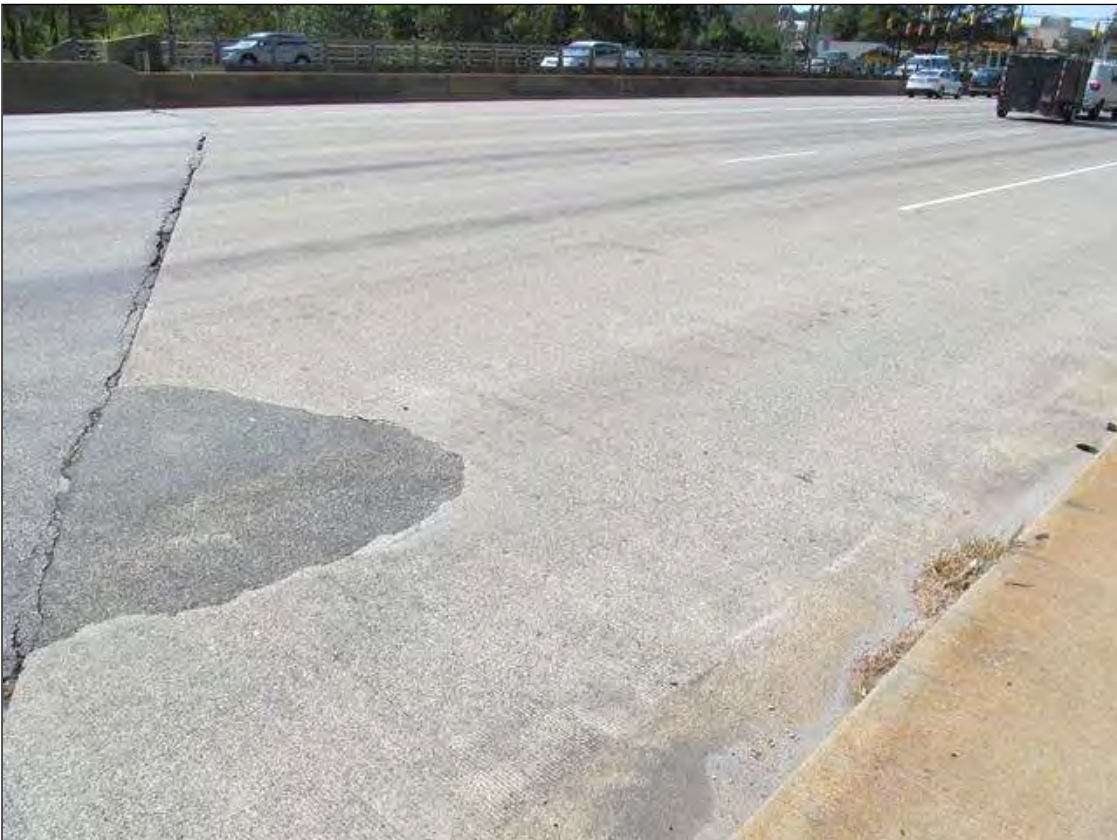
TOP OF DECK SPAN 4 (OTHERS SIMILAR)

| Bridge I&A Form 1(82)H<br>State of North Carolina<br>Dept. of Transportation<br>Division of Highways | | <h1 style="text-align: center;">FIELD INSPECTION REPORT</h1> <p style="text-align: center;"><u>Bridge Inspection &amp; Analysis</u></p> | |
|---|---|---|--|
| 2a | F | CONCRETE DECK:<br>- UNDERSIDE OF DECK IN SPAN 2 HAS TRANSVERSE CRACKS WITH EFFLO. IN BAY 11, SIMILAR IN OTHER SPANS.<br>- TOP OF DECK IN SPAN 2 ALONG JOINT OVER BENT 2 HAS PATCHES NEAR CENTERLINE, 14 SQ.FT.<br>- TOP OF DECK HAS FEW SCATTERED TRANSVERSE H/L CRACKS NEAR BENT 3, SIMILAR NEAR OTHER BENTS.<br>- TOP OF DECK IN SPAN 4 HAS LARGE PATCH NEAR LEFT CURB AT EAST END OF DECK 48 SQ.FT. | |
