NC DEPARTMENT OF TRANSPORTATION  
DIVISION OF HIGHWAYS  
STRUCTURE MANAGEMENT UNIT

## Structure Safety Report

### Routine Element Inspection - Contract

COUNTY: WAKE STRUCTURE NUMBER: 910252 FREQUENCY: 24 MONTHS

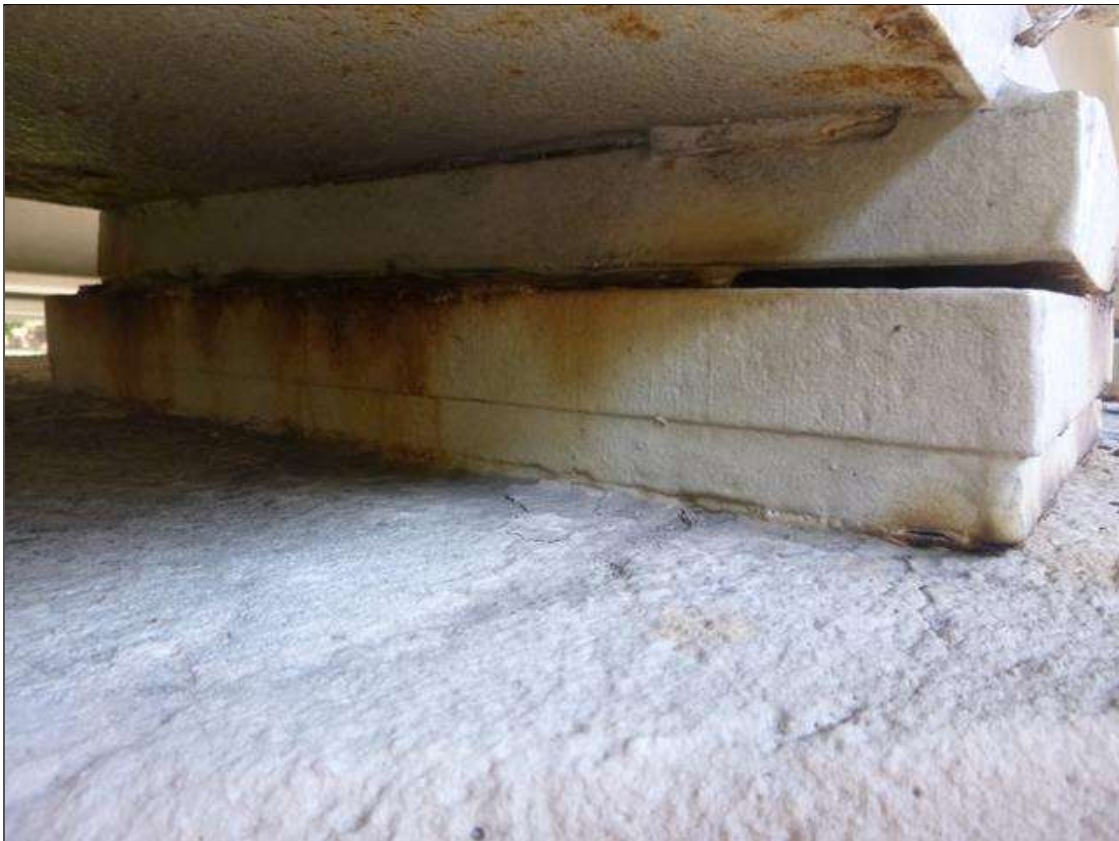
Span 3 Beam 1 Near Bearing: SPAN 3, BENT 2, BEAM 1, NEAR BEARING, FRECKLED RUST HAS STARTED

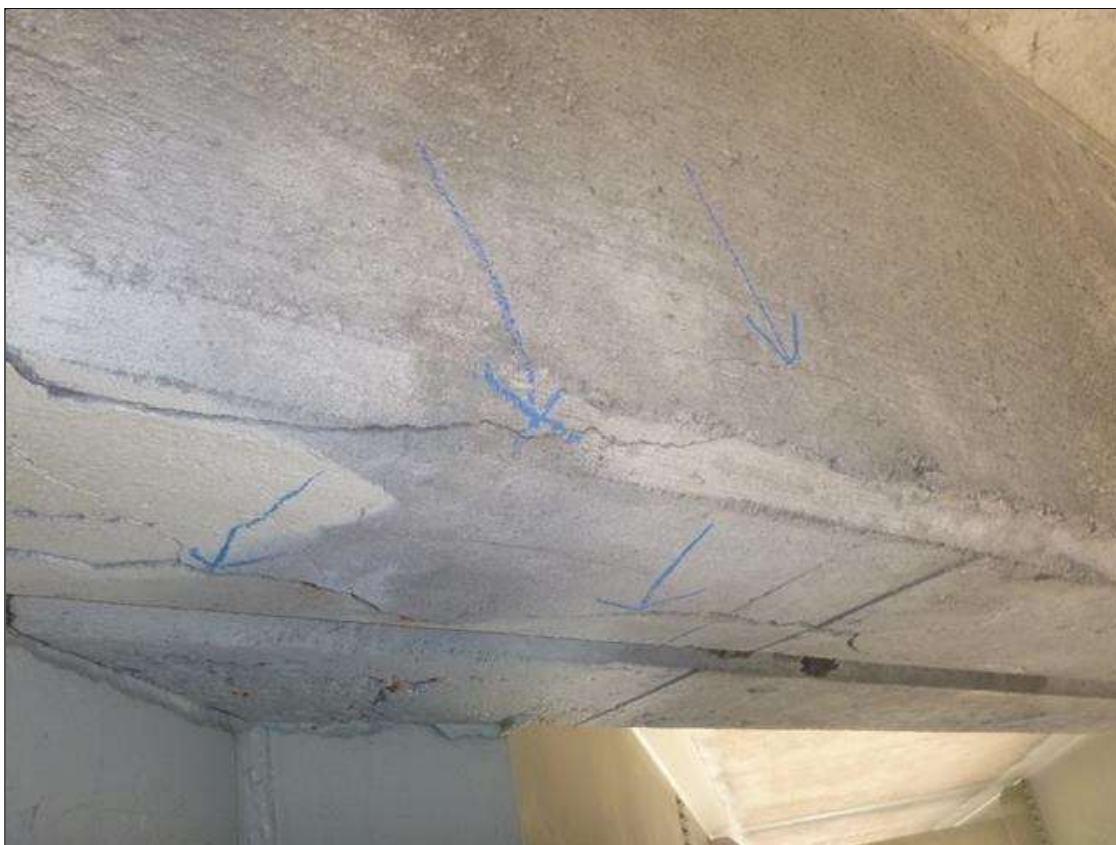
SPAN 3, BENT 2, BAY 1, BENT DIAPHRAGM HAS A CRACK ON THE BOTTOM, 1/4 IN. WIDE X FULL LENGTH

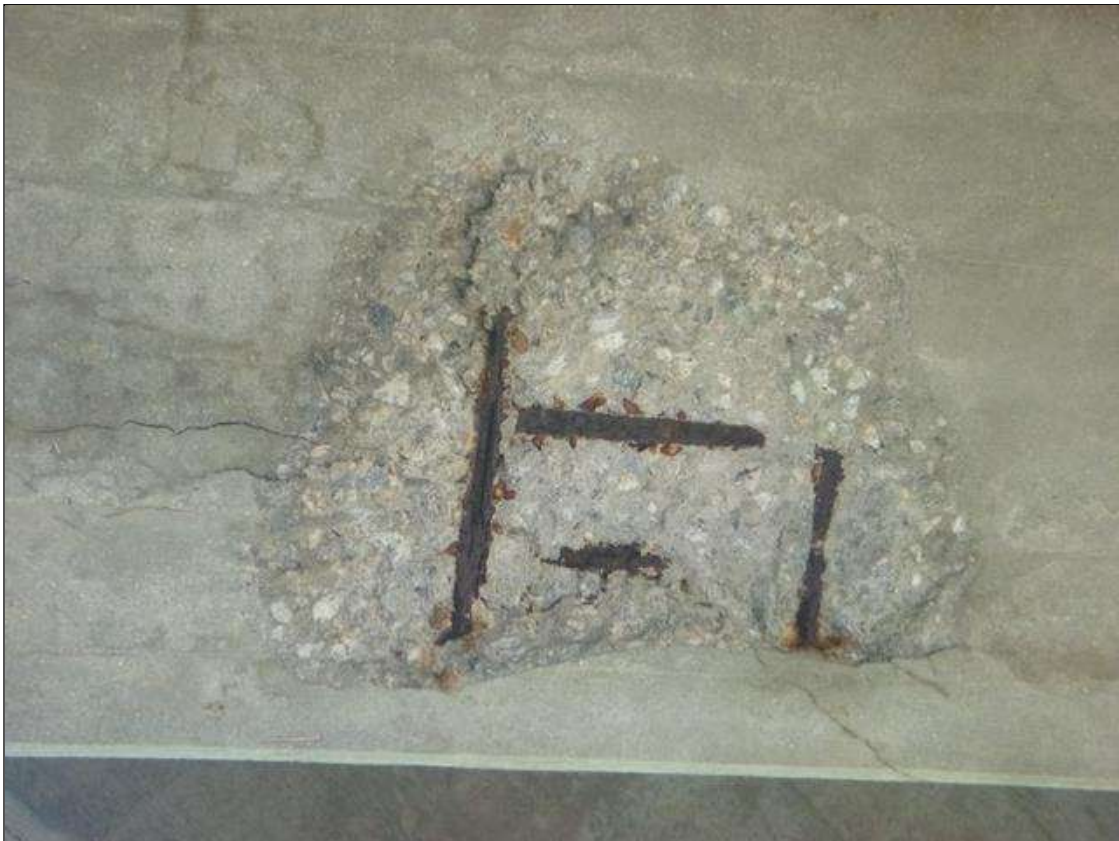
Bent 2 Cap 1: BENT 2 CAP, BETWEEN COLUMNS 2 AND 3, SPALL, 2 FT. IN DIAMETER X 3 IN. DEEP WITH REBAR EXPOSED

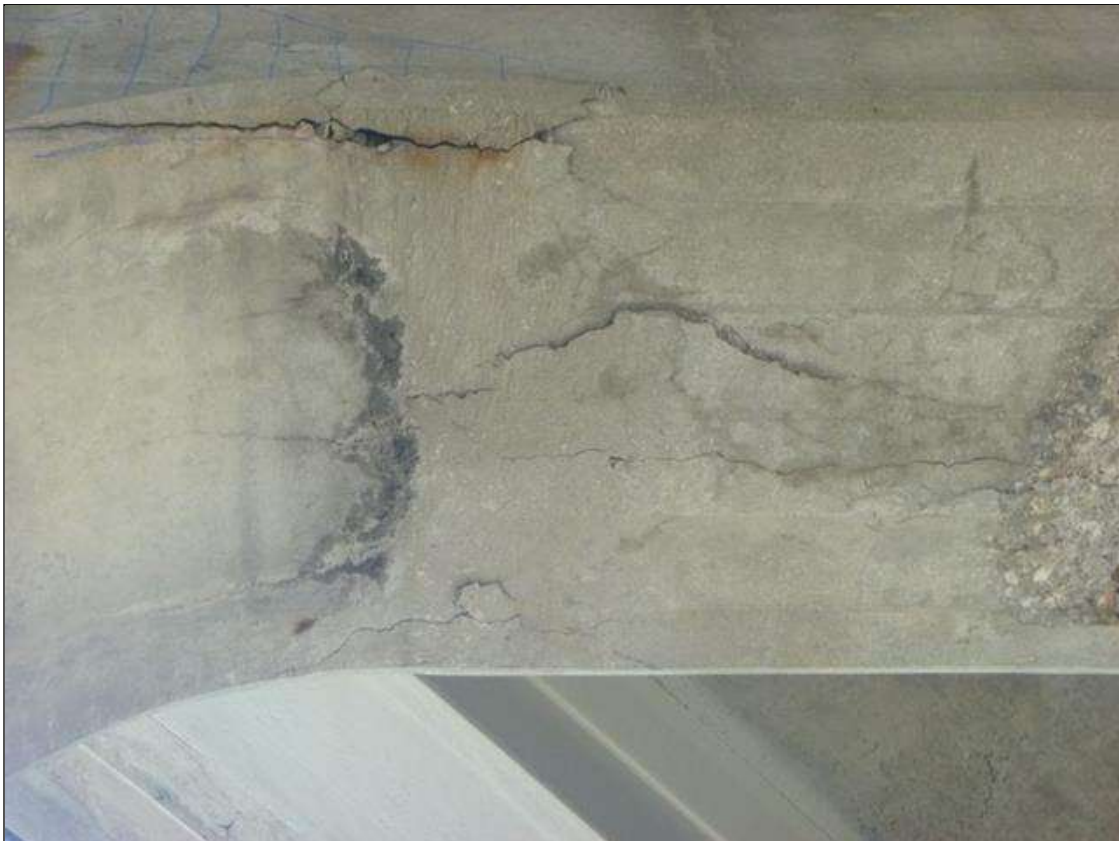
Bent 2 Cap 1: BENT 2 CAP, BETWEEN COLUMNS 2 AND 3 HAS AN AREA OF DELAMINATION ON THE BOTTOM OF THE CAP, 33 IN. WIDE X 4 FT. LONG

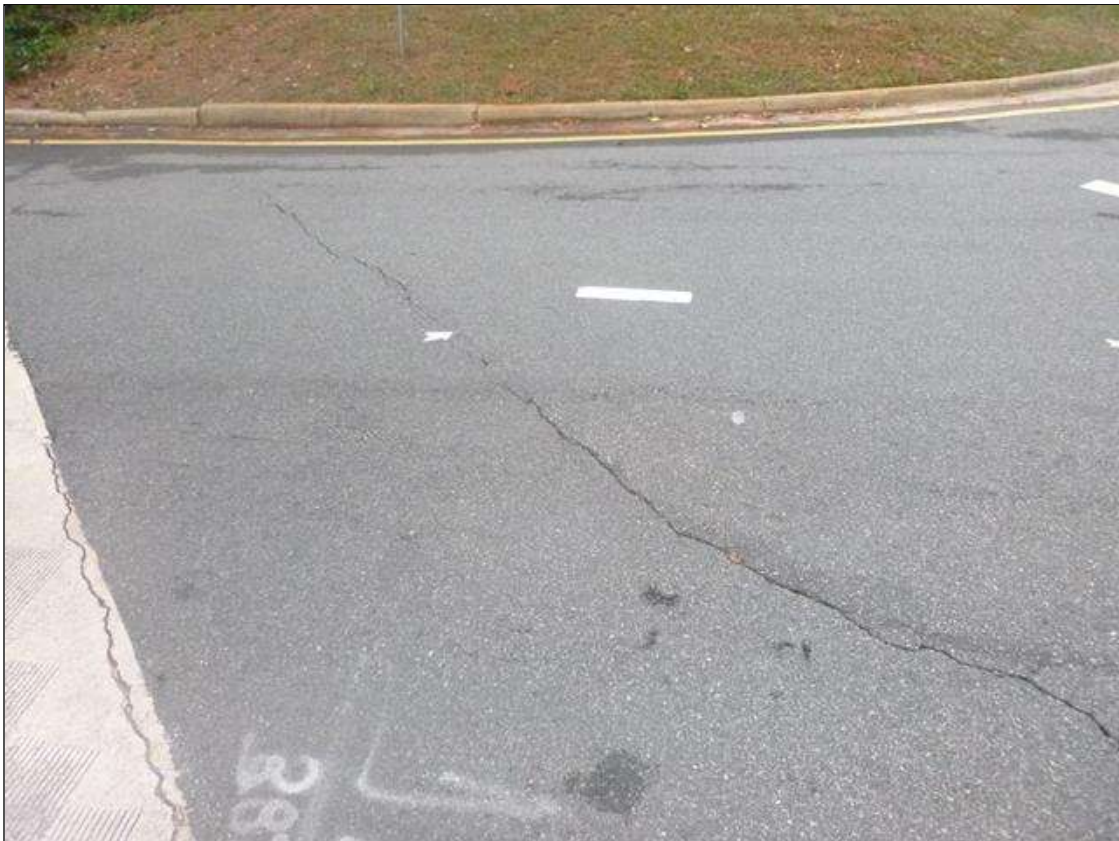
END BENT 2 APPROACH HAS 23 SQ. FT. OF 1/2 IN. WIDE TRANSVERSE CRACKING

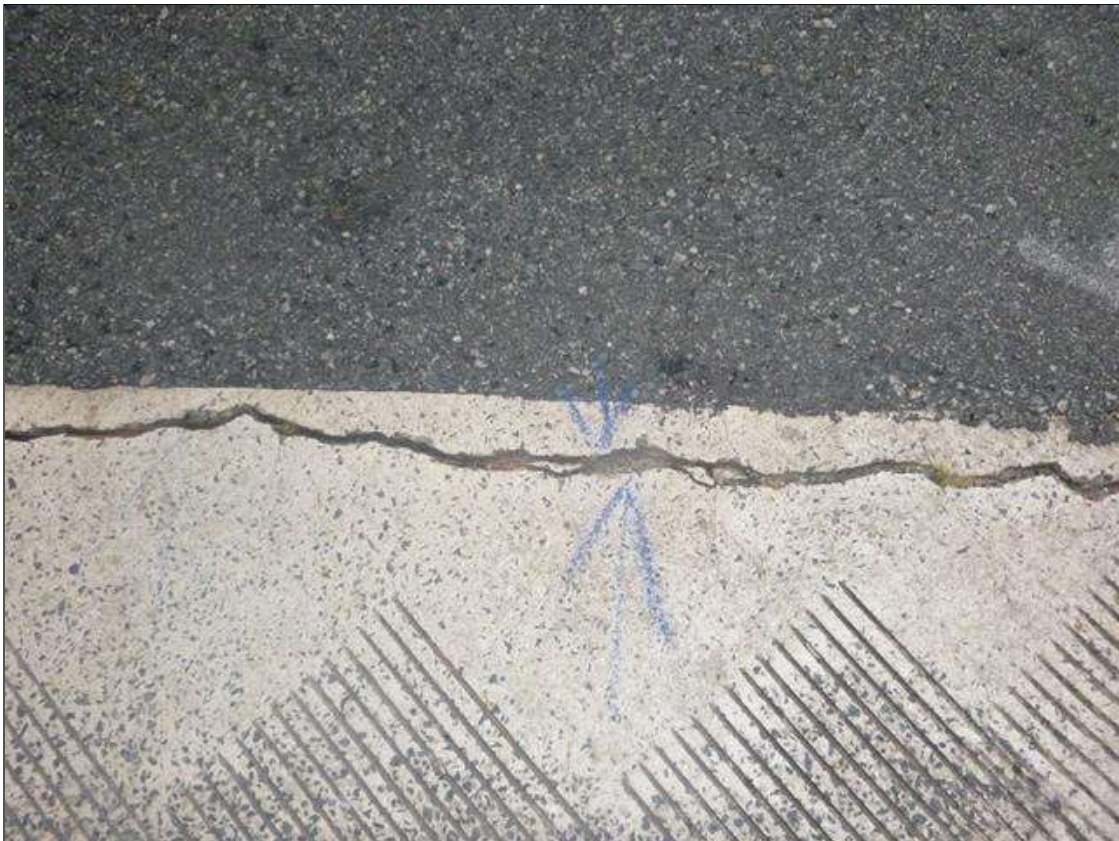
Span 5 Deck: SPAN 5, TOP OF DECK HAS A TRANSVERSE CRACK UP TO 1 IN. WIDE X 9 FT. LONG IN THE RIGHT LANE, ADJACENT TO END BENT 2 JOINT

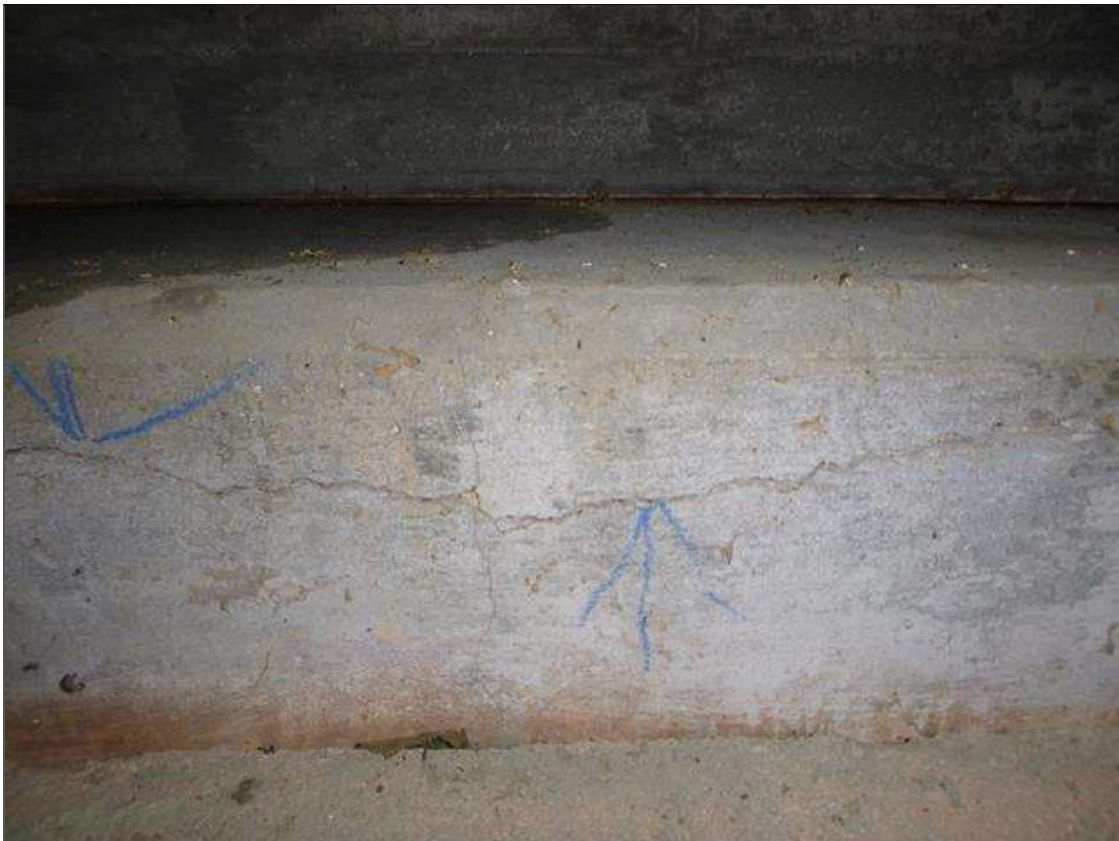
End Bent 2 Cap 1: END BENT 2 CAP, BAY 1 HAS A HORIZONTAL CRACK IN THE FACE OF THE CAP, NEAR TOP EDGE, UP TO 1/8 IN. WIDE X 6 FT. LONG

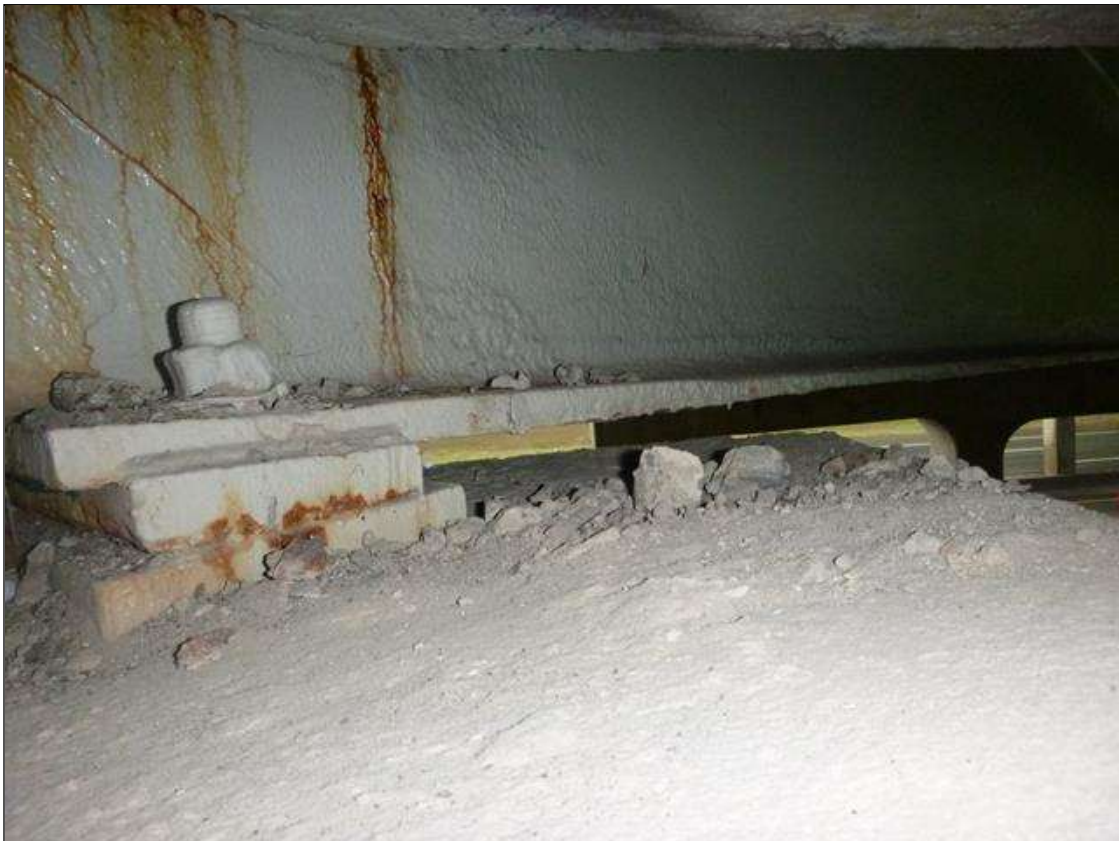
Span 4 Beam 1: SPAN 4, BEAM 1 HAS UP TO 3/16 IN. SECTION LOSS FROM PREVIOUS RUST ON THE BOTTOM FLANGE X FULL WIDTH X 5 FT. LONG. BEAM HAS BEEN CLEANED AND PAINTED.

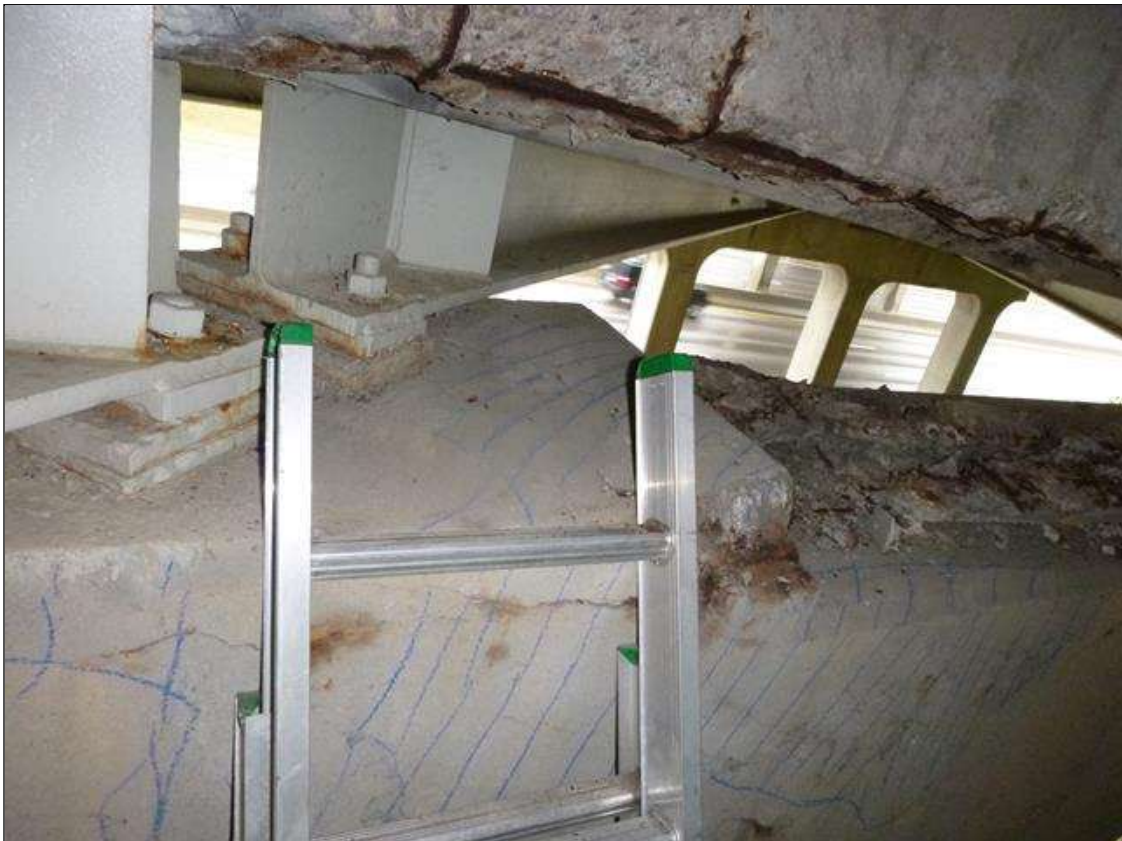
Bent 4 Cap 1: BENT 4 CAP SPAN 5 SIDE HAS AN AREA OF DELAMINATION IN THE FACE OF THE CAP, IN BAY 2, 7 FT. LONG X 2.83 FT. ACROSS THE TOP X 3 FT. DOWN THE FACE

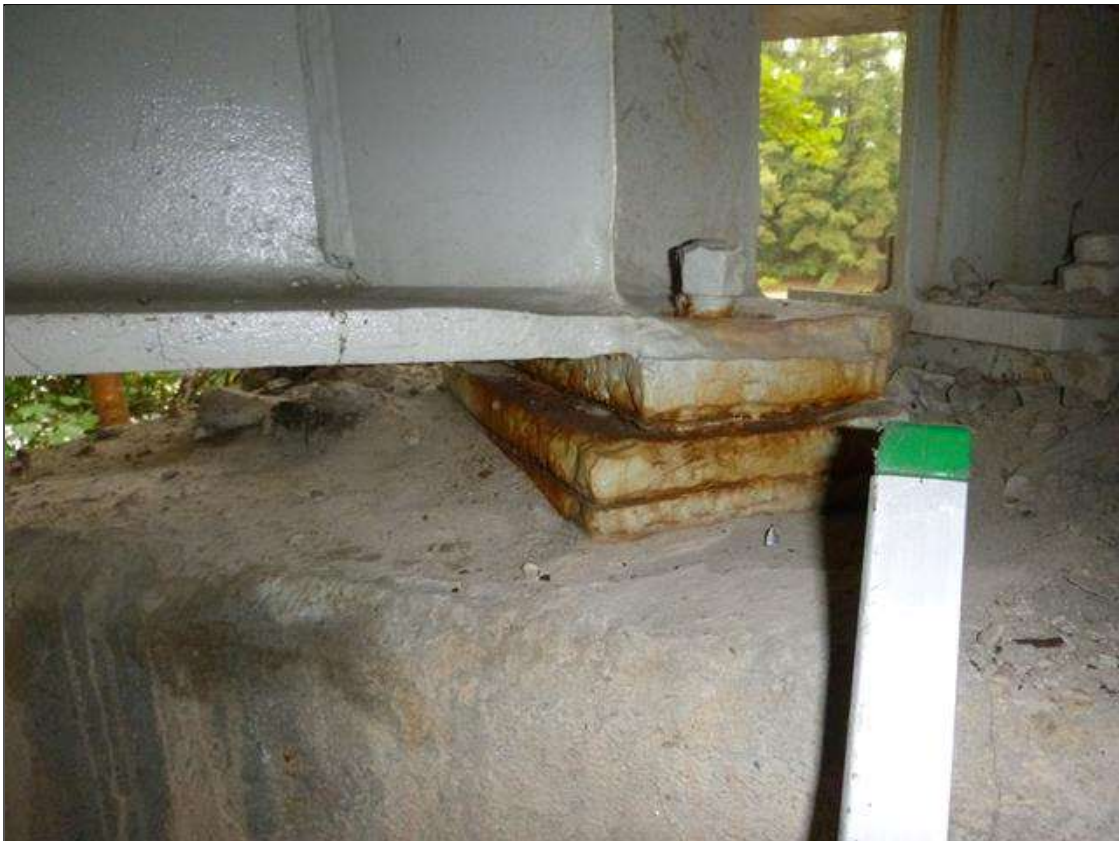
Span 5 Beam 4 Near Bearing: SPAN 5, BEAM 4, NEAR BEARING, HAS 1/8 IN. SECTION LOSS FROM PREVIOUS RUST AND PACK RUST STARTING

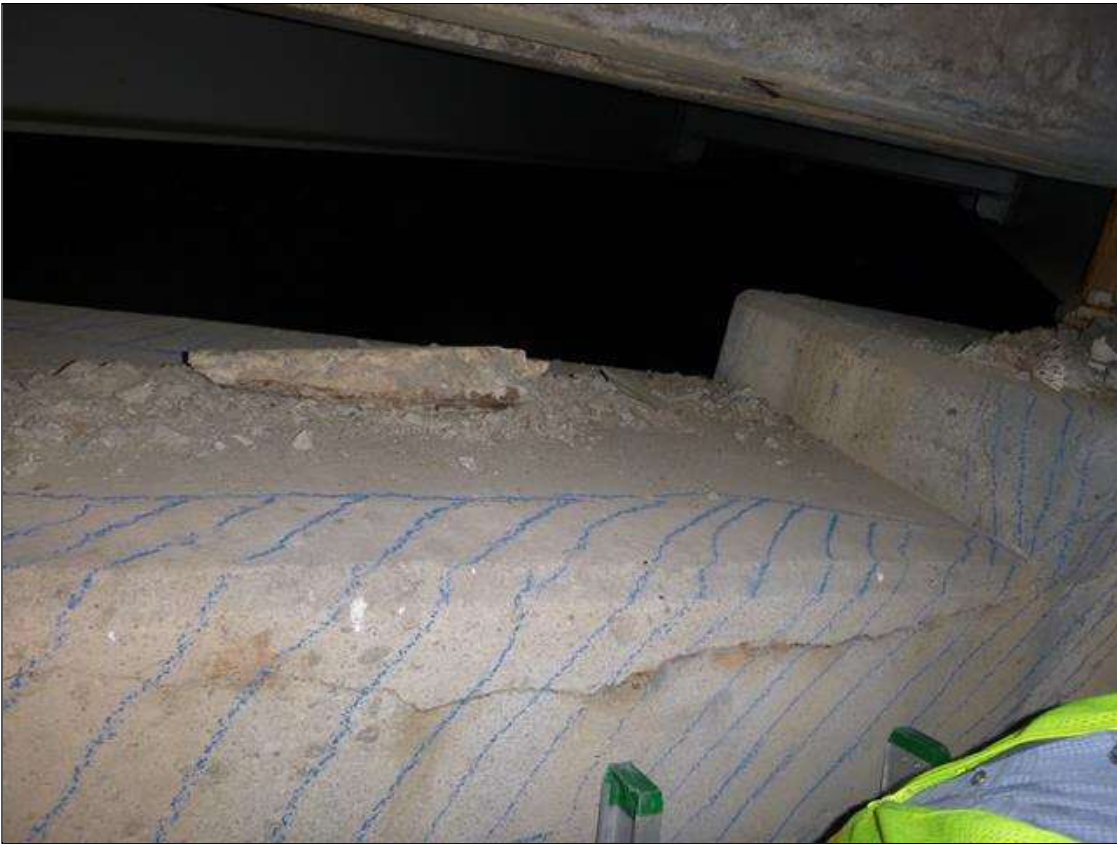
Bent 4 Cap 1: BENT 4 CAP, SPAN 4 SIDE HAS AN AREA OF DELAMINATION ON THE FACE OF THE CAP, 6 FT. LONG X 2 FT. DOWN THE FACE X 6 IN. ACROSS THE TOP, IN BAY 1, ADJACENT TO BEAM 2

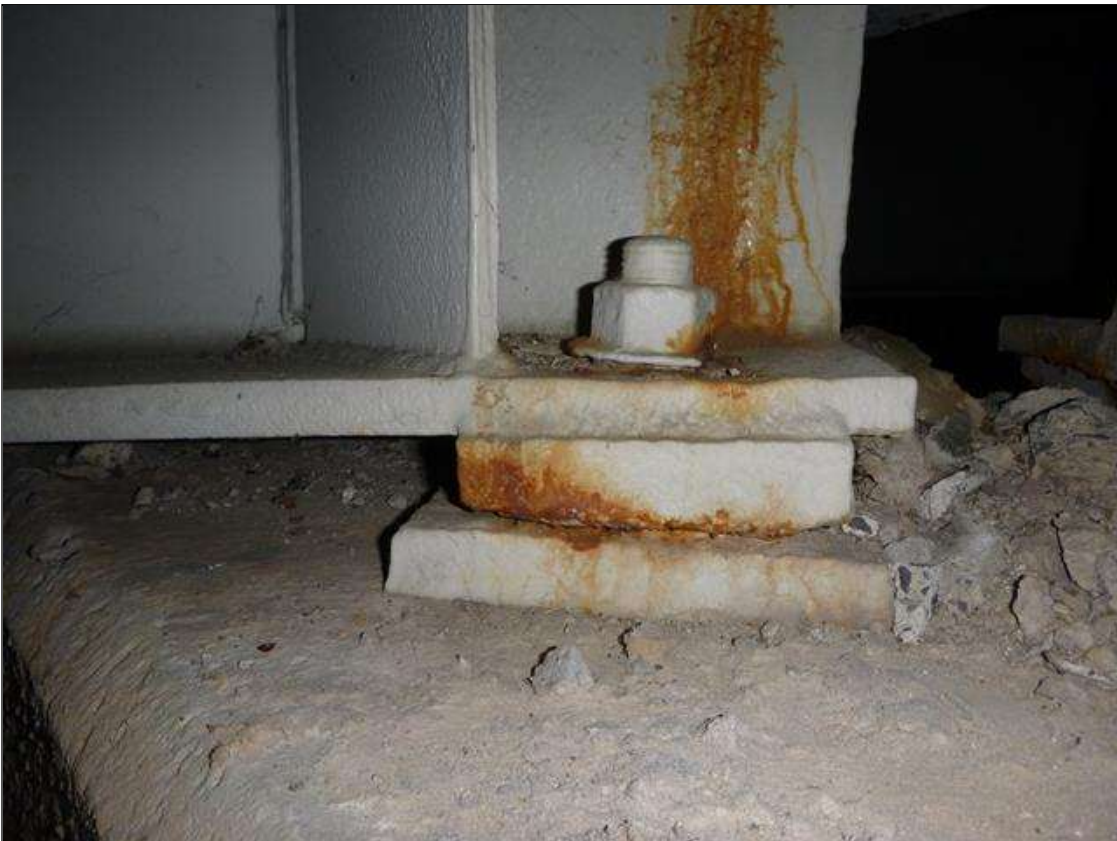
Span 4 Beam 2 Far Bearing: SPAN 4, BEAM 2, FAR BEARING, HAS 1/16 IN. SECTION LOSS FROM PREVIOUS RUST, BEARING HAS BEEN CLEANED AND PAINTED. FRECKLED RUST IS STARTING

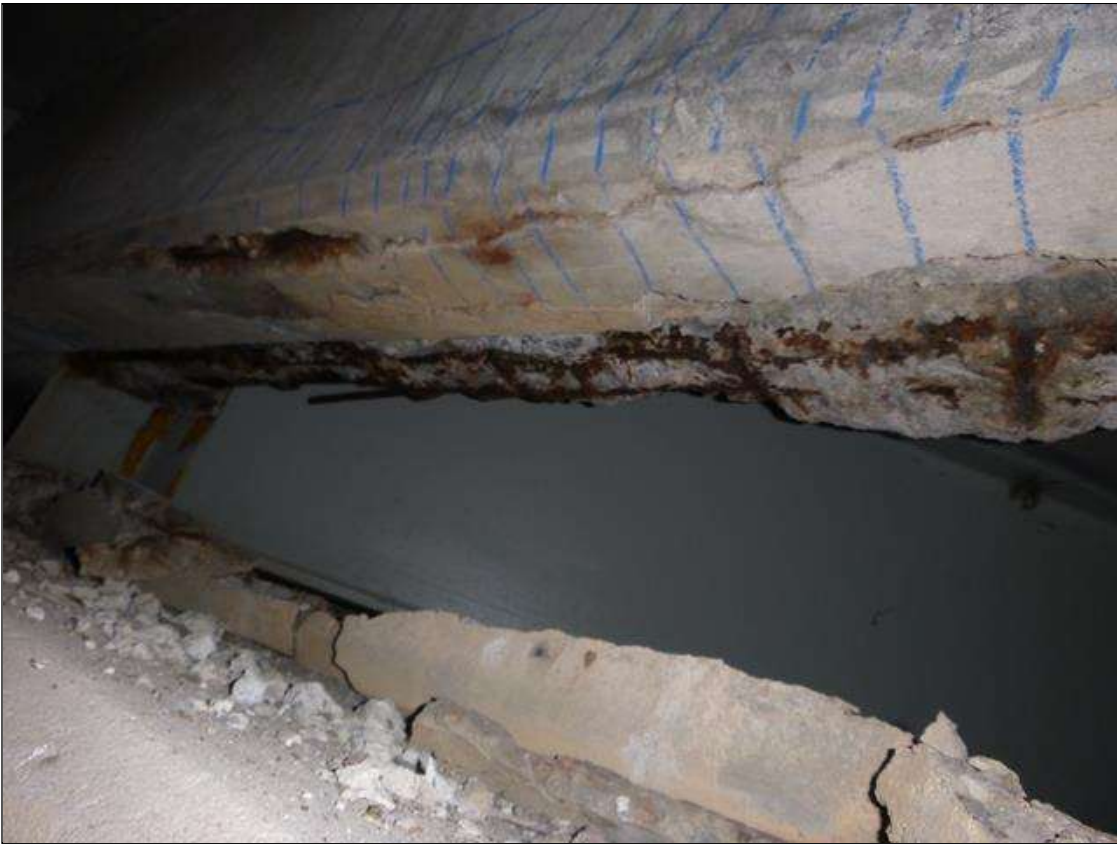
SPAN 4, BENT 4, BAY 2 BENT DIAPHRAGM HAS DELAMINATION ON THE BOTTOM, FULL WIDTH X 6 IN. UP THE FACE, WITH A SPALL, 2 FT. LONG X 3 IN. WIDE X 2 IN. DEEP WITH EXPOSED REBAR

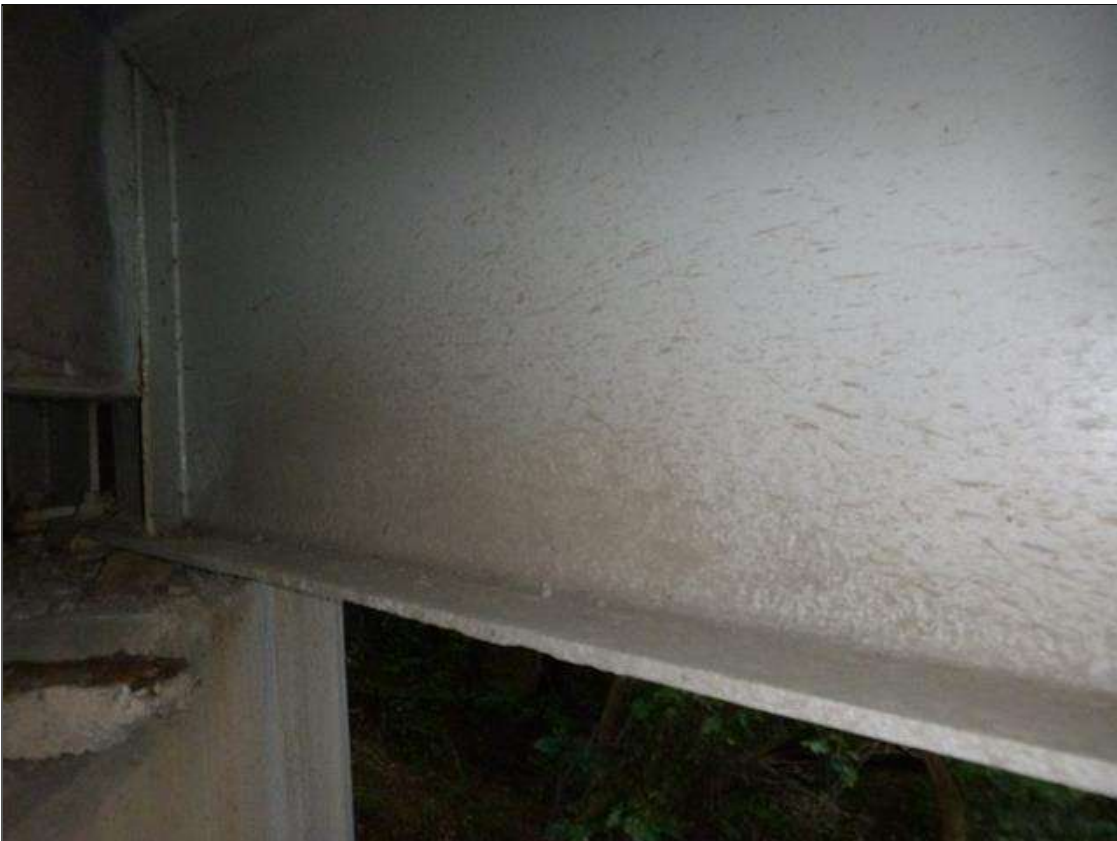
Span 4 Beam 4: SPAN 4, BENT 4, BEAM 4 HAS UP TO 3/16 IN. SECTION LOSS FROM PREVIOUS RUST ON THE BOTTOM FLANGE X FULL WIDTH X 10 FT. LONG. BEAM HAS BEEN CLEANED AND PAINTED.

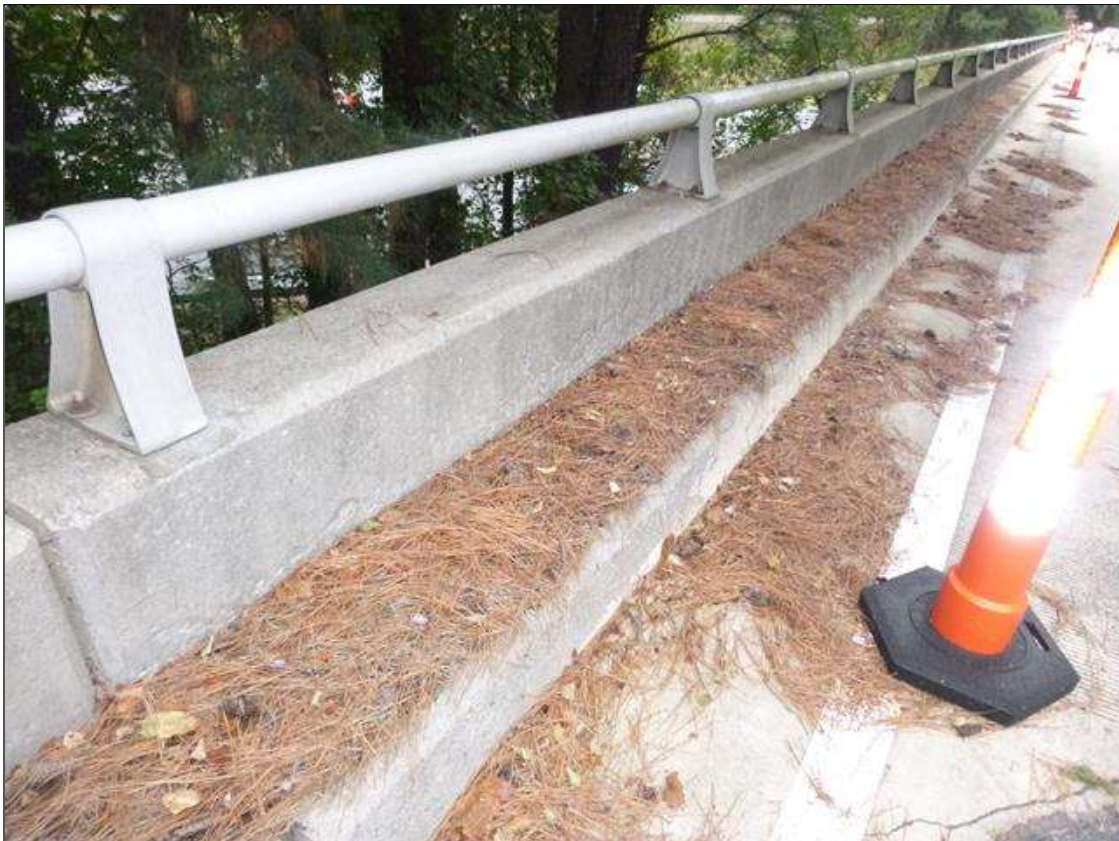
DEBRIS ON BOTH SIDES OF THE DECK IN SPANS 1 AND 5

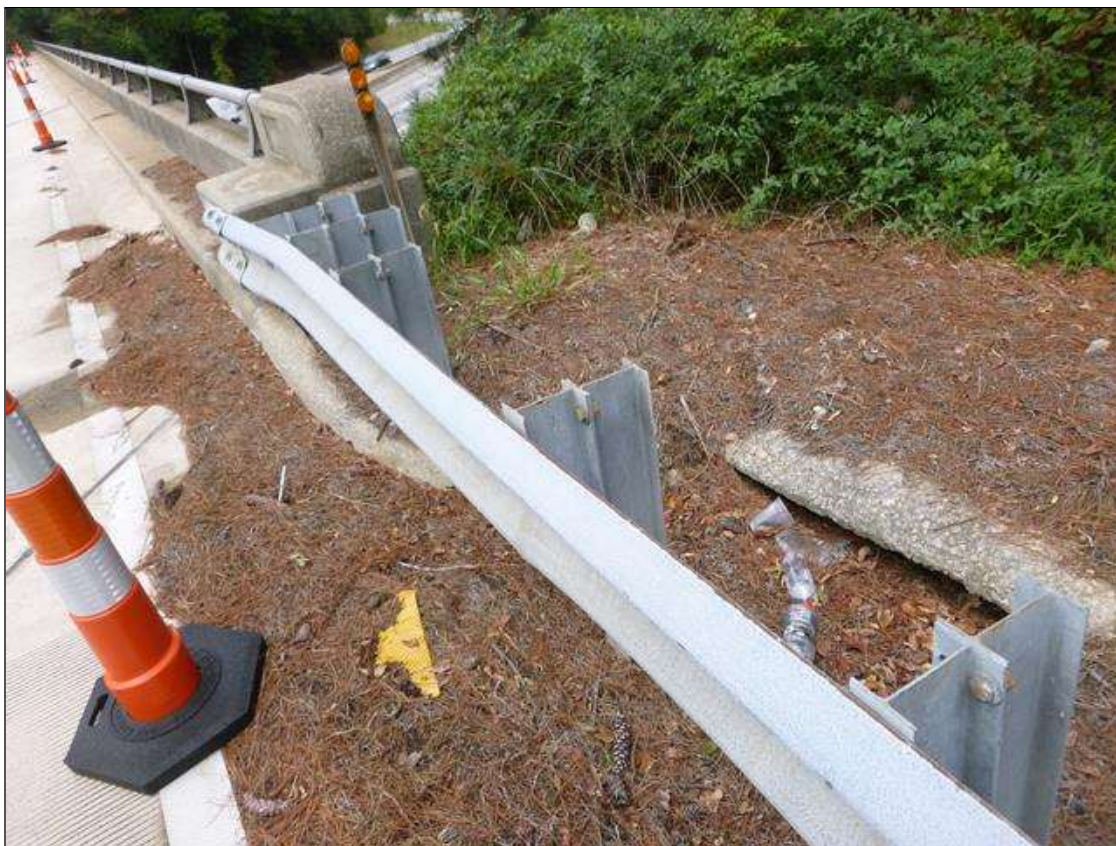
DRAIN AT THE SOUTH WEST CORNER OF THE BRIDGE IS PARTIALLY CLOGGED WITH DEBRIS

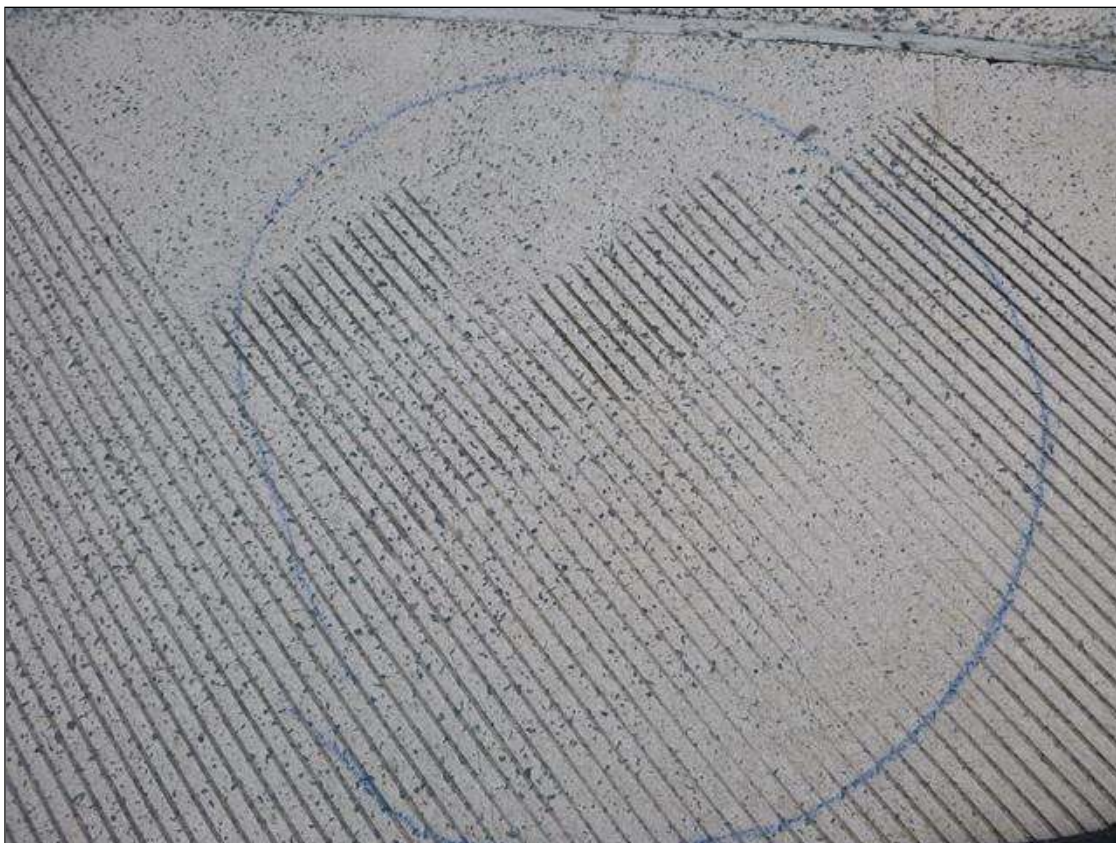
Approach 1: APPROACH SLAB 1 HAS 250 SQ. FT. OF HAIRLINE MAP CRACKING THRU OUT SLAB

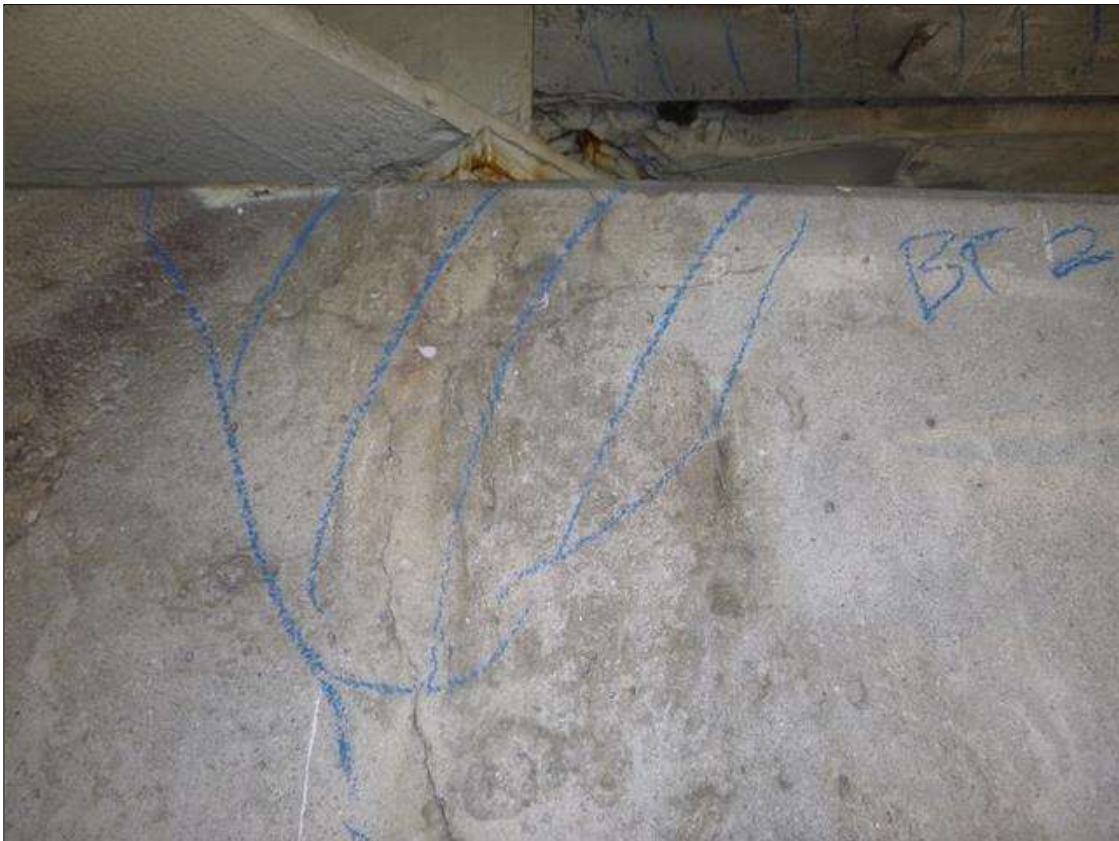
Bent 2 Cap 1: BENT 2 CAP, SPAN 2 SIDE HAS AN AREA OF DELAMINATION IN THE FACE OF THE CAP IN BAY 1, NEAR GIRDER 1, 14 IN. LONG X 12 IN. HIGH, WITH HAIRLINE VERTICAL CRACKING

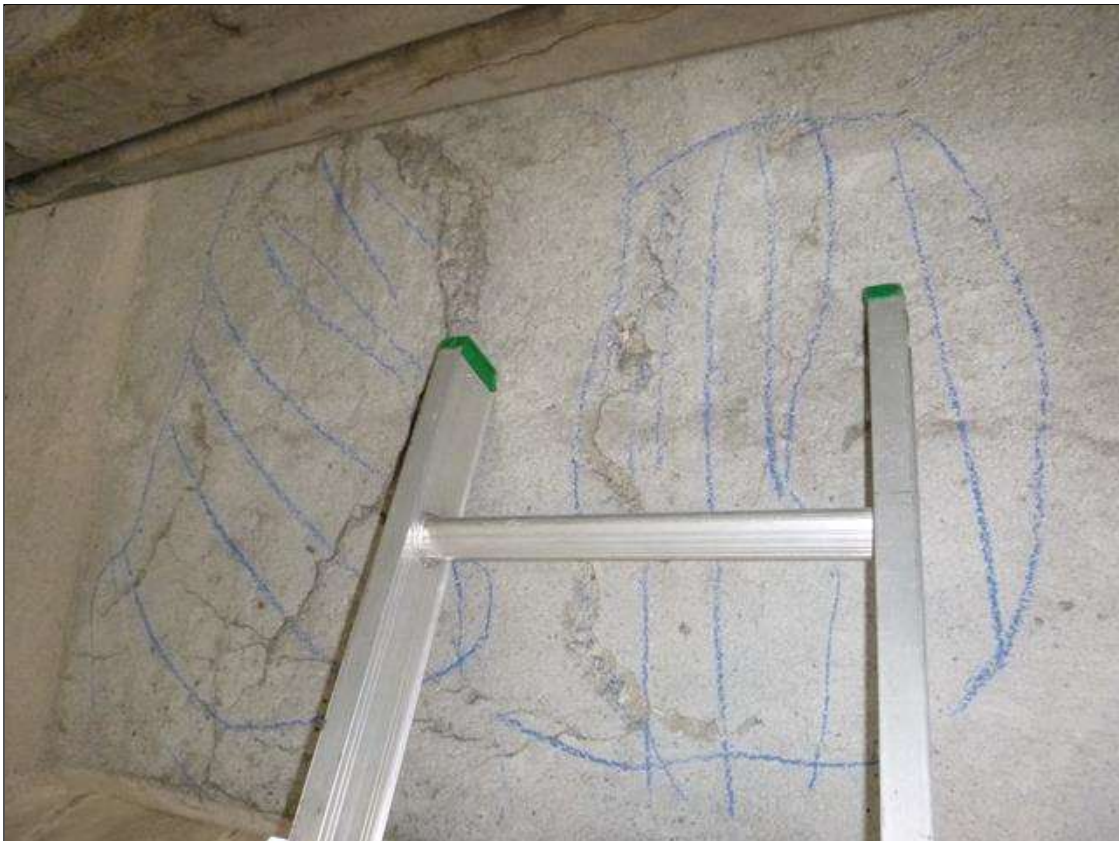
Bent 2 Cap 1: BENT 2 CAP, SPAN 2 SIDE HAS AN AREA OF DELAMINATION IN THE FACE OF THE CAP IN BAY 1, 3 FT. LONG X 2 FT. HIGH WITH 1/8 IN. WIDE CRACKING

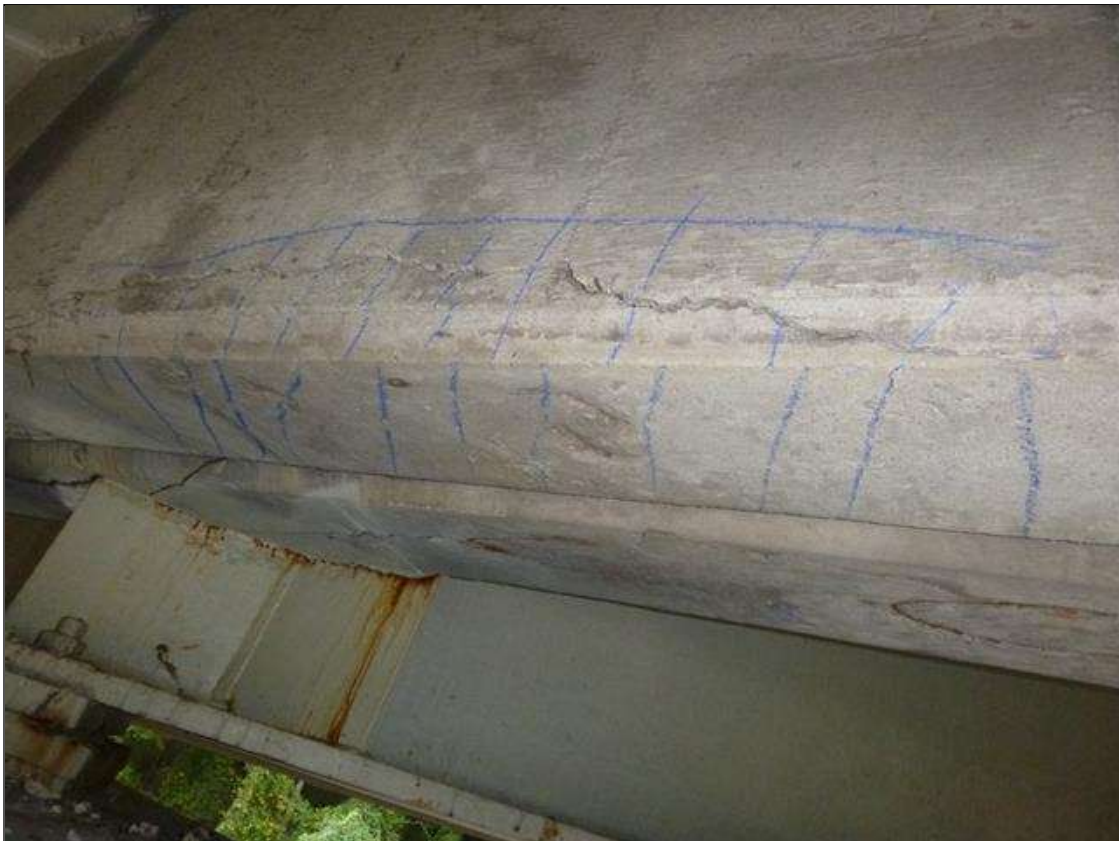
SPAN 2, BENT 2, BAY 2, BENT DIAPHRAGM HAS AN AREA OF DELAMINATION ON THE BOTTOM, 3 FT. LONG X FULL WIDTH X 4 IN. HIGH ON THE FACE

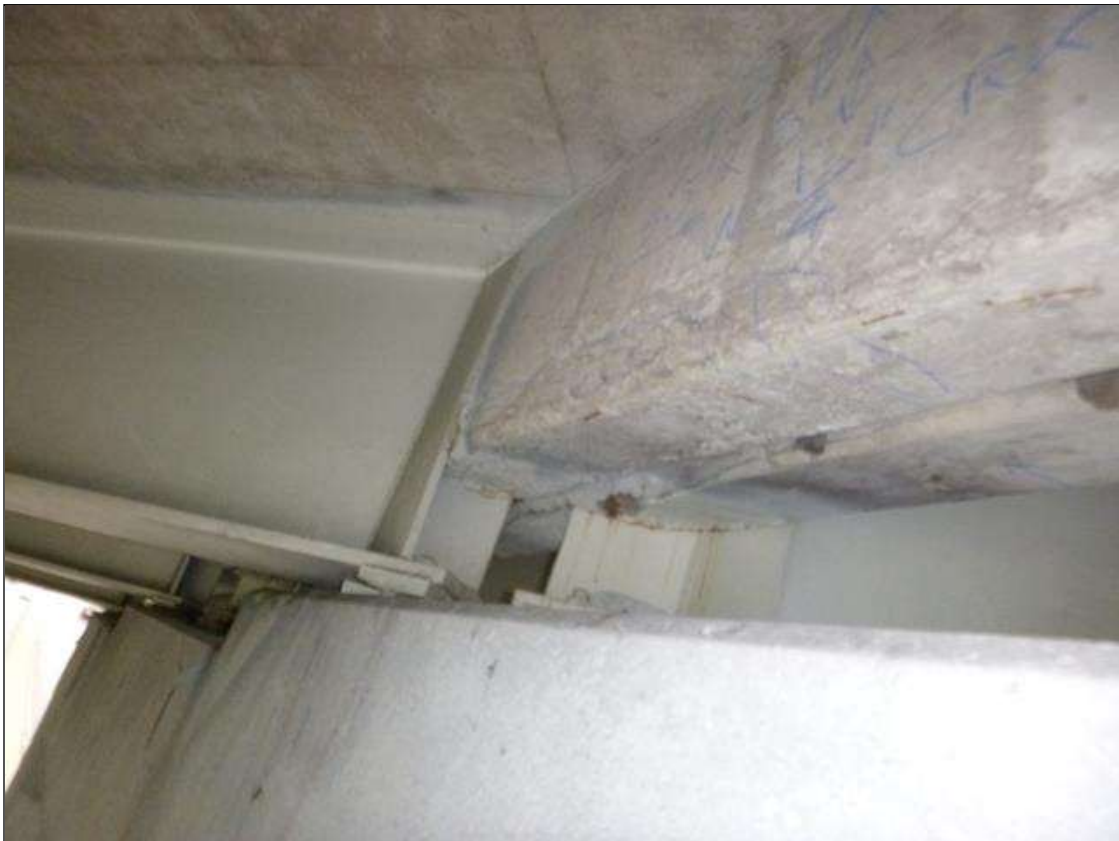
SPAN 2, BENT 2, BAY 3, BENT DIAPHRAGM HAS AN AREA OF DELAMINATION ON THE BOTTOM, 3.5 FT. LONG X FULL WIDTH X 5 IN. HIGH ON THE FACE, WITH 1/4 IN. WIDE CRACKING

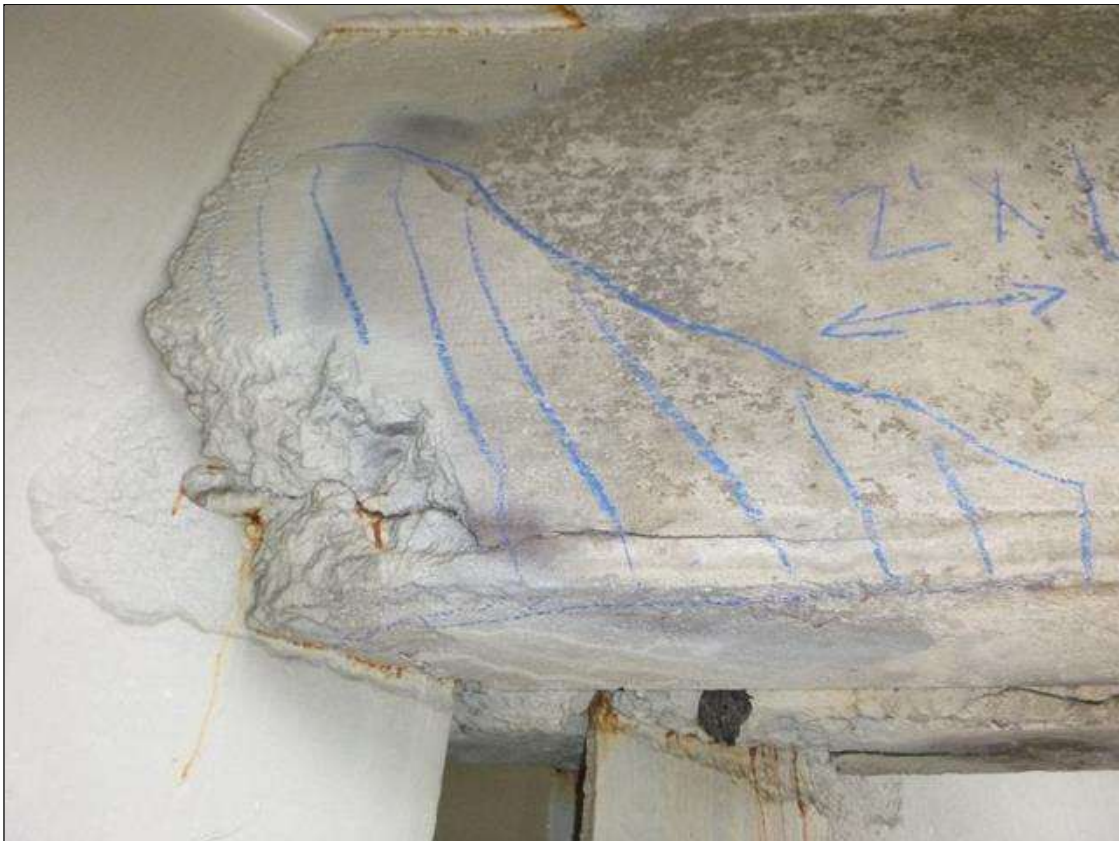
SPAN 2, BENT 2, BENT DIAPHRAGM IN THE RIGHT OVERHANG HAS A SPALL, 8 IN. LONG X 10 IN. HIGH X 4 IN. DEEP WITH REBAR EXPOSED

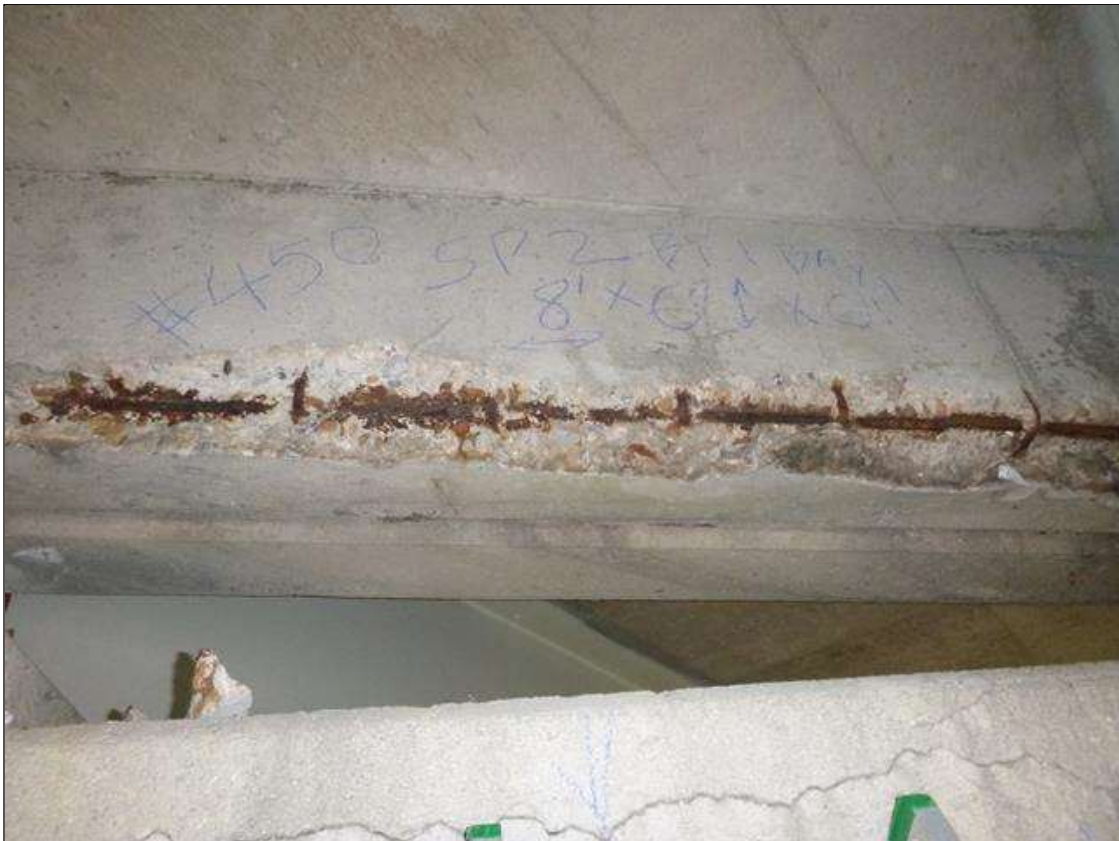
SPAN 2, BENT 1, BAY 1, BENT DIAPHRAGM HAS A SPALL ON THE BOTTOM CORNER, 8 FT. LONG X 6 IN. HIGH ON THE FACE X 6 IN. ACROSS THE BOTTOM, WITH REBAR EXPOSED
