NC DEPARTMENT OF TRANSPORTATION  
DIVISION OF HIGHWAYS  
STRUCTURE MANAGEMENT UNIT

## Structure Safety Report

### Routine Element Inspection - Contract

COUNTY: WAKE STRUCTURE NUMBER: 910252 FREQUENCY: 24 MONTHS

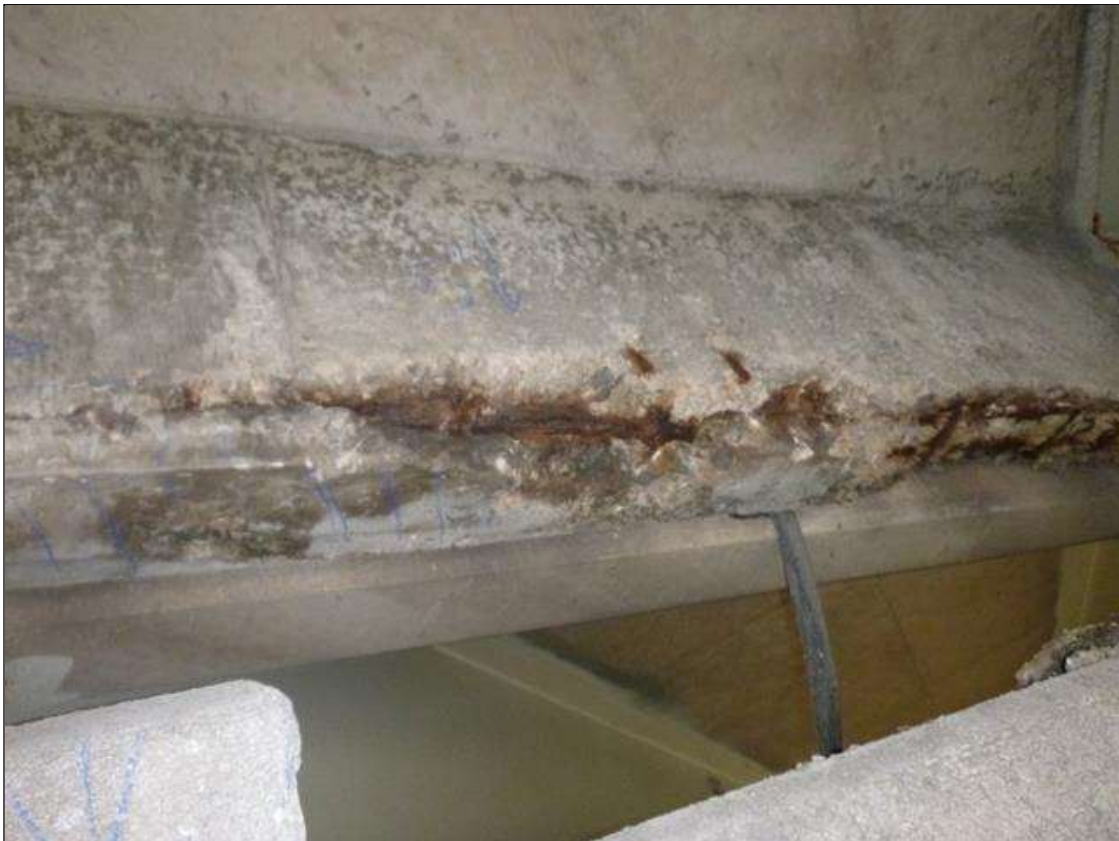
SPAN 2, BENT 1, BAY 2, BENT DIAPHRAGM HAS AN AREA OF DELAMINATION ON THE BOTTOM, 3 FT. LONG X FULL WIDTH X 5 IN. HIGH, WITH SPALL 6 FT. LONG X FULL WIDTH X 5 IN. DEEP WITH REBAR EXPOSED

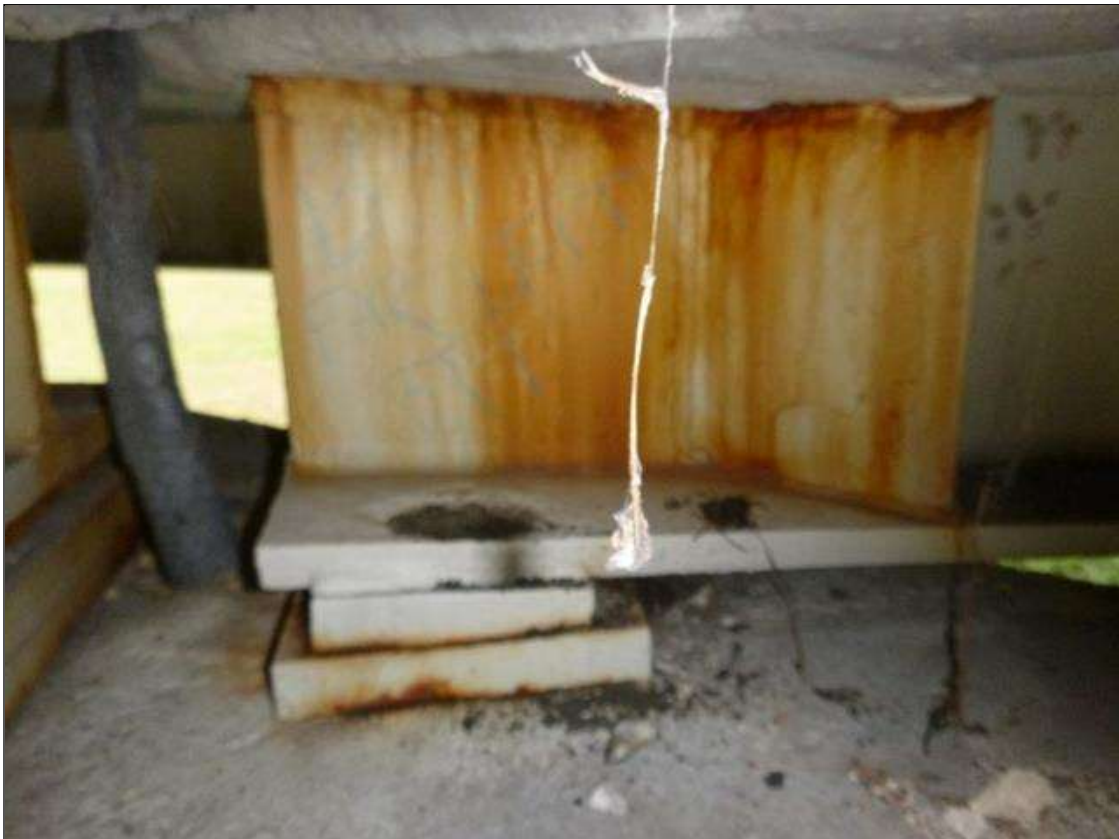
Span 1 Beam 3 Far Bearing: SPAN 1, BEAM 3, FAR BEARING, BOTH ANCHORS ARE MISSING

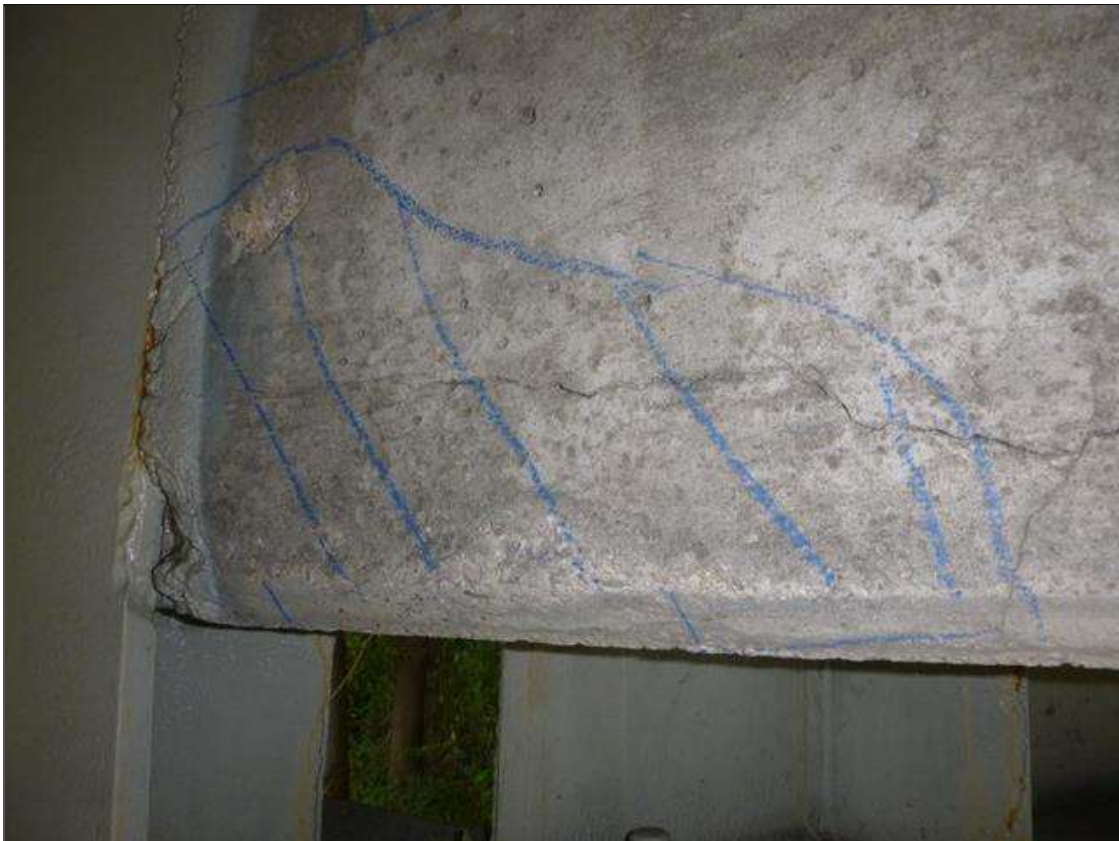
SPAN 3, BENT 3, BAY 1, BENT DIAPHRAGM HAS AN AREA OF DELAMINATION ON THE FACE NEAR BEAM 1, 16 IN. LONG X 8 IN. HIGH, WITH 1/16 IN. WIDE ADJACENT CRACKING

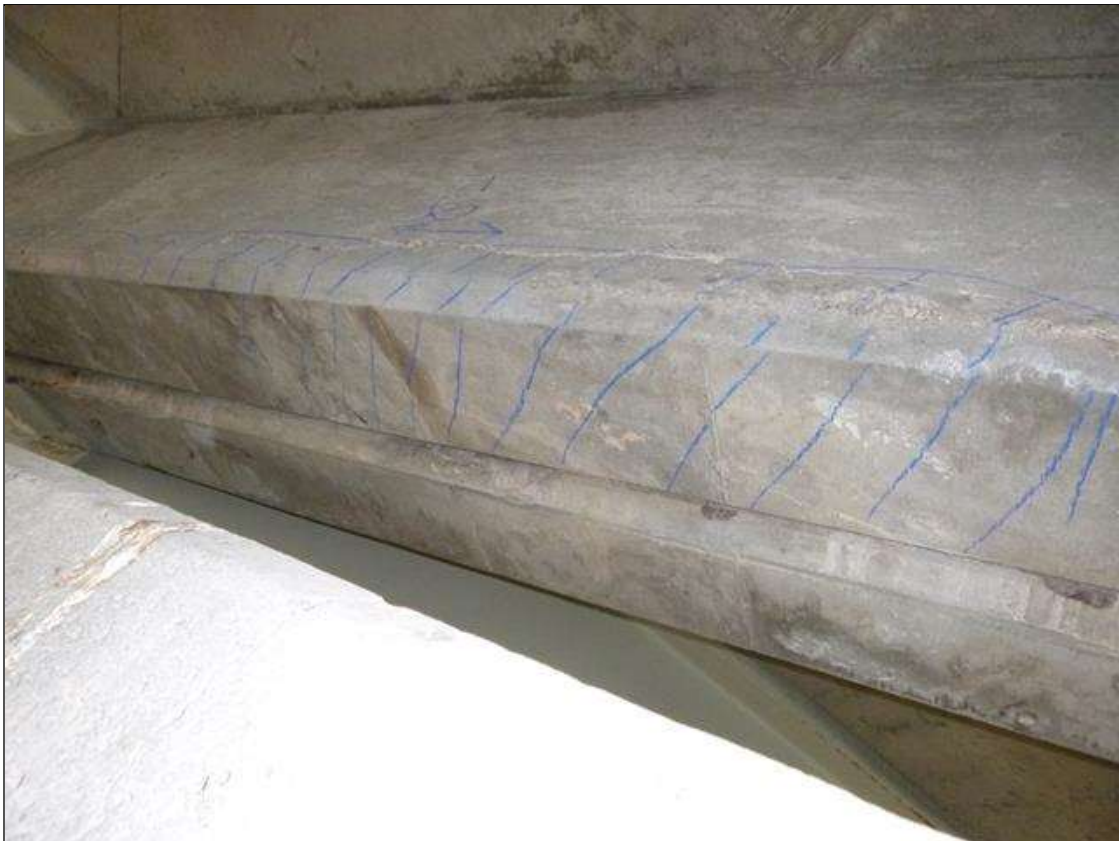
SPAN 3, BENT 3, BAY 2, BENT DIAPHRAGM, HAS AREA OF DELAMINATION ON THE BOTTOM, FULL WIDTH X 5 IN. HIGH X 6 FT. LONG, WITH 1/16 IN. WIDE CRACKING

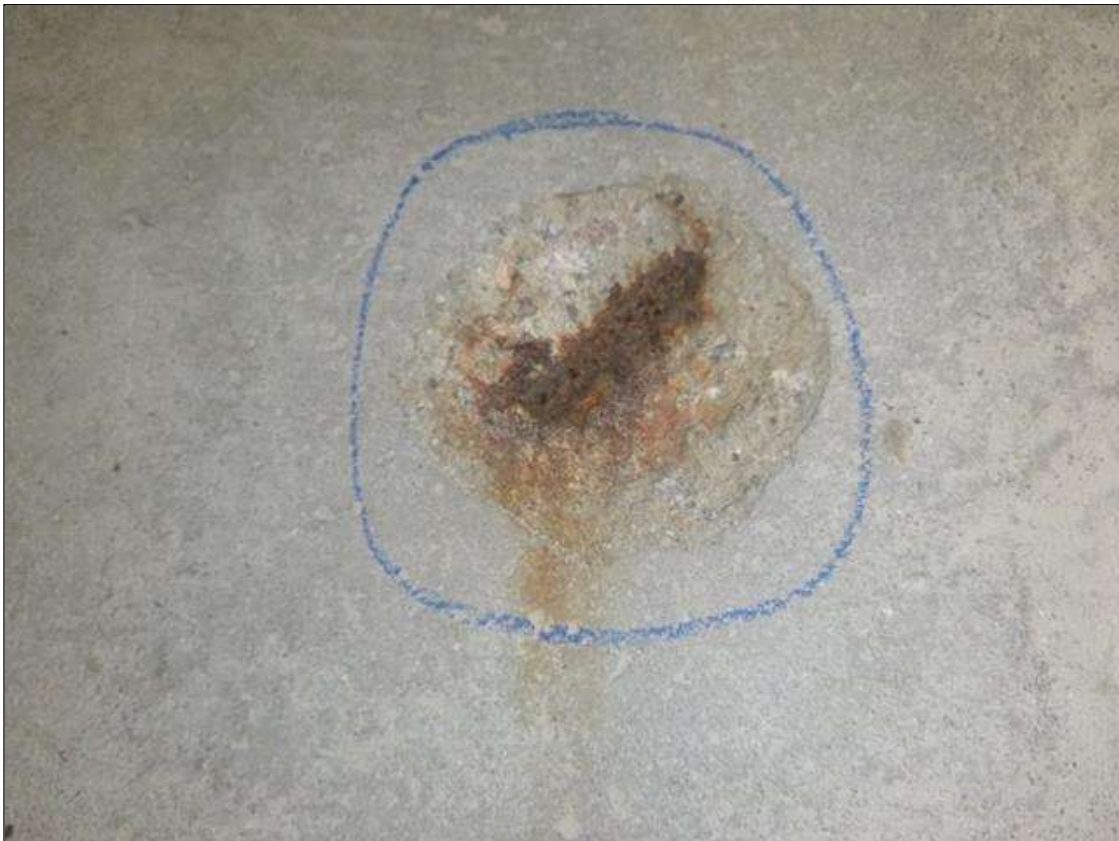
Bent 3 Pile 2: BENT 3, PILE 2 HAS A 6 IN. X 1/2 IN. DEEP DIAMETER SPALL ON THE EAST FACE, 1 FT. BELOW THE BOTTOM OF THE CAP WITH REBAR EXPOSED

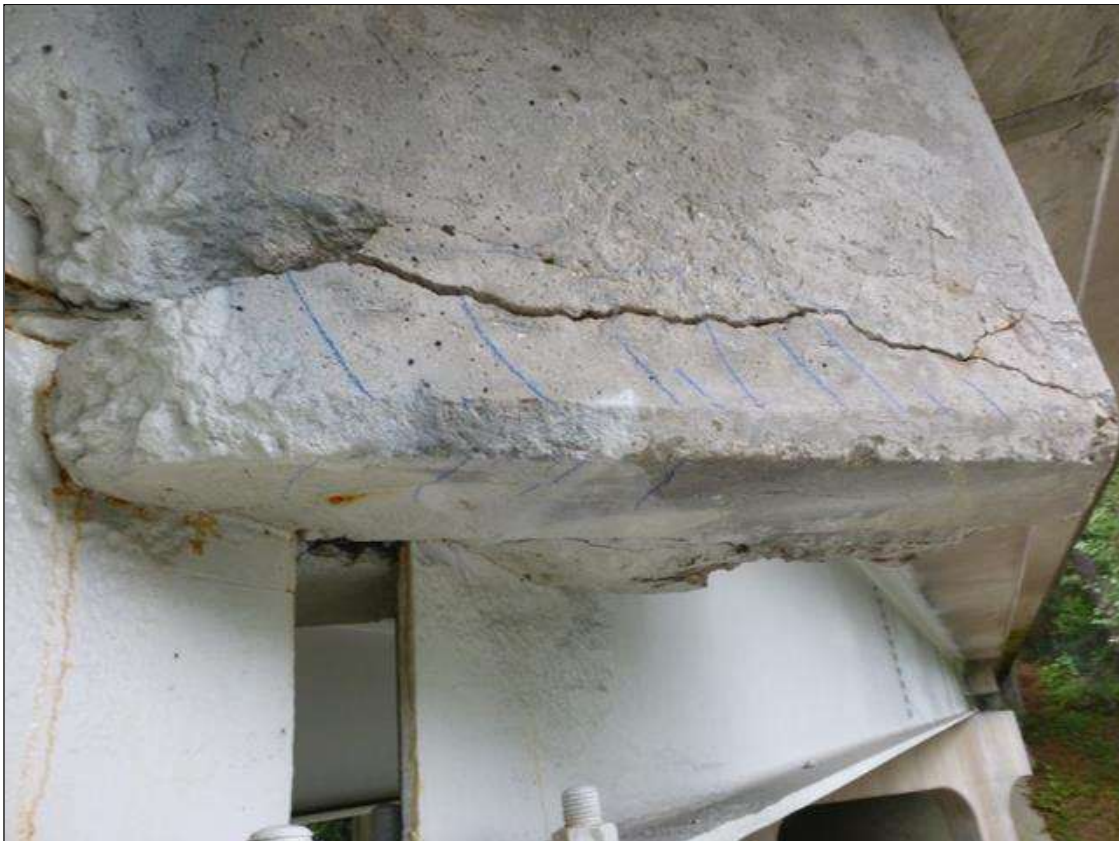
SPAN 3, BENT 3, BENT DIAPHRAGM IN THE RIGHT OVERHANG HAS A SPALL, 8 IN. WIDE X 1 FT. HIGH X 4 IN. DEEP, WITH REBAR EXPOSED, WITH ADJACENT DELAMINATION, 2.5 FT. WIDE X 6 IN. HIGH

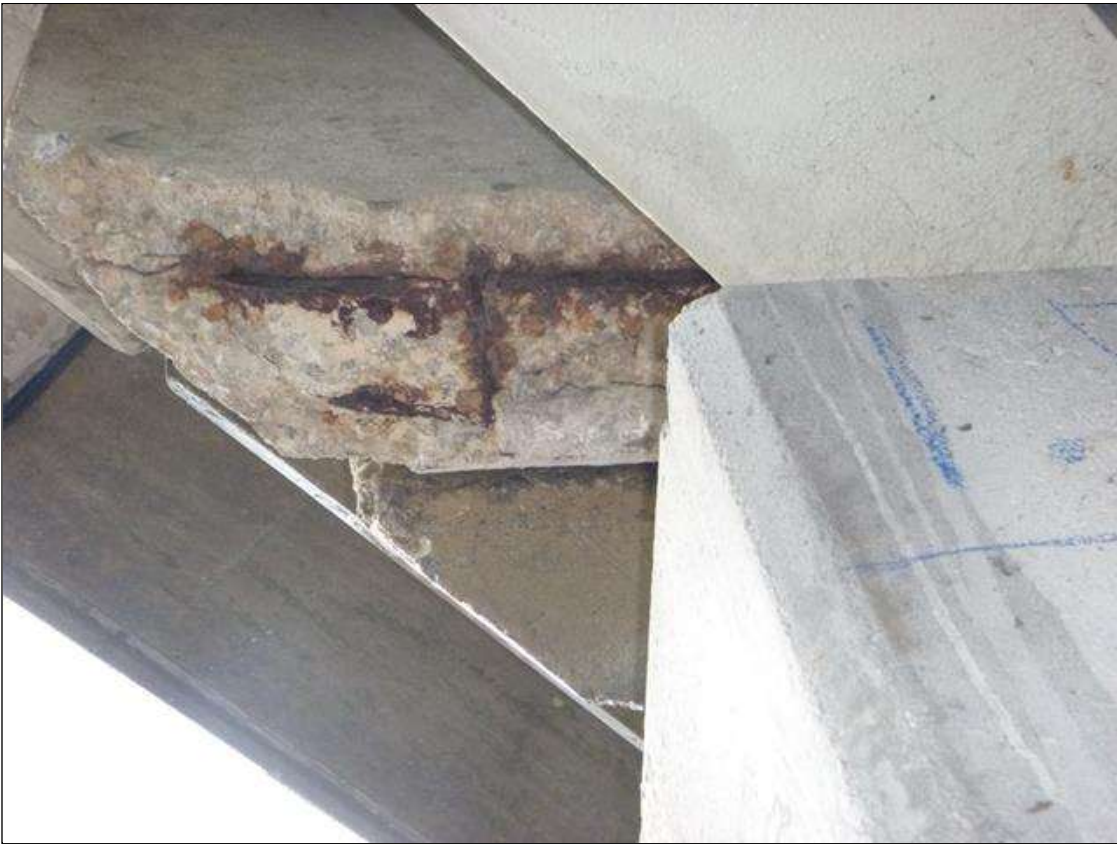
SPAN 4, BENT 3, BENT DIAPHRAGM IN THE RIGHT OVERHANG HAS A SPALL, 2.5 FT. LONG X 6 IN. HIGH X FULL DEPTH, WITH REBAR EXPOSED

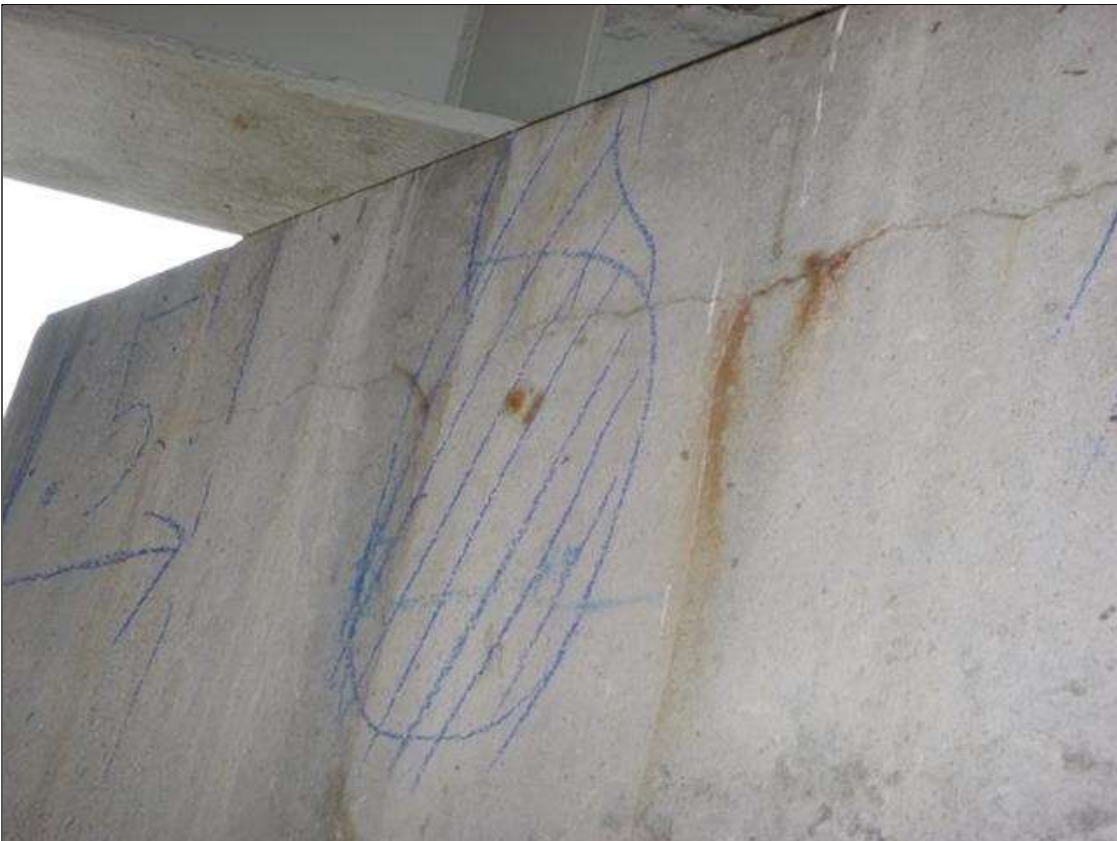
Bent 3 Cap 1: BENT 3 CAP, SPAN 4 SIDE HAS AN AREA OF DELAMINATION IN THE FACE OF THE CAP IN BAY 3, NEAR GIRDER 4, 10 IN. WIDE X 20 IN. LONG

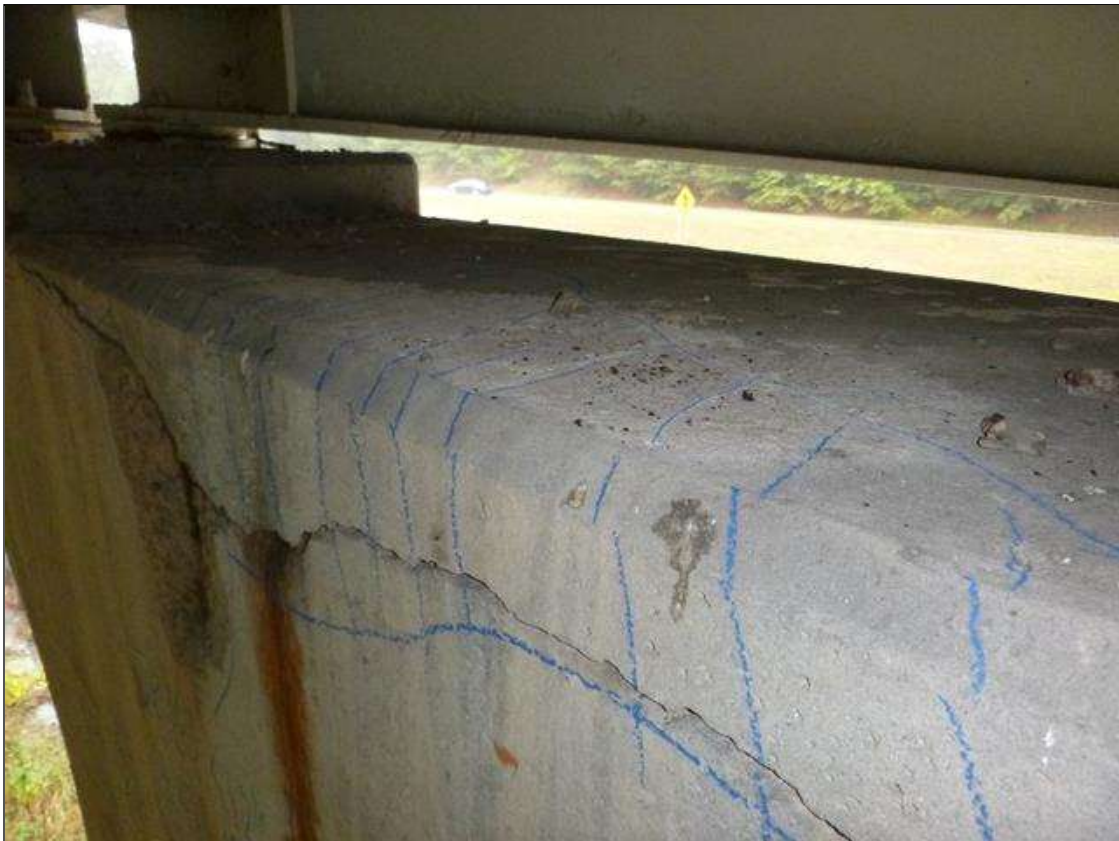
Bent 3 Cap 1: BENT 3 CAP, SPAN 4 SIDE HAS AN AREA OF DELAMINATION 6 FT. LONG X 8 IN. DOWN THE FACE X 2 FT. ACROSS THE TOP IN BAY 3

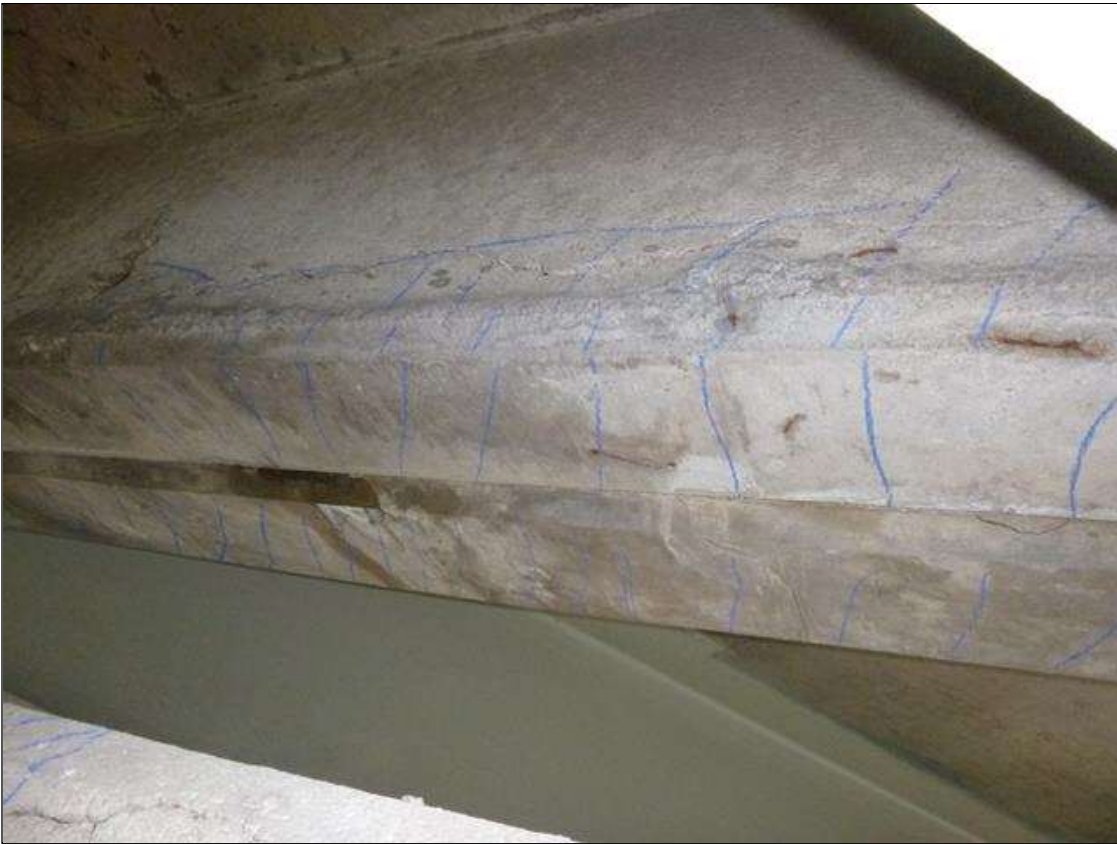
SPAN 4, BENT 3, BAY 2, BENT DIAPHRAGM HAS DELAMINATION ON THE BOTTOM, FULL WIDTH X 6 IN. HIGH X 6 FT. LONG

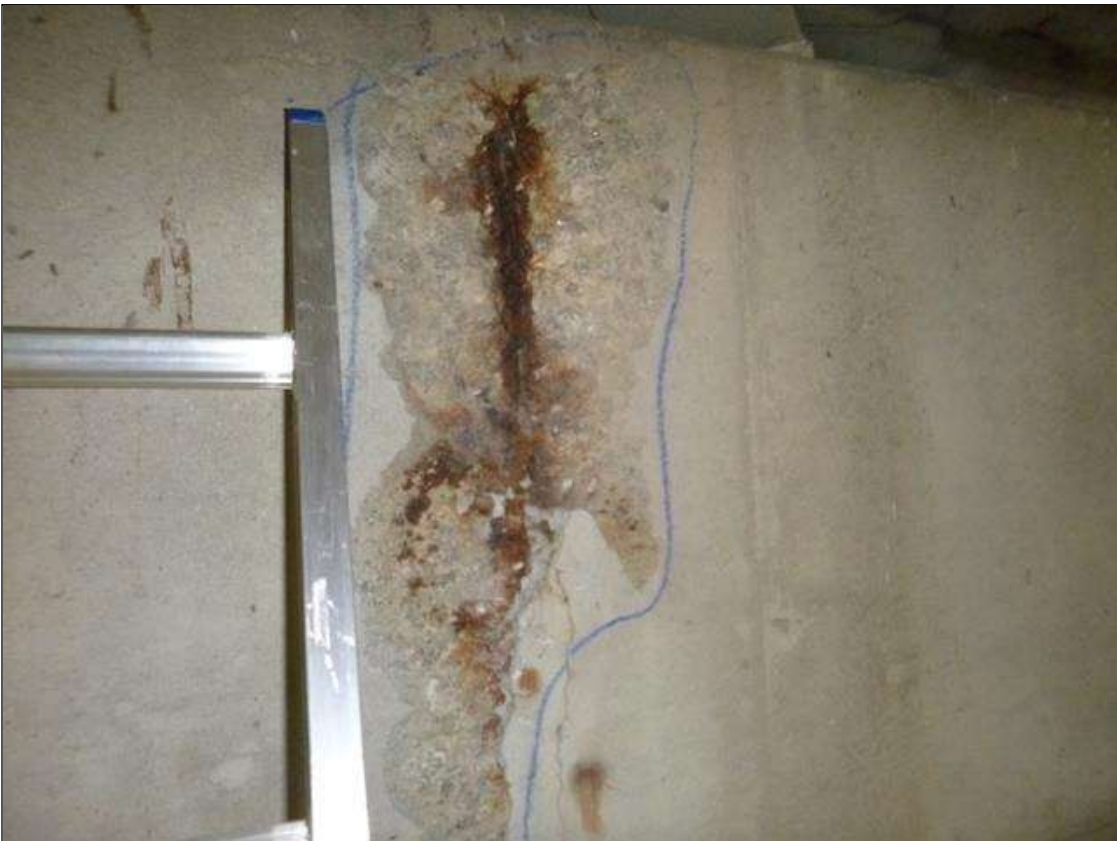
Bent 3 Cap 1: BENT 3 CAP, SPAN 4 SIDE HAS A SPALL ON THE FACE OF THE CAP UNDER BEAM 2, 12 IN. WIDE X 28 IN. HIGH X 1 IN. DEEP, WITH REBAR EXPOSED

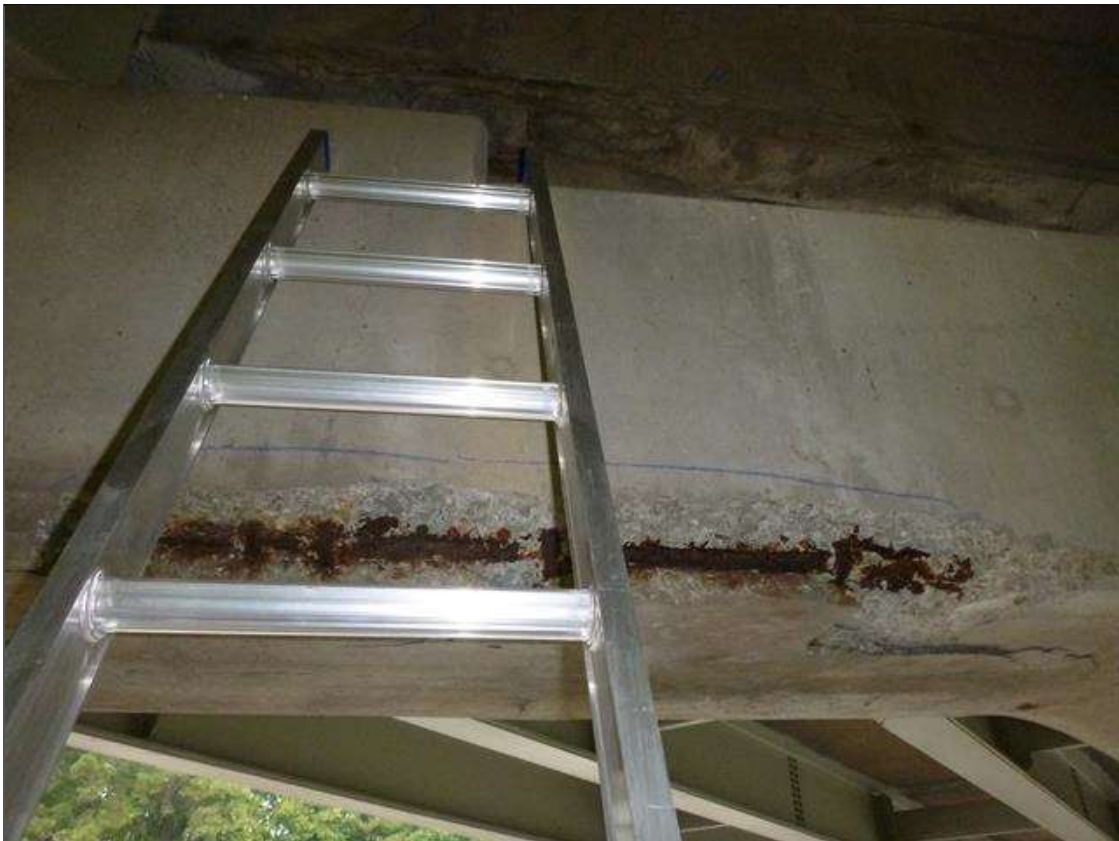
Bent 3 Cap 1: BENT 3 CAP, SPAN 4 SIDE HAS A SPALL ON THE BOTTOM CORNER, BETWEEN PILES 1 AND 2, 5 IN. HIGH ON THE FACE AND 12 IN. ACROSS THE BOTTOM, X 2 IN. DEEP WITH REBAR EXPOSED

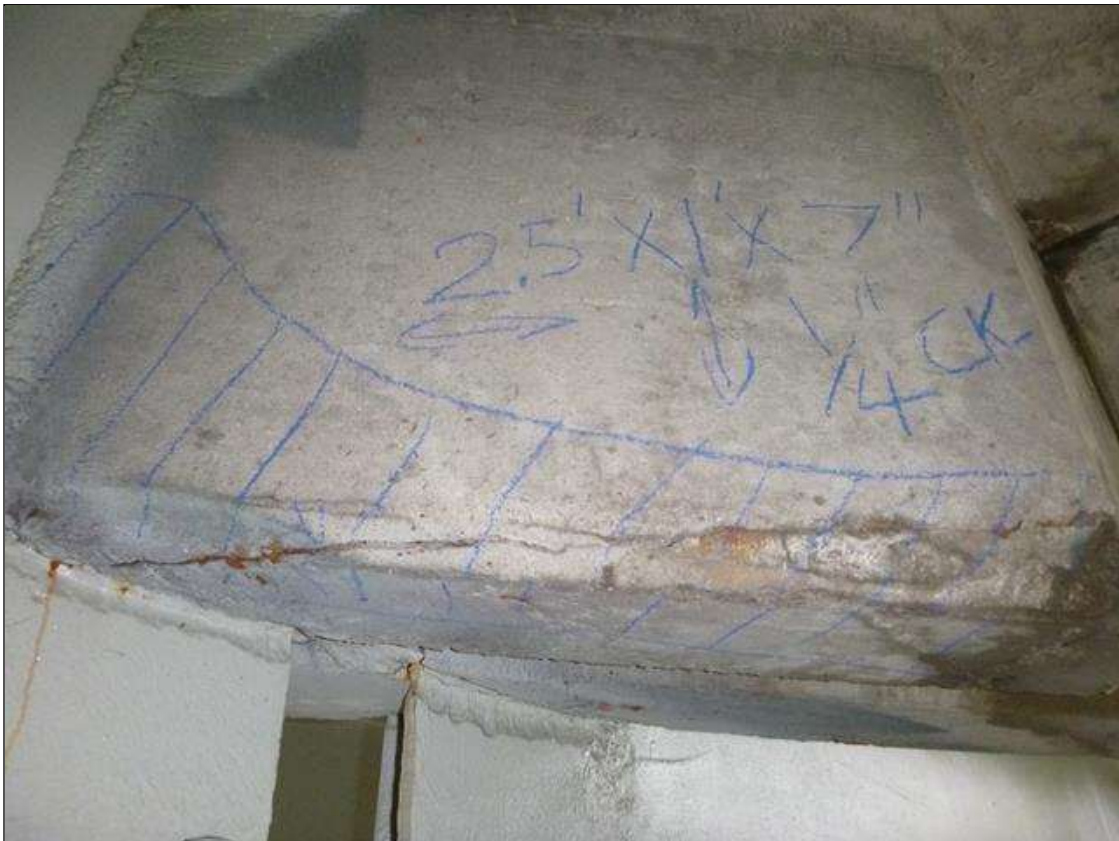
SPAN 4, BENT 3, BENT DIAPHRAGM IN THE LEFT OVERHANG HAS AREA OF DELAMINATION, 2 FT. LONG X 1 FT. HIGH X 6 IN. DEEP ACROSS THE BOTTOM, WITH 1/4 IN. WIDE CRACKING

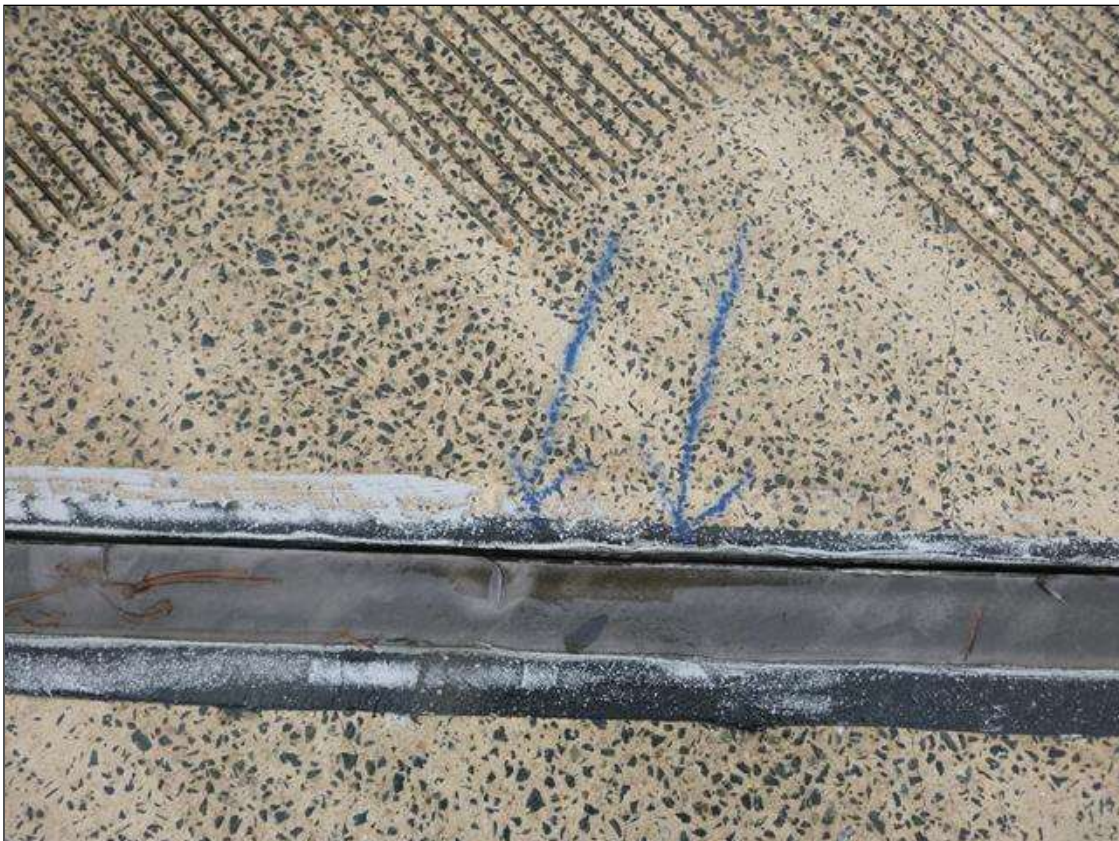
| Element Number | Defect Type | Defect Description | CS | CS Qty | Maint Qty |
|---|---|---|---|---|---|
| 301 | Seal Adhesion | BENT 2 EXPANSION JOINT SEPARATED FROM EACH SIDE OF THE DECK AND LEAKING | 3 | 40 | 40 Feet |

Expansion Joint : BENT 2 EXPANSION JOINT SEPARATED FROM EACH SIDE OF THE DECK AND LEAKING

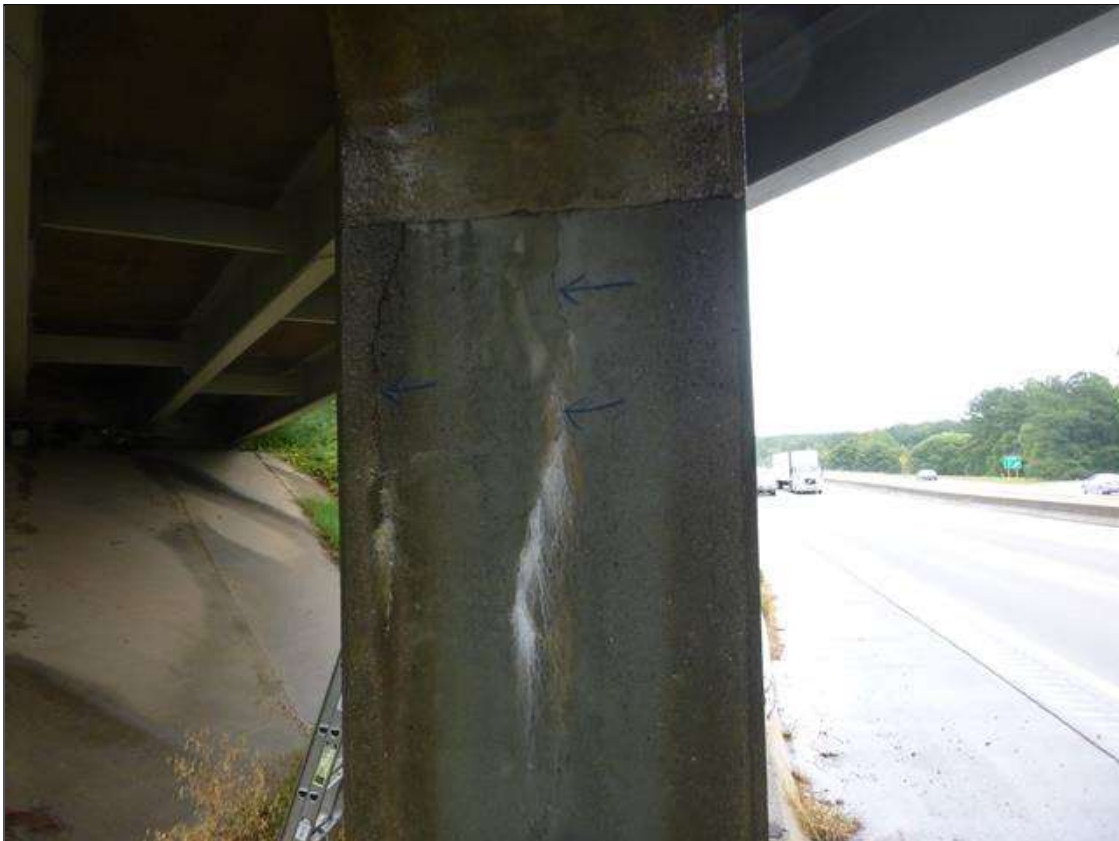
Bent 1 Pile 2: 2-VERTICAL CRACKS, 1/8 IN. WIDE X 3 FT. LONG ON SOUTH FACE OF COLUMN WITH EFFLO., 2 ON THE EAST FACE WITH EFFLO. AND 2 ON NORTH FACE.

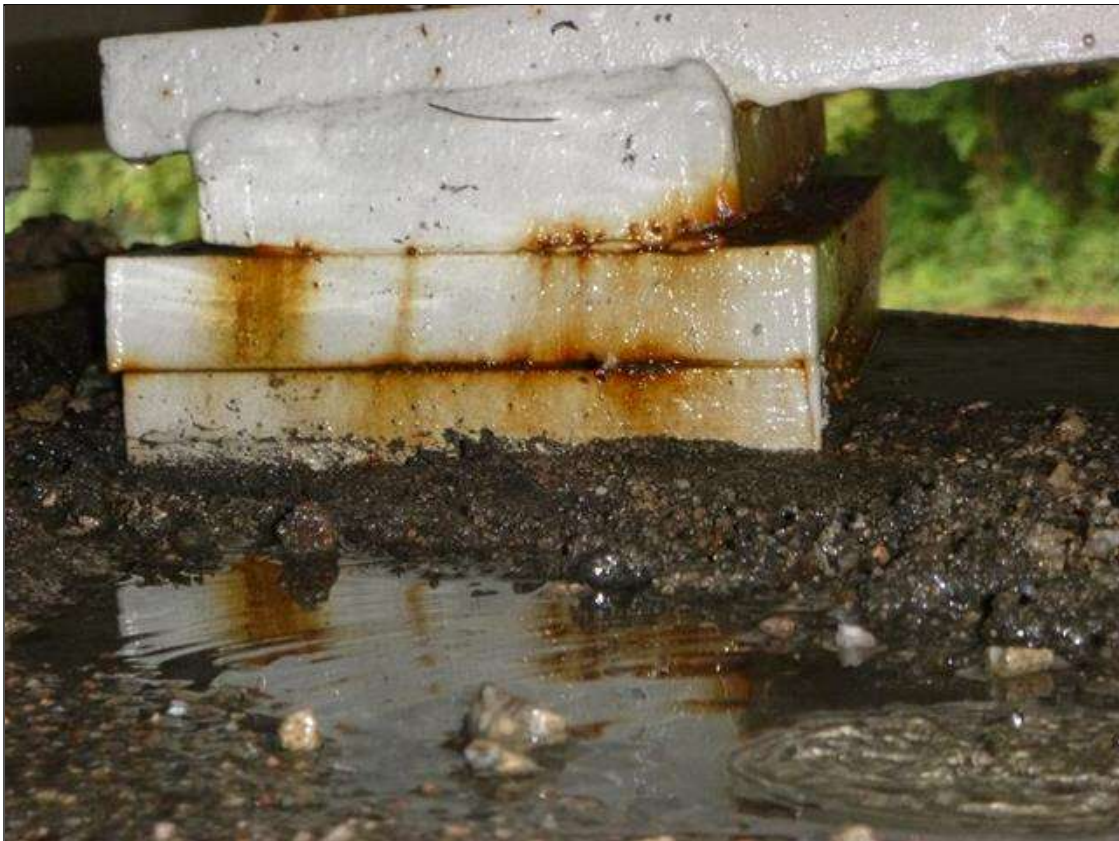
FRECKLED RUST ON BEARINGS AT BENT 1, BEAM 2

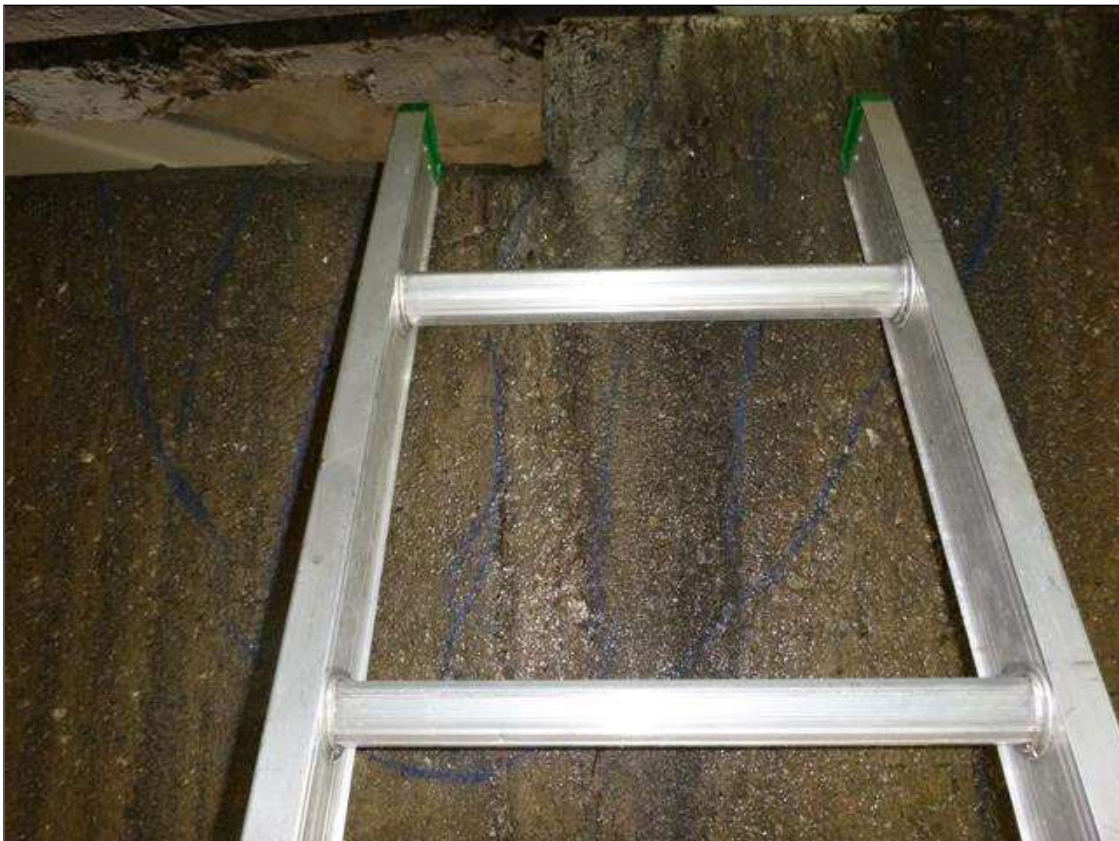
Bent 1 Cap 1: DELAMINATION 30 IN. LONG X 2 FT. HIGH WITH 1/16 IN. WIDE MAP CRACKING ON SPAN 1 FACE UNDER BEAM 3.

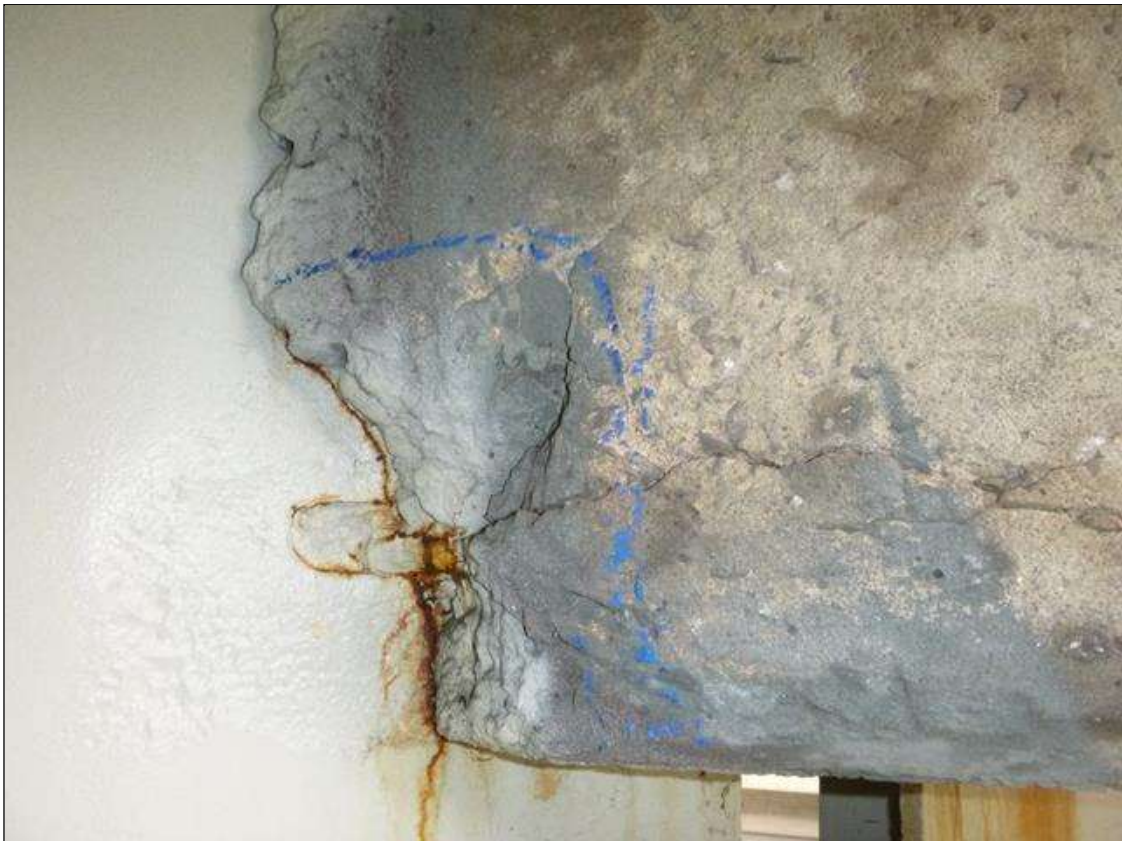
SPAN 1 BENT 1 RIGHT OVERHANG DIAPHRAGM, SPALL, 8 IN. HIGH X 10 IN. WIDE X 2 IN. DEEP WITH EXPOSED REBAR

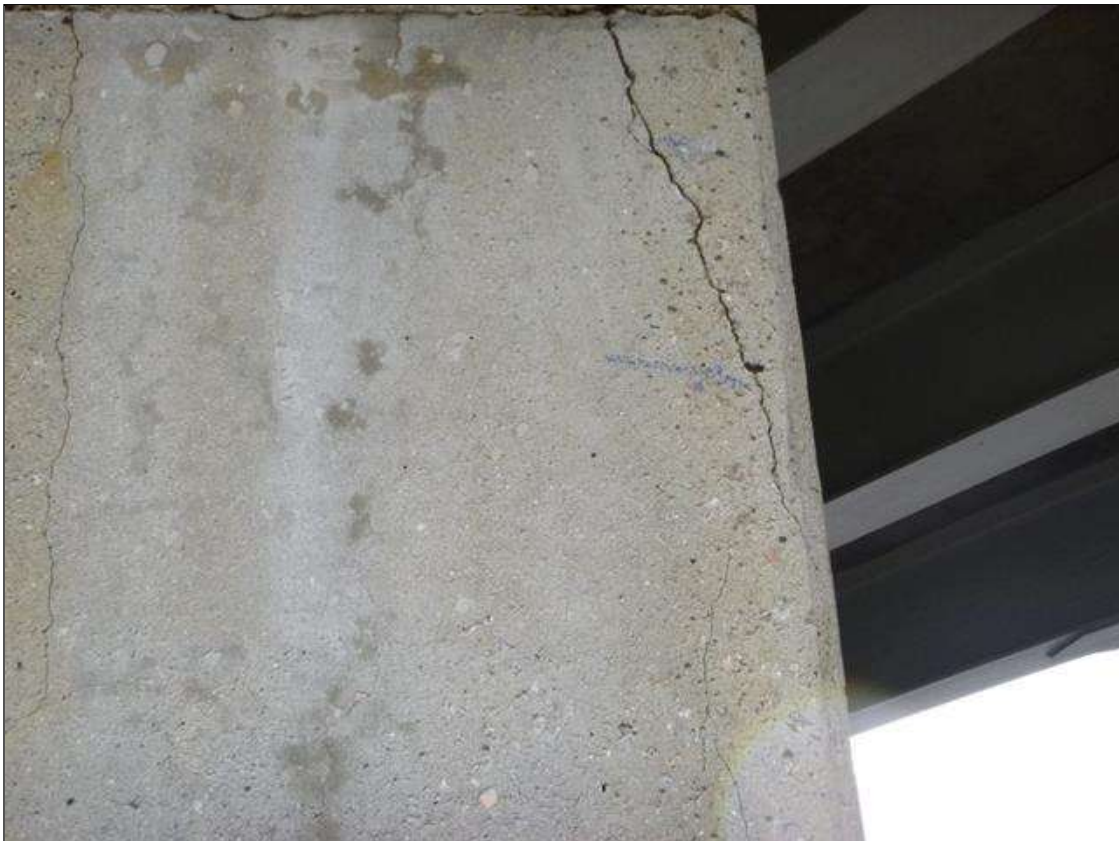
Bent 1 Pile 3: 6 VERTICAL CRACKS UP TO 1/8 IN. WIDE X 3' LONG, 4 ON SOUTH FACE, 1 EAST FACE AND 1 ON THE NORTH FACE.

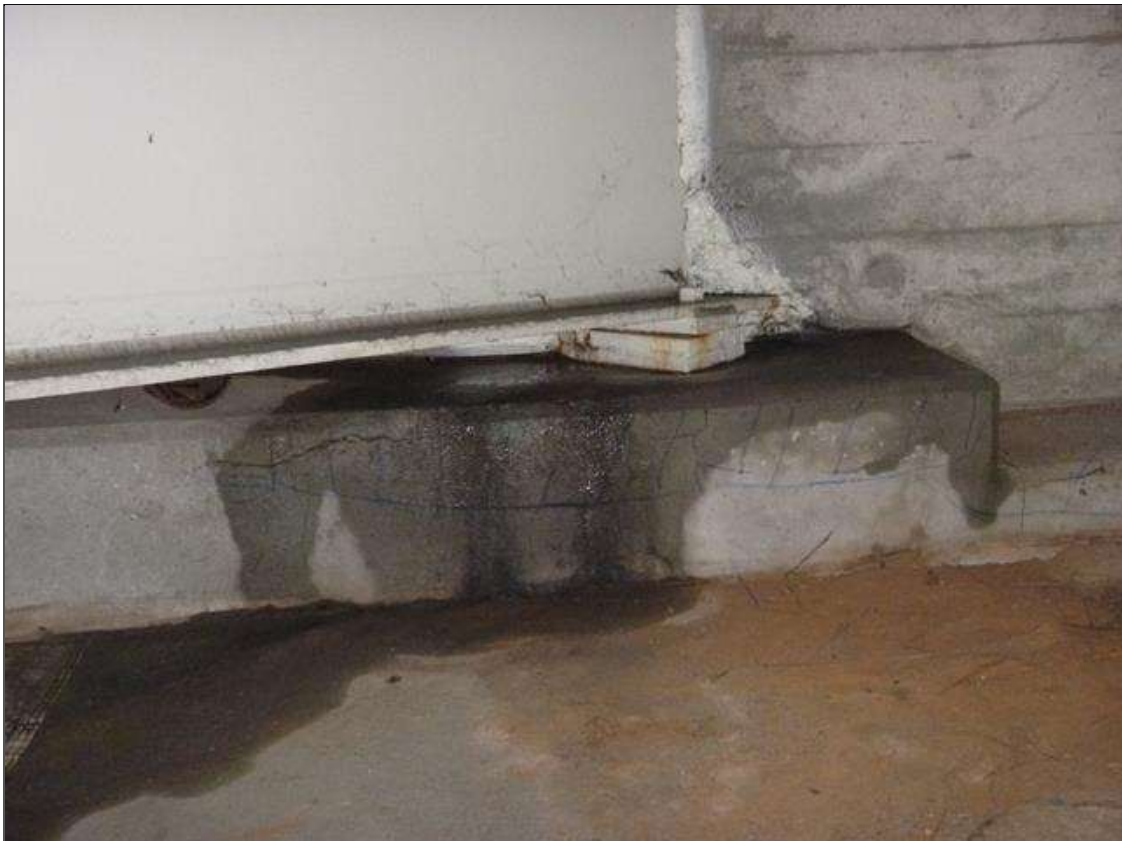
End Bent 1 Cap 1: DELAMINATION UNDER BEAM 2, 5 FT. LONG X 8 IN. HIGH X 4 IN. ON TOP, WITH ADJACENT 1/4 IN. CRACK ALONG THE LENGTH.

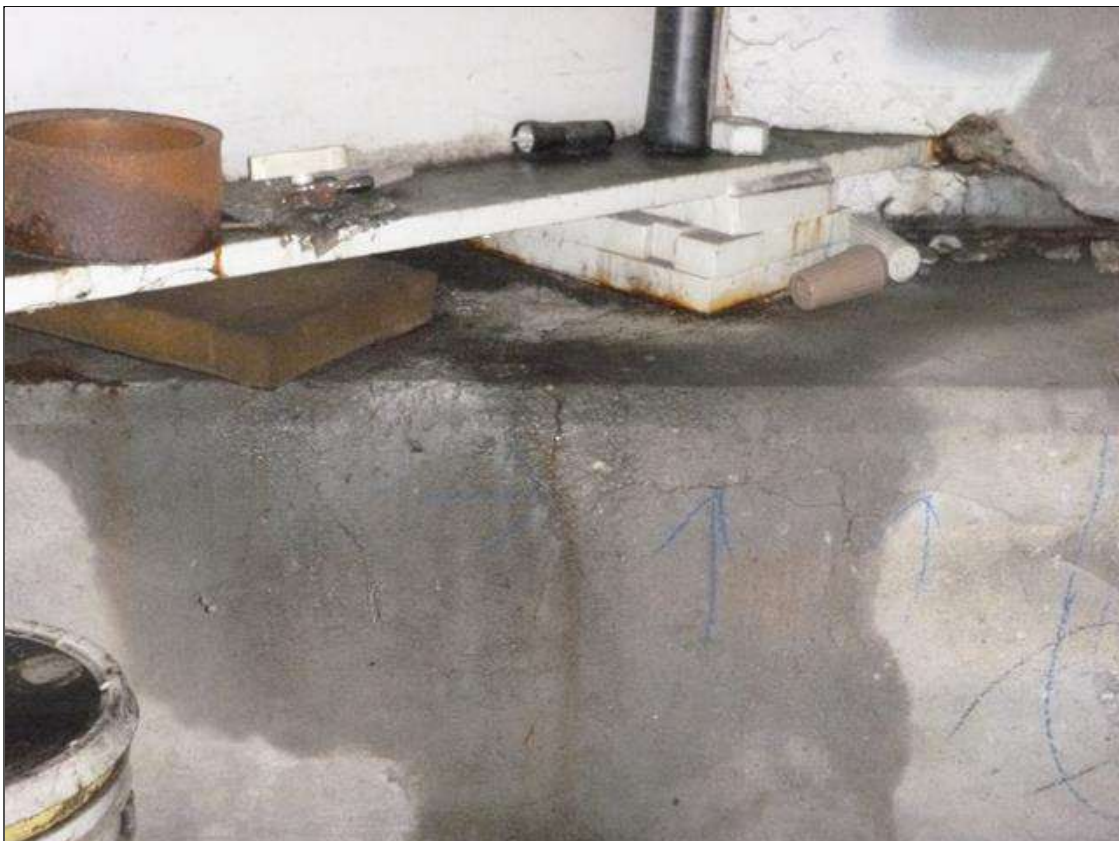
End Bent 1 Cap 1: MAP CRACKING ON FACE OF CAP NEAR TOP EDGE ADJACENT TO BEAM 3

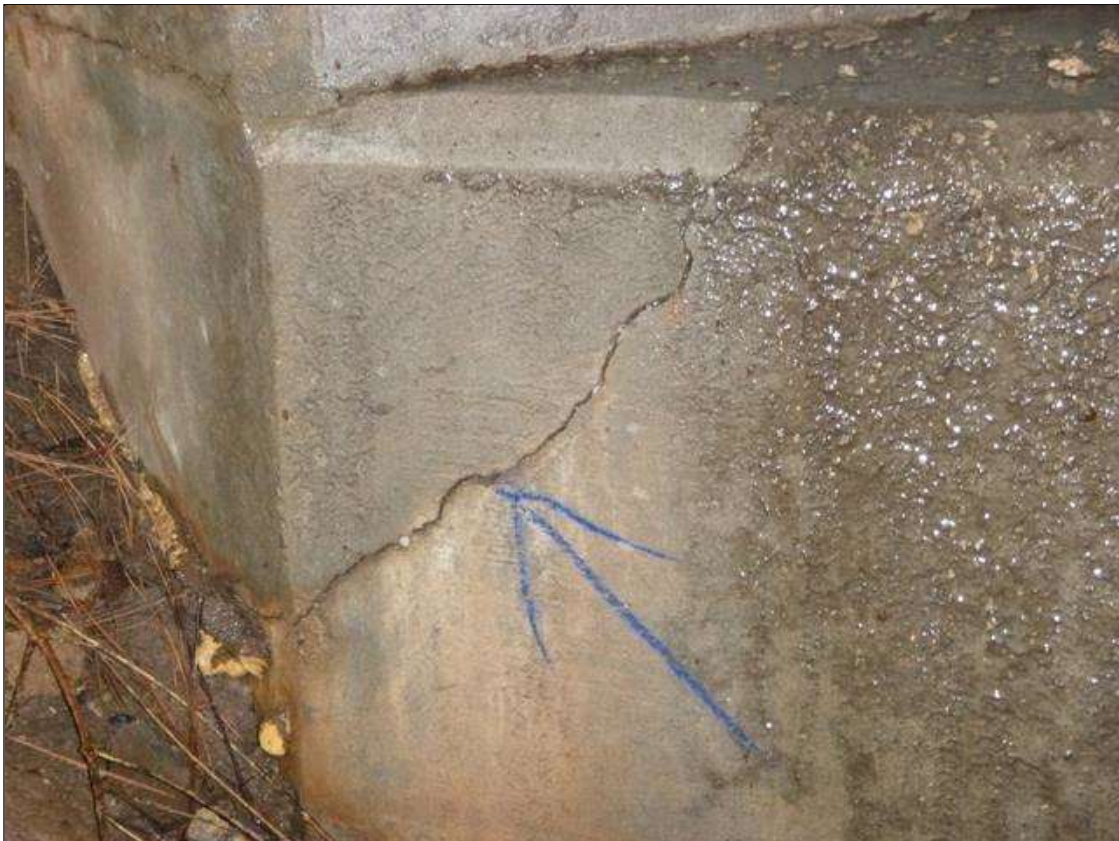
End Bent 1 Cap 1: DIAGONAL CRACK, 1/16 IN. WIDE X 12 IN. LONG ON FACE OF CAP NEAR BEAM 4

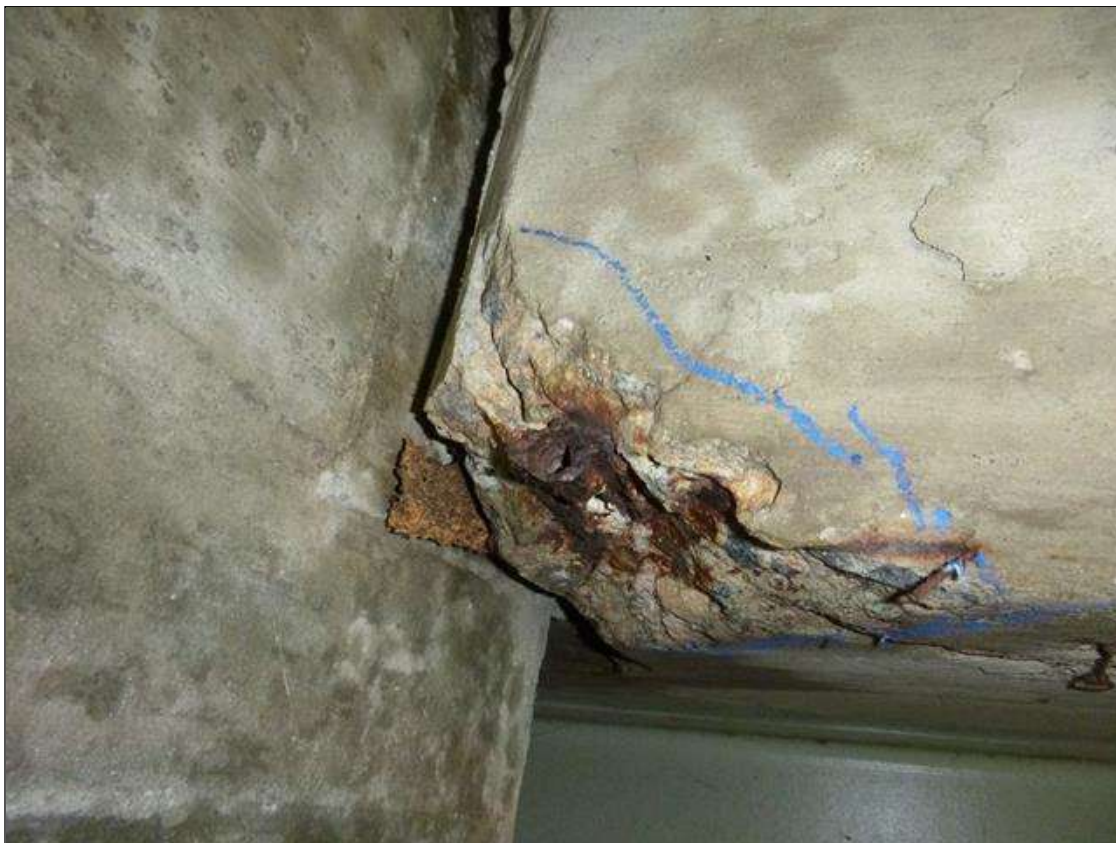
Span 1 Deck: SPALL 6 IN. X 8 IN. X 3 IN. DEEP AT END BENT 1 SOUTHWEST BACKWALL.
